FACILITY CONDITION ASSESSMENT

Richmond Public Schools
301 North Ninth Street
Richmond, VA 23219

Richmond Technical Center South
2020 Westwood Avenue
Richmond, VA 23230

May 9, 2024

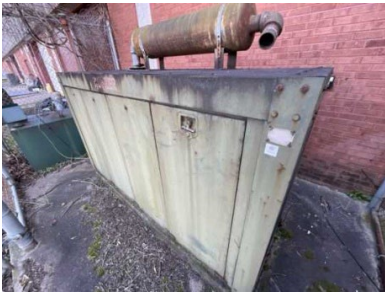
Generator in Poor condition.

Unit is aged well past its EUL and severely corroded. - AssetCALC ID: 7467922

Uniformat Code: D5010
Recommendation: **Replace in 2024**

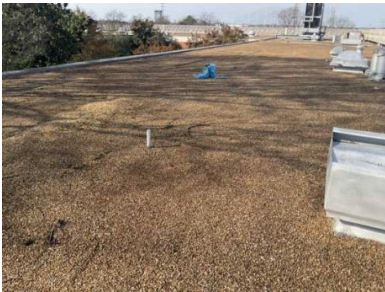
Roofing in Poor condition.

Leaks observed throughout - AssetCALC ID: 7467886

Uniformat Code: B3010
Recommendation: **Replace in 2025**

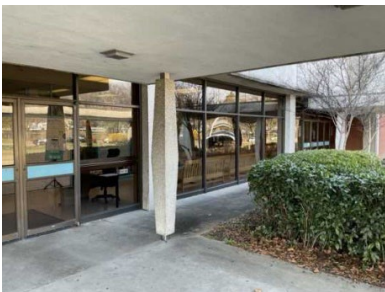
Storefront in Poor condition.

Windows reported to be problematic and leaking throughout - AssetCALC ID: 7467947

Uniformat Code: B2020
Recommendation: **Replace in 2025**

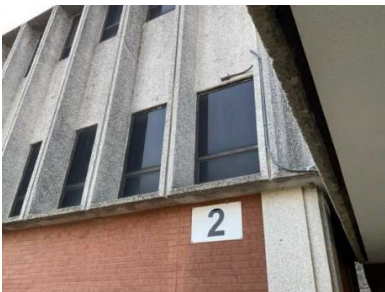
Window in Poor condition.

Windows reported to be problematic and leaking throughout - AssetCALC ID: 7467960

Uniformat Code: B2020
Recommendation: **Replace in 2025**

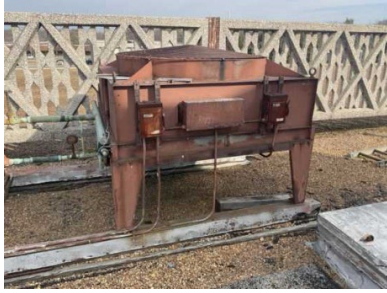
Cooling Tower in Poor condition.

Severe rust deterioration and likely no longer functioning. - AssetCALC ID: 7467929

Uniformat Code: D3030
Recommendation: **Replace in 2024**

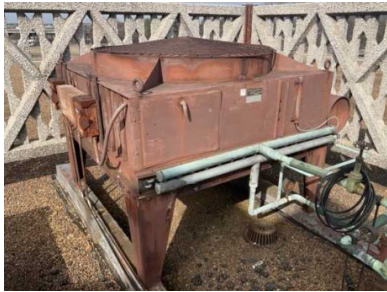
Cooling Tower in Poor condition.

Severe rust deterioration and likely no longer functioning. - AssetCALC ID: 7467855

Uniformat Code: D3030
Recommendation: **Replace in 2024**

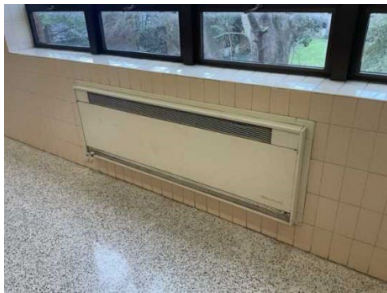
HVAC System in Poor condition.

Leaks reported throughout - AssetCALC ID: 7467863

Uniformat Code: D3050
Recommendation: **Replace in 2024**

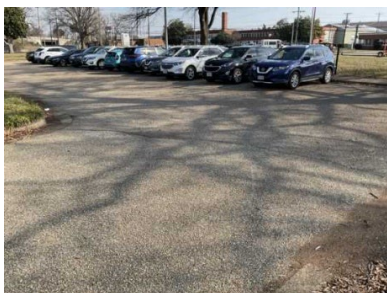
Parking Lots in Poor condition.

Major potholes, parking lot holds water, drainage system not efficient - AssetCALC ID: 7467850

Uniformat Code: G2020
Recommendation: **Mill & Overlay in 2025**

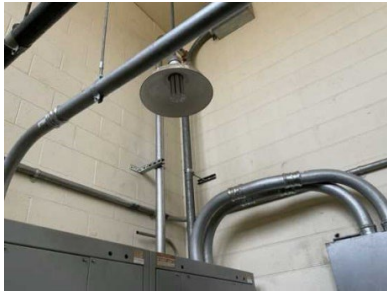
Electrical System in Poor condition.

Electrical was reported to be undersized and aged - AssetCALC ID: 7467839

Uniformat Code: D5030
Recommendation: **Replace in 2025**

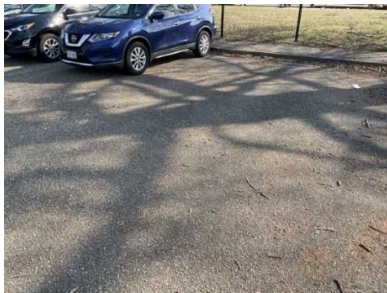
Parking Lots in Poor condition.

Paint is completely faded away throughout - AssetCALC ID: 7468001

Uniformat Code: G2020
Recommendation: **Seal & Stripe in 2025**

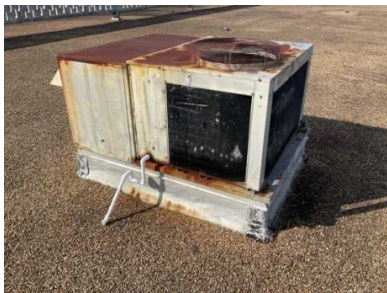
Packaged Unit in Poor condition.

Unit well exceeds its EUL and is severely rust corroded. - AssetCALC ID: 7467941

Uniformat Code: D3050
Recommendation: **Replace in 2024**

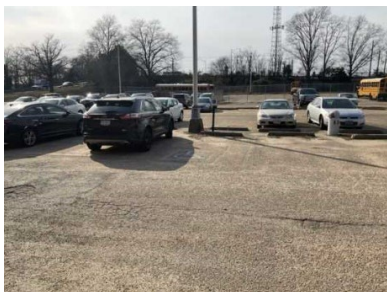
Recommended Follow-up Study: Civil, Site Drainage

It was reported that the parking lot holds water and the drainage system is not efficient. - AssetCALC ID: 7467861

Uniformat Code: P2030
Recommendation: **Evaluate/Report in 2024**

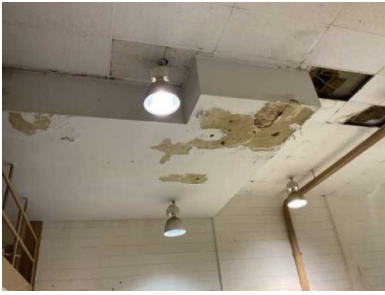
Ceiling Finishes in Poor condition.

Paint is significantly deteriorated and peeling. - AssetCALC ID: 7469324

Uniformat Code: C2050
Recommendation: **Prep & Paint in 2024**

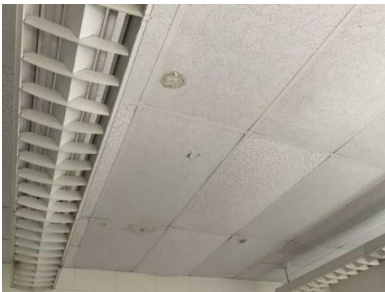
Suspended Ceilings in Poor condition.

Ceiling tiles are stained and missing in areas - AssetCALC ID: 7467857

Uniformat Code: C1070
Recommendation: **Replace in 2025**

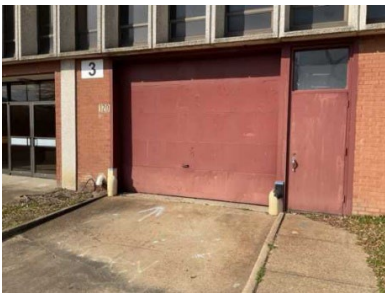
Overhead/Dock Door in Poor condition.

Exterior door hardware and frames are problematic - AssetCALC ID: 7467926

Uniformat Code: B2050
Recommendation: **Replace in 2025**

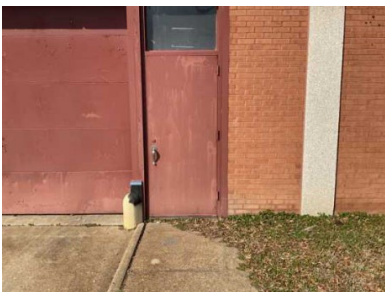
Exterior Door in Poor condition.

Exterior doors, hardware and frames are problematic and corroded. - AssetCALC ID: 7467918

Uniformat Code: B2050
Recommendation: **Replace in 2025**
