# FACILITY CONDITION ASSESSMENT

**Richmond Public Schools**  
301 North Ninth Street  
Richmond, VA 23219

Norrell Elementary School (Closed)  
2120 Fendall Avenue  
Richmond, VA 23230

*April 11, 2024*

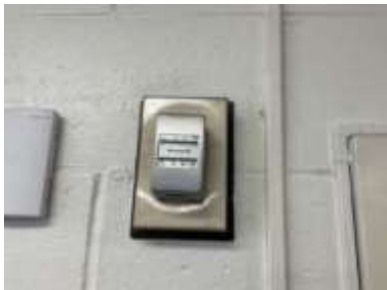
**BAS/HVAC Controls in Poor condition.**

Basic System or Legacy Upgrades  
Main Building Norrell Elementary School  
(Closed) Throughout building

Building is very hot on north end and cold on south end. Occupants complained about both summer and winter HVAC controls. Reported in PSQ that the BAS system does not maintain heating or cooling very well, system is a combination of air controls and more modern electronic controls. - AssetCALC ID: 7386966

Uniformat Code: D8010  
Recommendation: **Upgrade/Install in 2025**

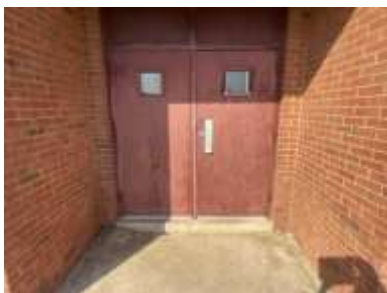
**Exterior Door in Poor condition.**

Wood, Solid-Core  
Main Building Norrell Elementary School  
(Closed) Building Exterior

Exterior door wood is checked and cracked - AssetCALC ID: 7386965

Uniformat Code: B2050  
Recommendation: **Replace in 2025**
