FACILITY CONDITION ASSESSMENT

Richmond Public Schools
301 North Ninth Street
Richmond, VA 23219

Norrell Elementary School (Closed)
2120 Fendall Avenue
Richmond, VA 23230

April 11, 2024

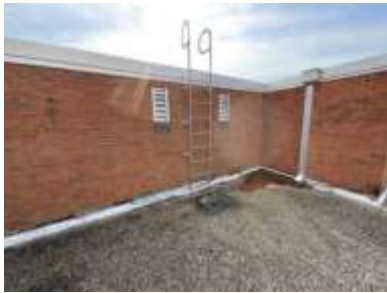
Roof Appurtenances in Poor condition.

Roof Access Ladder, Steel
Main Building Norrell Elementary School
(Closed) Roof

Ladders are poorly attached to exterior brick wall and are loose. - AssetCALC ID: 7386925

Uniformat Code: B3020
Recommendation: **Replace in 2025**

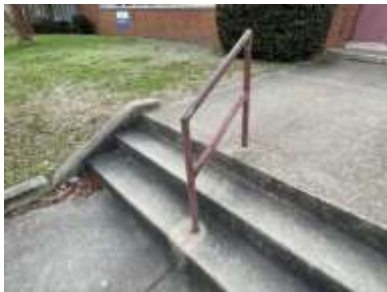
Site Stairs & Ramps in Poor condition.

Handrails, Metal
Site Norrell Elementary School (Closed) Site

Handrails are rusted and detached at base - AssetCALC ID: 7386958

Uniformat Code: G2030
Recommendation: **Install in 2024**

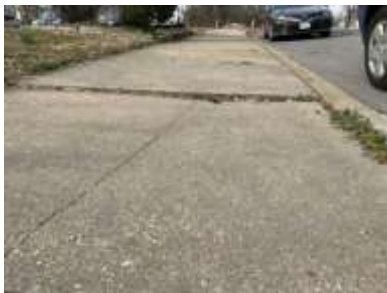
Sidewalk in Poor condition.

Concrete, Large Areas
Site Norrell Elementary School (Closed) Site

Concrete sidewalks are cracked, heaved and sunken, some areas have been patched with asphalt. Others are gravel. - AssetCALC ID: 7387015

Uniformat Code: G2030
Recommendation: **Replace in 2025**

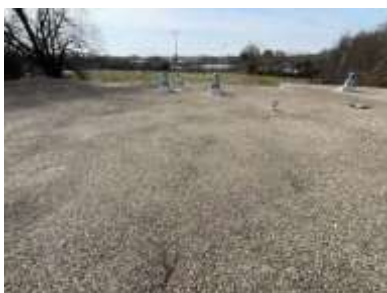
Roofing in Poor condition.

Built-Up
Main Building Norrell Elementary School
(Closed) Roof

Reported in PSQ that the roof leaks, evidence of roof leakage throughout building. - AssetCALC ID: 7387024

Uniformat Code: B3010
Recommendation: **Replace in 2025**

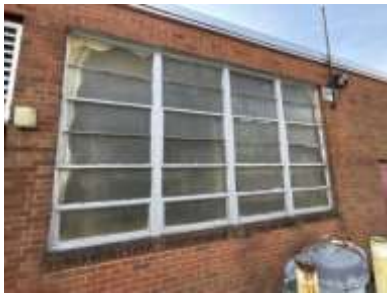
Glazing in Poor condition.

any type by SF
Main Building Norrell Elementary School
(Closed) Building Exterior

Original single pane, aluminum windows, have lots of built-up corrosion and loose leaking panes. -
AssetCALC ID: 7386928

Uniformat Code: B2020
Recommendation: **Replace in 2024**

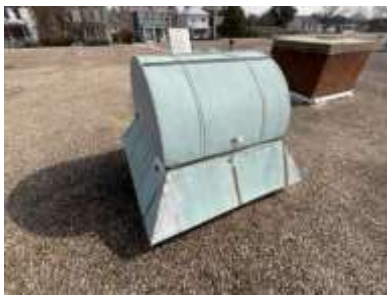
Exhaust Fan in Poor condition.

Roof or Wall-Mounted, 36"Damper
Main Building Norrell Elementary School
(Closed) Roof

Exhaust fan is very dated and does not appear to be operational - AssetCALC ID: 7386970

Uniformat Code: D3060
Recommendation: **Replace in 2025**

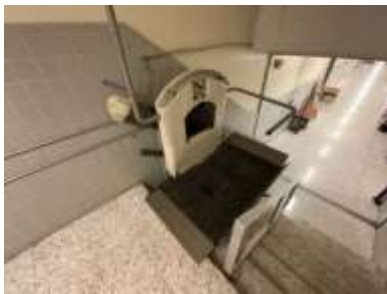
Vertical Lift in Poor condition.

Wheelchair, 5' Rise
Main Building Norrell Elementary School
(Closed) Hallway

Unreliable, with frequent service calls. - AssetCALC ID: 7386967

Uniformat Code: D1010
Recommendation: **Renovate in 2025**

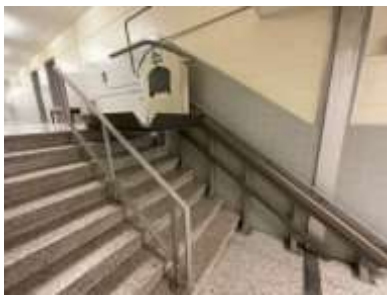
Vertical Lift in Poor condition.

Wheelchair, 5' Rise
Main Building Norrell Elementary School
(Closed) Hallway

Unreliable, with frequent service calls. - AssetCALC ID: 7386961

Uniformat Code: D1010
Recommendation: **Renovate in 2025**

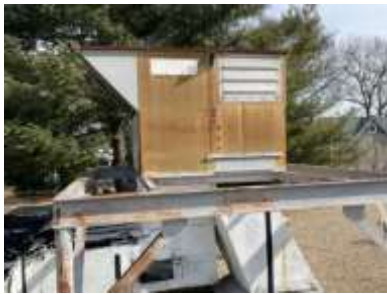
Air Handler in Poor condition.

Exterior AHU, 1201 to 2400 CFM
Main Building Norrell Elementary School
(Closed) Roof

Estimated size unit does not appear to have operated in quite a long time - AssetCALC ID: 7387017

Uniformat Code: D3050
Recommendation: **Replace in 2025**

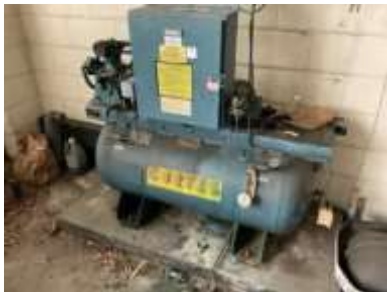
Air Compressor in Poor condition.

Tank-Style
Main Building Norrell Elementary School
(Closed) Boiler room

compressor is missing, unit is very dated - AssetCALC ID: 7386962

Uniformat Code: D2060
Recommendation: **Replace in 2025**

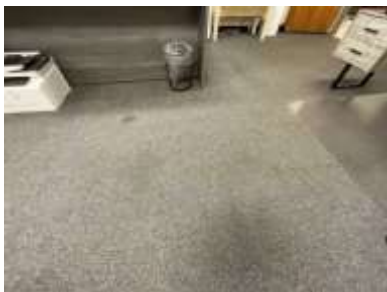
Flooring in Poor condition.

Carpet, Commercial Standard
Main Building Norrell Elementary School
(Closed) Main roof

Stained and worn - AssetCALC ID: 7386989

Uniformat Code: C2030
Recommendation: **Replace in 2025**

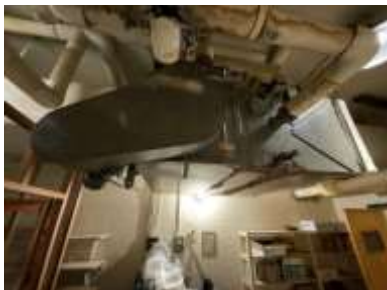
Air Handler in Poor condition.

Interior AHU, Easy/Moderate Access
Main Building Norrell Elementary School
(Closed) Gymnasium

Not currently operational, estimated size - AssetCALC ID: 7386952

Uniformat Code: D3050
Recommendation: **Replace in 2025**

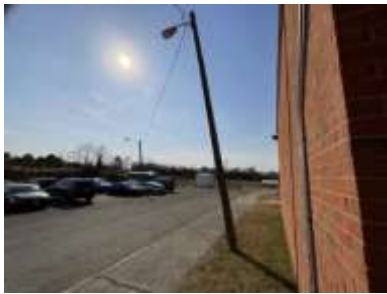
Pole Light Fixture w/ Lamps in Poor condition.

any type 30' High, w/ LED Replacement
Site Norrell Elementary School (Closed) Site

Both poles lean severely - AssetCALC ID: 7386941

Uniformat Code: G4050
Recommendation: **Replace/Install in 2025**

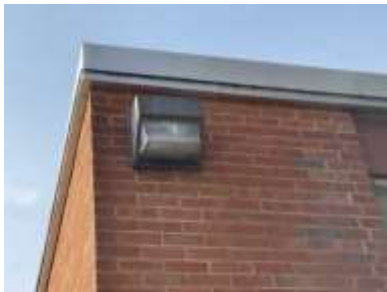
Exterior Fixture w/ Lamp in Poor condition.

any type, w/ LED Replacement
Main Building Norrell Elementary School
(Closed) Building Exterior

Lots of broken exterior fixtures, and reported on PSQ that exterior lighting was insufficient. - AssetCALC ID: 7386988

Uniformat Code: G4050
Recommendation: **Replace in 2025**

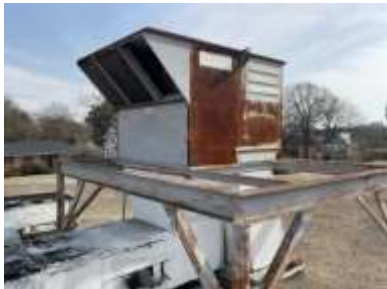
Air Handler in Poor condition.

Exterior AHU, 1201 to 2400 CFM
Main Building Norrell Elementary School
(Closed) Roof

Estimated size unit does not appear to have operated in quite a long time - AssetCALC ID: 7386948

Uniformat Code: D3050
Recommendation: **Replace in 2025**

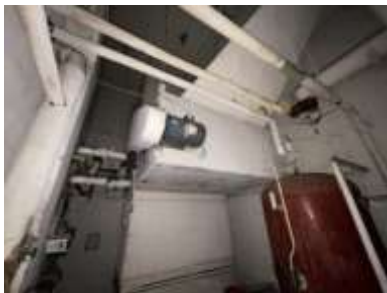
Air Handler in Poor condition.

Interior AHU, Easy/Moderate Access
Main Building Norrell Elementary School
(Closed) Gymnasium

Not currently operational, estimated size - AssetCALC ID: 7386931

Uniformat Code: D3050
Recommendation: **Replace in 2025**

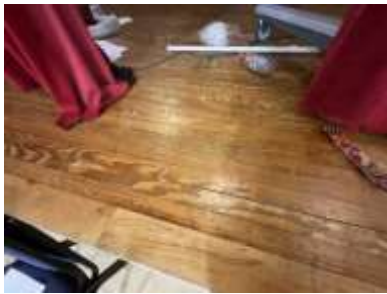
Flooring in Poor condition.

Wood, Strip
Main Building Norrell Elementary School
(Closed) Gymnasium

Finishes worn - AssetCALC ID: 7386985

Uniformat Code: C2030
Recommendation: **Refinish in 2025**

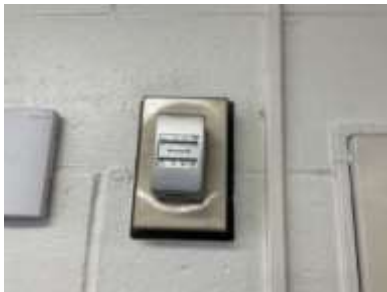
BAS/HVAC Controls in Poor condition.

Basic System or Legacy Upgrades
Main Building Norrell Elementary School
(Closed) Throughout building

Building is very hot on north end and cold on south end. Occupants complained about both summer and winter HVAC controls. Reported in PSQ that the BAS system does not maintain heating or cooling very well, system is a combination of air controls and more modern electronic controls. - AssetCALC ID: 7386966

Uniformat Code: D8010
Recommendation: **Upgrade/Install in 2025**

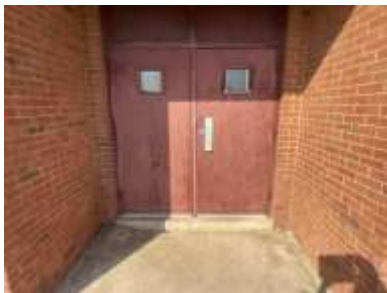
Exterior Door in Poor condition.

Wood, Solid-Core
Main Building Norrell Elementary School
(Closed) Building Exterior

Exterior door wood is checked and cracked - AssetCALC ID: 7386965

Uniformat Code: B2050
Recommendation: **Replace in 2025**

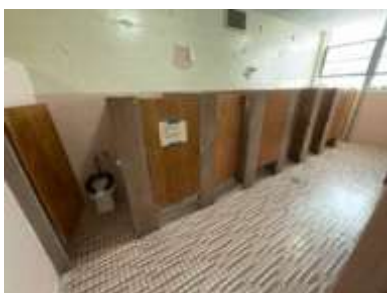
Toilet Partitions in Poor condition.

Marble
Main Building Norrell Elementary School
(Closed) Restrooms

Doors have been broken off many times - AssetCALC ID: 7387018

Uniformat Code: C1090
Recommendation: **Replace in 2025**

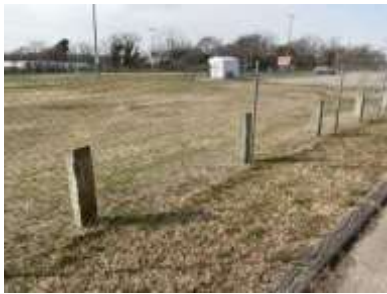
Fences & Gates in Poor condition.

Fence, Chain Link 6'
Site Norrell Elementary School (Closed) Site

Site fencing has lots of holes and down fencing - AssetCALC ID: 7386976

Uniformat Code: G2060
Recommendation: **Replace in 2025**

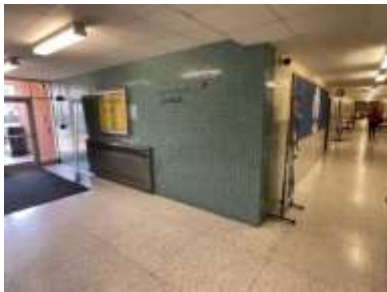
Wall Finishes in Poor condition.

any surface
Main Building Norrell Elementary School
(Closed) Throughout building

Peeling paint - AssetCALC ID: 7386971

Uniformat Code: C2010
Recommendation: **Prep & Paint in 2025**

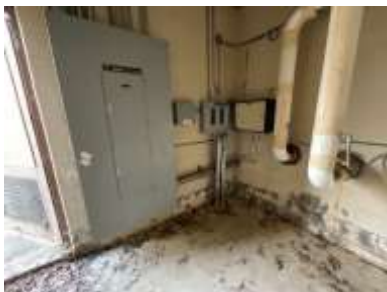
**Recommended Follow-up Study:
Environmental, Mold**

Environmental, Mold
Main Building Norrell Elementary School
(Closed) Throughout

Additional Studies	The interior ceiling and walls are in poor condition. Suspected mold on the interior walls and ceiling. A professional engineer, architect, or consultant must be retained to analyze the existing condition, provide recommendations and, if necessary, estimate the scope and cost of any required repairs. Due to the ambiguity of the required repair scope at the time of this assessment, the cost for any possible subsequent repairs is not included.	
Areas Observed	The interior spaces were observed to gain a clear understanding of the facility's overall condition. Other areas accessed and assessed included the exterior equipment and assets directly serving the buildings, the exterior walls of the facility, and the roofs.	
Key Spaces Not Observed	All key areas of the facility were accessible and observed.

Uniformat Code: P2030
Recommendation: **Evaluate/Report in 2024**
