# FACILITY CONDITION ASSESSMENT

**Richmond Public Schools**  
301 North Ninth Street  
Richmond, VA 23219

Swansboro Elementary School  
3160 Midlothian Turnpike  
Richmond, VA 23224

*May 12, 2024*

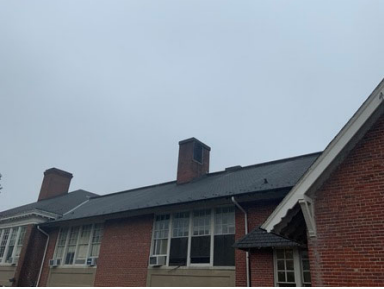
Most of the roof consists of asphalt shingles which need to be replaced all at one time instead of having sections of roof patched up when leaks happen. The flat built-up portion of the roof is uneven and has water pooling throughout.

**Roofing in Poor condition.** Priority Score: **89.8**

Asphalt Shingle, 30-Year Premium  
Main Building Swansboro Elementary School  
Roof

Shingles missing and patch work looks old - AssetCALC ID: 7500215

Uniformat Code: B3010  
Recommendation: **Replace in 2025**

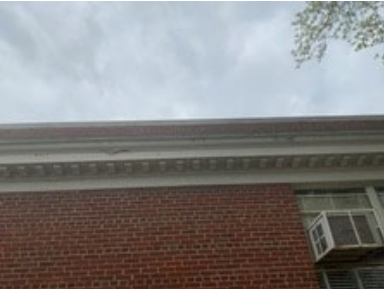
All the windows are made of wood and have never been replaced since construction date. The wood is deteriorating and has layers of paint peeling off. The molding around the exterior of the building has peeling paint that needs to be repaired.

**Exterior Walls in Poor condition.** Priority Score: **89.7**

any painted surface, 1-2 Story Building  
Main Building Swansboro Elementary School  
Building Exterior

Peeling paint on exterior molding and columns - AssetCALC ID: 7500216

Uniformat Code: B2010  
Recommendation: **Prep & Paint in 2025**

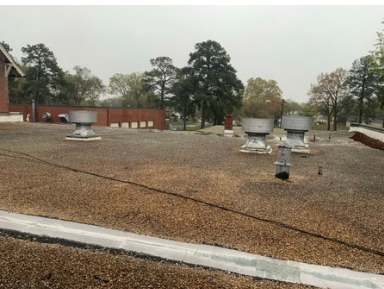
**Roofing in Poor condition.** Priority Score: **88.8**

Built-Up  
Main Building Swansboro Elementary School  
Roof

Uneven and has areas of pooling - AssetCALC ID: 7500301

Uniformat Code: B3010  
Recommendation: **Replace in 2025**

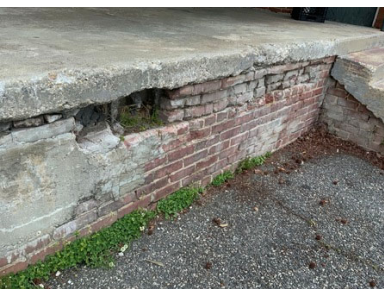
**Exterior Walls in Poor condition.** Priority Score: **88.8**

Brick  
Main Building Swansboro Elementary School  
Building Exterior

Bricks are missing and deteriorating. Some bricks are worn out from roof gutters not being connected properly.  
- AssetCALC ID: 7500285

Uniformat Code: B2010  
Recommendation: **Replace in 2025**

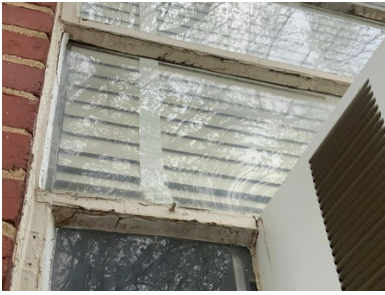
**Window in Poor condition.**

Wood, 28-40 SF  
Main Building Swansboro Elementary School  
Building Exterior

Peeling paint, old, and some windows have broken glass - AssetCALC ID: 7500246

Uniformat Code: B2020  
Recommendation: **Replace in 2025**

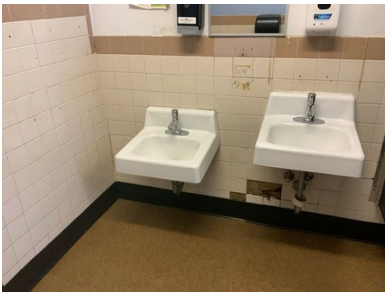
The ceramic tiles in the restrooms are outdated, and tiles are missing or damaged. The flooring in the hallway on the second floor is stained and needs a layer of paint. The wood flooring on the second floor is stained and scarred, and needs to be refinished.

**Wall Finishes in Poor condition.**

Ceramic Tile  
Main Building Swansboro Elementary School  
Restrooms

Some broken off areas of tile and very old - AssetCALC ID: 7500183

Uniformat Code: C2010  
Recommendation: **Replace in 2026**

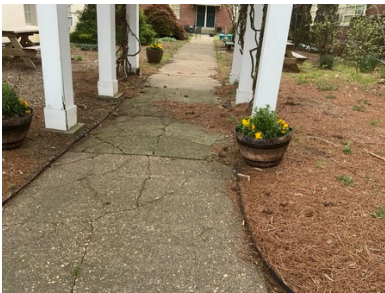
The concrete sidewalks at the front of the building have some cracks and upheaving from the surrounding trees, which can cause a trip hazard. Repair costs have been included.

**Sidewalk in Poor condition.**

Concrete, Small Areas/Sections  
Site Swansboro Elementary School Building  
front entrance

Cracks throughout and uneven from tree roots growing underneath - AssetCALC ID: 7500281

Uniformat Code: G2030  
Recommendation: **Replace in 2026**

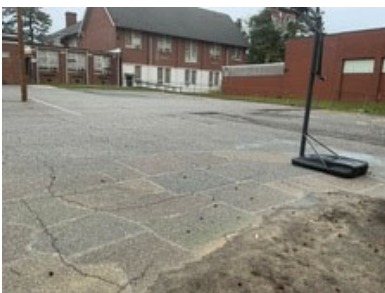
**Parking Lots in Poor condition.**

Pavement, Asphalt  
Site Swansboro Elementary School Rear  
parking lot

Uneven asphalt, alligator cracks, and potholes all around - AssetCALC ID: 7500309

Uniformat Code: G2020  
Recommendation: **Mill & Overlay in 2025**

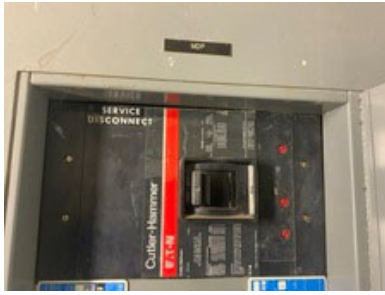
**Electrical System in Poor condition.**

Wiring & Switches, Average or Low Density/Complexity  
 Main Building Swansboro Elementary School  
 Throughout building

Electrical distribution is outdated and not sufficient for building needs. - AssetCALC ID: 7523831

Uniformat Code: D5030  
 Recommendation: **Replace in 2026**

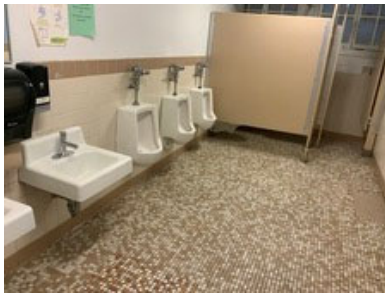
A 100-gallon gas water heater supplies the entire building with hot water. Toilet fixtures have been replaced since construction, but plumbing distribution is aged and will need to be replaced soon.

**Plumbing System in Poor condition.**

Supply & Sanitary, Medium Density (excludes fixtures)  
 Main Building Swansboro Elementary School  
 Throughout building

Aged plumbing system, unknown when last updated. - AssetCALC ID: 7523832

Uniformat Code: D2010  
 Recommendation: **Replace in 2026**

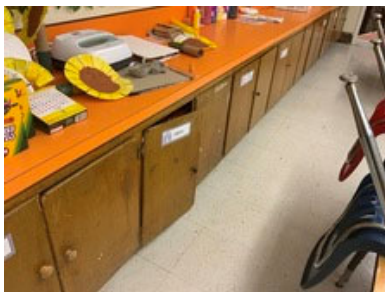
**Casework in Poor condition.**

Cabinetry Economy  
 Main Building Swansboro Elementary School  
 Kindergarten rooms

Old and deteriorating off hinges - AssetCALC ID: 7500224

Uniformat Code: E2010  
 Recommendation: **Replace in 2025**

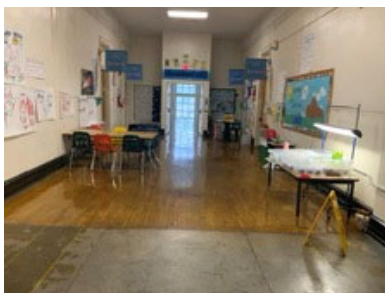
**Flooring in Poor condition.**

Wood, Strip  
 Main Building Swansboro Elementary School  
 2nd floor hallway and classrooms

Flooring has scraps and discoloration - AssetCALC ID: 7500220

Uniformat Code: C2030  
 Recommendation: **Refinish in 2026**

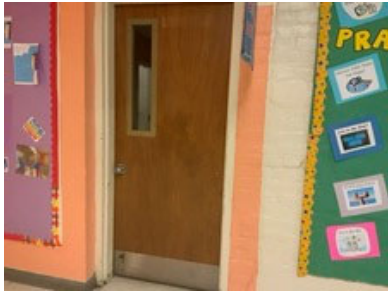
The interior doors all have knobs and are not ADA compliant. The sinks in the ADA restrooms do not have insulated pipes. A replacement cost to replace doorknobs with levers and to install insulation on sink plumbing is included.

## ADA Entrances & Doors

Hardware, Lever Handle  
Main Building Swansboro Elementary School  
Throughout building

Uniformat Code: Y1030  
Recommendation: **Install in 2024**
