FACILITY CONDITION ASSESSMENT

Richmond Public Schools
301 North Ninth Street
Richmond, VA 23219

Overby-Sheppard Elementary School
2300 First Avenue
Richmond, VA 23222

May 28, 2024

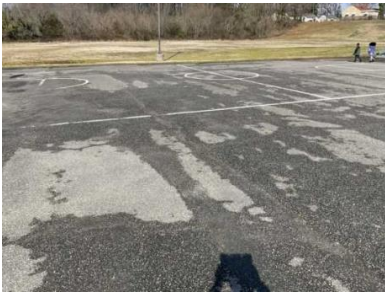
Athletic Surfaces & Courts in Poor condition.

Basketball/General, Asphalt Pavement
Site Overby-Sheppard Elementary School Site

Potholes and cracks throughout - AssetCALC ID: 7468410

Uniformat Code: G2050
Recommendation: **Mill & Overlay in 2025**

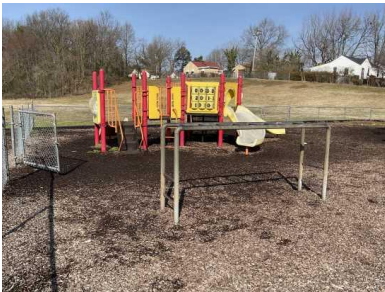
Playground Surfaces in Poor condition.

Engineered Wood Fiber, Chips 6" Depth
Overby-Sheppard Elementary School
Playground

Play surface is discolored and deleted. - AssetCALC ID: 7538568

Uniformat Code: G2050
Recommendation: **Replace in 2025**

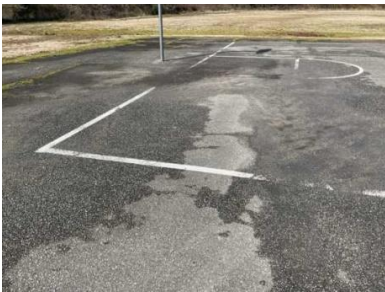
Athletic Surfaces & Courts in Poor condition.

Basketball/General, Asphalt Pavement
Site Overby-Sheppard Elementary School Site

Paint has faded away - AssetCALC ID: 7468311

Uniformat Code: G2050
Recommendation: **Seal & Stripe in 2025**

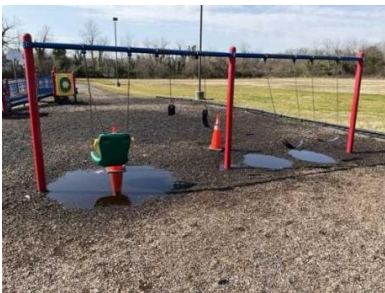
There are drainage issues reported and observed on the right and rear of the property.

Recommended Follow-up Study: Civil, Site Drainage

Civil, Site Drainage
Site Overby-Sheppard Elementary School Site

Uniformat Code: P2030
Recommendation: **Evaluate/Report in 2024**
