# FACILITY CONDITION ASSESSMENT

**Richmond Public Schools**  
301 North Ninth Street  
Richmond, VA 23219

Thomas Jefferson High School  
4100 West Grace Street  
Richmond, VA 23230

May 24, 2024

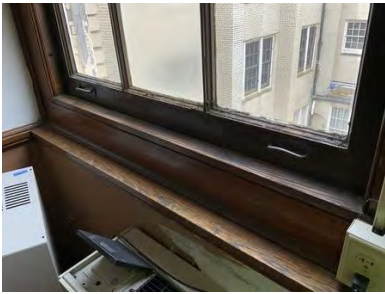
**Window in Poor condition.**

Wood Historical, 16-25 SF  
Main Building Thomas Jefferson High School  
Building Exterior

Single pane and most, if not all do not close properly. Interior and exterior sill plates are rotten and have not been painted in years. - AssetCALC ID: 7519674

Uniformat Code: B2020  
Recommendation: **Replace in 2025**

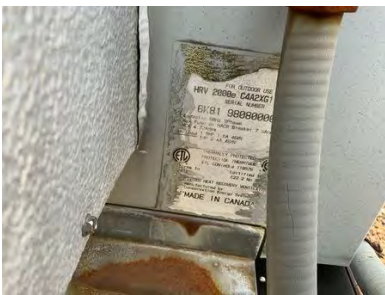
**Ventilator, Heat Recovery in Poor condition.**

1501 to 2000 CFM  
Main Building Thomas Jefferson High School  
on roof

Unit is aged and corroded. - AssetCALC ID: 7519656

Uniformat Code: D3030  
Recommendation: **Replace in 2025**

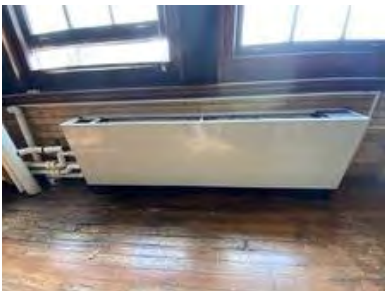
**Fan Coil Unit in Poor condition.**

Hydronic Terminal  
Main Building Thomas Jefferson High School  
Classrooms room 306

Fins are crushed and piping is corroded. - AssetCALC ID: 7519746

Uniformat Code: D3050  
Recommendation: **Replace in 2025**

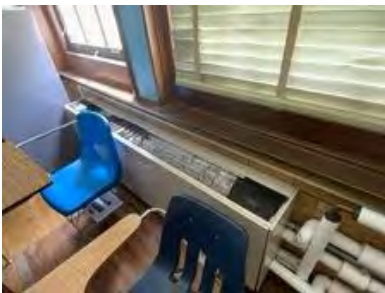
**Fan Coil Unit in Poor condition.**

Hydronic Terminal  
Main Building Thomas Jefferson High School  
Classrooms room 109

Fins are crushed - AssetCALC ID: 7519691

Uniformat Code: D3050  
Recommendation: **Replace in 2025**

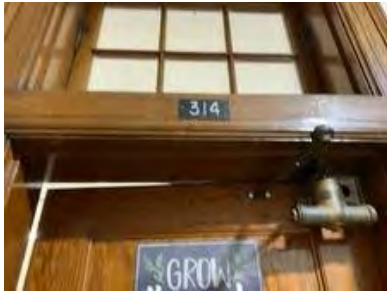
**Fan Coil Unit in Poor condition.**

Hydronic Terminal  
Main Building Thomas Jefferson High School  
Classrooms room 314

Fins are all crushed. - AssetCALC ID: 7519718

Uniformat Code: D3050  
Recommendation: **Replace in 2025**

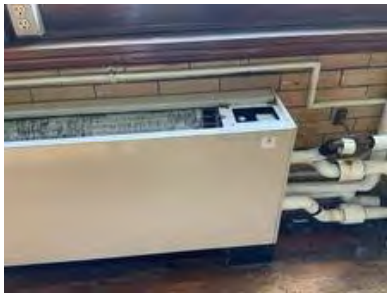
**Fan Coil Unit in Poor condition.**

Hydronic Terminal  
Main Building Thomas Jefferson High School  
Classrooms room 306

Fins are crushed and piping is corroded. - AssetCALC ID: 7519647

Uniformat Code: D3050  
Recommendation: **Replace in 2025**

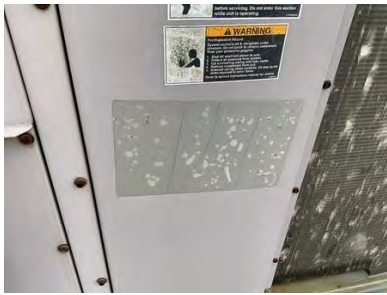
**Packaged Unit in Poor condition.**

RTU, Pad or Roof-Mounted, 3 TON  
Main Building Thomas Jefferson High School  
Roof

Unit was hidden on the roof and has not been serviced in years. Do not know if in service or functioning. Fins are crushed. - AssetCALC ID: 7519744

Uniformat Code: D3050  
Recommendation: **Replace in 2025**

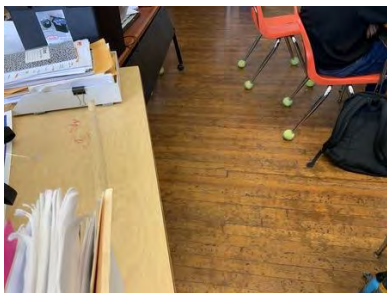
**Flooring in Poor condition.**

Wood, Strip  
Main Building Thomas Jefferson High School  
Classrooms

Wood flooring in many of the classrooms has rotten wood with holes. Flooring has not been refinished in many years. - AssetCALC ID: 7519633

Uniformat Code: C2030  
Recommendation: **Replace in 2025**

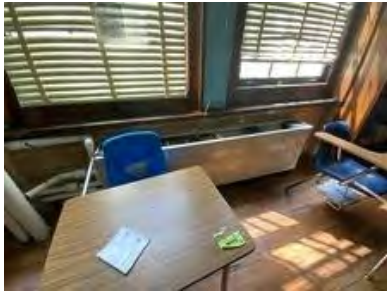
**Fan Coil Unit in Poor condition.**

Hydronic Terminal  
Main Building Thomas Jefferson High School  
Classrooms room 109

Fins are crushed and piping is rotted - AssetCALC ID: 7519813

Uniformat Code: D3050  
Recommendation: **Replace in 2025**

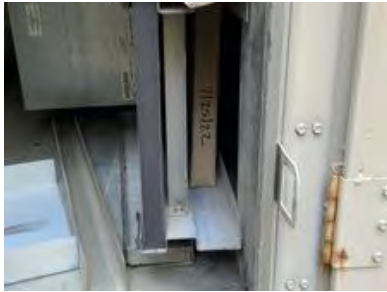
**Air Handler in Poor condition.**

Exterior AHU, 15001 to 20000 CFM  
Main Building Thomas Jefferson High School  
Lower middle roof

All filters clogged. Unit services cafeteria, and several rooms on the first floor. - AssetCALC ID: 7519761

Uniformat Code: D3050  
Recommendation: **Replace in 2025**

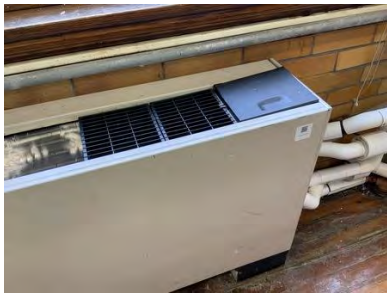
**Fan Coil Unit in Poor condition.**

Hydronic Terminal, 401 to 800 CFM  
Main Building Thomas Jefferson High School  
Classrooms room 312

Uniformat Code: D3050  
Recommendation: **Replace in 2025**

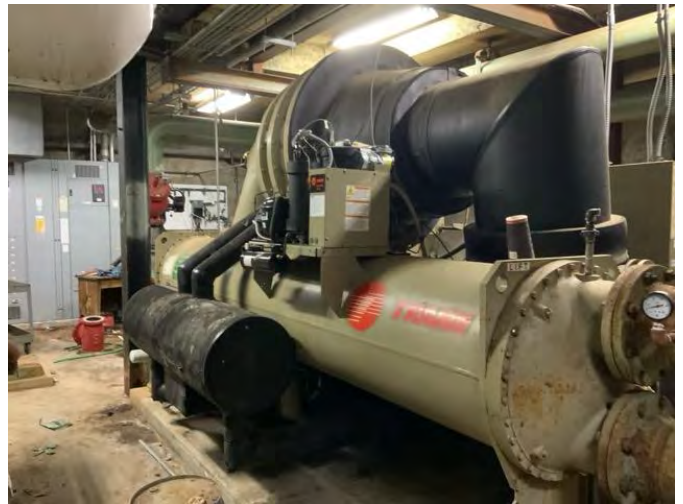
10 - MECHANICAL ROOM - CHILLER

The facility utilizes a 4-pipe HVAC central system. The HVAC system has newer condensing boilers and air-cooling tower. The chiller is past its useful life and needs replacement. Of concern is it is located under the rear stairs and parking lot which is showing signs of failure to the roof structure. The cooling tower for the chiller was replaced two years ago and is in good condition. The dual-temperature system struggles to provide adequate comfort, especially on mild days where heating and cooling needs may both be required simultaneously. The pneumatic controls should be replaced by an upgraded building automation system, thereby improving efficiency and performance. Except for the two RTU's installed on the roof, the remaining HVAC systems are past their useful life and need replacement. It appears the HVAC systems have only been marginally maintained in recent years. The hallways also lack any sort of air conditioning, which strains the current system on hot days.
