FACILITY CONDITION ASSESSMENT

Richmond Public Schools
301 North Ninth Street
Richmond, VA 23219

Summer Hill Preschool
2717 Alexander Avenue
Richmond, VA 23234

July 2, 2024

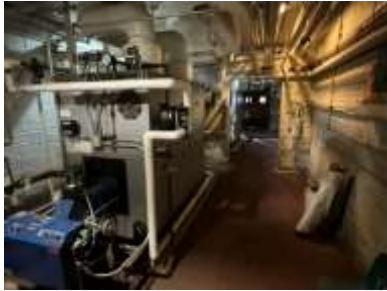
Piping & Valves in Poor condition.

Priority Score: **85.8**

The water piping insulation was noted to be deteriorated and causing ceiling stains. - AssetCALC ID: 7648822

Uniformat Code: D3050
Recommendation: **Replace in 2025**

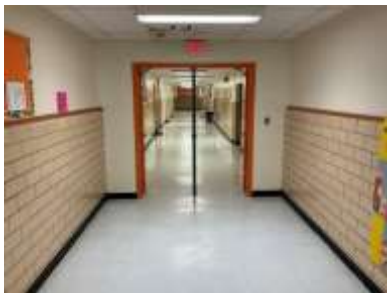
HVAC System

Priority Score: **54.8**

Uniformat Code: D3050
Recommendation: **Install in 2025**
