# FACILITY CONDITION ASSESSMENT

**Richmond Public Schools**  
301 North Ninth Street  
Richmond, VA 23219

Westover Hills Elementary School  
1211 Jahnke Road  
Richmond, VA 23225

*May 21, 2024*

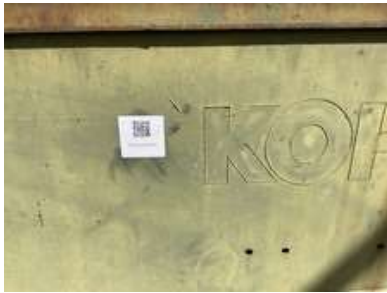
#### Generator in Poor condition.

Diesel  
Main Building Westover Hills Elementary School Site

The generator Does not appear to be functioning. The maintenance staff is not aware of the status. - AssetCALC ID: 7567457

Uniformat Code: D5010  
Recommendation: **Replace in 2024**

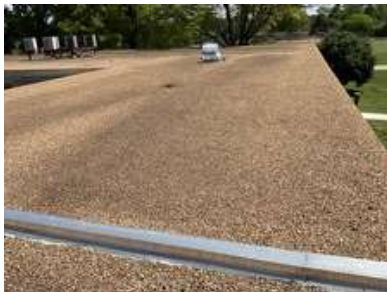
#### Roofing in Poor condition.

Built-Up  
Main Building Westover Hills Elementary School Roof

It was reported that there are active roof leaks throughout the school - AssetCALC ID: 7567467

Uniformat Code: B3010  
Recommendation: **Replace in 2025**

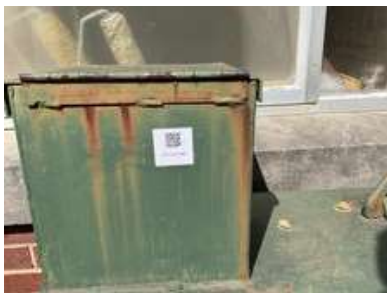
#### Storage Tank in Poor condition.

Fuel, Interior  
Site Westover Hills Elementary School Site

The fuel tank is badly rusted and quite dated. It is not known if the generator is working. - AssetCALC ID: 7567451

Uniformat Code: D3010  
Recommendation: **Replace in 2024**

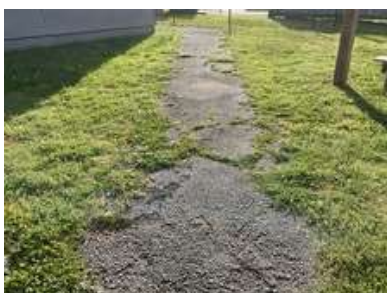
#### Sidewalk in Poor condition.

Asphalt  
Site Westover Hills Elementary School Site

The walkway is overgrown with grass and weeds and is uneven. - AssetCALC ID: 7567400

Uniformat Code: G2030  
Recommendation: **Replace in 2024**

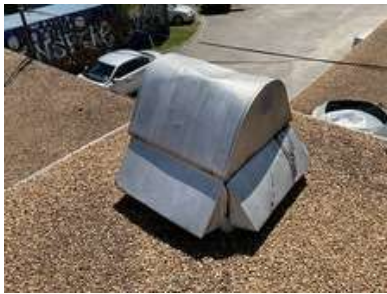
**Exhaust Fan in Poor condition.**

Centrifugal, 16" Damper  
Main Building Westover Hills Elementary  
School Roof

Unit does not appear to be functioning - AssetCALC ID: 7567350

Uniformat Code: D3060  
Recommendation: **Replace in 2025**

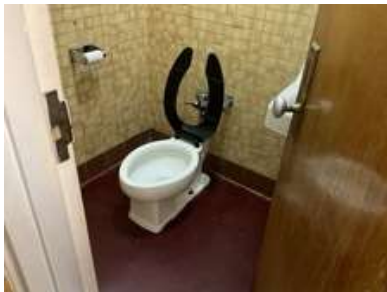
**Toilet in Poor condition.**

Child-Sized  
Main Building Westover Hills Elementary  
School Room 6

Teacher reports the toilet leaks frequently. It is blocked off and not used due to this problem. - AssetCALC ID: 7567273

Uniformat Code: D2010  
Recommendation: **Replace in 2024**

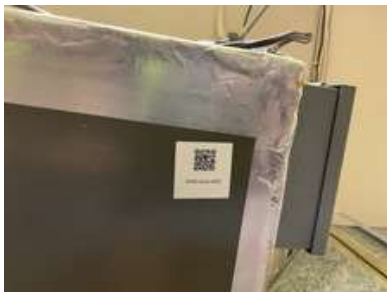
**Split System in Poor condition.**

Fan Coil Unit, DX  
Main Building Westover Hills Elementary  
School Room 29

The unit reportedly does not function in air-conditioning mode - AssetCALC ID: 7567389

Uniformat Code: D3030  
Recommendation: **Replace in 2024**

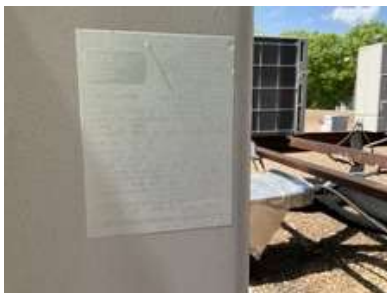
**Split System Ductless in Poor condition.**

Single Zone, 1.5 to 2 TON  
Main Building Westover Hills Elementary  
School Roof - 5

Unit frequently does not work. It is currently not working. - AssetCALC ID: 7567471

Uniformat Code: D3030  
Recommendation: **Replace in 2024**

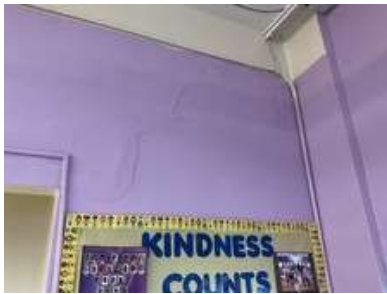
**Recommended Follow-up Study:  
Structural, Superstructure**

Structural, Superstructure  
Main Building Westover Hills Elementary  
School Room 5

Cracking was reported in Room 5. It could potentially be a structural issue and a professional engineer should be retained to evaluate. - AssetCALC ID: 7567416

Uniformat Code: P2030  
Recommendation: **Evaluate/Report in 2024**

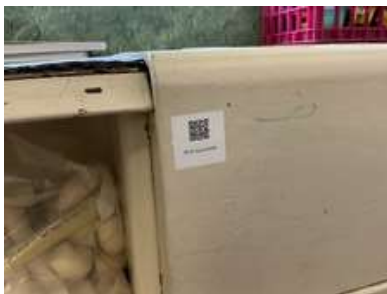
**Unit Ventilator in Poor condition.**

Approx/nominal 4 Ton  
Main Building Westover Hills Elementary  
School Throughout classrooms

Unit ventilators are antiquated and do not keep rooms at comfortable temperature. - AssetCALC ID: 7567419

Uniformat Code: D3030  
Recommendation: **Replace in 2024**

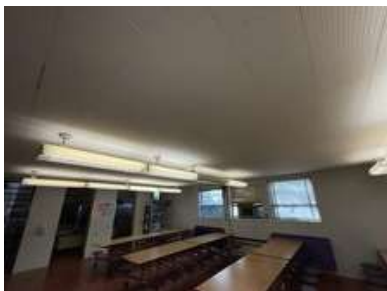
**Suspended Ceilings in Poor  
condition.**

Hard Tile, ACM Abatement & Replacement w/  
ACT  
Main Building Westover Hills Elementary  
School Cafeteria

Ceiling tiles show previous repairs and stains. - AssetCALC ID: 7567365

Uniformat Code: C1070  
Recommendation: **Replace in 2025**

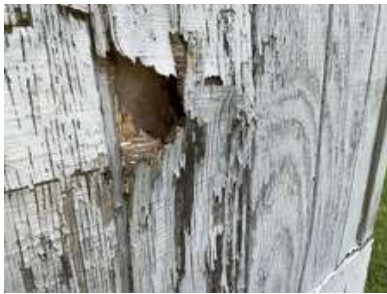
### Ancillary Building in Poor condition.

Classroom/Office Module, Standard/Permanent  
Site Westover Hills Elementary School Site

Modular building exterior wood siding is delaminating in multiple areas. Some of the holes are large enough that rodents are getting into the structure. The HVAC units are dated and have a difficult time conditioning the room. The roof is starting to leak and the VCT tiles are chipped in several areas. - AssetCALC ID: 7567397

Uniformat Code: F1020  
Recommendation: **Replace in 2025**

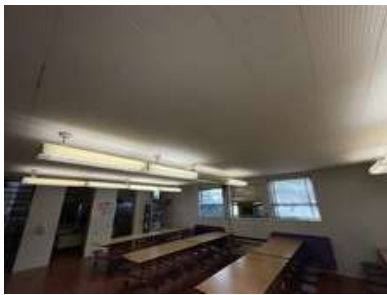
### Recommended Follow-up Study: Environmental, Asbestos (ACM) & Lead Base Paint (LBP)

Environmental, Asbestos (ACM) & Lead Base Paint (LBP)  
Main Building Westover Hills Elementary School Throughout building

Uniformat Code: P2030  
Recommendation: **Evaluate/Report in 2024**
