HOPE-PAGE PUBLIC SCHOOLS FACILITIES ASSESSMENT REPORT

HIGH SCHOOL

ELEMENTARY SCHOOL

February 2019

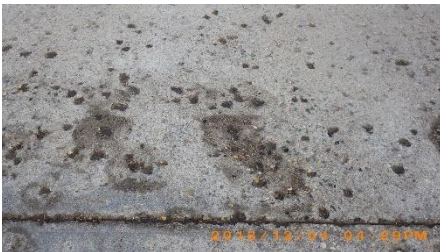
Deteriorated sidewalk

- Deteriorated surfaces and cracked panels were observed.
 - Building stoops are generally flush with adjacent sidewalks.
 - The north entrance has a step.

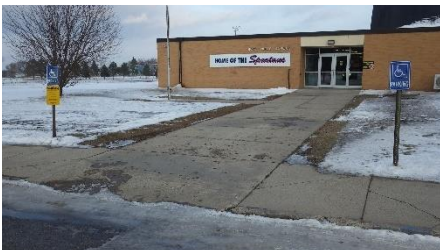
Parking is not ADA compliant

- The signed accessible parking outside the main entrance on the west side does not meet ADA guidelines.
 - Deficiencies include improper striping and signage.

- Deteriorated/inadequate pavement surfaces (gravel, cracking, gaps, elevation changes, lack of detectable warnings at ramp).
 - Inadequate quantity of accessible spaces.

- Concerns about poor drainage in the parking area were noted. Consideration to paving part of the parking lot may solve several issues (drainage, traffic flow, ADA).

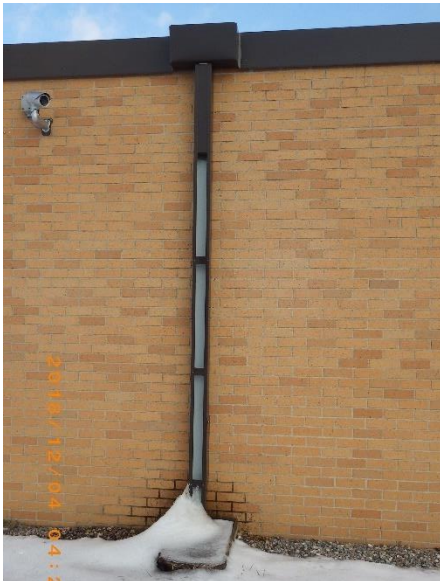
- Some ground settlement was observed around downspouts. Some minor deficiencies related to downspouts and/or splash blocks has caused the settlement as well as surface staining on the masonry.

Roof drainage; Moisture causing stains at brick

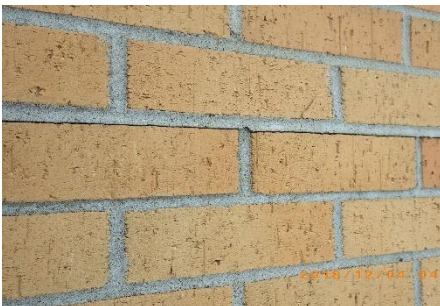
Example of mortar joint with hairline crack

- Selective tuck-pointing at the exterior walls is needed. Some mortar joints need repaired as a result of expansion/contraction, lack of control joints, and deterioration from moisture/normal wearing.

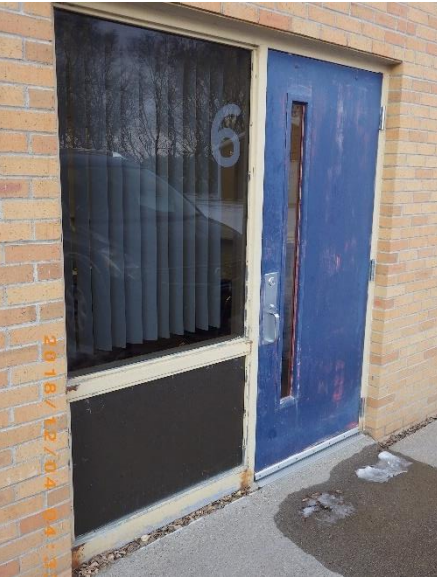
Hollow metal frame/door with rust and faded paint

- The paint finish on these doors/frames was observed to be faded and chalking with some rust. They should be routinely repainted, along with all exposed exterior metals.

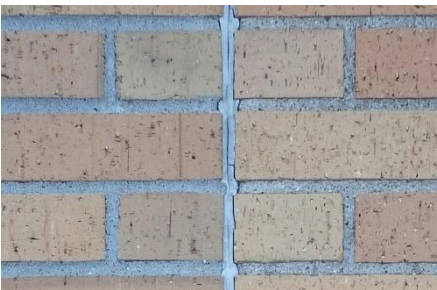
Deteriorated sealant at masonry control joint

- Joint sealants around the building are showing signs of deterioration.
 - The joint sealant at select masonry controls joints, where masonry abuts stucco, and around exterior louvers/building penetrations is starting to deteriorate and crack.
 - Joint sealant at the control joints below the windows is missing entirely, exposing the wall cavity to moisture, air infiltration, insects and could cause damage if they are not sealed.

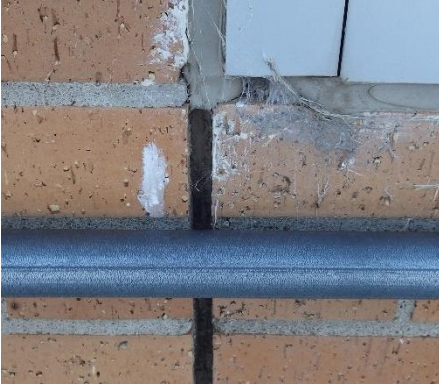
Aluminum window with missing sealant under vertical framing; control joint below window with no mortar or sealant

- Joint sealant at the aluminum storefront windows and doors is in good condition. Some select locations were missing sealant along the bottom of the vertical framing members.
- The expected useful life of joint sealants is 10-20 years depending on the type used and the environmental conditions in which it is exposed. Many of the joint sealants have exceeded their expected useful life and should be replaced entirely to prevent future moisture and air infiltration.

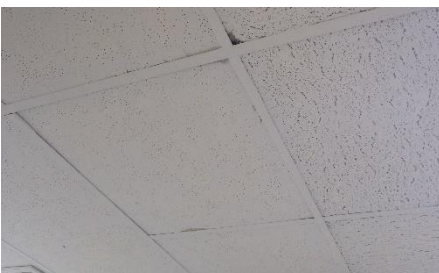
Various styles of ceiling tiles in the same room

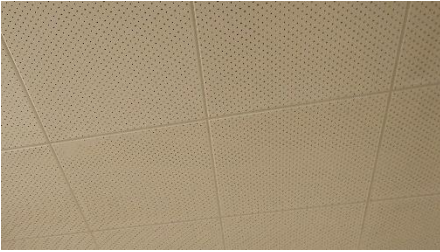
Perforated acoustical metal tile at kitchen

- The ceiling at the kitchen is a perforated acoustical metal tile. A solid ceiling with a smooth, cleanable surface is recommended such as drywall or suspended ceiling grid and smooth 2x2 tiles.
- Ceilings in various smaller rooms have a smooth plaster ceiling with painted finish. We recommend testing to verify if they contain asbestos.
- Ceilings in select larger areas are exposed finish:
 - Wood decking at gym/stage
 - Exposed steel joist/deck at locker rooms, shop, storage rooms.

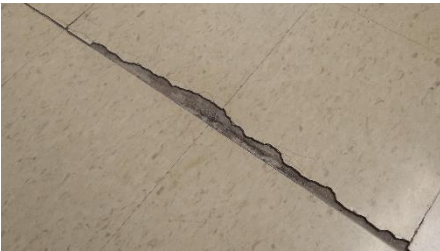
Deteriorated VCT flooring at main corridor

- Vinyl floor tile in the corridors was cracking and shifting. The worst areas where cracking occurred aligned with control joints in the concrete floor.

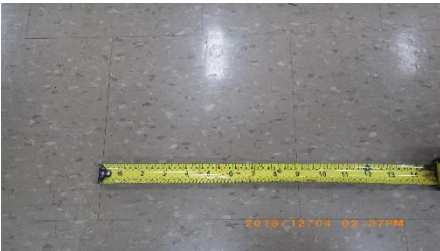
9x9 vinyl asbestos tile (VAT) at stage

- Hard flooring surfaces throughout the 1961 building was originally noted as vinyl asbestos tile (VAT), which is usually 9"x9" in size. Much of this VAT remains in place.

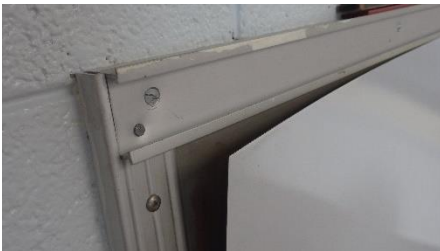
Markerboard installed over original chalkboards. Ghosting on surface observed.

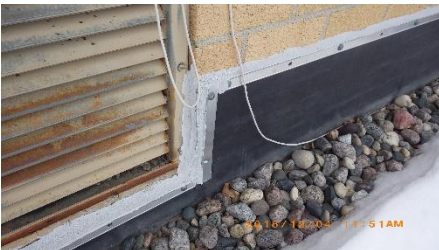
Rust at louver, deteriorating sealant at roof

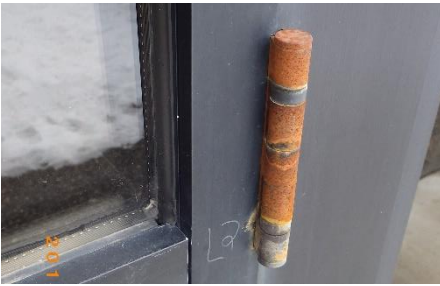
Rusted hinge at aluminum entrance door

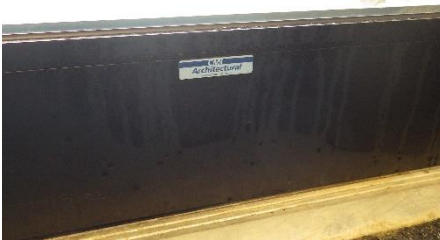
Condensation on interior side of aluminum

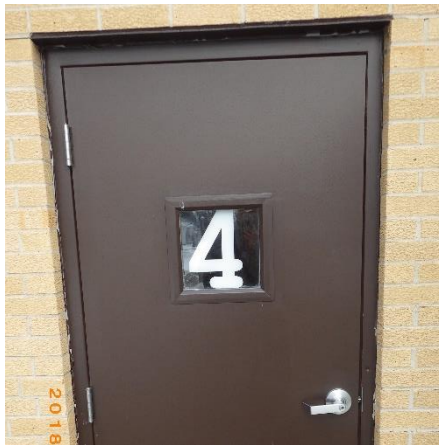
Hollow metal frame & door; peeling paint on lintel

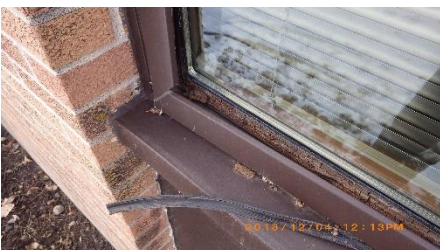
Rotted sash at exterior window

- Exterior windows consist of operable, aluminum clad wood windows with insulated glazing. The original drawings indicate that glass block was once located above these windows, which appears to have been abandoned in place and covered with paneling.
 - Sashes and framing at the wood windows are rotted, falling apart. Windows around the entire building should be replaced.

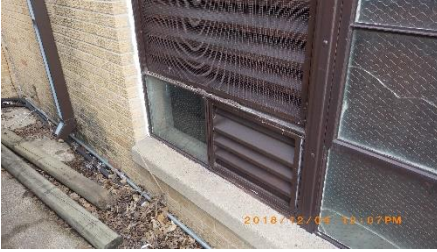
Original steel frame window with broken glazing

- The windows are known to leak.
- The boiler room has the original steel framed window with non-insulated wire glass and louver. The glass is cracked.
 - The window system should be replaced or infilled.
- Interior sides of windows have wood trim/sills and should be replaced with the windows.
- The window blinds are integral with the windows.
 - New blinds will be required.

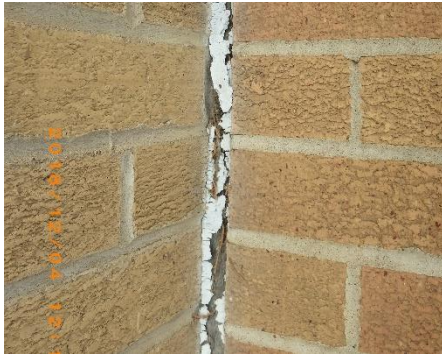
Deteriorated joint sealant

- Joint sealants around the building are showing signs of deterioration.
 - The joint sealant at select masonry controls joints, where masonry abuts the wood fascia, and around exterior louvers/building penetrations is starting to deteriorate and crack.
 - Most joint sealant on the exterior of the building should be completely removed and replaced.
- The expected useful life of joint sealants is 10-20 years depending on the type used and the environmental conditions in which it is exposed. Many of the joint sealants have exceeded their expected useful life and should be replaced entirely to prevent future moisture and air infiltration.

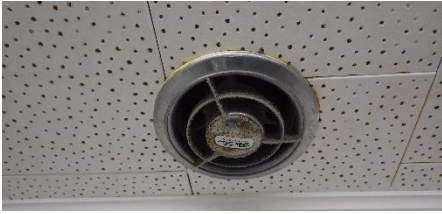
12x12 acoustical tile (may have asbestos glue)

- Restroom ceilings in the 1954 building have painted 12"x12 fiber acoustical tile and suspended (concealed) steel framing. We recommend testing to verify if the tiles or the glue contain asbestos.

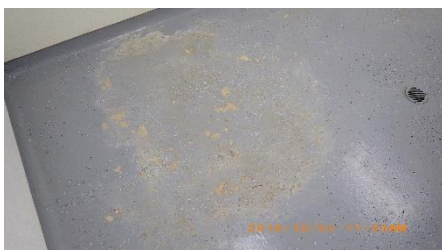
Painted floor at shower is deteriorated, peeling.

- Flooring at the corridors have broadloom (roll) carpeting.
- The locker rooms have a painted concrete floor. The finish at the shower areas is deteriorated (peeling and bubbling).
