Harrisburg School District

District Wide Facility Study

June 12, 2023

Crabtree, Rohrbaugh & Associates
Architects

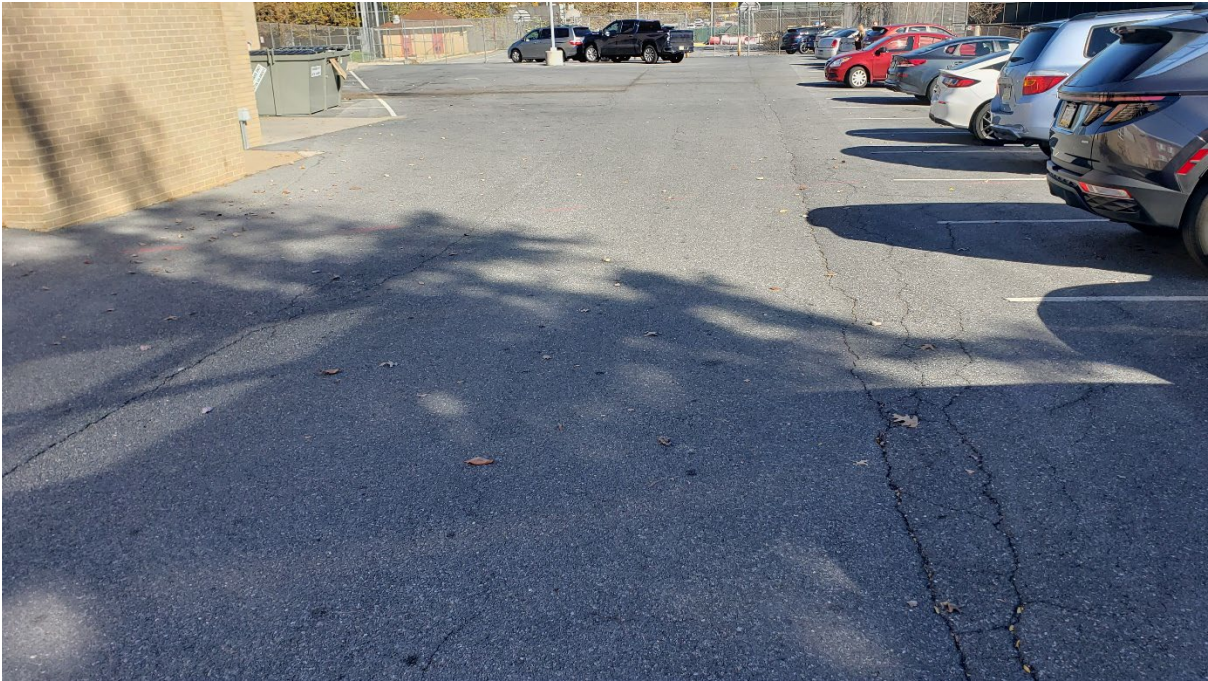
Painted metal railings are due for new coats of paint.

Asphalt pavement is in relatively good condition. The drive areas should be re-sealed. Concrete sidewalks are in fair condition, with some areas in need of repair, particularly at a stair to one of the building's exit points.

- Seal Coat asphalt paving as part of ongoing maintenance.
- Repair concrete stair.
- Repaint railings which were previously painted.

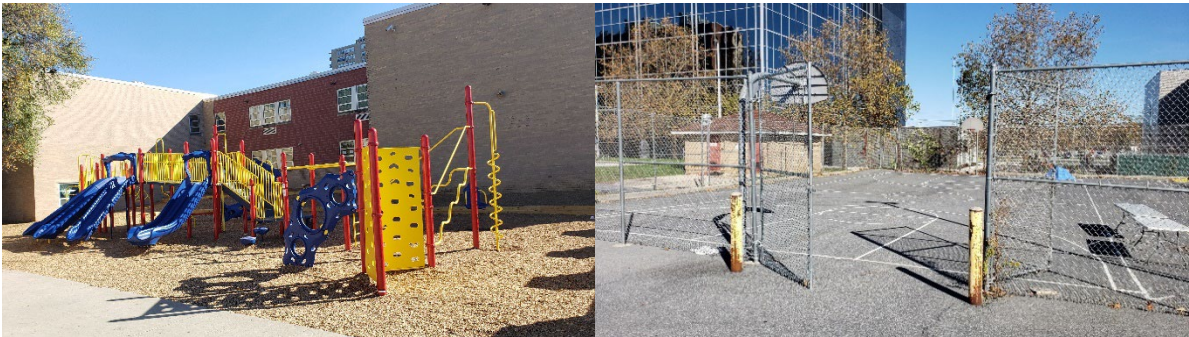
Within the courtyard defined by the U-shaped building is a play area with playground equipment. The Play area is enclosed from the adjacent drive and parking lot along N. 6th Street with a gated aluminum picket fence with masonry piers. The playground equipment appears to be in good condition.

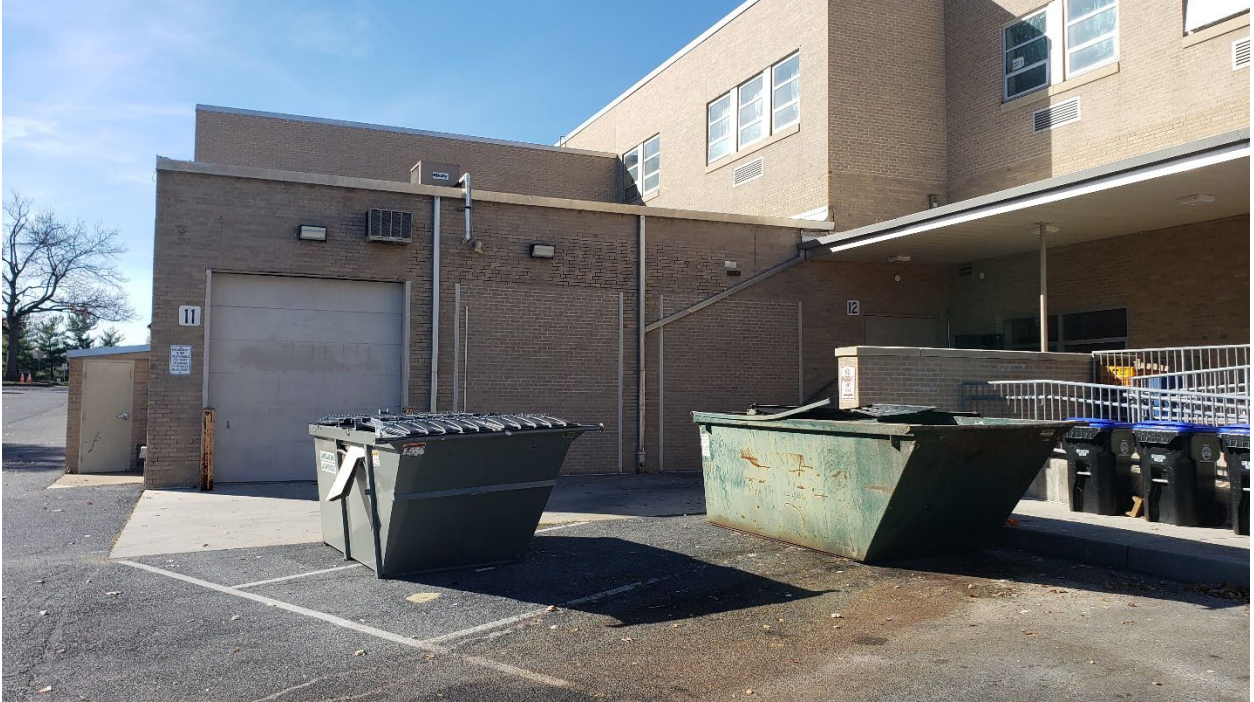
The building exterior consists of masonry walls with modular brick veneers. Older areas of the building are not cavity walls, and therefore insulation has been added to the interior sides of these walls over time. Newer areas of the building have insulated masonry cavity walls with brick and split face CMU veneers. Window stools are precast. The masonry veneer is generally in good condition, although it is stained at a small storage room in the service area of the building, where no means for its roof to drain except to shed down the side of the building. There is also some staining on the north-facing parts of the structure which do not get much sun exposure.

- Brick veneer should be cleaned around stained areas, including precast sills. Repointing should be done as required.
- Joints should be re-caulked.

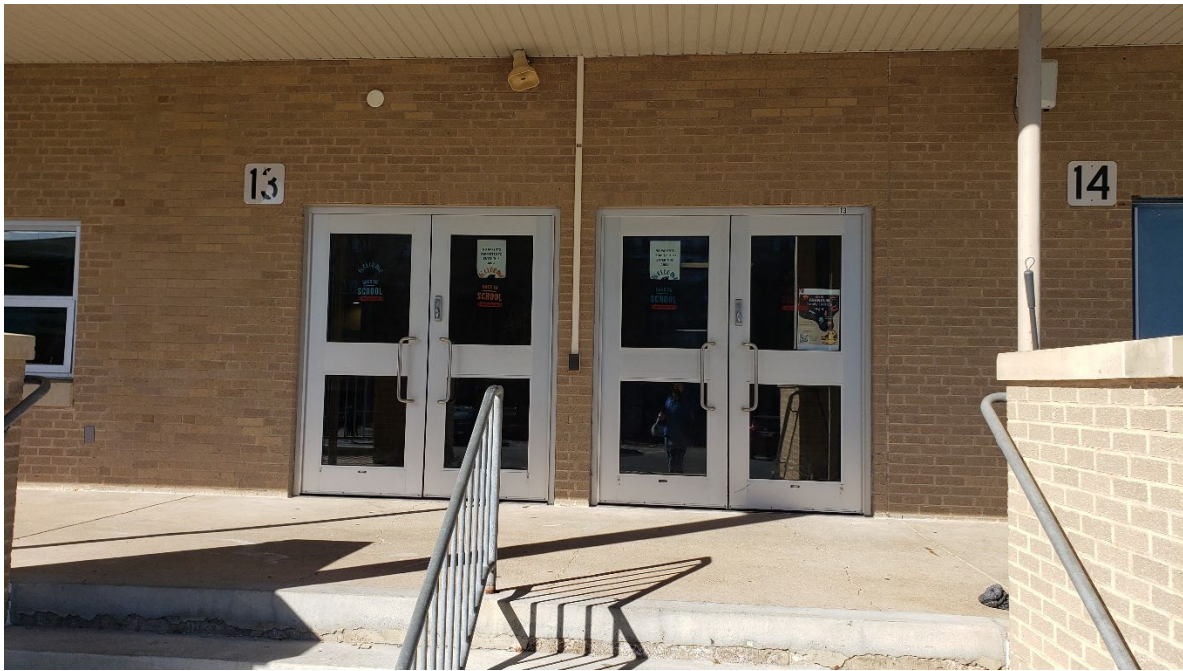
Typical window and entrance systems throughout the building are operable, awning-style aluminum storefront windows. The multi-purpose room has four curtain wall frame systems. Windows are generally in good condition. The door hardware at double door entrances/exits should be replaced so that doors cannot be chained together – a security concern.

- Scrape and paint hollow metal doors and frames.
- Replace door hardware at exterior doors.

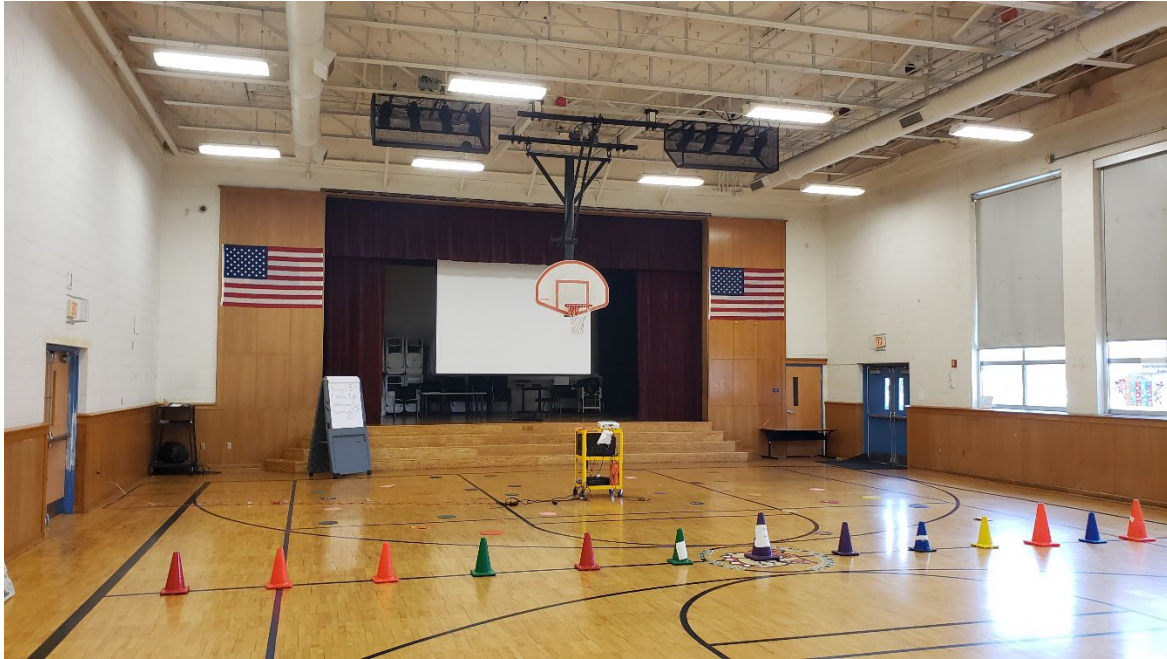
The theatrical equipment (curtains, lighting, projection screen) is in good condition. The stage and risers show wear.

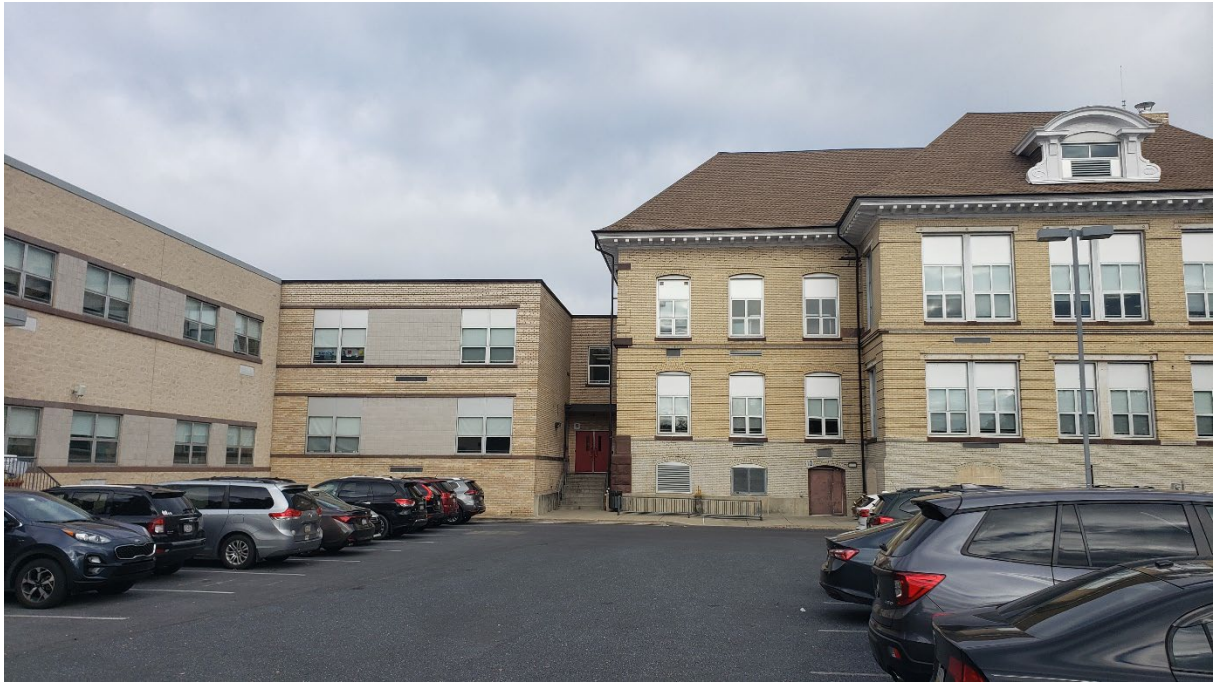
There is sufficient space to park approximately 65 vehicles. Additional staff and visitors are reliant on the on-street parking in the neighborhood. The on-site parking does not include any accessible parking spaces. The refuse and service area is off North 16th Street.

Asphalt pavement is in good condition. Concrete sidewalks are in fair condition, with some areas in need of repair/replacement.

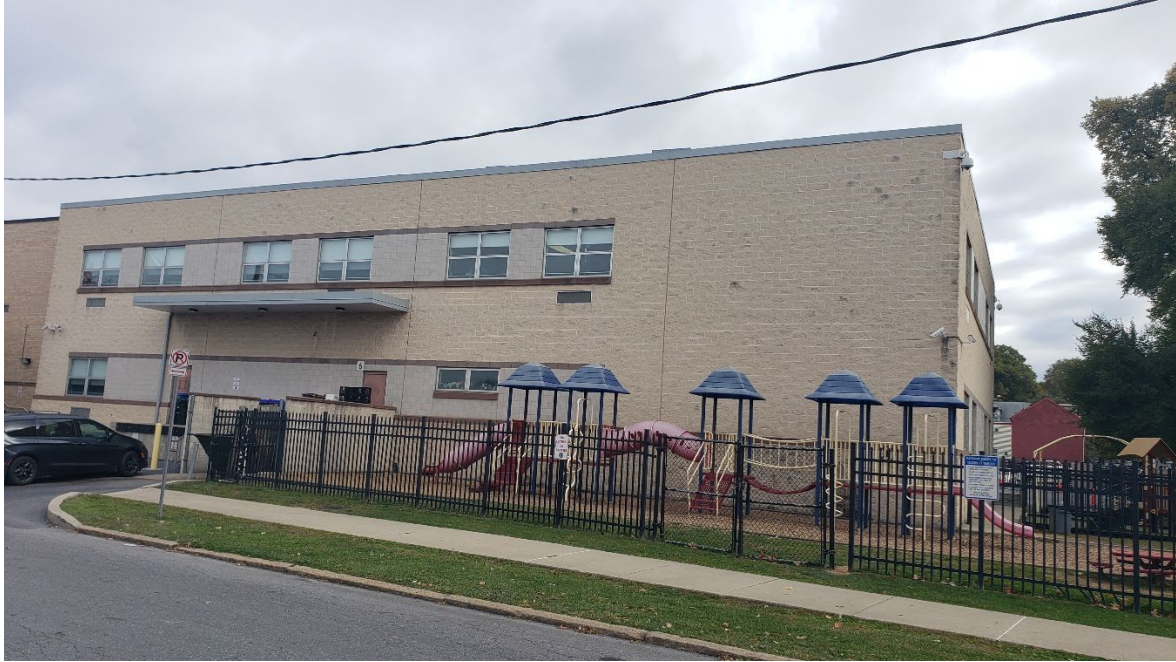
There is a small, gated soft-surface play area with playground equipment in the southwest corner of the site. The hard surface playground has been repurposed for parking. The playground equipment has faded from sunlight but appears to be otherwise in good condition.

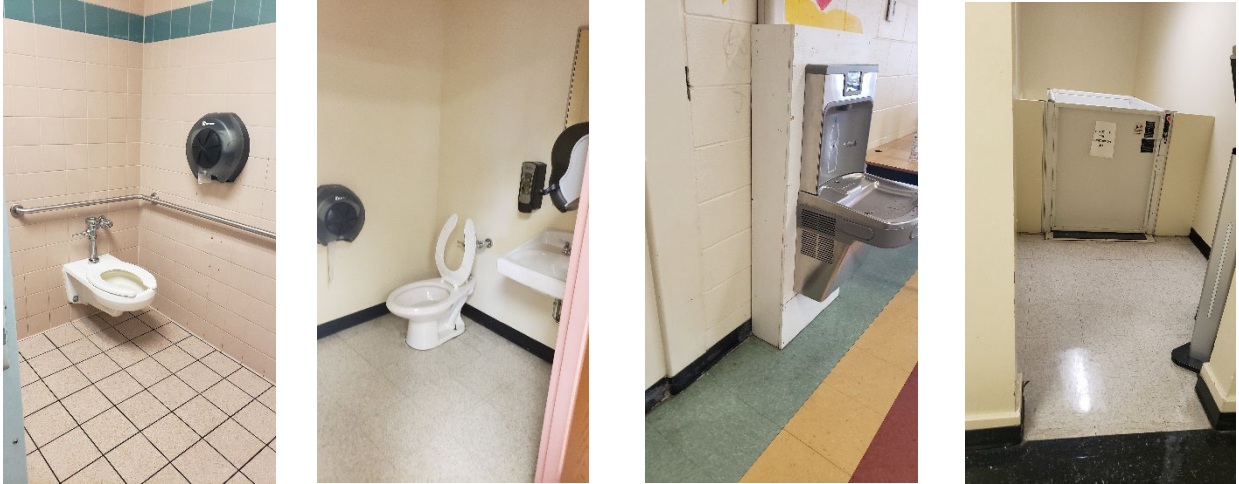
Drinking fountains, while many recently replaced, are often located such that they project into paths of travel, an accessibility concern due to blind persons not being able to sense their presence.

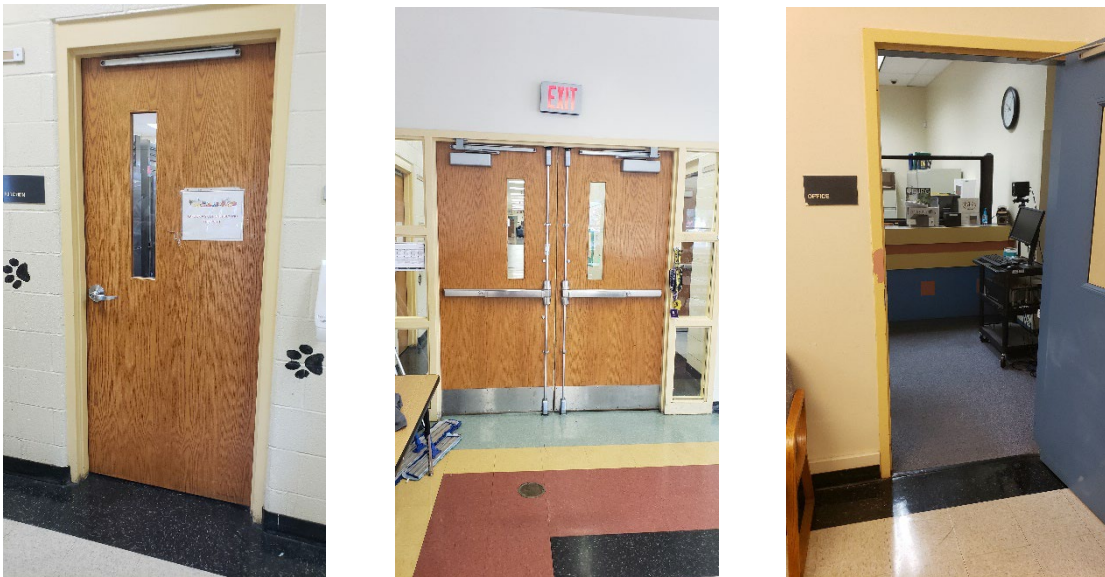
Interior doors are primarily wood set in hollow metal frames. Doors and frames are generally in fair to good condition.

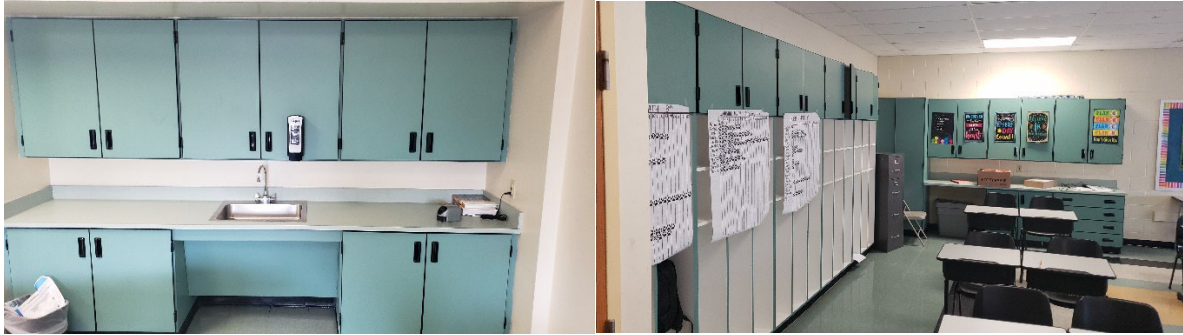
Typical classrooms have built-in shelving along the exterior wall adjacent to the unit ventilators. If the unit ventilators are removed as part of an HVAC upgrade, this casework would need to be infilled or removed and adjacent finishes patched and repaired.

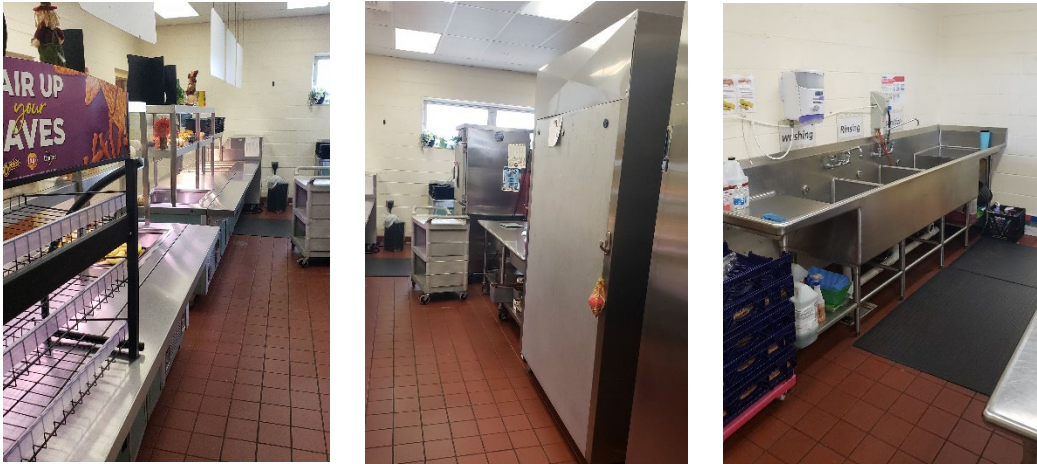
The cooking for Cougar Academy is done on site. Cold storage space at this school is inadequate, with small refrigerator/freezer units located separate from one another within the kitchen. The food service equipment was replaced in 2000 and is approaching the end of its useful life.

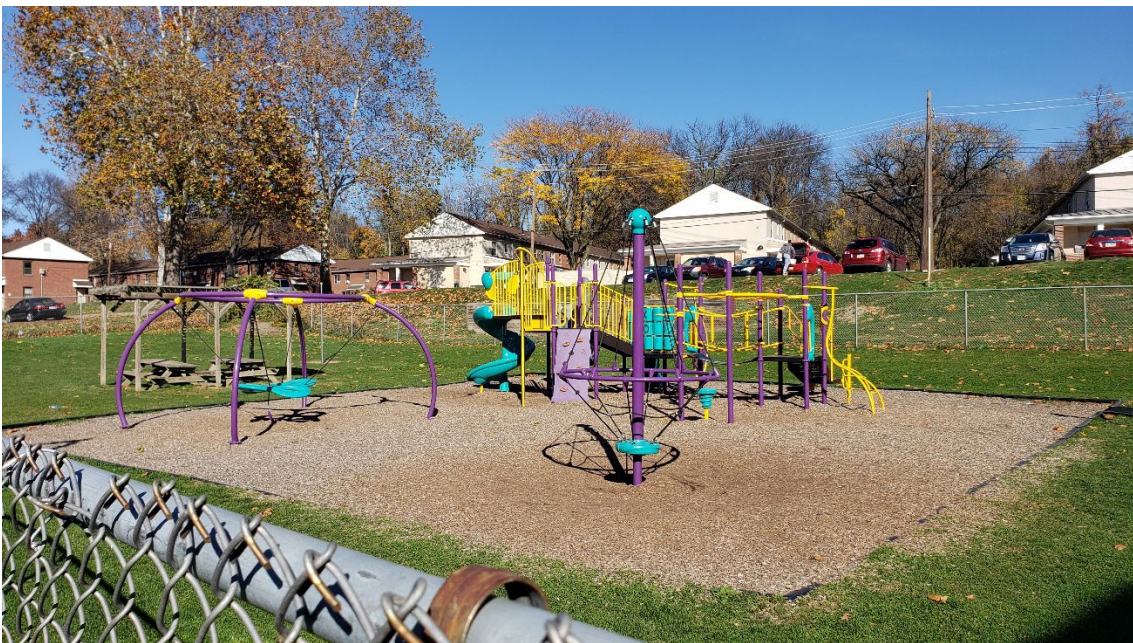
There are two playground/soft surface play areas, both within fence enclosures – one at the south corner and one at the north corner of the school site. The playground equipment at the south end of the building is older, but still in useful condition. The north playground equipment is newer and in good condition. There is also a hard surface play area on the east side of the building adjacent to the north playground.

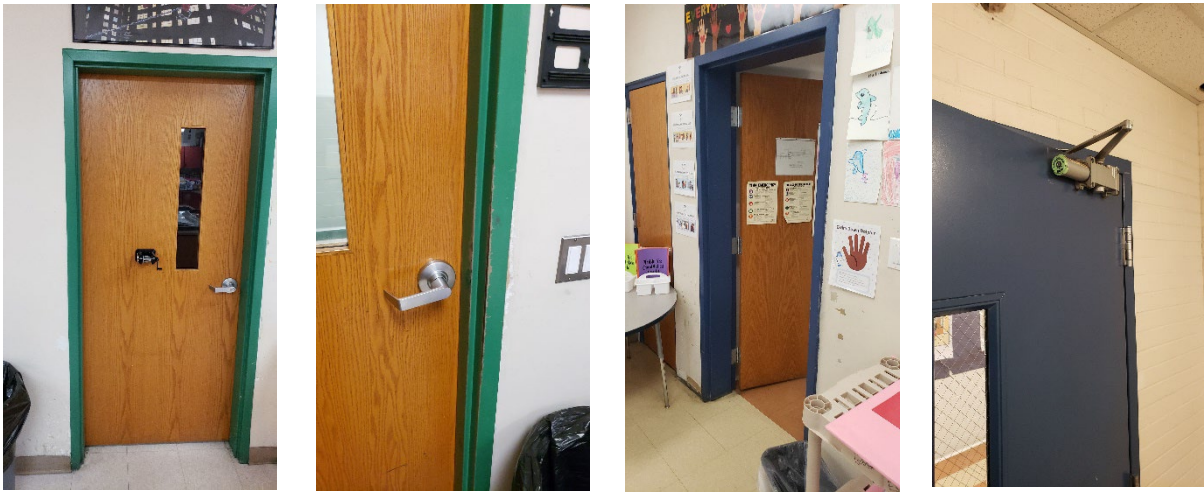
Most interior doors are wood with ADA-compliant hardware in fair condition, with hollow metal frames. Many doors have scratches and residue which remains from items being hung/taped to them over the years. Hollow metal doors and frames are in fair condition, most requiring scraping and painting. The vision panels that view down to the gymnasium should be replaced with masonry infill.

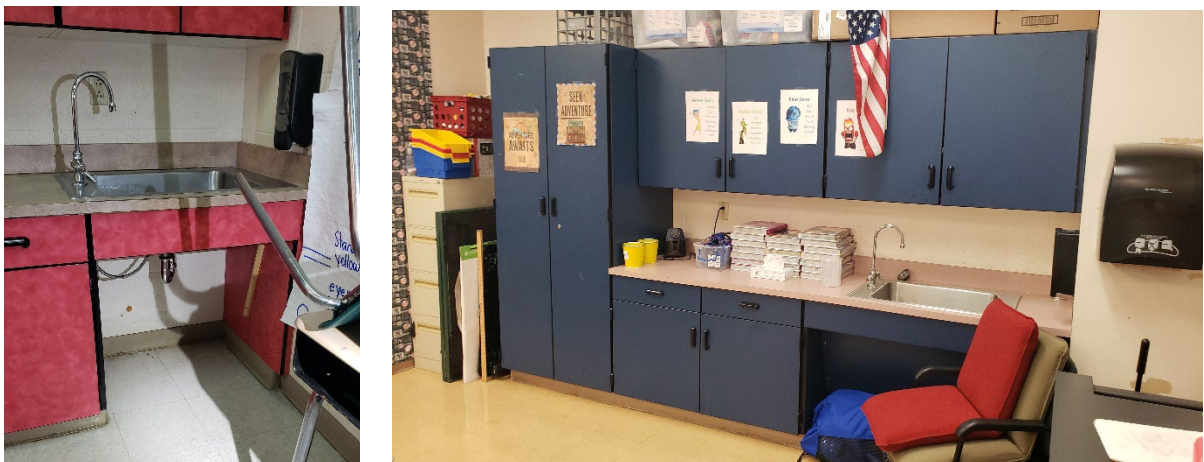
Typical classrooms have built-in shelving along the exterior wall adjacent to the unit ventilators. If the unit ventilators are removed as part of an HVAC upgrade, this casework would need to be infilled or removed and adjacent finishes patched and repaired.

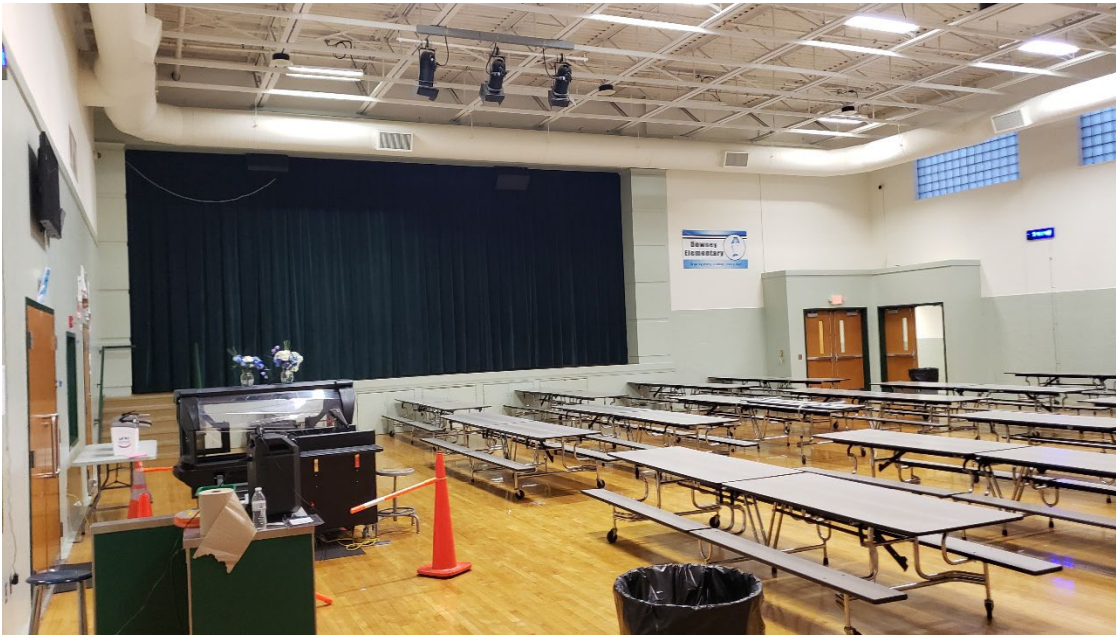
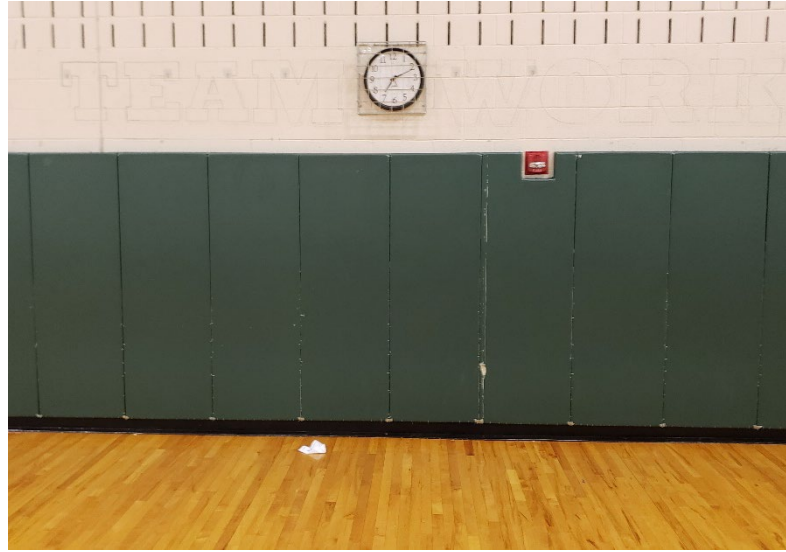
The theatrical equipment (curtains, lighting, projection screen) is in good condition. Most gymnasium equipment appears to be in good condition, however wall pads should be replaced.

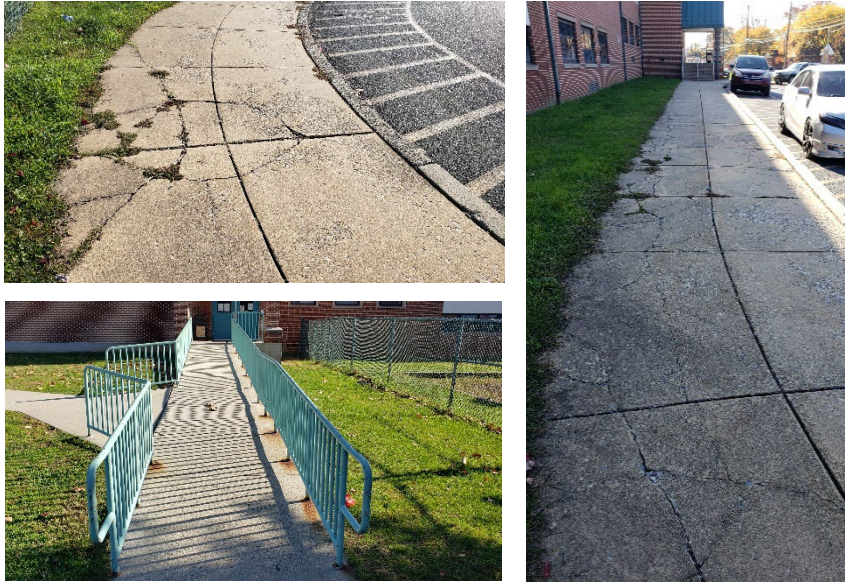
Handrails at walkways are due for new paint.

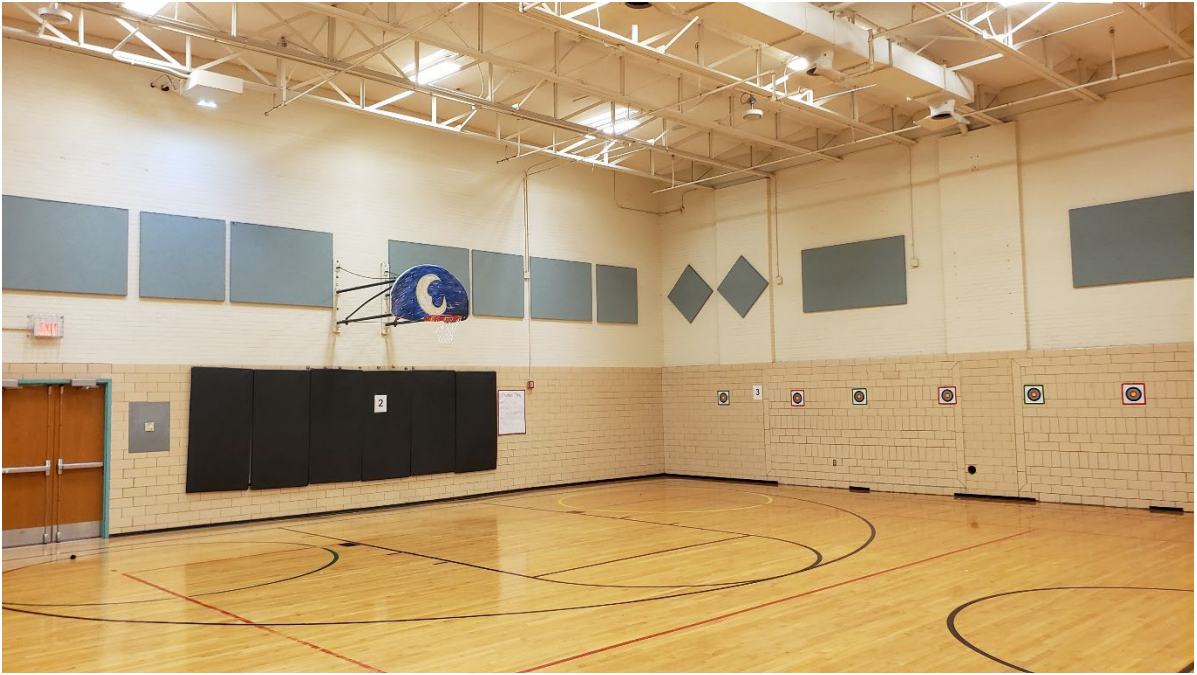
The gymnasium equipment is also original to the building. The basketball goals are fixed to the walls and not adjustable. Wall pads are due for replacement. Bleachers were removed during the renovations in the early 2000's.

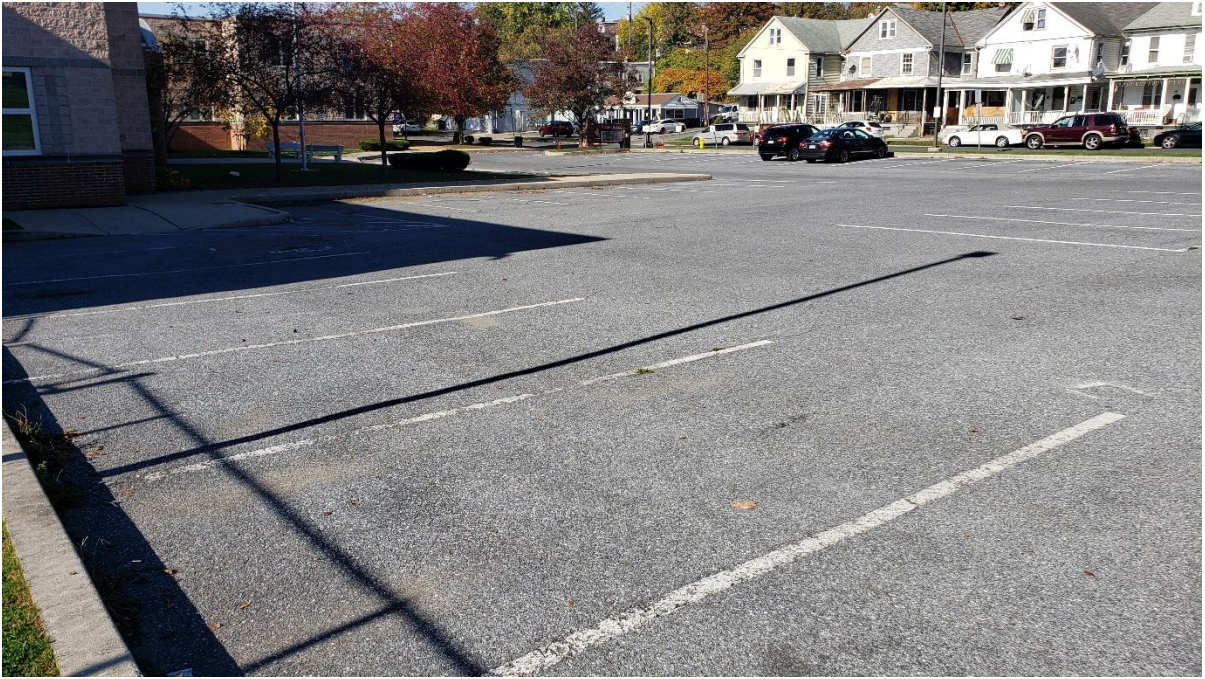
There are approximately 40 on-site parking spaces. The number of parking spaces is not adequate for the school's needs. Additional staff and visitors are reliant on the on-street parking in the neighborhood. The refuse area is off Thompson Street behind the school. Thompson street, a small alley, is in significant need of repaving, however it is a city street.

Asphalt pavement is in fair condition, with cracks appearing and ground settling where car wheels rest when parked. Lines are due to be restriped. Concrete sidewalks are in fair condition, with some areas in need of repair/replacement.

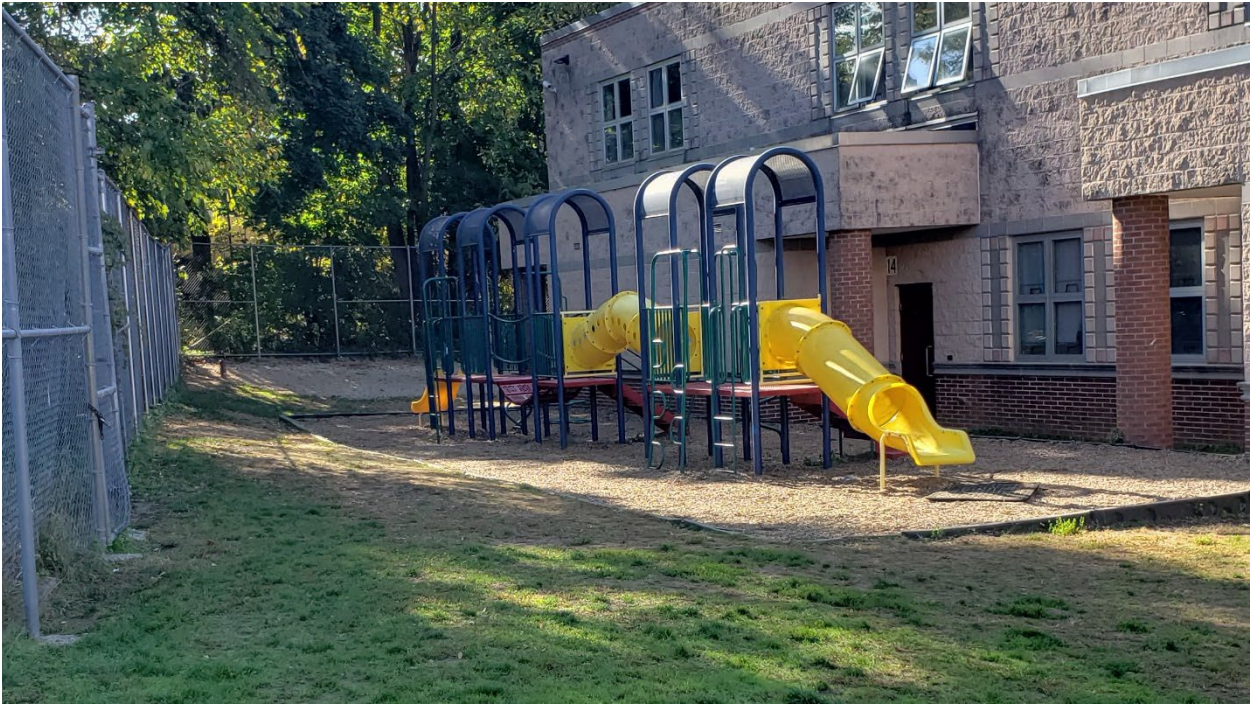
At the southeast corner of the building there is soft and hard surface playground. The play equipment appears to be relatively new and in good condition. The playground is separated from other site elements with chain link fence.

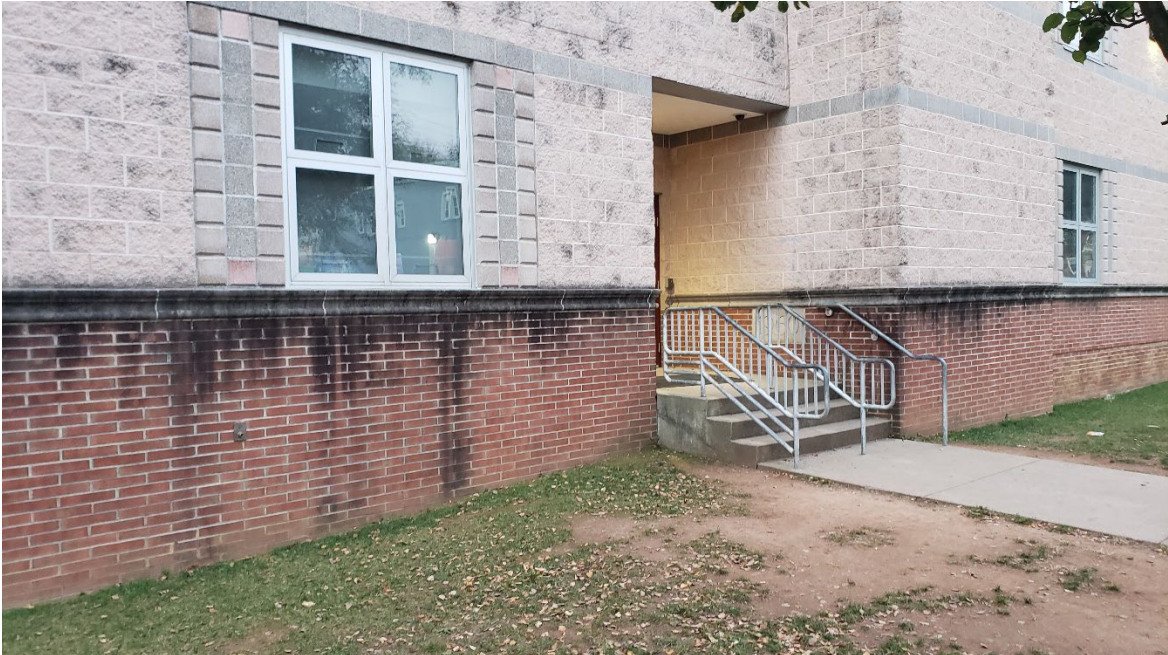
The building exterior consists of an insulated masonry cavity wall with modular brick and split/ground face CMU veneers at areas constructed in 2002. Older areas are similar except walls are not cavity construction. Precast stone stools and water table trim are included with window embellishments. The brick veneer is stained and darkened in areas, particularly below the water table cast stone and at the 2nd floor window sills. This is indicative of the sills and cast stone not having proper drip edges to prevent water from running down the face of the building.

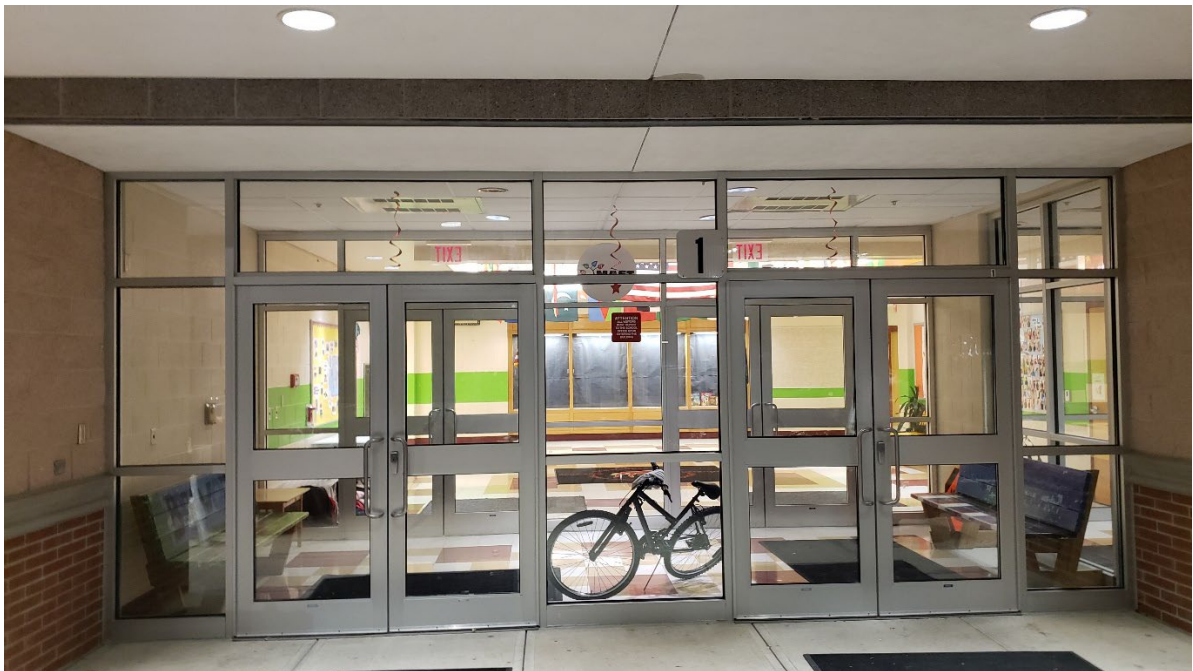
Windows are operable awning style aluminum windows with insulated glass. Entrances are aluminum storefront glazing systems. Doors and windows appear to be in good condition, except for issues with the sill details previous mentioned. Exterior double doors at entrances/exits should have pulls replaced so that doors cannot be chained together – a safety/security concern.

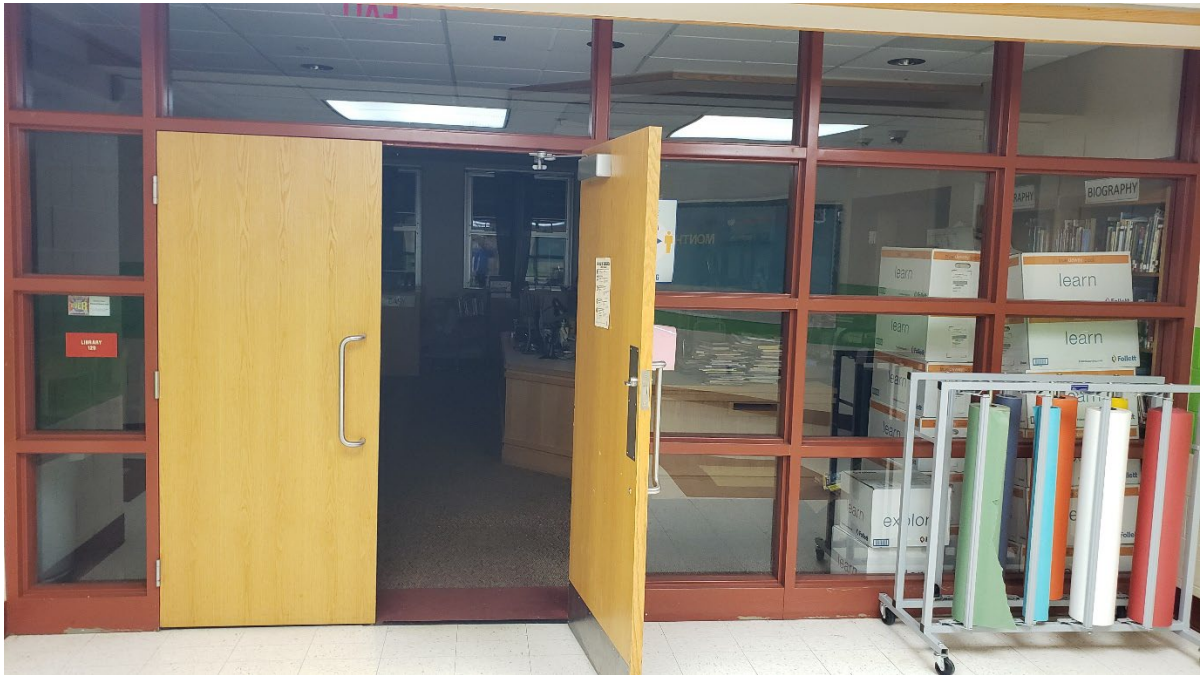
Interior doors are primarily wood set in hollow metal frames. Many frames are due for repainting. Doors generally are in fair to good condition.

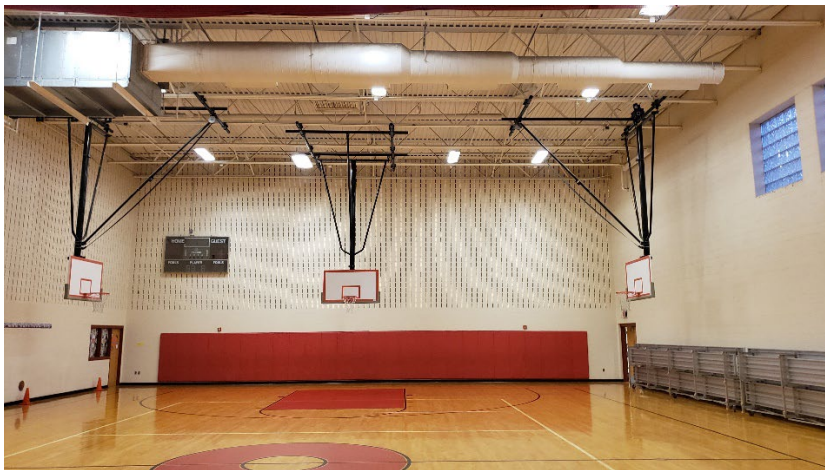
Acoustical wall pads in the multi-purpose room are heavily stained and should be replaced. The gymnasium has one main court and two side courts for a total of six basketball goals, which are in good condition. Wall pads in the gymnasium are in good condition. Corridor lockers are in good condition. Handrails and guard rails in stairways are due for repainting. Theatrical Equipment at the multi-purpose room stage is insufficient for performances. The stage floor is also in poor condition and should be replaced.

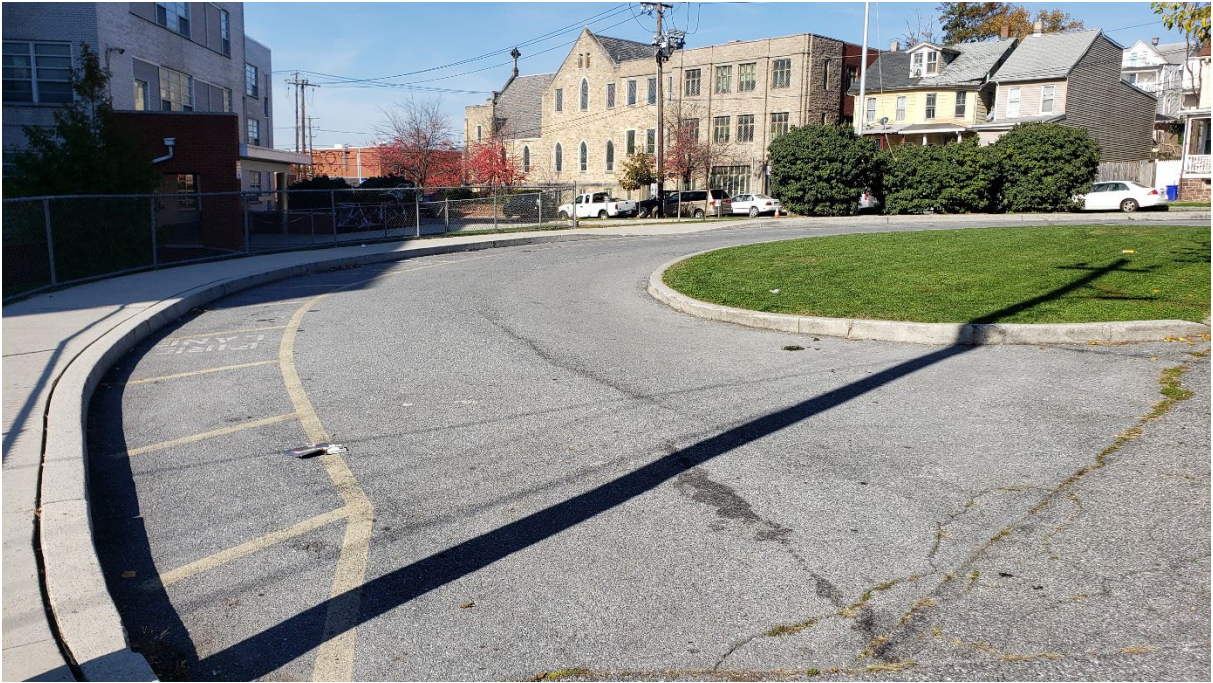
There are three on-site parking spaces. Staff and visitors rely on on-street parking within the surrounding neighborhood. There is an adjacent property with hard and soft surface play area, in addition to a soft-surface play area on the school property along Derry Street. The service/loading and refuse areas for the kitchen and school are on the east side of the school off of Berryhill Street.

Asphalt pavement is cracking on the north drop-off area. Concrete sidewalks are in fair condition, with some areas in need of repair. There is no accessible parking.

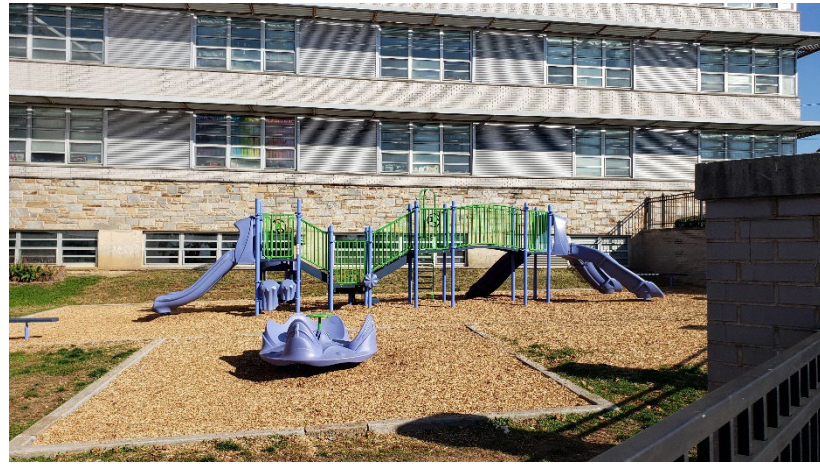
In the southeast corner of the building along Derry and Berryhill Streets is a soft surface playground. The play equipment appears to be relatively new and in good condition. The other soft-surface play area on the adjacent property also has relatively new equipment in good condition. The adjacent hard surface area with basketball goals is in fair condition with lines worn down.

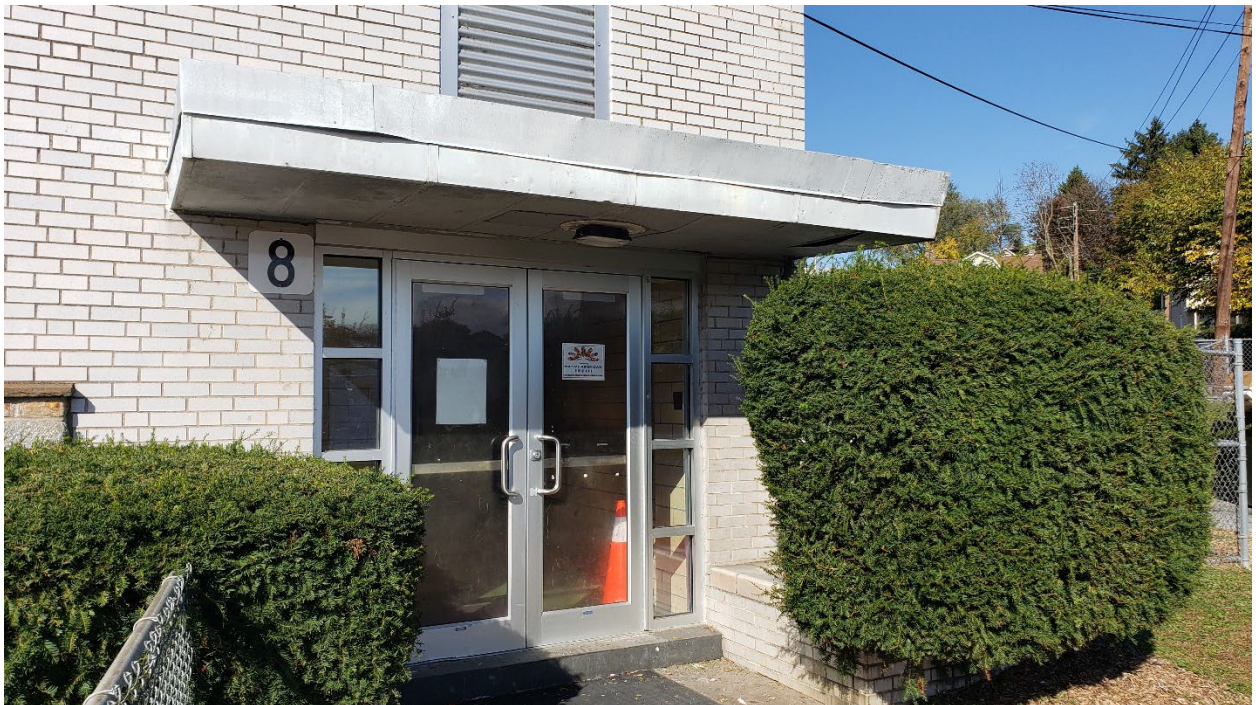
Windows are operable, hopper style aluminum storefront windows in generally good condition. Service doors are aluminum and have been recently replaced. Aluminum entrances are also in good condition, with only routine maintenance required. Exterior door hardware could allow double doors to be chained together, which is a safety and security concern.

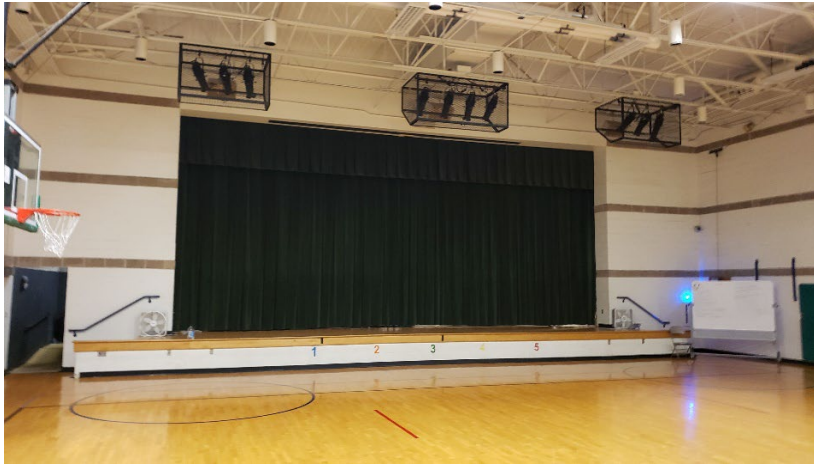
The multipurpose room has (1) half main basketball courts and (1) side court and are in good condition. Bleachers also appear to be in good condition. The stage curtains are torn and due for replacement. Lockers are generally in good condition.

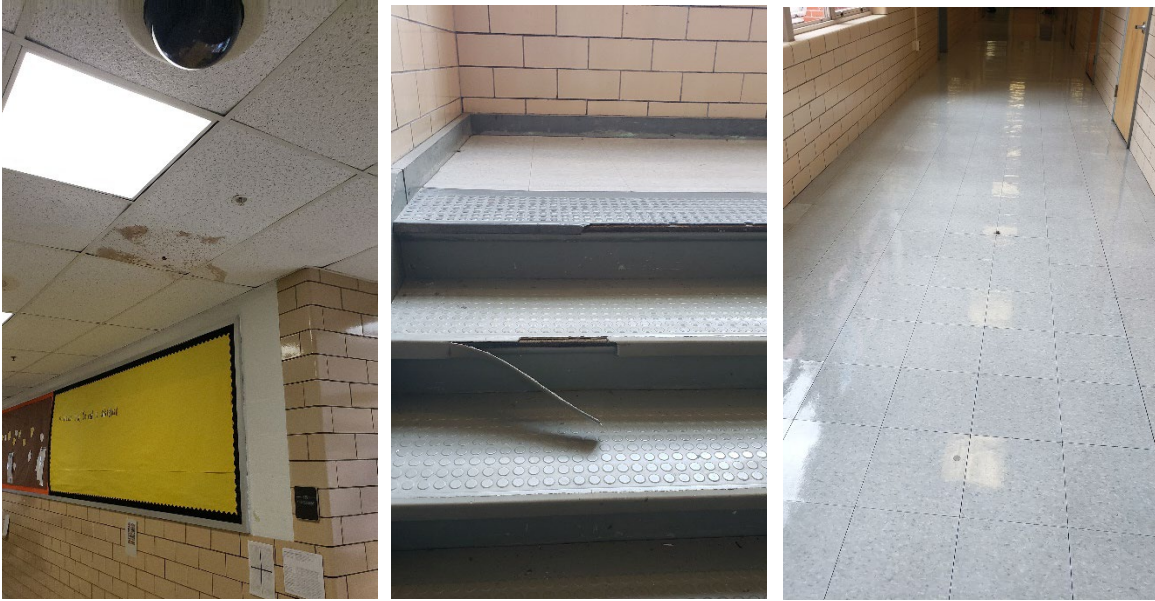
Ceilings are primarily suspended ACT, with some areas of painted plaster. The ceilings, regardless of type, are frequently damaged from water leaks – paint is peeling off of plaster and many ACT ceilings are sagging or stained.

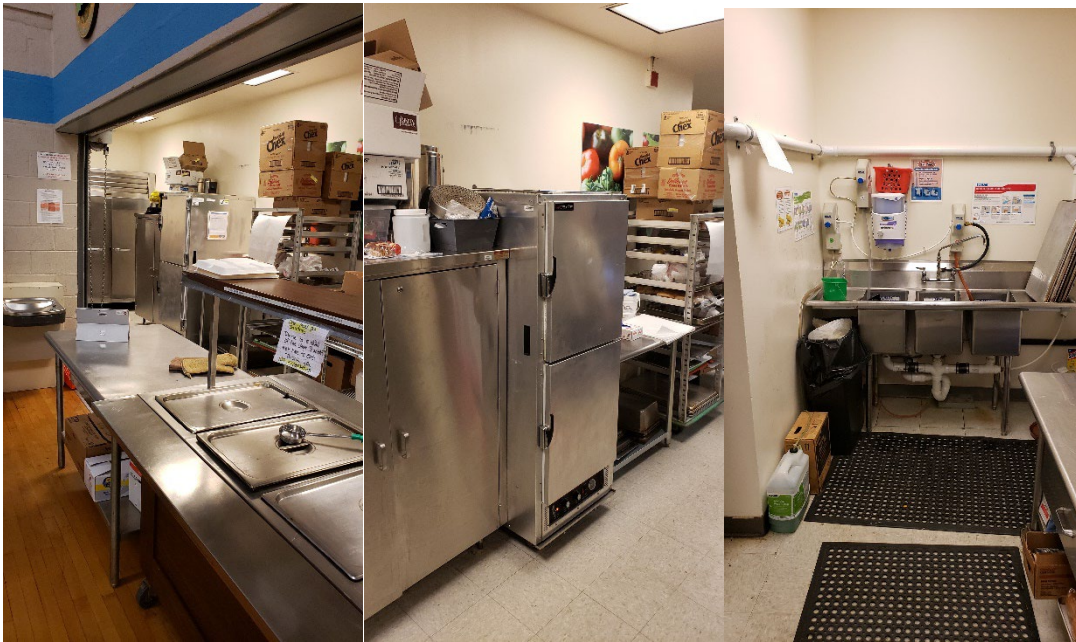
The cooking for Hamilton School is done on site. However, the entire Kitchen is extremely limited in size and equipment. The food service equipment was replaced in 1998 and is approaching the end of its useful life.
