Harrisburg School District

District Wide Facility Study

June 12, 2023

Crabtree, Rohrbaugh & Associates
Architects

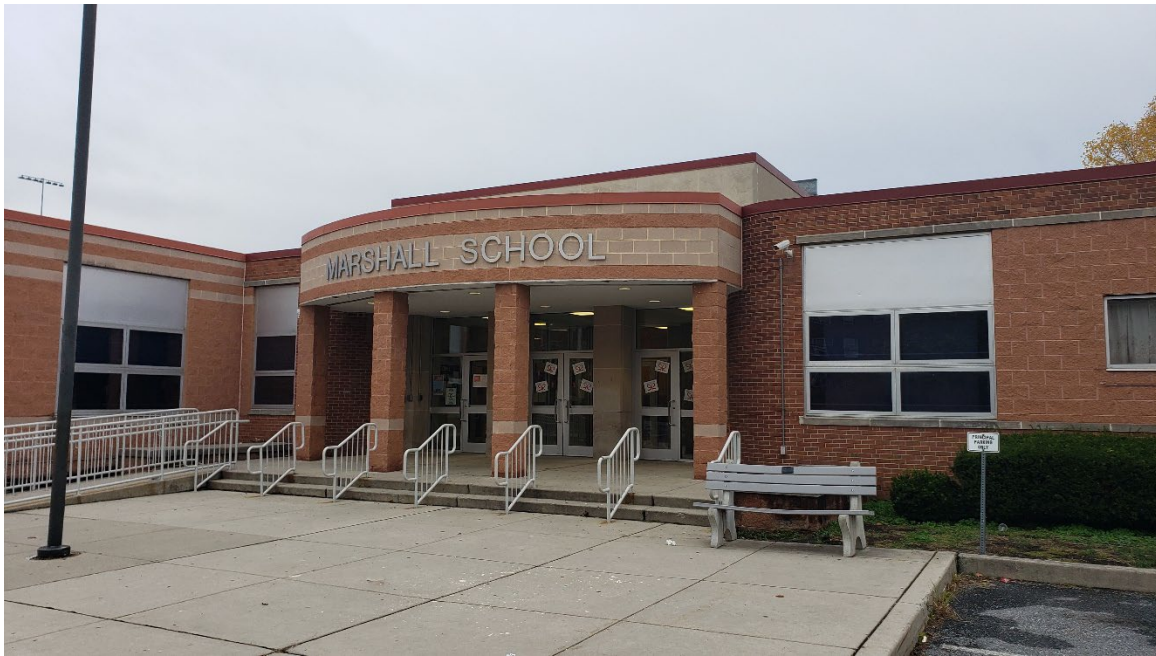
Sidewalks around the property are in good condition, however retaining walls around concrete stairs are deteriorating and should be replaced. Many galvanized handrails on site are also deteriorating and should be replaced.

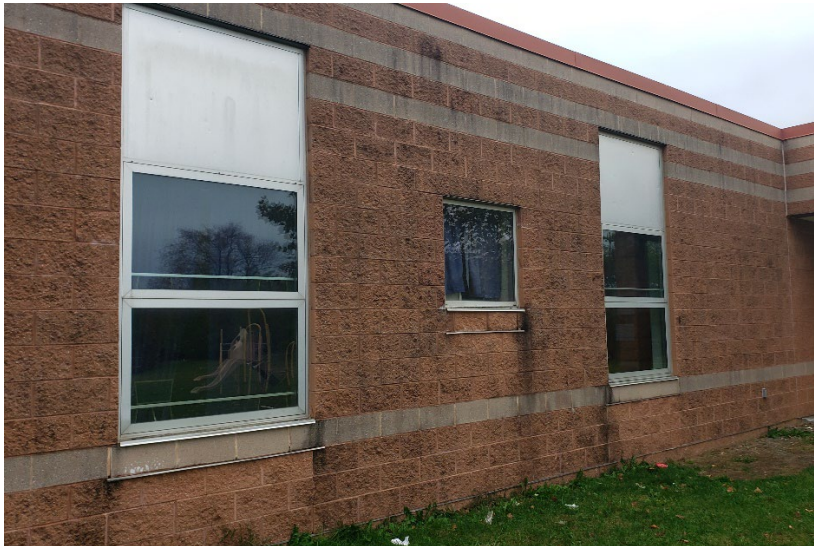
The exterior walls made up of a combination of modular brick and split face and ground face CMU. The entire façade is extremely dirty and due for cleaning all around.

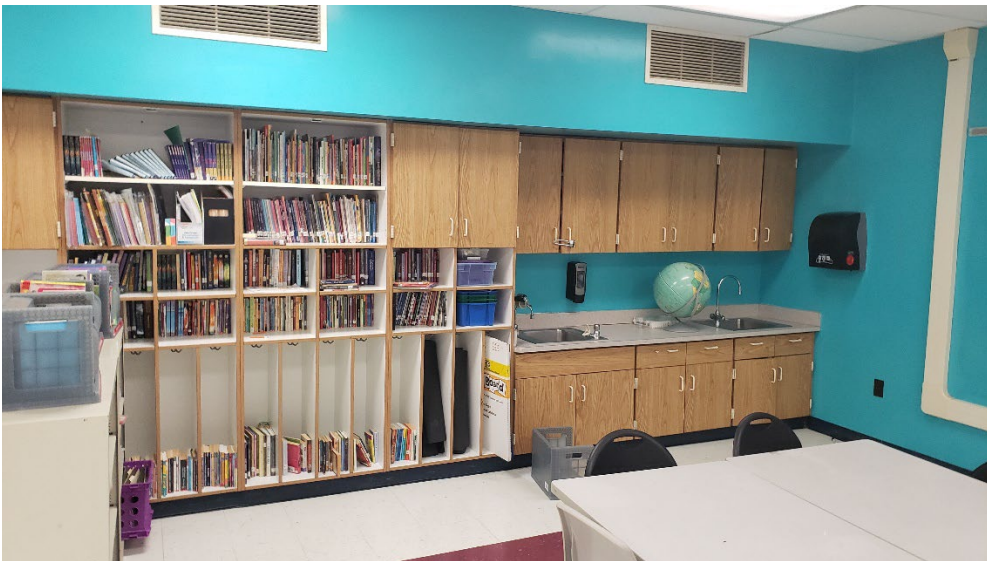
Casework throughout the building was replaced in the 2002 additions and renovations. Most casework is in good condition however sinks in casework are not compliant with ADA.

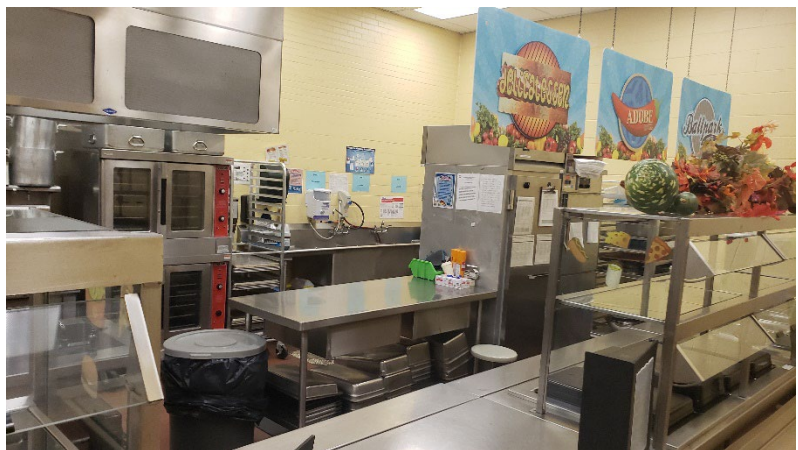
The cooking for Marshall Academy is done on site. Cold storage space at this school is inadequate, with small refrigerator/freezer units located within the cafeteria area. The food service equipment was replaced in the early 2000's and is approaching the end of its useful life. Dry storage space is also limited.

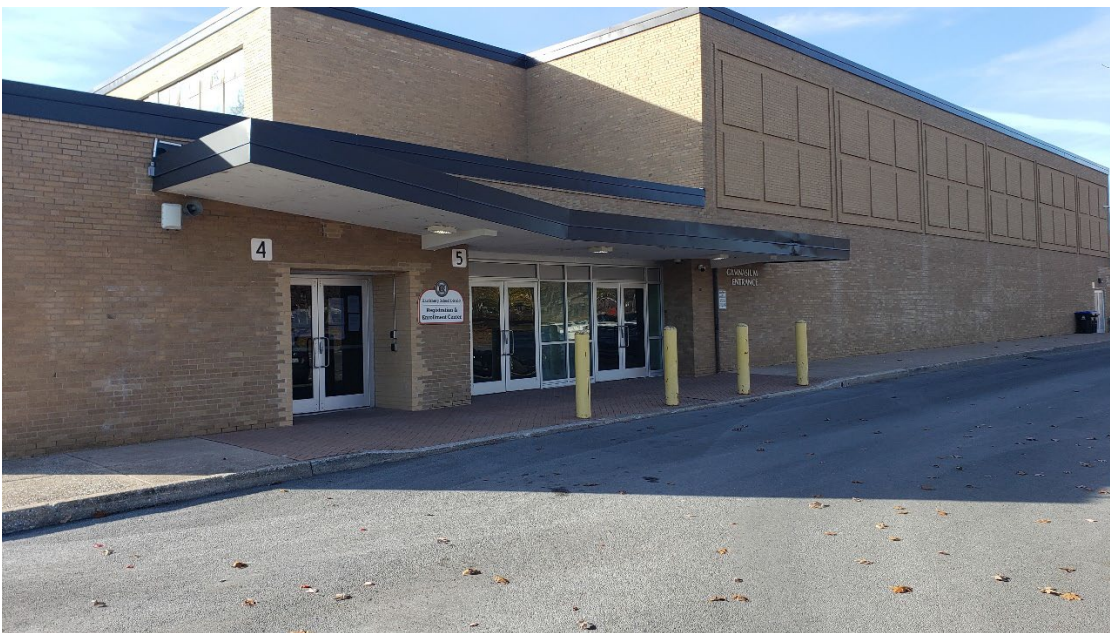
There are approximately 145 on-site parking spaces, split between the lots to the north of the building and the parking along the drop-off lane to the east of the building. Parking appears to be adequate for the school's needs. The service/loading areas for the kitchen and school receiving are part located near the north parking lots where they connect to the access drive between William Penn and Camp Curtin Academy. Dumpsters are located across the drive from the facility, in an enclosure.

Asphalt pavement is in fair to poor condition, with significant cracking and faded striping. Concrete sidewalks are in good condition, with occasional areas in need of repair, including at the curb cuts for wheelchair access. At the north entrance near the gymnasium, the asphalt drive and concrete sidewalk are level with the first floor elevation with bollards only partially blocking cars from driving onto the sidewalk. Additional bollards should be added.

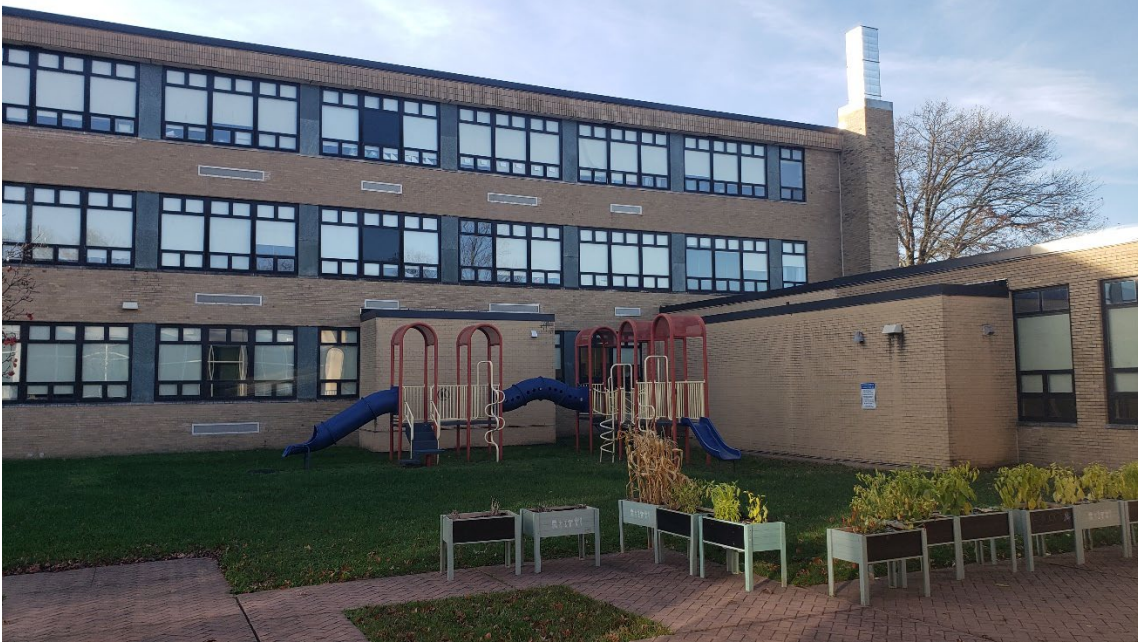
Within the courtyard there is playground equipment which is in fair condition. There is also hard surface play area with basketball and other equipment just southeast of the facility within a mostly fence-enclosed area.
