## Eastern Lebanon County School District

District-Wide Facilities Assessment

January 5, 2017

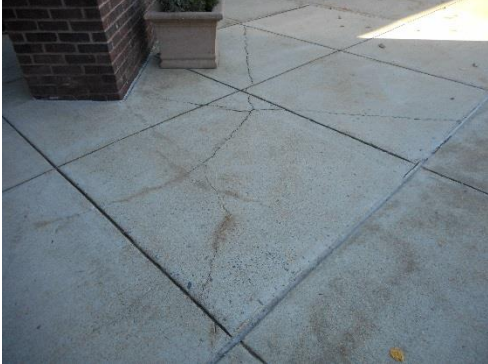
Sidewalks and Paving: The sidewalk along the front of the school appears to be in good condition with handicap access directly across from the existing handicap accessible parking spaces. The curb at the front entrance is deteriorating at the handicap entrance. Some heave and drop was noted in several areas at the front of the building and approach.

Area of heave and drop with cracking

ZES.SI.01 Repair areas of heave and drop to create level pavement.

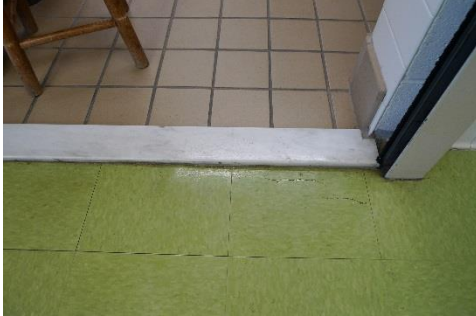
Flooring: The entry is VCT and in good condition. Several roll-up walk off mats were in use in the building entry and did not appear to cause tripping issues. Hallways/library were carpeted and appeared in good condition. Hallway surrounding the central area was traffic worn and damaged at the drinking fountain. Carpet in classroom wings appeared in good condition. Classrooms are partially VCT and carpet and were in good condition. Tripping hazard was noted at the transition from cafeteria to kitchen along the primary serving line.

Transition at cafeteria to kitchen – trip hazard

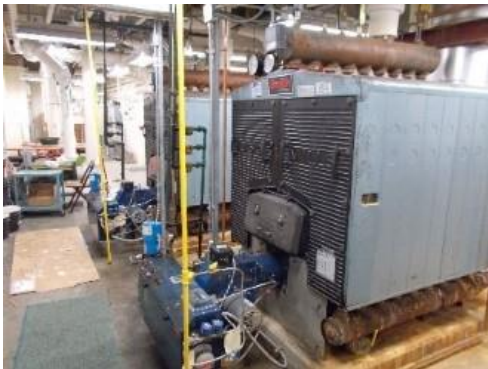
Hot water boilers

Two hot water boilers in the mechanical room serve the entire school. They were found to be in good condition except that they leak water at every shutdown and startup of the system which is causing premature corrosion.

- ZES.HVAC.01 Repair boilers to stop water leakage.
- ZES.HVAC.02 Replace exterior chilled water piping insulation.
- ZES.HVAC.03 Lower the height of thermostats.

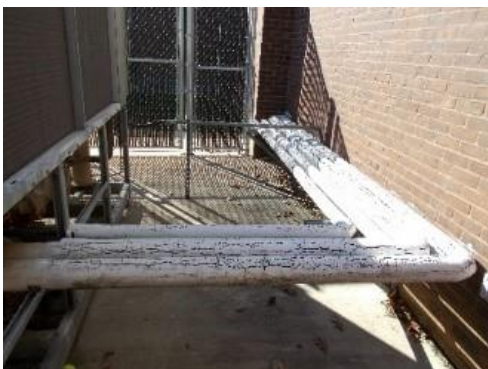
The chiller is located outside the building and was found to be in good condition. The exterior chilled water piping insulation is deteriorating and in need of replacement.

Exterior piping insulation

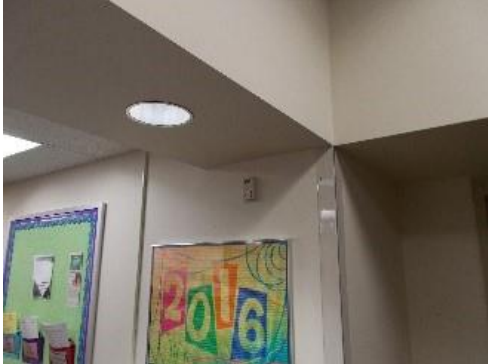
Many thermostats in the building were found to be installed high on the wall in spaces. This location may cause comfort issues due to not measuring the temperature at the occupied level of the room. We recommend lowering the thermostats to a more desirable height.

Thermostat

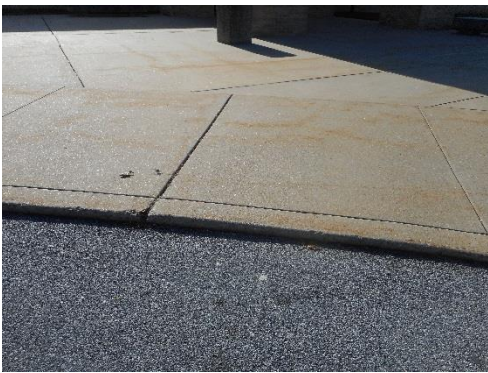
Sidewalks and Paving: The sidewalk along the front of the school appears to be in good condition but does not provide a flush section to allow for handicap access directly across from the existing handicap accessible parking spaces. The curb at the front entrance is deteriorating. Some heave and drop in the pavement elevation was noted at several spots.

Curb at building entry

JES.SI.03 Consider correcting uneven surfaces.

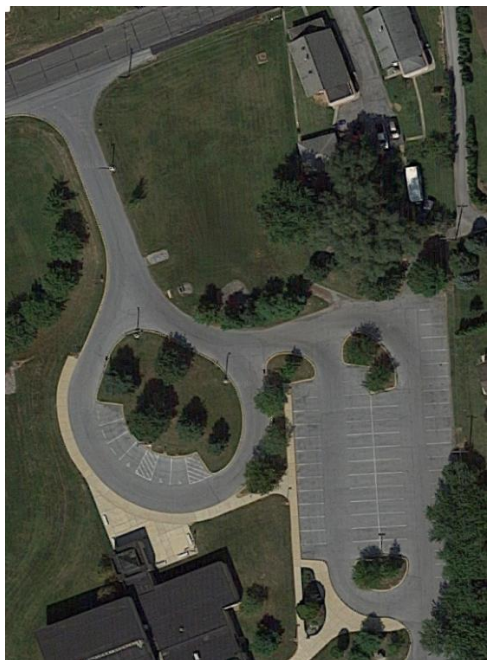
Storm Water Management: It appears that there is some type of detention basin or collection area to the east and west of the access road from Main Street. It was noted that the roadway and parking flood in that immediate area near the eastern retention basin.

Flooding at parking access

JES.SI.04 Review drainage in area of flooding and consider options to alleviate pooling of water on roadway and parking.

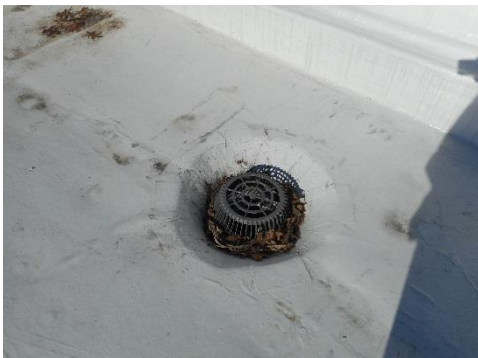
Roof: Restored coating to entire roof in 2015, Tremco 12 year treatment (reflective) warranty over black EPDM. Roof drain noted as clogged with organic debris.

*Roof drain with debris*

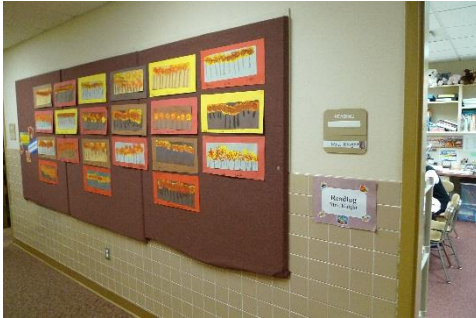
Delaminating tackable surface

Walls: Interior walls were a mixture of GWB, tile, and block depending on the location. Most wall surfaces were noted to be in good condition. Tackable wall surfaces in hallways were noted to be delaminating.

**JES.BI.03 Repair or replace tackable wall surfaces.**

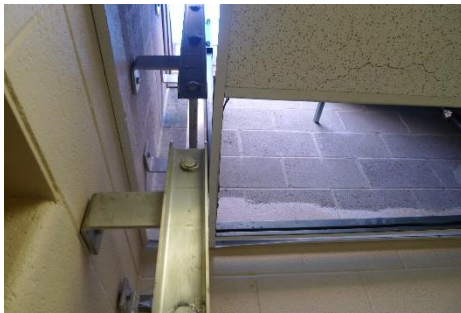
Ceilings: ACT ceilings were used throughout with areas of GWB ceilings. ACT ceiling at roof access causes an awkward obstruction and unsafe condition.

ACT at roof access

**JES.BI.04 Consider modifying/removing ACT ceiling at roof access to avoid obstruction.**

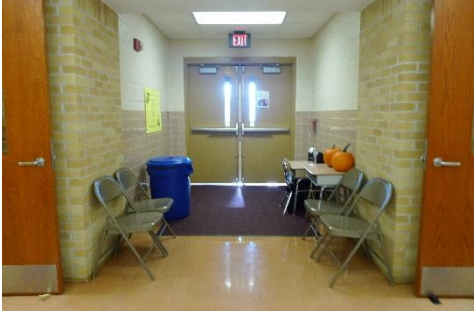
Egress path obstructions

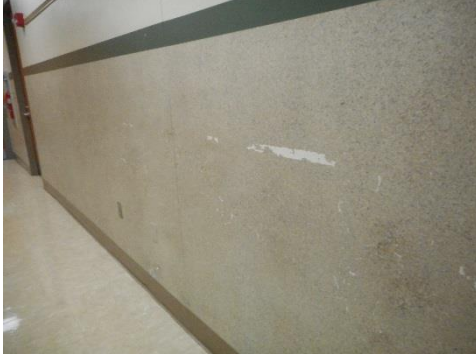
*Damaged GWB with specialty paint*

**EMS.BI.02 Consider an alternative to the specialty paint in high traffic areas.**

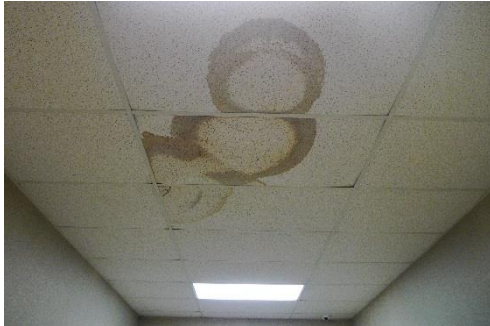
Visible water damage at ACT ceiling

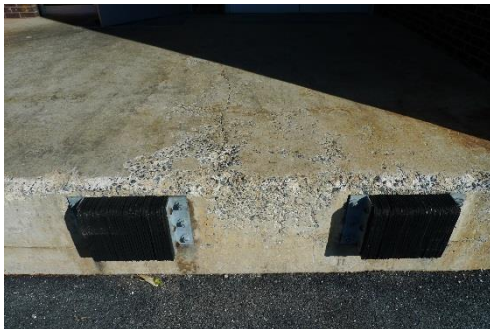
Deteriorating concrete loading dock edge

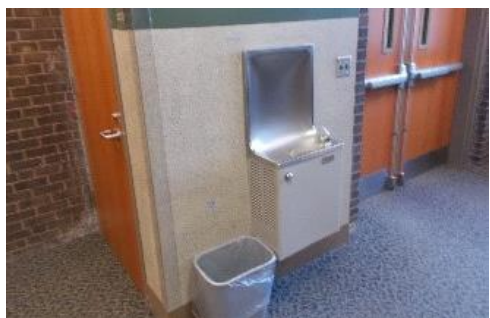
The plumbing system was found to be generally in good condition. The fixtures are in good condition and meet current ADA standards except for the water coolers. Current codes require both an ADA and Non-ADA water cooler be installed.

Water coolers not ADA compliant

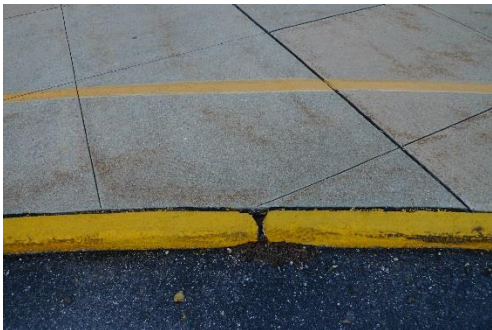
Portion of deteriorating curb at main entrance

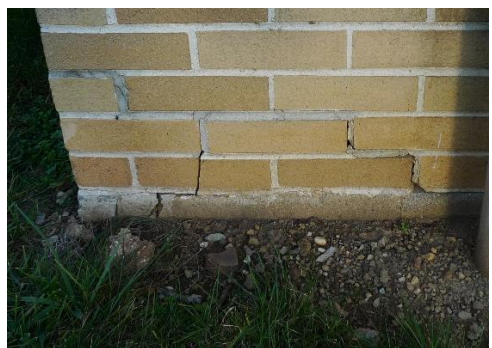
Typical brick and mortar deterioration

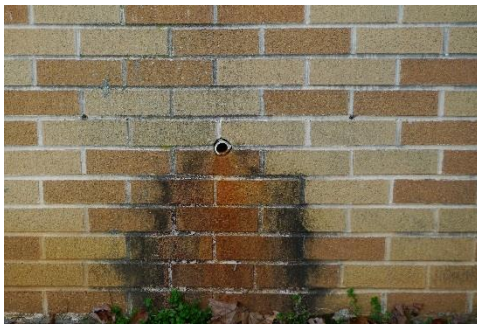
*Typical water discharge and deterioration*

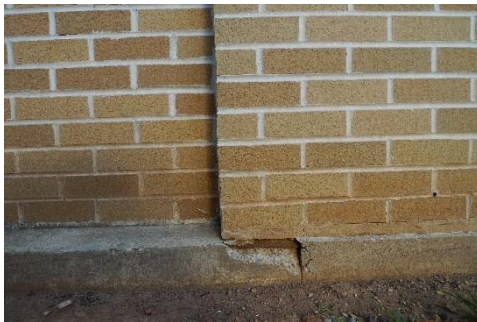
*Concrete deterioration at base*

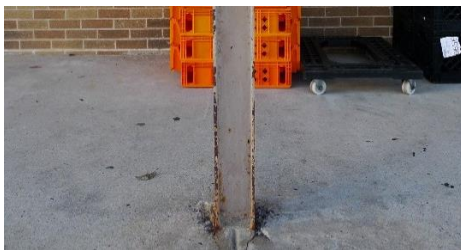
Exposed structural steel

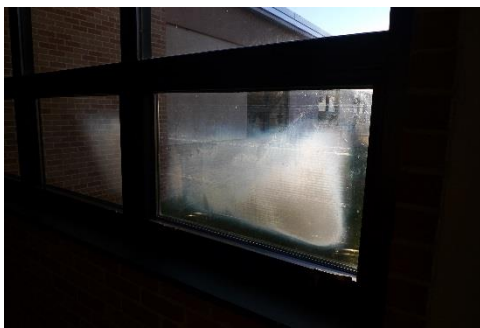
Seal failure on exterior glazing

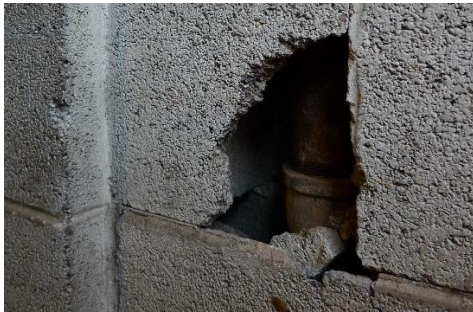
*Deteriorated block at interior*

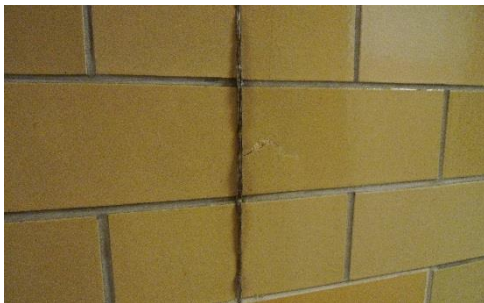
*Crack in block near mechanical room*

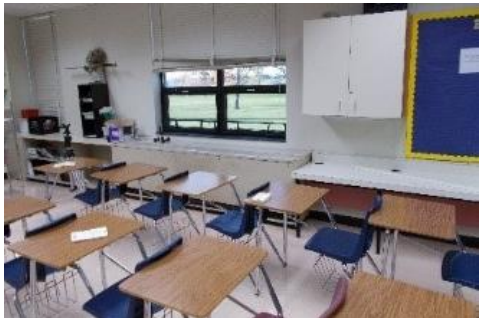
Outdoor air ventilation is provided through the classroom unit ventilators and through the rooftop units and air handlers. Ventilating classrooms through unit ventilators is not a modern approach and does not typically provide adequate ventilation.

*Typical classroom unit ventilator*
