# **INDOOR AIR QUALITY WATER DAMAGE ASSESSMENT**

**Barnstable United Elementary School  
730 Osterville W. Barnstable Road  
Marstons Mills, MA**

Prepared by:  
Massachusetts Department of Public Health  
Bureau of Climate and Environmental Health  
Indoor Air Quality Program  
September 2024

# **INDOOR AIR QUALITY ASSESSMENT**

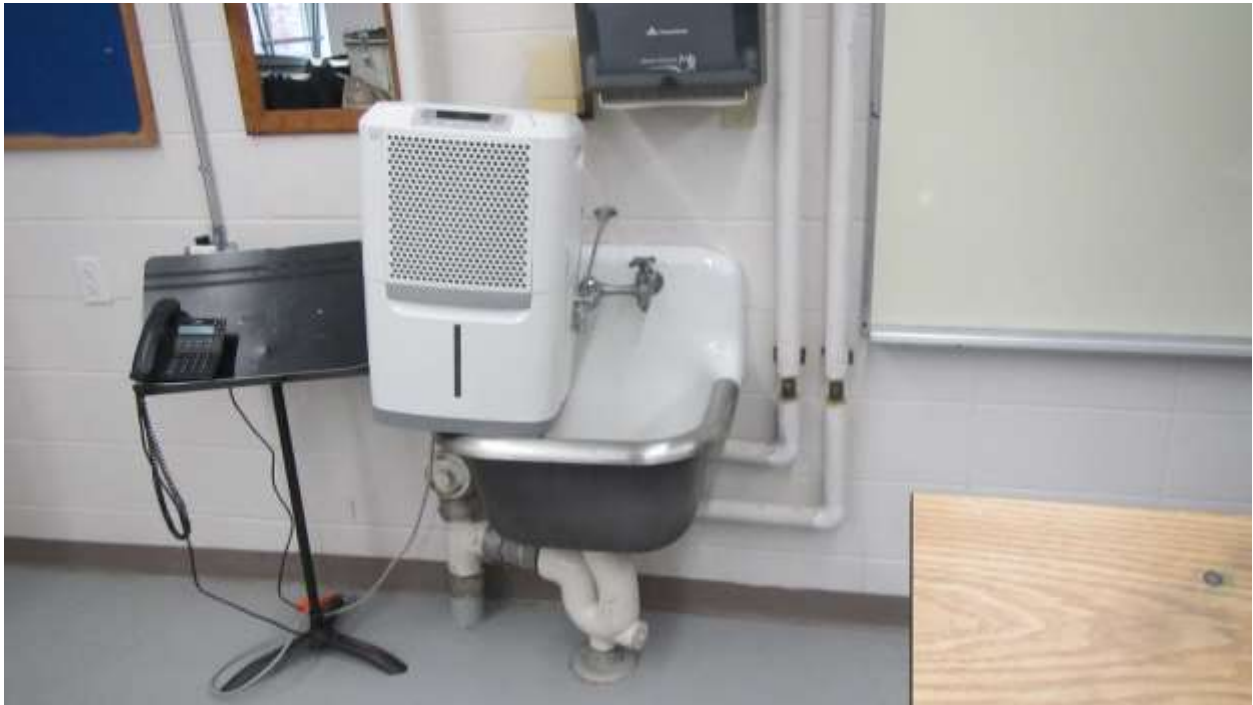
**Picture 1**

**Custodial sink with mold odor from dry drain trap**

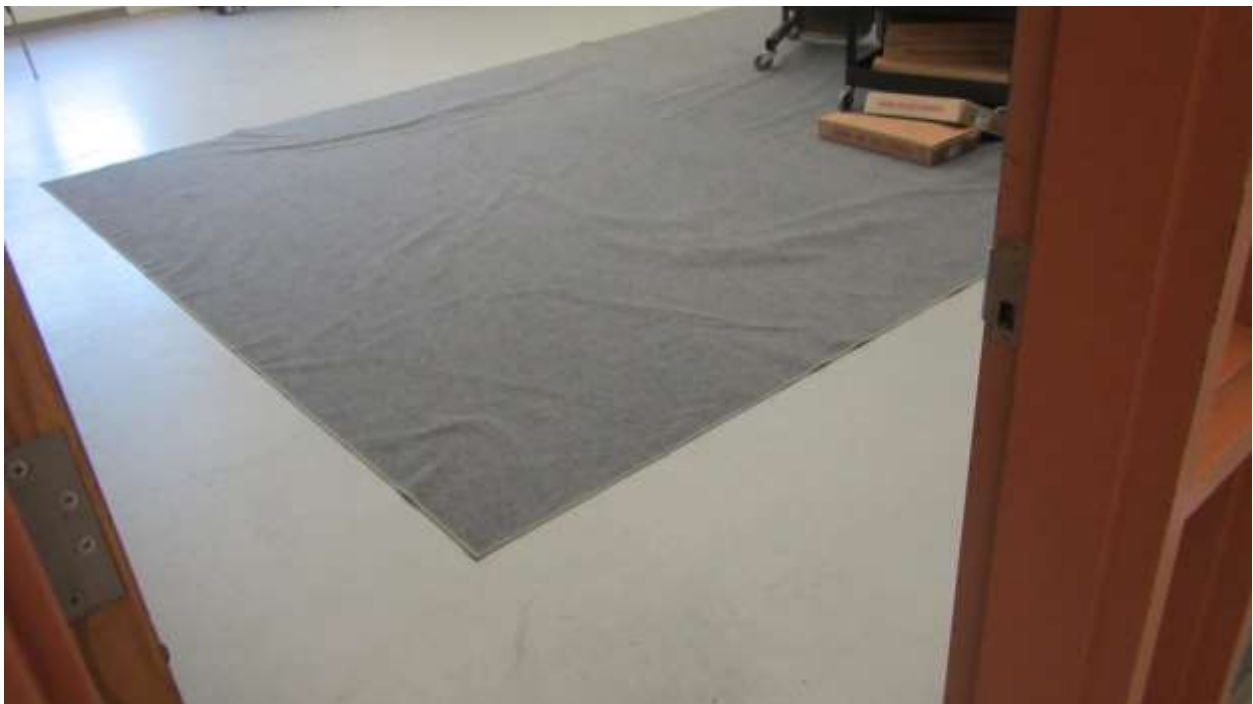
**Picture 2**

or staining, its location on the ground floor near the custodial sink with mold odors would make this carpet possibly cross-contaminated by mold (Picture 2).

**Carpet in music room**

7. Consider discarding the carpet in Picture 2.
8. Use of HEPA filter equipped air cleaners is recommended in classrooms to capture any airborne dust and debris, including mold, mold spores and/or pollen.

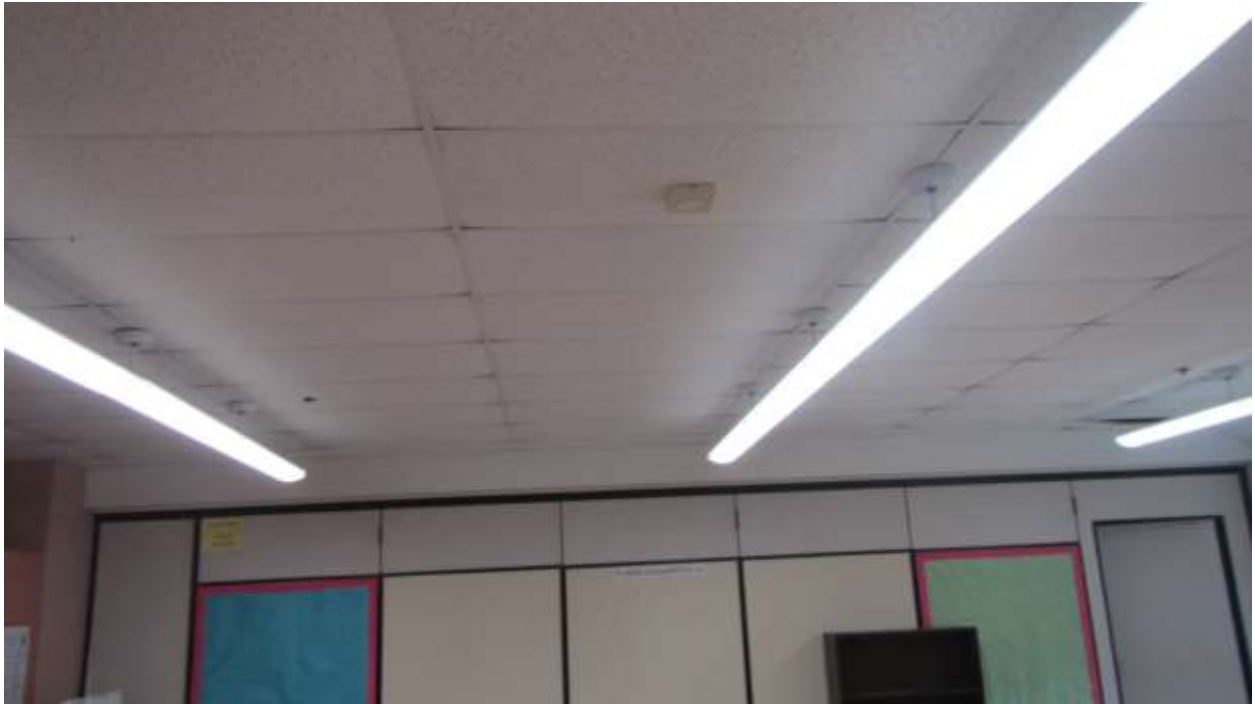
**Picture 3**

One sign of high relative humidity in the BUES is the presence of bowed ceiling tiles (Picture 3). If a building experiences high relative humidity (+70%) indoors over an extended period of time, moisture exposure may cause ceiling tiles to bow. It is recommended that porous material be dried with fans and heating within 24 to 48 hours of becoming wet (US EPA, 2008). If relative humidity is experienced indoors above 70%, use of open windows and floor fans to create air movement will help reduce stagnant air and mold growth.

Bowed ceiling tiles without discoloration or stains are not mold-colonized but are a sign of water vapor exposure. Bowing ceiling tiles are typically found in classrooms and cafeterias with sink or floor drains where the trap has dried. A trap is a section of pipe below the drain opening that fills with water to form an airtight seal. The airtight seal prevents sewer gas, odors, and water vapor from the drain systems from backup up the drain to enter occupied space. Depending on various conditions, water evaporates from the trap if a plumbing device is not used for several days.

**Bowed ceiling tiles**

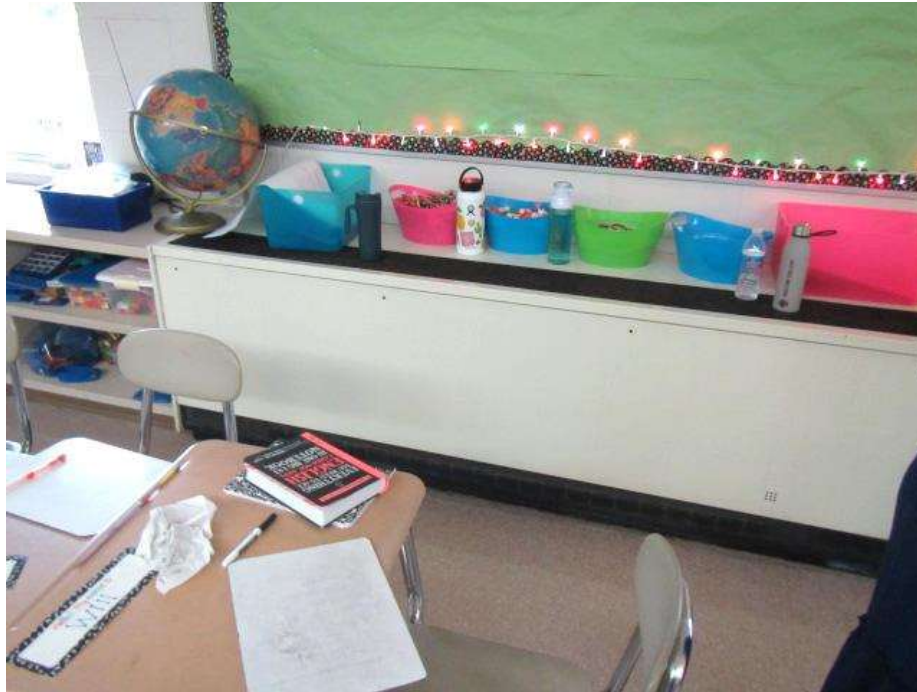
**Picture 1**

**Classroom univent**

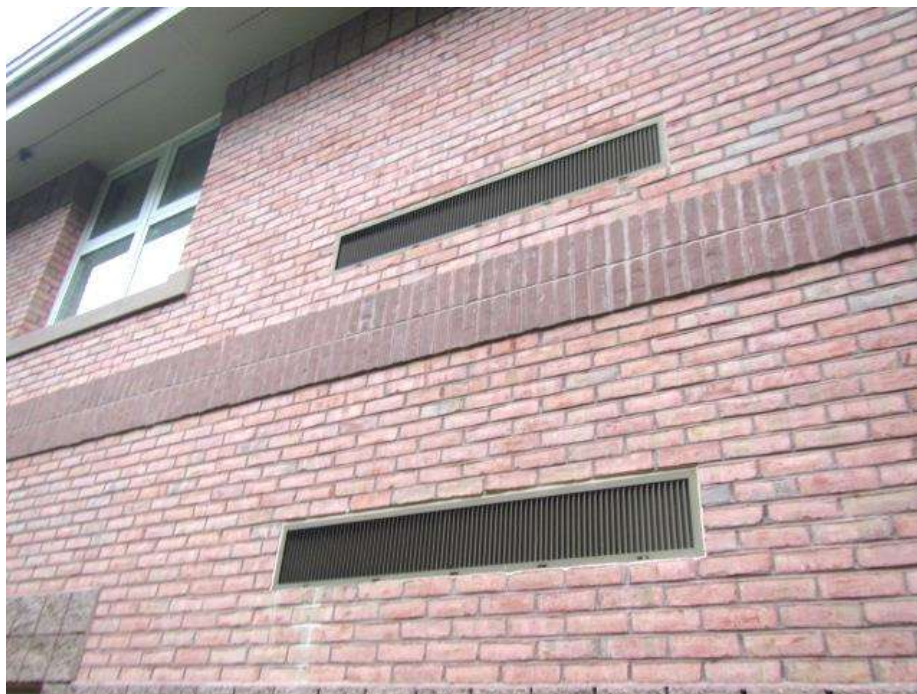
**Picture 2**

**Univent fresh air intakes**

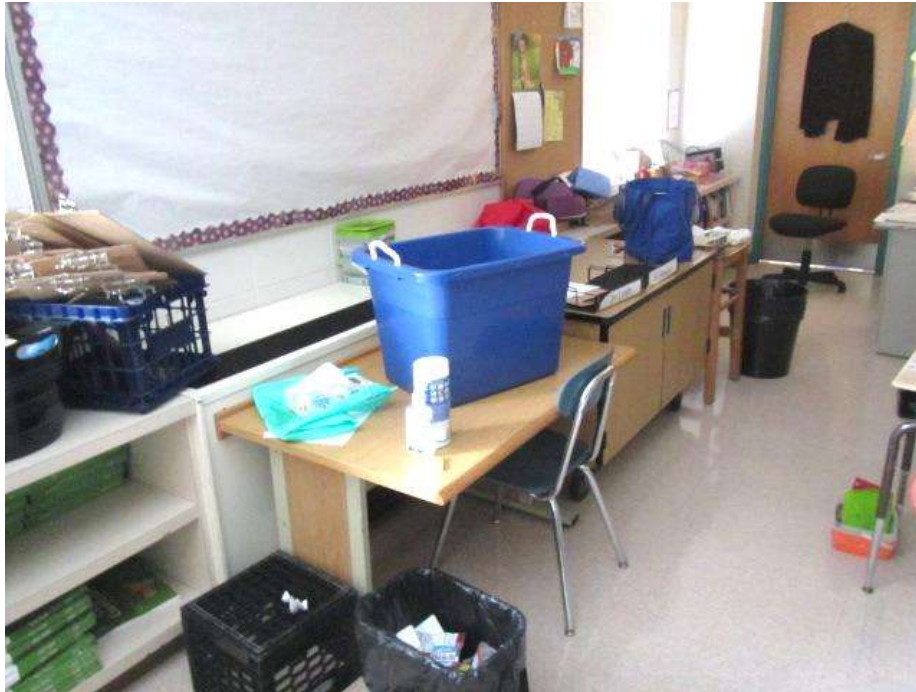
**Picture 3**

**Univent return vent (bottom front) obstructed by classroom furniture**

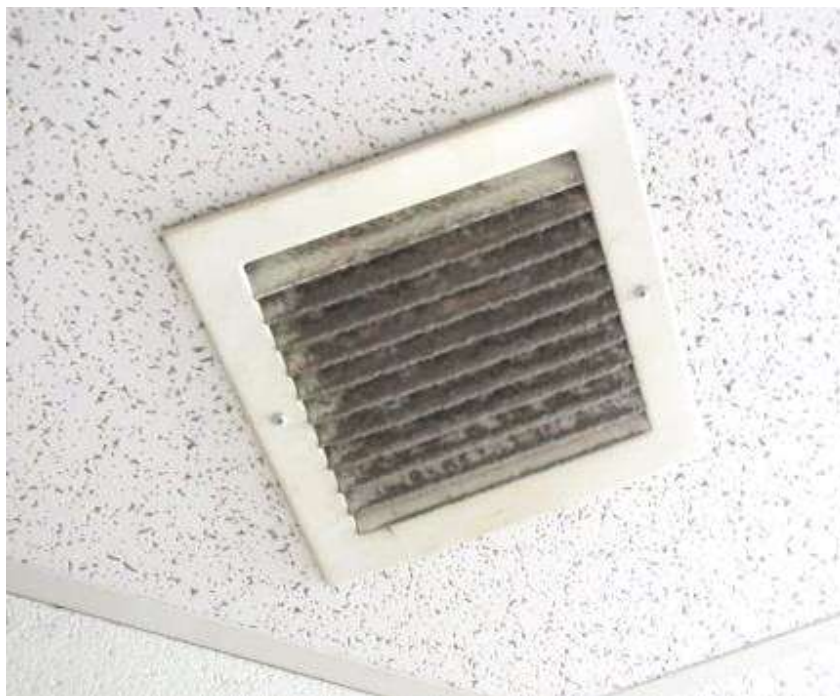
**Picture 4**

Classroom exhaust vents are located in the ceilings (Picture 4) and are connected with ducts to exhaust fans on the roof. A number of these exhaust vents were not drawing air during the assessment. Note that in many classrooms, exhaust vents were located near classroom doors (Picture 5). This design works best with the doors to the hallway closed, otherwise the exhaust vents tend to draw air from the hallway rather than the room which reduces the effectiveness of air circulation. Without adequate supply and exhaust ventilation, excess heat/humidity and environmental pollutants can build up and lead to indoor air/comfort complaints.

**Classroom exhaust vent, note accumulated dust/debris**

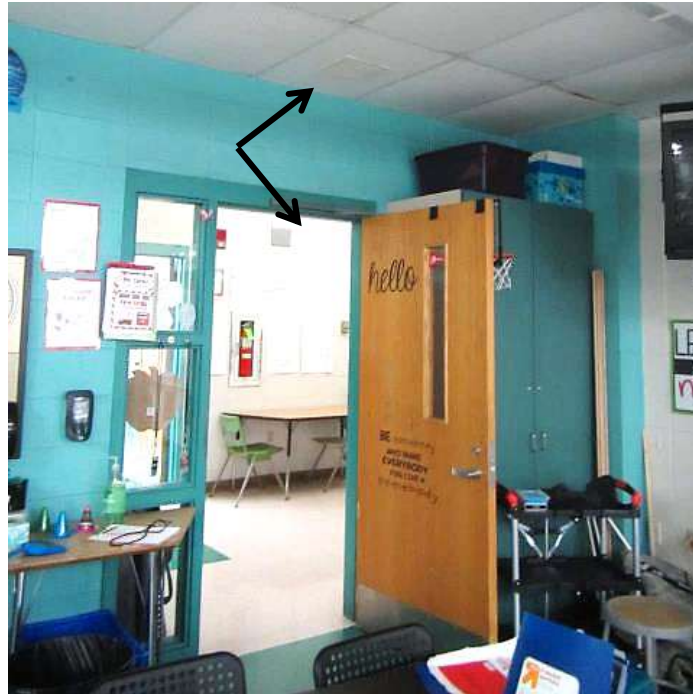
**Picture 5**

**Proximity of classroom exhaust vent (arrows) to open hallway door**

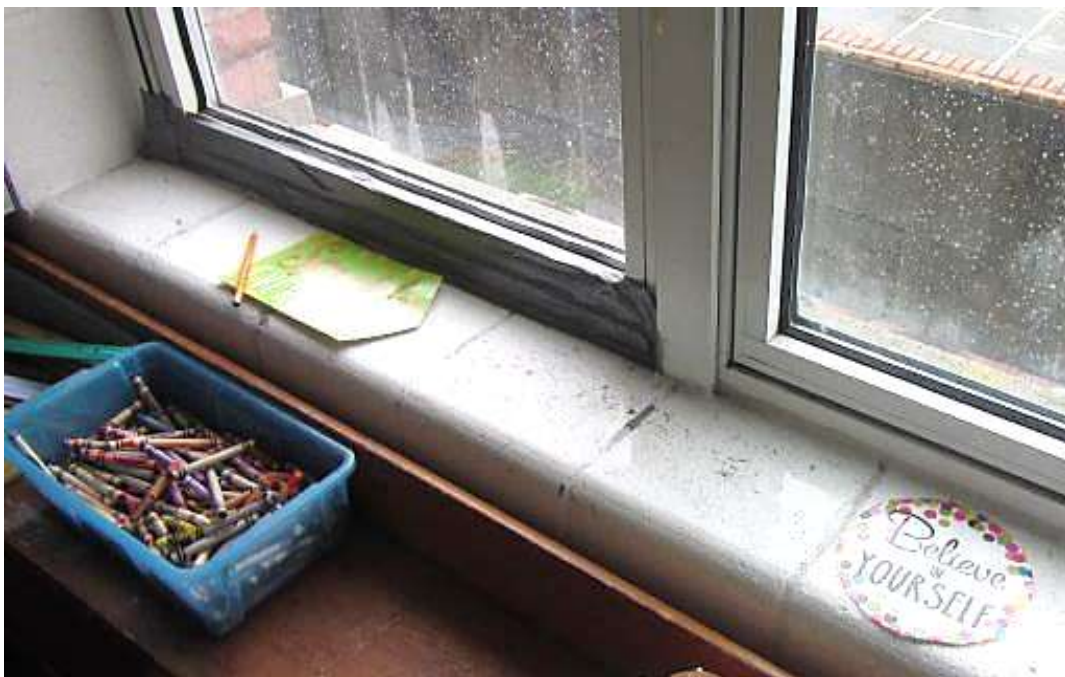
**Picture 6**

In order for building materials to support mold growth, a source of water exposure is necessary. Identification and elimination of the source of water moistening building materials is necessary to control mold growth. In the case of the BUES, the main sources of moisture creating conditions conducive to mold growth are relative humidity and operation of the AC system. However other sources of water damage are typically present in most buildings such as roof/window leaks (Picture 6) as well as leaks/condensation from HVAC systems and plumbing.

**Standing water from active leak on masonry/windowsill in classroom 215, note duct tape on left window**

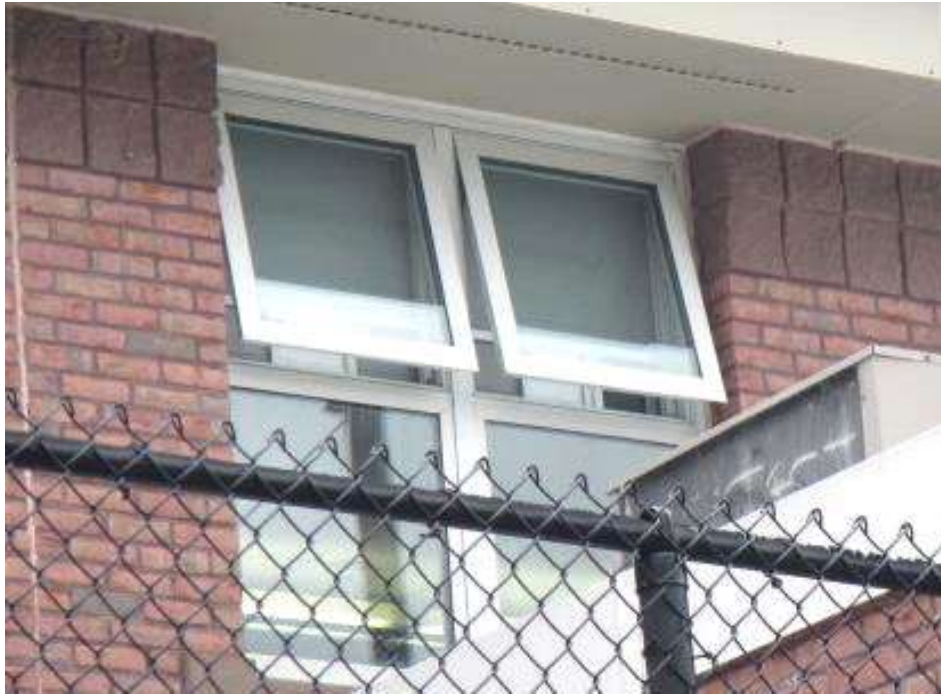
**Picture 7**

**Classroom windows open while AC system in operation**

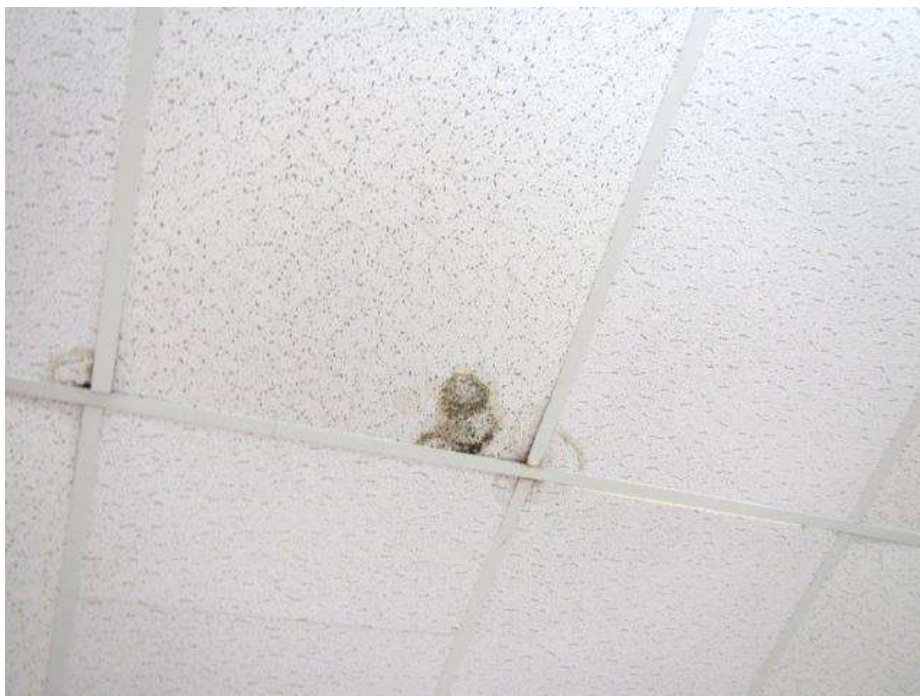
**Picture 8**

**Water-damage/mold growth on ceiling tiles room 219**

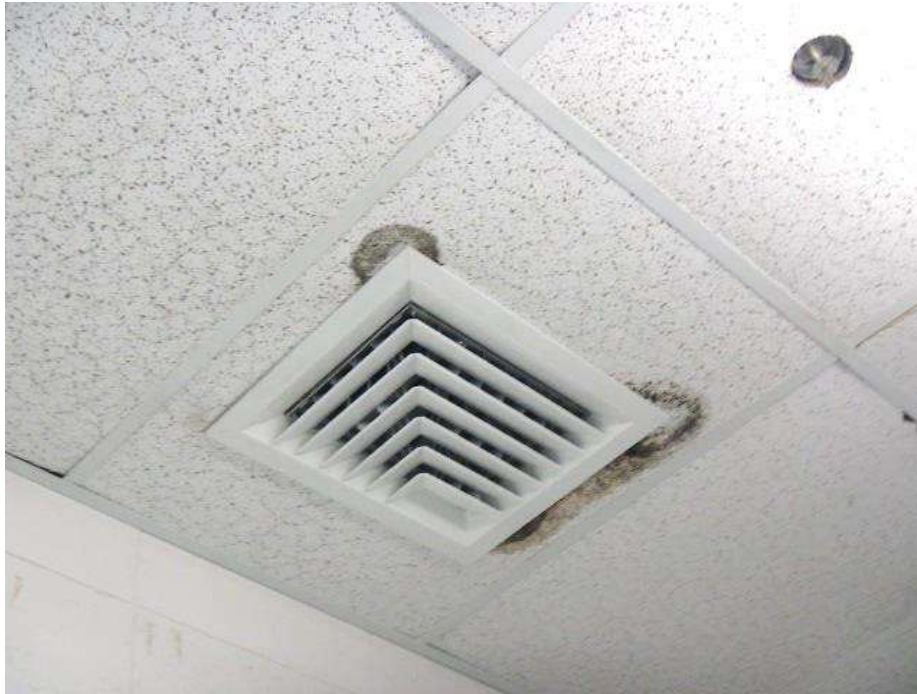
**Picture 9**

**Water damage/mold growth on ceiling tiles room 107**

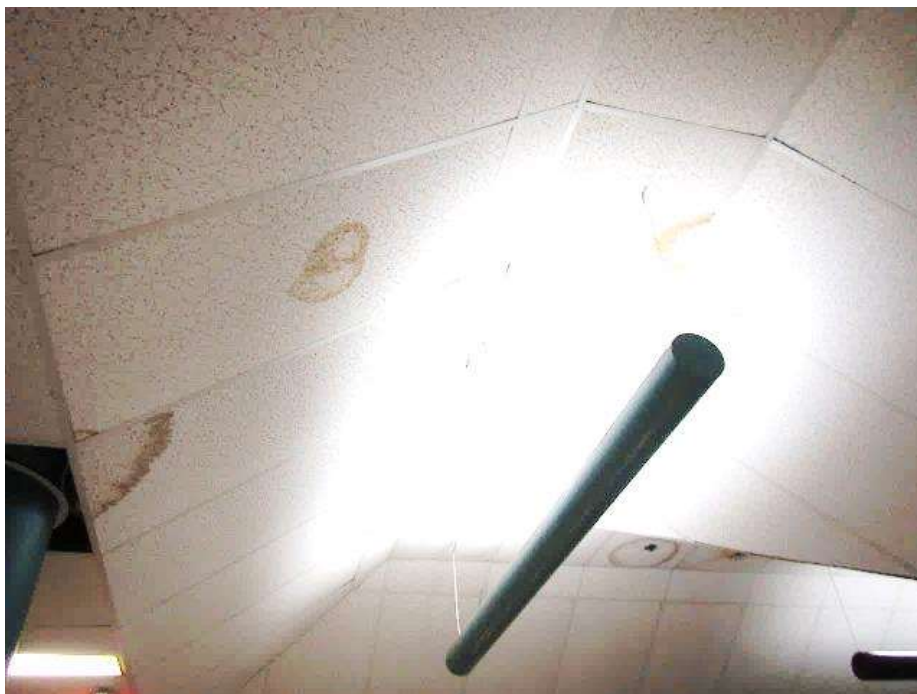
**Picture 10**

**Water-damaged ceiling tiles in 2<sup>nd</sup> floor hallway near Room 217**

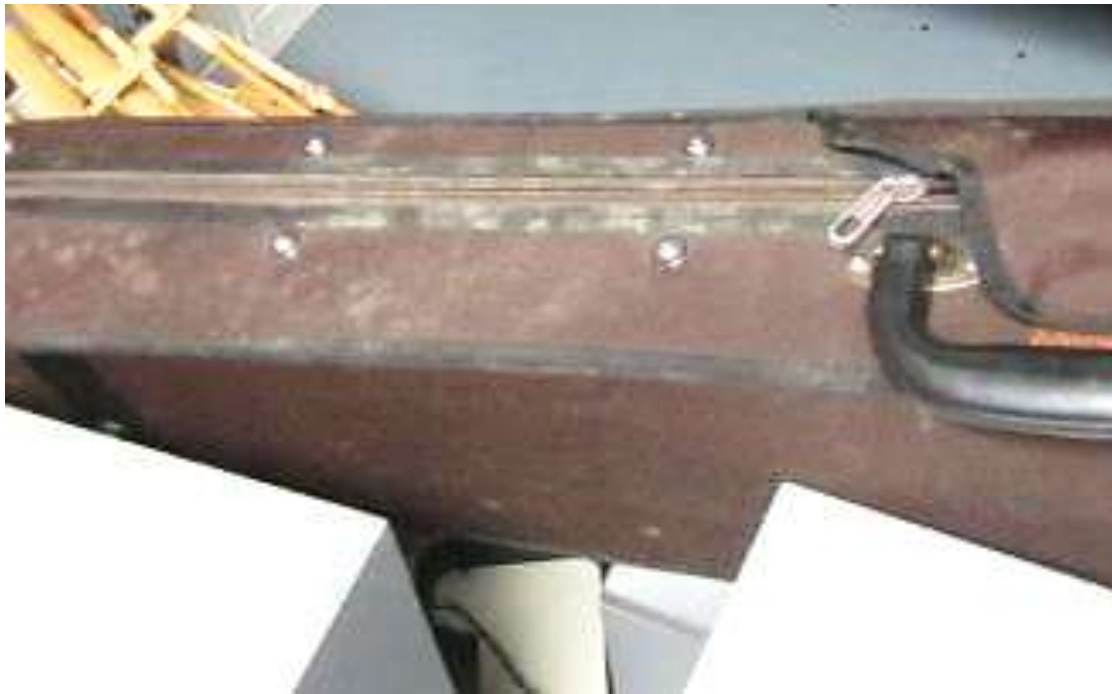
**Picture 11**

**Mold growth on instrument case in band storage room**

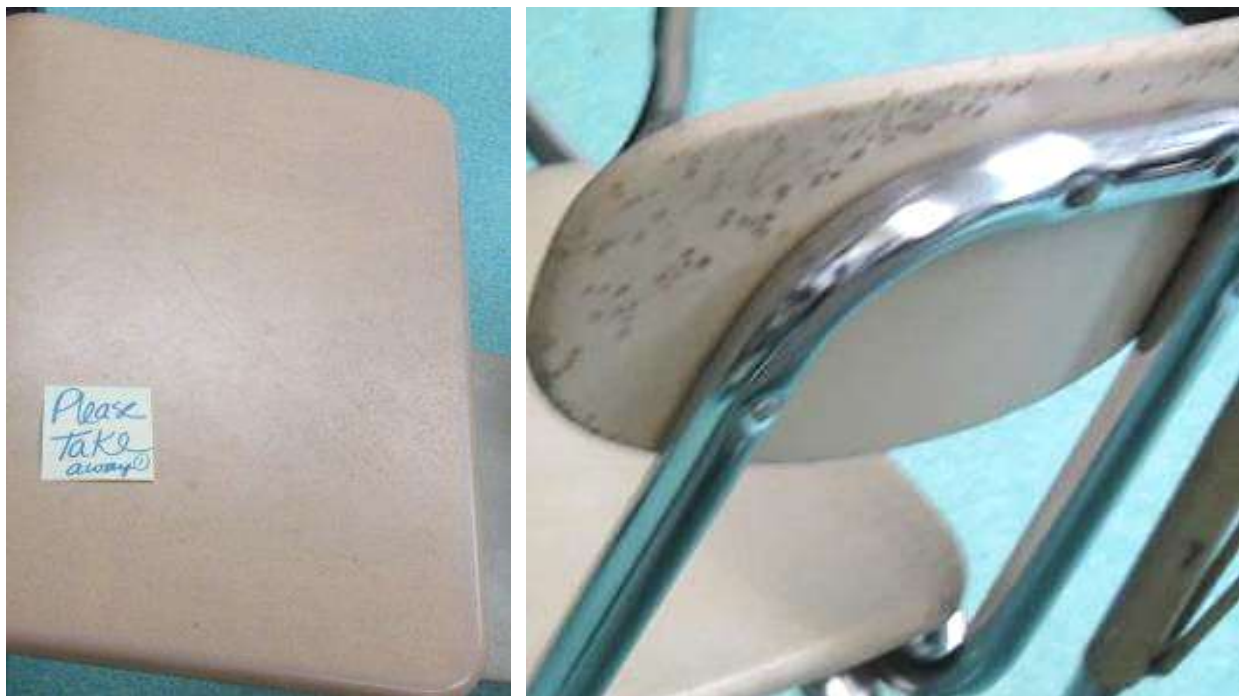
**Pictures 12a and 12b**

**Mold growth on chair/desk unit labeled "Please Take away"**

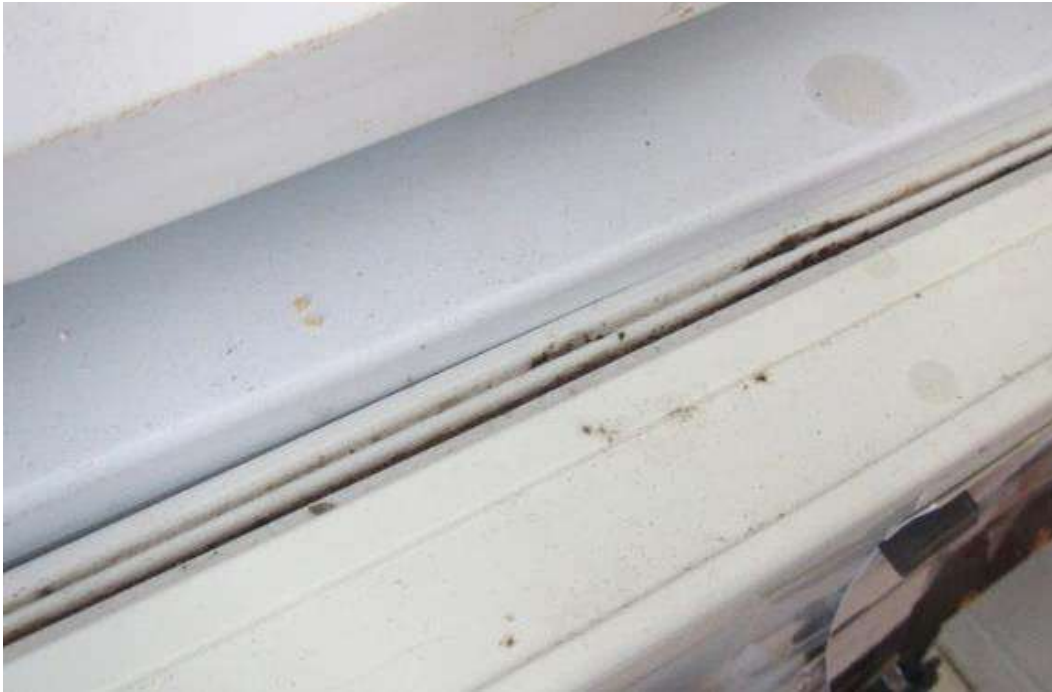
**Picture 13**

**Debris/mold growth on mini-fridge gasket in classroom**

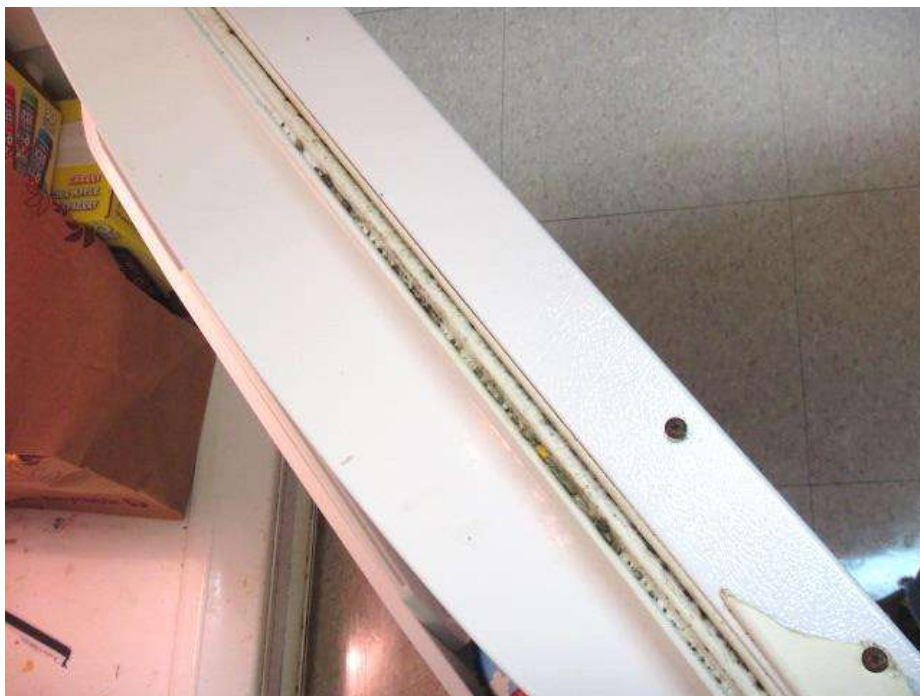
**Picture 14**

**Debris/mold growth on mini-fridge gasket in Faculty Lounge**

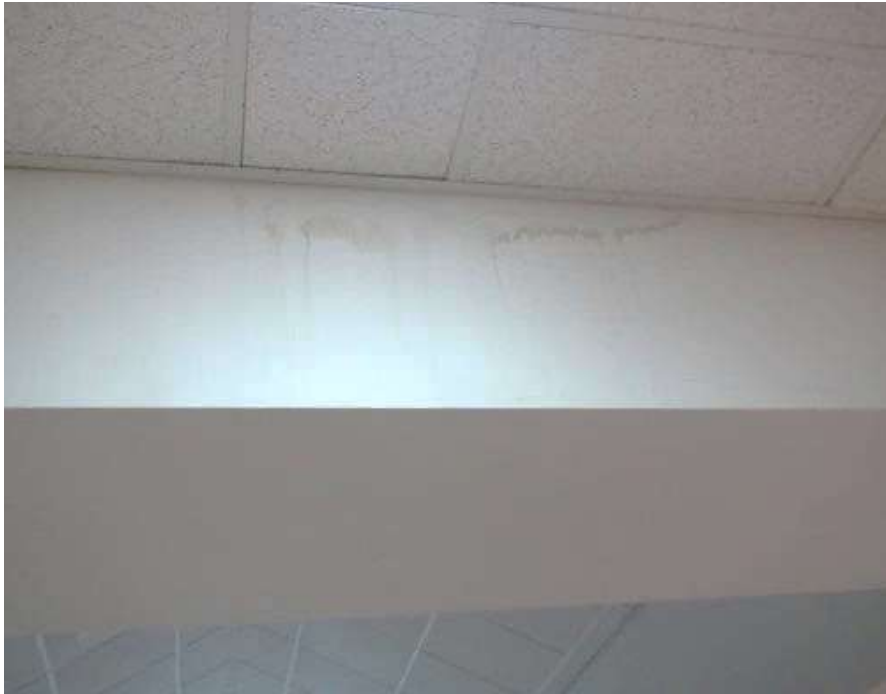
**Picture 15**

**Water-stained gypsum wallboard outside Library**

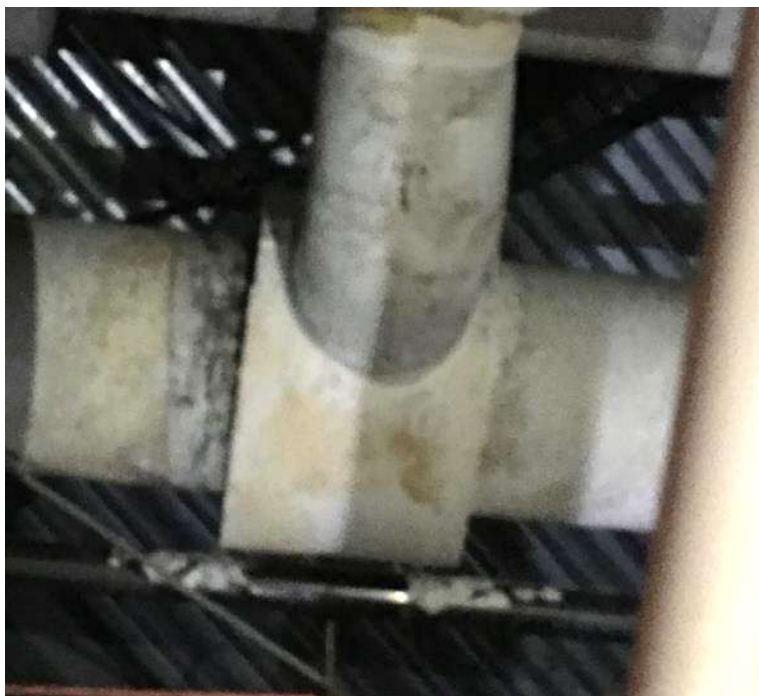
**Picture 16**

**Insulation material in art room closet**

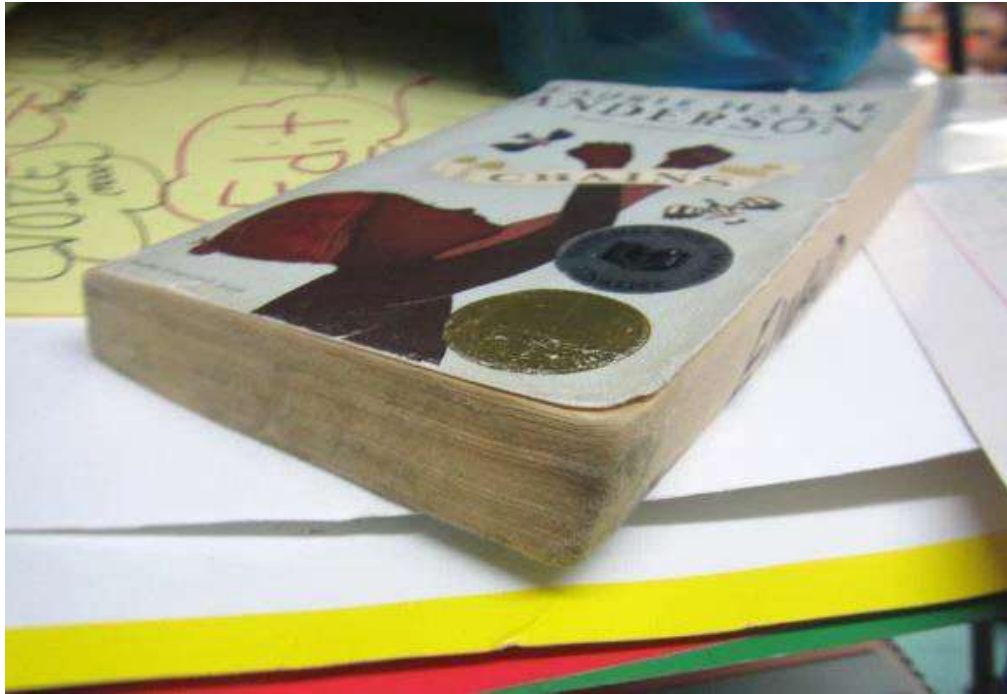
**Picture 17**

**Mold growth on book in closet in Room 207**

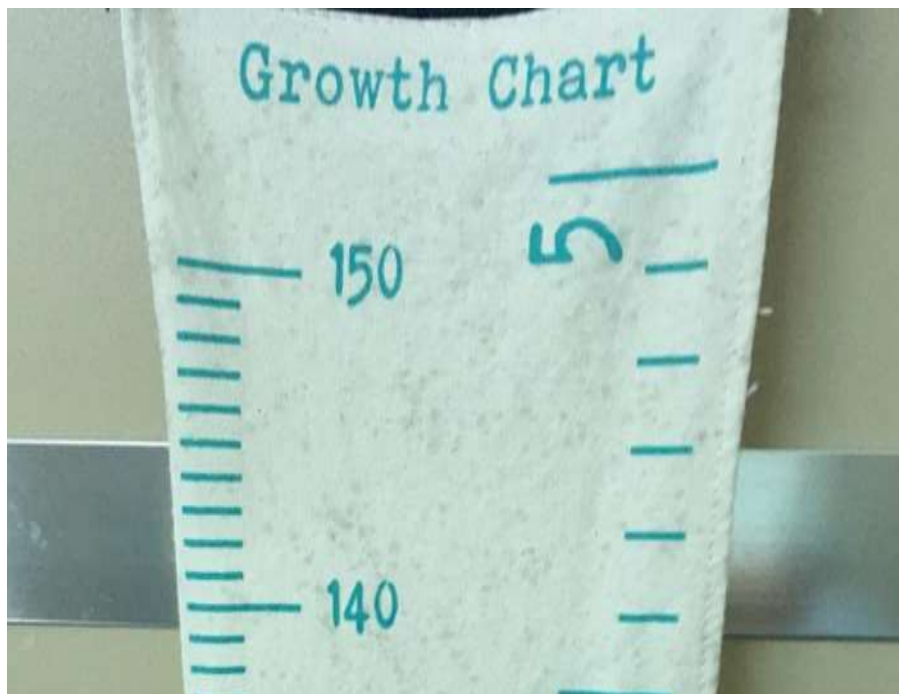
**Picture 18**

**Staining from mold growth on fabric classroom item**

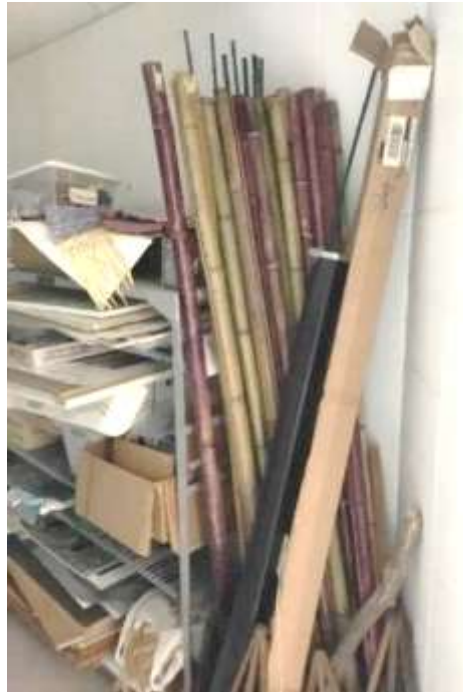
**Picture 19**

**Moldy/odorous bamboo in Art room closet**

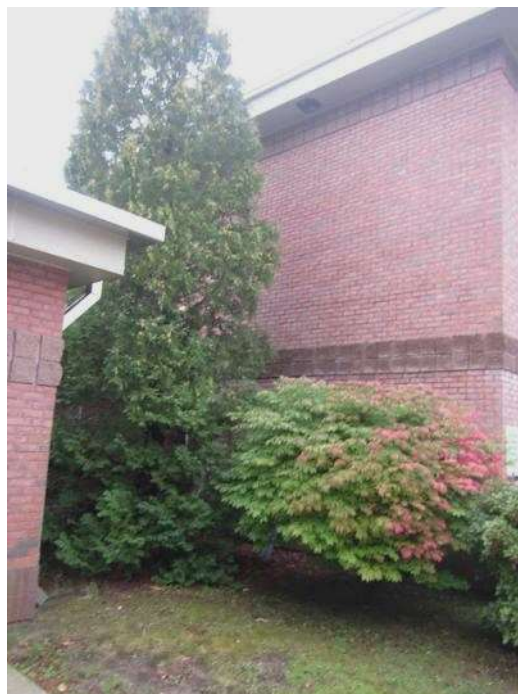
**Picture 20**

**Trees/shrubbery in close contact with exterior walls**

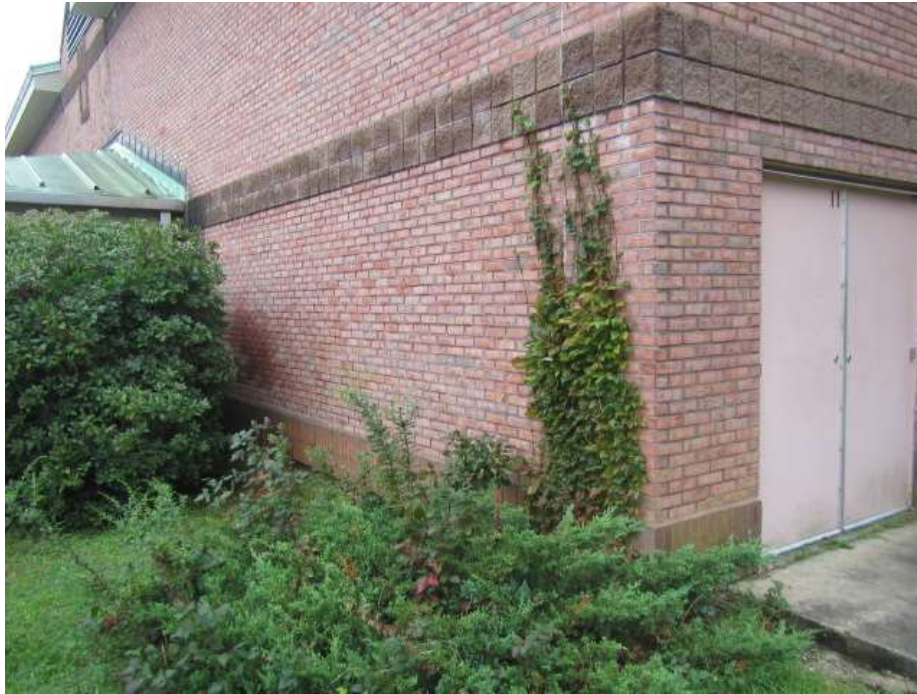
**Picture 21**

**Trees/shrubbery in close contact with exterior walls, also note clinging plants**

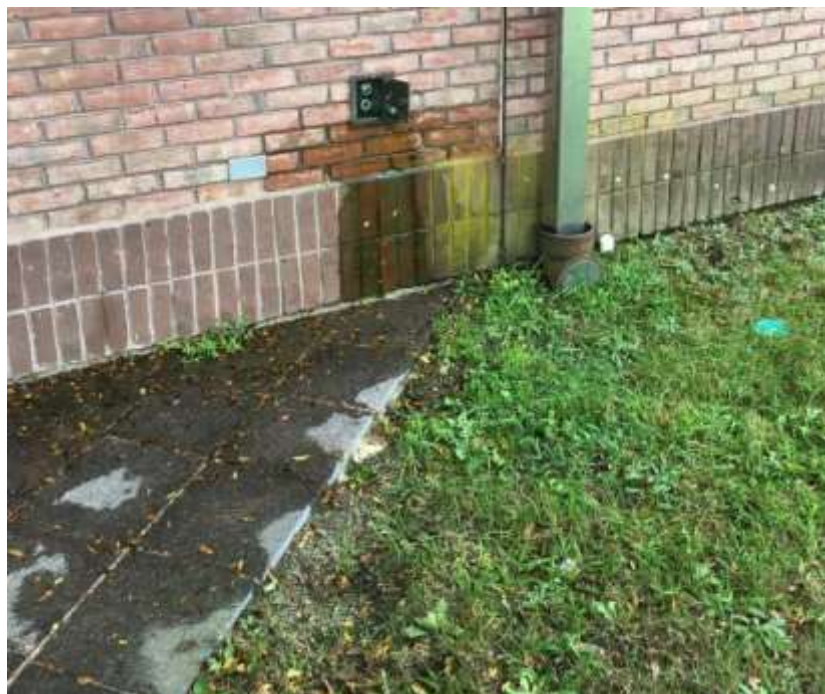
**Picture 22**

**Leaking plumbing fixture**

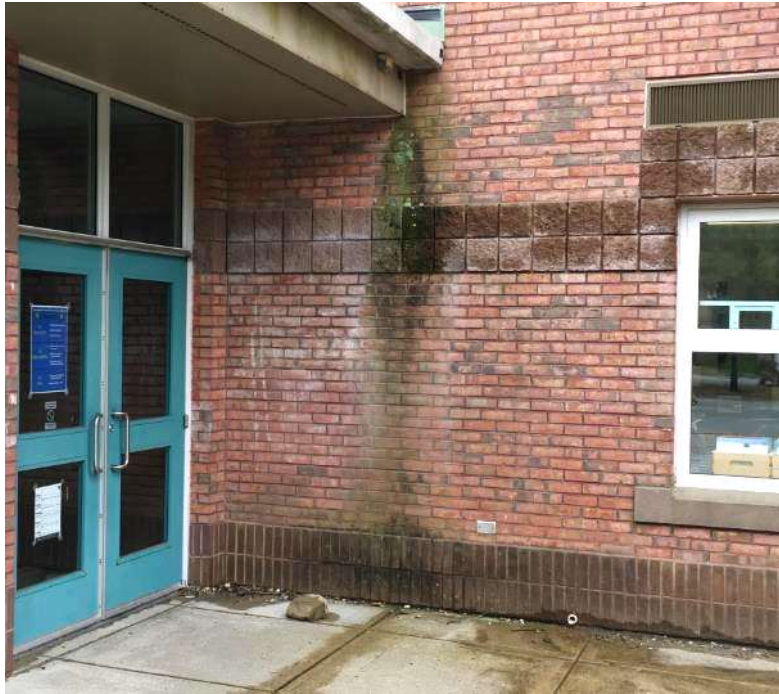
**Picture 23**

**Moss growth from chronic water exposure on exterior walls**

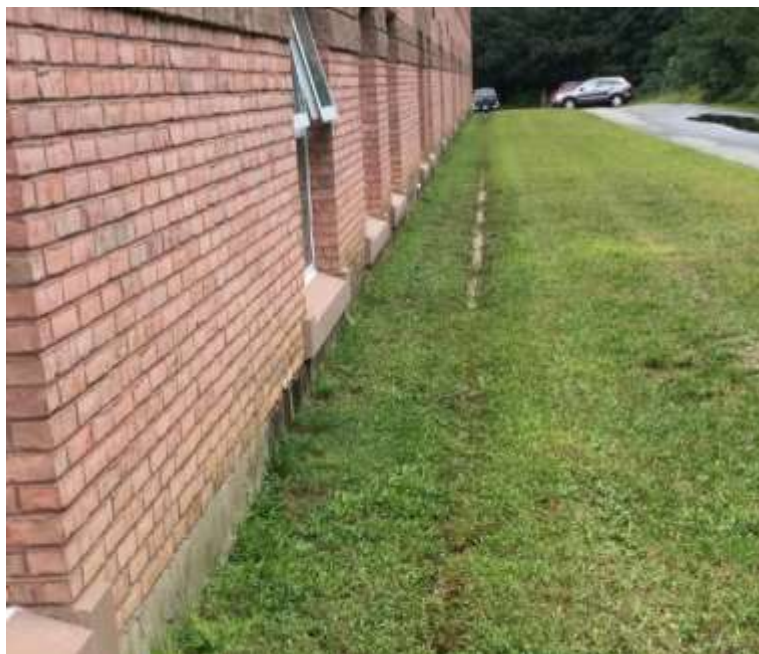
**Picture 24**

**Trough along exterior of building due to roof runoff/lack of gutters, also note open classroom window while AC system operating**

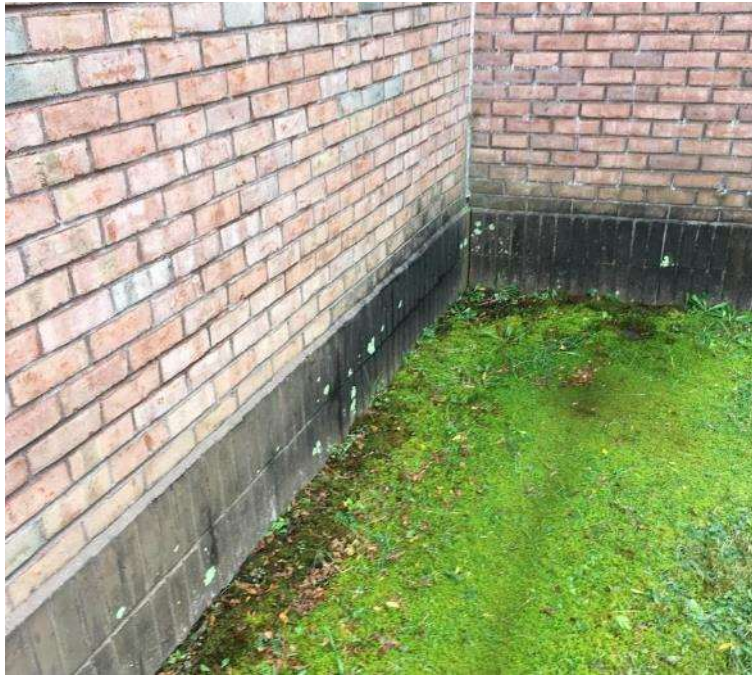
**Picture 25**

**Heavy moss growth/discoloration of foundation due to chronic water exposure (i.e., splash back) from lack of drainage/gutters/downspouts**

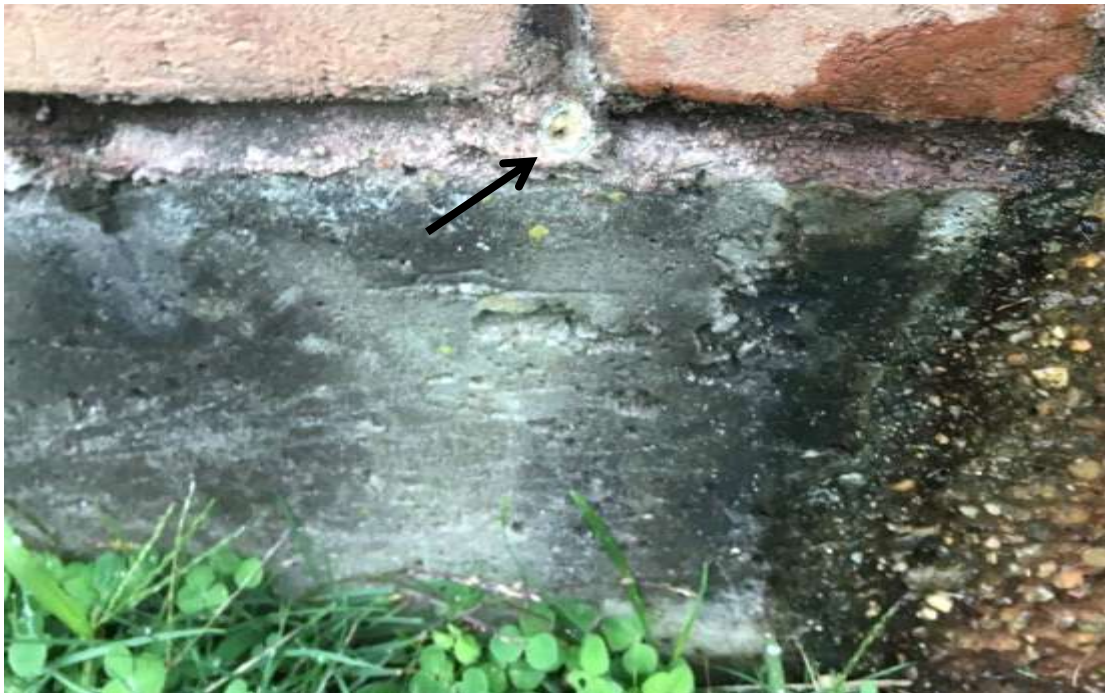
**Picture 26**

During the exterior examination MDPH/IAQ Program staff also noted exterior wall drainage hindered by clogged/plugged weep holes (Pictures 26 and 27). In modern construction, brick exterior wall systems are usually designed to prevent moisture penetration into the building interior. An exterior wall system usually consists of an exterior brick curtain wall ([Figure 2](#)). Behind the curtain wall is an air space that allows for water to drain downward and for the exterior cladding system to dry. At the base of the curtain wall should be weep holes that allow for water drainage. Opposite the exterior wall and across the air space is a continuous, water-resistant material adhered to the backup wall that forms the drainage plane.

**Clogged/plugged weep hole (arrow)**

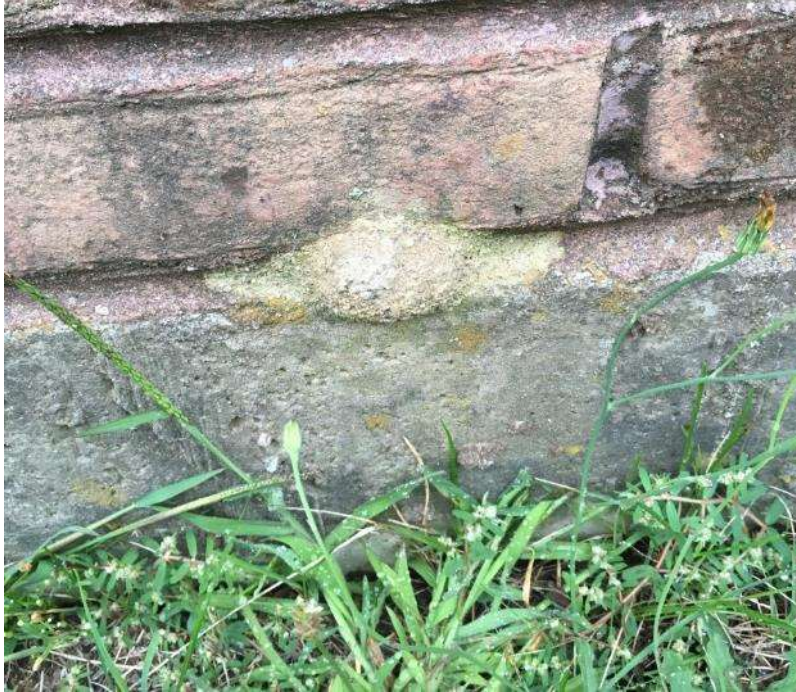
**Picture 27**

**Clogged/plugged weep hole**

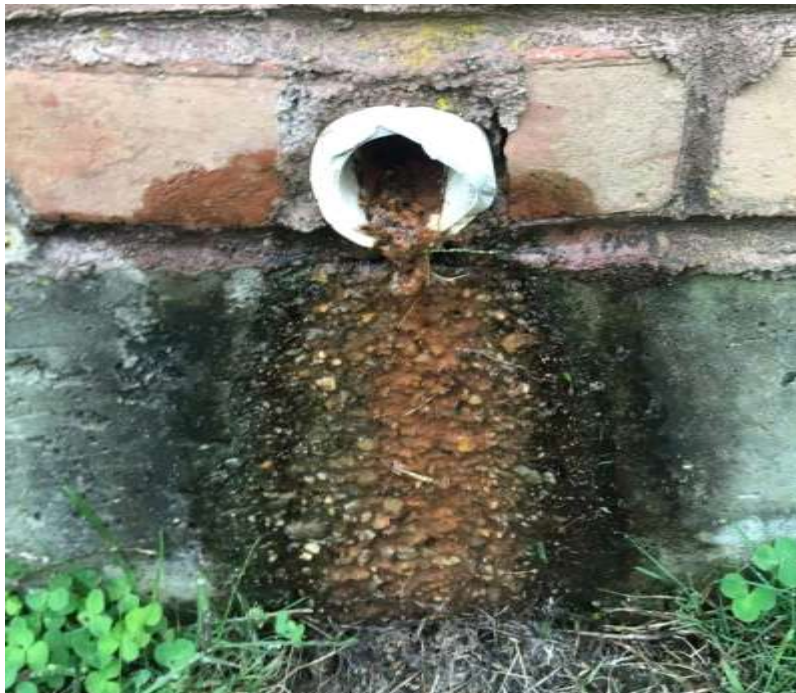
**Picture 28**

Also noted on exterior walls was the presence of rust-colored scale/debris from AC condensation pipes (Picture 28). This may indicate that metal drip pans are corroded/at the end of their service life. It is important that drip pans be smooth/clean and drain properly to prevent debris from clogging drain holes, which can lead to standing water and bacterial/mold growth and associated odors within units.

**Debris/scale from condensate pipe/drip pans**

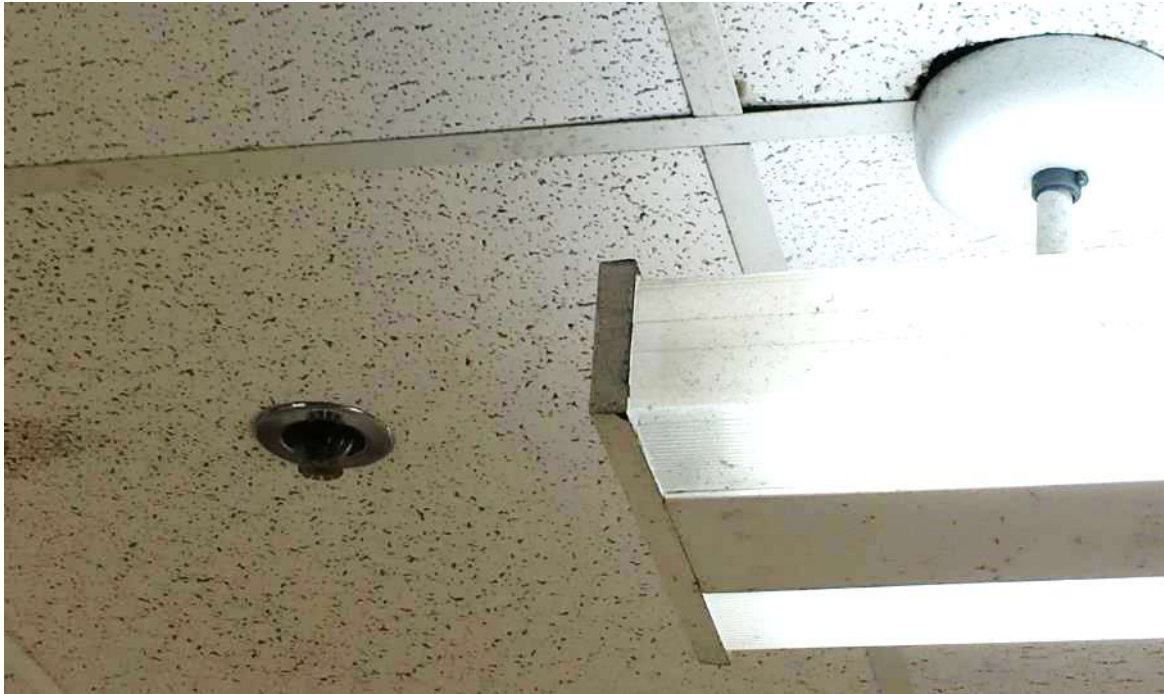
**Picture 29**

**Dust/debris/staining on light fixture directly in front of univent, also note sprinkler head**

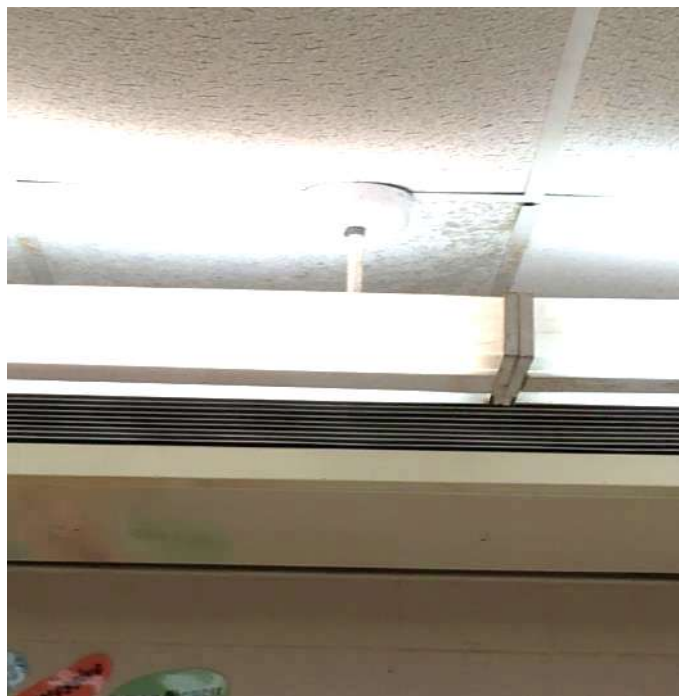
**Picture 30**

**Suspended lighting fixture and stained tile in front of univent**
