# **INDOOR AIR QUALITY WATER DAMAGE ASSESSMENT**

**Barnstable United Elementary School  
730 Osterville W. Barnstable Road  
Marstons Mills, MA**

Prepared by:  
Massachusetts Department of Public Health  
Bureau of Climate and Environmental Health  
Indoor Air Quality Program  
September 2024

# **INDOOR AIR QUALITY ASSESSMENT**

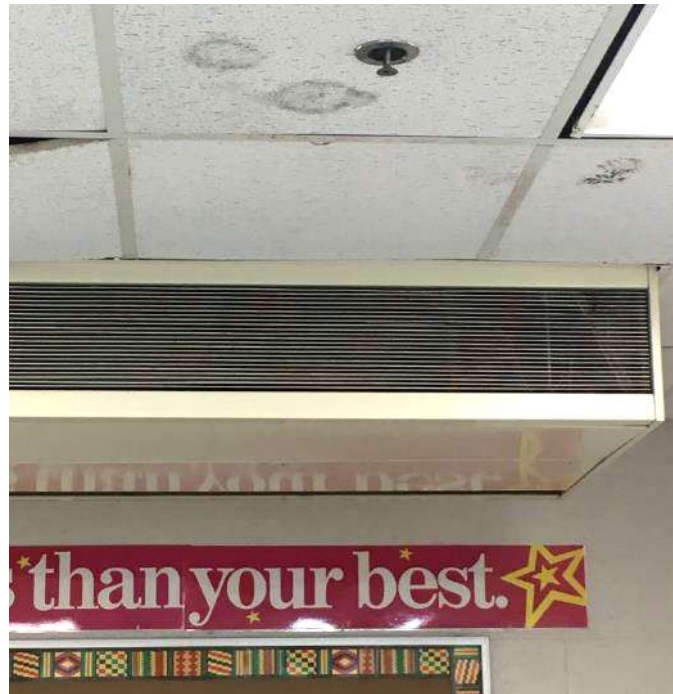
**Picture 31**

**Water-damaged/moldy ceiling tiles and metal sprinkler head directly in front of univent**

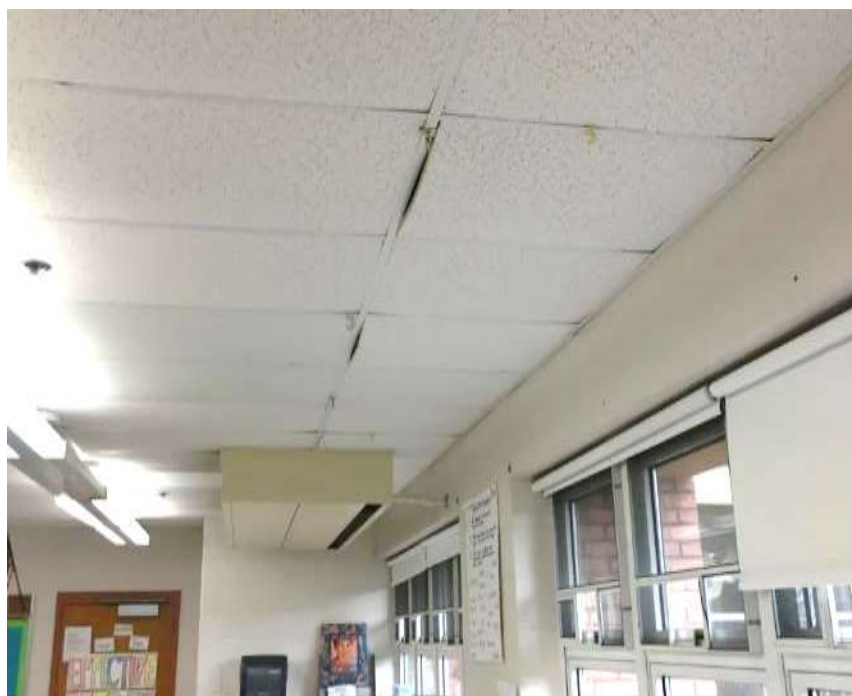
**Picture 32**

Of particular concern are weather patterns of high temperatures (heat waves) and elevated humidity conditions (> 70%) for extended periods of time (three/more consecutive days). If a building does not have either adequate exhaust ventilation and/or air chilling capacity to remove/reduce relative humidity from outside air, then hot, moist air can be introduced into a building and linger to increase occupant discomfort as well as possibly moisten materials that may lead to mold growth. The MDPH recommends a comfort range of 40 to 60 percent for indoor air relative humidity, which were exceeded throughout the building during the September 12<sup>th</sup> visit. Chronic issues with excess humidity were evident by the presence of “bowed” (i.e., non-flush) ceiling tiles throughout the building (Picture 32).

**“Bowed” (non-flush) ceiling tiles in first floor classroom**

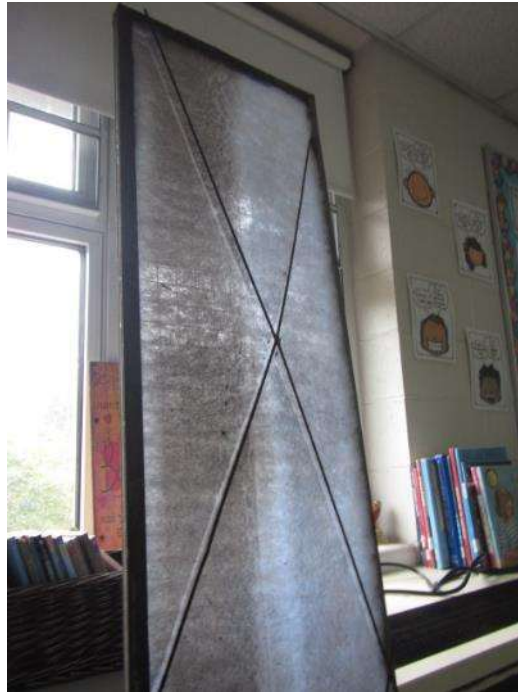
**Picture 33**

**Metal filter rack and media that needs to be “cut to size” and installed in univents**

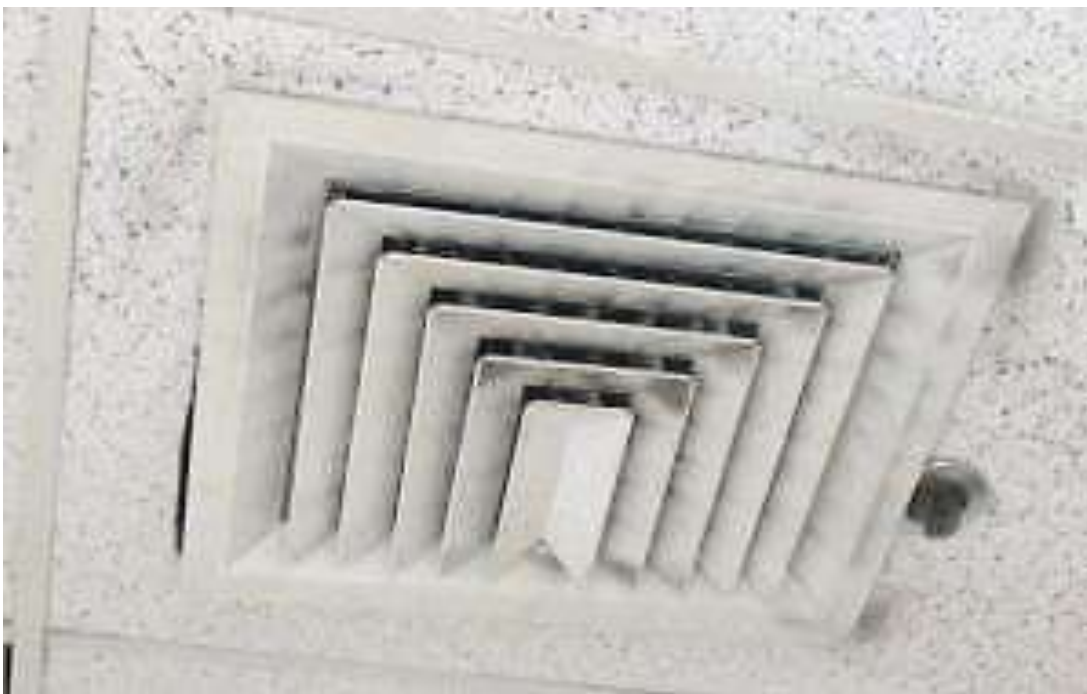
**Picture 34**

**Accumulated dust/debris on supply diffuser and surrounding ceiling tile**

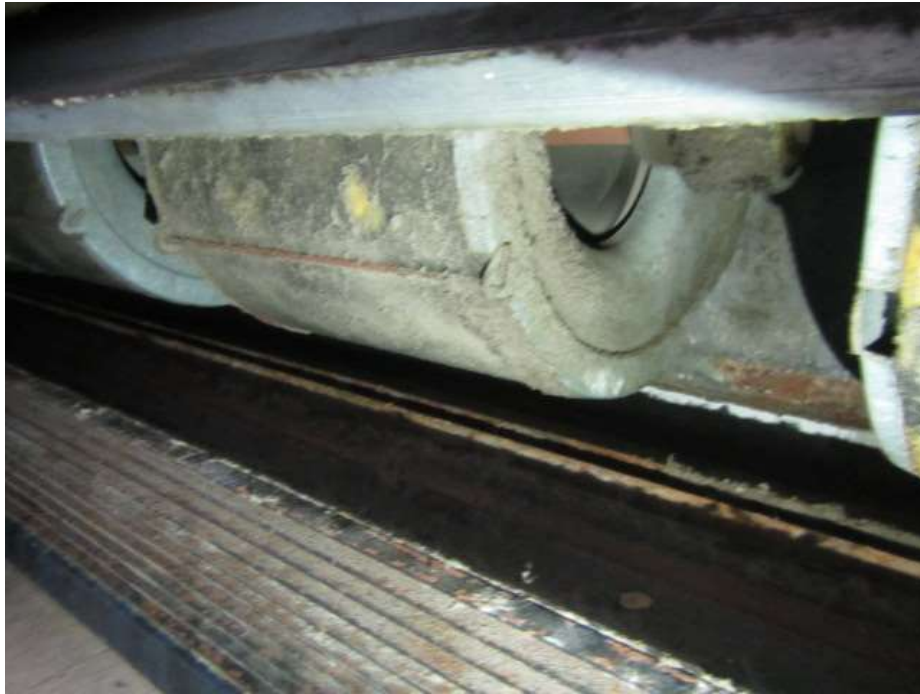
**Picture 35**

**Accumulated dust/debris on interior univent components**

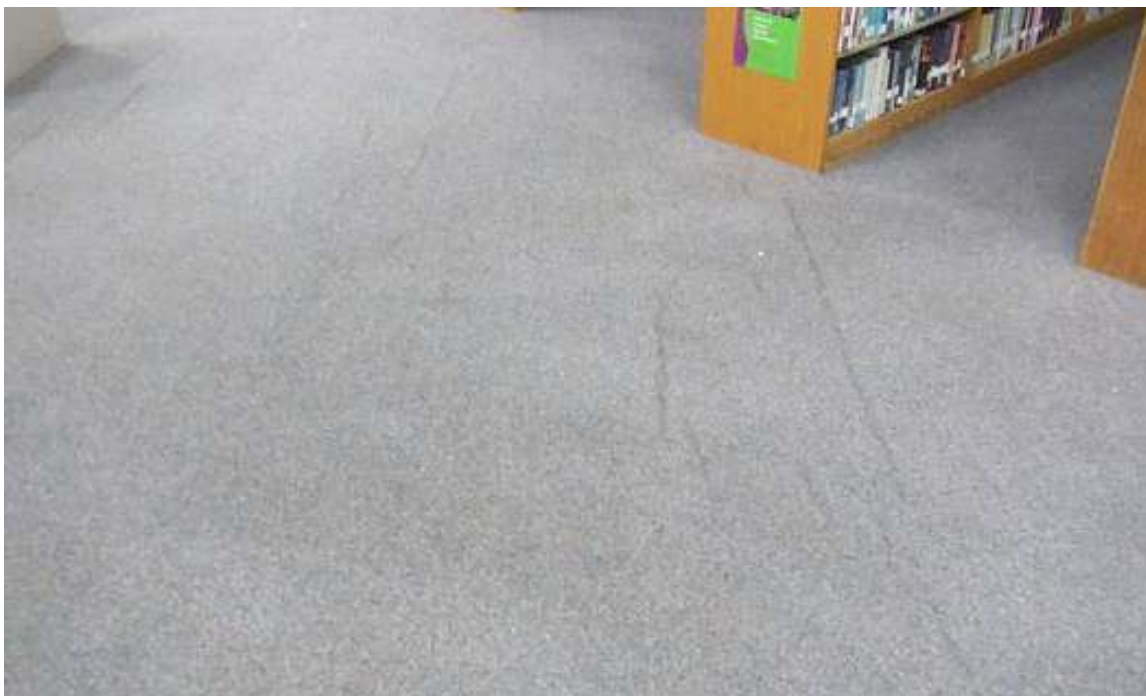
**Picture 36**

**Original (20+ yr.)/wrinkled carpeting in Library**

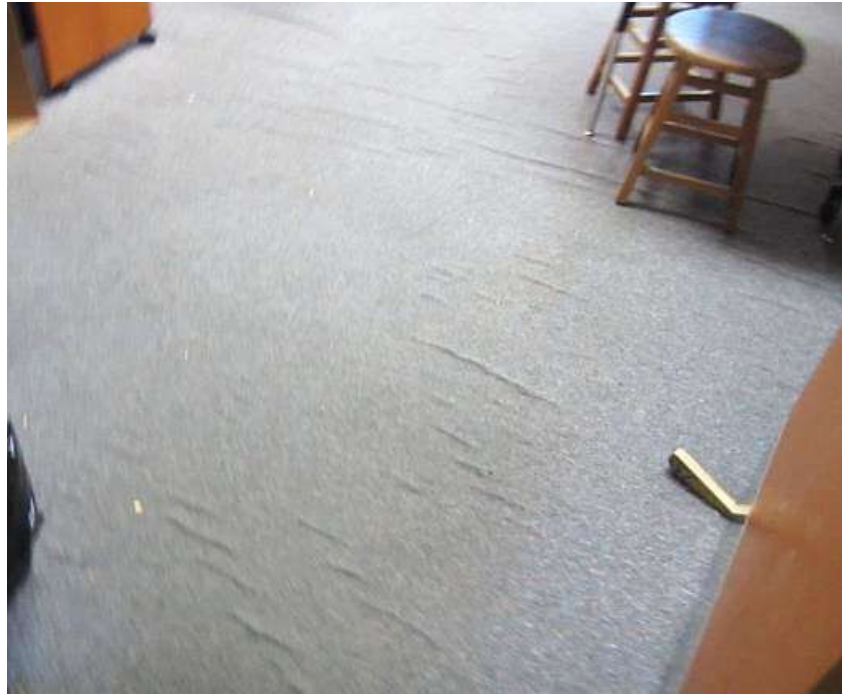
**Picture 37**

**Original (20+ yr.)/wrinkled carpeting in Guidance Dept**

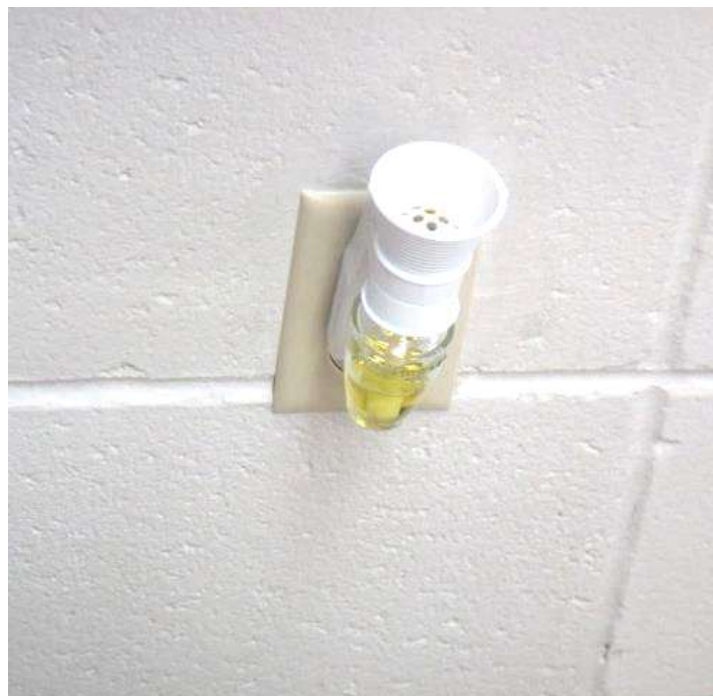
**Picture 38**

**Plug-in air freshener in classroom**
