# **INDOOR AIR QUALITY ASSESSMENT**

**Barnstable United Elementary School  
730 Osterville W. Barnstable Road  
Marstons Mills, Massachusetts**

Prepared by:  
Massachusetts Department of Public Health  
Bureau of Environmental Health  
Indoor Air Quality Program  
October 2019

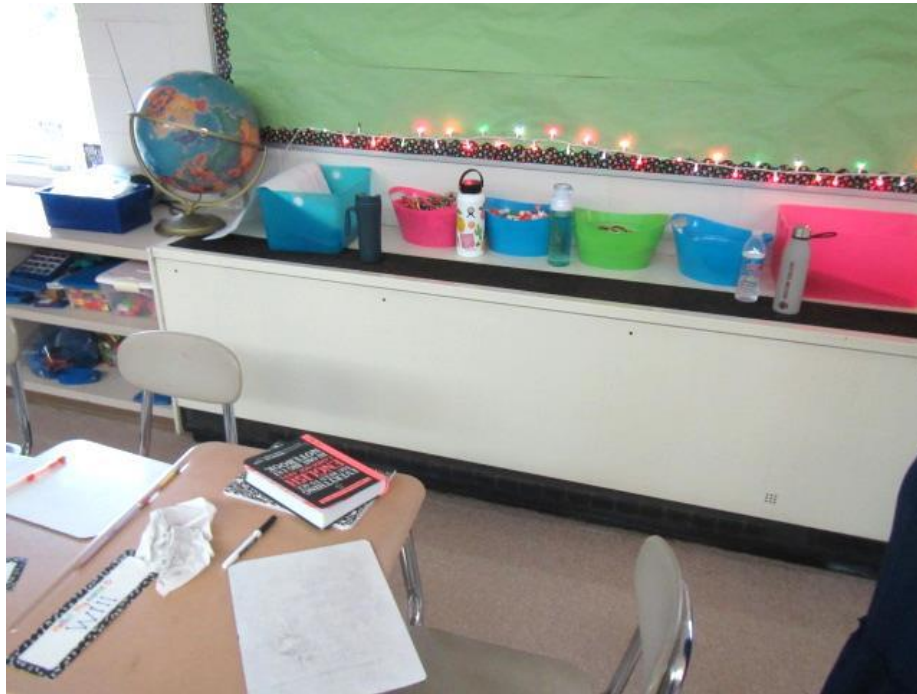
**Picture 1**

**Classroom univent**

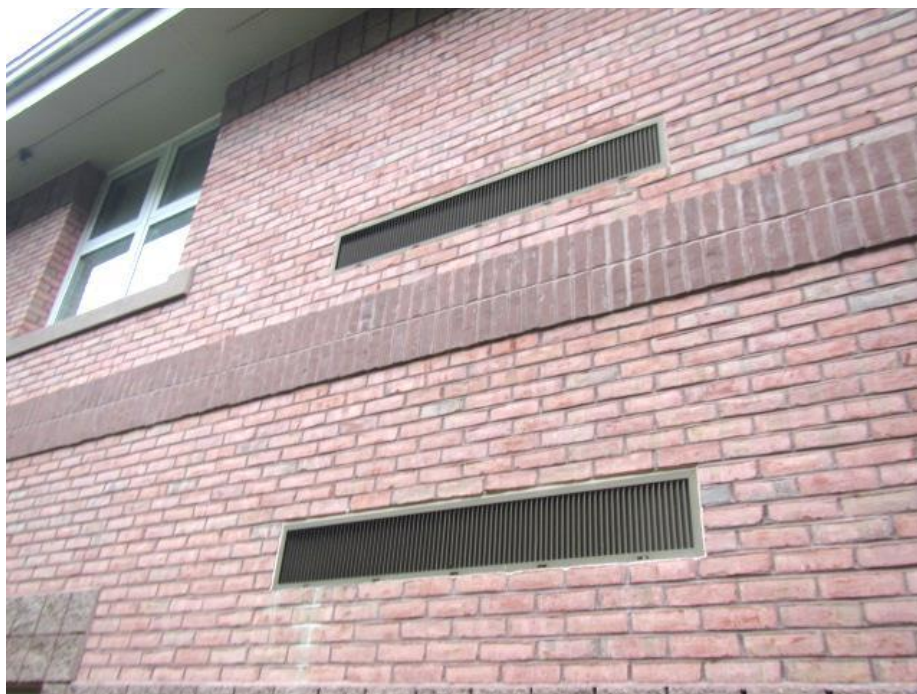
**Picture 2**

**Univent fresh air intakes**

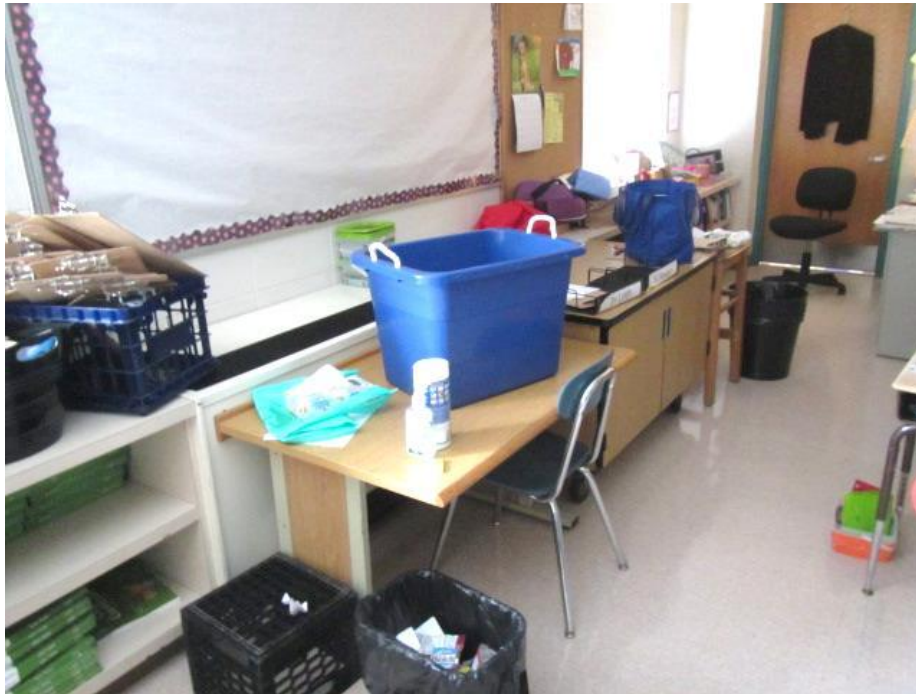
**Picture 3**

**Univent return vent (bottom front) obstructed by classroom furniture**

5. Remove furniture and items blocking the front and top of univents.
6. Periodically assess whether exhaust vents (classrooms and restrooms) are drawing air and make repairs as needed.

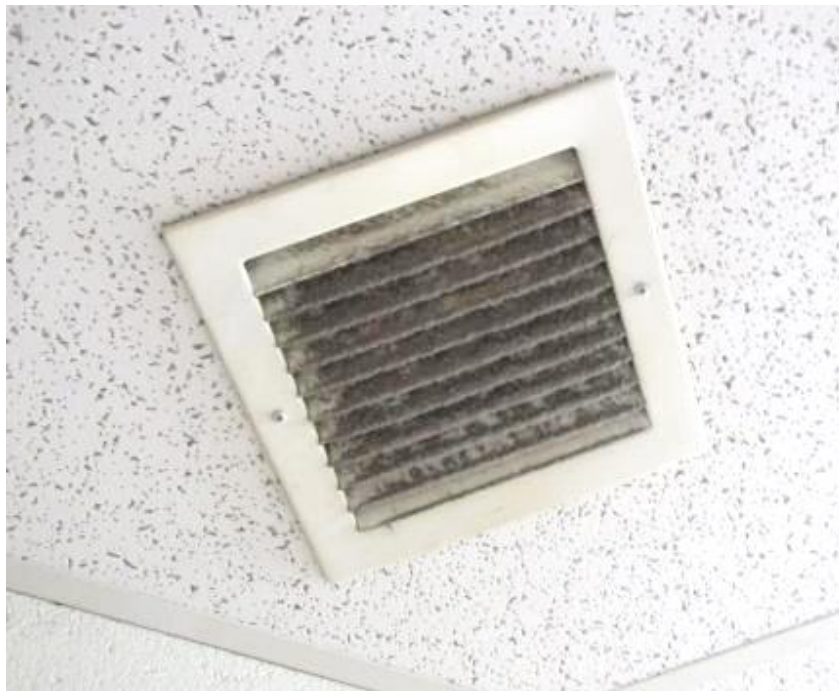
**Picture 4**

Classroom exhaust vents are located in the ceilings (Picture 4) and are connected with ducts to exhaust fans on the roof. A number of these exhaust vents were not drawing air during the assessment. Note that in many classrooms, exhaust vents were located near classroom doors (Picture 5). This design works best with the doors to the hallway closed, otherwise the exhaust vents tend to draw air from the hallway rather than the room which reduces the effectiveness of air circulation. Without adequate supply and exhaust ventilation, excess heat/humidity and environmental pollutants can build up and lead to indoor air/comfort complaints.

In some areas, exhaust vents, supply diffusers and the interior of univents had accumulated dust/debris (Table 1, Pictures 4, 34 and 35). This dust can be reaerosolized under certain conditions, and can also be a medium for mold growth. Univent cabinets can also accumulate dust and debris which should be cleaned when filters are changed (2-4 times/year).

**Classroom exhaust vent, note accumulated dust/debris**

20. Consider using disposable, pleated cardboard filters instead of filter media that needs to be hand cut and installed in metal racks.
21. Clean supply/exhaust vents and personal fans regularly to remove accumulated dust/debris. Replace surrounding ceiling tiles that cannot be adequately cleaned.

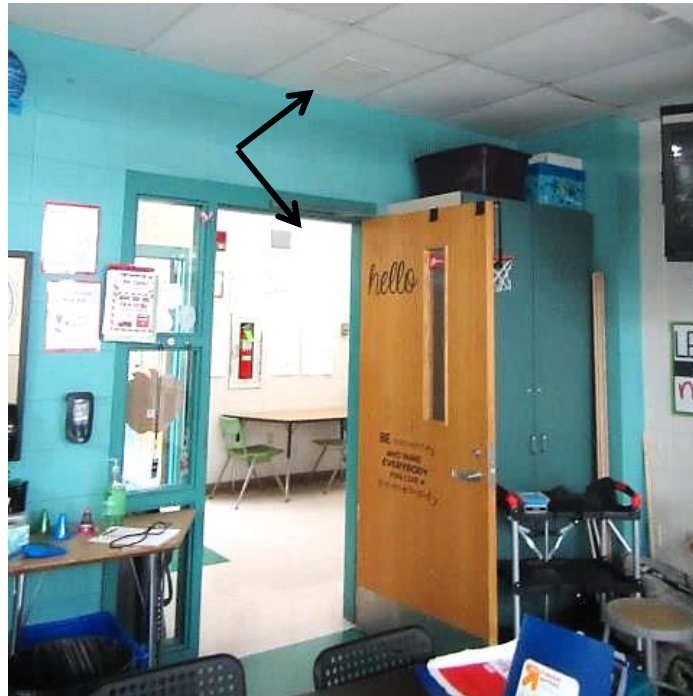
**Picture 5**

**Proximity of classroom exhaust vent (arrows) to open hallway door**

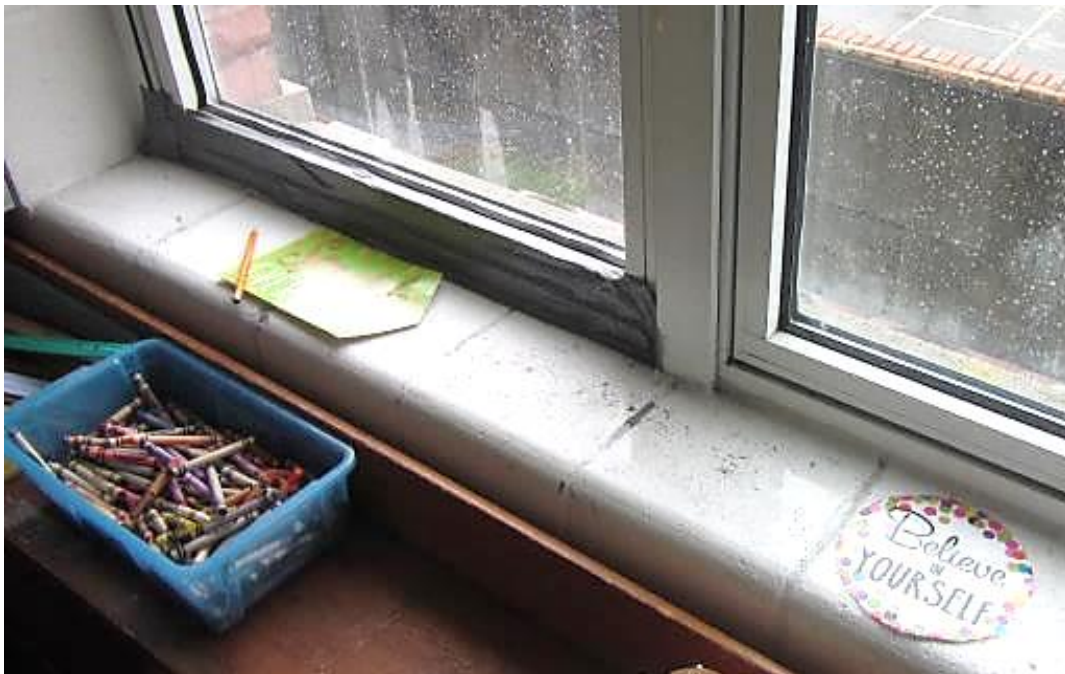
**Picture 6**

In order for building materials to support mold growth, a source of water exposure is necessary. Identification and elimination of the source of water moistening building materials is necessary to control mold growth. In the case of the BUES, the main sources of moisture creating conditions conducive to mold growth are relative humidity and operation of the AC system. However other sources of water damage are typically present in most buildings such as roof/window leaks (Picture 6) as well as leaks/condensation from HVAC systems and plumbing.

**Standing water from active leak on masonry/windowsill in classroom 215, note duct tape on left window**

12. Work with a roofing contractor/building engineer to investigate/repair building envelope leaks (e.g., 2<sup>nd</sup> floor hallway/windows in Room 215). Until this has been completed, avoid storing porous materials in areas of known leaks.

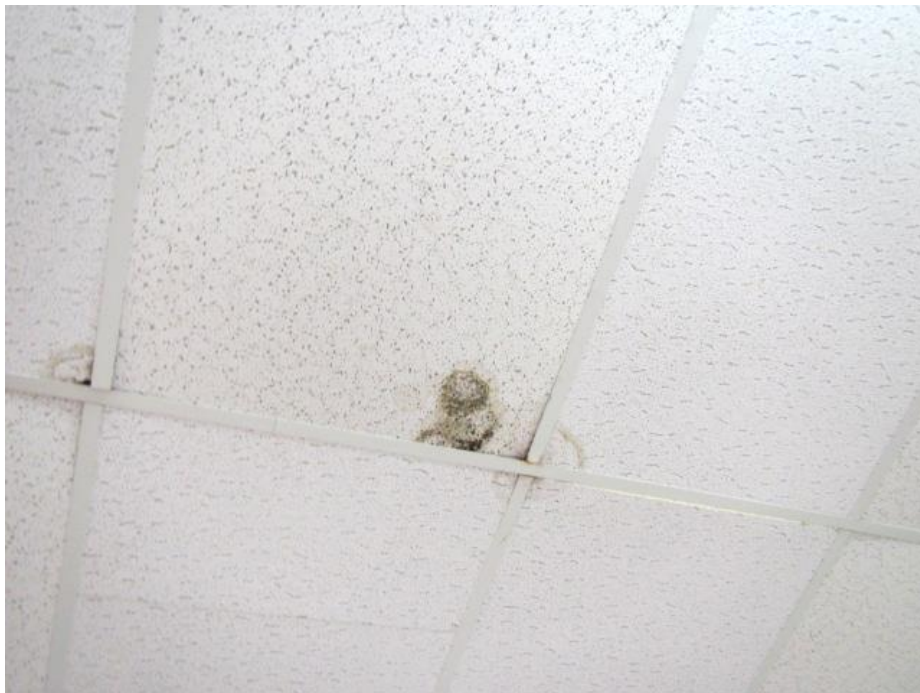
**Picture 8**

- Ceiling tiles (Pictures 8 and 9), which can indicate current/historic roof/plumbing leaks or other water infiltration. Active leaks were reported on the second floor in the hallway (near Room 217), where school staff reported ceiling tiles had been recently changed (Picture 10). Water-damaged ceiling tiles can provide a source of mold and should be replaced after a water leak is discovered and repaired;
- Instrument cases in the band room (Picture 11);
- Desk/chair unit in unoccupied Room 107 (Pictures 12a and 12b);
- Refrigerator gaskets in classrooms and the Teacher's Lounge (Pictures 13 and 14);
- Water-stained gypsum wallboard outside the library (Picture 15). Note, this material was tested for moisture content on September 17 and found dry;
- Insulation material in ceiling above art room closet (Picture 16); and
- Various classroom items (Pictures 17 through 19).

**Water-damage/mold growth on ceiling tiles room 219**

13. Once repairs are made, replace water-damaged ceiling tiles and refinish areas of water damage. Inspect the area above the stained tiles for water damage or odors and remediate or clean as necessary.

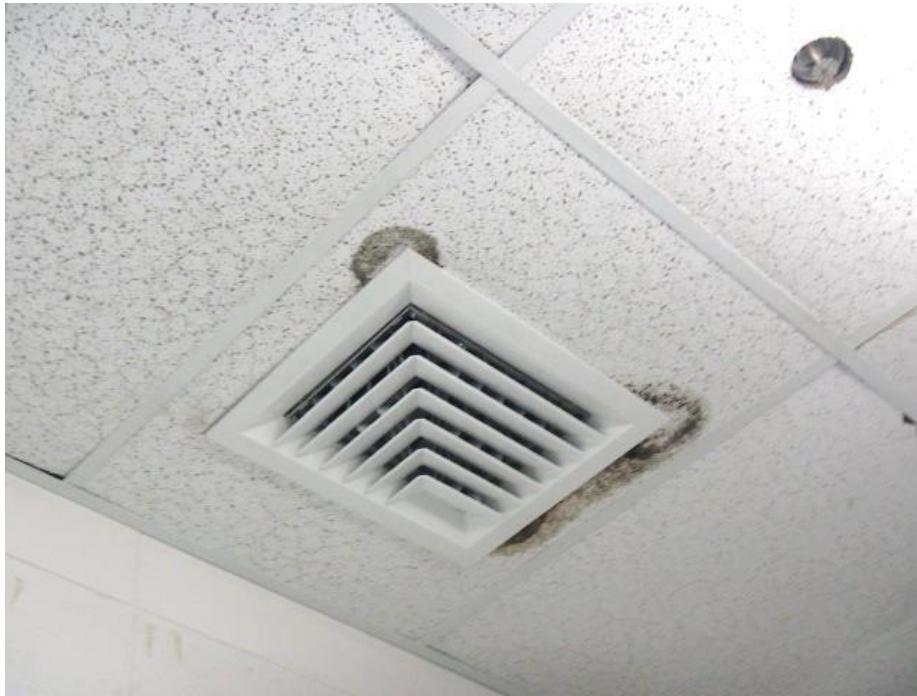
**Picture 9**

**Water-damage/mold growth on ceiling tiles room 107**

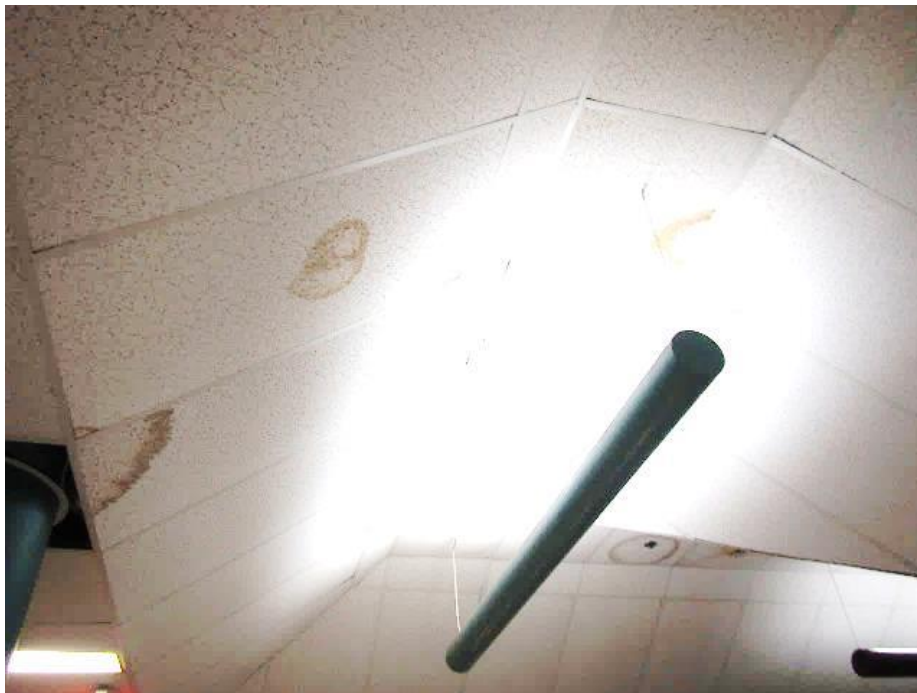
**Picture 10**

**Water-damaged ceiling tiles in 2<sup>nd</sup> floor hallway near Room 217**

| Location | Carbon Dioxide (ppm) | Carbon Monoxide (ppm) | Temp (°F) | Relative Humidity (%) | PM2.5 (µg/m³) | Occupants in Room | Windows Openable | Ventilation | | Remarks |
|---|---|---|---|---|---|---|---|---|---|---|
| 2 <sup>nd</sup> Fl Hallway (near 217) | | | | | | | | | | WD CTs (current leak?) |

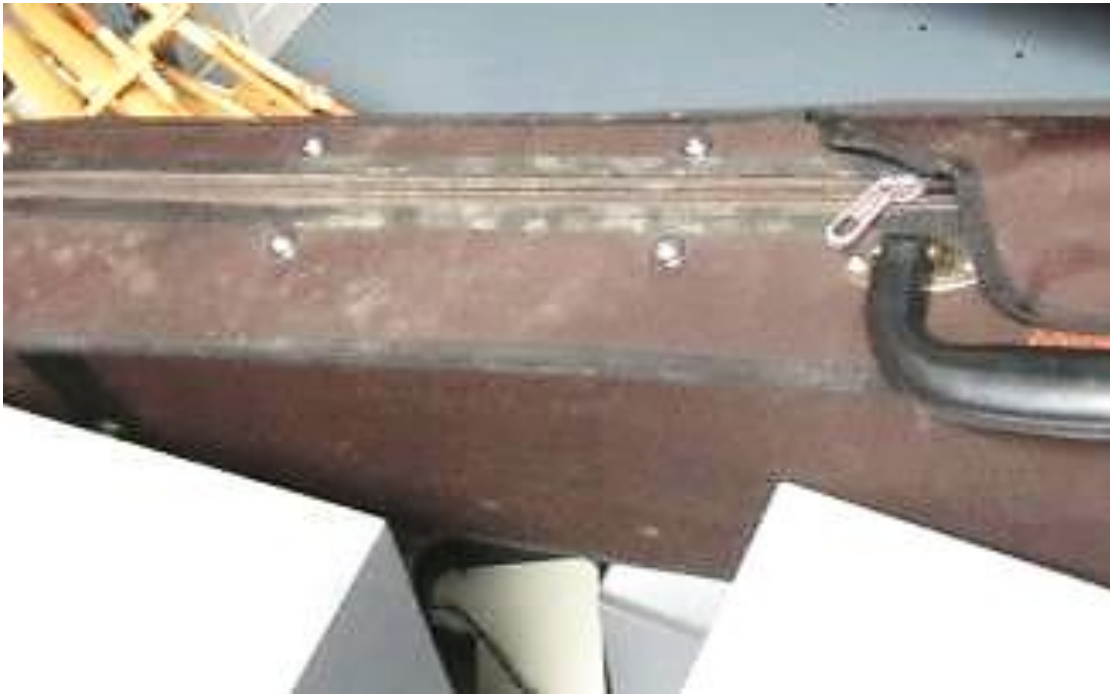
**Picture 11**

**Mold growth on instrument case in band storage room**

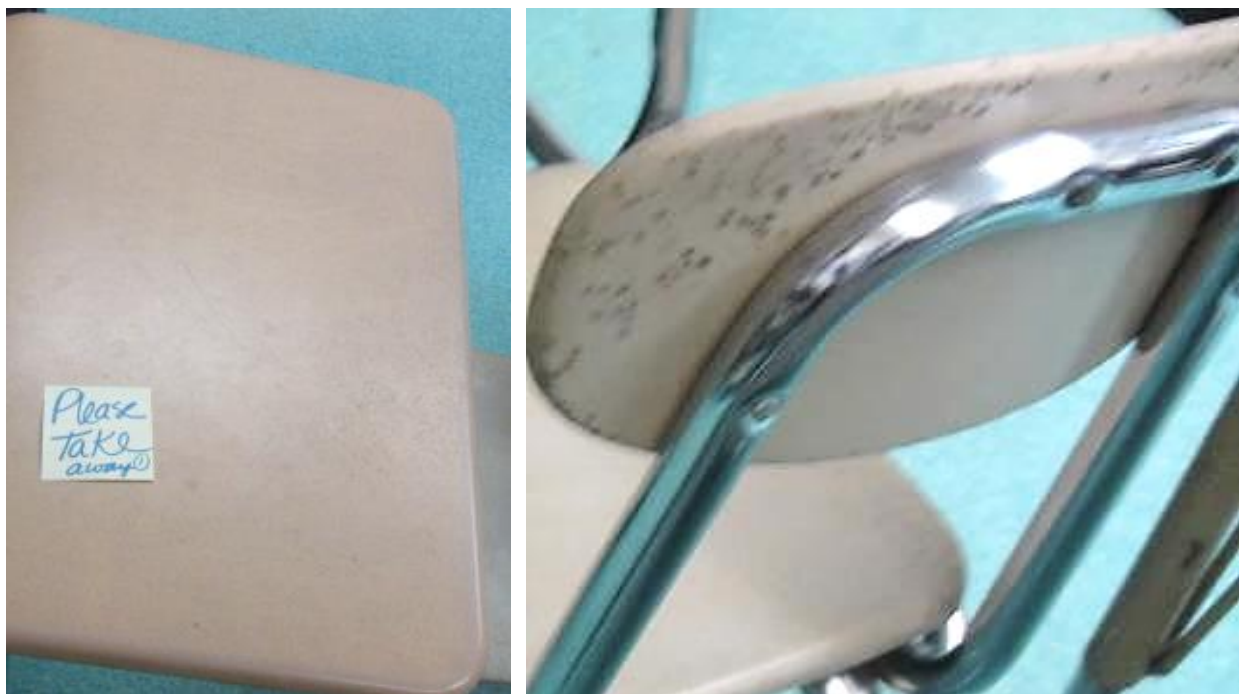
**Pictures 12a and 12b**

**Mold growth on chair/desk unit labeled "Please Take away"**

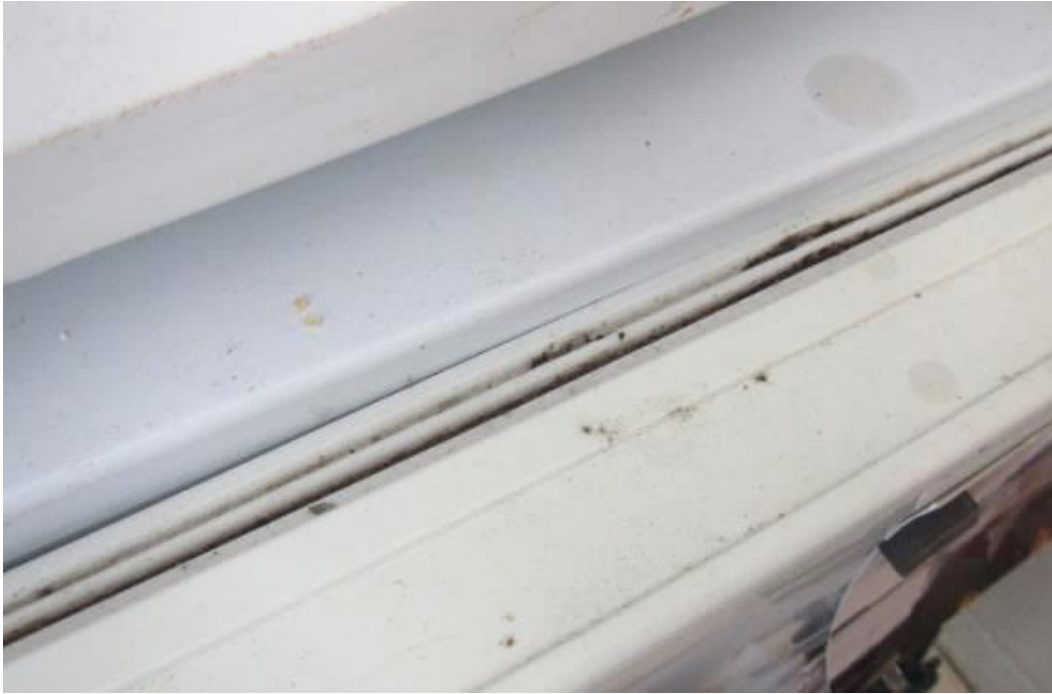
**Picture 13**

**Debris/mold growth on mini-fridge gasket in classroom**

22. Ensure all refrigerators are kept clean to prevent microbial growth and odors. Clean gaskets and other surfaces with a mild antimicrobial solution to remove debris and mold. If cannot be adequately cleaned-replace.

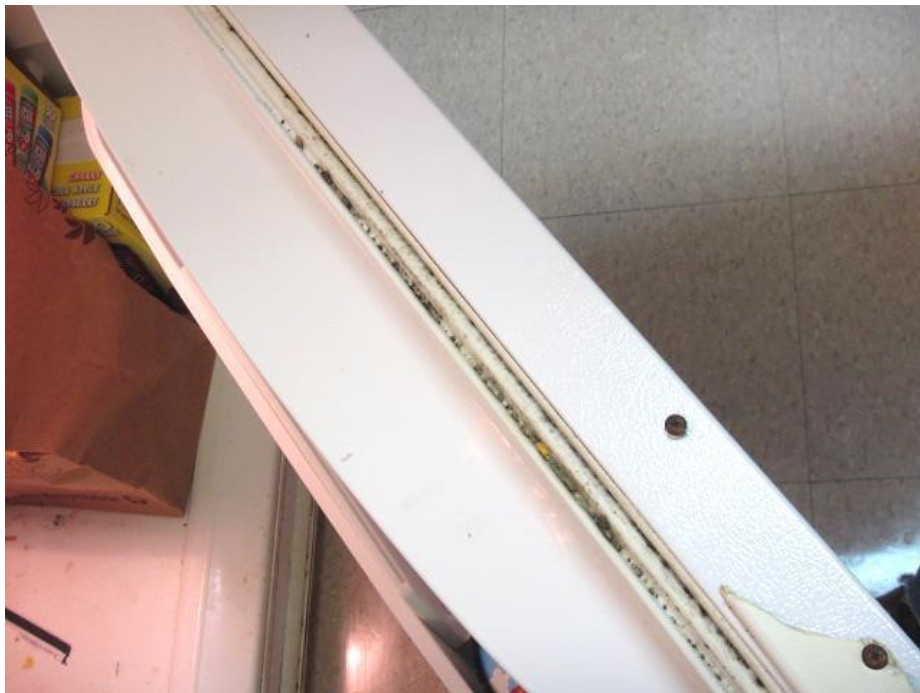
**Picture 14**

**Debris/mold growth on mini-fridge gasket in Faculty Lounge**

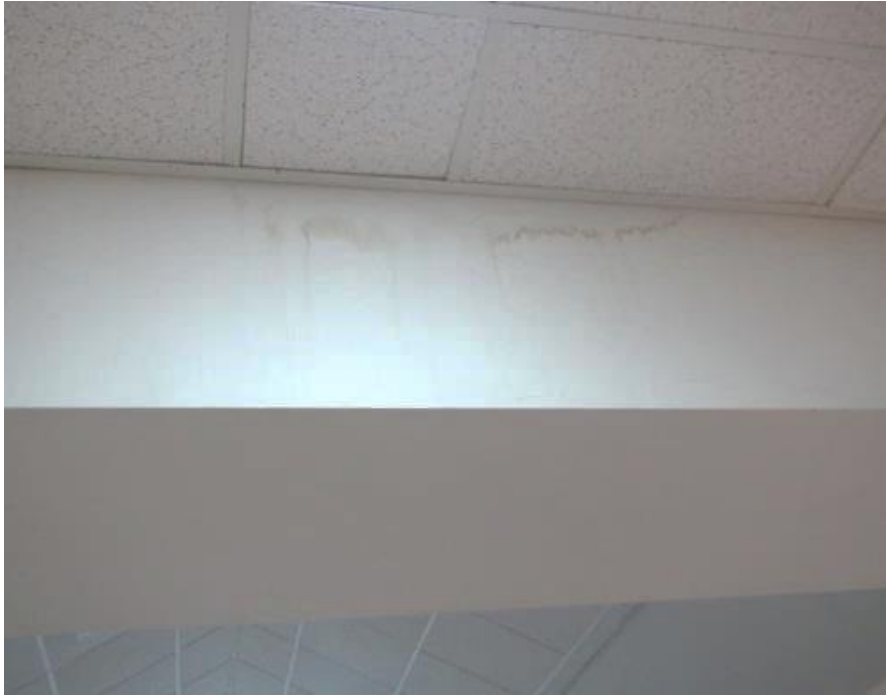
**Picture 15**

**Water-stained gypsum wallboard outside Library**

| Location | Carbon Dioxide (ppm) | Carbon Monoxide (ppm) | Temp (°F) | Relative Humidity (%) | PM2.5 (µg/m³) | Occupants in Room | Windows Openable | Ventilation | | Remarks |
|---|---|---|---|---|---|---|---|---|---|---|
| 2 <sup>nd</sup> Floor Hallway outside Library | | | | | | | | | | WD GW-stains, WD CTs |

27. Repair/replace all water-damaged/mold-colonized porous building materials (e.g., ceiling tiles, gypsum wallboard) in classrooms, hallways and common areas in a manner consistent with the U.S. Environmental Protection Agency's guidelines (US EPA, 2008).

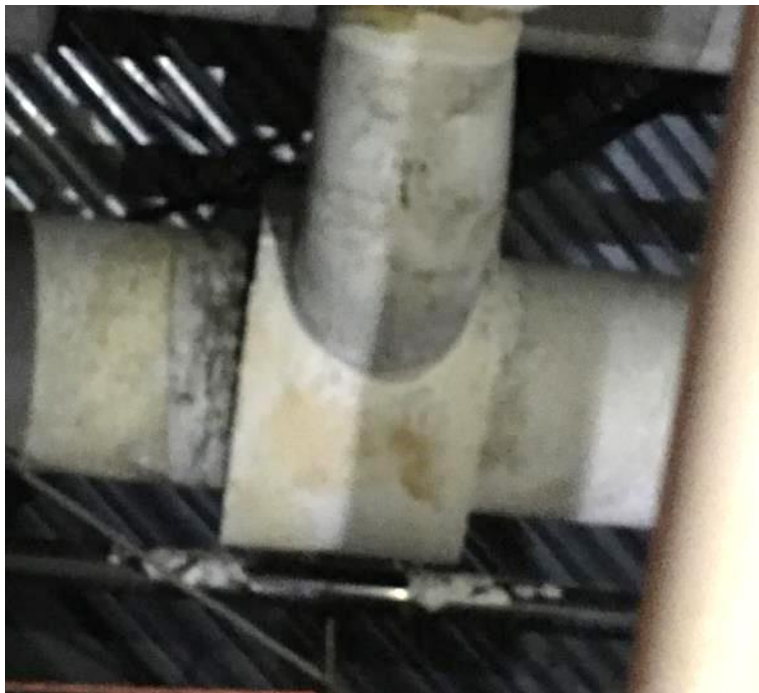
**Picture 16**

**Insulation material in art room closet**

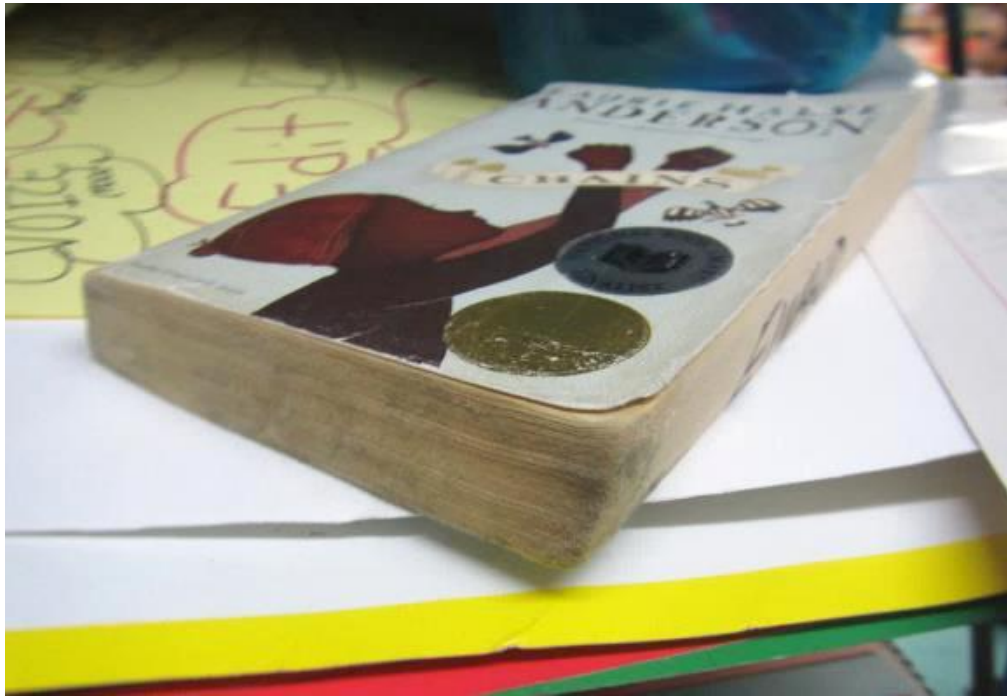
**Picture 17**

**Mold growth on book in closet in Room 207**

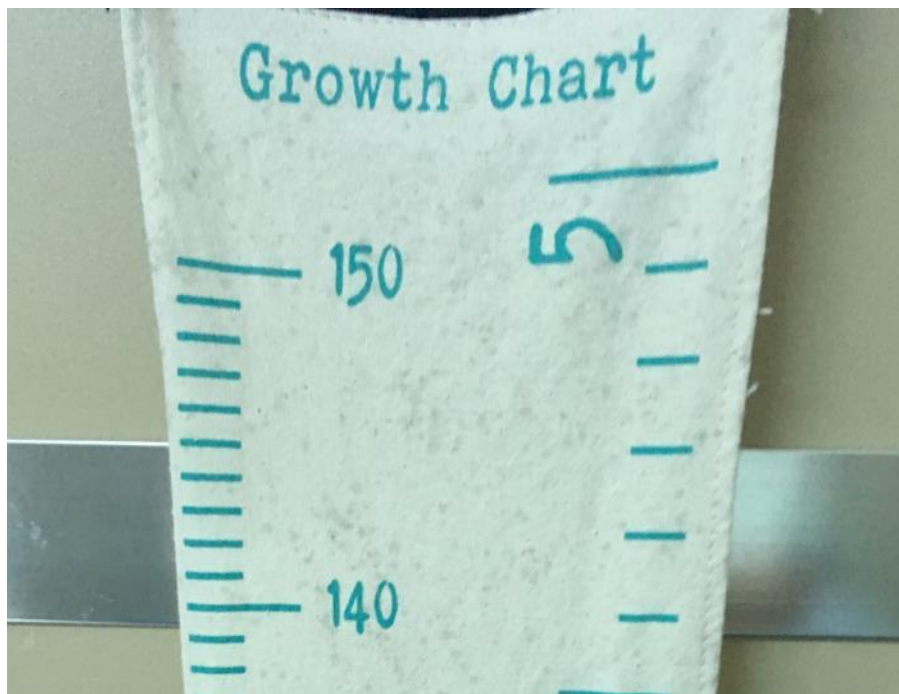
**Picture 18**

**Staining from mold growth on fabric classroom item**

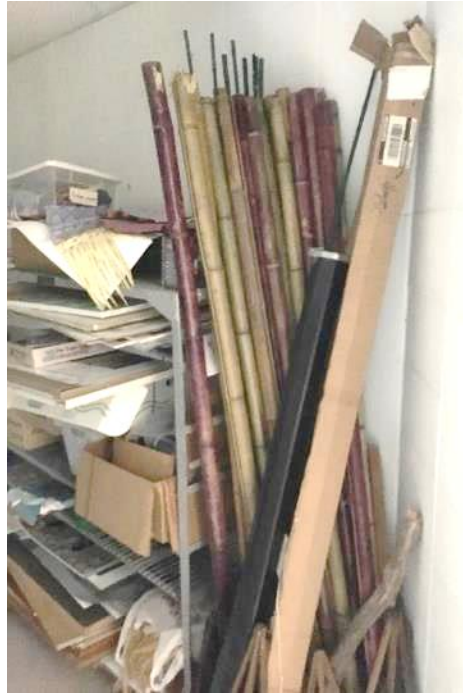
**Picture 19**

**Moldy/odorous bamboo in Art room closet**

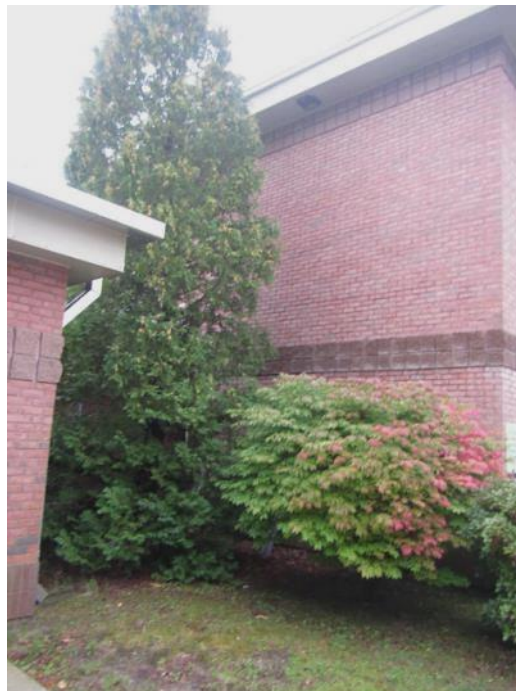
**Picture 20**

- Wooden fascia board was exposed near the roof (near front of building);
- Plants/shrubbery in close contact with exterior walls (Pictures 20 and 21);
- Clinging plants on masonry (Picture 21);
- A leaking plumbing fixture (Picture 22); and
- Lack of gutters and downspouts on parts of the roof that cause splash back against exterior walls (Pictures 23 through 25).

**Trees/shrubbery in close contact with exterior walls**

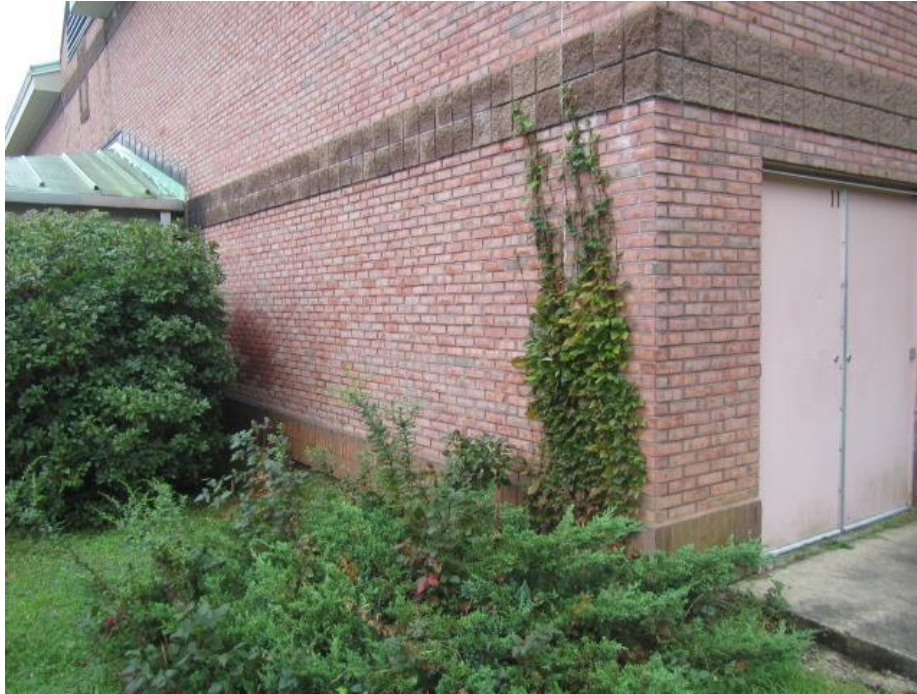
**Picture 21**

**Trees/shrubbery in close contact with exterior walls, also note clinging plants**

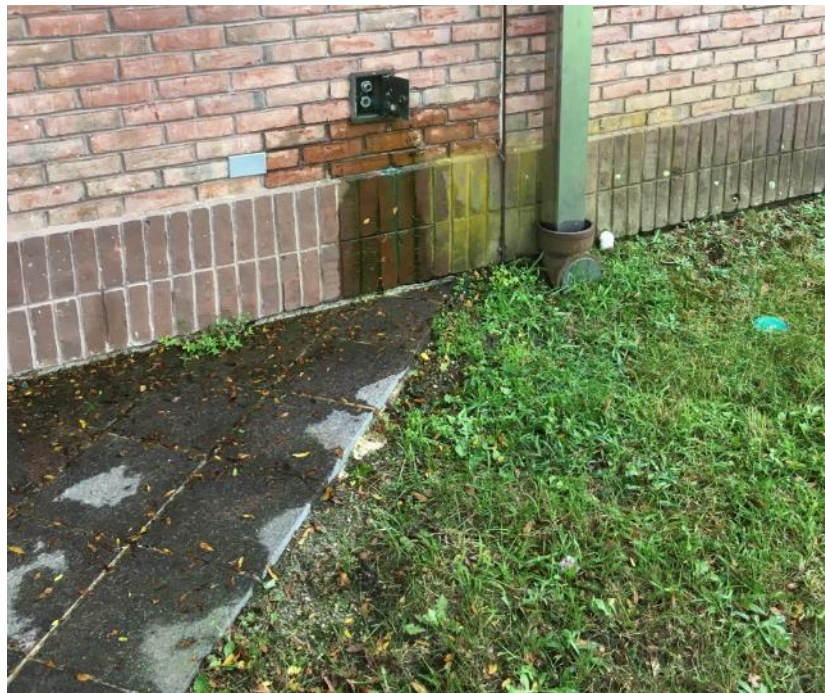
**Picture 22**

**Leaking plumbing fixture**

25. Fix plumbing leak shown in Picture 22.
26. Continue to utilize portable dehumidifiers as needed during excessive relative humidity periods (>70%). Ensure dehumidifiers are cleaned/maintained as per the manufacturer's instructions to prevent mold/bacterial growth.

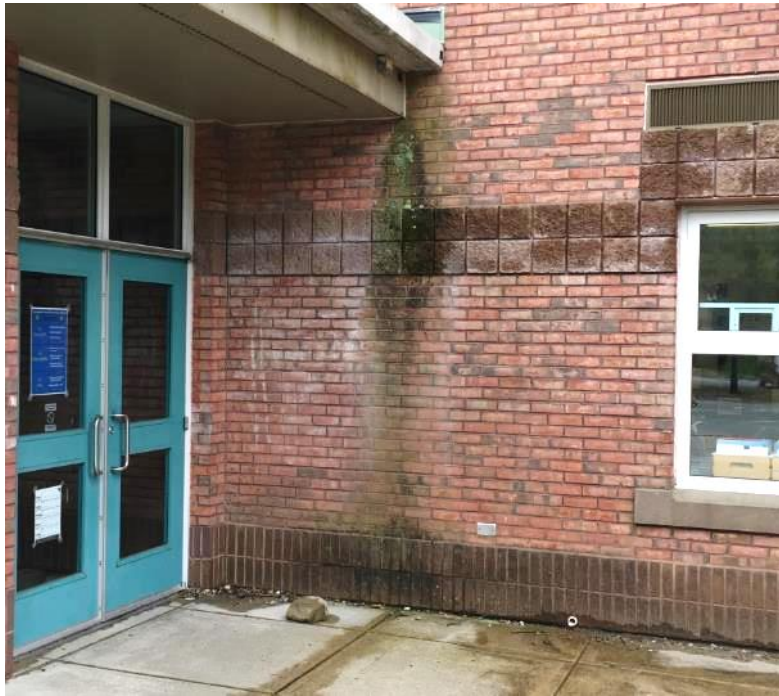
**Picture 23**

**Moss growth from chronic water exposure on exterior walls**

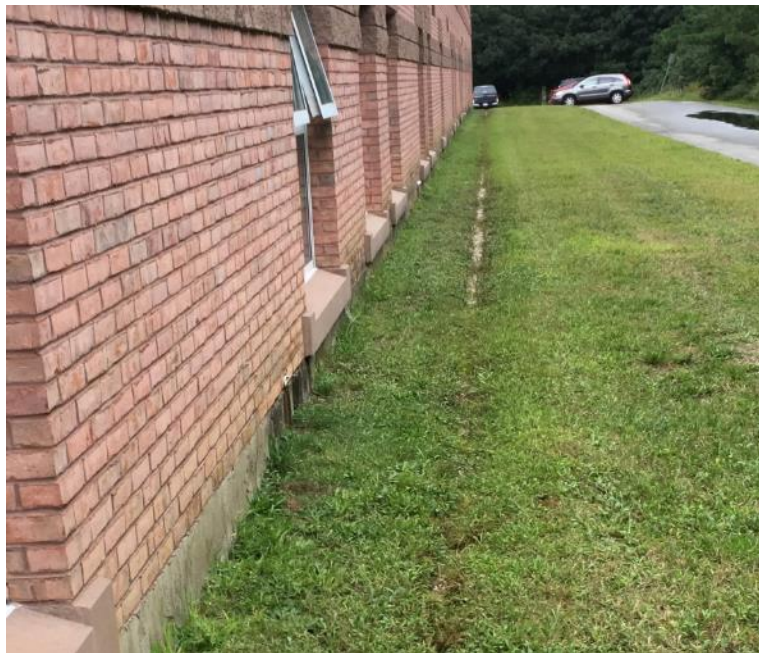
**Picture 24**

**Trough along exterior of building due to roof runoff/lack of gutters, also note open classroom window while AC system operating**

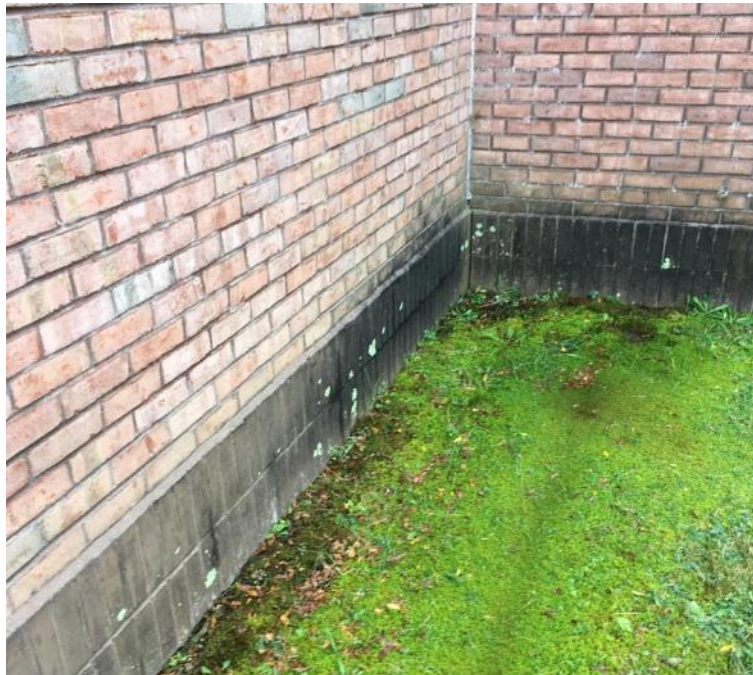
**Picture 25**

**Heavy moss growth/discoloration of foundation due to chronic water exposure (i.e., splash back) from lack of drainage/gutters/downspouts**

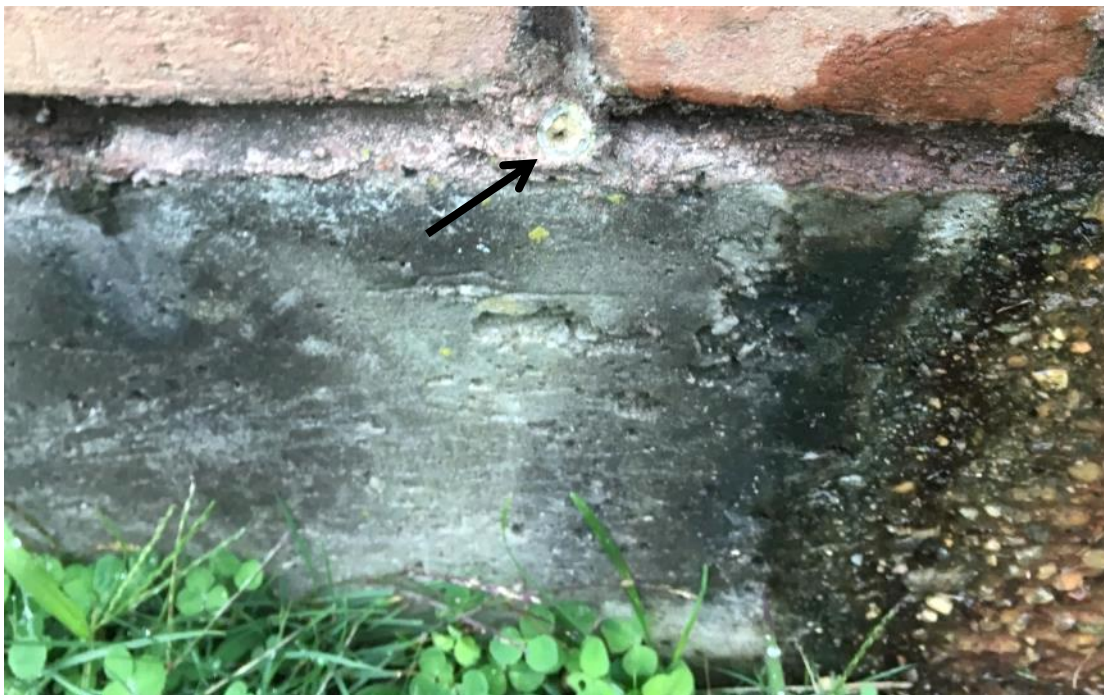
**Picture 26**

During the exterior examination MDPH/IAQ Program staff also noted exterior wall drainage hindered by clogged/plugged weep holes (Pictures 26 and 27). In modern construction, brick exterior wall systems are usually designed to prevent moisture penetration into the building interior. An exterior wall system usually consists of an exterior brick curtain wall ([Figure 2](#)). Behind the curtain wall is an air space that allows for water to drain downward and for the exterior cladding system to dry. At the base of the curtain wall should be weep holes that allow for water drainage. Opposite the exterior wall and across the air space is a continuous, water-resistant material adhered to the backup wall that forms the drainage plane.

**Clogged/plugged weep hole (arrow)**

2. Examine drip pans building-wide for corrosion/proper drainage and replace as necessary.
3. Remove blockages from affected weep holes to ensure proper operation of drainage plane.

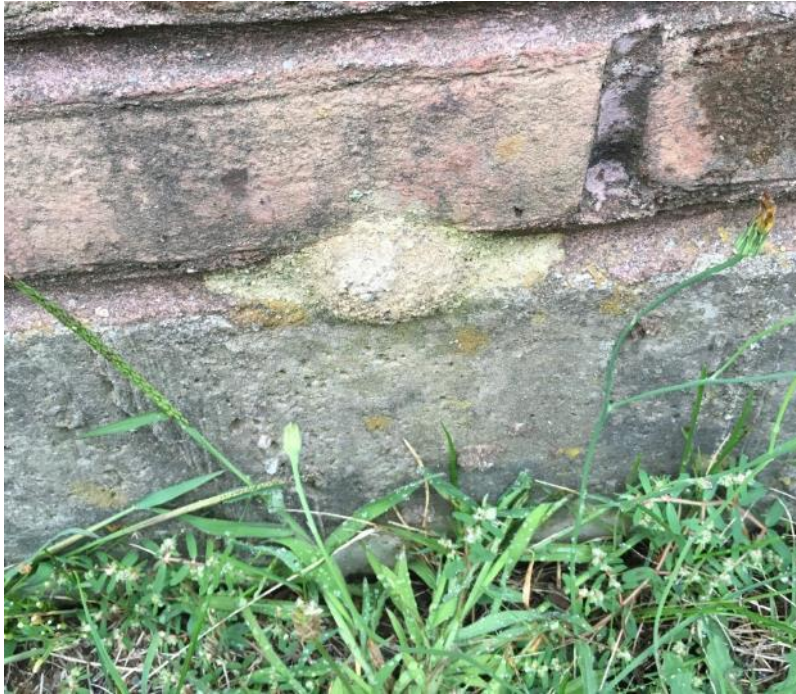
**Picture 27**

**Clogged/plugged weep hole**

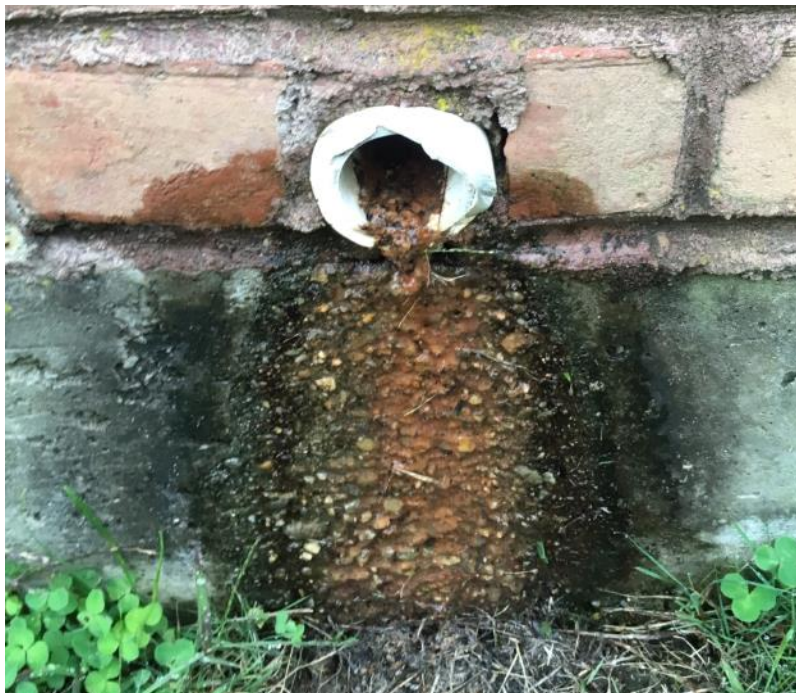
**Picture 28**

Also noted on exterior walls was the presence of rust-colored scale/debris from AC condensation pipes (Picture 28). This may indicate that metal drip pans are corroded/at the end of their service life. It is important that drip pans be smooth/clean and drain properly to prevent debris from clogging drain holes, which can lead to standing water and bacterial/mold growth and associated odors within units.

**Debris/scale from condensate pipe/drip pans**

23. Ensure that condensation from AC equipment is draining properly. Check collector pans, piping and any associated pumps for clogs and leaks and clean periodically to prevent stagnant water build-up and remove debris that may provide a medium for microbial growth.

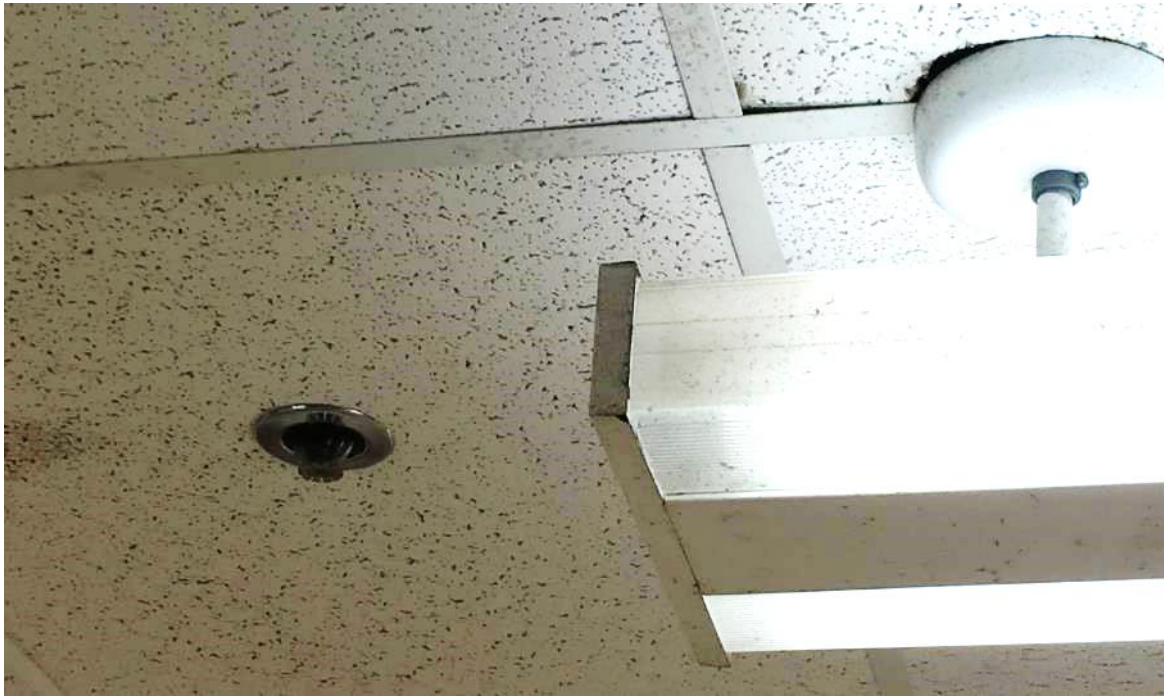
**Picture 29**

**Dust/debris/staining on light fixture directly in front of univent, also note sprinkler head**

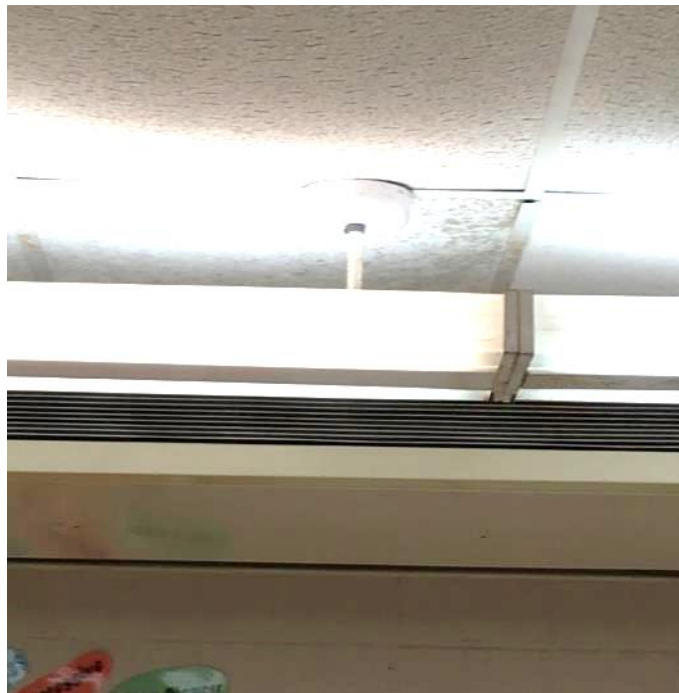
**Picture 30**

**Suspended lighting fixture and stained tile in front of univent**

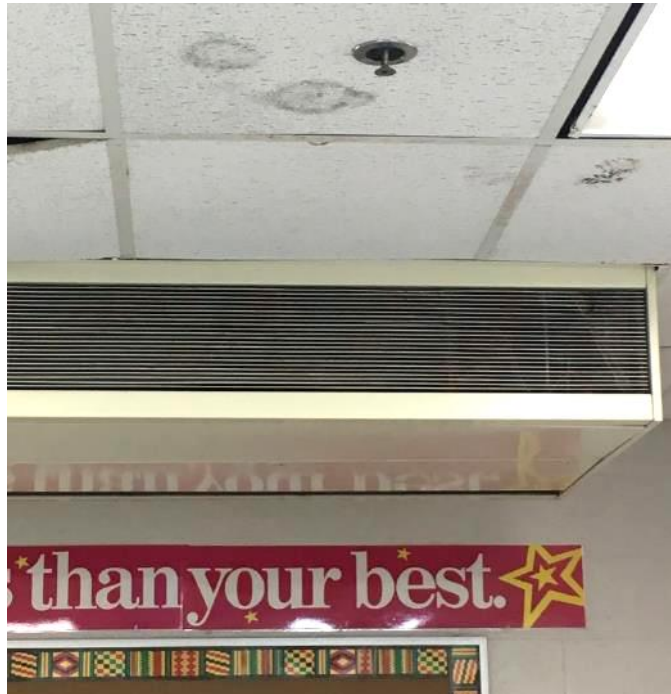
**Picture 31**

**Water-damaged/moldy ceiling tiles and metal sprinkler head directly in front of univent**

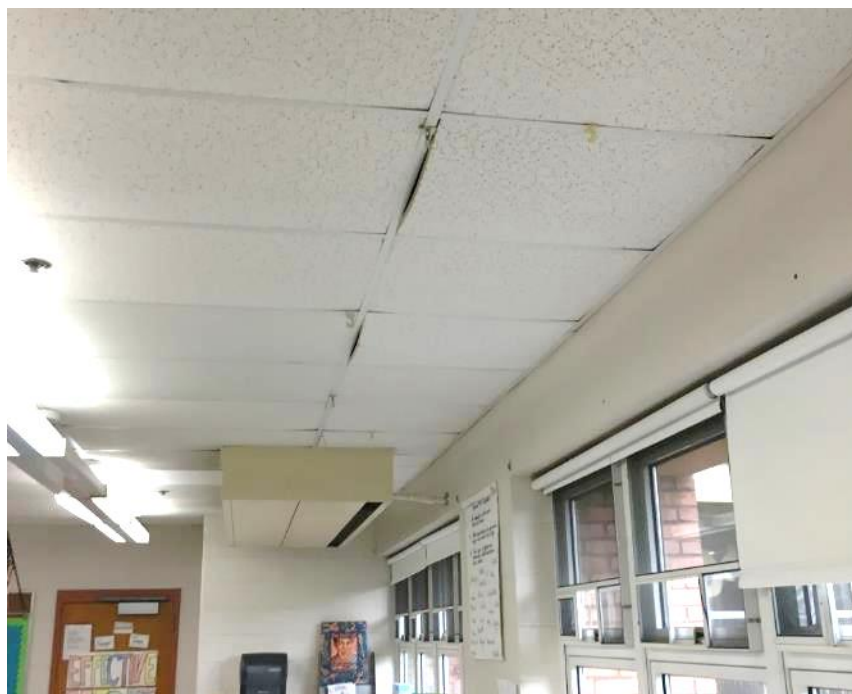
**Picture 32**

Of particular concern are weather patterns of high temperatures (heat waves) and elevated humidity conditions (> 70%) for extended periods of time (three/more consecutive days). If a building does not have either adequate exhaust ventilation and/or air chilling capacity to remove/reduce relative humidity from outside air, then hot, moist air can be introduced into a building and linger to increase occupant discomfort as well as possibly moisten materials that may lead to mold growth. The MDPH recommends a comfort range of 40 to 60 percent for indoor air relative humidity, which were exceeded throughout the building during the September 12<sup>th</sup> visit. Chronic issues with excess humidity were evident by the presence of “bowed” (i.e., non-flush) ceiling tiles throughout the building (Picture 32).

**“Bowed” (non-flush) ceiling tiles in first floor classroom**

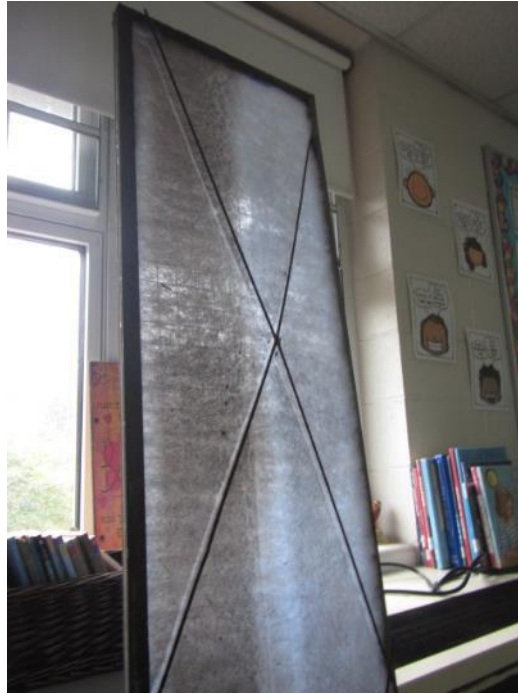
**Picture 33**

**Metal filter rack and media that needs to be “cut to size” and installed in univents**

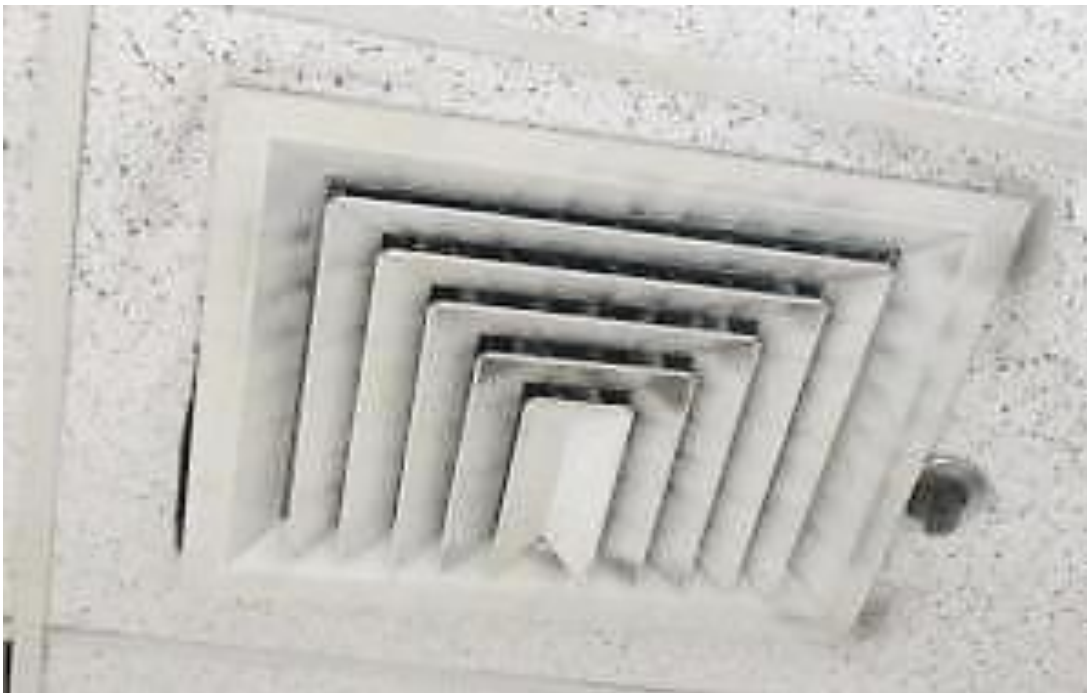
**Picture 34**

**Accumulated dust/debris on supply diffuser and surrounding ceiling tile**
