# **INDOOR AIR QUALITY ASSESSMENT**

**Barnstable United Elementary School  
730 Osterville W. Barnstable Road  
Marstons Mills, Massachusetts**

Prepared by:  
Massachusetts Department of Public Health  
Bureau of Environmental Health  
Indoor Air Quality Program  
October 2019

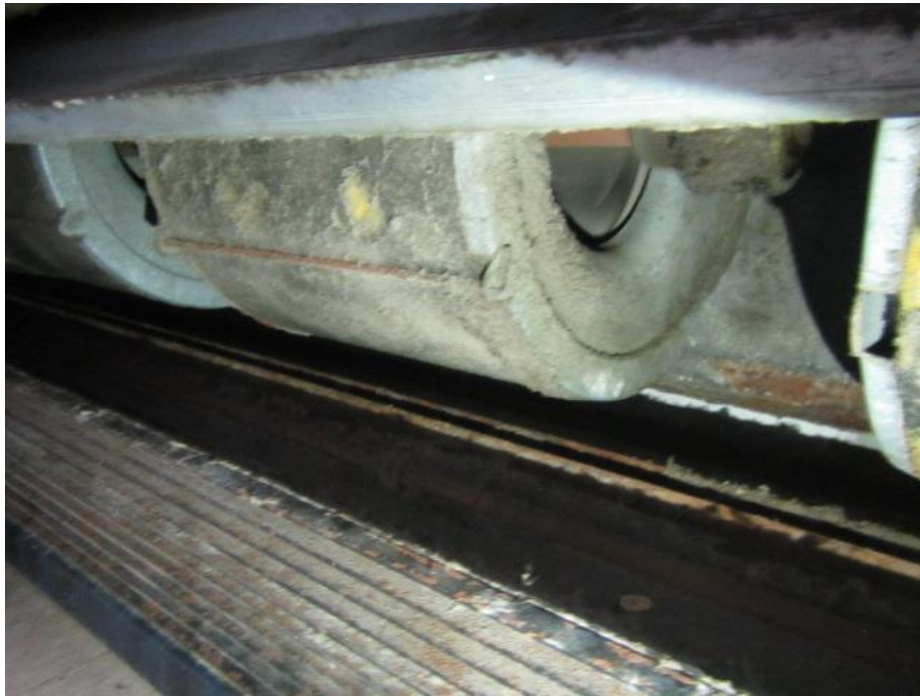
**Picture 35**

In some areas, exhaust vents, supply diffusers and the interior of univents had accumulated dust/debris (Table 1, Pictures 4, 34 and 35). This dust can be reaerosolized under certain conditions, and can also be a medium for mold growth. Univent cabinets can also accumulate dust and debris which should be cleaned when filters are changed (2-4 times/year).

**Accumulated dust/debris on interior univent components**

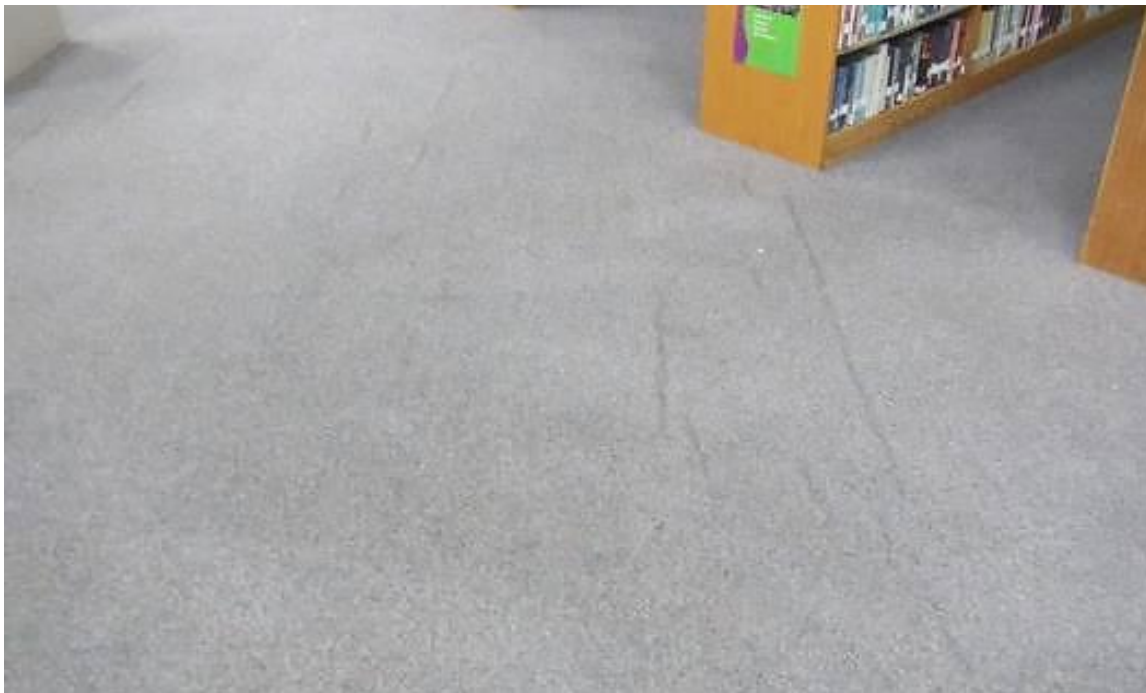
**Picture 36**

Some areas had wall to wall carpeting, in some cases the carpet was wrinkled/worn and appeared to be past its useful life (Pictures 36 and 37). The service life of carpeting in schools is approximately 10-11 years (IICRC, 2002). Aging carpet can produce fibers that can be irritating to the respiratory system. In addition, tears or lifting carpet can create tripping hazards. Area rugs were also observed in many classrooms (Table 1). Carpets should be cleaned annually (or semi-annually in soiled/high traffic areas) in accordance with Institute of Inspection, Cleaning and Restoration Certification (IICRC) recommendations, (IICRC, 2012). Regular cleaning with a high efficiency particulate air (HEPA) filtered vacuum in combination with an annual cleaning will help to reduce accumulation and potential aerosolization of materials from carpeting. Area carpets too worn to be effectively cleaned should be replaced. Area rugs should be rolled up and stored in a clean, dry place when rooms are not occupied during the summer months to prevent moistening due to condensation.

**Original (20+ yr.)/wrinkled carpeting in Library**

32. Consider a long-term plan to replace all carpeting in the building as funds become available. Consider replacing carpeting with a non-porous surface such as vinyl tile particularly in below-grade areas.

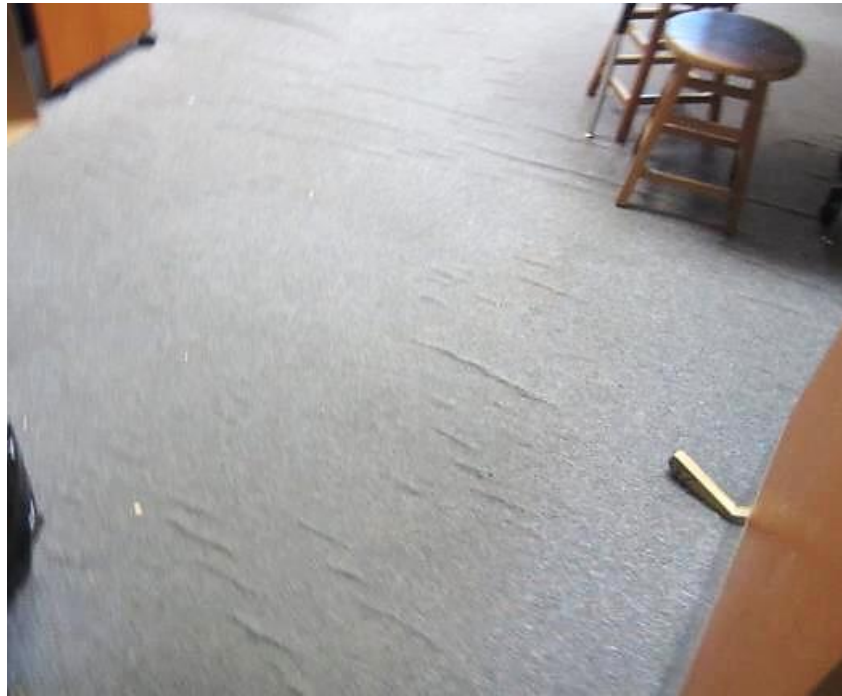
**Picture 37**

**Original (20+ yr.)/wrinkled carpeting in Guidance Dept**

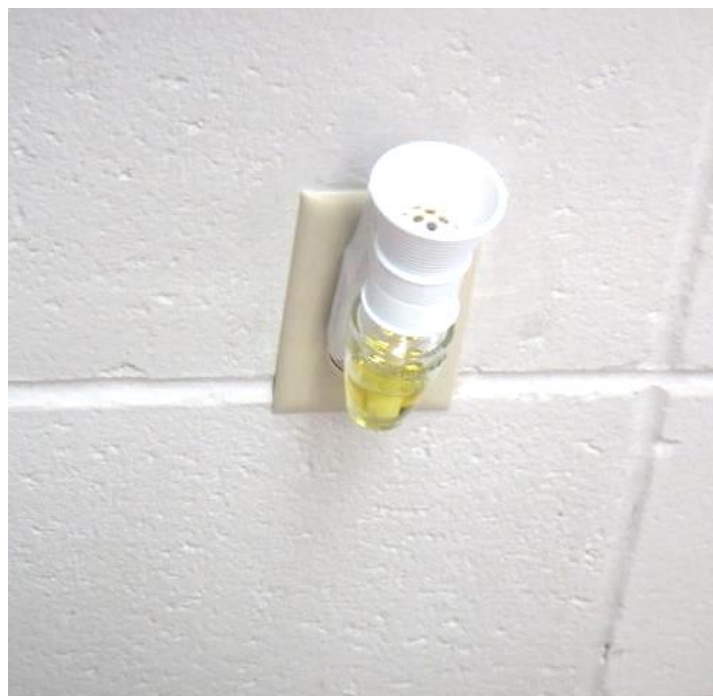
**Picture 38**

**Plug-in air freshener in classroom**
