Monomoy Regional Middle School

Siding Replacement Feasibility Study

School Committee Meeting

October 24, 2024

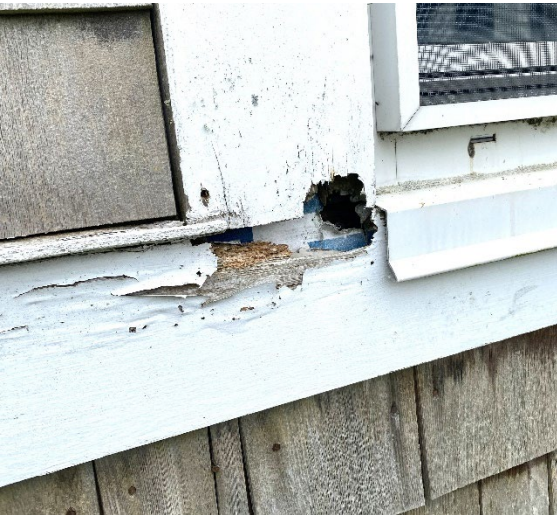
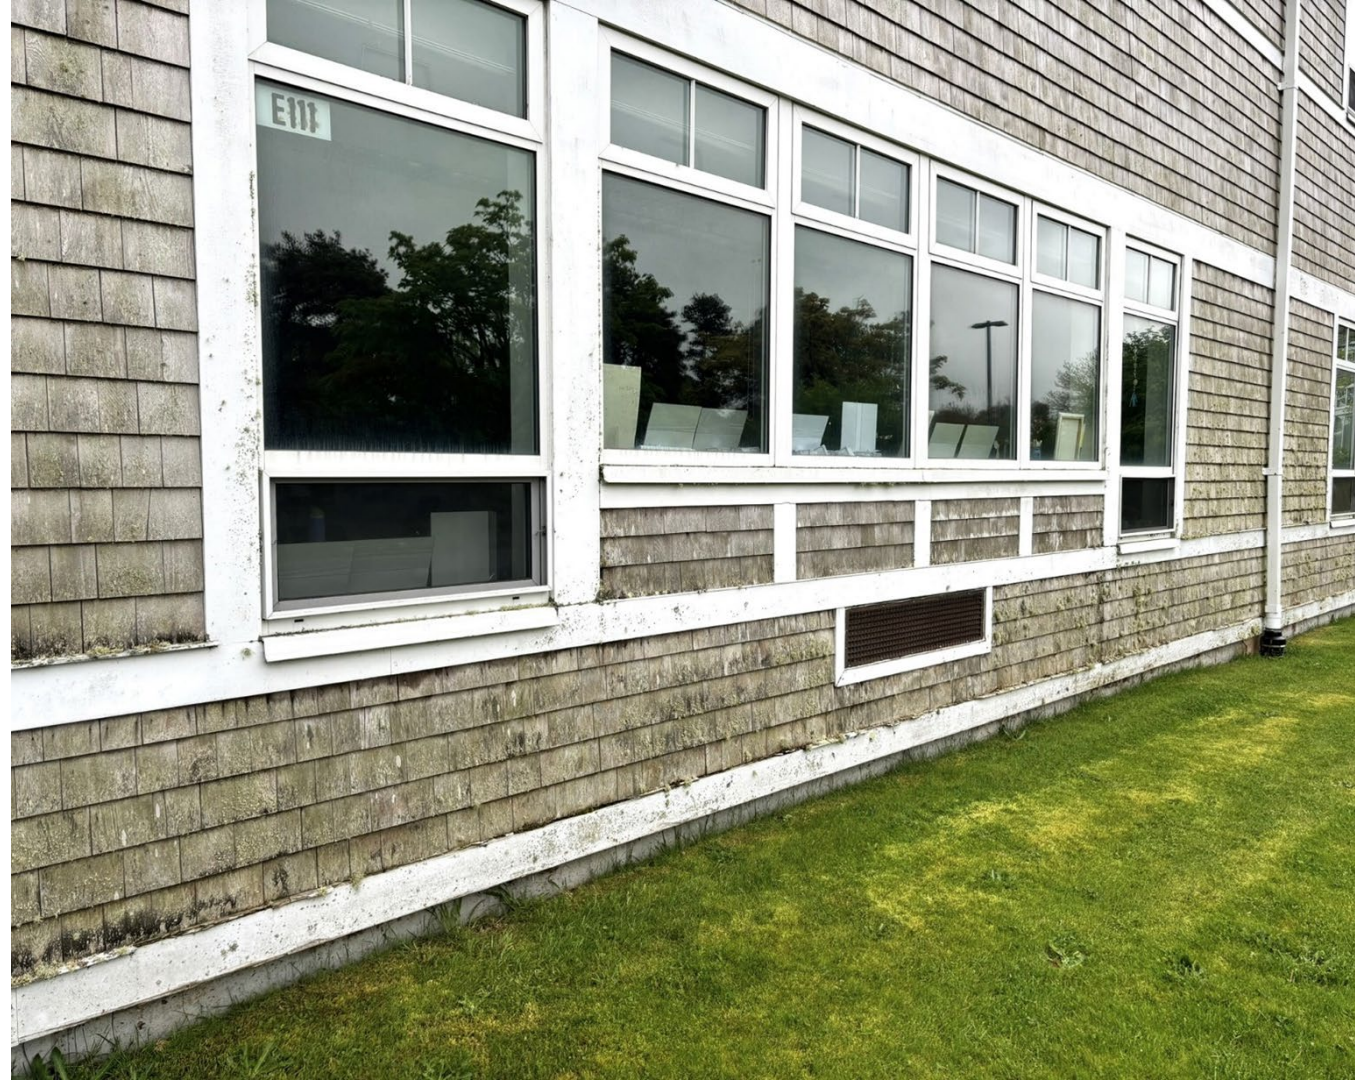
- Evident Decay upon Closer Look
- Extensive Lichen Growth
- Soft and Stained Shingles
- Substrate Exposed by Rot

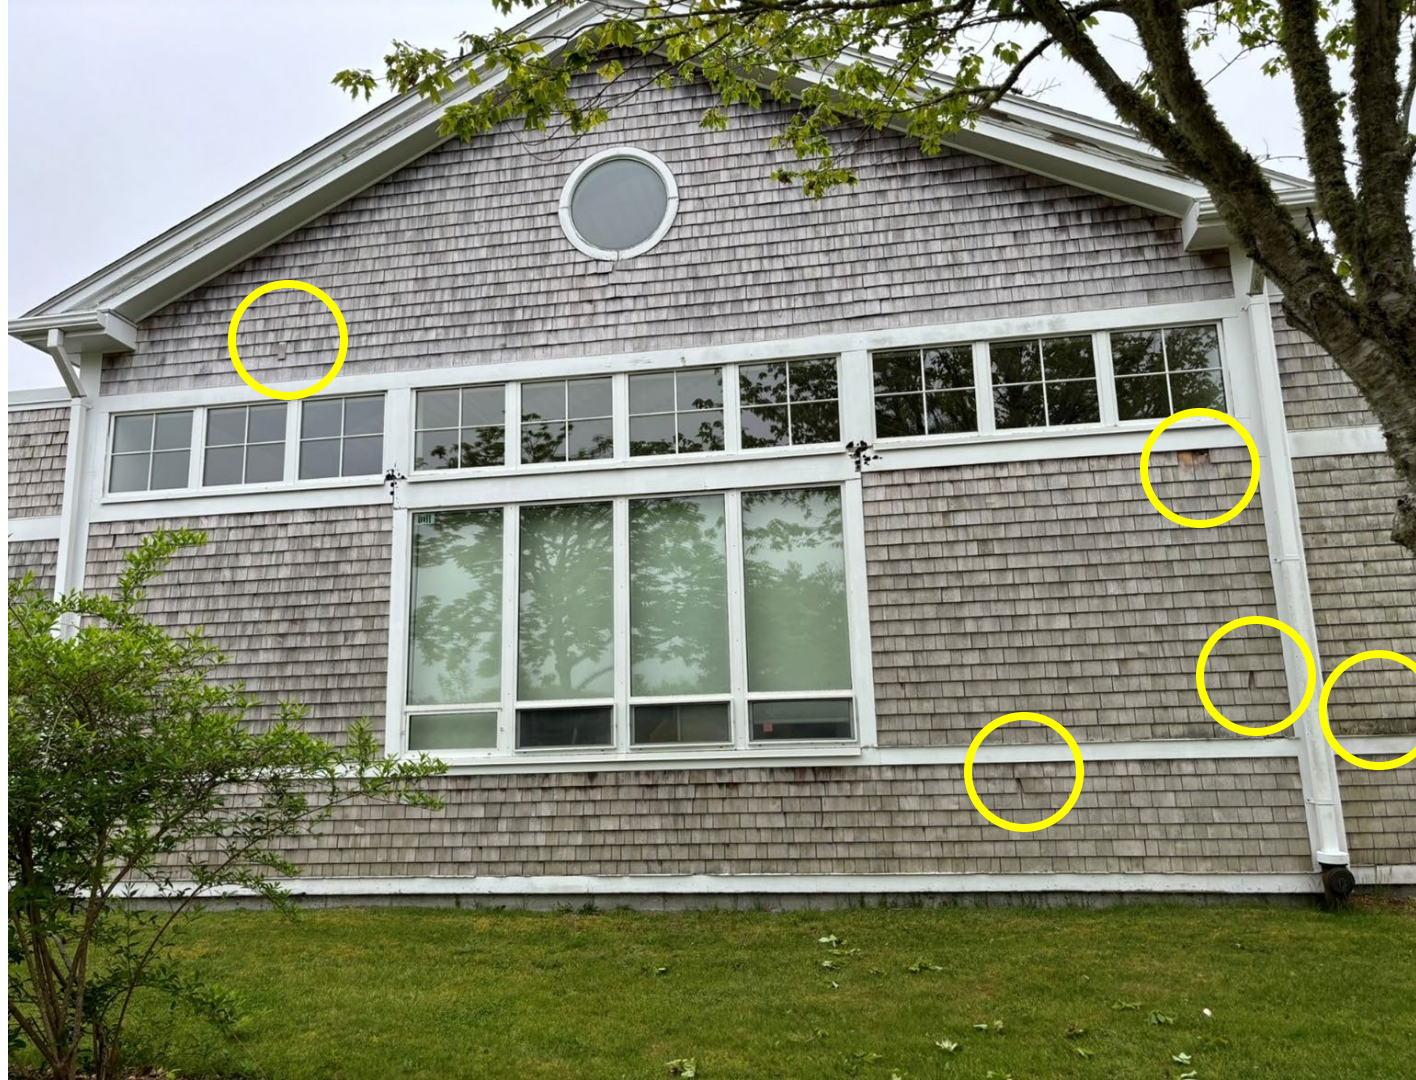
- Loose Shingles
- Missing Shingles
- Lichen & Mildew Hbst

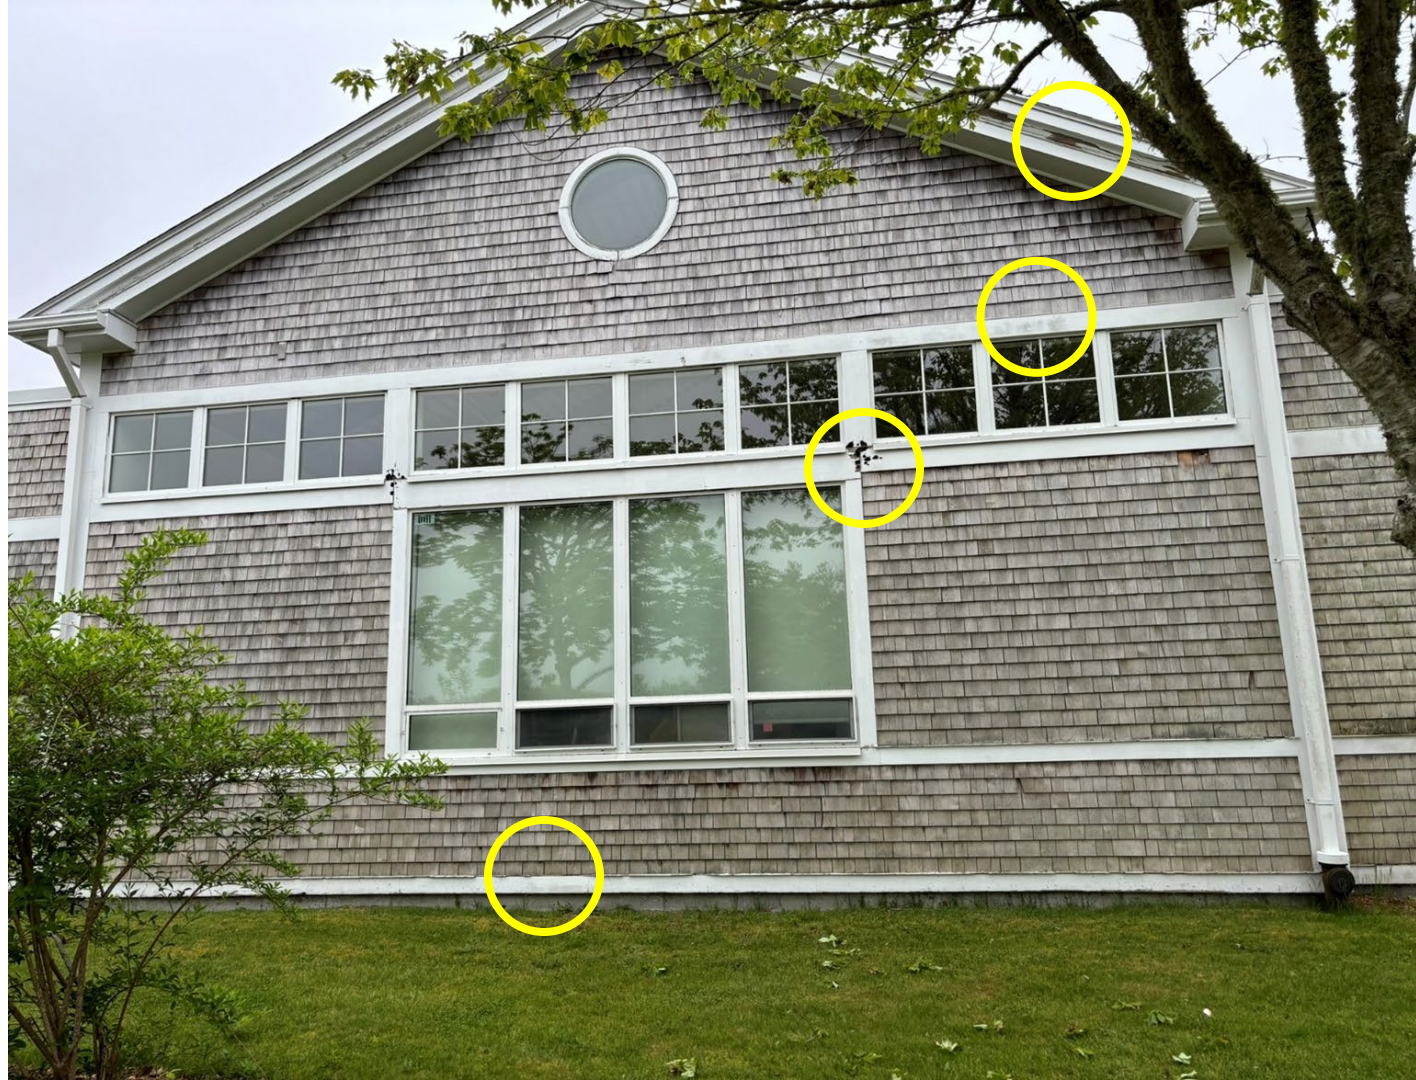
- Rotted Trim
- Rotted & Missing Cap Trim
- Worn & Peeling Paint

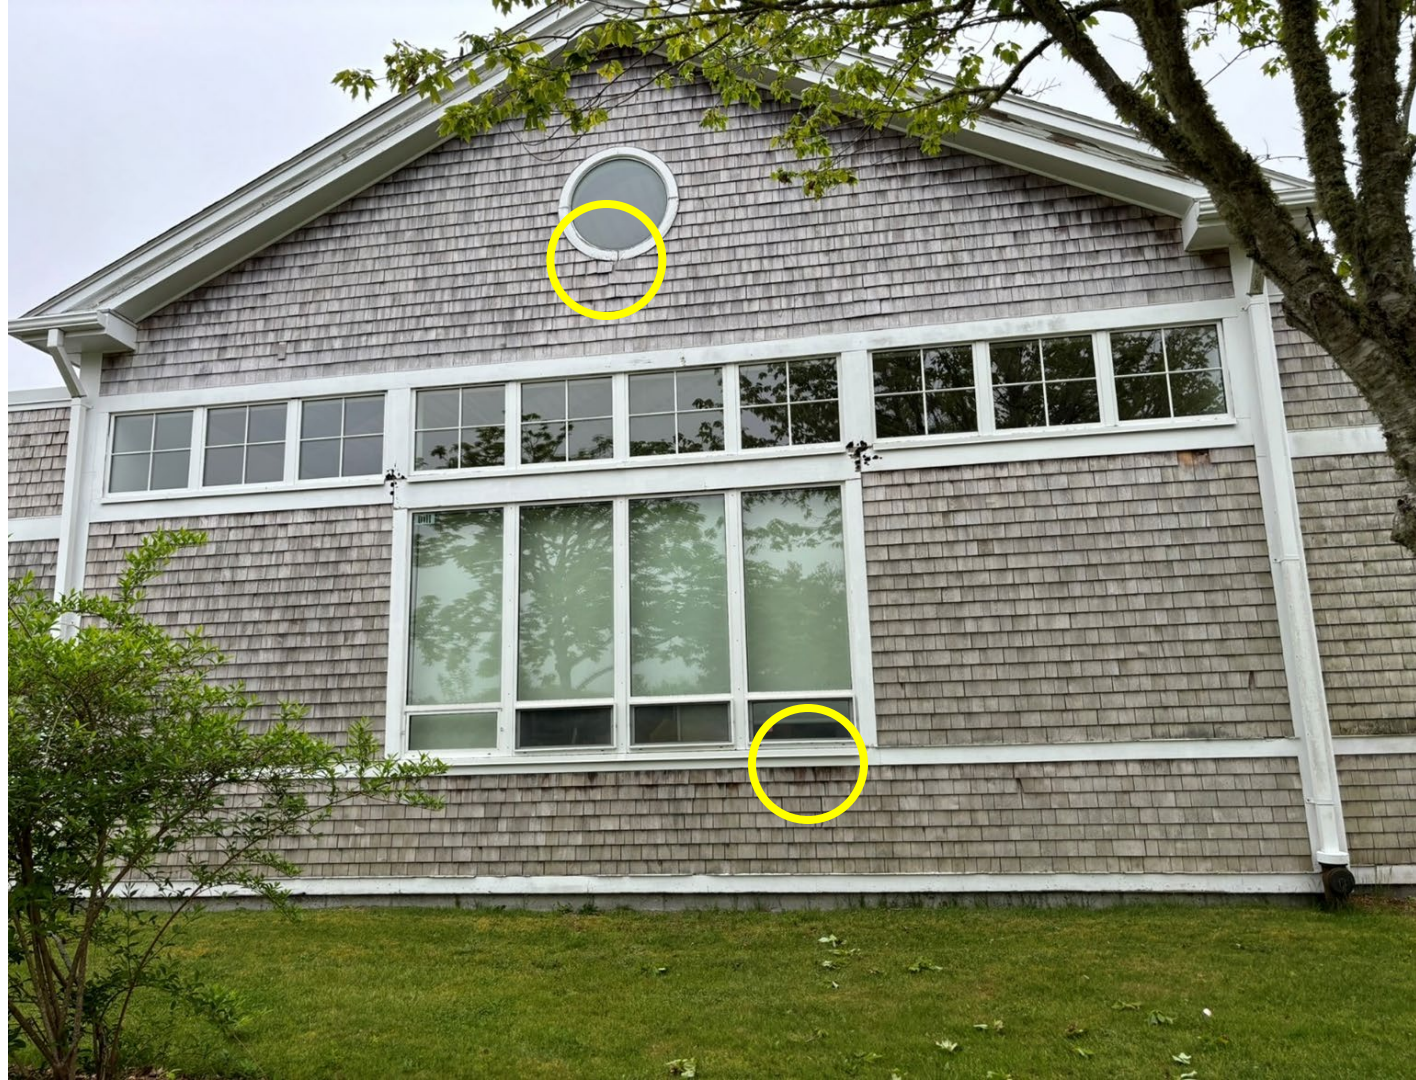
- Evidence of Water Infiltration
- Buckled Shingles
- Staining Below Sills

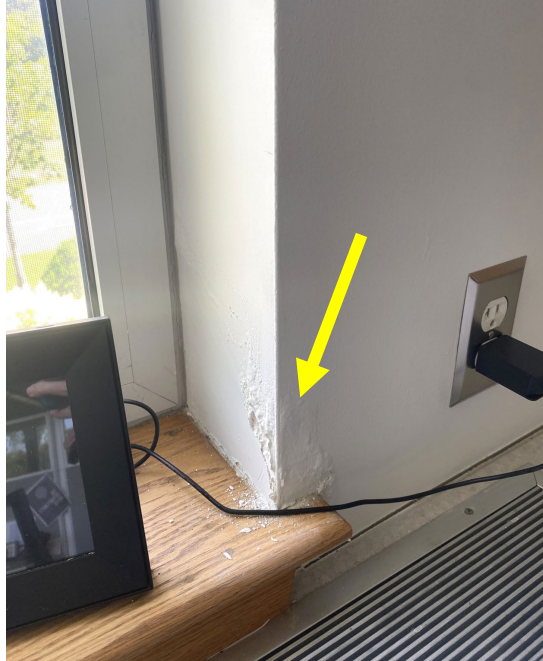
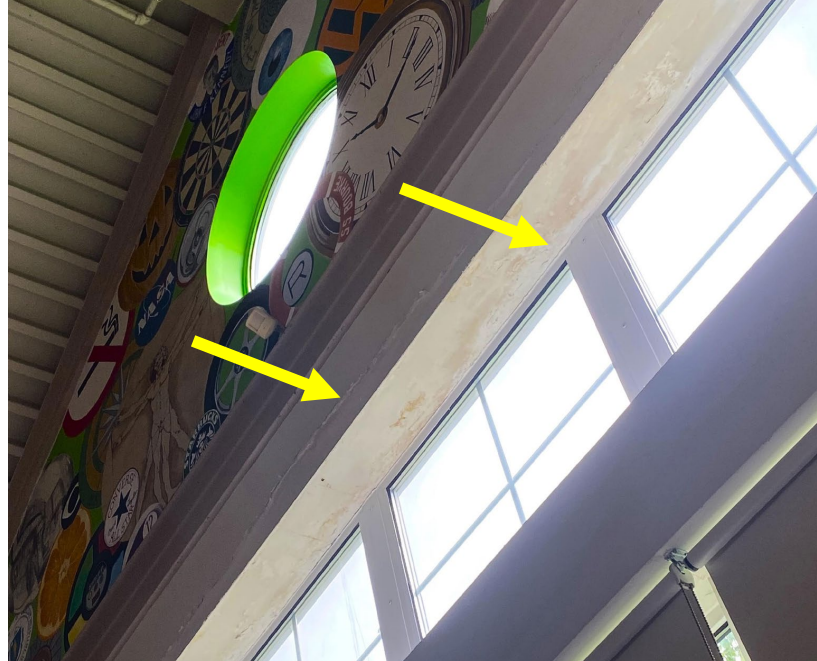
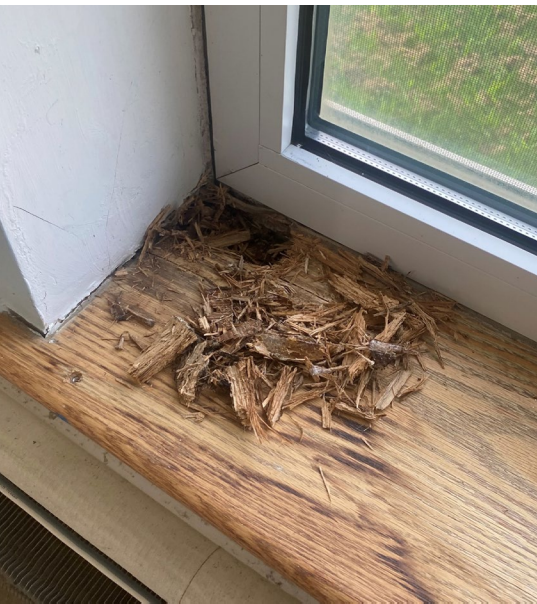
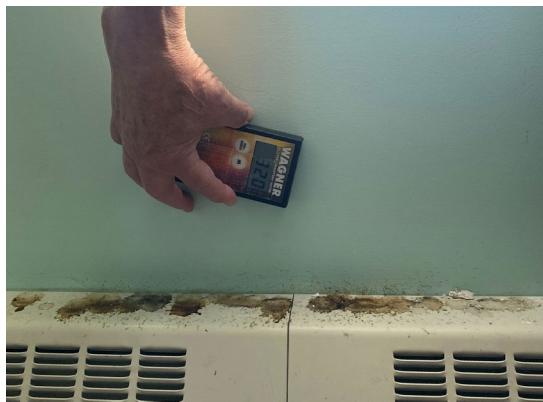
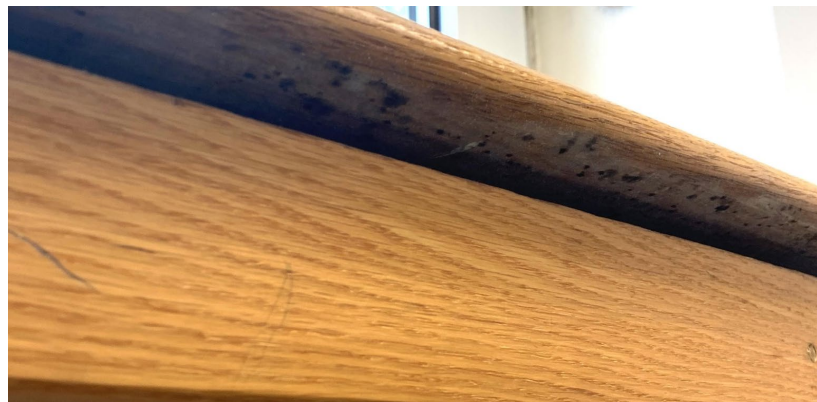
- Water Damage to Finishes
- Leak Stains
- Suspect Mold Growth at Window Sills

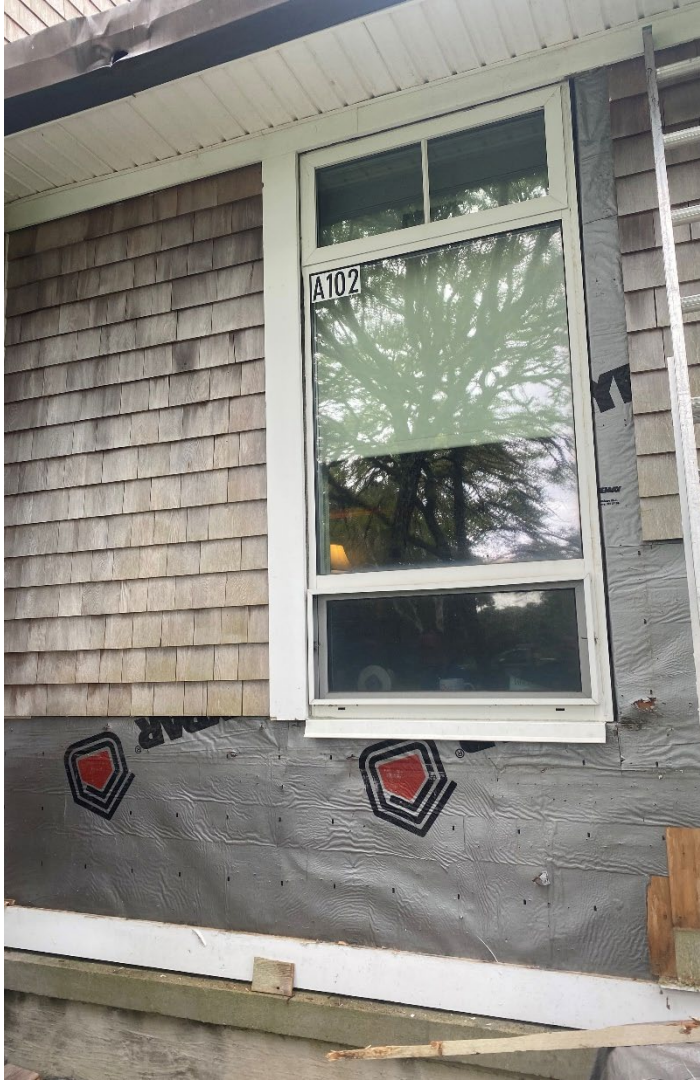
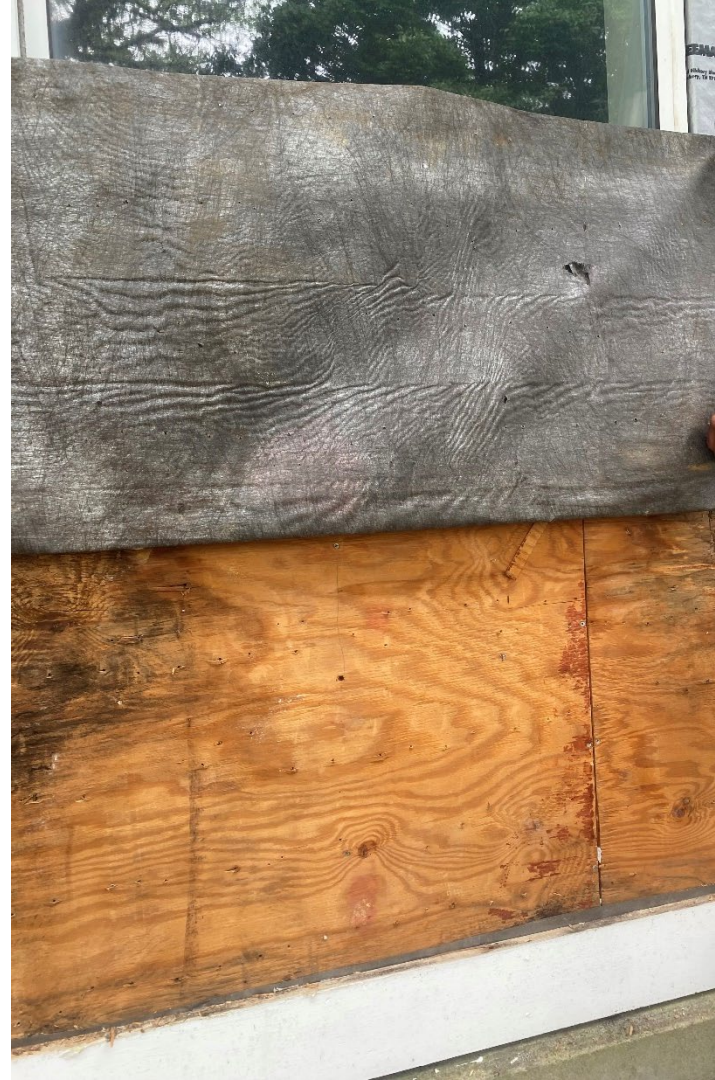
- Identify the Infiltration paths and the makeup and condition of the substrates
- Insufficient Window Flashing
- Plywood Sheathing Stained and Rotted
- Evidence of Water Infiltration Behind Air/Water Barrier
- Water Testing Showed No Leaks Through Window Unit
- Insufficient Window Flashing of Rough Opening is a Likely Primary Source

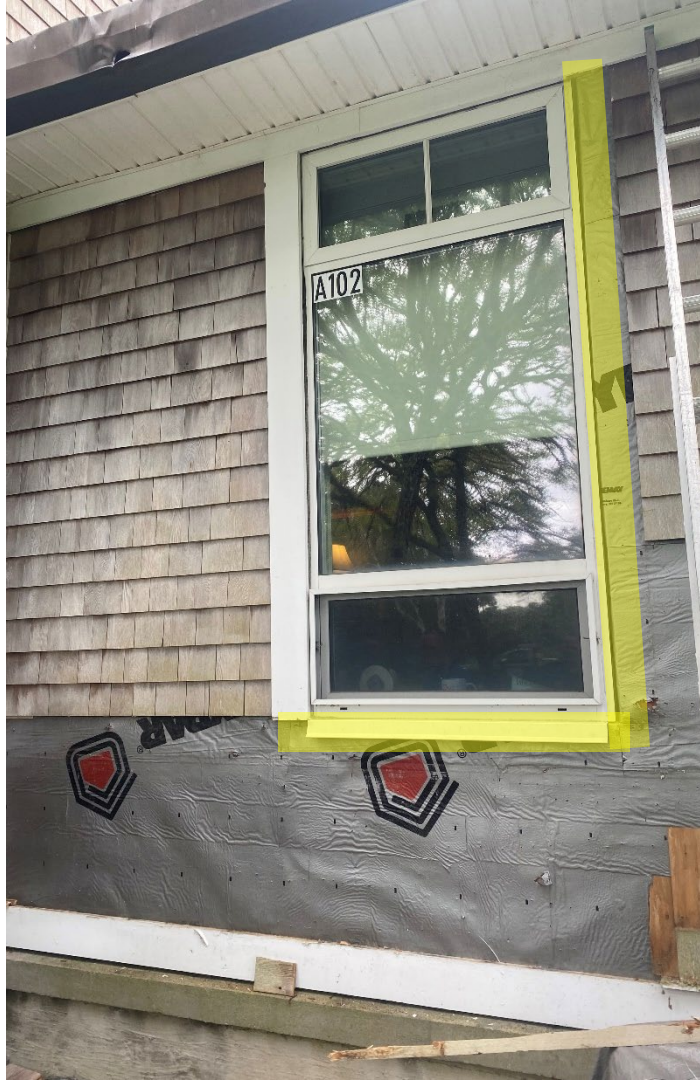
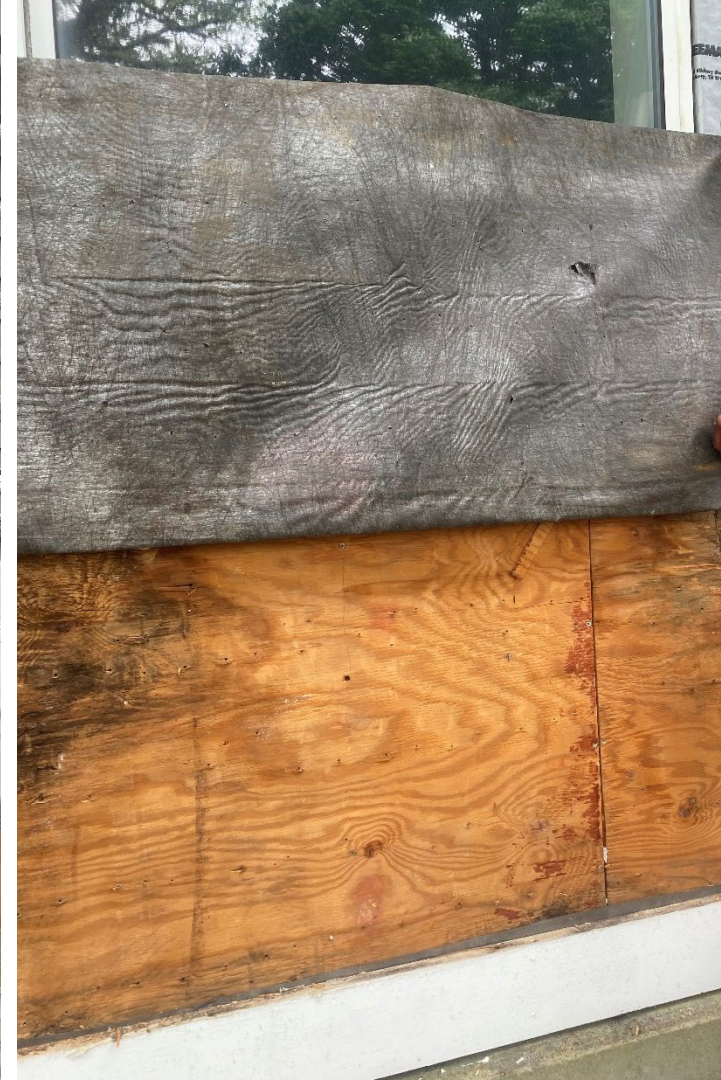
- **Where is the Water Infiltrating?**
- **Peel Back Siding Layers**
- **Insufficient Window Flashing**
- **Flywood Sheathing Stained and Rotted**
- **Evidence of Water Infiltration Behind Air/Water Barrier**
- **Water Testing Showed No Leaks Through Window Unit**
- **Insufficient Window Flashing of Rough Openings**

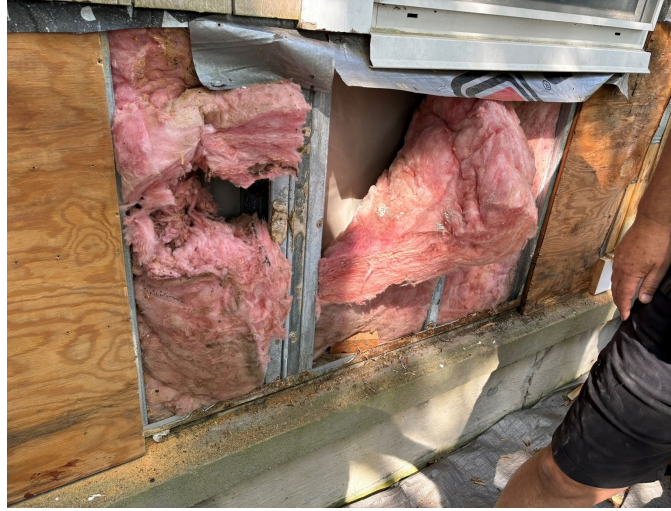
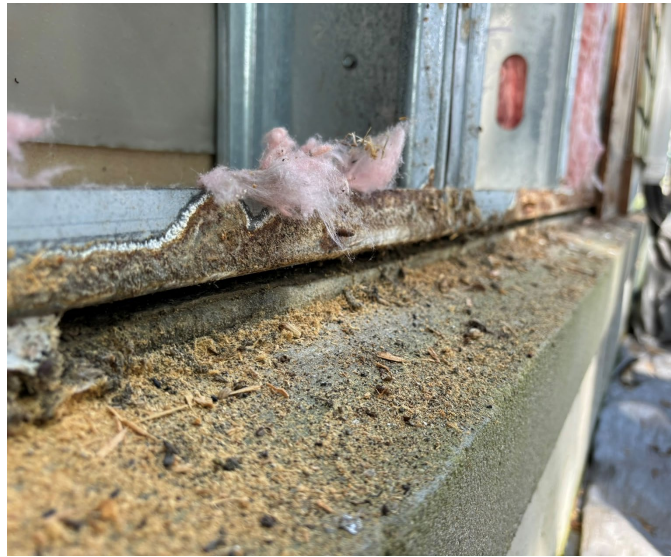
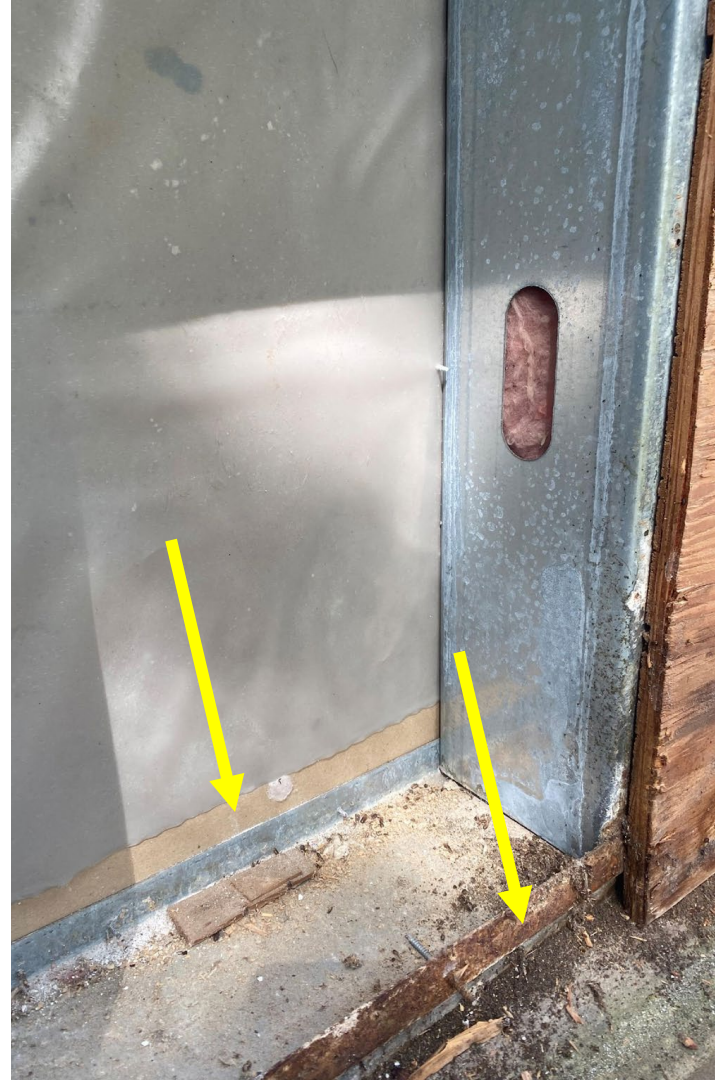
- Damaged Insulation
- Rodent Infilt ration
- Oxidized (Rust ed) Framing
- Gap in Vapor Barrier – Interior Side of Wall

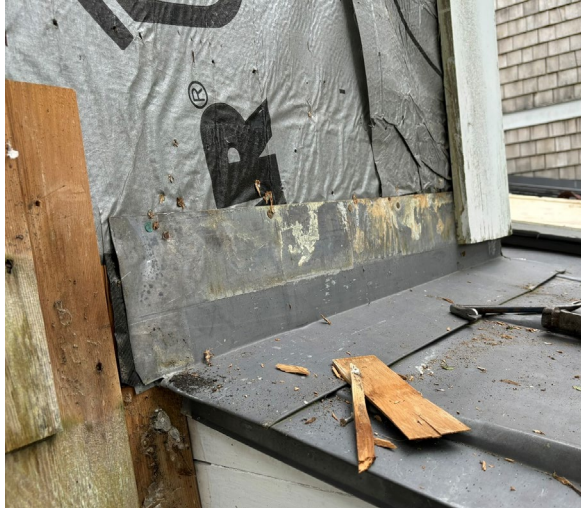
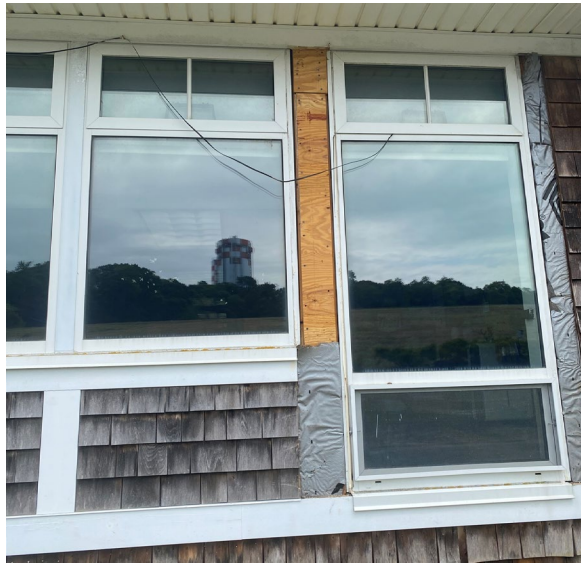
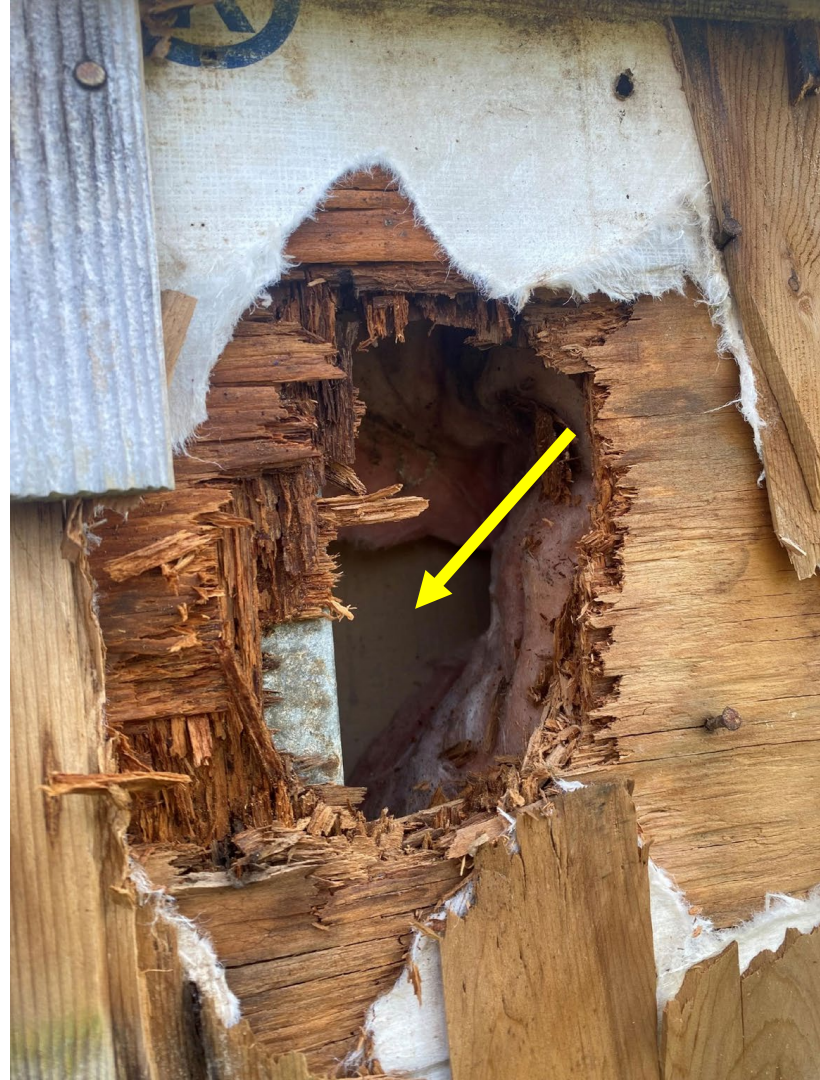
- “Backwards” Base Flashing
- Severely Rotted Sheathing
- Dissimilar Air/Water Barrier
- Absent Vapor Barrier
- Missing Air/Water Barrier

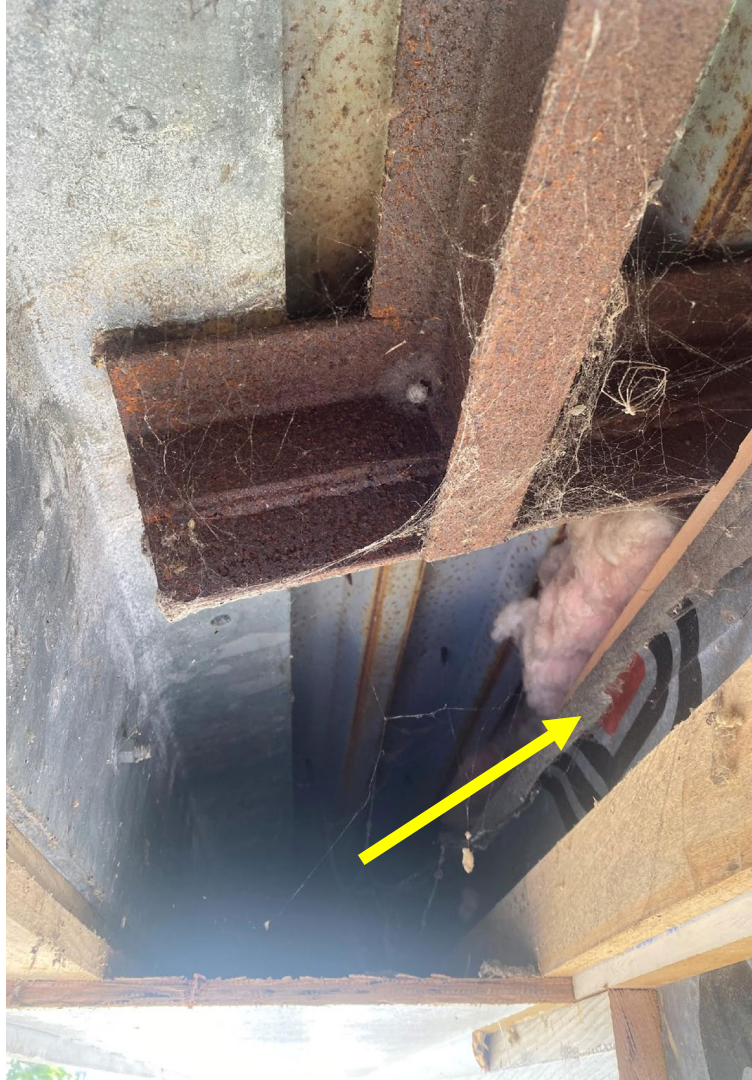
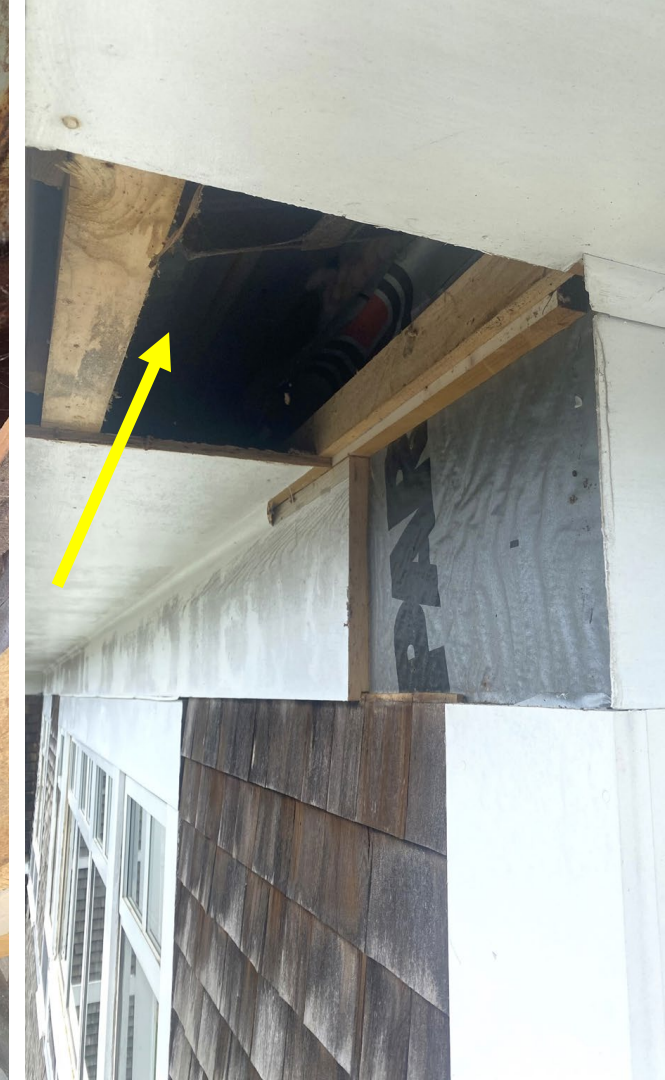
- Discontinuous Vapor Barrier
- Unsealed Air/Water Barrier Termination
- Oxidized Framing and Decking

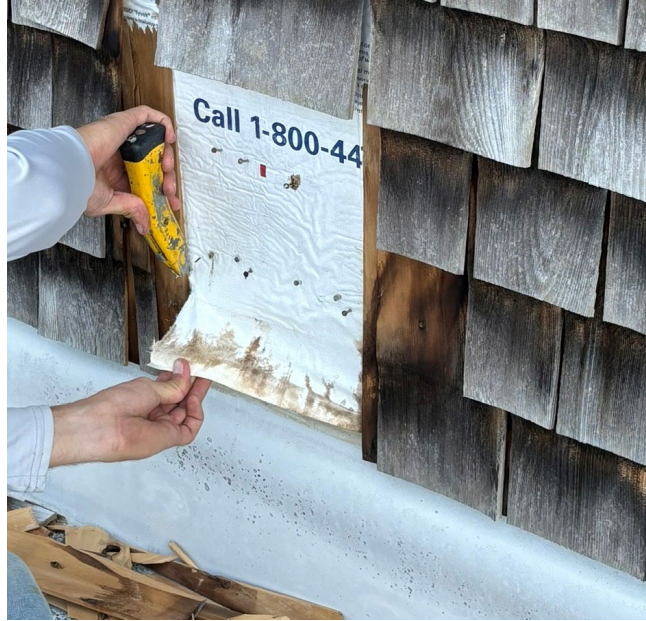
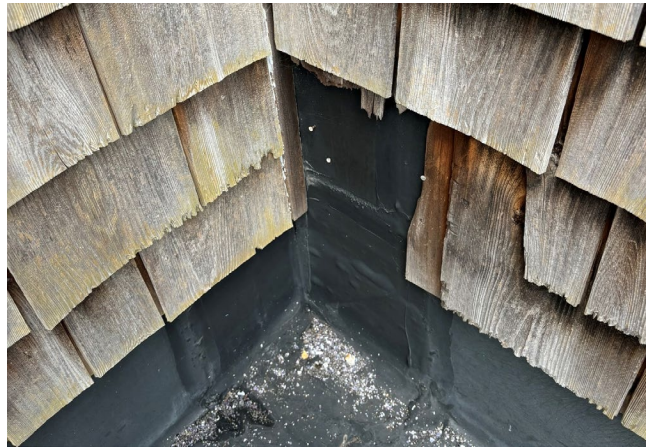
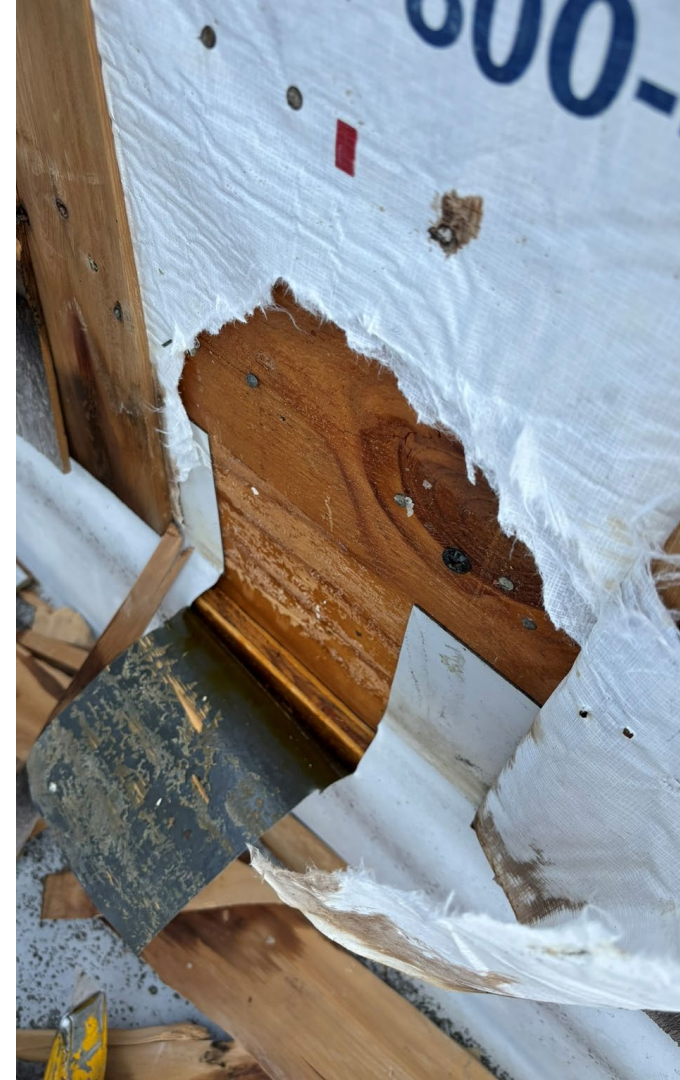
- Roof Cuts did Not Show Signs of Water Infiltration
- Upturned & Adhered Membrane Terminations
- Dry Sheathing

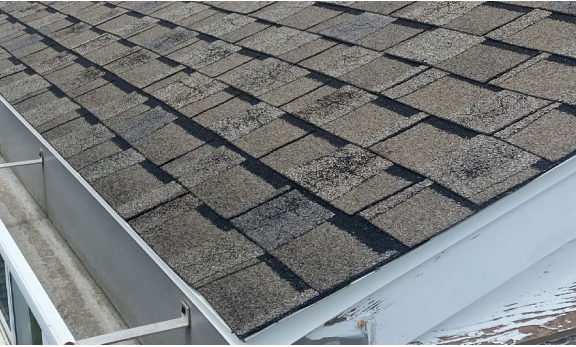
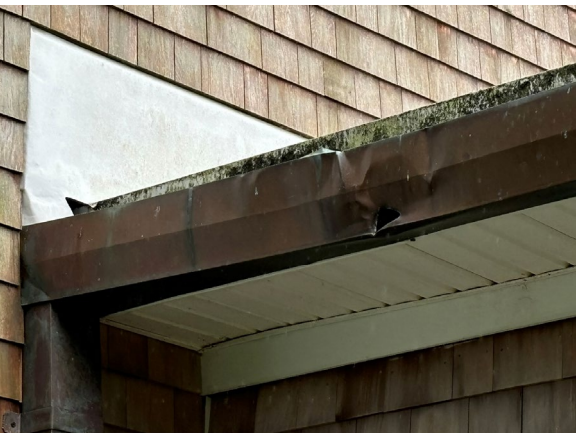
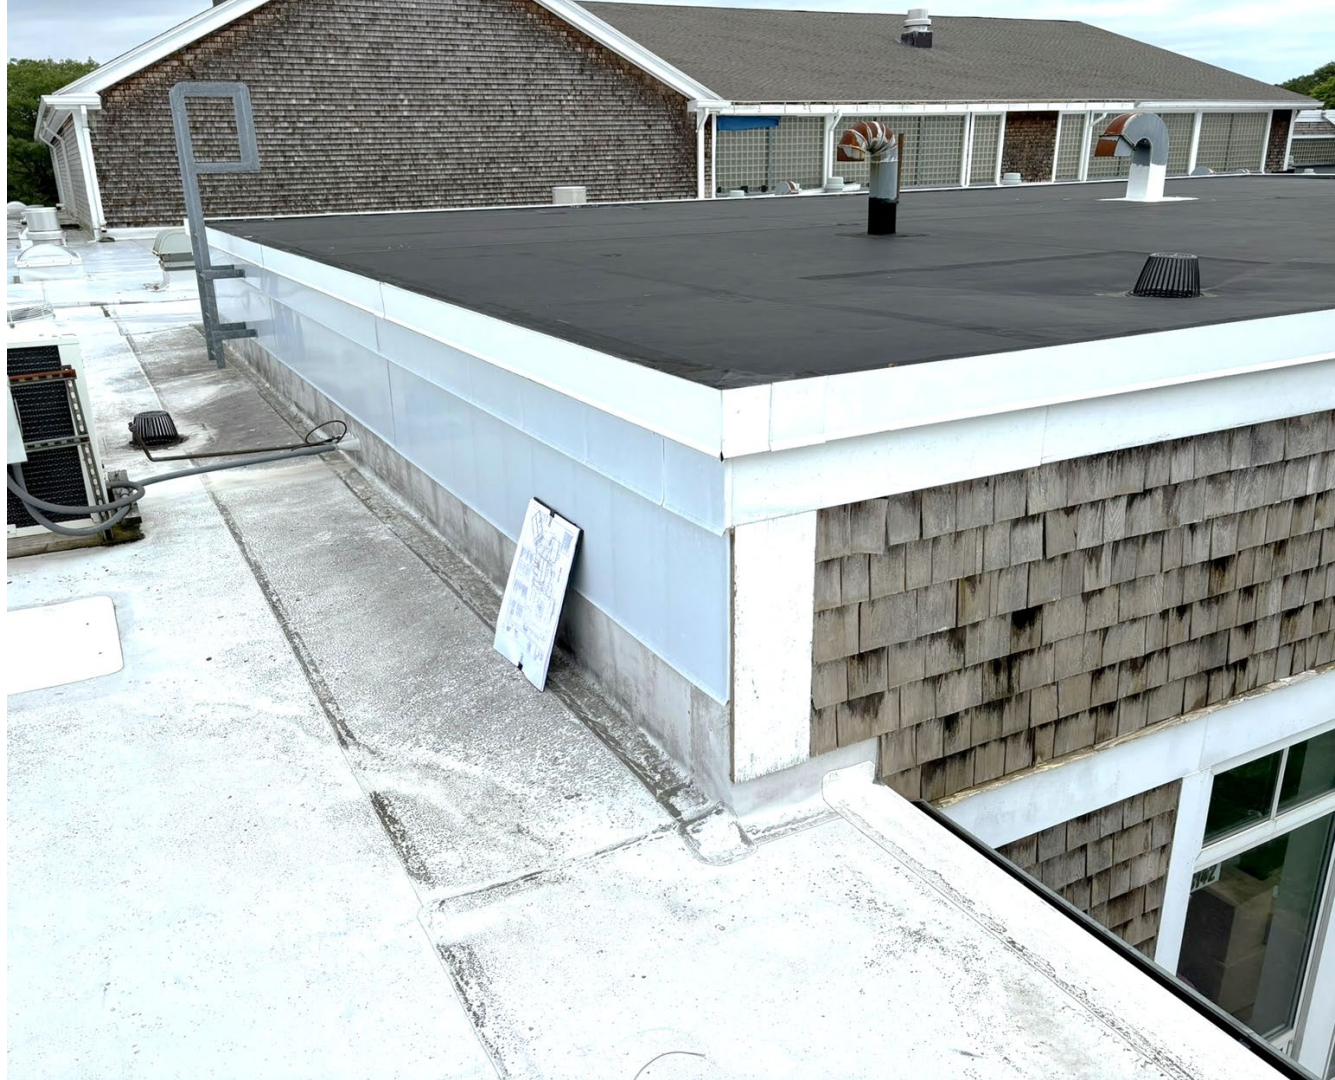
- Roofing Shows Age but Few Signs it has Failed

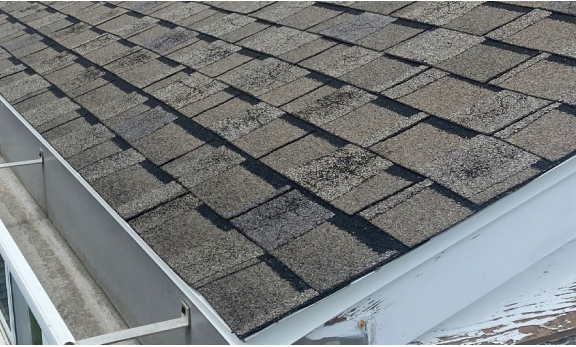
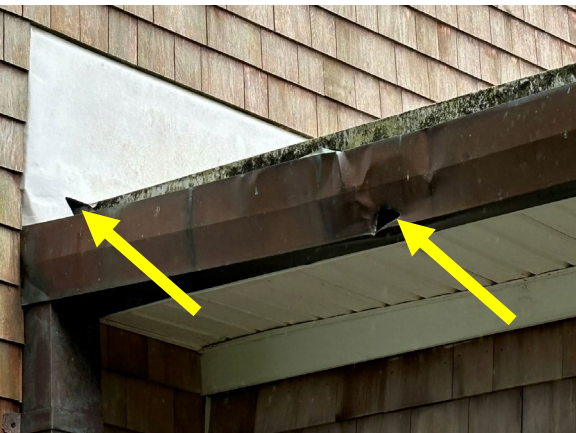
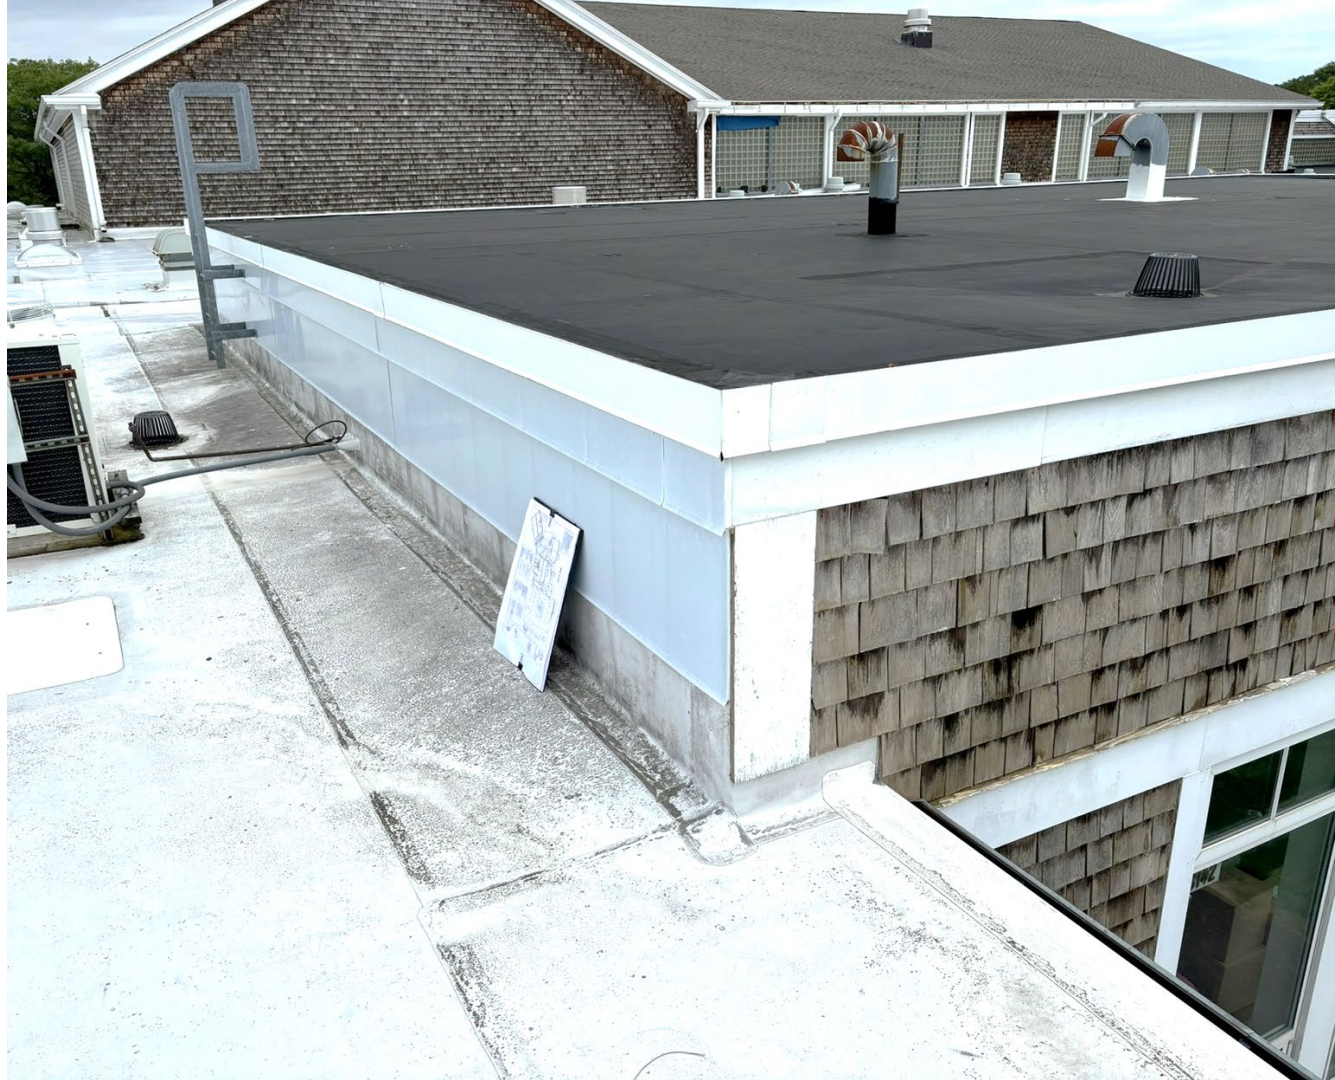
- Repairable Deficiencies, Dings, and Dents

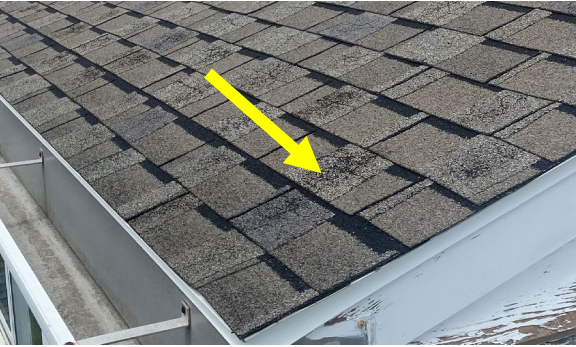
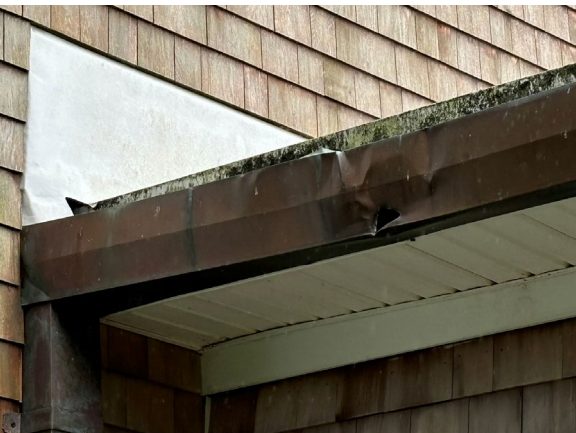
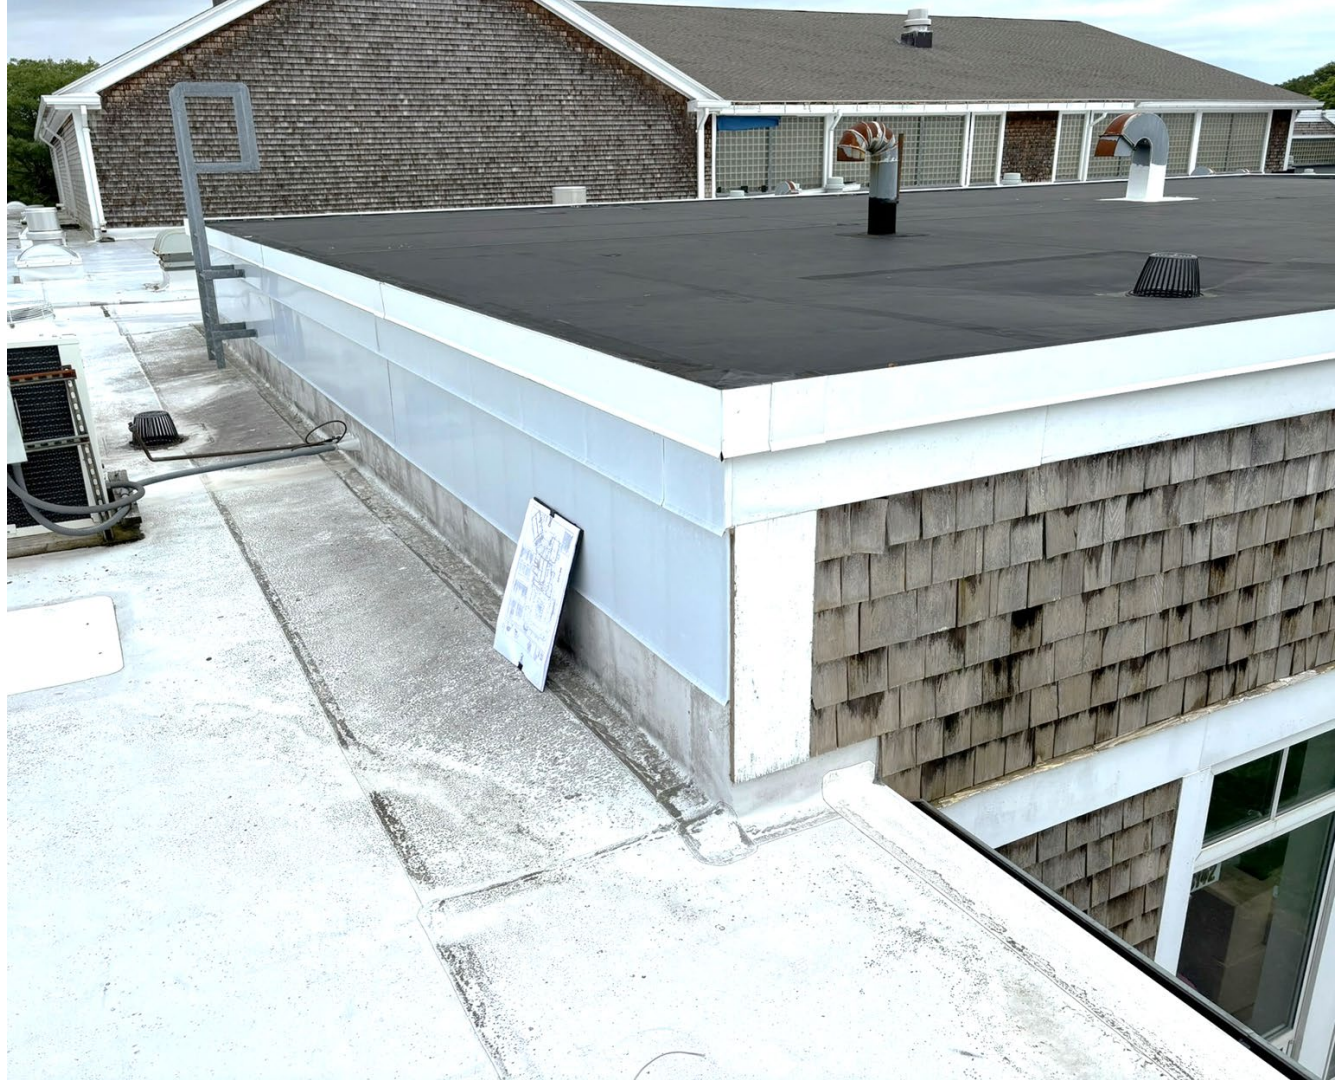
- Surface Granule Deterioration
