Monomoy Regional Middle School

Siding Replacement Feasibility Study

School Committee Meeting

October 24, 2024

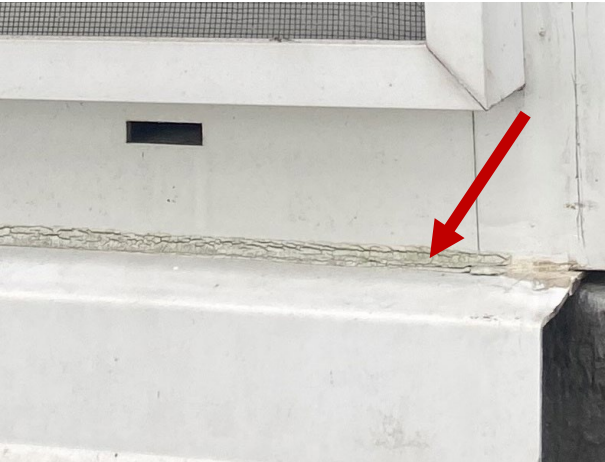
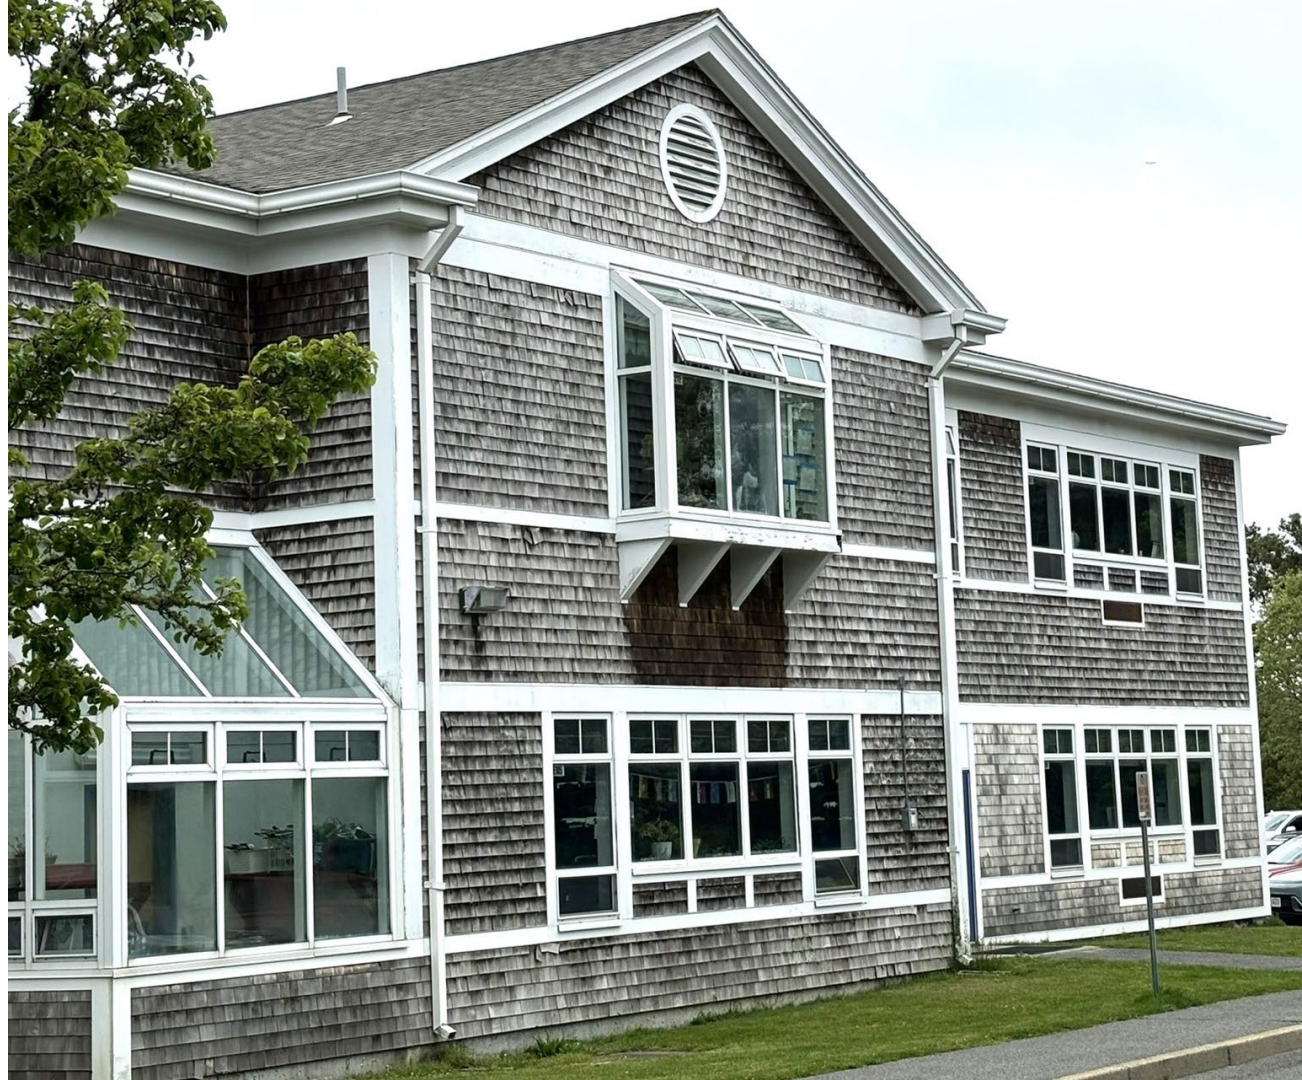
- Most Glass is Clear and Intact
- Nearing End of Expected Life Span but few signs of failure
- Bay Windows are Exception
- Deteriorated Sealants

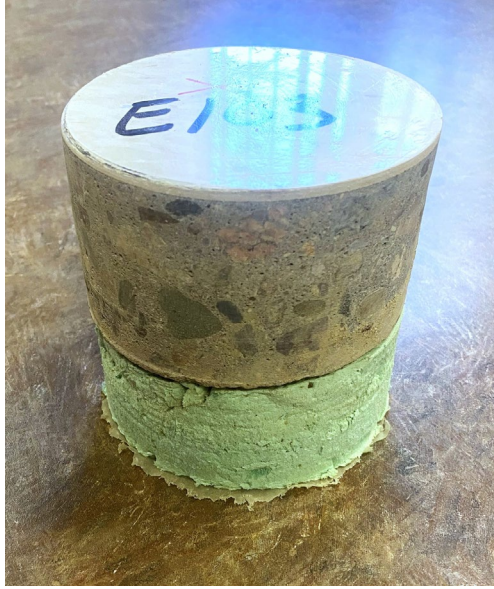
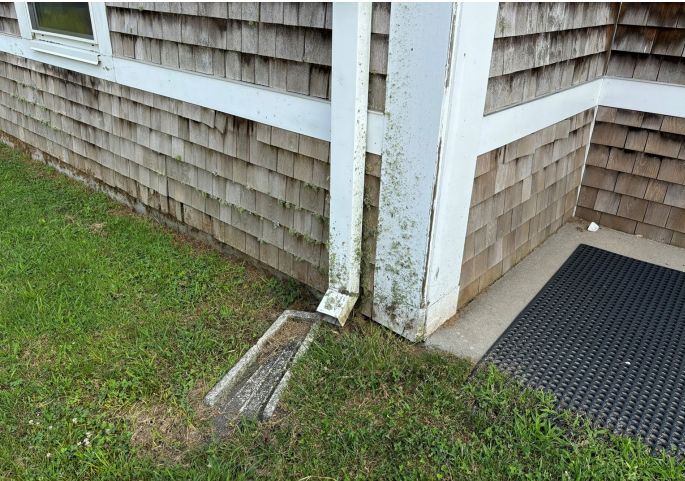
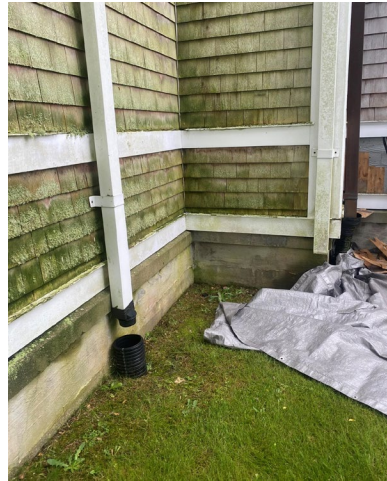
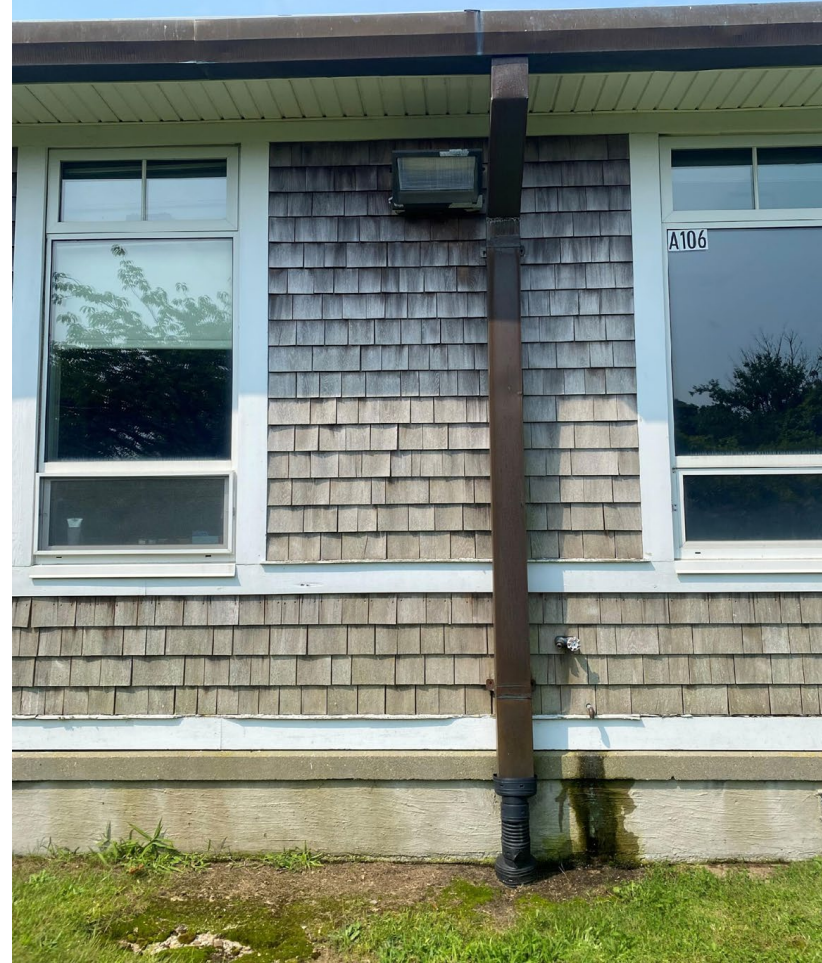
- Slab Test Cores Extracted, Good Condition
- Surface Stains from Condensate Run-Off
- Disconnect ed Downspout s, Insuff icient Leaders
