## **Monomoy Regional Middle School Air Quality Testing Report**

# **MONOMOY REGIONAL MIDDLE SCHOOL**

## **Siding Replacement Feasibility Study**

Presented by  
**Raymond Design Associates, Inc.**

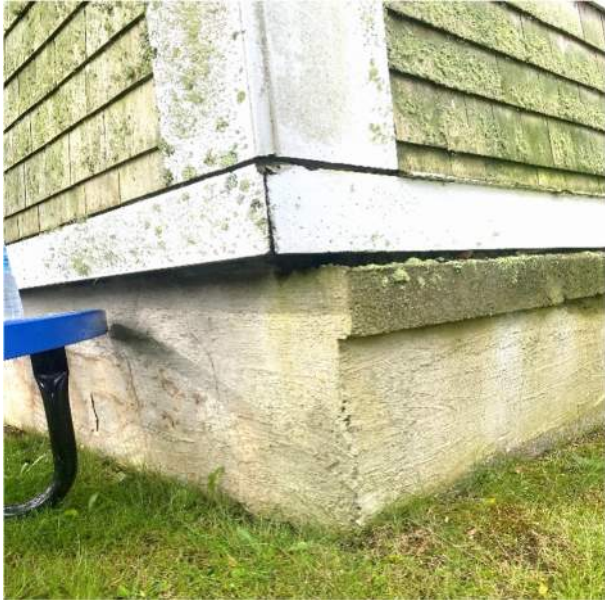
| Existing Conditions Photos | | |
|---|---|---|
| 1. | | View of original 1963 chamfered foundation wall edge. This photo also shows lichen growth and trim rot which is consistent throughout all elevations. |

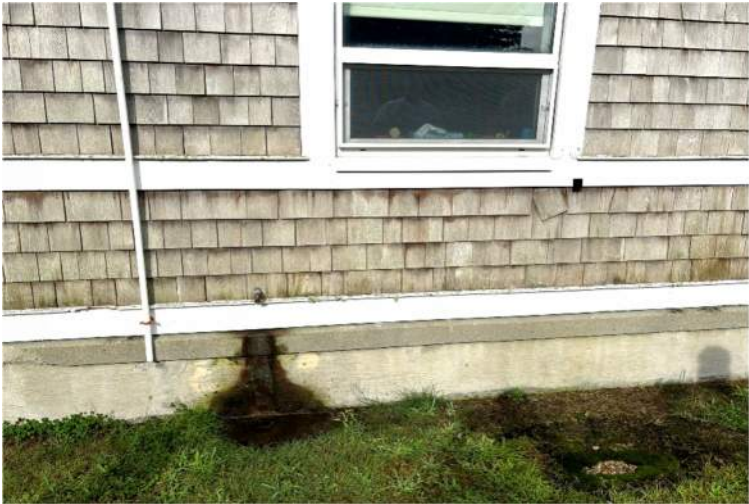
| Existing Conditions Photos | | |
|---|---|---|
| 2. | | <p>View of foundation wall in otherwise good condition becoming stained and damaged by condensate pipe run-off. Discharged water is pooling at grade against the foundation and nearby moss in the grass indicates consistent high moisture levels in the soil.</p> <p>Note the loose, nearly falling wood shingle below white trim.</p> |

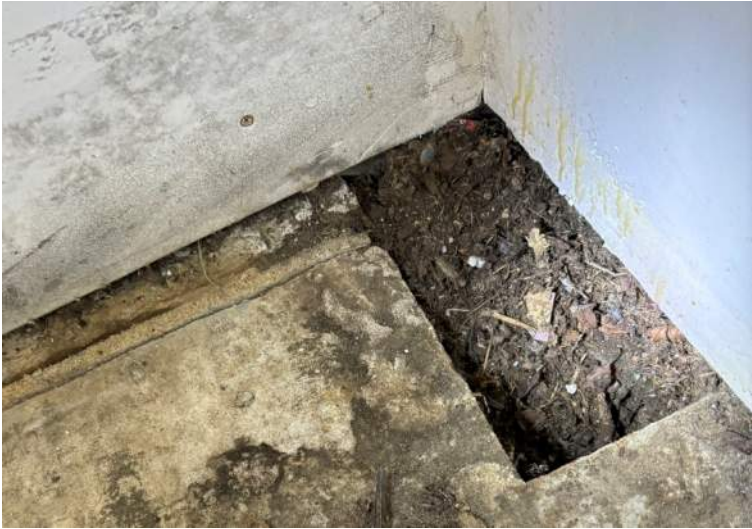
prior to our investigation exposed a small hole in the slab which appears to have been left unfilled during original construction and may have been a sub-standard footing pocket installation (Photo 4). The void does not appear to have negatively affected the surrounding slab area but did allow rodents to nest and damage exterior wall insulation.

| 4. | A close-up photograph looking into a triangular void or 'footing pocket' between concrete foundation slabs. The area is filled with dark, loose soil, organic debris, and some small pieces of wood or twigs, indicating rodent nesting. | <p>View of “footing pocket” slab void discovered in Room E114 when the District removed cabinetry and flooring. Dirt and organic debris are the result of rodent nesting, but there were no signs of current pest activity likely because the District repaired the exterior wall at this location prior to our investigation.</p> |

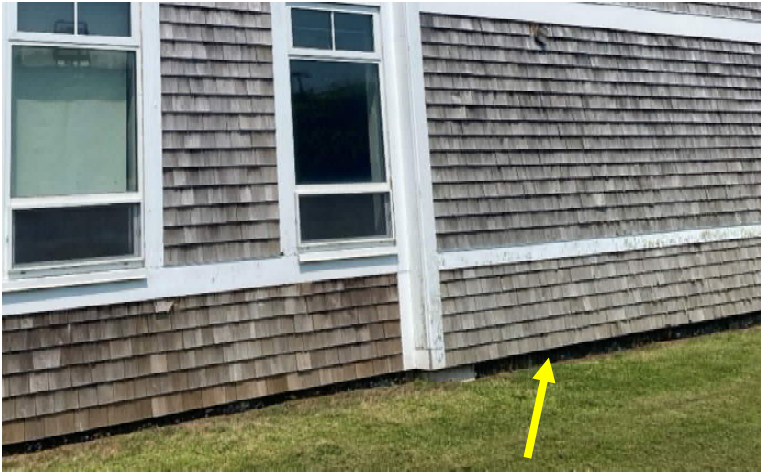
| 5. | A photograph of a building's exterior wall with grey shingle siding and white window frames. A yellow arrow points to a dark, horizontal line of liquid-applied waterproofing membrane along the base of the foundation wall, just above the grass. | <p>View of liquid-applied foundation wall waterproofing membrane visible on the E-Wing gable end wall.</p> |

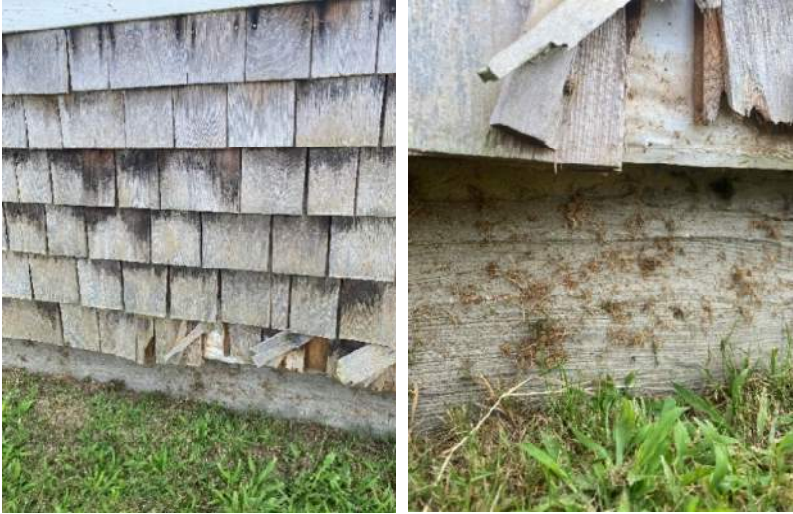
| 7. | | <p>View of missing, broken and cracked cedar shingles.</p> |

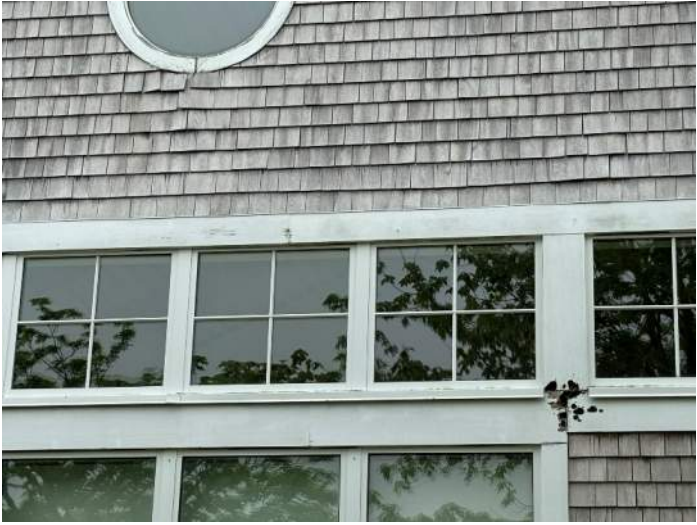
| 8. | | <p>Example of typical shingle and trim damaged observed. Round window casing joint is split and is likely allowing water infiltration, evidenced by heaving shingles directly below and rotting of casing. Large rot voids in wood trim are visible on window casing below rectangular ribbon windows.</p> |

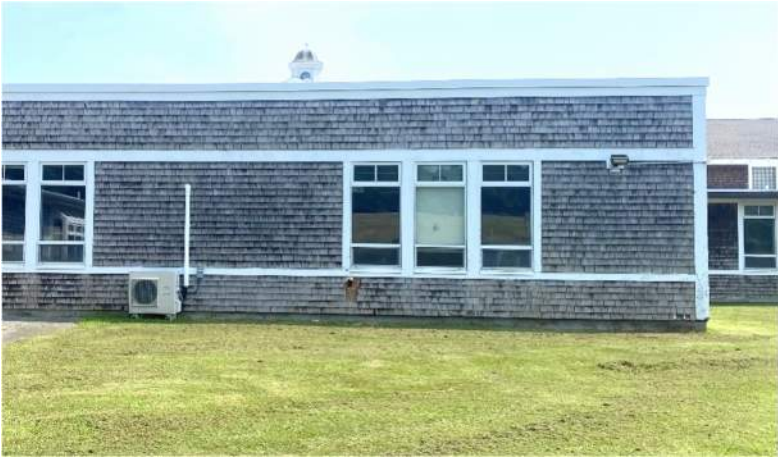
| 10. | | View of more typical wood shingle staining and deterioration. Shingles are missing on the lower right-hand building corner. The hole beneath the triple-wide window was a partial test cut that revealed severely rotted plywood sheathing. |

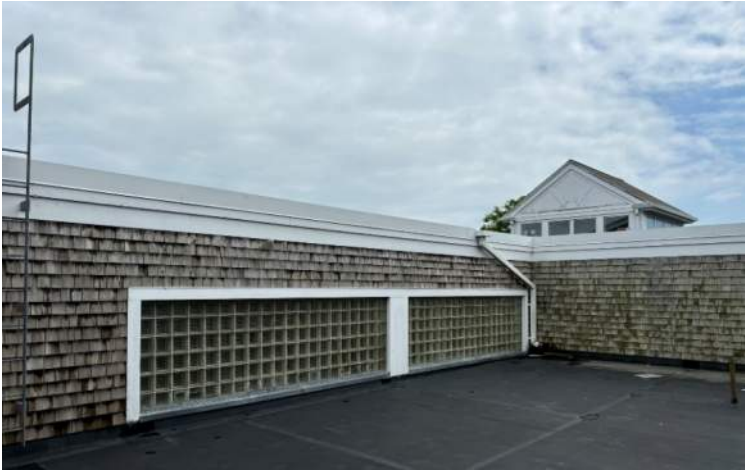
| 12. | | View of existing cheek wall above flat roofing that shows consistent wear and tear, including water stains between shingle courses. |

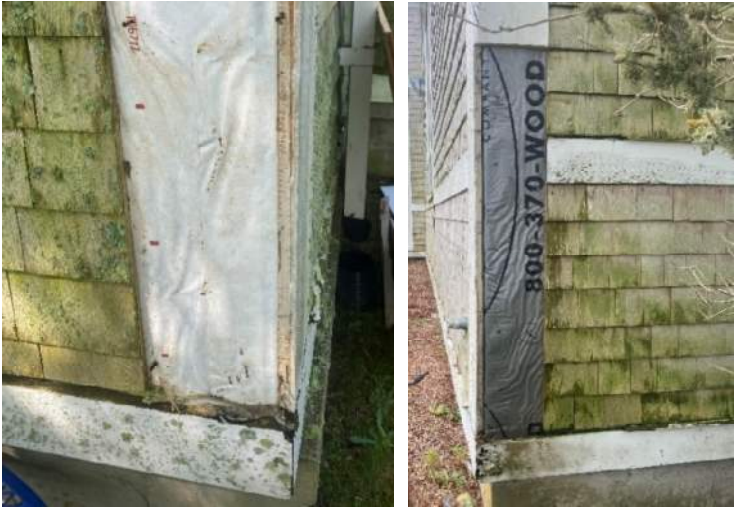
| 15. | | View of varying air-infiltration barrier products. These building corners are close to each other (near the main entrance) but one appears to be Typar brand (gray) and the other appears to be Tyvek brand (white). |

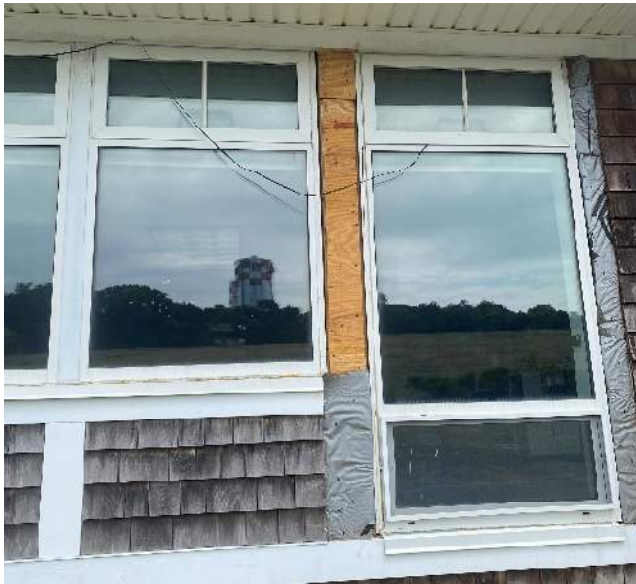
| 17. | | View of a test cut revealing no building wrap installed over the mull between two windows so the wood trim was installed directly onto the plywood sheathing. This is not in line with accepted building practices. |

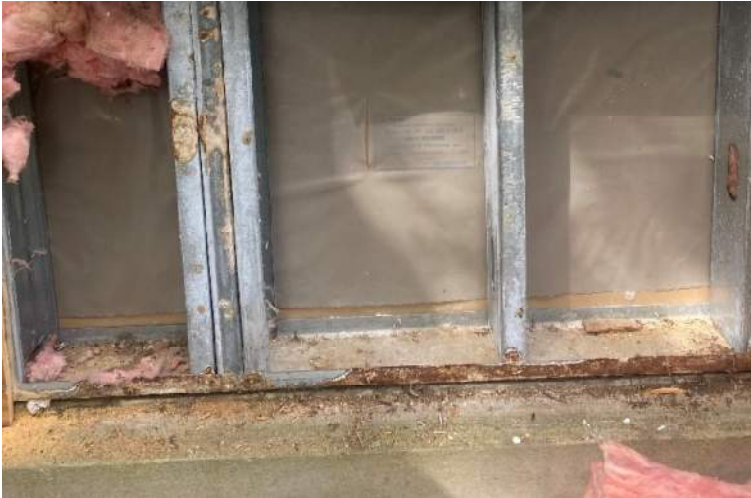
| 23. | A photograph showing a gap between the bottom edge of a white vapor barrier and the exterior wall. The wall is made of concrete and shows signs of weathering and discoloration. The vapor barrier is held in place by a metal frame. A small, rectangular label with illegible text is visible on the barrier. | Additional view of gap between bottom of exterior wall and bottom edge of vapor barrier. |

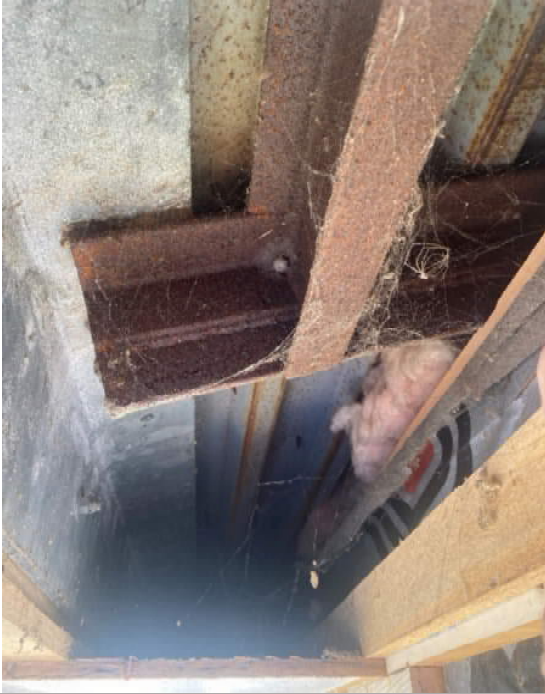
| 26. | | Close-up view of E-Wing soffit test cut showing premature oxidation of steel roof decking underside and structural steel components. |

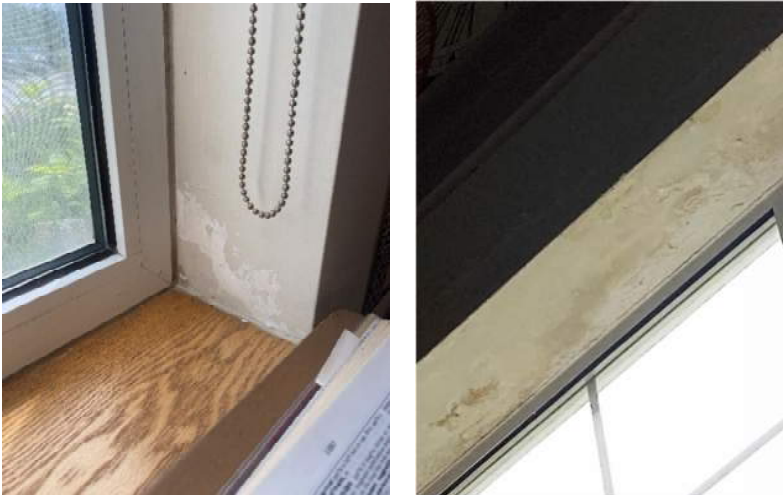
| 27. | | Example views of water damage to interior window jambs and heads that were observed at many window locations. |

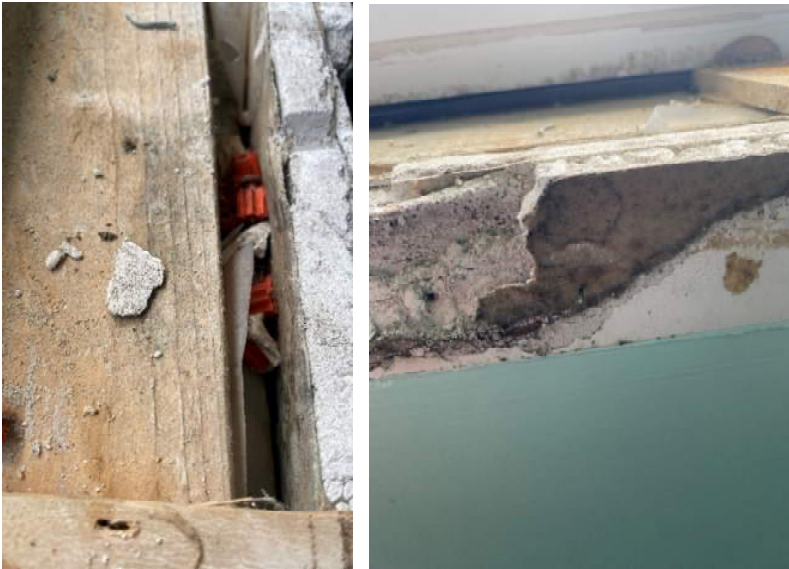
| 29. | | View close-up views of effect that excess moisture within exterior walls has had on GWB finishes. Here, mildew growth on both sides of the wall board is evidence of this moisture build-up. |

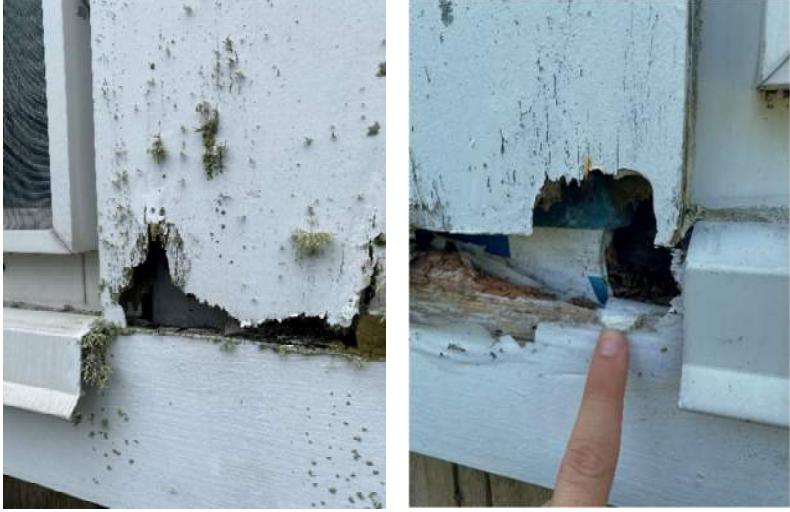
| 34. | | <p>View of existing window trim that is rotted through to the point of exposing the air-infiltration barrier behind it.</p> |

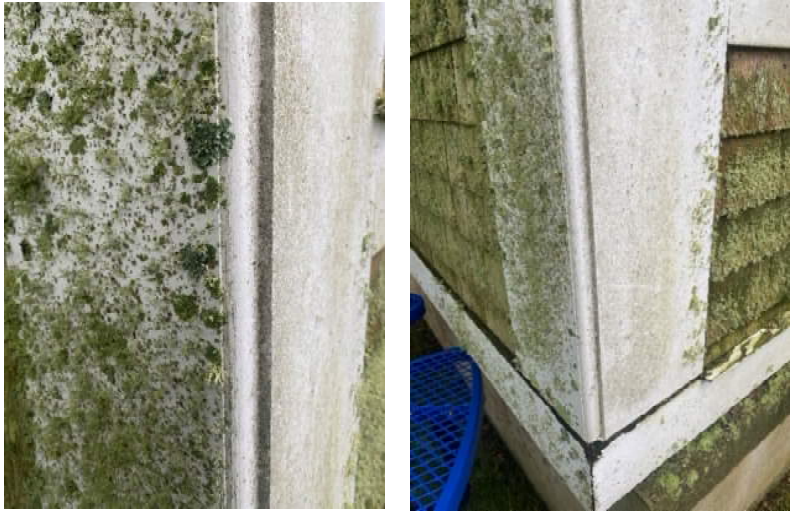
| 35. | | <p>View of existing corner trim boards harboring extensive lichen growth and showing rot at the base trim.</p> |

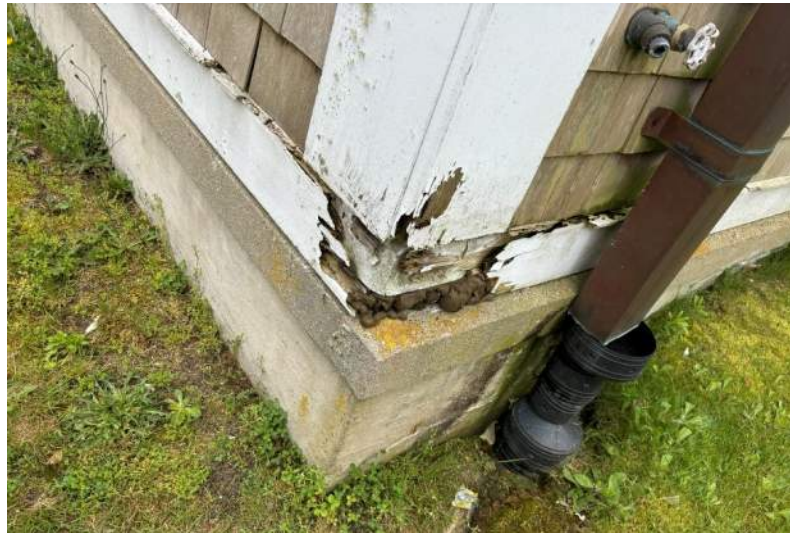
| 36. | | <p>View of severely rotted corner trim where MRSD staff have applied foam sealant as a temporary repair to prevent direct water infiltration. Still, the air-infiltration barrier is exposed.</p> |

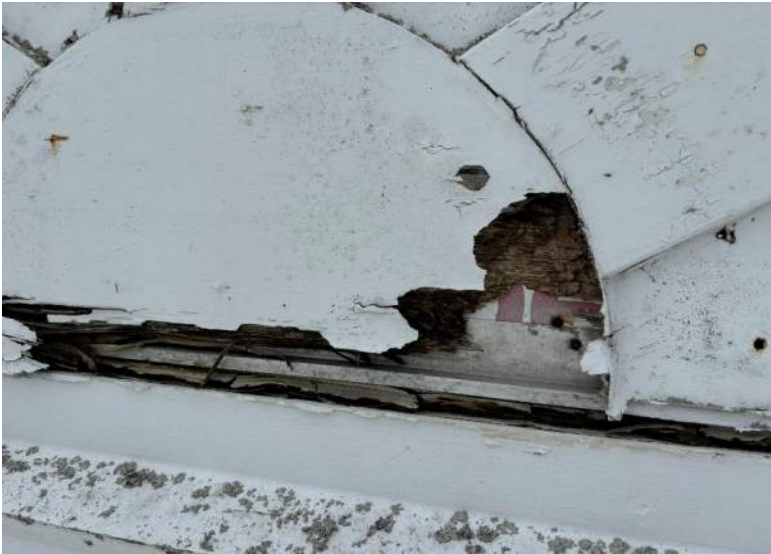
| 37. | | View of upper level trim which is also rotting through to the point of exposing the air-infiltration barrier, further demonstrating how wide spread trim deterioration is throughout the building from foundation to gable end walls. |

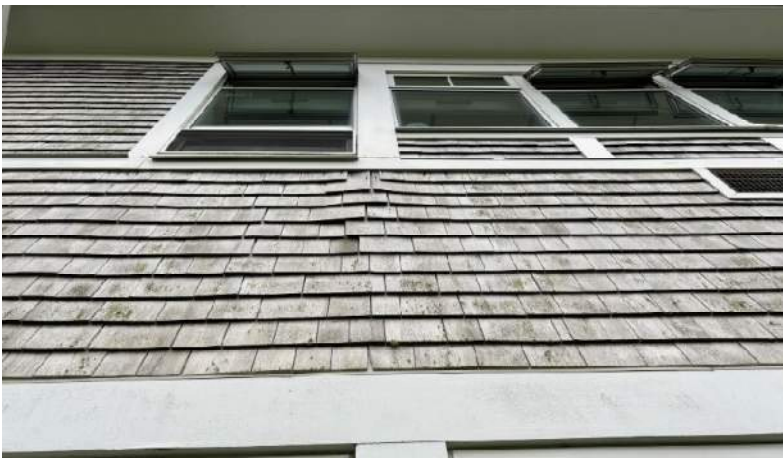
| 39. | | View of heaved shingles directly below window casing trim which indicates frequent leaking originating at the window rough opening and running down behind the shingles. |

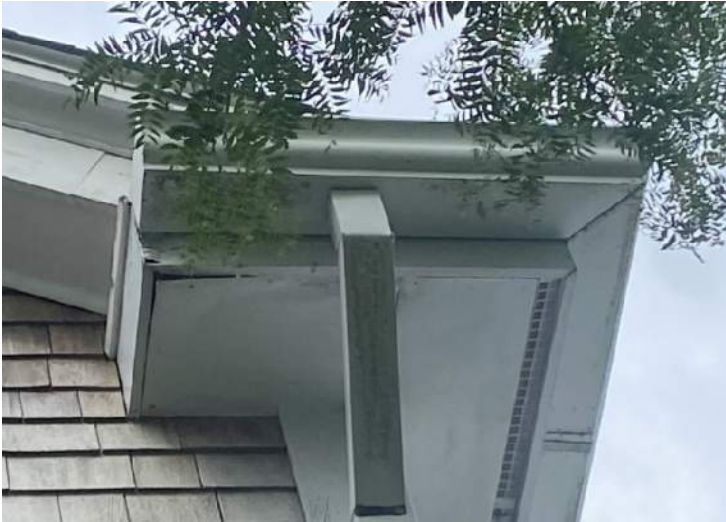
| 41. | | View of a wood soffit location that appears to have been water damaged. Soffits are in generally acceptable conditions, but selective spot repairs should be included in the siding work. |

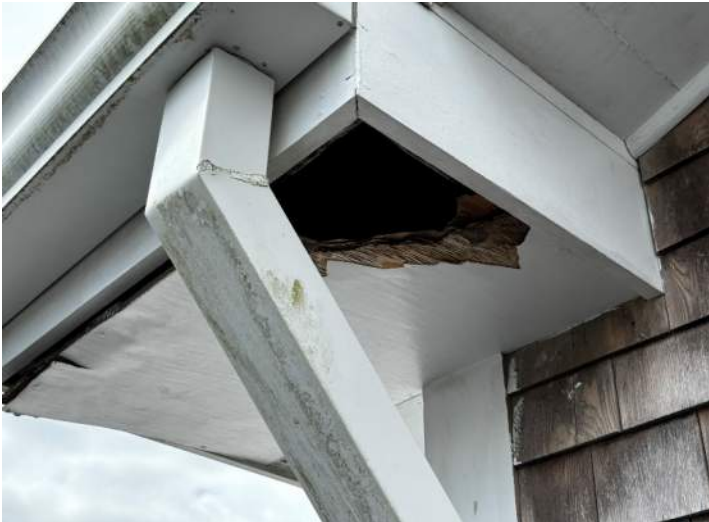
| 42. | | View of an additional wood soffit location that appears to have been water damaged resulting in a large opening. Note that, based on our findings, the soffit is open to the building interior and is therefore susceptible to pest infiltration through the opening. |

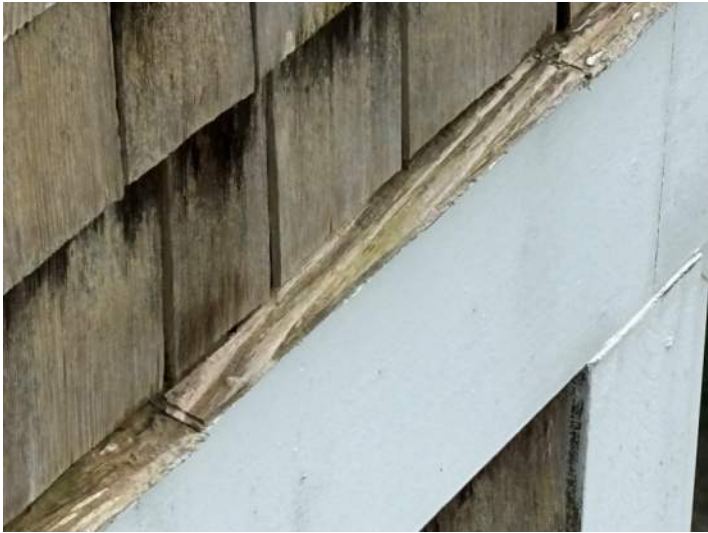
| 43. | | <p>View of the top of a horizontal trim board with <u>no</u> drip cap flashing protection. The wood is stained, worn, split and may be absorbing standing water.</p> |

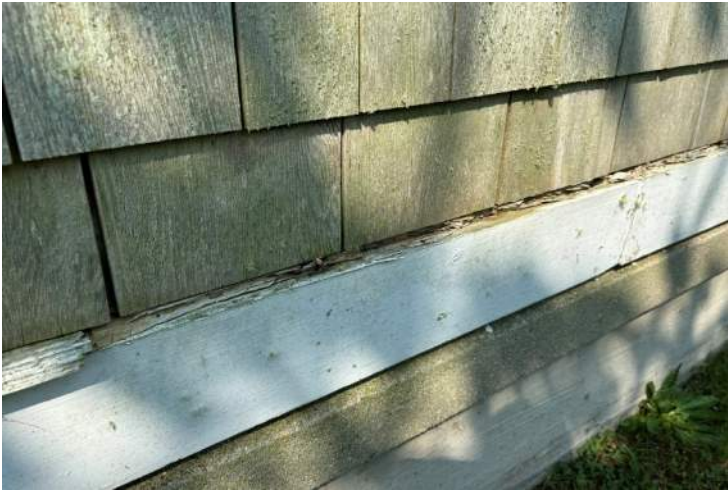
| 46. | | View of one of many areas where the wood drip cap has rotted away, leaving a gap for water infiltration. |

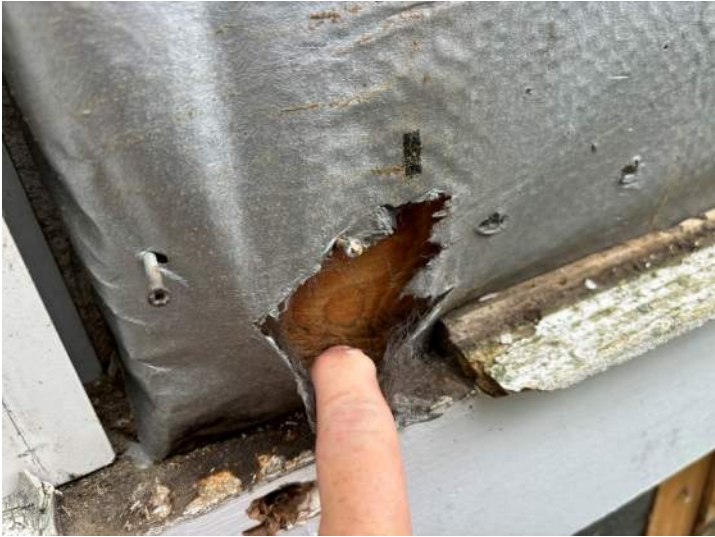
| 47. | | View of tear in the air-infiltration barrier that was exposed during the investigation, behind rotted wood trim cap. The plywood sheathing exposed by the tear was damp to the touch. |

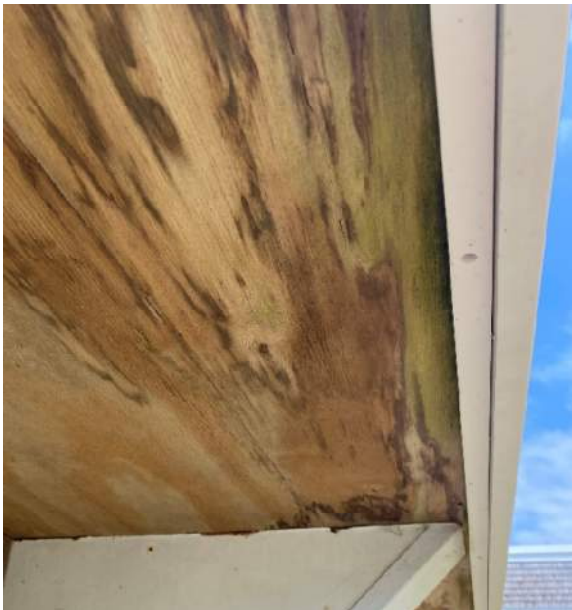
| 57. | | View of recently replaced bay window base plywood (by MRSD) that is already staining, damaged and growing algae due to the extent of leaking around the bay window units above. |

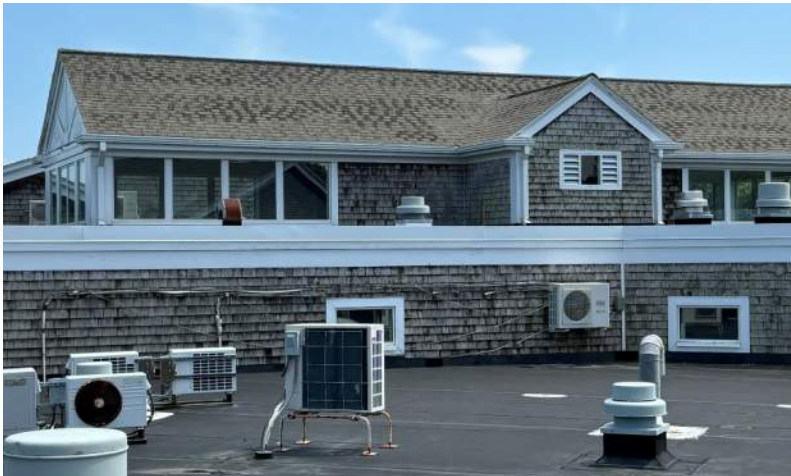
| 63. | | Additional view of asphalt shingle roofing (EPDM roofing is also shown) with evidence surface granule loss which appears as darkened areas in the photo. |

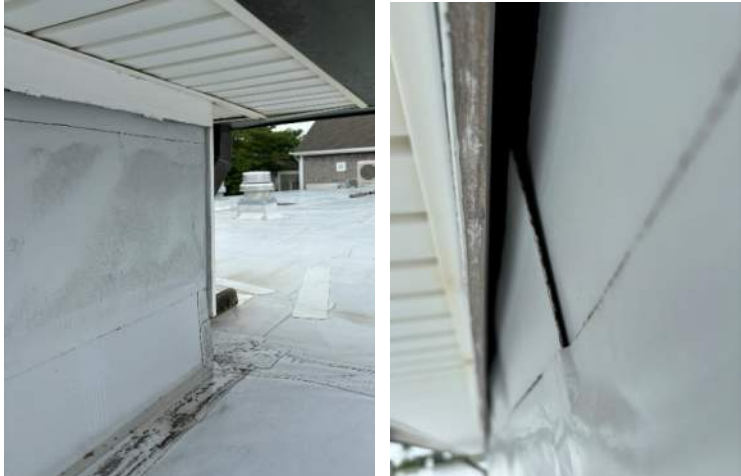
| 67. | | <p>Some cheek wall areas are clad with PVC or EPDM membrane (left photo). We observed selective breaks in seams (right photo) which should be repaired during regular roofing maintenance work.</p> |

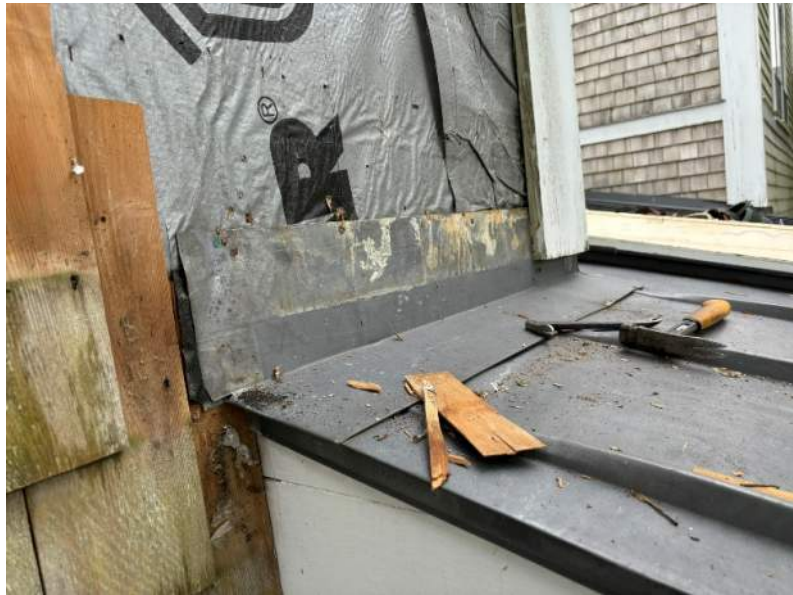
| 71. | | View of a test cut location that revealed “backwards” flashing where the air-infiltration barrier is tucked behind the standing seam metal roofing base flashing. This condition directs water behind the flashing and potentially into the standing seam metal roofing system. |

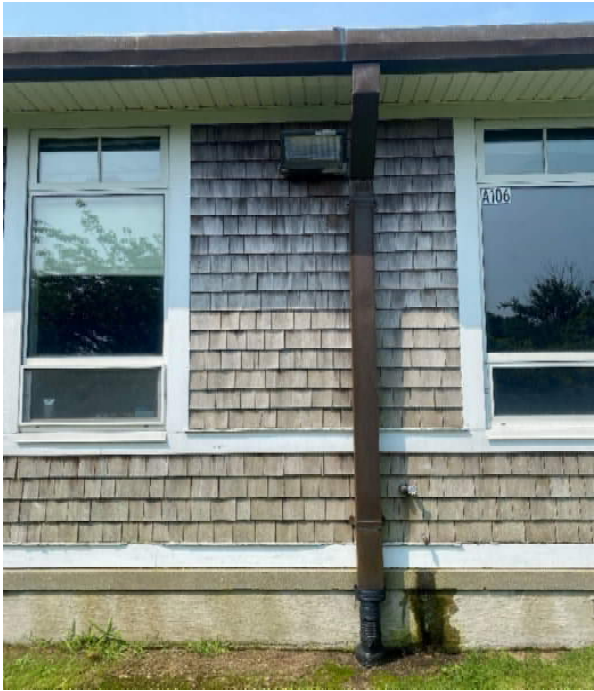
| 73. | | View of typical copper gutter and downspout. Copper gutters have reached the end of their useful life span. |

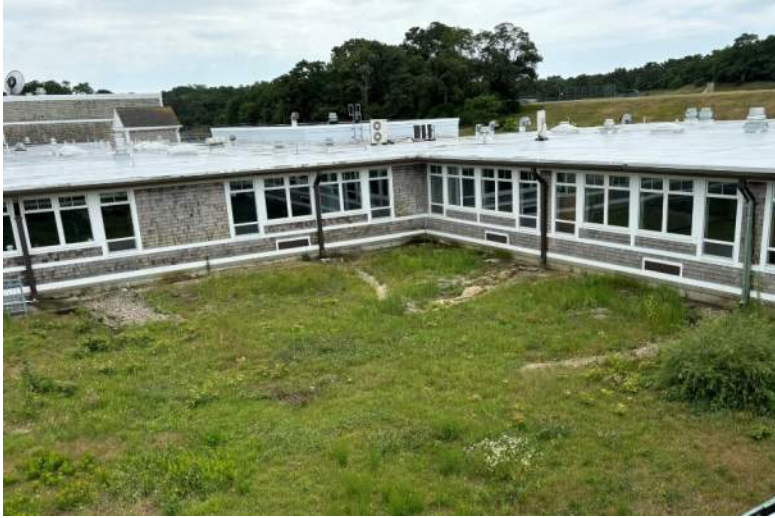
79.

View of several typical courtyard downspouts which drain onto splash blocks where run-off has created trenches in the sandy courtyard soil.

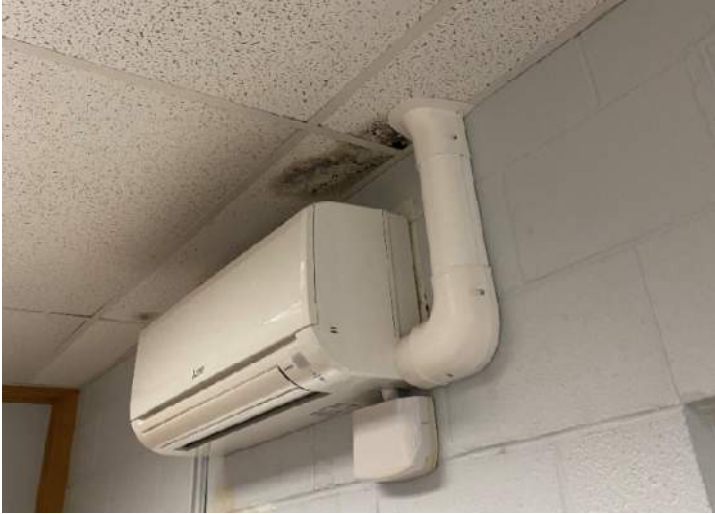
| 86. | | <p>View of mildew growth above an interior mini-split cassette that appears to have been caused by excess humidity that caused condensation on the surface of piping above the ceiling, which then dripped down to soak the ceiling tile. MRSD reported that this condition was repaired following our investigation.</p> |

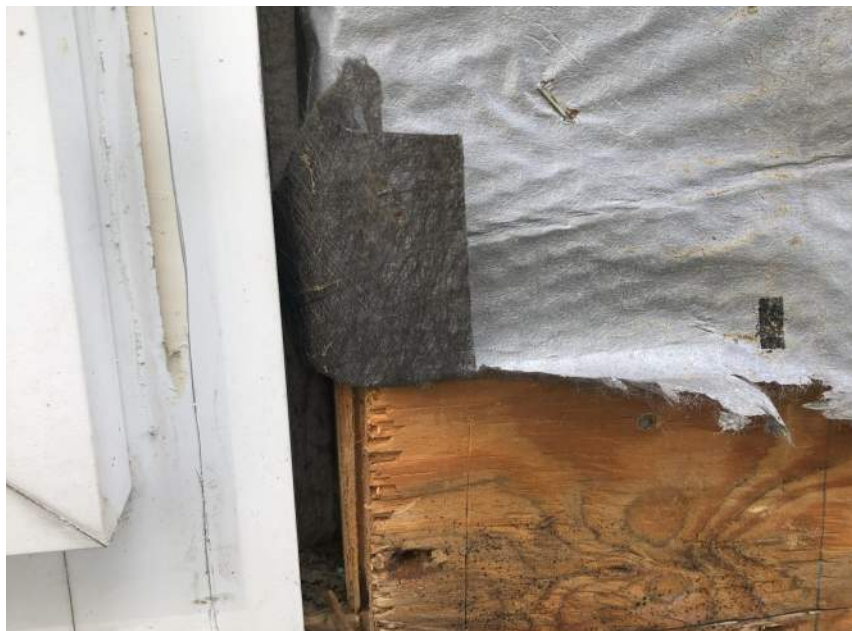
Photograph depicts general view of A102 window unit missing flashing tape.

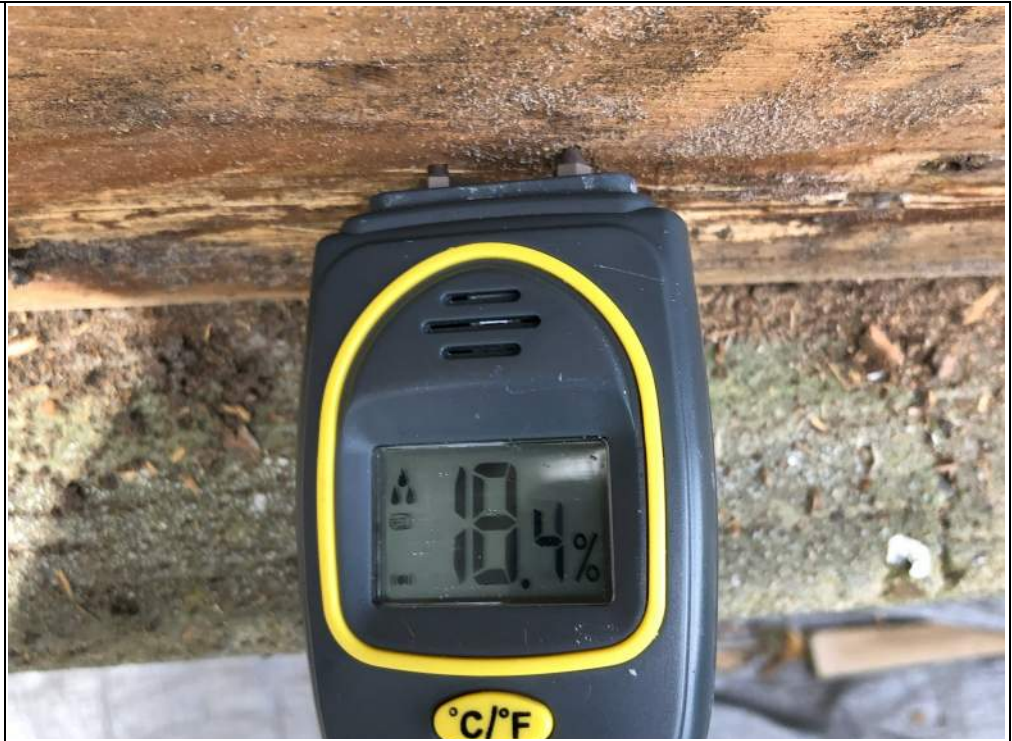
Photograph depicts general view of suspect mold growth and moisture reading on plywood sheathing under A102 window area.

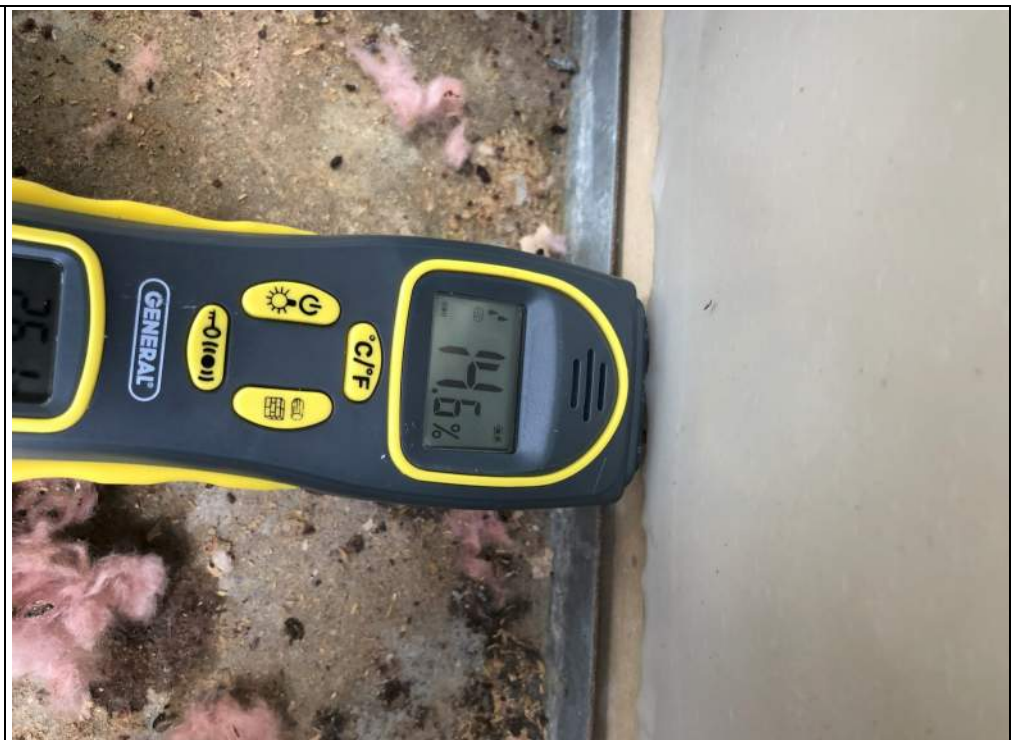
**Photograph: 4****Description:**

Photograph depicts general view of non-continuous poly vapor barrier and moisture reading on backside of gypsum board under A102 window area.

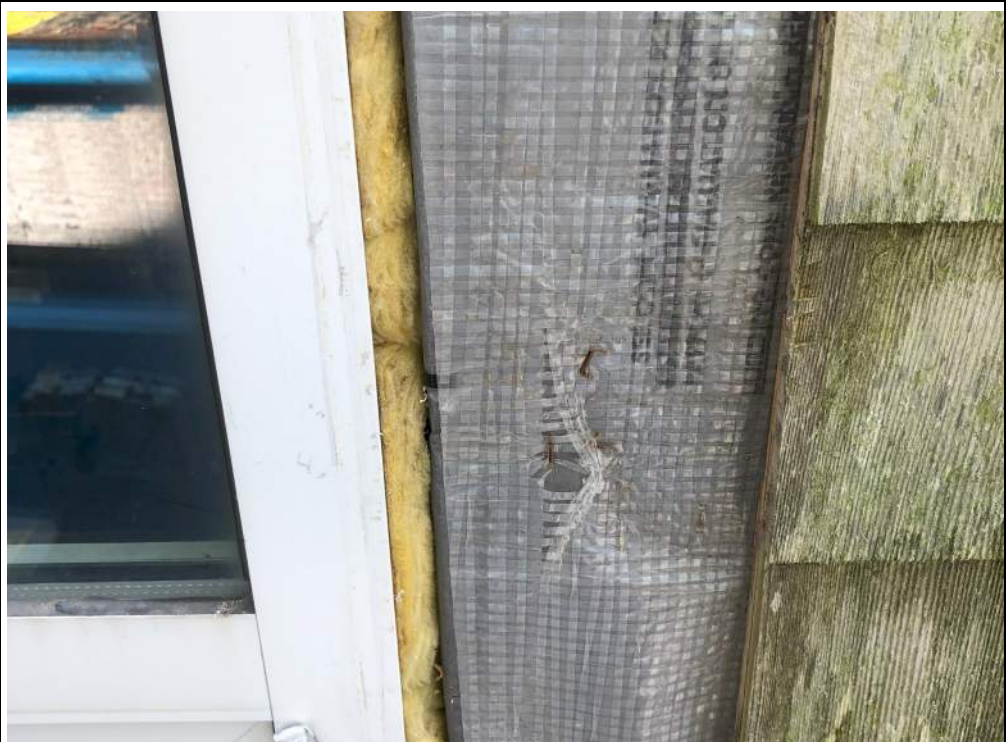
**Photograph: 6****Description:**

Photograph depicts general view of E205 window unit missing flashing tape.

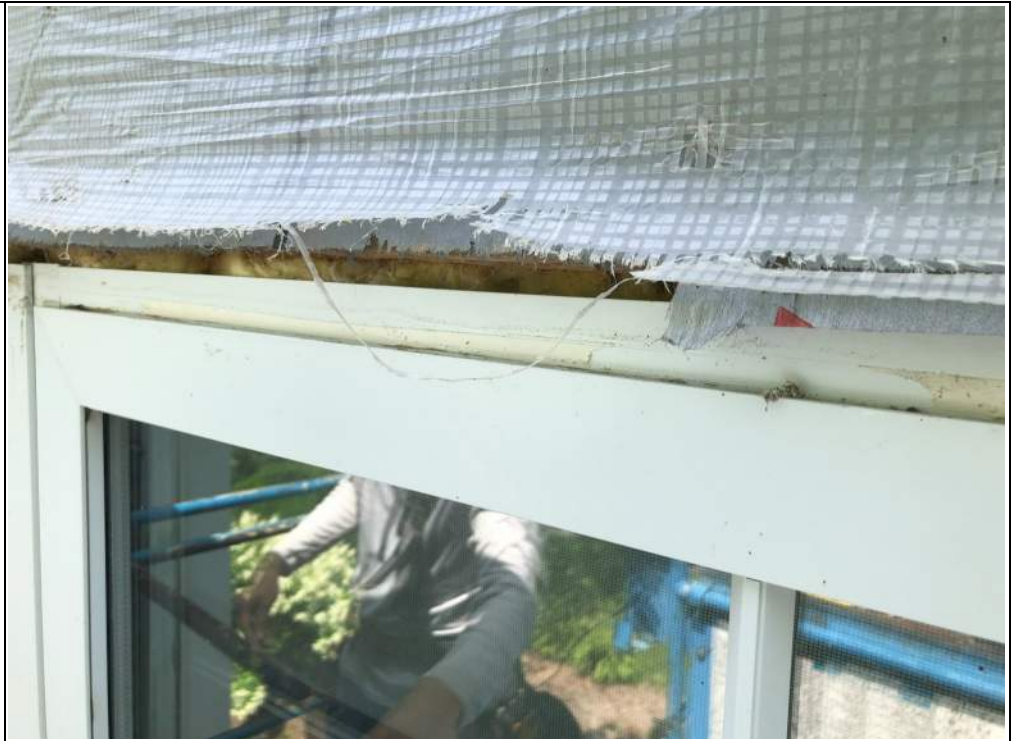
Photograph depicts general view of E205 window unit missing flashing tape.

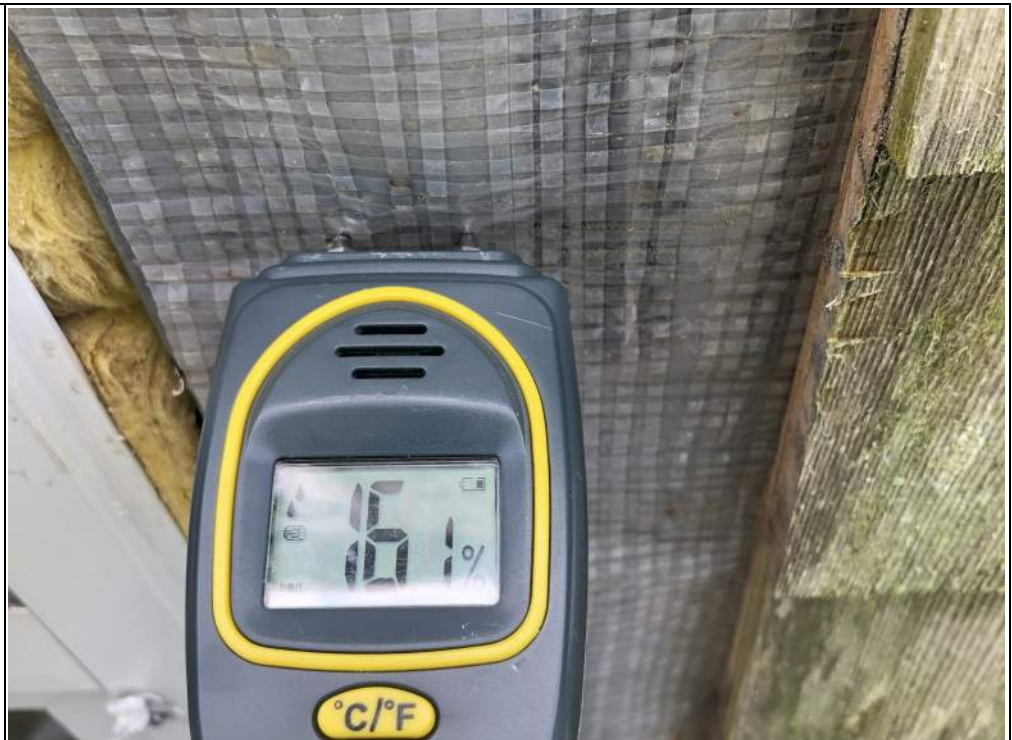
**Photograph: 8****Description:**

Photograph depicts general view of moisture reading on the plywood sheathing adjacent to the E205 window area.
