# INDOOR AIR QUALITY ASSESSMENT

## Centerville Elementary School

658 Bay Lane  
Centerville, MA  
November 2024

Prepared by:  
Massachusetts Department of Public Health  
Bureau of Climate and Environmental Health  
Division of Environmental Health Regulations and Standards

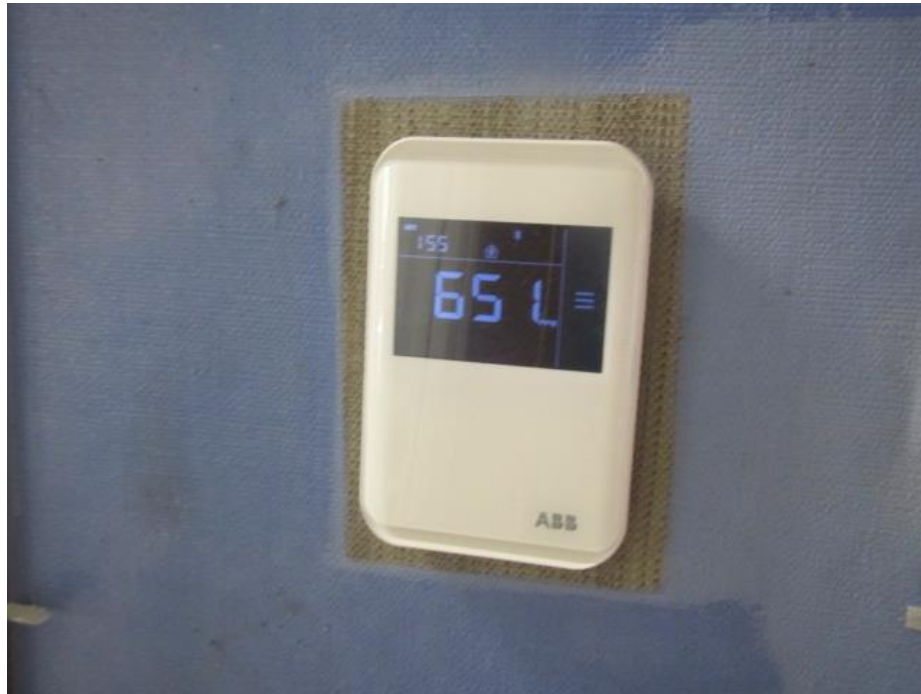
Picture 3

Digital thermostats mounted near the hallway door had several parameters listed including carbon dioxide, and relative humidity (Picture 3). The measurement of carbon dioxide is important to adjust outdoor air intake by opening dampers and increasing the fresh air percentage. It was not known at what “trigger” the carbon dioxide sensors were set to. In addition, it is important to note that gas-measuring sensors should be calibrated or replaced

Digital Thermostat displaying carbon dioxide measurement in parts per million

| HVAC System | | Helpful Links |
|---|---|---|
| 4. | Ensure carbon dioxide sensors are calibrated or replaced periodically per the manufacturers' recommendations to ensure accuracy. | |

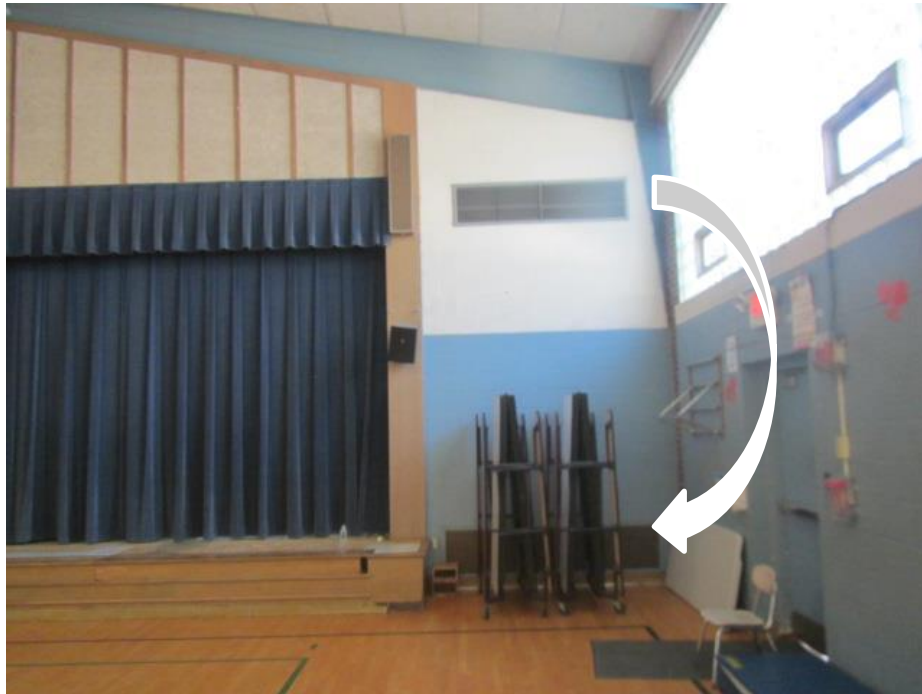
Picture 5

Short-circuiting of AHU in gymnasium, arrow shows airflow

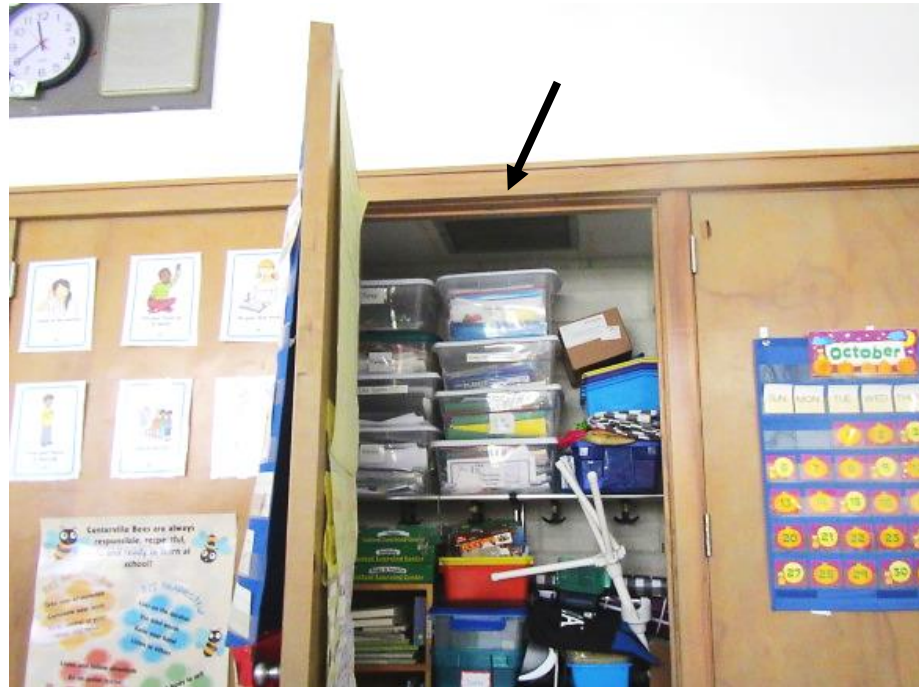
Picture 7

At the time of assessment, exhaust ventilation in most rooms was not operating. It was not known whether these vents were not functional or just deactivated. Exhaust vents in classrooms are located in coat closets (Picture 7) or are wall-mounted (Picture 8). In a number of areas wall mounted exhaust vents were found obstructed by classroom furniture and other items (Pictures 8 and 9). Without proper supply and exhaust ventilation, normally occurring environmental pollutants can build up and lead to indoor air quality/comfort complaints. In addition, without proper exhaust ventilation, excess moisture cannot be removed from the building, which can lead to mold growth conditions over the summer.

Exhaust vent in the top of coat closet (arrow)

| HVAC System | | Helpful Links |
|---|---|---|
| 1. | Have the mechanical exhaust systems evaluated building-wide (e.g., classrooms, kitchen hood, restrooms) for operation and repair. | |

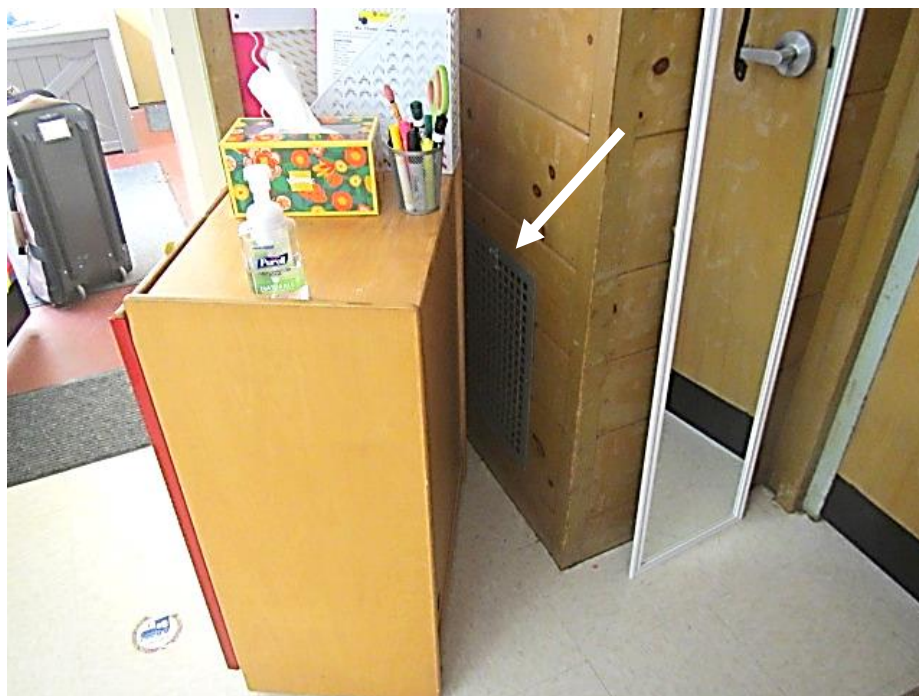
Picture 8

Wall-mounted exhaust vent (arrow) behind bookcase in classroom

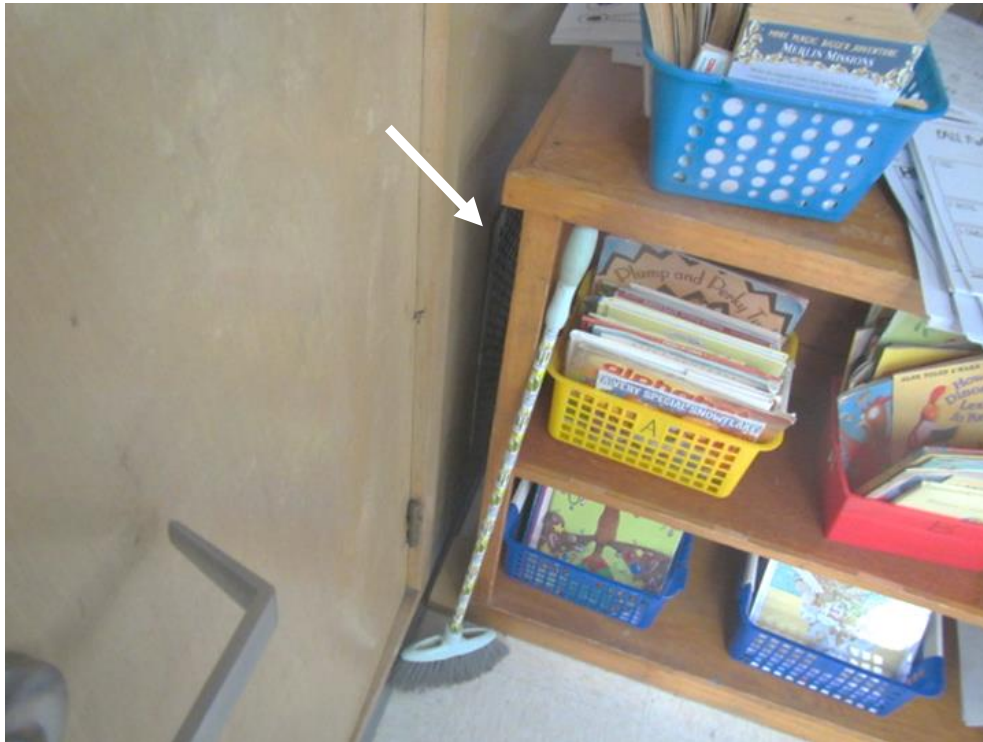
Picture 9

Exhaust vent behind shelf in classroom (arrow)

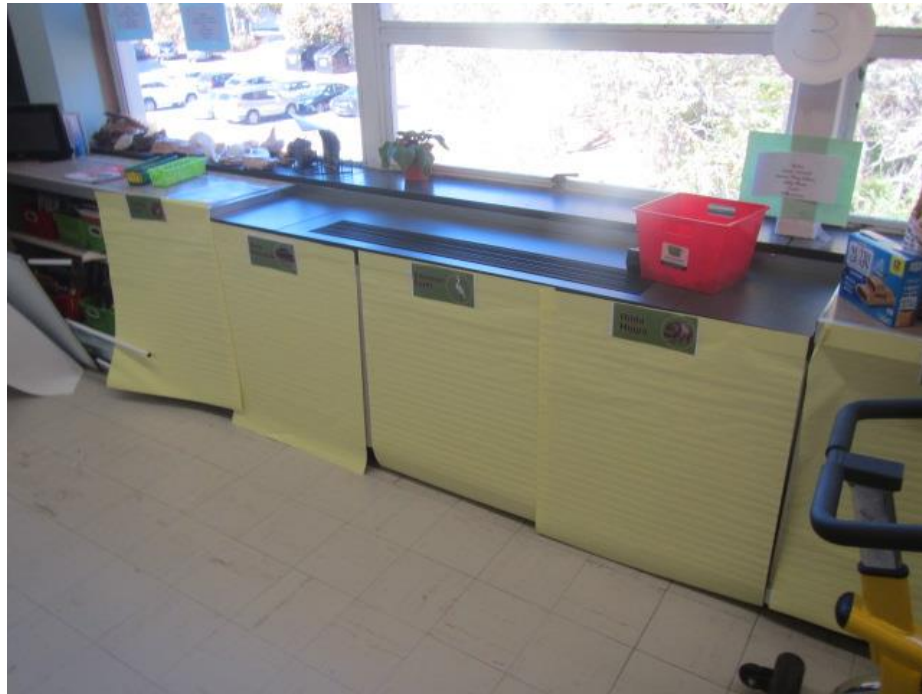
Picture 13

Univent return vent (bottom front) obstructed by paper preventing airflow into unit

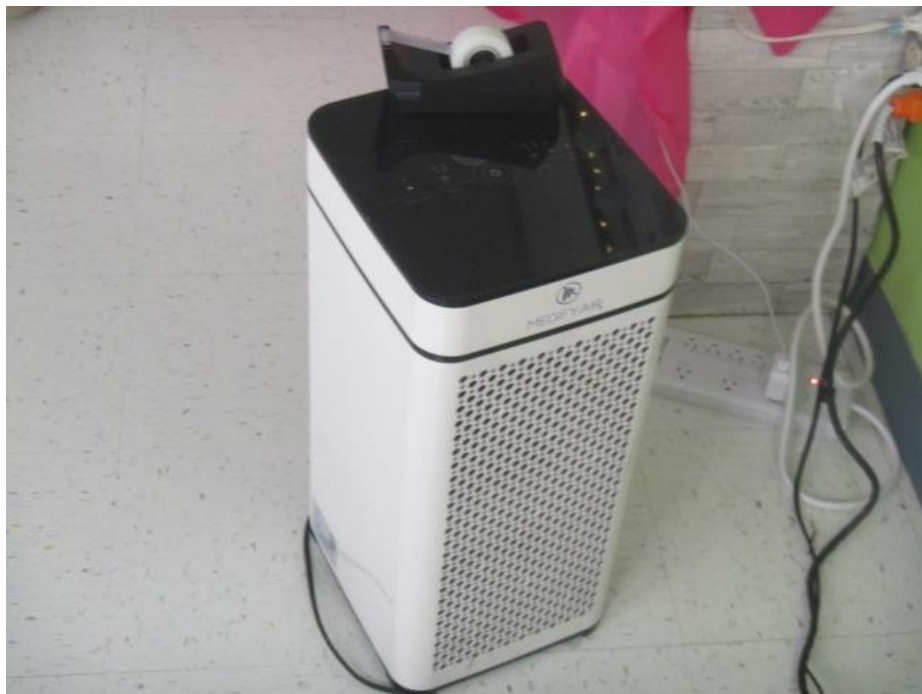
Picture 14

Air purifier in classroom

- **It was not clear if the local exhaust hood for the kitchen was operable.**
- **Air purifiers were also found in classrooms (Picture 14).** Air purifiers should be placed away from walls to ensure proper air intake.

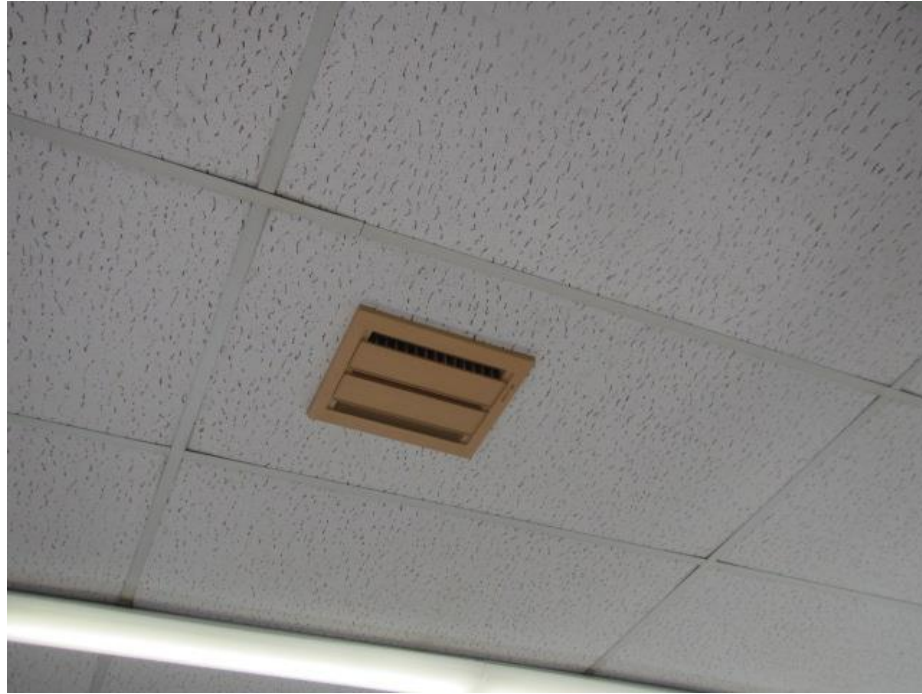
Picture 15

- **An abandoned local exhaust vent was observed in the ceiling of the Teacher's Room (Picture 15).** This vent possibly served as a smoking vent from decades ago (as suggested by reports of cigarette odors). Although the vent is likely not operational, replacement with a *local exhaust* vent should be considered for the photocopiers and lamination machines that are in use in this area to remove excess heat, particulates, and odors.

Abandoned vent in ceiling of Teacher's Room (possible former *smoking* vent)

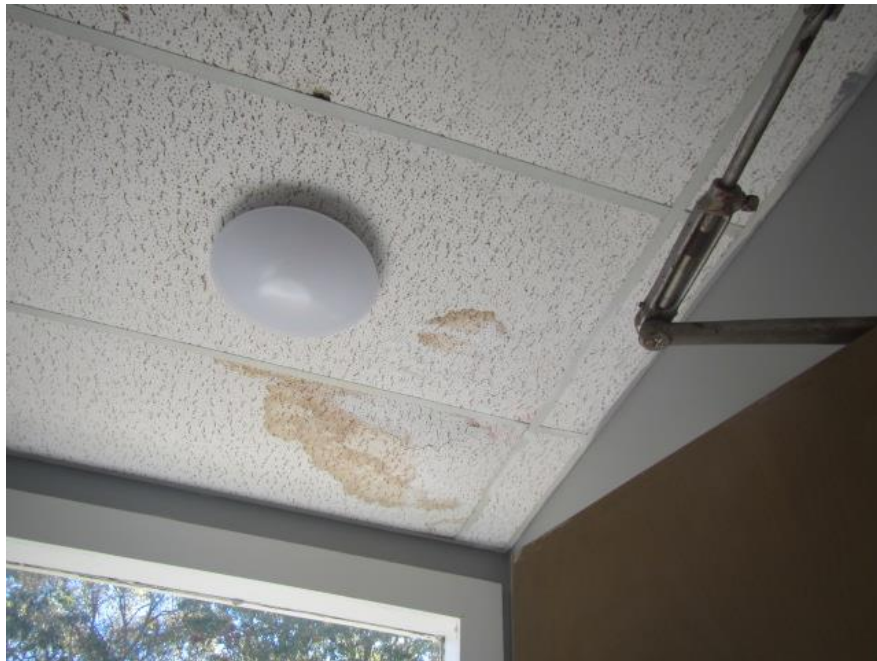
Picture 16

- **Water-damaged ceiling tiles were found in several locations (Table 1),** which can indicate current/historic roof/plumbing leaks or other water infiltration. Water-damaged ceiling tiles can provide a source of mold and should be replaced after a water leak is discovered and repaired. Suspended ceiling tiles (Picture 16) should be discarded and replaced. Some ceiling tiles are of a type that are adhered directly to

Water-damaged *suspended* ceiling tile

| 19. | Replace water-damaged suspended ceiling tiles. Repeated water damage to ceiling tiles indicates leaks from the roof or plumbing/HVAC system which should be repaired. | <a href="http://www.epa.gov/mold/mold-remediation-schools-and-commercial-buildings-guide">http://www.epa.gov/mold/mold-remediation-schools-and-commercial-buildings-guide</a> |

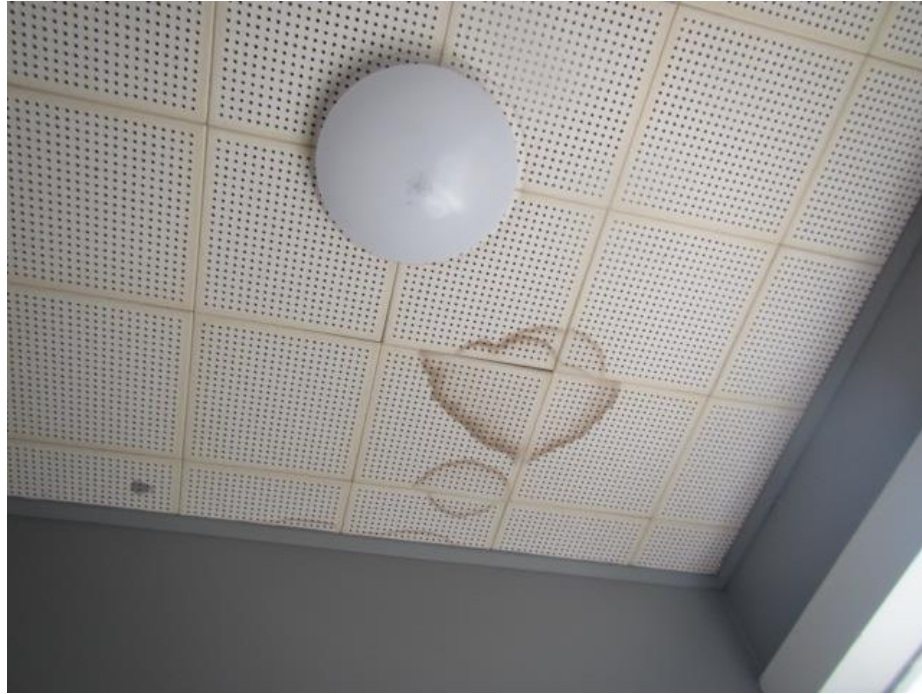
**Picture 17**

the ceiling substrate (Picture 17). These tiles are difficult to replace and necessitate the destruction of the tile. Furthermore, replacement tiles are most likely obsolete and difficult to obtain.

**Water-damaged original ceiling tiles *adhered directly* to ceiling substrate**

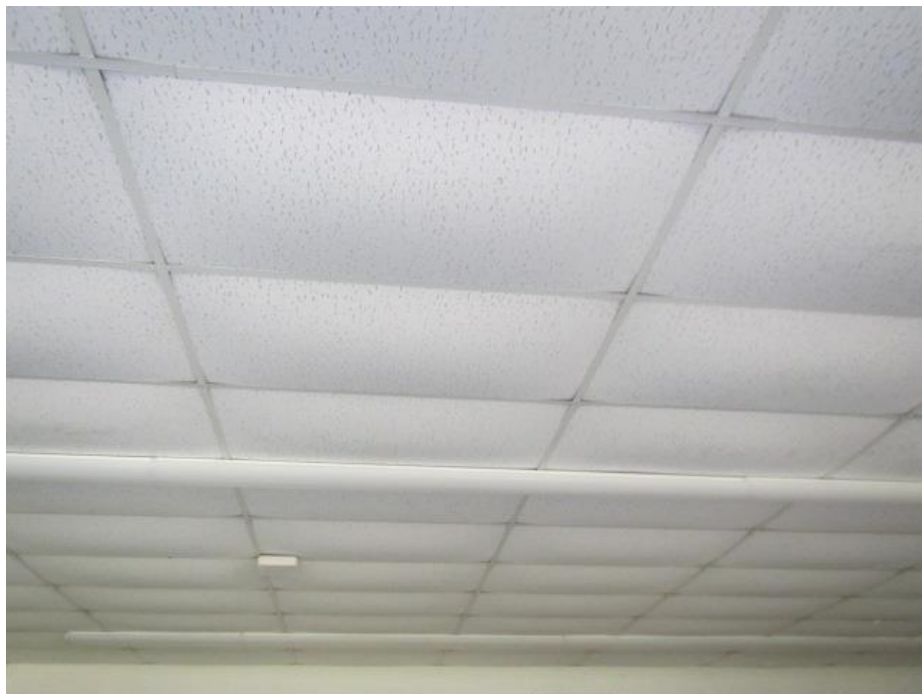
**Picture 18**

- **Bowed or sagging ceiling tiles were found in some locations** (Picture 18), particularly along the rear (shaded) side of the building. This is likely the result of moisture exposure from elevated relative humidity conditions. While bowing tiles are not a direct IAQ issue, it is a reminder that long periods of high relative humidity may lead to water damage to other materials, particularly those stored in contact with cooler temperatures such as on uninsulated floors, and in the airstream of air conditioning.

**Bowed ceiling tiles in classroom**

| 26. | While bowed/sagging ceiling tiles are not a source of mold, they indicate extended exposure to high humidity. Therefore, care should be taken with storage of materials | |

| | in these areas during hot, humid weather and over the summer. | |

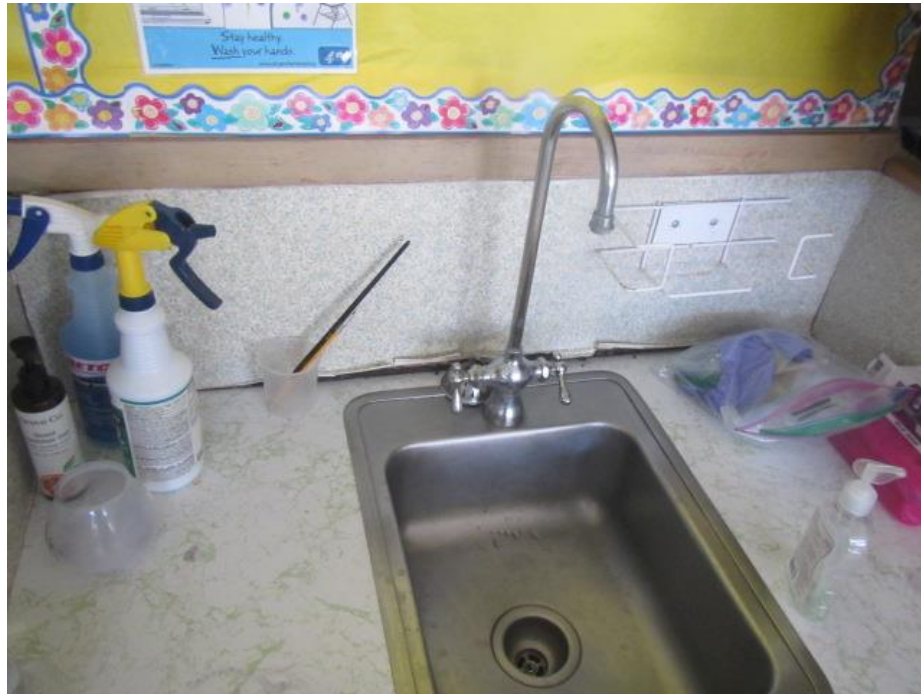
**Picture 19**

**Missing/damaged caulking around sink in Classroom 6**

| 35. | Make repairs to caulking around sink in Classroom 6. | |

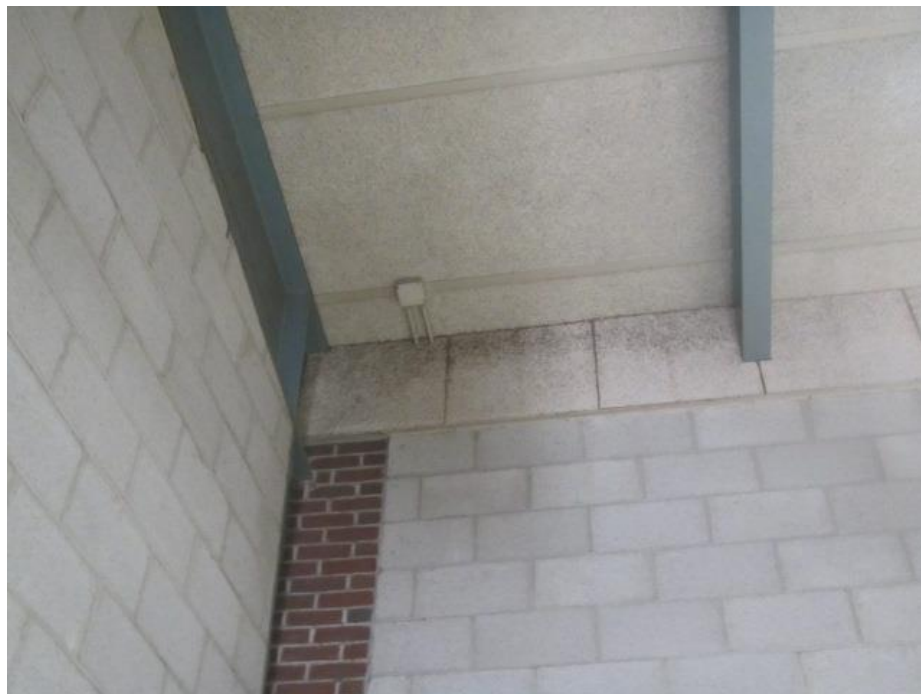
**Picture 20**

- **Room 6 had missing/damaged caulking around the sink** (Picture 19), which can lead to water damage and mold growth underneath.
- **The gymnasium had accumulations of dust and debris along the surface of the wall panels near the ceiling** (Picture 20). Although these wall panels are made of a non-porous material that would be resistant to mold growth, the textured surface of the panels make them prone to accumulate debris, including naturally occurring mold spores that can grow if moistened repeatedly, such as during elevated relative humidity conditions over the summer.

**Dark staining on wall panels indicating accumulated dust/debris near ceiling of gymnasium**

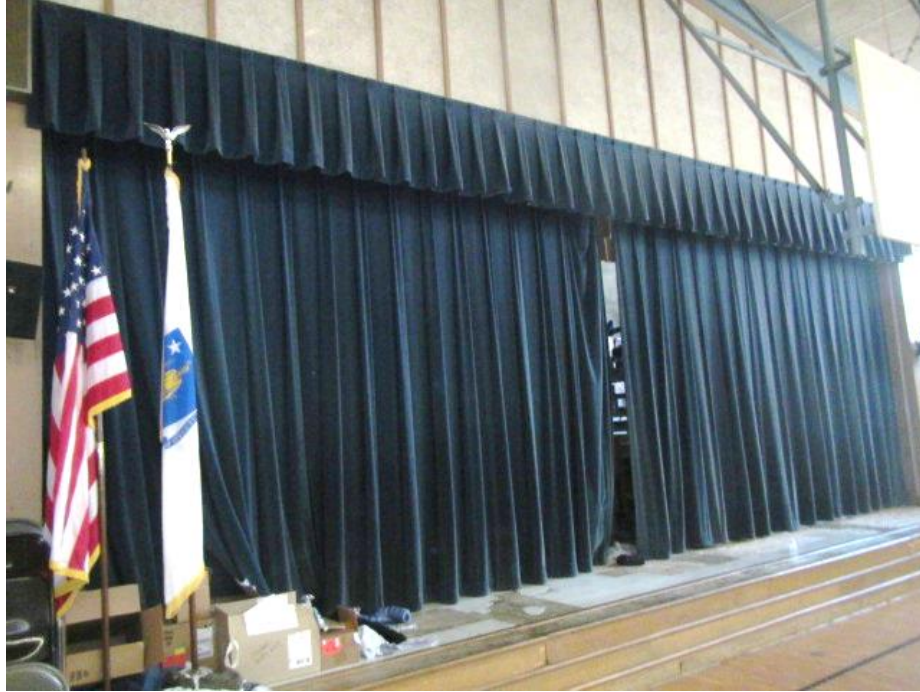
**Picture 21**

- **Musty odors were detected in the gymnasium, which may be due to the curtain mounted on the stage** (Picture 21). It was not known when the last time the curtain was removed and laundered. Porous materials can accumulate dust/debris and absorb moisture over summer months and provide a source for mold growth or musty odors.

**Curtain in gymnasium**

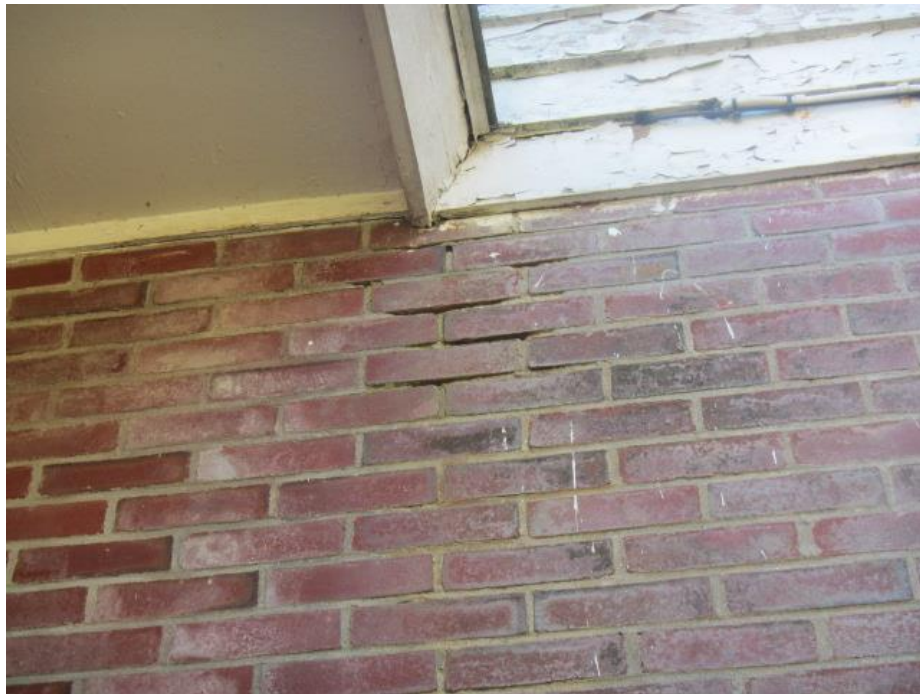
**Picture 22**

**Missing/damaged mortar around exterior brick**

| 30. | Conduct a thorough building envelope evaluation to make repairs/repointing efforts to eliminate leaks. Building occupants should ensure they report active leaks to building management for investigation and repairs. | |

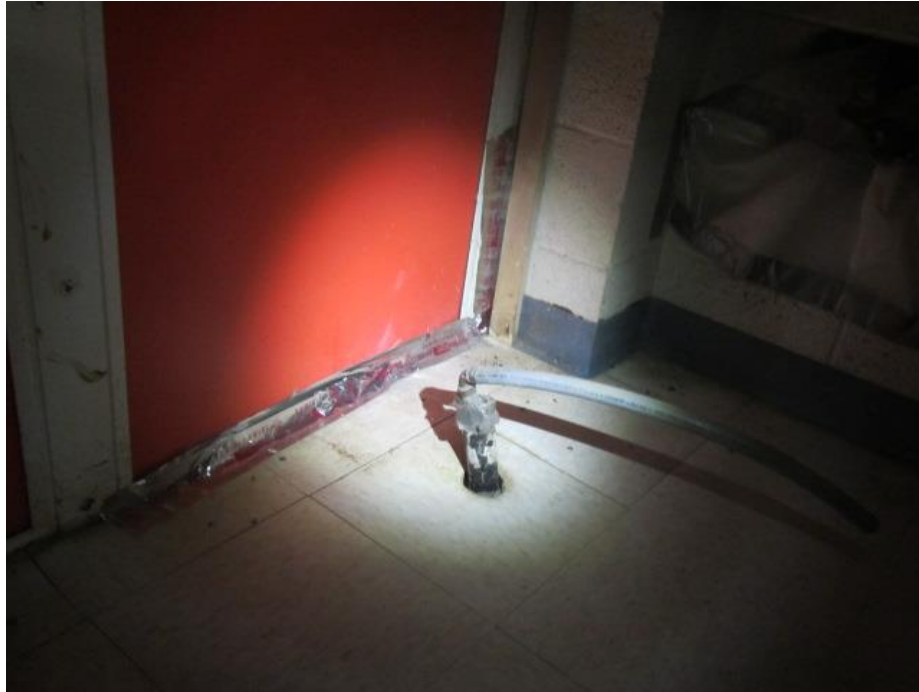
**Picture 23**

**Breach around exterior door under stairwell across from Staff Room**

| 34. | Make repairs to breach around access door across from Staff Room (Picture 23). | |

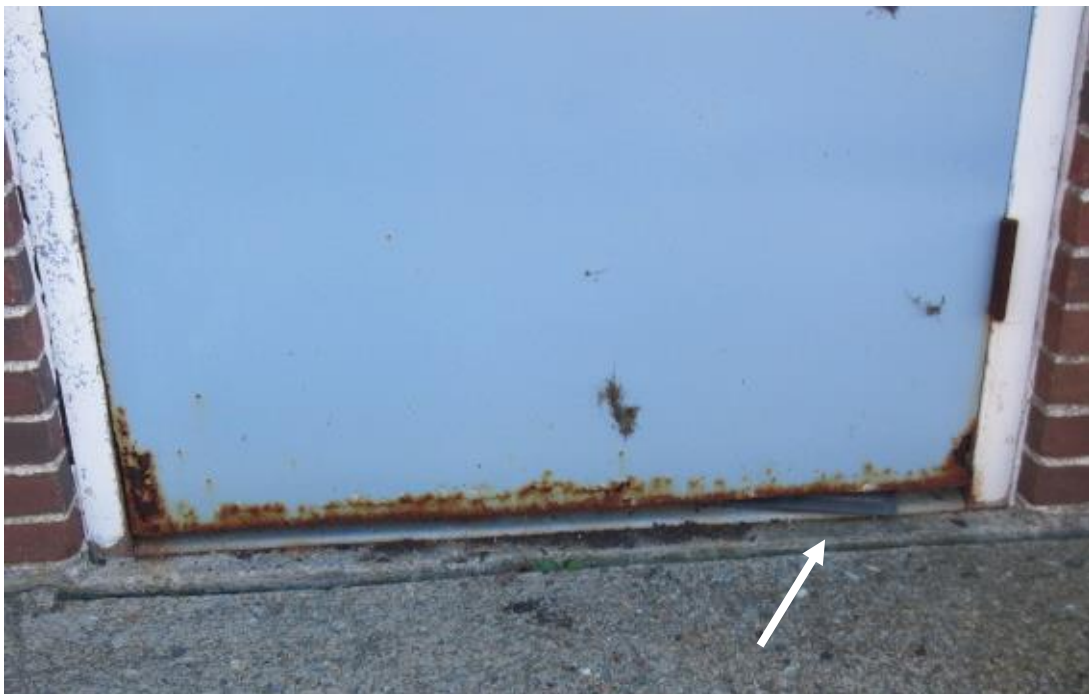
**Picture 24**

- **Exterior doors/frames were corroded and damaged** creating gaps that allow for uncontrolled drafts, moisture, and pest entry (Pictures 24 through 26). These conditions can make it difficult to control temperature leading to comfort complaints and condensation issues that can lead to mold growth.

**Corroded exterior door, note damaged weatherstripping below (arrow)**

| 32. | Install/replace weather-stripping around exterior doors. | |

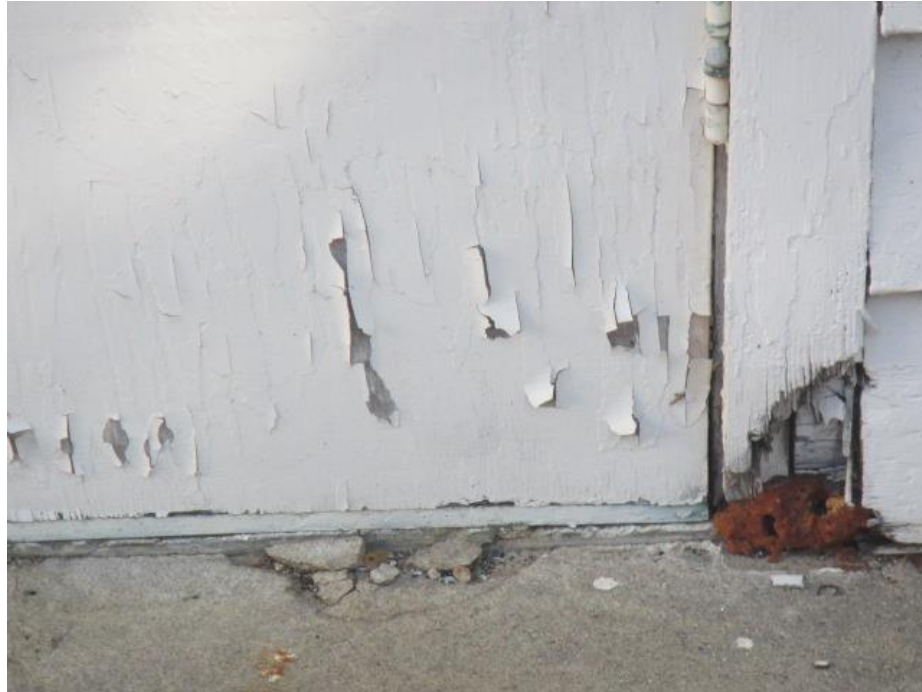
Picture 25

Rotted door frame (filled with foam) and delaminating exterior door

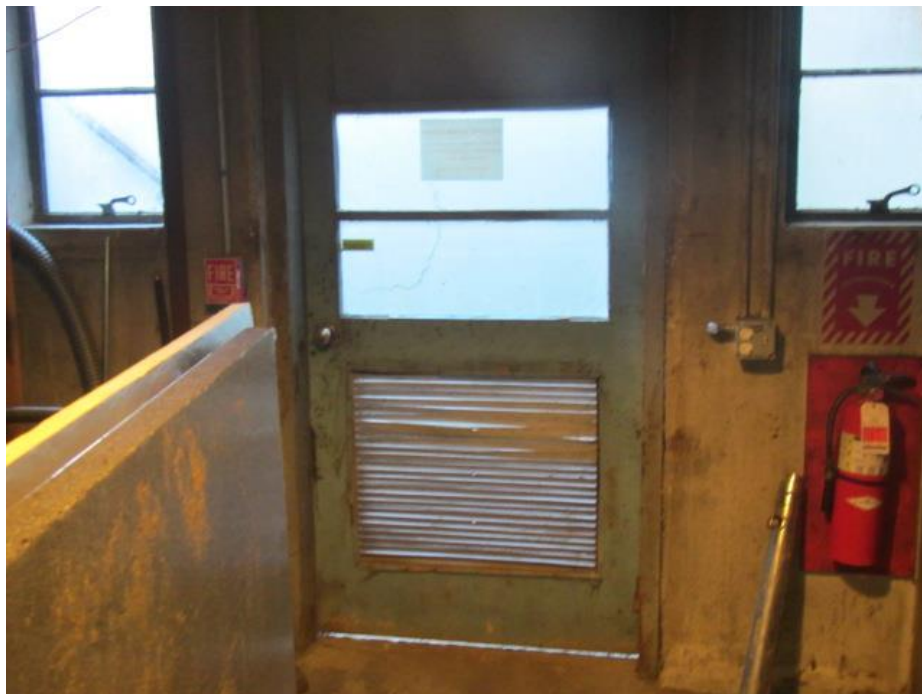
Picture 26

Light penetrating through damaged vent and below exterior door

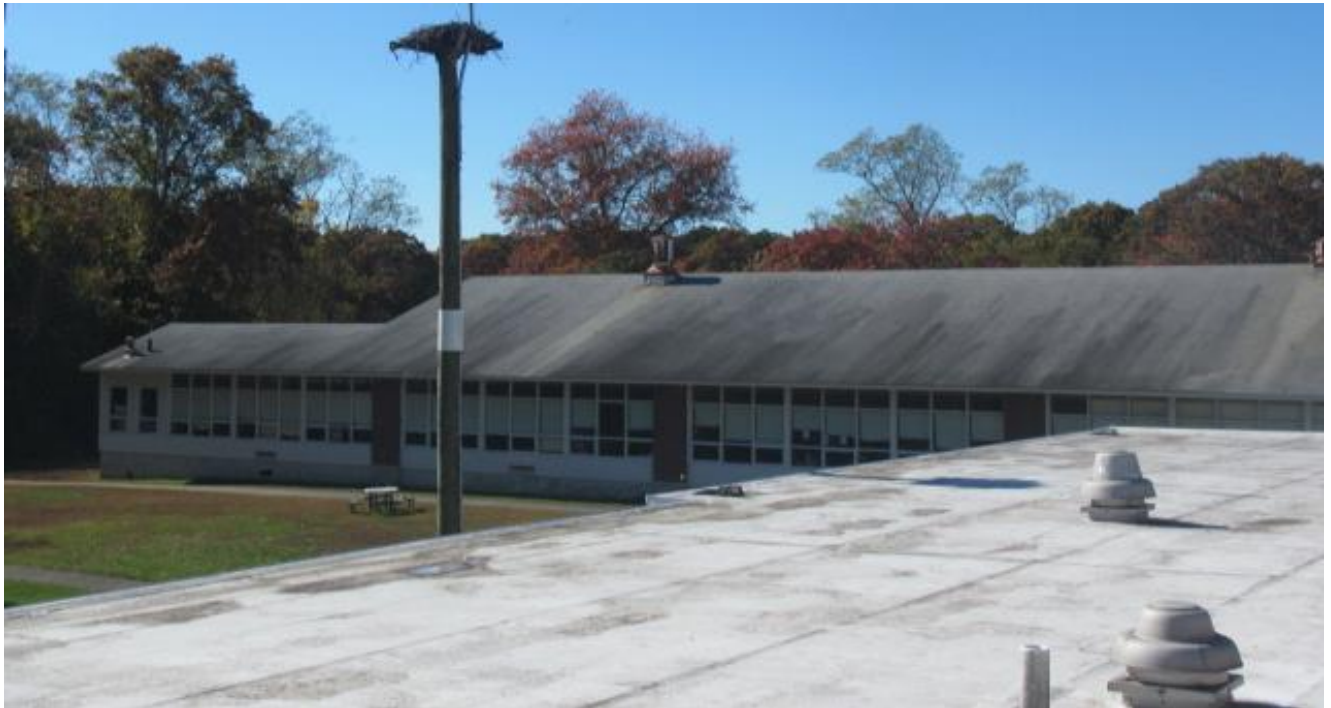
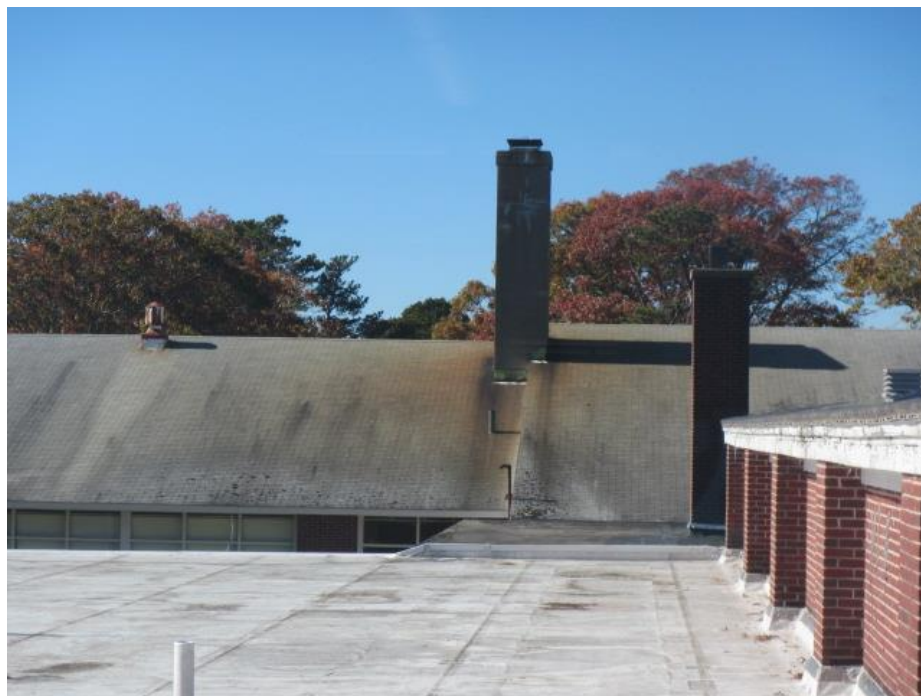
- **The roof is past its life expectancy and is need of replacement** (Pictures 27 and 28).
- **Window frames along the front of the building have been replaced.** The remainder of the building has original, single-paned windows that are not energy efficient and in need of replacement.

**Roof is past its life expectancy and is need of replacement**

| 20. | Until roof can be replaced continue to monitor for roof leaks and make repairs as needed. | |

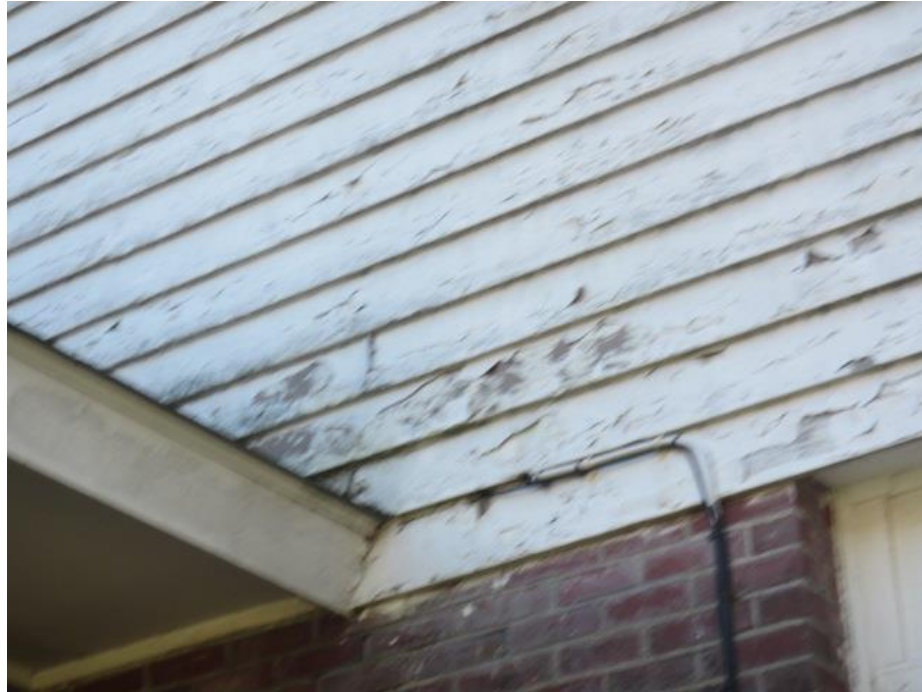
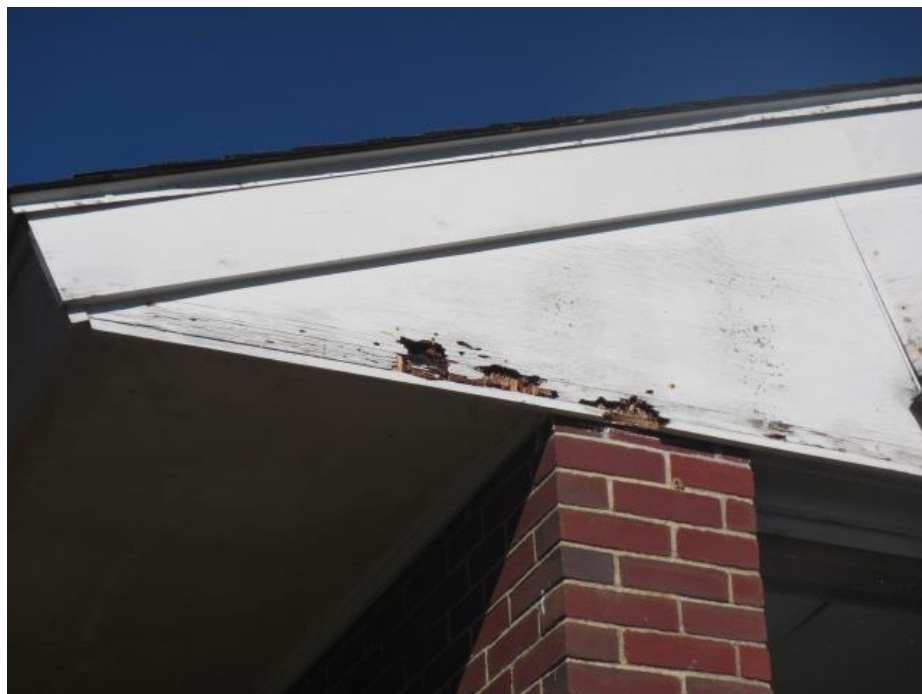
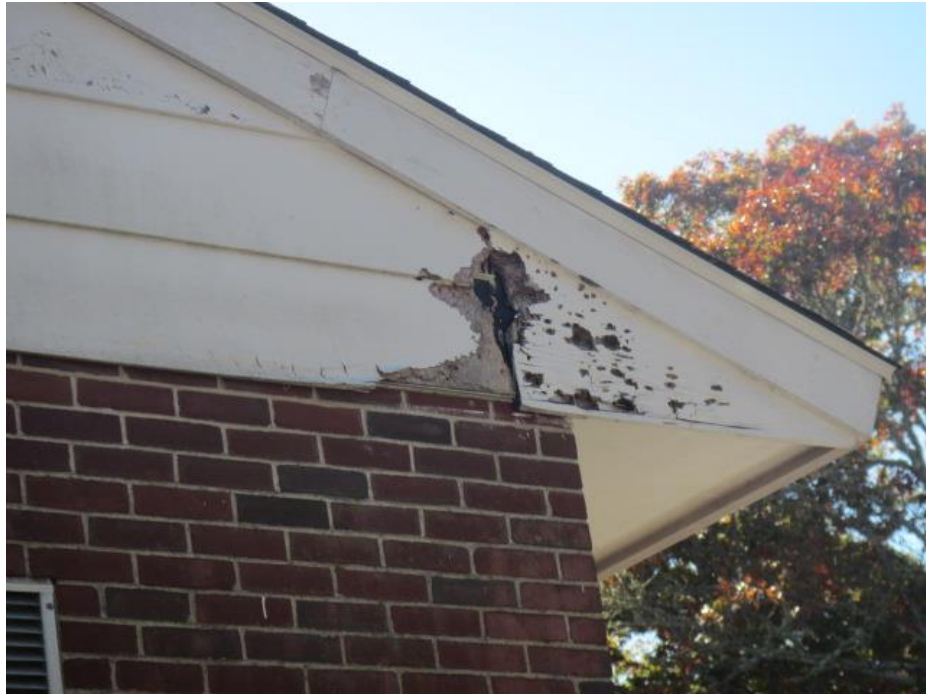
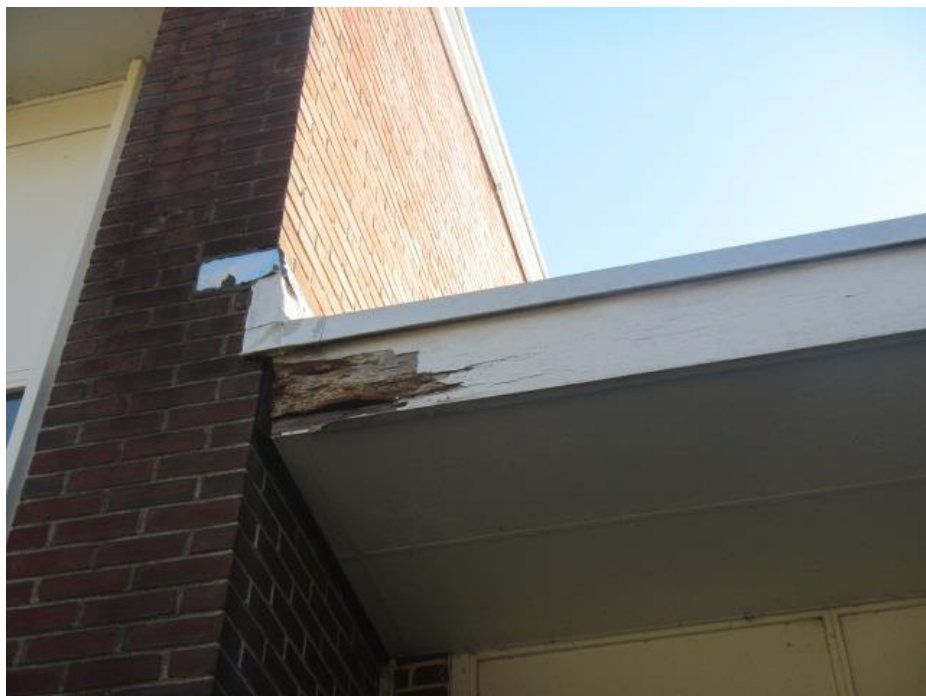
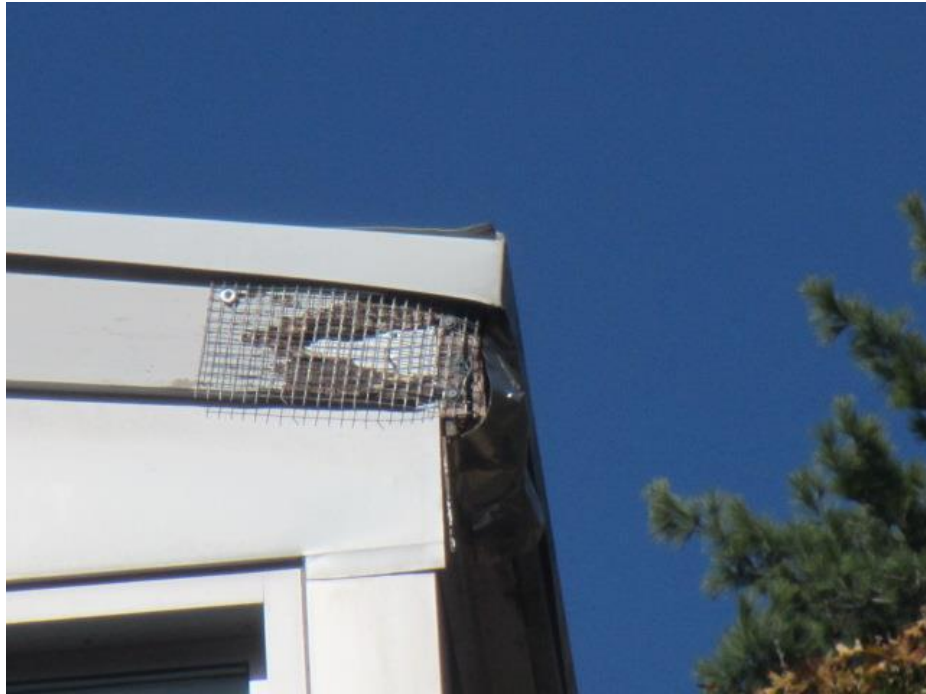
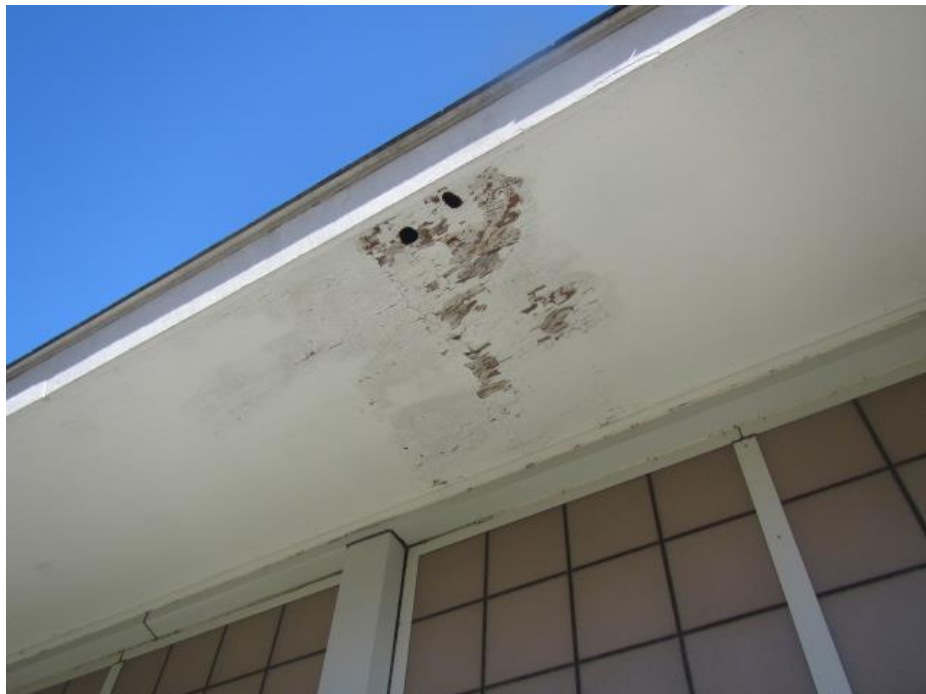
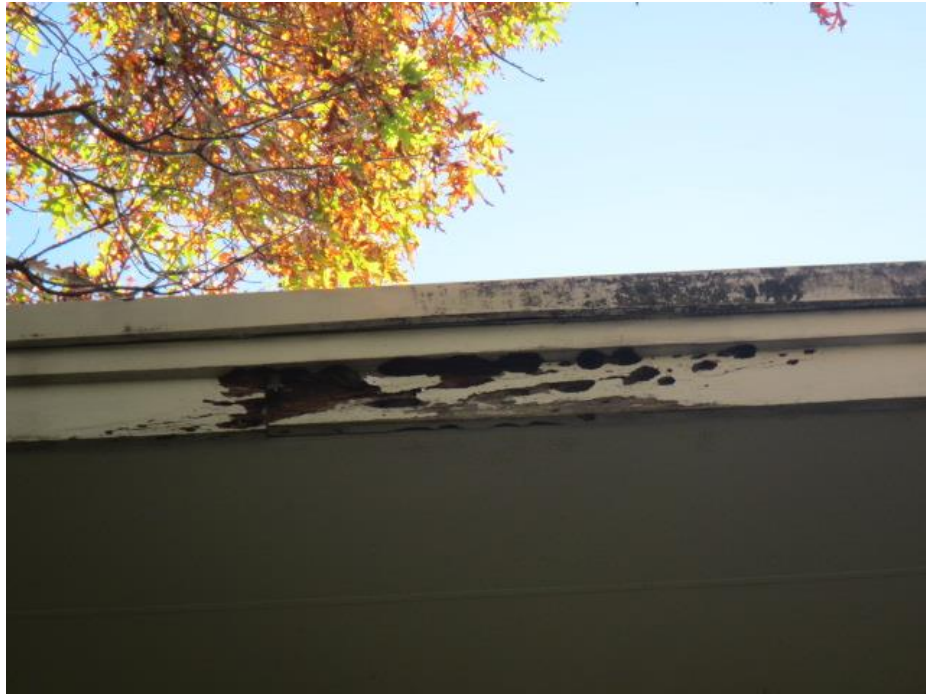
- **Damaged wood and delaminating paint were found along the roof eaves, trim, and exterior walls,** which can accelerate water damage and rot (Pictures 29 through 35) allowing a pathway for drafts, moisture, and pest entry into the building.

**Rotted/delaminating wood along roof/exterior walls**

**Rotted/delaminating wood along roof**

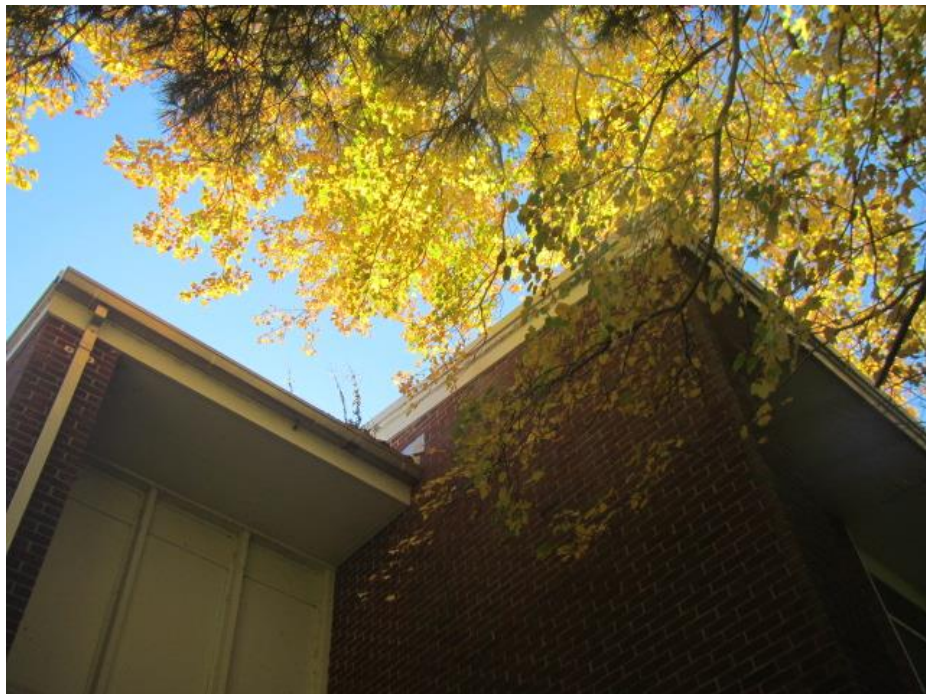
**Picture 36**

- **Clogged gutters and overhanging branches** were noted near the roof/exterior walls (Pictures 36 and 37).

**Branches overhanging roof/close proximity to exterior walls**

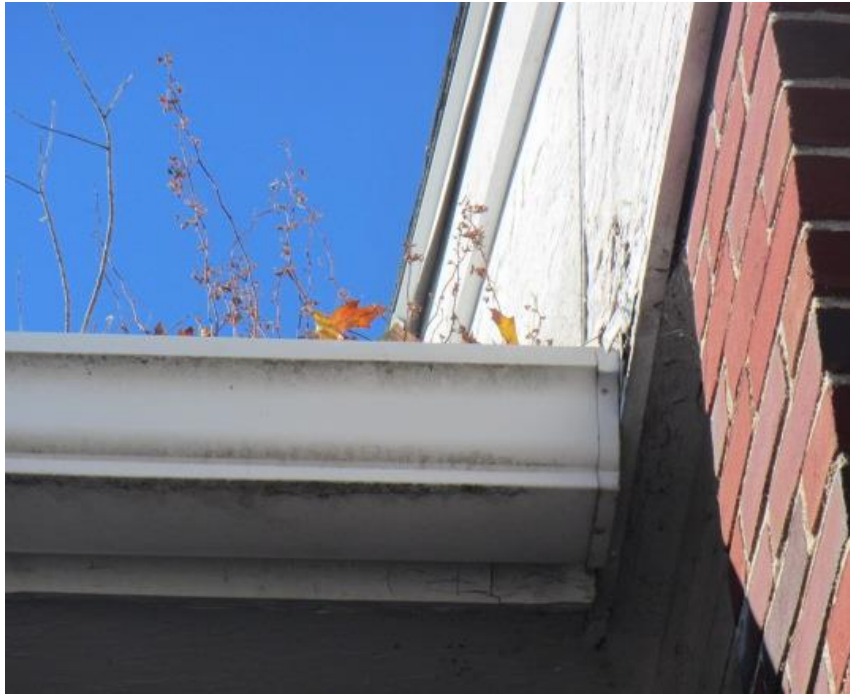
**Picture 37**

**Gutter clogged with debris**

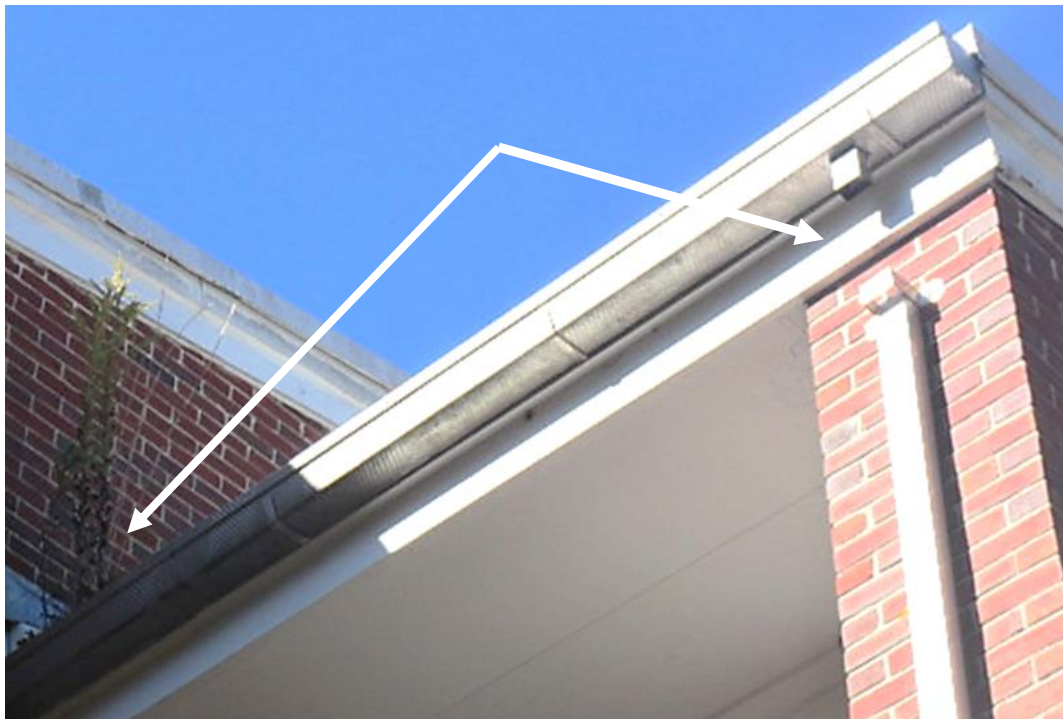
**Picture 38**

- Missing/damaged gutters and downspouts were noted (Pictures 38 through 40).
- A clogged drain was found at the bottom of the boiler room stairwell (Picture 41).
- Missing/damaged caulking/sealant around univent fresh air intakes was noted in several areas (Picture 42).

**Missing/damaged downspout, note plant growth in gutter (arrows)**
