# INDOOR AIR QUALITY ASSESSMENT

## Centerville Elementary School

658 Bay Lane  
Centerville, MA  
November 2024

Prepared by:  
Massachusetts Department of Public Health  
Bureau of Climate and Environmental Health  
Division of Environmental Health Regulations and Standards

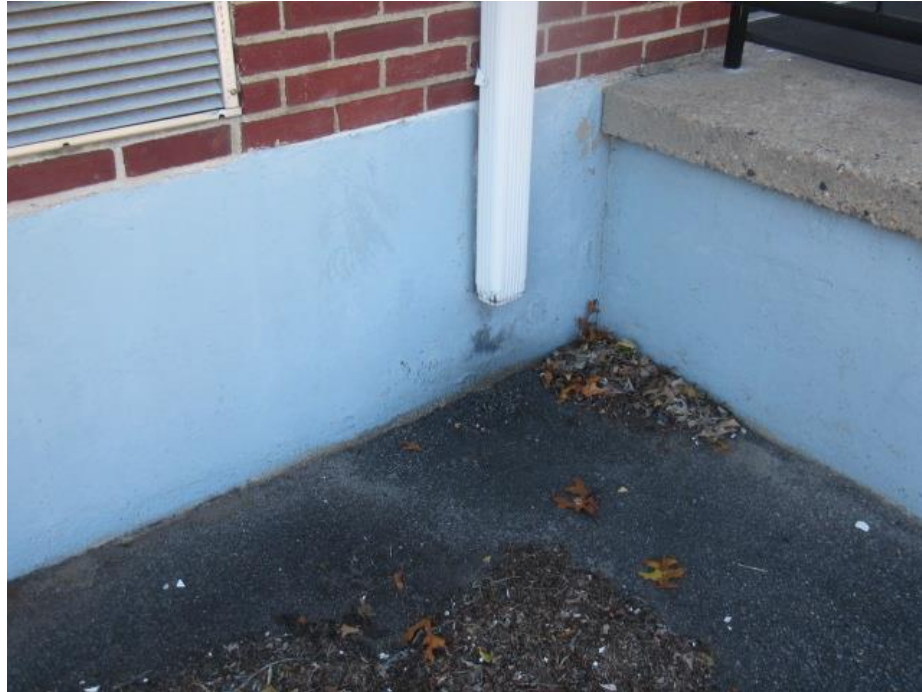
**Picture 39**

**Missing elbow extension at bottom of downspout to drain water away from building**

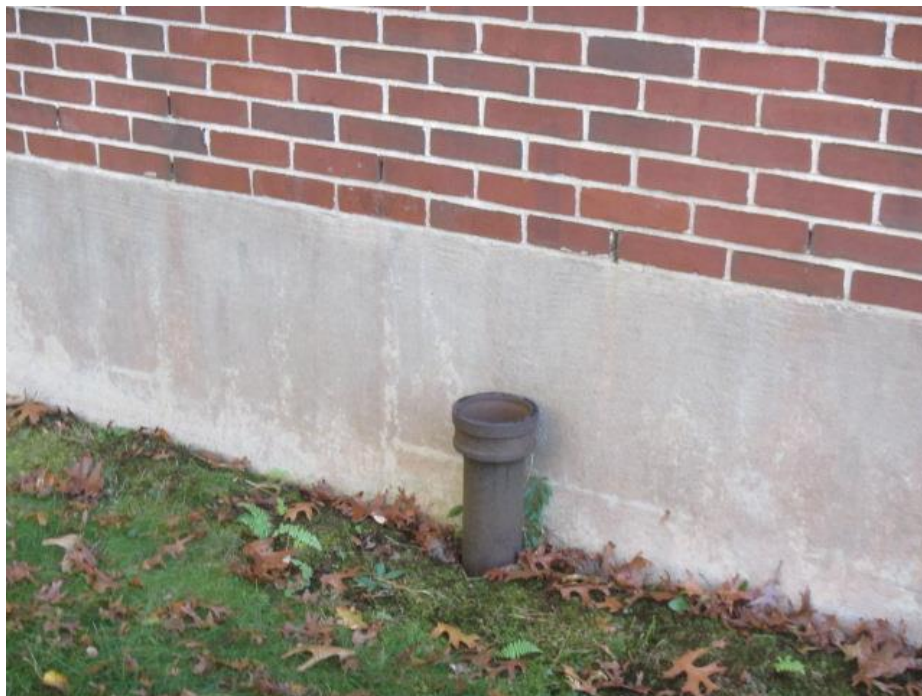
**Picture 40**

**Abandoned drainage pipe for gutter/downspout system**

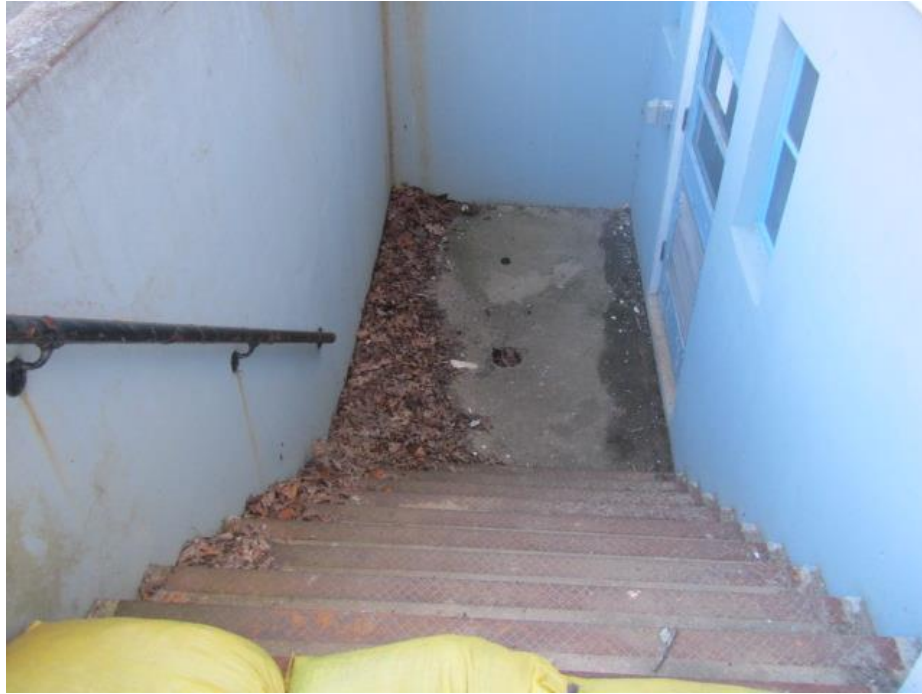
**Picture 41**

**Clogged drain at bottom of boiler room stairwell**

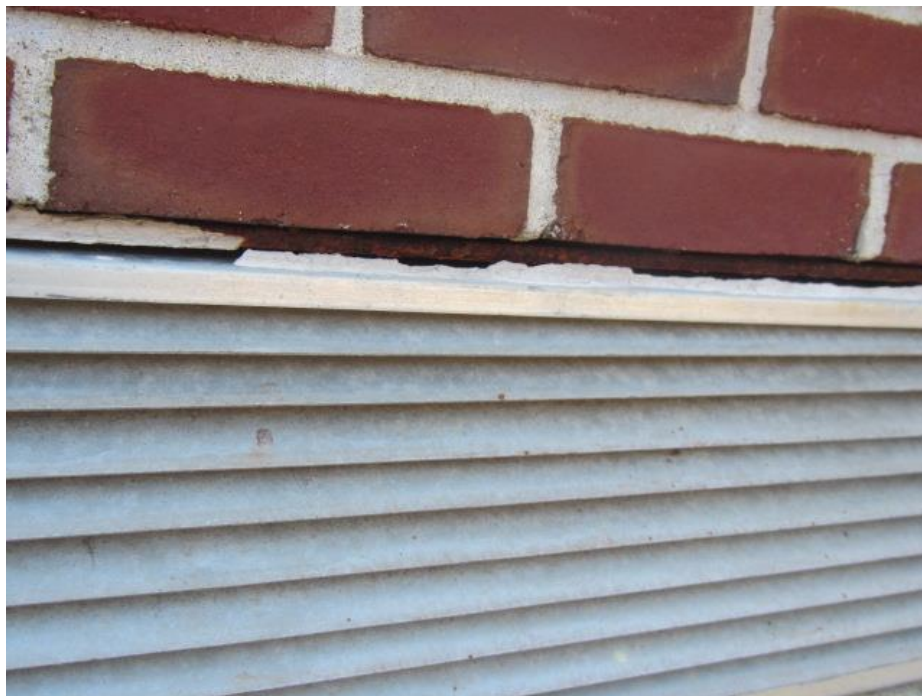
**Picture 42**

**Missing/damaged sealant/caulking around univent fresh air intake**

| 31. | Replace missing/damaged caulking around univent air intakes. | |

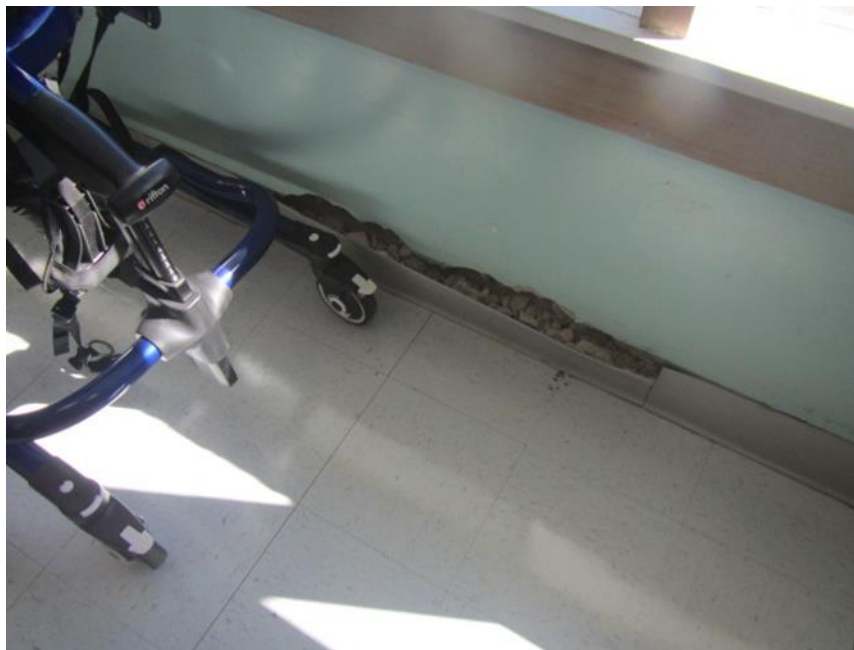
Picture 44

- **Classroom 4 (OT/PT) had damage to the base of the exterior wall (Picture 44).** This breach can serve as a pathway for drafts, particulates, or odors from the wall cavity into the building.

Wall damage in Classroom4 (OT/PT Room)
