## **Monomoy Regional Middle School Air Quality Testing Report**

**Description:** Limited indoor air quality sampling and a visual assessment.

Re: **Limited Indoor Air Quality Assessment**  
Monomoy Regional Middle School  
425 Crowell Road  
Chatham, Massachusetts 02633  
**VERTEX Project No. 92262**

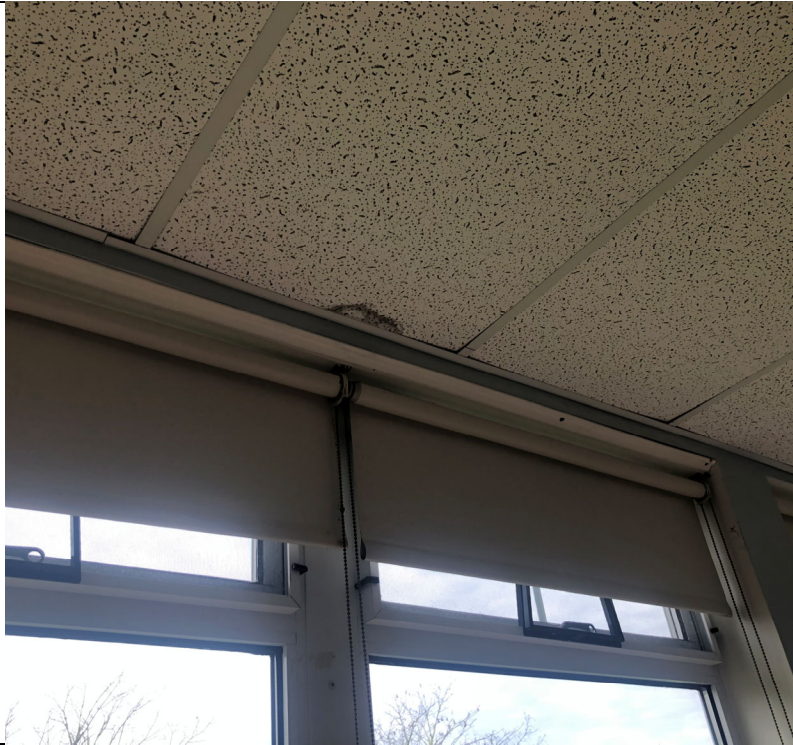
#### Photograph: 1

- Water staining was observed on a ceiling tile above the window area within Room E113. (See Photo 1). Further inspection below the window area revealed water damaged gypsum board adjacent to the window area (See Photograph 2). Moisture mapping of the water damaged gypsum board did not reveal elevated moisture content.

Photograph depicts general view of water stained ceiling tile within Room E113.

- Retain a reputable contractor remove and replace water damaged gypsum board in E113 and E109. Ensure that the source(s) of water intrusion are investigated and repaired during this process. Potential sources of water damage may include excessive condensation around windows due to temperature differentials, damaged siding/window trim on the exterior or plumbing leaks above the false ceilings in these areas.

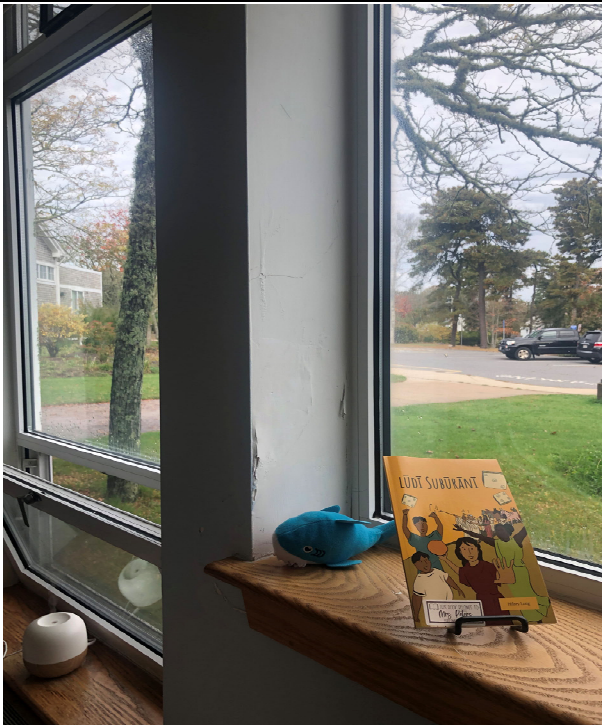
#### Photograph: 2

- Water damaged gypsum board adjacent to the window areas was observed in Classrooms E109 and E113. Moisture mapping of the water damaged gypsum board did not reveal elevated moisture content.

Photograph depicts general view of water damaged gypsum board within Room E113 adjacent to the window area.

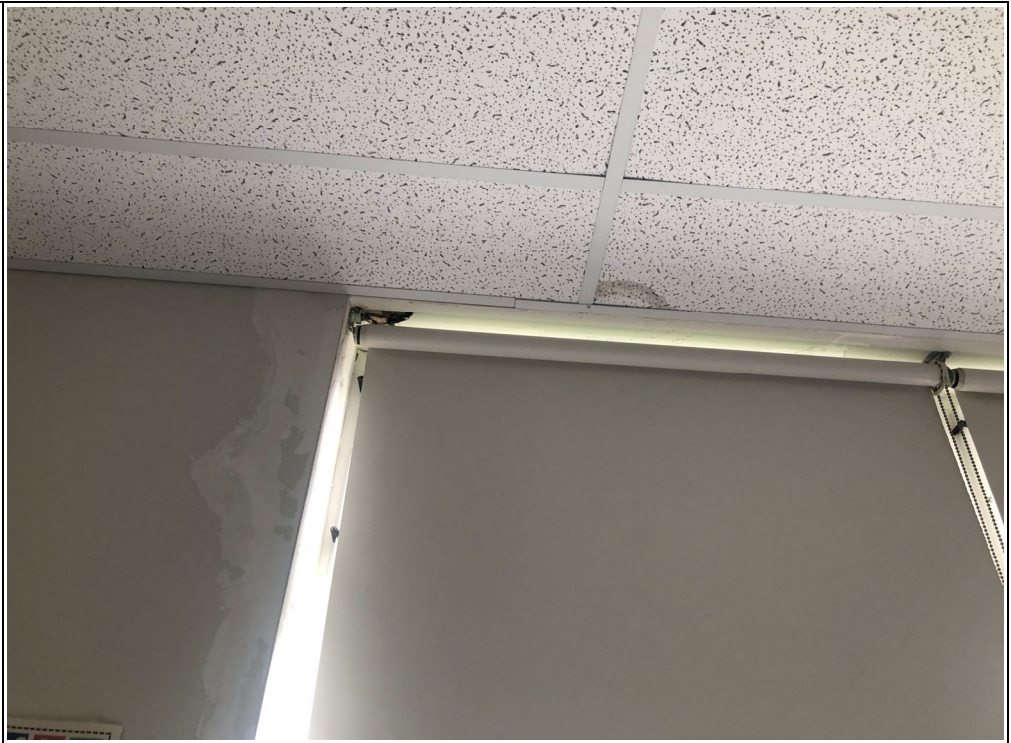
#### Photograph: 3

- Water staining was observed on a ceiling tile and water damage above the window area within Room E09. (See Photo 3). Further inspection below the window area revealed water damaged gypsum board adjacent to the window area (See Photograph 4). Moisture mapping of the water damaged gypsum board did not reveal elevated moisture content.

Photograph depicts general view of water stained ceiling tile within Room E109.

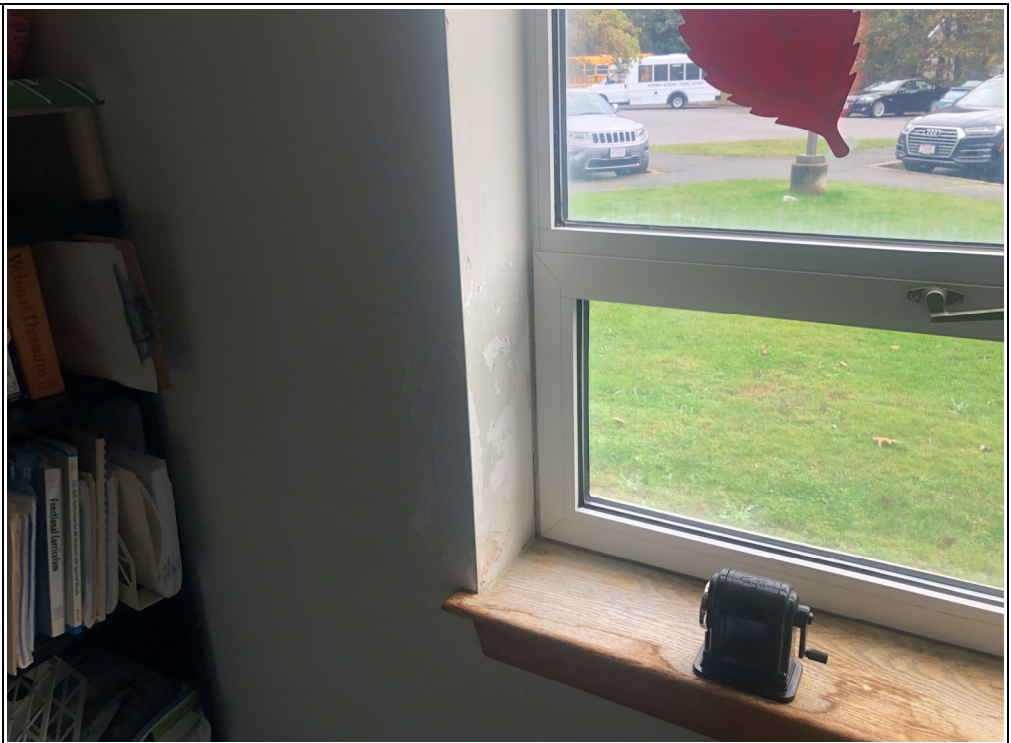
#### Photograph: 4

Photograph depicts general view of water damaged gypsum board within Room E109 adjacent to the window area.

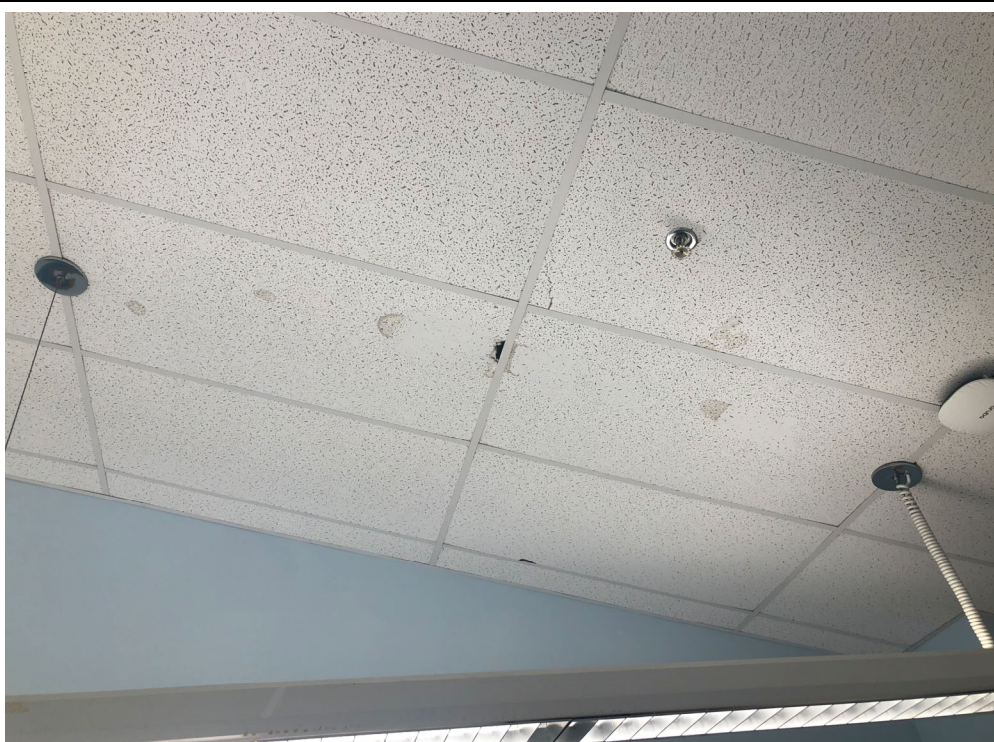
**Photograph: 6****Description:**

- Water staining was observed on three (3) ceiling tiles within Room E215 (See Photo 6).
- Water staining was observed on two (2) ceiling tiles within Room E212 (See Photo 7).

Photograph depicts general view of the water-stained ceiling tiles in Room E215.

- Remove and inspect water source of the water-stained ceiling tiles observed within E212, E215 D114, D126, B131 and B137. Correct water source and replace ceiling tiles. When inspecting the source(s) of water intrusion in these areas, attention should be paid to:

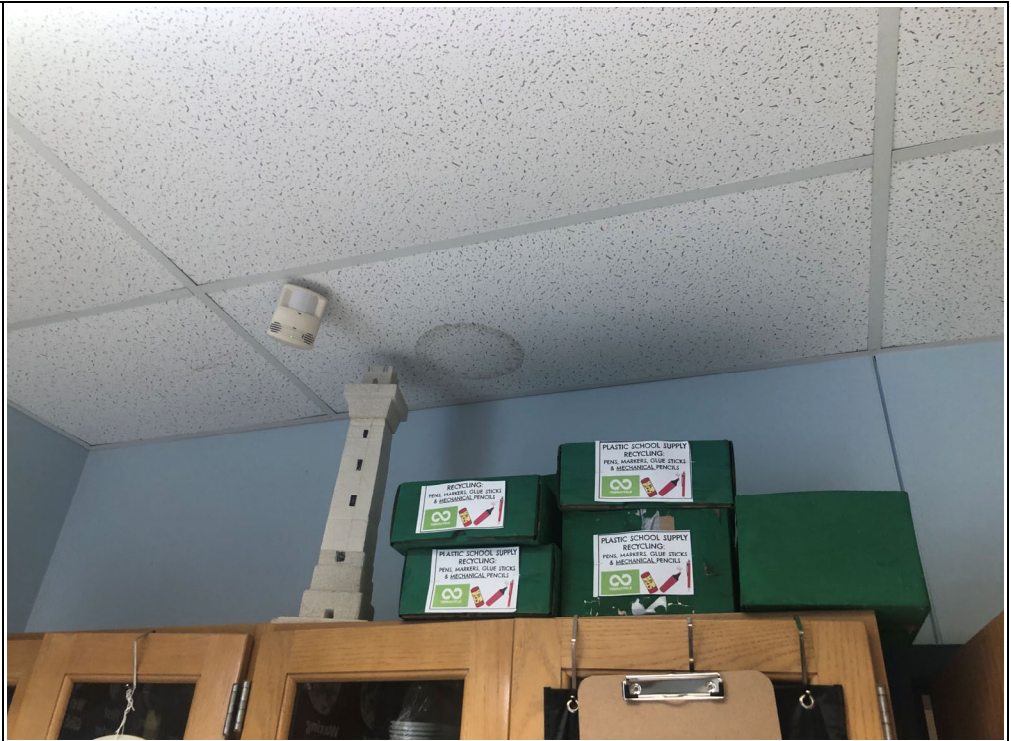
### Photograph: 7

Photograph depicts general view of the water-stained ceiling tiles in Room E215.

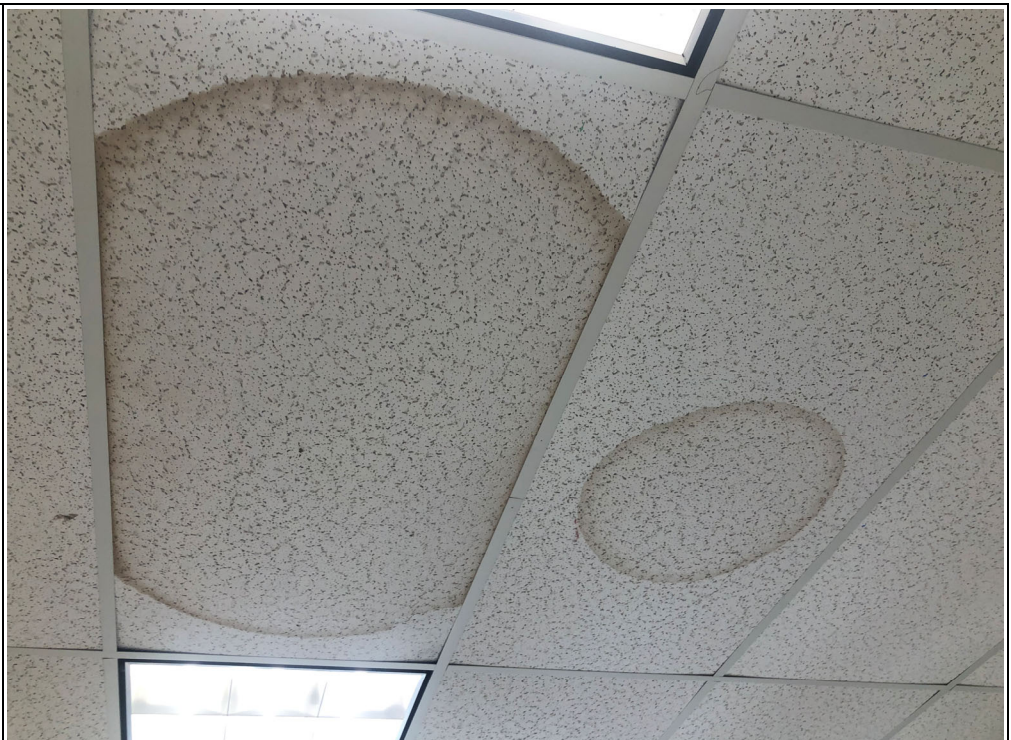
### Photograph: 8

- Water staining was observed on two (2) ceiling tiles within Room D126 (See Photo 8).
- Water staining was observed on two (2) ceiling tiles within Room D114 (See Photo 9).

Photograph depicts general view of the water-stained ceiling tiles in Room D126.

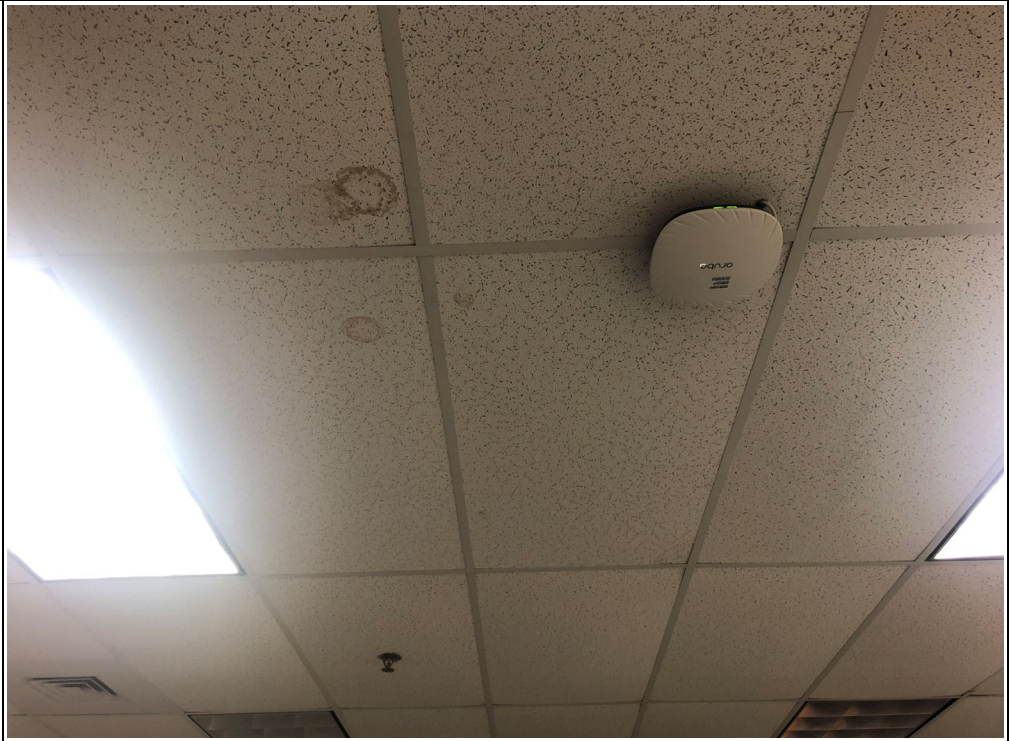
### Photograph: 9

Photograph depicts general view of the water-stained ceiling tiles in Room D114.

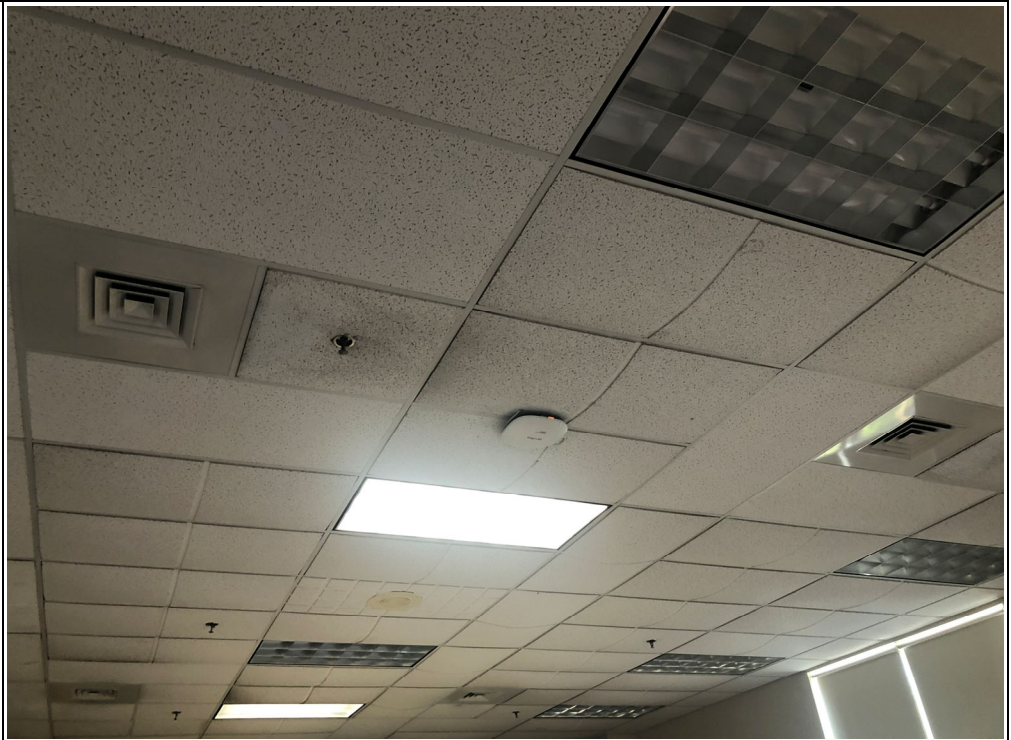
### Photograph: 10

- Particulate accumulation was observed on ceiling tiles adjacent to several air supply diffusers within the Library (See Photo 10).
- Particulate accumulation was observed on ceiling tiles adjacent to air supply diffusers within the Lobby (See Photo 11).

Photograph depicts general view of particulate accumulation on the ceiling tile adjacent to the air supply diffuser within the library.

- Areas where roof may be leaking during storm events
  - Fire suppression line leaks or other plumbing/HVAC condensate leaks above the false ceiling
- Ensure that all supply diffusers and return air grills and covers are cleaned on a regular basis such that they are free of dust, debris, or obstructions.

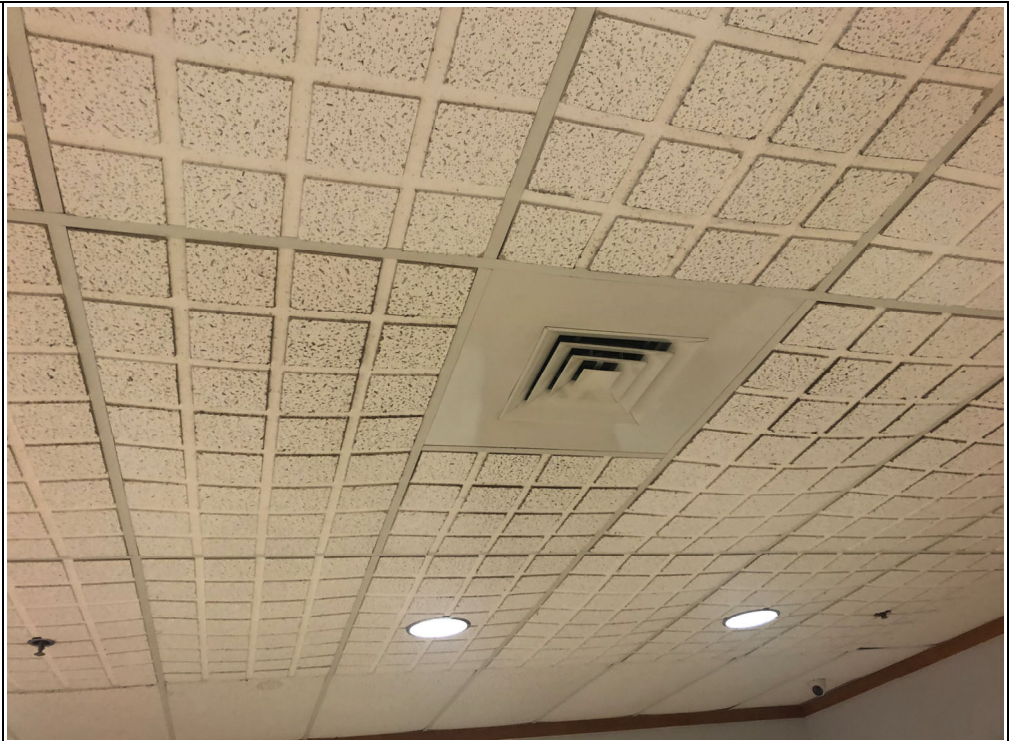
### Photograph: 11

Photograph depicts general view of particulate accumulation on the ceiling tile adjacent to the air supply diffuser within the lobby.

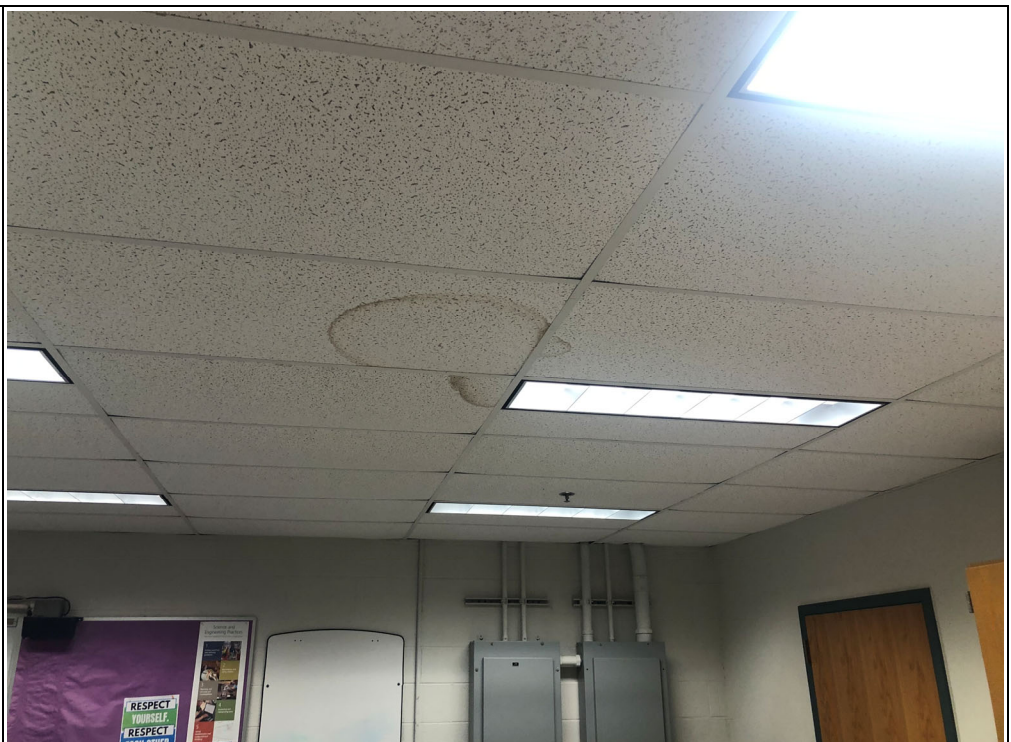
### Photograph: 12

- Water staining was observed on one (1) ceiling tile within Room B131.
- Water staining was observed on three (3) ceiling tiles within Room B137 (See Photo 12).

Photograph depicts general view of the water-stained ceiling tiles in Room B137.

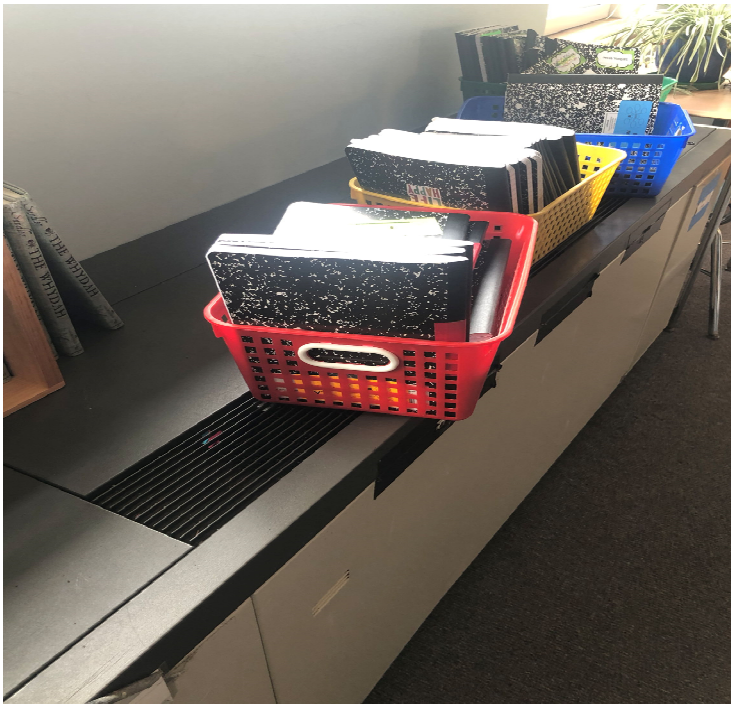
#### Photograph: 14

- Unit-vent supply blocked with book storage within Room B104 (See Photo 14).
- All classroom unit-ventilators appeared to be operable at the time of the assessment with the exception of E207 and E208 which were manually turned off by the occupants.

Photograph depicts general view of book storage on unit-ventilator air supply within Room B104.

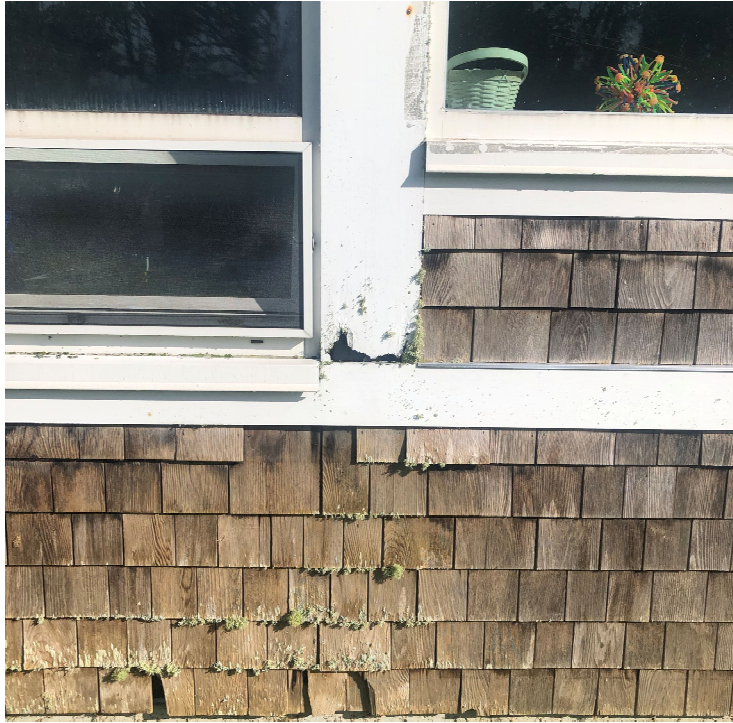
**Photograph: 15****Description:**

- Areas of suspect visible mold growth was not observed at the time of assessment.
- Inspection of the exterior revealed weathered wood siding shingles, water damaged wood trim around several window units and around the base of the perimeter of the school, as well as disconnected downspouts. (See Photos 14, 15, 16, 17, 18, 19 and 20).

Photograph depicts general view of the weathered wood shingles and water damaged wood trim board outside Room E119.

- Retain a reputable siding contractor to remove and replace water damaged wood trim boards and weathered shingles to prevent water intrusion into the building envelope.
- Inspect and repair disconnected downspouts to manage water away from the site building.

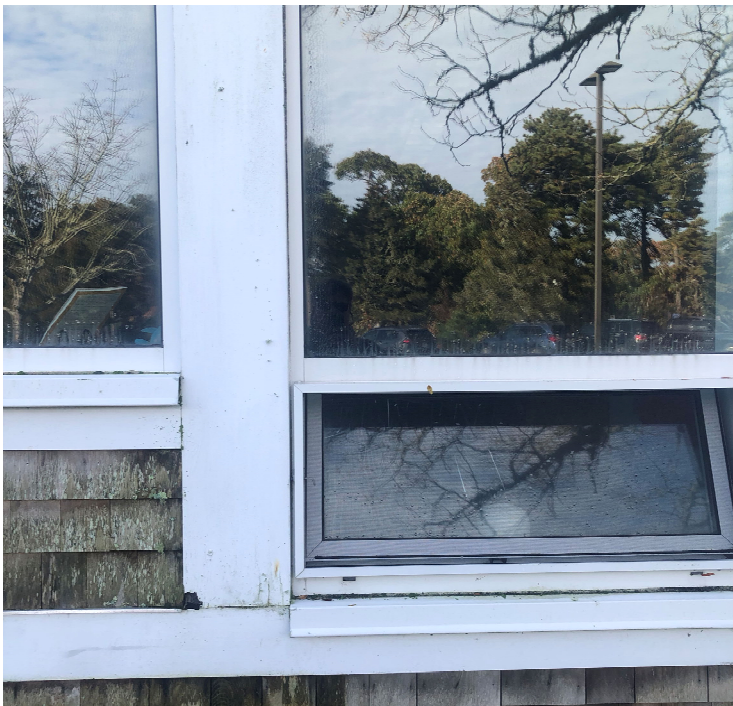
**Photograph: 16****Description:**

Photograph depicts general view of the weathered wood shingles and water damaged wood trim board outside Room E109.

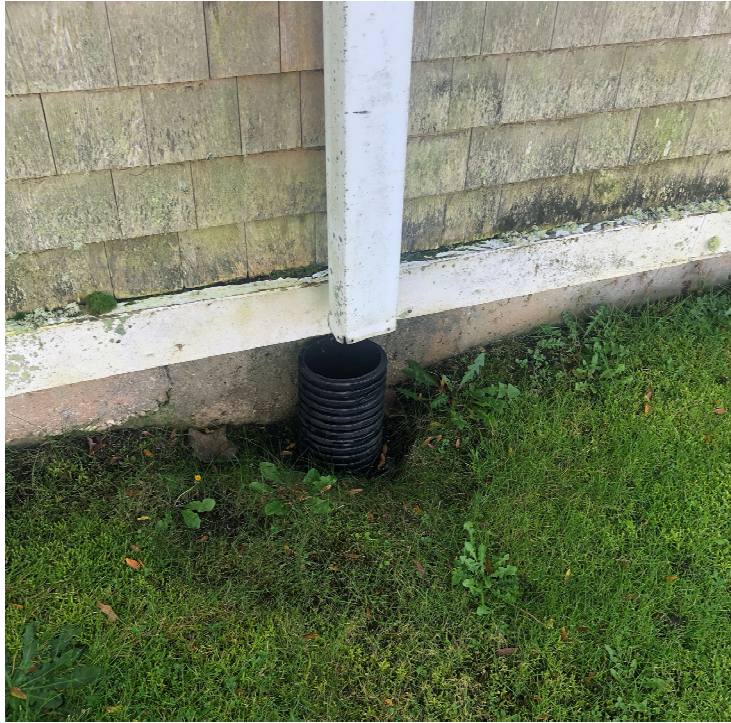
**Photograph: 17****Description:**

Photograph depicts general view of the weathered wood shingles and water damaged wood trim board as well as disconnected down spout.

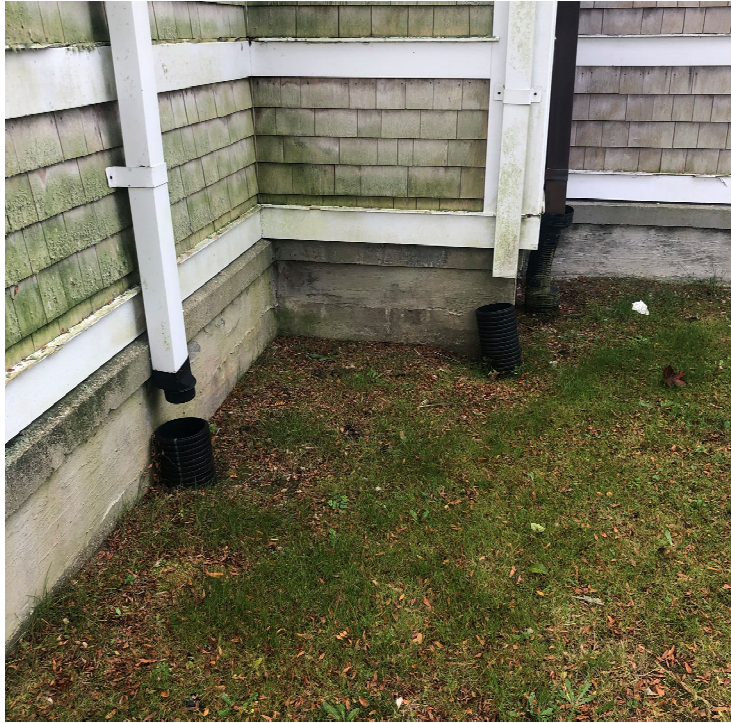
**Photograph: 19****Description:**

Photograph depicts general view of the weathered wood shingles and disconnected down spouts.

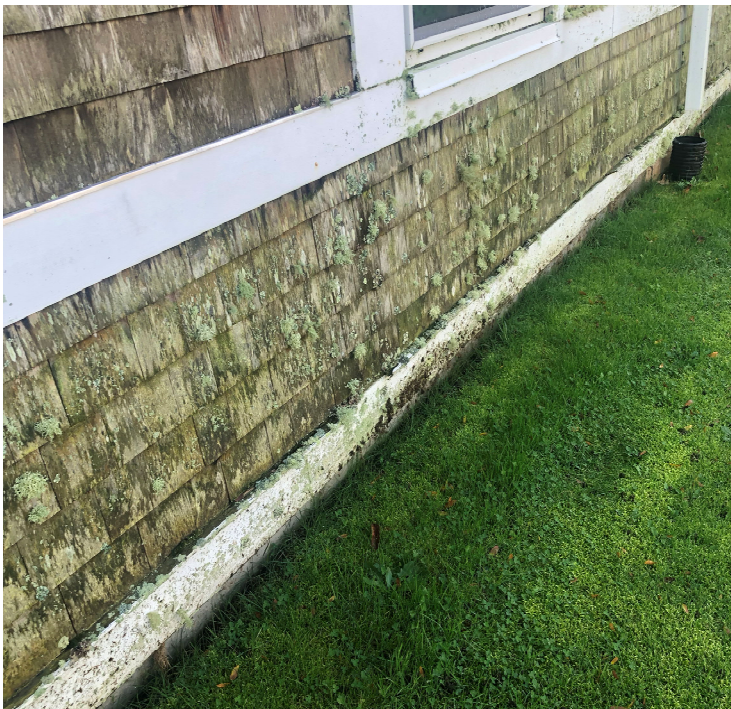
**Photograph: 20****Description:**

Photograph depicts general view of the weathered wood shingles and water damaged wood trim board at the base of the building.
