Burr Elementary School

Fairfield Public Schools Recommissioning (RCx) and Testing, Adjusting, & Balancing (TAB) Study van Zelm Project # 2020102.00 (08-BES) November 20, 2022

FAIRFIELD PUBLIC SCHOOLS RECOMMISSIONING (RCx) AND TESTING, ADJUSTING, & BALANCING (TAB) STUDY

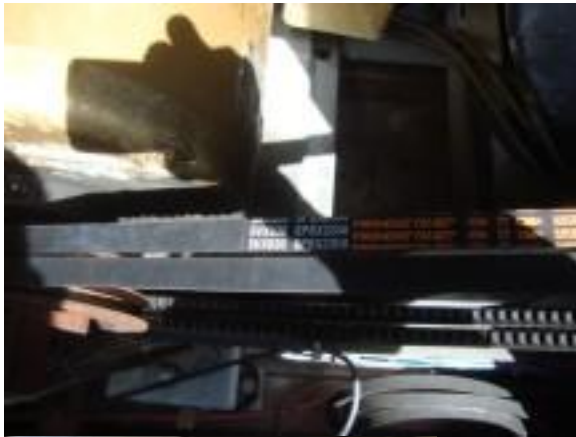
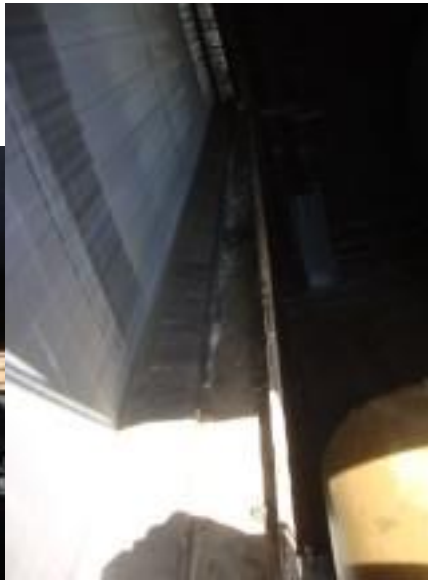
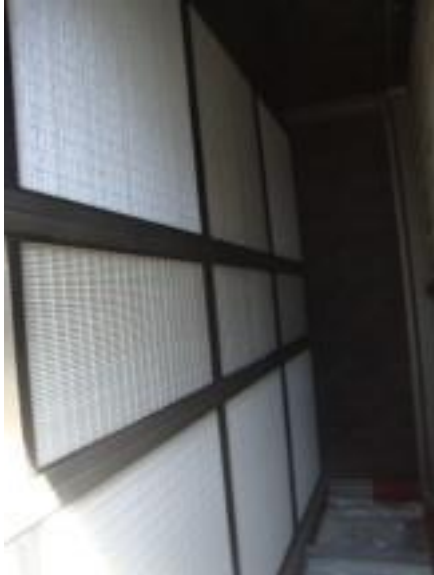
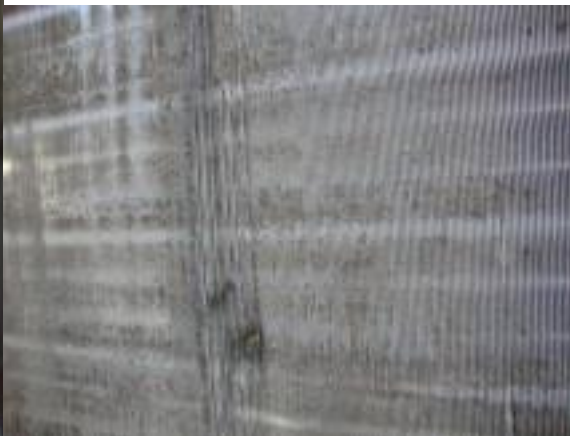
Controls	Functionally it is unclear as to what mode system is in, Retro Cx recommended	
Drain Pan Status	OK, Flush after coil cleaning,	
Notes:	Door Hardware, rusted, adjust, and lubricate

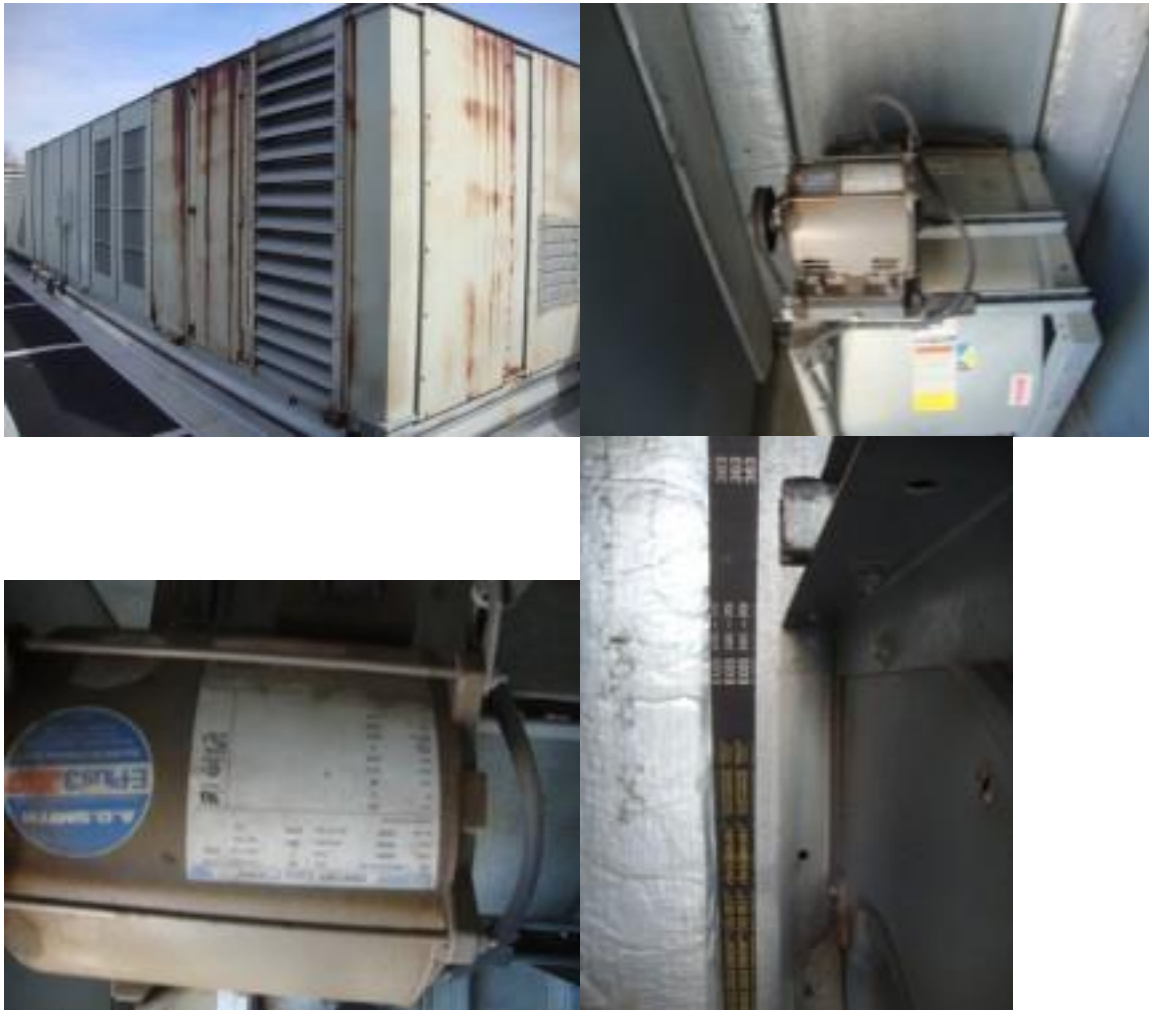
<u>Unit Tag</u>	<u>AC-2</u>	<u>Addition comments descriptions</u>
Location	Roof Pit	
Serving	Northwest Classrooms (Per JCI Docs)	
Config/Style	Packaged RTU, DX Cooling ERW, HW Heating	
Mfr.	Trane Intellipak	
Model #	SLHFC50ED577S8BD9000	
Serial #	C03J0842	
Age (years)	2003	
System CFM		
Max OA CFM		
V/Hz/Ph	200/60/3	
SF Qty/HP	(1) 30.0 (2) 5VX930 Belts	
SF VFD Data	VFD, Fans and electronics dirty	
EF Qty/HP	(1) 15.0 (1) BX-81 Belts	
EF VFD Data	VFD, Fans and electronics dirty	
Filter Data (Size Quantity)	(3) 12x24x2, (3) 12x12x4 (9) 24x24x2 (9) 24x24x4	
Filter Status	Filters are clean, proper spacer	4-5-22 Change date
Controls Type	Electronic DDC, Packaged BAS, Trane Package	
Controls Mfr.	Factory	
Economizer	Packaged economizer, found damper actuator missing bolt, fixed temporarily.	
CO ₂ DCV	-	
Damper Styles	Factory parallel,	
Damper Status	Seals falling off, Clean adjust and Lubricate.	
Heating Type	Hot Water

Wheel Exhaust	5.0 HP, Twin City Size 81 - Type BAB-DW, Belt BX-65	
Controls	Functionally it is unclear as to what mode system is in, Retro Cx recommended	
Drain Pan Status	OK, Flush after coil cleaning,	
Notes:	Door Hardware, rusted, adjust, and lubricate

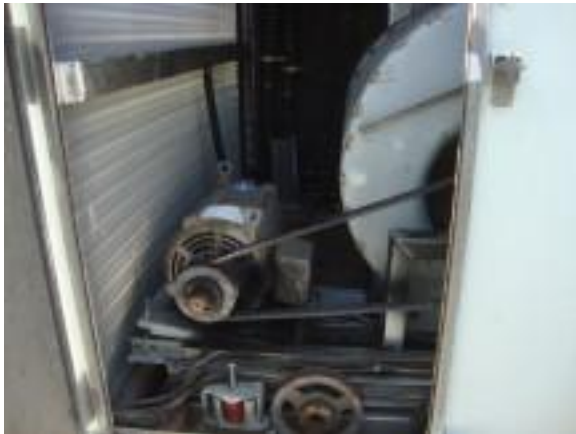
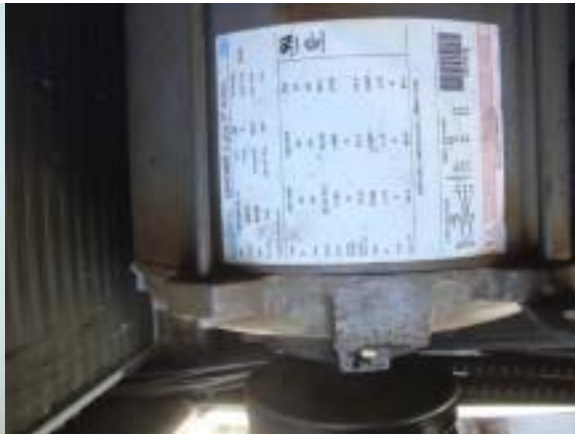
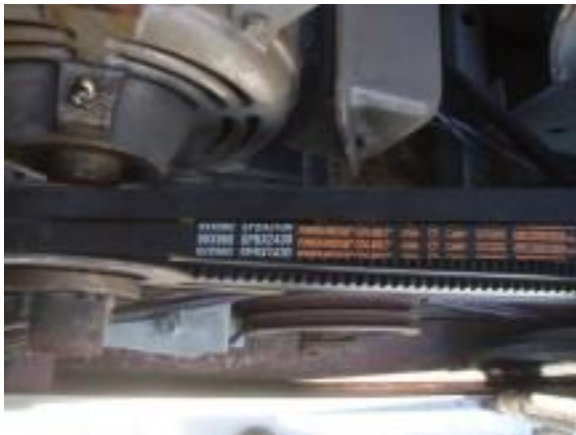
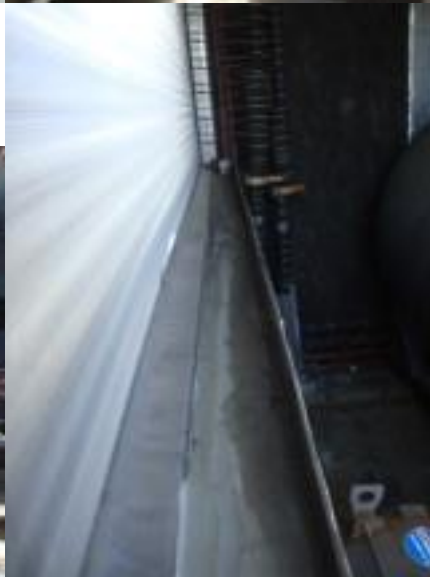
<u>Unit Tag</u>	<u>AC-3</u>	<u>Addition comments descriptions</u>
Location	Roof Pit	
Serving	Gymnasium (Per JCI Docs)	
Config/Style	Packaged RTU, DX Cooling ERW, HW Heating	
Mfr.	Trane Intellipak	
Model #	SLHFC50ED567S7B01000AOZ	
Serial #	C03J08046	
Age (years)	2003	
System CFM		
Max OA CFM		
V/Hz/Ph	200/60/3	
SF Qty/HP	(1) 25.0 (2) 5VX930 Belts	
SF VFD Data	N/A	
EF Qty/HP	(1) 10.0 (1) BX-87 Belts	
EF VFD Data	N/A	
Filter Data (Size Quantity)	(3) 12x24x2, (9) 24x24x2 (3) 12x24x4 (9) 24x24x4	
Filter Status	Filters are clean, proper spacer	4-5-22 Change date
Controls Type	Electronic DDC, Packaged BAS, Trane Package	
Controls Mfr.	Factory	
Economizer	Packaged economizer	
CO ₂ DCV	-	
Damper Styles	Factory parallel,	
Damper Status	Seals falling off, Clean adjust and Lubricate.	
Heating Type	Hot Water	
Heating Coil Condition	Unknown, no access doors for inspection, assumed dirty coils	
Cooling Type	DX Package	
Cooling Coil Condition	Dirty, Needs cleaning

Controls	Functionally it is unclear as to what mode system is in, Retro Cx recommended	
Drain Pan Status	OK, Flush after coil cleaning,	
Notes:	Door Hardware, rusted, adjust, and lubricate

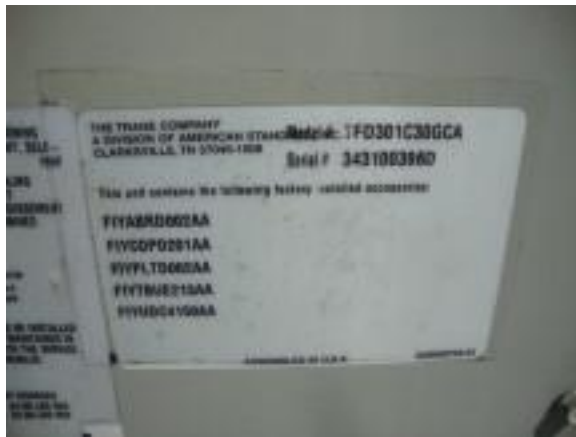
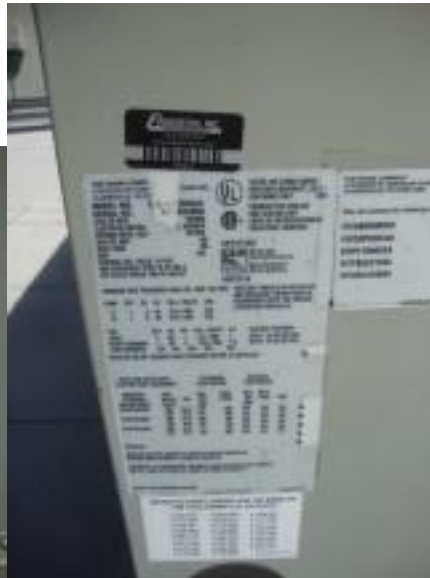
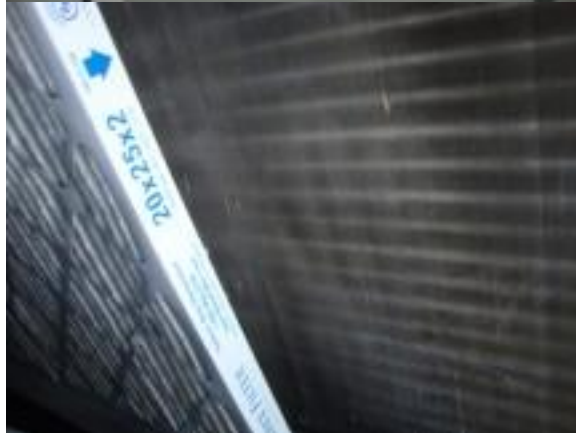
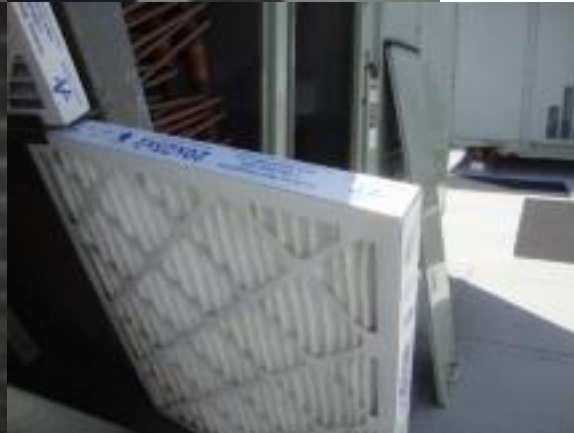
<u>Unit Tag</u>	<u>ERU-4</u>	<u>AC-4</u>
Location	Roof Pit	Roof Pit
Serving	Cafeteria (Per JCI Docs)	Cafeteria (Per JCI Docs)
Config/Style	ERW, Supply and Exhaust Fans	Packaged RTU, DX Cooling, HW Heating
Mfr.	Semco ERU	Trane Voyager
Model #	FV5000T-4RN4AB	TFD301C30GCA
Serial #	33266/M017531-01	343100396D
Age (years)	11/2003	10/2003
System CFM		
Max OA CFM		
V/Hz/Ph	200/60/3	200/60/3
SF Qty/HP	(1) 2.0 (1) Adj. Belt Fan section dirty	(1) 7.5 (1) BX-81 Belt
SF VFD Data	N/A	N/A
EF Qty/HP	(1) 3.0 (1) Belt	N/A
EF VFD Data	N/A	N/A
Filter Data (Size Quantity)	(3) 16x25x1 Aluminum dirty, Replace	(4) 20x20x2 (4) 20x25x2
Filter Status	Filters are dirty	Clean 4-5-22 Change date
Controls Type	Electronic DDC, Packaged BAS, Trane Package	JCI Metasys
Controls Mfr.	Factory	
Economizer	Packaged economizer, 100% O.A. If functional?	
CO ₂ DCV	-	
Damper Styles	Factory Slide, O.A. Needs to be cleaned adjusted and lubricated	N/A
Damper Status	Sketchy, Clean adjust and lubricate.	N/A

Controls	Functionally is unclear as to if it works and or what mode system is in, Retro Cx recommended	
Drain Pan Status		OK, Flush after coil cleaning,
Notes:	Door Hardware, rusted, adjust, and lubricate

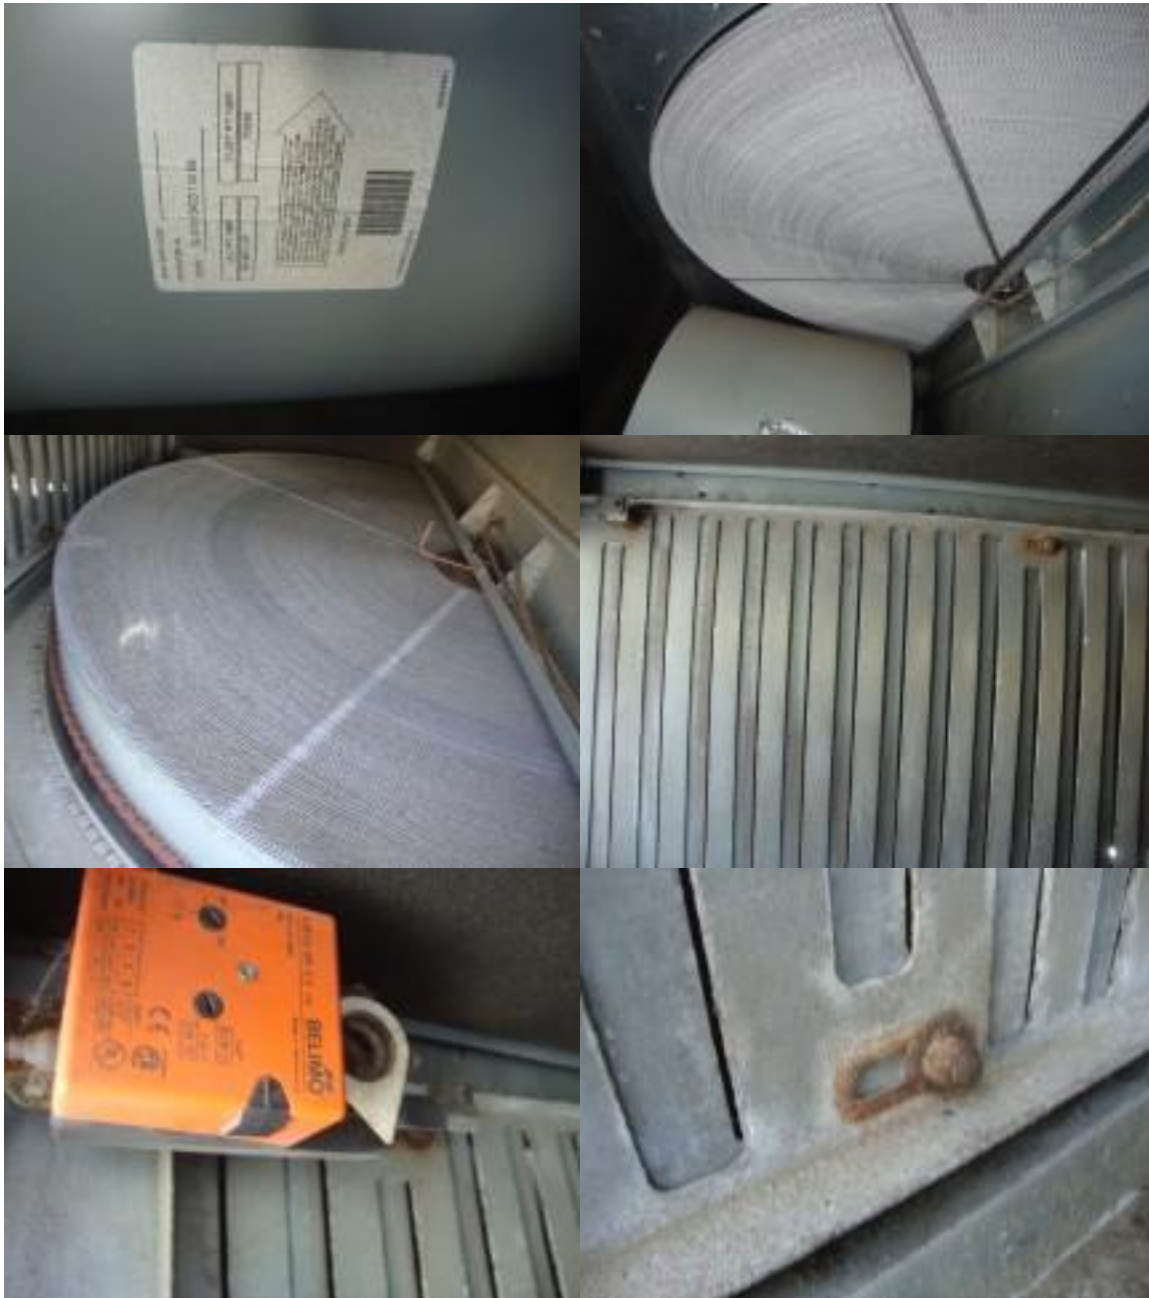
<u>Unit Tag</u>	<u>ERU-5</u>	<u>AC-5</u>
Location	Roof Pit	Roof Pit
Serving	Library (Per JCI Docs)	Library (Per JCI Docs)
Config/Style	ERW, Supply and Exhaust Fans	Packaged RTU, DX Cooling, HW Heating
Mfr.	Semco ERU	Trane Voyager
Model #	FV5000T-4RN4AB	TFD301C30GCA
Serial #	33266/M017532-01	343100435D
Age (years)	11/2003	10/2003
System CFM		
Max OA CFM		
V/Hz/Ph	200/60/3	200/60/3
SF Qty/HP	(1) 1.5 (1) AX-51Belt Loose	(1) 7.5 (1) BX-81 Belt
SF VFD Data	N/A	N/A
EF Qty/HP	(1) 1.5 (1) Belt AX-51	N/A
EF VFD Data	N/A	N/A
Filter Data (Size Quantity)	(3) 16x25x1 Aluminum dirty, Replace	(4) 20x20x2 (4) 20x25x2
Filter Status	Filters are dirty	Clean 4-5-22 Change date
Controls Type	Electronic DDC, Packaged BAS, Trane Package	JCI Metasys
Controls Mfr.	Factory	
Economizer	Packaged economizer, 100% O.A. If functional	
CO ₂ DCV	-	
Damper Styles	Factory Slide, O.A. Needs to be cleaned adjusted and lubricated	N/A
Damper Status	Sketchy, Clean adjust and lubricate.	N/A

Controls	Functionally is unclear as to if it works and or what mode system is in, Retro Cx recommended	
Drain Pan Status		OK, Flush after coil cleaning,
Notes:	Door Hardware, rusted, adjust, and lubricate

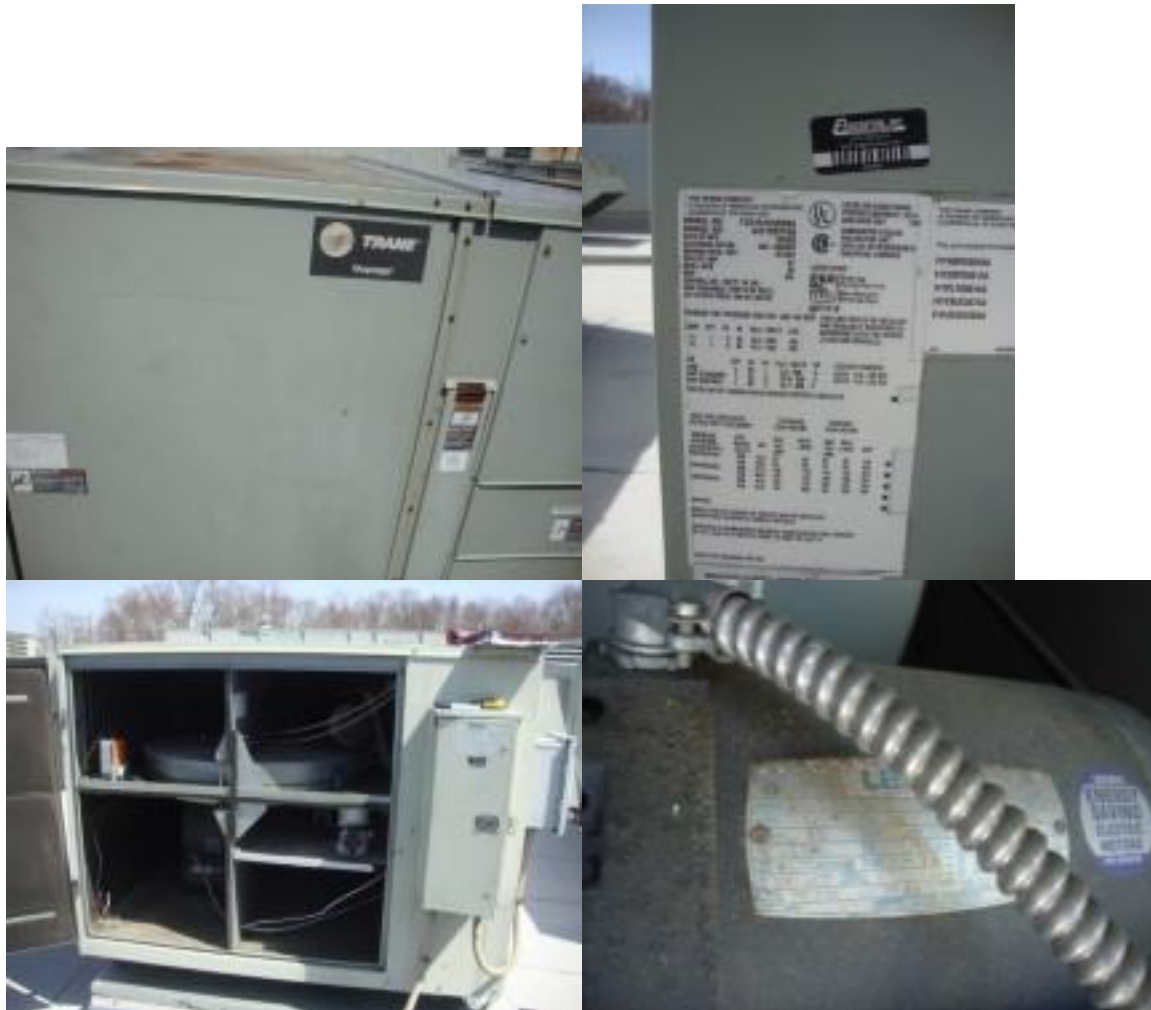
<u>Unit Tag</u>	<u>ERU-6</u>	<u>AC-6</u>
Location	Roof Pit	Roof Pit
Serving	Music (Per JCI Docs)	Music (Per JCI Docs)
Config/Style	ERW, Supply and Exhaust Fans	Packaged RTU, DX Cooling, HW Heating
Mfr.	Semco ERU	Trane Voyager
Model #	FV5000T-4RN4AB	TFD151C30GCA
Serial #	33266/M017533-01	343100374D
Age (years)	11/2003	10/2003
System CFM		
Max OA CFM		
V/Hz/Ph	200/60/3	200/60/3
SF Qty/HP	(1) 1.5 (1) AX-42	(1) 3.0 (1) BX-62 Belt
SF VFD Data	N/A	N/A
EF Qty/HP	(1) 1.5 (1) Belt 4L-490	N/A
EF VFD Data	N/A	N/A
20Filter Data (Size Quantity)	(2) 16x20x1 Aluminum dirty, Replace	(4) 20x20x2 (4) 20x25x2
Filter Status	Filters are dirty	Clean 4-5-22 Change date
Controls Type	Electronic DDC, Packaged BAS, Trane Package	JCI Metasys
Controls Mfr.	Factory	
Economizer	Packaged economizer, 100% O.A. If functional	
CO ₂ DCV	-	
Damper Styles	Factory Slide, O.A. Linkage is broken, Needs to be fixed, cleaned adjusted and lubricated	N/A

Controls	Functionally is unclear as to if it works and or what mode system is in, Retro Cx recommended	
Drain Pan Status	N/A	OK, Flush after coil cleaning,
Notes:	Door Hardware, rusted, adjust, and lubricate, unit appears to be off

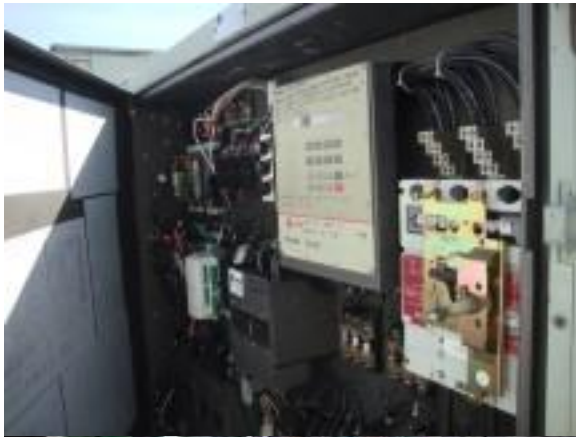
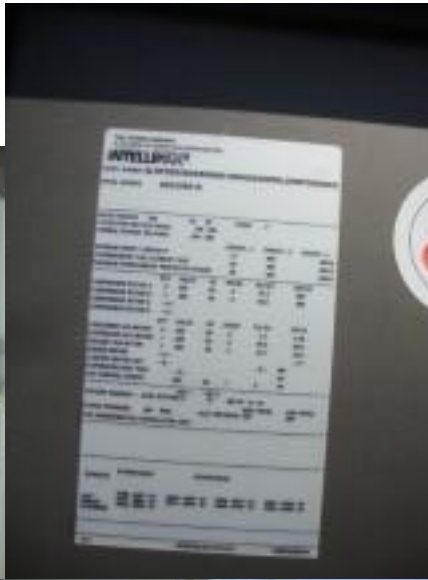
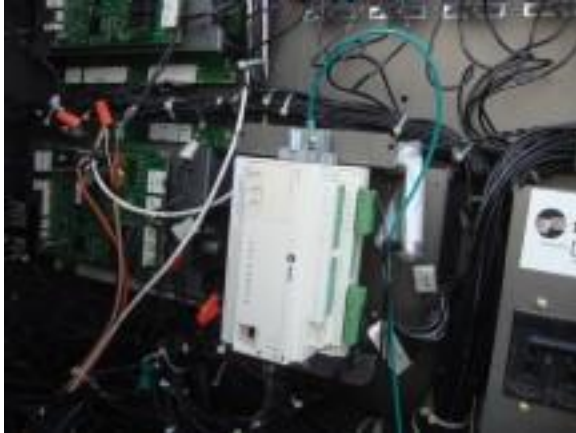
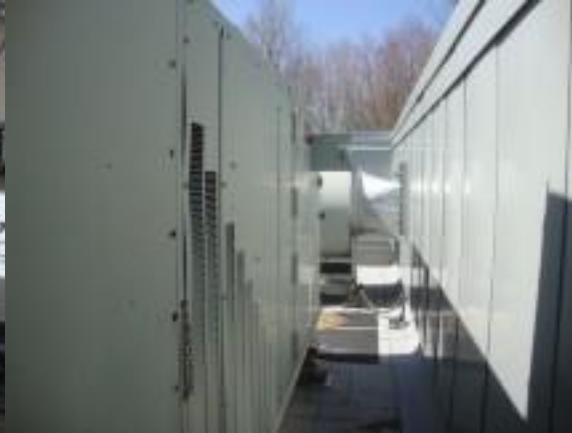
Controls	Functionally it is unclear as to what mode system is in, Retro Cx recommended	
Drain Pan Status	OK, Flush after coil cleaning,	
Notes:	Door Hardware, rusted, adjust, and lubricate
