Timothy Dwight Elementary School

Fairfield Public Schools Recommissioning (RCx) and Testing, Adjusting, & Balancing (TAB) Study

van Zelm Project # 2020102.00 (03-DES)

June 28, 2022

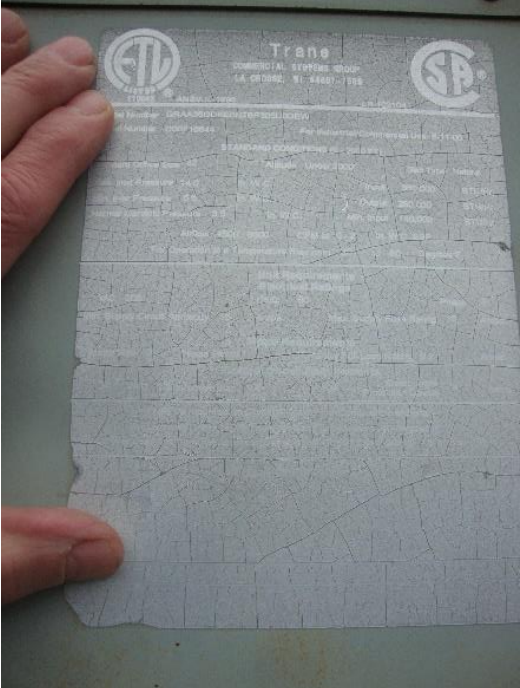
<u>Unit Tag</u>	<u>Gym Office RTU</u>	<u>Addition comments descriptions</u>
Location	Roof	Unit was Off
Serving	Gym Office	
Config/Style	Gas/Dx Package	
Mfr.	Trane	
Model #	YCC018F1LOBJ	
Serial #	4293LUC2H	
Age (years)	7/2004	
System CFM		
Max OA CFM		
V/Hz/Ph	208/230V 60 1-PHASE	
SF Qty/HP	Unknown	
SF VFD Data	N/A	
RF Qty/HP	N/A	
RF VFD Data	N/A	
Filter Data (Size Quantity)	(1) 22"X16" (1) 22"X8"	
Filter Status	Change required (9-15-21)	
Controls Type	Factory	
Controls Mfr.		
Economizer	Yes	
CO ₂ DCV		
Damper Styles	Opposed	
Damper Status	OK, operational unknown	
Heating Type	Gas	
Heating Coil Condition	Burner	
Cooling Type	DX	
Cooling Coil Condition	OK	
CU Mfr.	N/A	
CU Model	N/A	
CU Serial	N/A	
Drain Pan Status	OK	
Notes:	Unit was off, functionality unknown. Compressor was wrapped, noise concerns?

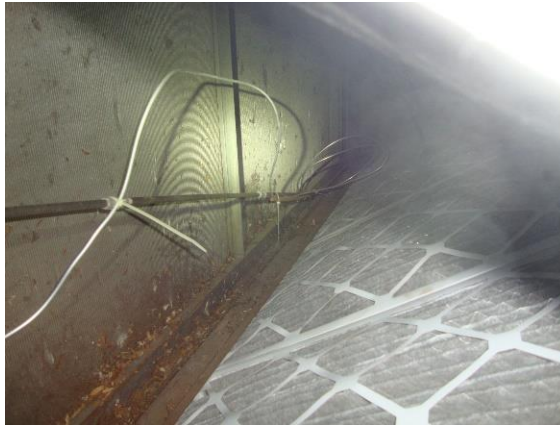
Filters: Photo shows heating coil and leaving airside of filters.
