# McKinley Elementary School

## **Fairfield Public Schools Recommissioning (RCx) and Testing, Adjusting, & Balancing (TAB) Study** van Zelm Project # 2020102.00 (11-McKES) September 15, 2022

### **FAIRFIELD PUBLIC SCHOOLS RECOMMISSIONING (RCx) AND TESTING, ADJUSTING, & BALANCING (TAB) STUDY**

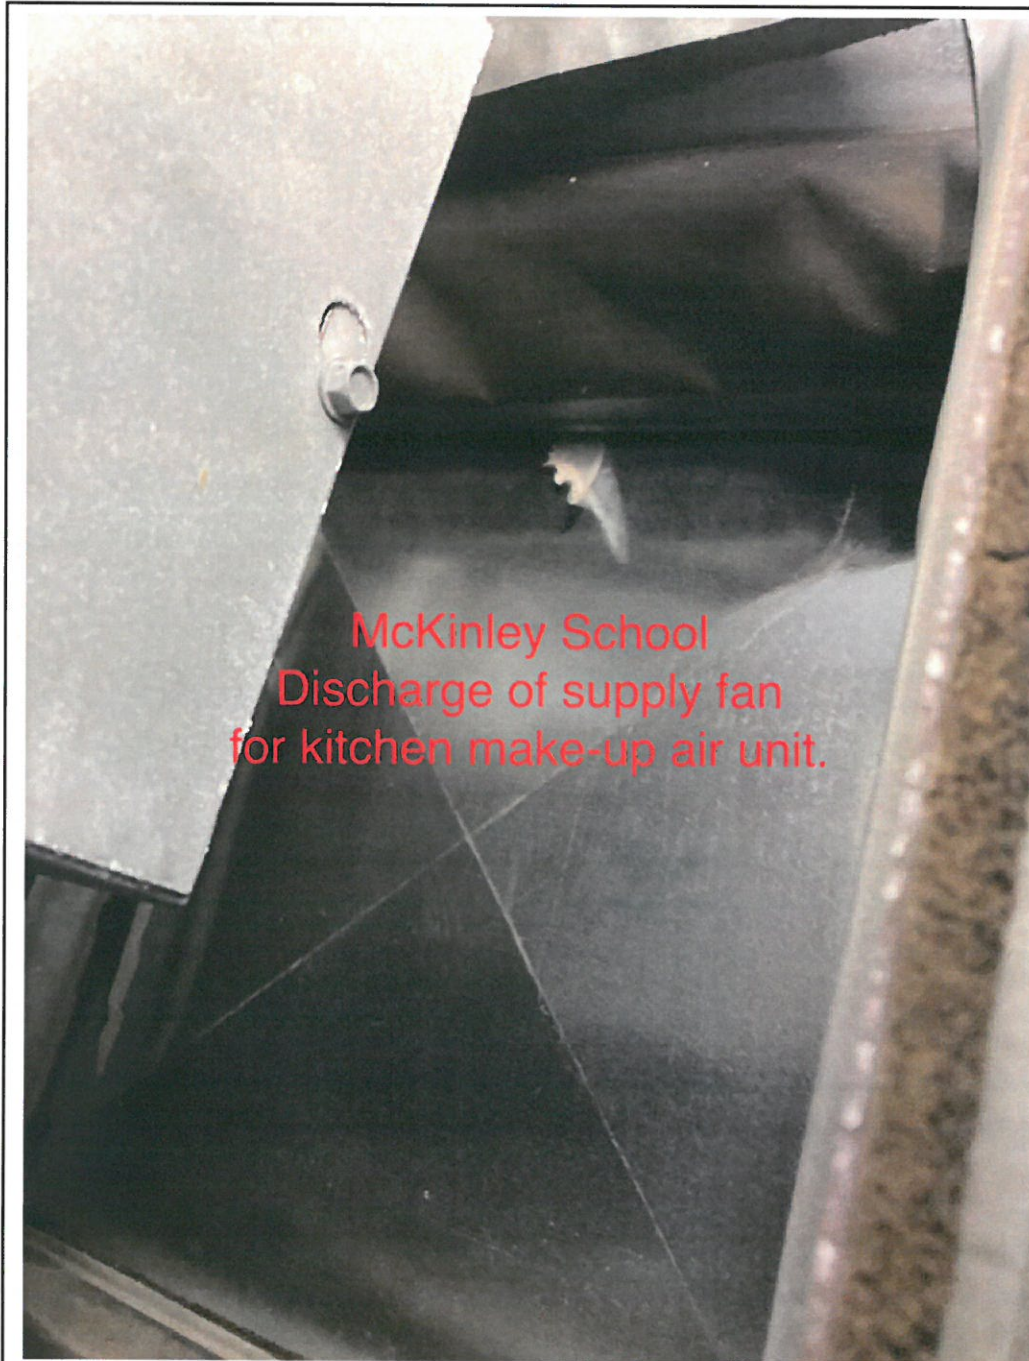
McKinley School  
Discharge of supply fan  
for kitchen make-up air unit.

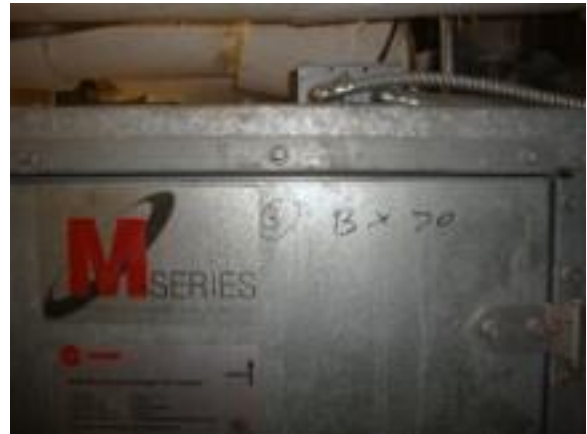
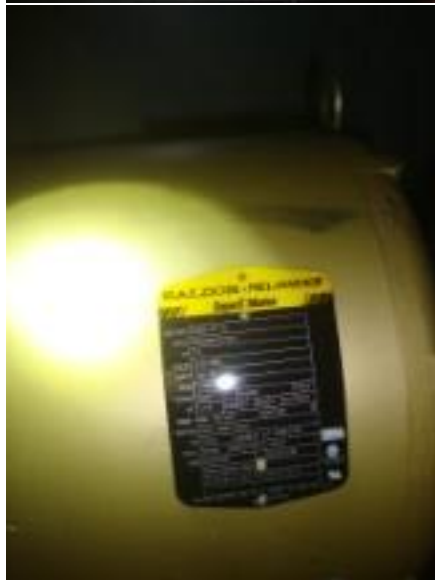
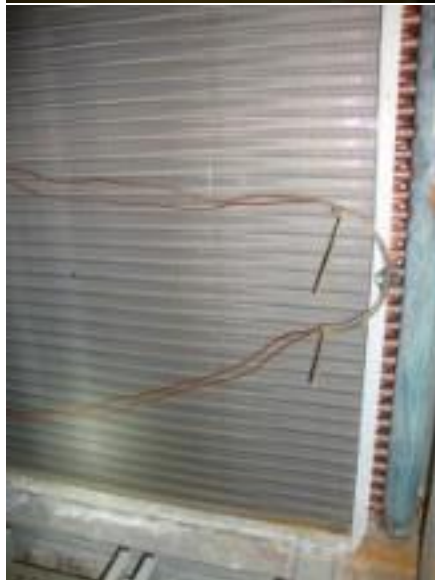
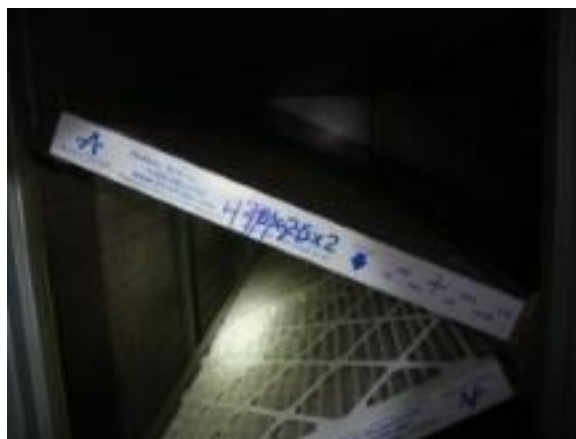
<u>Unit Tag</u>	<u>AHU-2</u>	<u>Addition comments descriptions</u>
Location	MER 205	
Serving	Gym	
Config/Style	Climate Changer	
Mfr.	Trane	
Model #	MCCB025UAOAOUA	
Serial #	KO3A00217	
Age (years)		
System CFM		
Max OA CFM		
V/Hz/Ph	460/60/3	
SF Qty/HP	15 (3) BX70	
SF VFD Data	VFD ABB	
RF Qty/HP	7.5 Inline Greenheck 24-TCF-9 (2) BX-61	
RF VFD Data	VFD ABB	
Filter Data (Size Quantity)	(12) 20x25x2	
Filter Status	OK 4/7/22	
Controls Type	DDC Metasys	
Controls Mfr.		
Economizer	Available	
CO <sub>2</sub> DCV		
Damper Styles	Ductwork mounted, Opposed blade	
Damper Status	OK, clean, adjust and lubricate	
Heating Type	Hot Water	
Heating Coil Condition	Dirty	
Cooling Type	Chilled water	
Cooling Coil Condition	Dirty	
Drain Pan Status	Rusty Galv.	
Notes:	Room full of lint from Gym non ducted return.

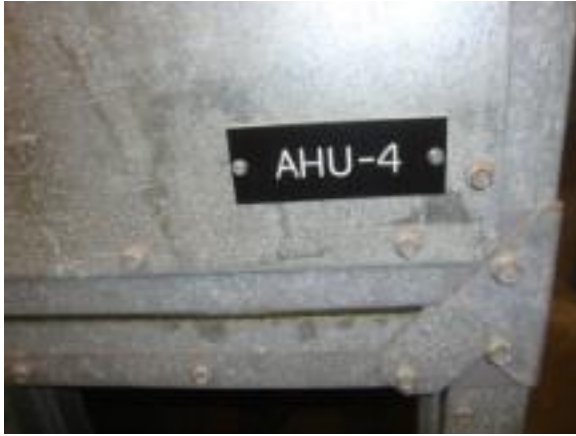
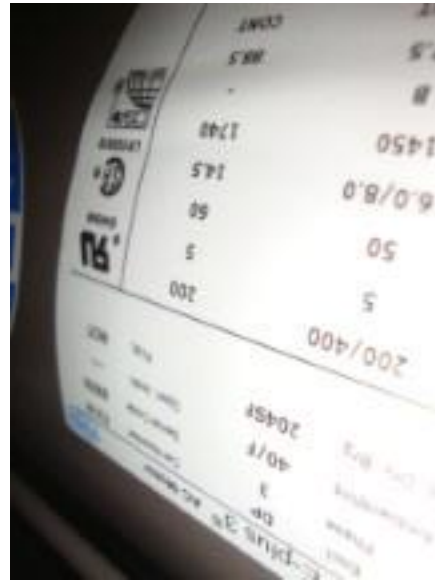
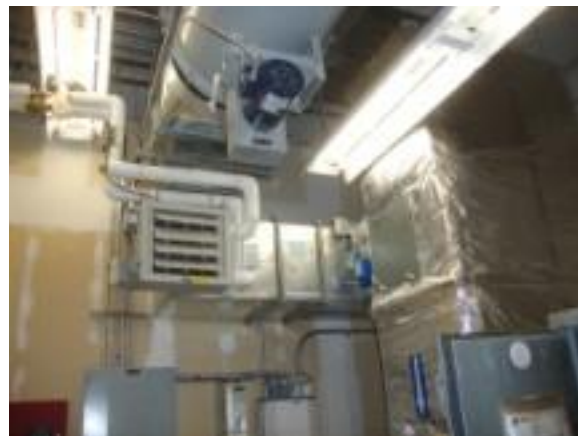
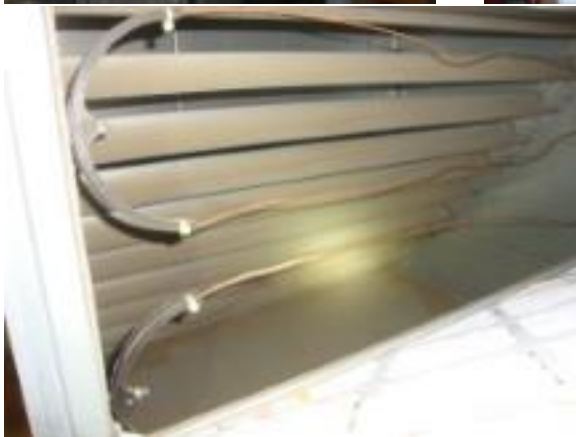
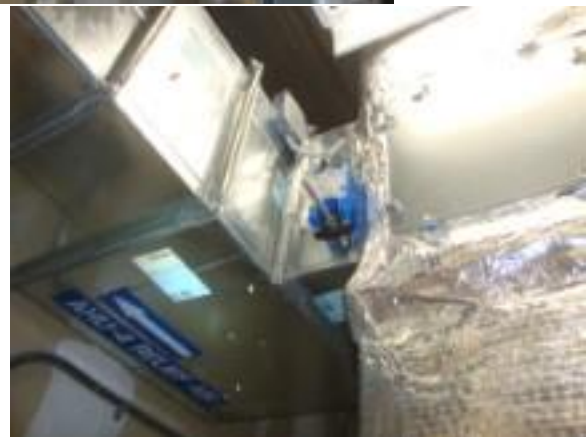
<u>Unit Tag</u>	<u>AHU-4</u>	<u>Addition comments descriptions</u>
Location	MER 113	
Serving	Main Offices	
Config/Style	Climate Changer	
Mfr.	Trane	
Model #	MCCB008UAOAOUB	
Serial #	KO3A00222	
Age (years)		
System CFM		
Max OA CFM		
V/Hz/Ph	460/60/3	
SF Qty/HP	5 (1) AX60	
SF VFD Data	VFD ABB	
RF Qty/HP	3.0 Inline Greenheck TCF-18 (2) A-60	
RF VFD Data	VFD ABB	
Filter Data (Size Quantity)	(4) 20x20x2	
Filter Status	OK 4/7/22	
Controls Type	DDC Metasys	
Controls Mfr.		
Economizer	Available	
CO <sub>2</sub> DCV		
Damper Styles	Ductwork mounted, Opposed blade	
Damper Status	OK, clean, adjust and lubricate	
Heating Type	Hot Water	
Heating Coil Condition	Dirty	
Cooling Type	Chilled water	
Cooling Coil Condition	Dirty	
Drain Pan Status	Rusty Galv.	
Notes:	Damper operations unknown
