Riverfield Elementary School

Fairfield Public Schools Recommissioning (RCx) and Testing, Adjusting, & Balancing (TAB) Study van Zelm Project # 2020102.00 (14-RES) October 07, 2022

FAIRFIELD PUBLIC SCHOOLS RECOMMISSIONING (RCX) AND TESTING, ADJUSTING, & BALANCING (TAB) STUDY

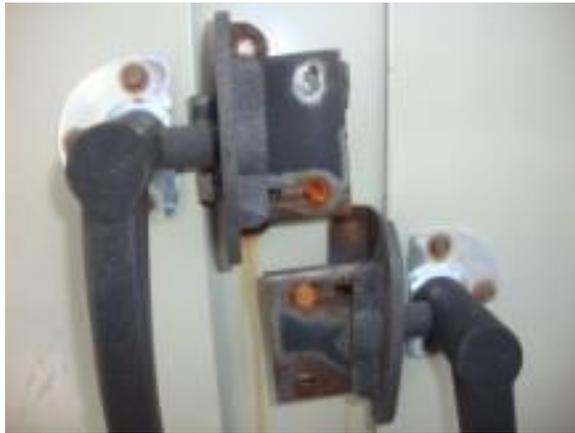
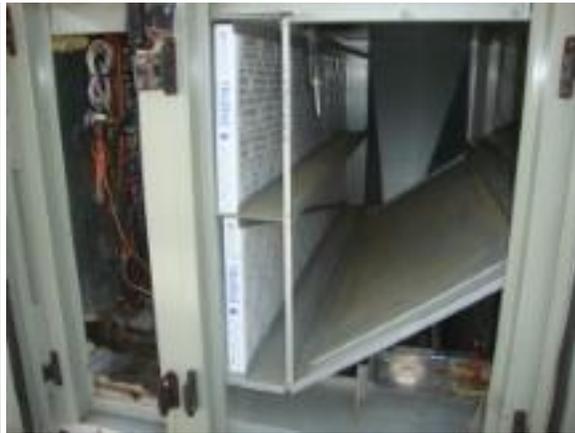
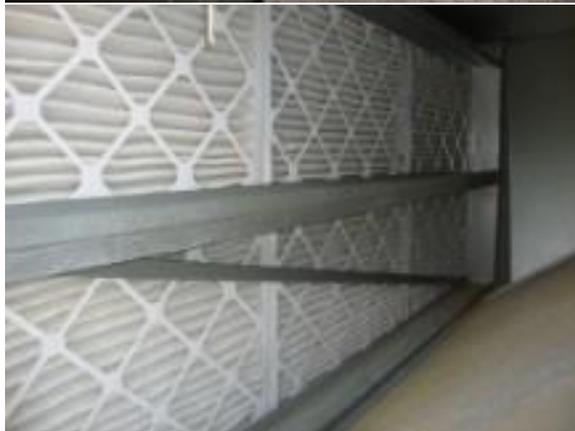
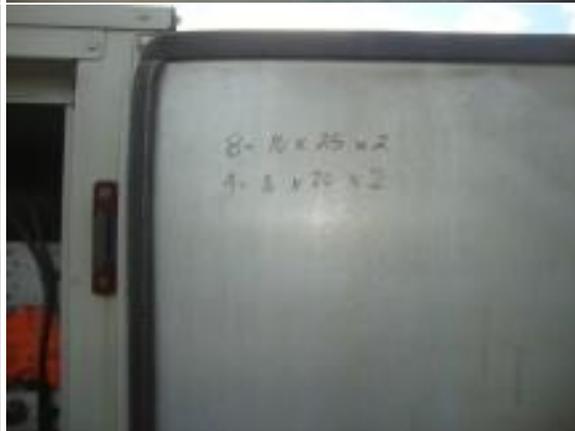
Wheel Mfr.	Semco, Model-VCPERP-0040/238171-2-1, Ser-64872-1	
Drain Pan Status	Clean	
Notes:	Door latches are rusted and need adjustment

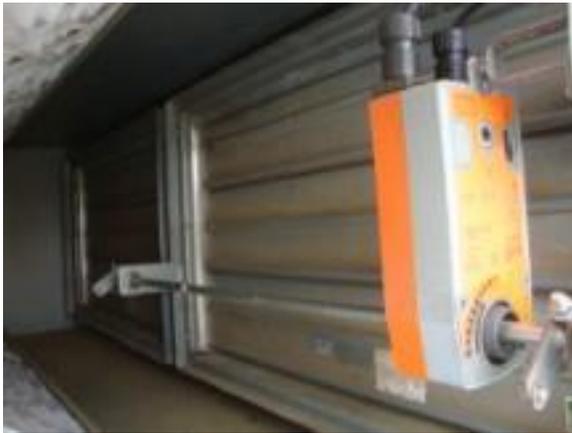
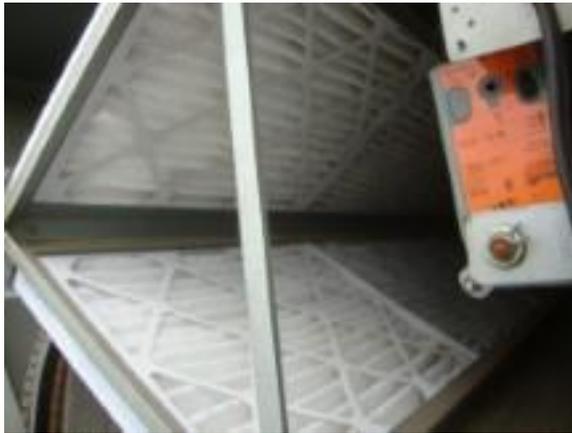
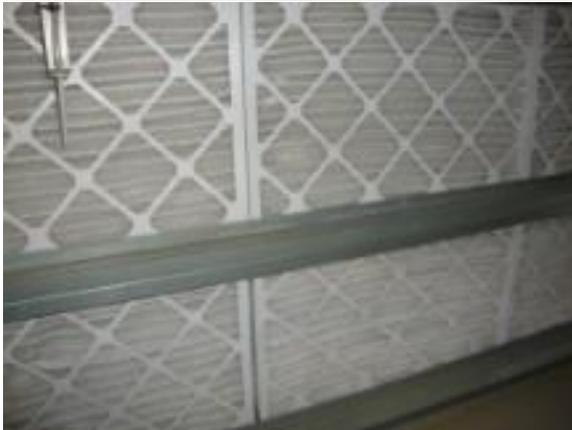
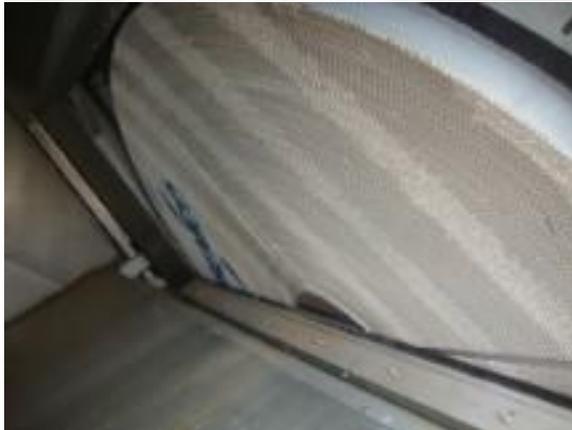
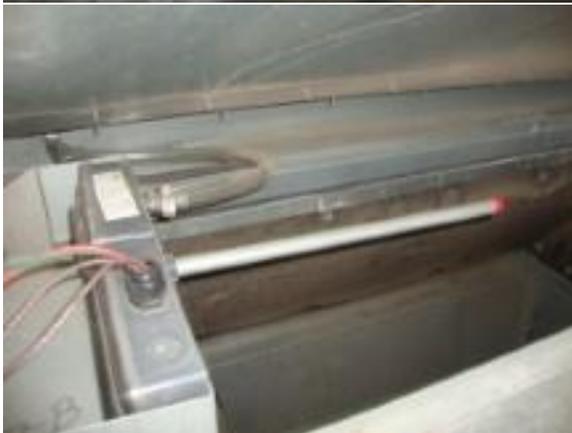
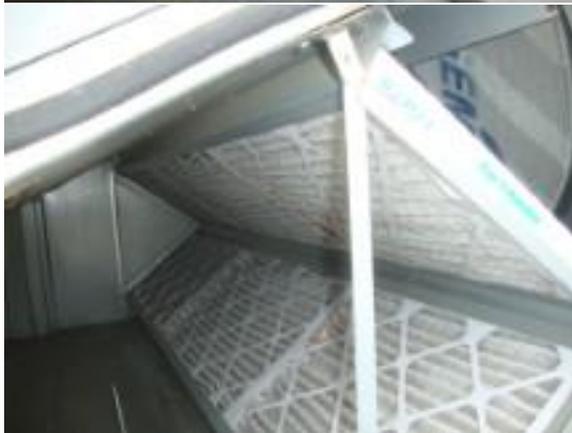
Drain Pan Status	Clean, casing rusted	
Notes:	Door latches are rusted and need adjustment	Not much clearance for PM

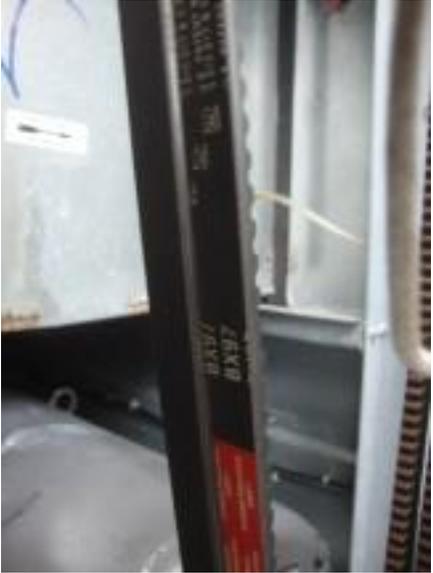
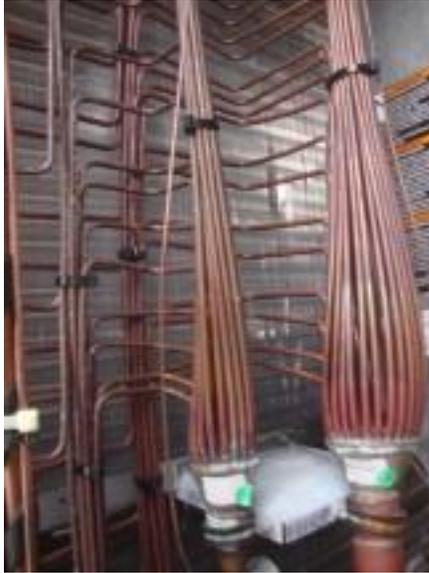
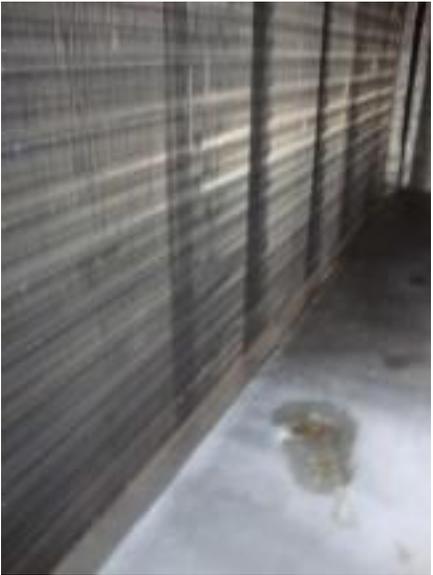
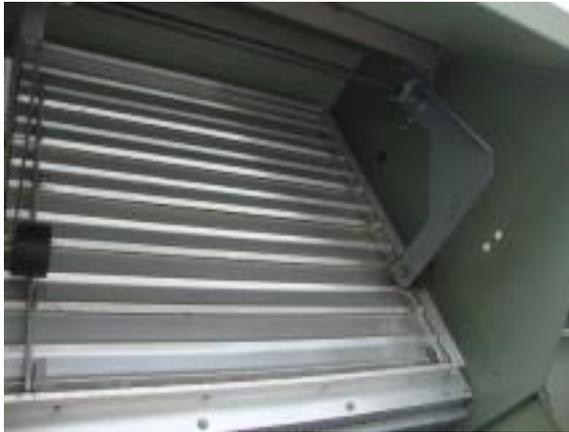
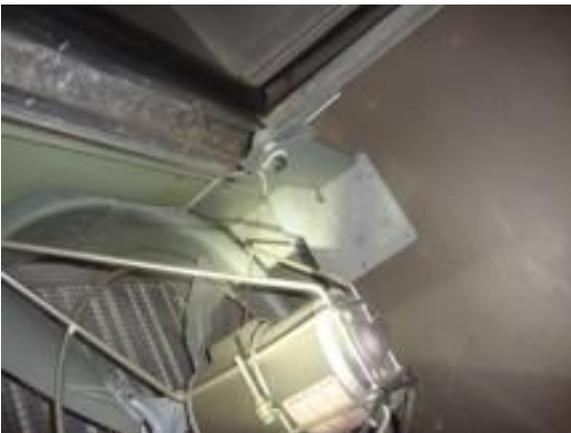
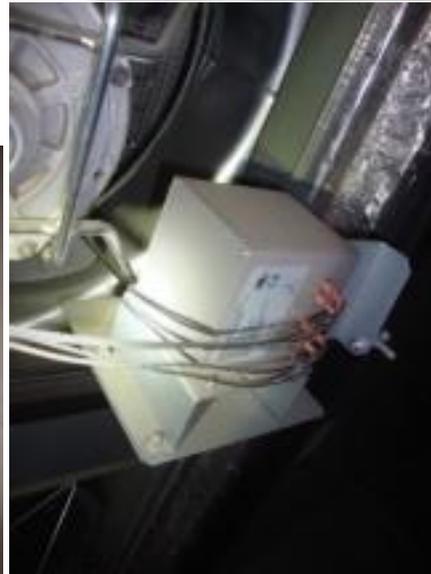
Drain Pan Status	OK	
Notes:	Outdoor air pressure sensor broken

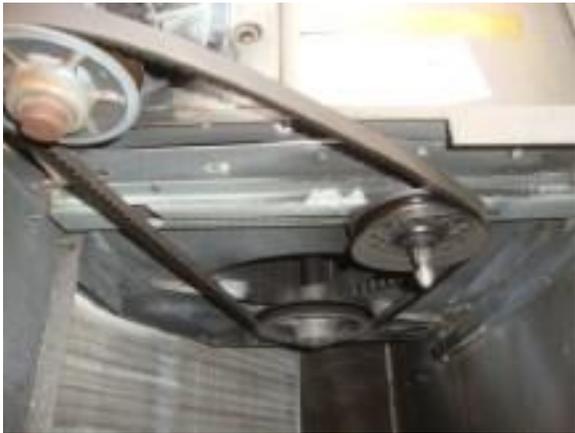
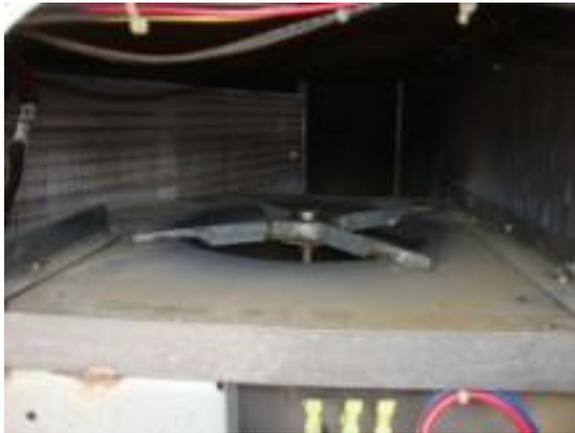
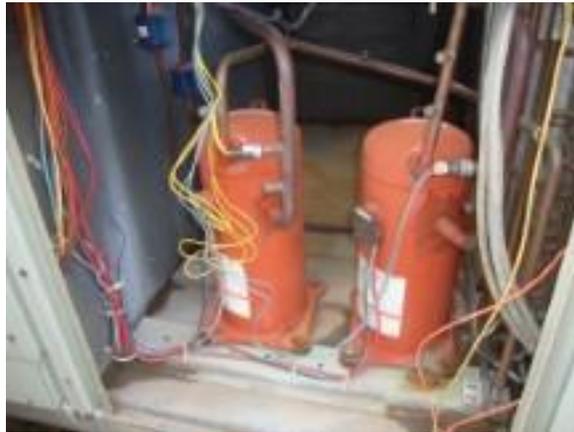
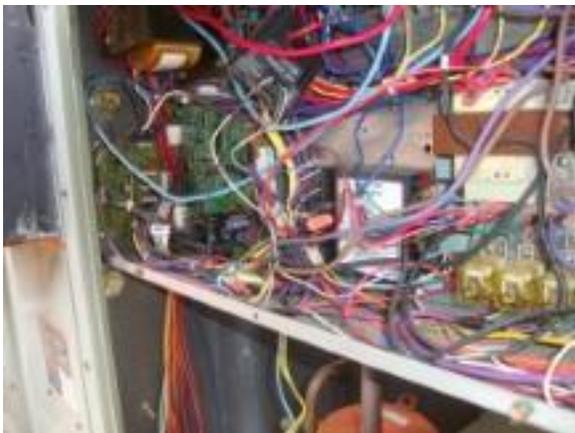
<u>Unit Tag</u>	<u>RTU-2</u>	<u>Addition comments descriptions</u>
Location	Roof	Unit is old and should be considered for replacement
Serving	Media Center	
Config/Style	Gas-fired rooftop unit with DX cooling-Voyager	
Mfr.	Trane	
Model #	YCH150C3H0CA	
Serial #	R331015202	
Age (years)	2000	
System CFM		
Max OA CFM		
V/Hz/Ph	208-230/60/3	
SF Qty/HP	3.0 (1) BX-62	
SF VFD Data	N/A	
RF Qty/HP	N/A	
RF VFD Data	N/A	
Filter Data (Size Quantity)	(4) 20x25x2	
Filter Status	Clean 4-26-22	
Controls Type	Electronic DDC Factory	
Controls Mfr.	Trane-Allerton	
Economizer	Available, not witnessed	
CO ₂ DCV		
Damper Styles	Parallel	
Damper Status	Clean adjust and lubricate,	
Heating Type	Gas	
Heating Coil Condition	Burner	
Cooling Type	DX Twin Compressors	
Cooling Coil Condition	Very Dirty	
Drain Pan Status	Dirty	
Notes:	Old and tired

Open	RTU-2	Belts	The fan belt seemed loose even with the tensioner in place
	Open	RTU-2	Drain Pan	After the coil has been cleaned, the drain pan should also be cleaned
	Open	RTU-2	Replacement	This unit is near the end of its useful life and its replacement should be scheduled soon
	Open	RTU-3	Coils	The cooling coil fins show signs of damage and should be combed straight.
	Open	RTU-3	Dampers	The seals are falling off the blades and need to be replaced

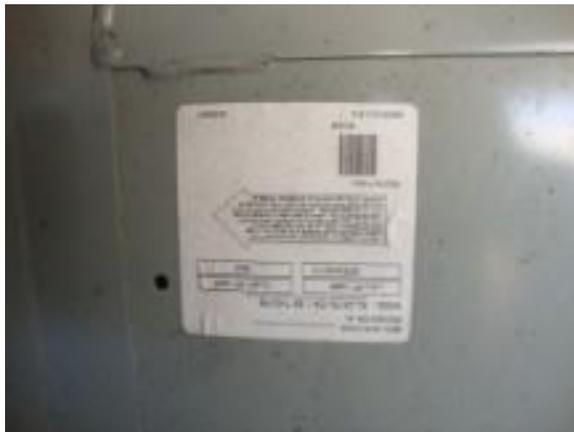
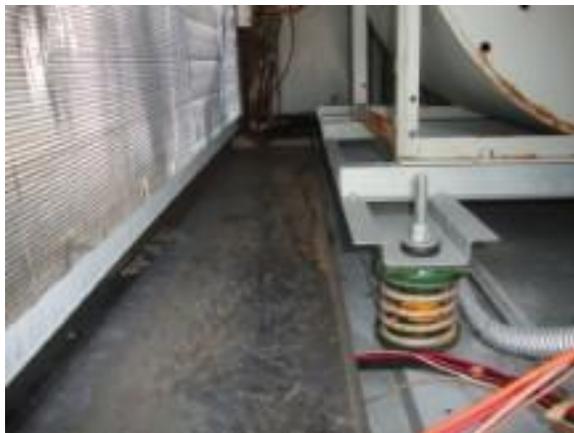
<u>Unit Tag</u>	<u>RTU-3</u>	<u>Addition comments descriptions</u>
Location	Roof	
Serving	Classrooms	
Config/Style	Gas-fired rooftop unit with DX cooling-	
Mfr.	Johnson Controls (JCI)	
Model #	V33AT52C6KDVAK0002A	
Serial #	N1H4043202	
Age (years)	Unknown	
System CFM		
Max OA CFM		
V/Hz/Ph	208-230/60/3	
SF Qty/HP	15 (2) Belts, size unknown	
SF VFD Data	VFD Danfoss	
RF Qty/HP	7.5-5.0	
RF VFD Data	VFD Danfoss	
Filter Data (Size Quantity)	(6) 20x25x2 (4) 16x25x2	
Filter Status	Clean 4-26-22	
Controls Type	Electronic DDC Factory	
Controls Mfr.	JCI	
Economizer	Available, Power Exhaust fans on VFD, Danfoss	
CO ₂ DCV		
Damper Styles	Parallel, seals falling off blades	
Damper Status	Clean adjust and lubricate,	
Heating Type	Gas	
Heating Coil Condition	Twin Burners	
Cooling Type	DX Four Compressors, 4-Expansion valves	
Cooling Coil Condition	Dirty needs cleaning, Condense coils dirty	
Drain Pan Status	S.S. cleans after coils

Action Taken	Status	Unit/Zone	Serving/Room Name	Maintenance Issue (28)
	Open	RTU-3	Drain Pan	After the coil has been cleaned, the drain pan should also be cleaned
	Open	RTUs	Access	Many of the RTU panel door handles are rusty and difficult to operate. This will discourage service and maintenance. If possible, these should be repaired or replaced
