Roger Ludlowe Middle School 689 Unquowa Rd

Fairfield Public Schools Recommissioning (RCx) and Testing, Adjusting, & Balancing (TAB) Study van Zelm Project # 2020102.00 (02-RLMS) June 09, 2022

ROGER LUDLOWE MIDDLE SCHOOL

FAIRFIELD PUBLIC SCHOOLS RECOMMISSIONING (RCX) AND TESTING, ADJUSTING, & BALANCING (TAB) STUDY

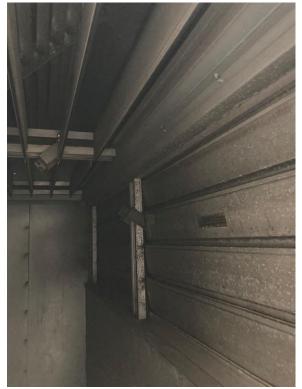
AHU-3 Min. O.A.

- AHU-3, which serves mostly classrooms and as mentioned above, did not have a functioning OA damper. The BAS was commanding the damper to 35% open but it remained closed. It is not clear at this time if that damper position will supply the necessary quantity of outside air. This will need to be assessed later after repairs or adjustments have been made.

Immediate action should be taken regarding the units delivering 0 CFM outside air. The six units that are either not running or have malfunctioning outside air dampers (AHU-3, 4, 6, RTU-3, 15, and 16) should be repaired with the assistance of a control technician and TAB Contractor to confirm proper control operation and positioning of the unit dampers. This alone will bring some quantity of outside air to spaces that currently have none and will necessarily improve building performance as a result . The HVAC systems should holistically be rebalanced to current design requirements after the BAS control system has been upgraded with new end devices where needed.

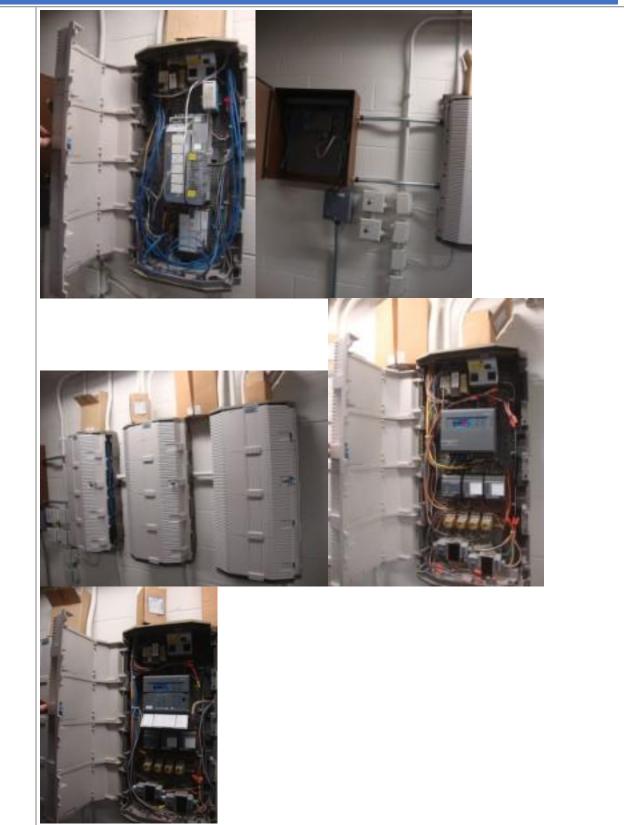
Open	AHU-3	Classrooms 221-237	The pre-filter is dirty and needs to be changed.
	Open	AHU-3	Classrooms 221-237	Dampers need to be cleaned and lubricated
	Open	AHU-3	Classrooms 221-237	It is not clear at this time if the 35% open damper position will supply the necessary quantity of outside air and this will need to be assessed later after repairs or adjustments have been made.
	Open	AHU-4	Classrooms 301-319	The heating and cooling coils are dirty
	Open	AHU-4	Classrooms 301-319	Dampers need to be cleaned and lubricated
	Open	AHU-4	Classrooms 301-319	Was providing only 16.3% of its total capacity as outside air. All associated rooms failed but some were less than 10 CFM from the minimum required and the worst case was off by about 150 CFM. This unit's OA damper could reasonably be opened up at minimum.

Unit Tag	RLMS AHU-3	Addition comments descriptions
Location	MER 220	•
Serving	Classrooms 221-237	
Config/Style		
Mfr.	Ventrol	
Model #		
Serial #		
Age (years)	2003	
System CFM	14520@5.3" 1,315 RPM	
Max OA CFM		
V/Hz/Ph		
SF Qty/HP	(1) 25.0	
SF VFD Data	АВВ	
RF Qty/HP	(1) 10.0 BELTS MIS-MATCHED	Greenheck TCB-2-36-100X
RF VFD Data	АВВ	
Filter Data (Size Quantity)	(6) 24X24-12 (6) 12X24X2	
Filter Status	PRE-FILTER DIRTY	
Controls Type		
Controls Mfr.		
Economizer	YES	
CO ₂ DCV		
Damper Styles	OBD TAMCO	
Damper Status	Ok CLEAN LUBRICATE AND ADJUST	Min OA Damper linkage missing
Heating Type	Glycol hot water	
Heating Coil Condition	dirty	
Cooling Type	Glycol chilled water	
Cooling Coil Condition	ok	
CU Mfr.	N/A	
CU Model	N/A	
CU Serial	N/A	
Drain Pan Status	S.S. SHOULD BE CLEANED	
Notes:		
L	1	1

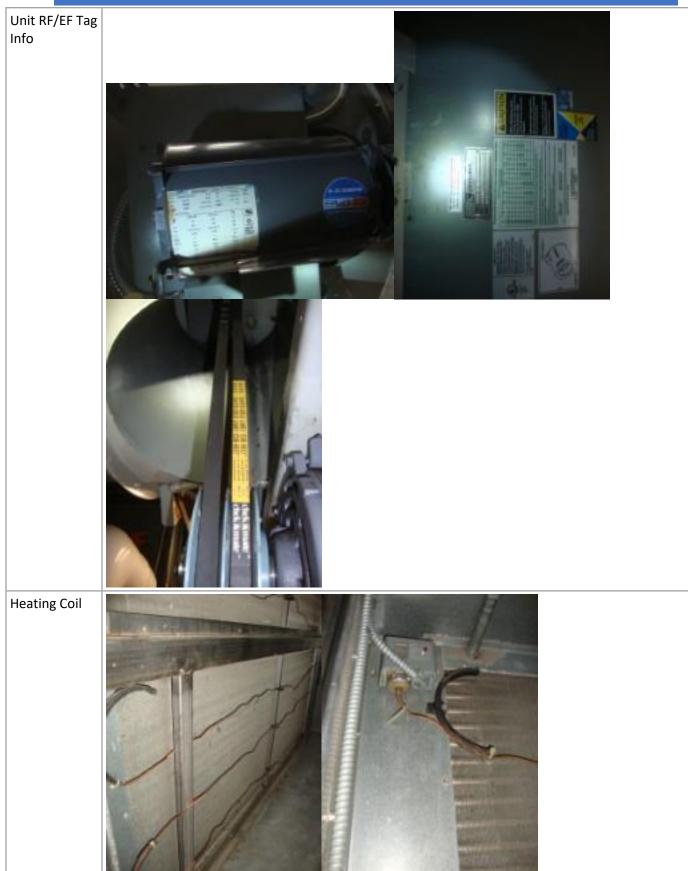
Action Taken	Status	Unit/Zone	Serving/Room Name	Indoor Air Quality And Ventilation Issue (92)
	Open	AHU-4	Classrooms 301-319	A handful of spaces had little-to-no conditioned air supplied, which requires further investigation.
	Open	AHU-5	Admin, Nurse, Team	Pre-filters are dirty and need to be changed
	Open	AHU-5	Admin, Nurse, Team	Dampers need to be cleaned and lubricated
	Open	AHU-5	Admin, Nurse, Team	The mixed air plenum is positively pressurized to MER so RA is exhausting through O.A. intake, reducing or completely limiting the amount of outside air delivered to the space.
	Open	AHU-5	Admin, Nurse, Team	Was providing only 15% of its capacity as OA, and adjusting the minimum OA damper setpoint might improve ventilation here.
	Open	AHU-5	Admin, Nurse, Team	The unit's mixed air plenum is positively pressurized to the mechanical equipment room, so return air was observed exhausting through the outside air intake section.

Unit Tag	RLMS AHU-4	Addition comments descriptions
Location	MER 220	
Serving		
Config/Style		
Mfr.	Ventrol	
Model #		
Serial #		
Age (years)	2003	
System CFM	15070@5.28" 1,329 RPM	(3) BX93
Max OA CFM		
V/Hz/Ph		
SF Qty/HP	25.0	
SF VFD Data	АВВ	
RF Qty/HP	10.0	Greenheck TCB-2-36
RF VFD Data	АВВ	(2) BX105
Filter Data (Size Quantity)		
Filter Status		
Controls Type		
Controls Mfr.		
Economizer	YES	
CO ₂ DCV		
Damper Styles	Tamco OBD	
Damper Status	Clean adjust and lubricate	Dampers need adjustments Min OA damper linkage missing
Heating Type	Glycol hot water	
Heating Coil Condition	dirty	
Cooling Type	Glycol chilled water	
Cooling Coil Condition	dirty	
CU Mfr.	n/a	
CU Model	n/a	
CU Serial	n/a	
Drain Pan Status	S.S.	
Notes:	Flex connection torn on fan section, sup belts mis- matched

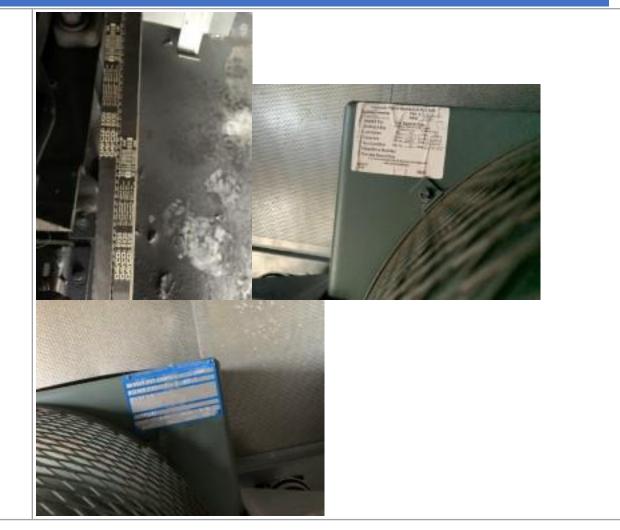
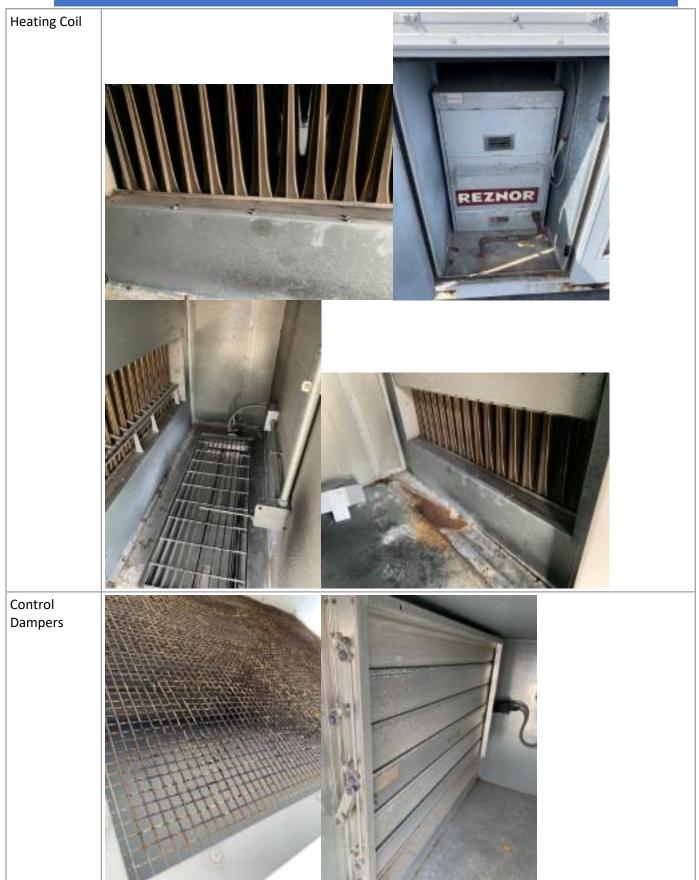
- RTU-3 serves the kitchen as a makeup air unit. The unit was found off and did not run in either hand or auto. The filter media was pristine, indicating it had not run at least since the previous filter change. While kitchens do not directly have outside air requirements for ventilation, they do have exhaust requirements and the kitchen exhaust fans can drive a building negative, at least locally. A non-functioning makeup air unit also provides no thermal load and could adversely affect the users.

Unit Tag	RLMS RTU-3	Addition comments descriptions
Location	A roof, west	
Serving	Kitchen Makeup	
Config/Style	MAU 100% OA with gas heat, heating only	
Mfr.	Ventrol	
Model #	unknown	
Serial #	unknown	
Age (years)	20	
System CFM	4800	
Max OA CFM	4800	
V/Hz/Ph		
SF Qty/HP	1, 7.5hp, 230V/460V, 20A/10A, 1760rpm	Unit appears to have not run for months, at least since the previous filter change in September 2021
SF VFD Data		Fan motor is covered in grease
RF Qty/HP	N/A	No Return/Exhaust in this unit
RF VFD Data	N/A	
Filter Data (Size Quantity)	2" MERV 13, 12" MERV 13	
Filter Status	Filter media is pristine but the casings are covered with either moisture or colorful, dried growth	
Controls Type		Unit was found with exterior HOA switch turned to "OFF"
Controls Mfr.		
Economizer	100% OA only, no recirc	
CO ₂ DCV	No	
Damper Styles	Tamco parallel blade	
Damper Status	Ok	
Heating Type	Gas furnace (Reznor)	
Heating Coil Condition	Ok

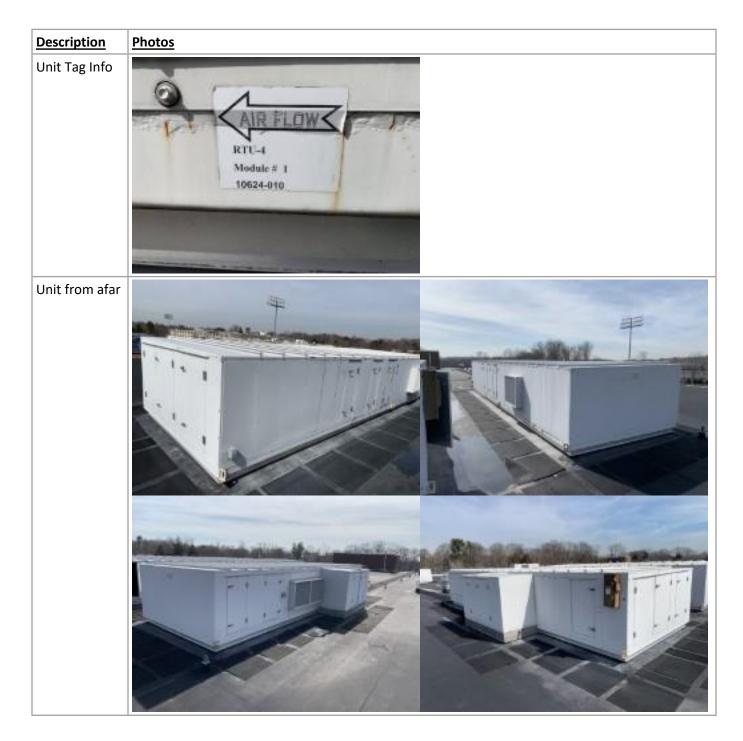
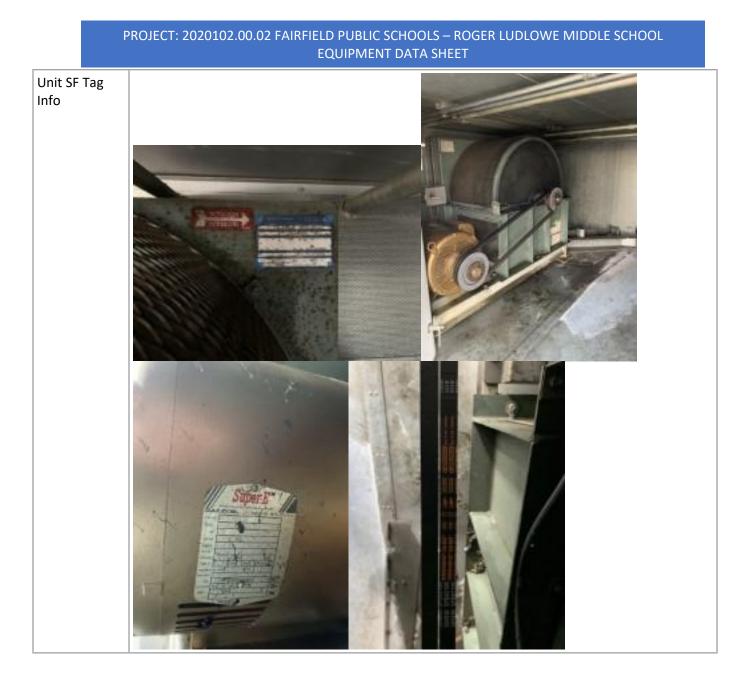
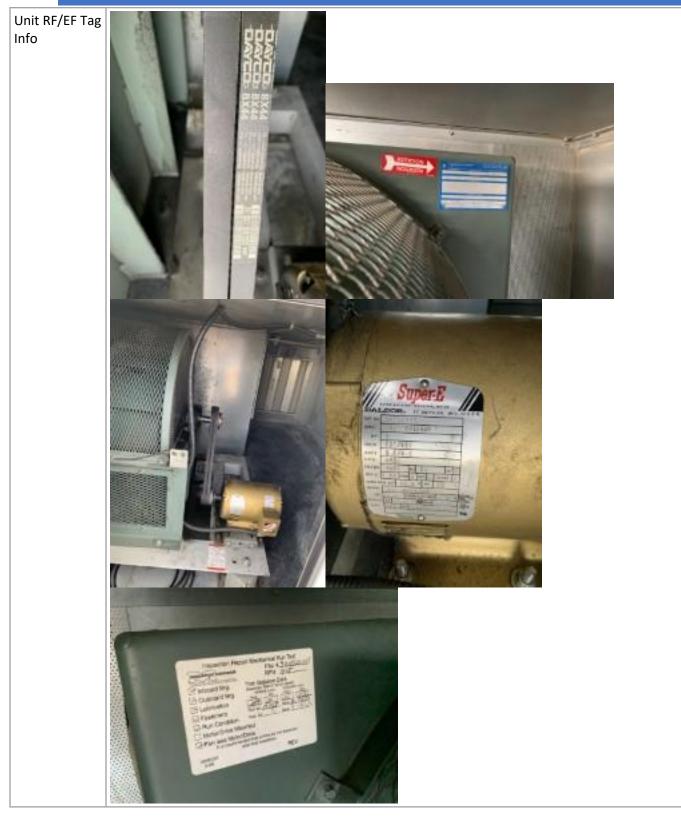
Heating Coil Condition	Ok	
Cooling Type	Dual-temperature Chilled Water	
Cooling Coil Condition	Minor header corrosion	
CU Mfr.	N/A

CU Model	N/A	
CU Serial	N/A	
Drain Pan Status	Significant rust located in the pan between the HW and CHW coils.	This section is not drained (typical)
Notes:

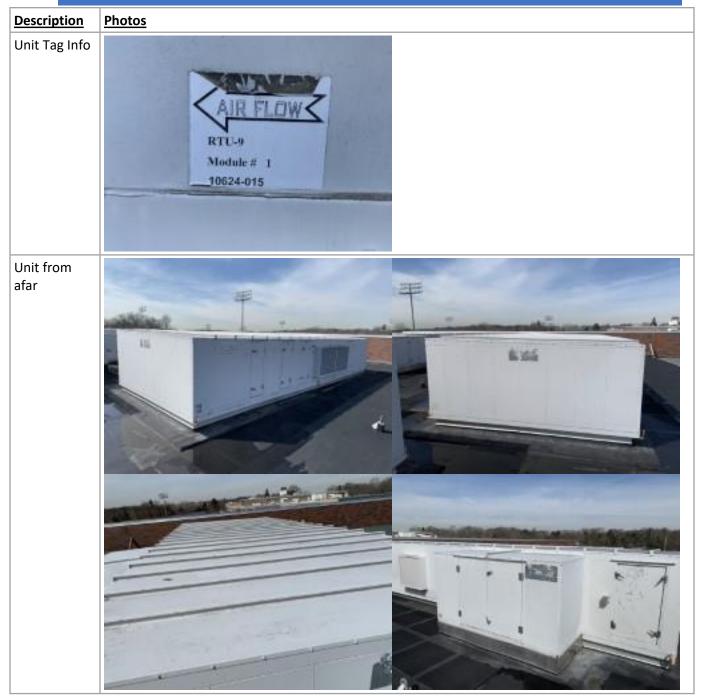
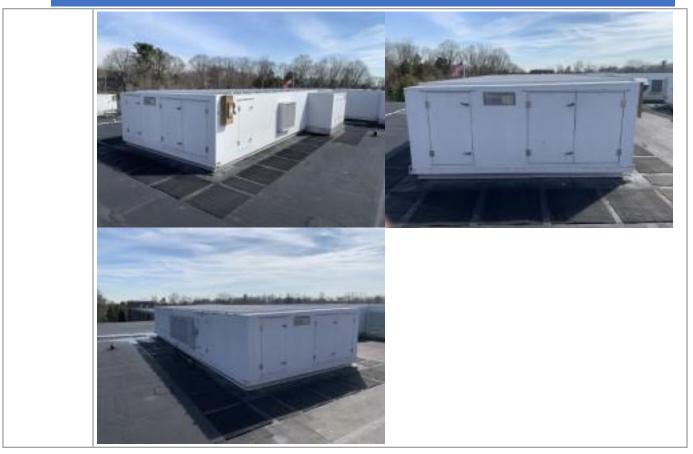
Unit Tag	RLMS RTU-9	Addition comments descriptions
Location	Central Roof	
Serving	Classrooms 248-269, Lobby	
Config/Style	S/R with economizer control and DT H/CHW	
Mfr.	Ventrol	
Model #	unknown	
Serial #	unknown	
Age (years)	20	
System CFM	16000	
Max OA CFM	16000	
V/Hz/Ph		
SF Qty/HP	1, 30hp, 230V/460V, 72A/36A, 1775rpm	Supply fan section door has no hinges
SF VFD Data	ABB M# H550-VH-045A-4, S# 2121403079	
RF Qty/HP	2, 5hp, 230V/460V, 13A/6.5A, 1750rpm	
RF VFD Data	ABB M# ACH401C00932, C# 6431673	480V, 14.8A
Filter Data (Size Quantity)	2" MERV 13, 12" MERV 13	
Filter Status	Pre-filters Dirty, final filters clean	
Controls Type		
Controls Mfr.		
Economizer	Yes	
CO ₂ DCV	Unknown	
Damper Styles	Tamco parallel blade	
Damper Status	Need to be cleaned	
Heating Type	Dual-temperature Hot Water	
Heating Coil Condition	Coil is ok, temperature sensor has poor coverage	
Cooling Type	Dual-temperature Chilled Water	
Cooling Coil Condition	Minor corrosion on the header

CU Mfr.	N/A	
CU Model	N/A	
CU Serial	N/A	
Drain Pan Status	Minor rust in the pan	
Notes:

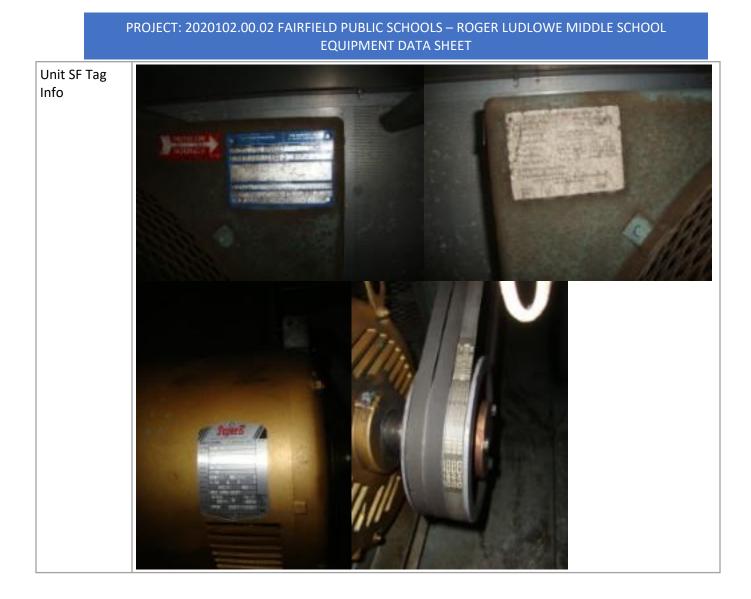
- RTU-11 serves more upper level classrooms and all spaces failed. For whatever reason, the unit OA damper command from the BAS was 0% but the damper was not fully closed, providing 27.5% OA as unit capacity. The VAVs for these spaces vary in how far off the spaces were from meeting requirements, so aside from investigating the OA damper command, the minimum OA needs to be adjusted and rebalancing must occur.

Unit Tag	RLMS RTU-11	Addition comments descriptions
Location	Central Roof	
Serving	Classrooms 339-351	
Config/Style		
Mfr.	Ventrol	
Model #		
Serial #		
Age (years)	2003	
System CFM	12500@6.1: 1,887 RPM	(2) BX81
Max OA CFM		
V/Hz/Ph		
SF Qty/HP	20?	
SF VFD Data	АВВ	
RF Qty/HP	(2) 3.0	(2) BX84 ea.
RF VFD Data	АВВ	
Filter Data (Size Quantity)		
Filter Status	Prefilter very bad	9-27-21
Controls Type		
Controls Mfr.		
Economizer	Yes	
CO ₂ DCV		
Damper Styles	Tamco OBD	
Damper Status	Clean Adjust and lubricate	
Heating Type	Glycol Hot water	
Heating Coil Condition	Dirty	
Cooling Type	Glycol Chilled water	
Cooling Coil Condition	ОК	
CU Mfr.	n/a	
CU Model	n/a	
CU Serial	n/a	
Drain Pan Status	S.S	
Notes:	Belt guards removed, Freeze stats set @38	Heavy grease on pillow blocks
CU Model CU Serial Drain Pan Status	n/a n/a S.S	Heavy grease on pillow blocks

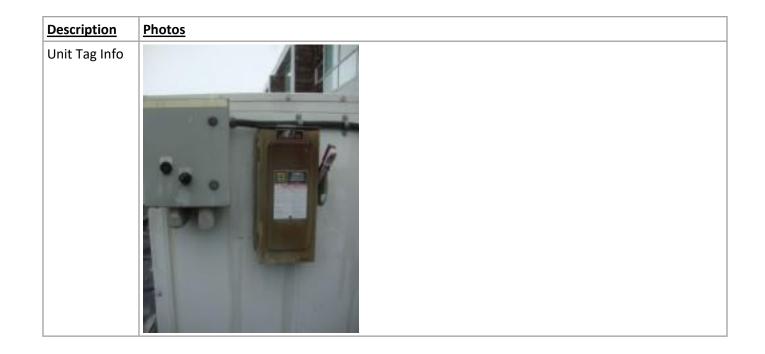
Unit Tag	RLMS RTU-13	Addition comments descriptions
Location	Gym Roof	
Serving	Fitness Center	
Config/Style	Custom	
Mfr.	Ventrol	
Model #		
Serial #		
Age (years)		
System CFM	2650	
Max OA CFM		
V/Hz/Ph	460/60/3	
SF Qty/HP	7-1/2 (2) BX-35 belts loose, guards removed	
SF VFD Data	N/A	
RF Qty/HP	1-1/2 (2) BX-32 belts mis-matched, guards removed	
RF VFD Data	N/A	
Filter Data (Size Quantity)	 (1) 12x24x2 (1) 24x24x12 (1) 12x24x2 (1) 24x24x12 	
Filter Status	Dirty 9/27/21	
Controls Type	Factory DDC	
Controls Mfr.	Metasys (ALC)	
Economizer	Available	
CO ₂ DCV	unknown	
Damper Styles	Parallel Tamco	
Damper Status	Clean, Lubricate and adjust	Damper positions unknown
Heating Type	Hot Water	
Heating Coil Condition	Dirty	
Cooling Type	Chilled Water	
Cooling Coil Condition	Dirty	
Air flow probes	Grease covered, requires cleaning and calibration.	
Drain Pan Status	Stainless Steel, clean after coils are completed	
Notes:	Prime rusted areas on unit exterior. Exposed insulation on exterior ductwork has failed, repair.

Unit Tag	RLMS RTU-14	Addition comments descriptions
Location	Gym Roof	
Serving	Project Room	
Config/Style	CV Dual Temp Htg, Clg.	
Mfr.	Ventrol	
Model #	No Tag	
Serial #		
Age (years)	19 (2003)	
Supply CFM	2650@5,3 4,412 RPM	(2) BX35. Belt Guard removed
Max OA CFM		
V/Hz/Ph	230-460 3-Phase	
SF Qty/HP	7.5	
SF VFD Data	None	
RF Qty/HP	1 1/2 HP	(2) BX32 Belts. Belt Guard removed 2650 CFM
RF VFD Data	None	
Filter Data (Size Quantity)	1-24x24x2, 1-24x24x2, 1-24x12x12, 1-24x24x12 Box	Merv 13
Filter Status	Dirty Pre needs cleaning	Last changed 9-27-21
Controls Type		
Controls Mfr.		
Economizer	Yes	
CO ₂ DCV		
Damper Styles	Tamco OBD	
Damper Status	Clean adjust and lubricate	
Heating Type	Duel Temp HW	
Heating Coil Condition	Should be cleaned	
Cooling Type	Dual Temp Chilled Water	
Cooling Coil Condition	Should be cleaned	
CU Mfr.	n/a	
CU Model	n/a	
CU Serial	n/a	
Drain Pan Status	Loose scale/dirt	
Notes:	Belt guards off side return and discharge Motor Bearings over-greased, RF fan wheel could be cleaned	Overall in good condition with a need for enhanced Maintenance

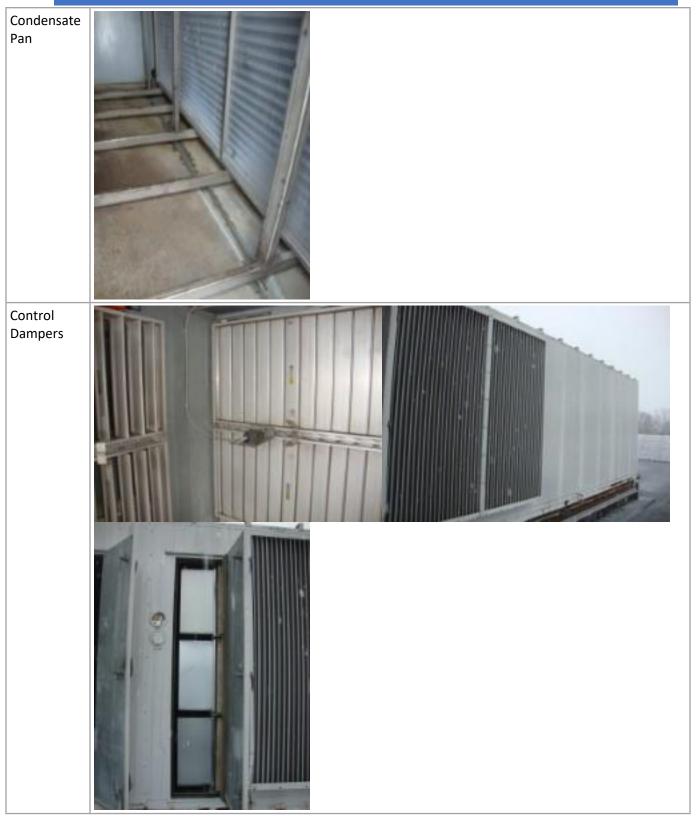
- RTU-15 and 16 serve the locker rooms and main gym, respectively. Despite receiving OA damper position commands from the BAS, neither of these units' OA dampers moved in a way that allowed for outside air to be introduced to these spaces, rather what little could be opened was resulting in air exhausting through outside air intake sections. The units did exhaust air normally as well, which caused these areas to produce a strong negative pressure area. This caused doors in the gym corridor and in the core stairwell to be pulled open. This effect was observed on every level of the stairwell. RTU-15 does not have a strict OA flow requirement but RTU-16 does, and a majority of this pressure issue is caused by that unit. The dampers on both units should be repaired immediately and adjusted to meet space OA and pressure demand.

Unit Tag	RLMS RTU-16	Addition comments descriptions
Location	Gym Roof	
Serving	Gym	
Config/Style	VAV	
Mfr.	Ventrol	
Model #		
Serial #		
Age (years)		
System CFM	24,000	
Max OA CFM		
V/Hz/Ph	460/60/3	
SF Qty/HP	50.0	
SF VFD Data	N/A	
RF Qty/HP	15.0	New, 10/27/14
RF VFD Data	N/A	
Filter Data (Size Quantity)	(12) 24x24x2 (12) 24x24x12	
Filter Status	Dirty	
Controls Type	Factory DDC	
Controls Mfr.	Metasys, ALC	
Economizer	Yes	
CO ₂ DCV		
Damper Styles	Tamco OBD	
Damper Status	Clean, Lubricate and Adjust	Min OA damper linkage missing
Heating Type	Glycol Hot water	
Heating Coil Condition	Dirty	
Cooling Type	Glycol Chilled water	
Cooling Coil Condition	Dirty	
CU Mfr.	n/a	
CU Model	n/a	
CU Serial	n/a	
Drain Pan Status	OK, S.S. clean pan after coil is washed	
Notes:		
L
