Roger Sherman Elementary School

Fairfield Public Schools Recommissioning (RCx) and Testing, Adjusting, & Balancing (TAB) Study van Zelm Project # 2020102.00 (07-RSES) October 07, 2022

FAIRFIELD PUBLIC SCHOOLS RECOMMISSIONING (RCx) AND TESTING, ADJUSTING, & BALANCING (TAB) STUDY

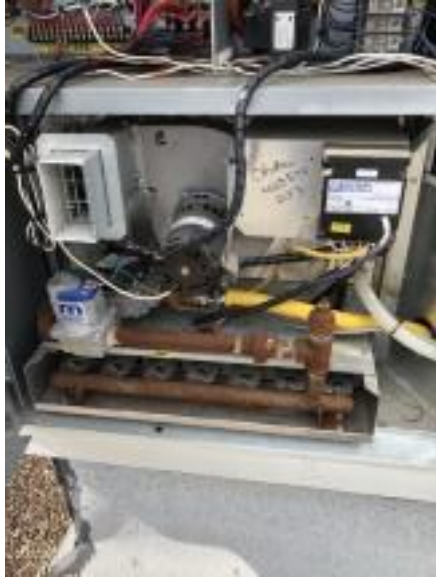
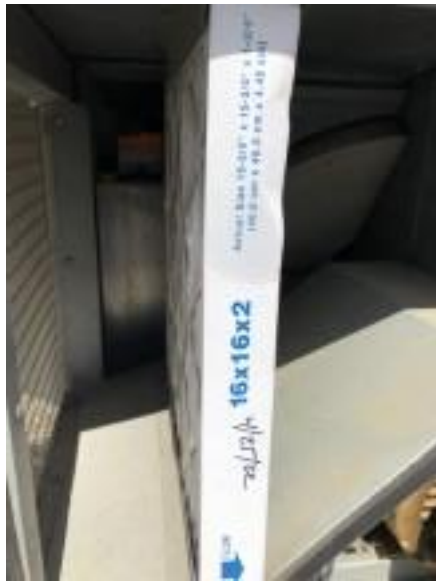
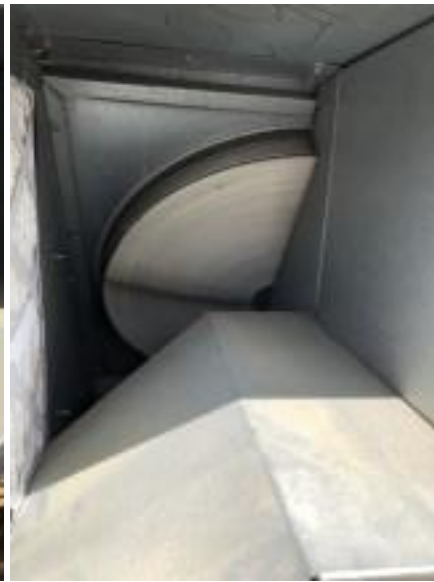
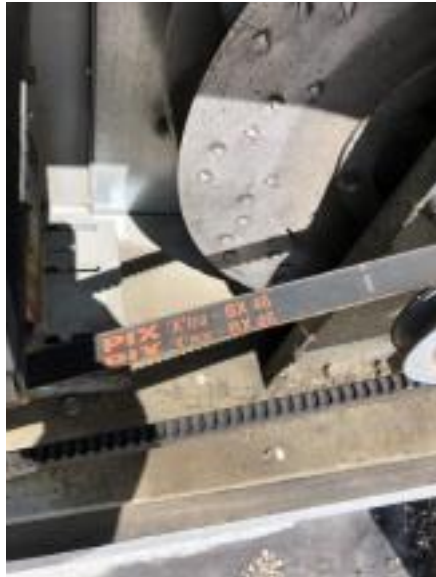
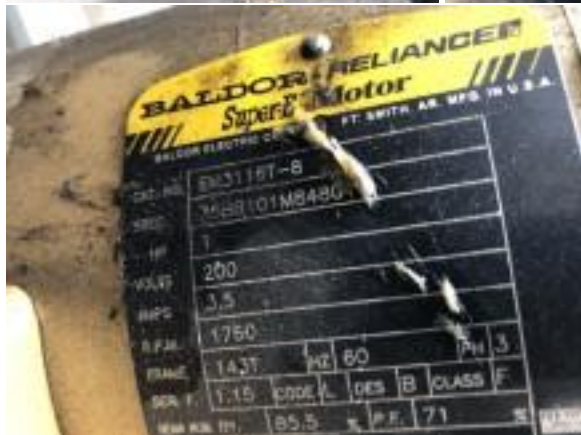
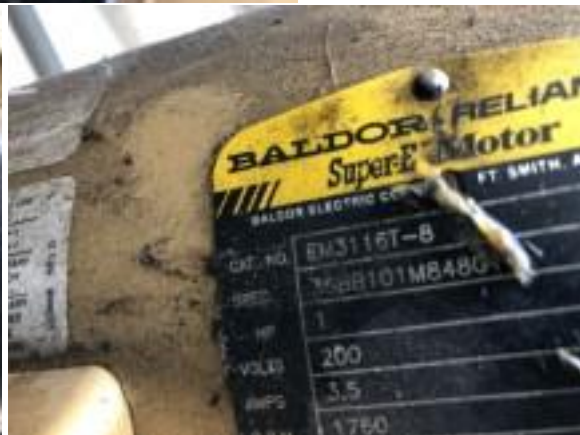
<u>Unit Tag</u>	<u>DOAS-5</u>	<u>Addition comments descriptions</u>
Location	Main Roof Front Left	
Serving	Classroom 7-8	
Config/Style	Packaged Heating DOAS with ERW	
Mfr.	AAON	
Model #	RQ-004-8-V-0000-359	
Serial #	201205-AYGJD03324	
Age (years)	2012	
System CFM		
Max OA CFM		
V/Hz/Ph	208 / 60 /3	
SF Qty/HP	2 HP Direct Drive	
SF VFD Data	YASKAWA J1000 Series	
RF Qty/HP	1 with BX 46 Belt	Fan section and motor very dirty
RF VFD Data		
Filter Data (Size Quantity)	(1) 16 X 16 X 2 Pre, (2) 20 X 20 X 4	
Filter Status	Clean 4-25-22 changed	
Controls Type	JCI FX Explorer	
Controls Mfr.	JCI	
Economizer	Packaged with Power Exhaust	
CO ₂ DCV	NA	
Damper Styles	Opposed	ODA almost cracked open
Damper Status	Need Cleaning and Lubrication	
Heating Type	Natural Gas	113.4 MBH
Heating Coil Condition	Burners Clean but header showing age	
Cooling Type	DX 1 Compressors	
Cooling Coil Condition		
Drain Pan Status	Should be cleaned	
Notes:	Power Exhaust off with ERW off and bypass open, ODA closed. Low to no outside air being introduced

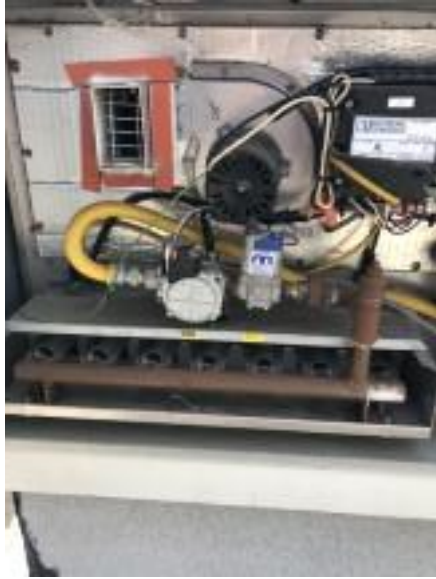
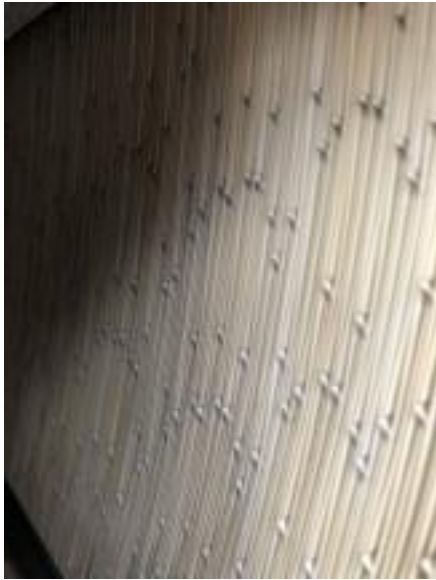
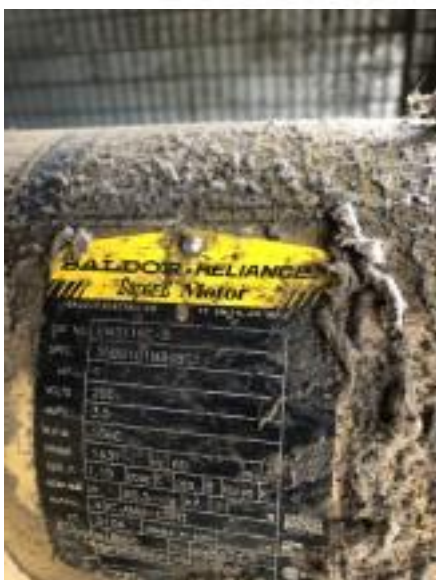
<u>Unit Tag</u>	<u>DOAS-6</u>	<u>Addition comments descriptions</u>
Location	Main Roof Back Left	
Serving	Classrooms 10-11	
Config/Style	Packaged Heating DOAS with ERW	
Mfr.	AAON	
Model #	RN-010 -8-0-0000-3L9	
Serial #	201205-ANGJ22560	
Age (years)	2012	
System CFM		
Max OA CFM		
V/Hz/Ph	208 / 60 /3	
SF Qty/HP	2 hp Direct Drive	Behind Door with Duct Smoke on Panel. Did not open for concern of DSD trip
SF VFD Data	YASKAWA J1000 Series	
RF Qty/HP	1HP Very dirty motor/fan	A-48 Belt
RF VFD Data		
Filter Data (Size Quantity)	(1) 16 X 25 X 4 Pre, (4) 20 X 16 X 4	
Filter Status	Clean 4-26-22 changed	
Controls Type	JCI FX Explorer	
Controls Mfr.	JCI	
Economizer	Packaged with Power Exhaust	
CO ₂ DCV	NA	
Damper Styles	Opposed	ODA Closed
Damper Status	Need Cleaning and Lubrication	
Heating Type	Natural Gas	168 MBH
Heating Coil Condition	Burners Clean but header showing age	Piping Rusty
Cooling Type	DX 1 Compressors	
Cooling Coil Condition

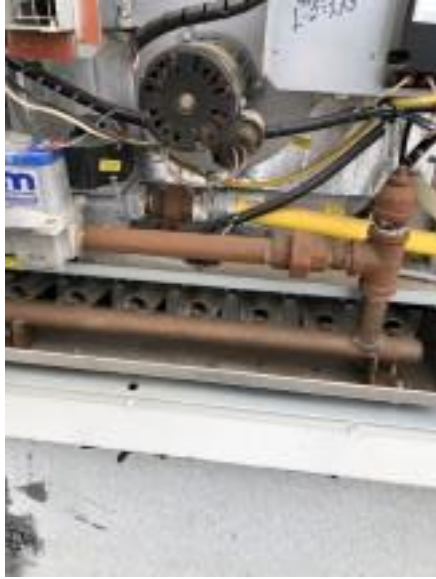
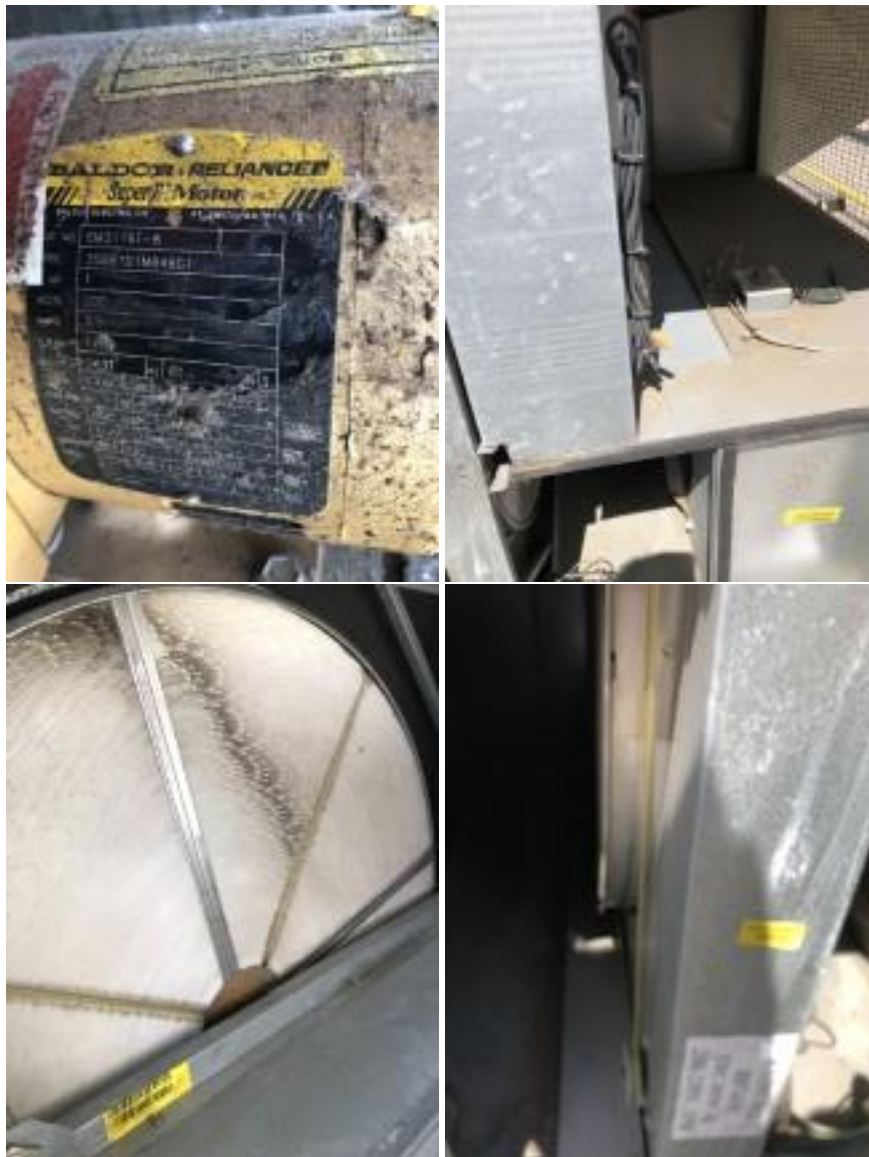
<u>Unit Tag</u>	<u>DOAS-7</u>	<u>Addition comments descriptions</u>
Location	Main Roof Back Center	
Serving	Classrooms 12	
Config/Style	Packaged Heating DOAS with ERW	
Mfr.	AAON	
Model #	RN-010 -8-0-0000-3L9	
Serial #	201205-ANGJ22567	
Age (years)	2012	
System CFM		
Max OA CFM		
V/Hz/Ph	208 / 60 /3	
SF Qty/HP	2 hp Direct Drive	Behind Door with Duct Smoke on Panel. Did not open for concern of DSD trip
SF VFD Data	YASKAWA J1000 Series	
RF Qty/HP	1 Hp	A-48 Belt
RF VFD Data		
Filter Data (Size Quantity)	(1) 16 X 25 X 4 Pre, (4) 20 X 16 X 4	
Filter Status	Clean 4-26-22 changed	
Controls Type	JCI FX Explorer	
Controls Mfr.	JCI	
Economizer	Packaged with Power Exhaust	
CO ₂ DCV	NA	
Damper Styles	Opposed	ODA Closed
Damper Status	Need Cleaning and Lubrication	
Heating Type	Natural Gas	168 MBH
Heating Coil Condition	Burners Clean but header showing age	Piping Rusty
Cooling Type	DX 1 Compressors	
Cooling Coil Condition		
Drain Pan Status	Should be cleaned

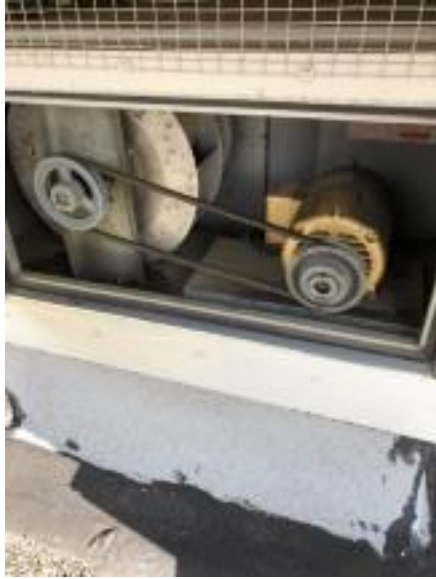
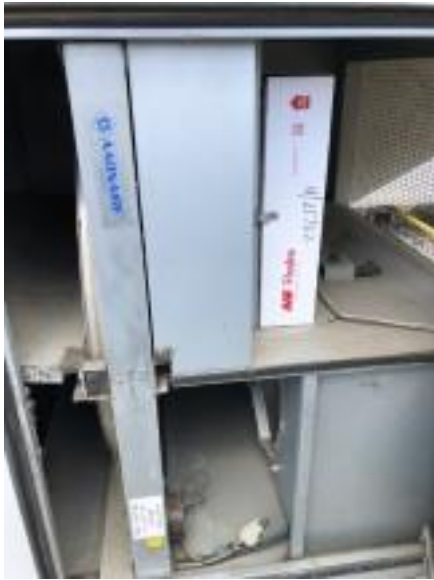
<u>Unit Tag</u>	<u>DOAS-8</u>	<u>Addition comments descriptions</u>
Location	Main Roof Back Left	
Serving	Classrooms 13-14	
Config/Style	Packaged Heating DOAS with ERW	
Mfr.	AAON	
Model #	RN-010 -8-0-0000-3L9	
Serial #	201205-ANGJ22559	
Age (years)	2012	
System CFM		
Max OA CFM		
V/Hz/Ph	208 / 60 /3	
SF Qty/HP	2 hp Direct Drive	Behind Door with Duct Smoke on Panel. Did not open for concern of DSD trip
SF VFD Data	YASKAWA J1000 Series	
RF Qty/HP	1 Hp	A-48 Belt
RF VFD Data		
Filter Data (Size Quantity)	(1) 16 X 25 X 4 Pre, (4) 20 X 16 X 4	
Filter Status	Clean 4-26-22 changed	
Controls Type	JCI FX Explorer	
Controls Mfr.	JCI	
Economizer	Packaged with Power Exhaust	
CO ₂ DCV	NA	
Damper Styles	Opposed	ODA Closed
Damper Status	Need Cleaning and Lubrication	
Heating Type	Natural Gas	168 MBH
Heating Coil Condition	Burners Clean but header showing age	
Cooling Type	DX 1 Compressors	
Cooling Coil Condition		
Drain Pan Status	Should be cleaned

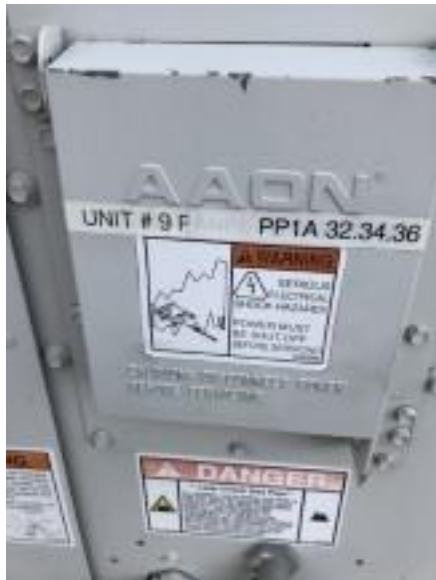
<u>Unit Tag</u>	<u>DOAS-9</u>	<u>Addition comments descriptions</u>
Location	Main Roof Back Right	
Serving	Classrooms 17-18	
Config/Style	Packaged Heating DOAS with ERW	
Mfr.	AAON	
Model #	RN-010 -8-0-0000-3L9	
Serial #	201205-ANGJ22566	
Age (years)	2012	
System CFM		
Max OA CFM		
V/Hz/Ph	208 / 60 /3	
SF Qty/HP	2 hp Direct Drive	Behind Door with Duct Smoke on Panel. Did not open for concern of DSD trip
SF VFD Data	YASKAWA J1000 Series	
RF Qty/HP	1 Hp	A-48 Belt
RF VFD Data		
Filter Data (Size Quantity)	(1) 16 X 25 X 4 Pre, (4) 20 X 16 X 4	
Filter Status	Clean 4-26-22 changed	
Controls Type	JCI FX Explorer	
Controls Mfr.	JCI	
Economizer	Packaged with Power Exhaust	
CO ₂ DCV	NA	
Damper Styles	Opposed	ODA Closed
Damper Status	Need Cleaning and Lubrication	
Heating Type	Natural Gas	168 MBH
Heating Coil Condition	Burners Clean but header showing age	
Cooling Type	DX 1 Compressors	
Cooling Coil Condition		
Drain Pan Status	Should be cleaned

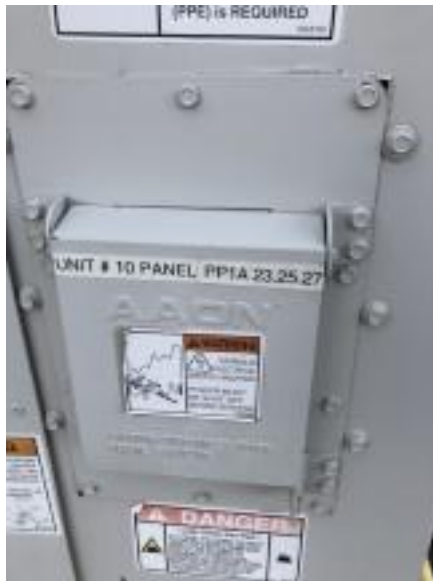
<u>Unit Tag</u>	<u>DOAS-10</u>	<u>Addition comments descriptions</u>
Location	Main Roof Back Right	
Serving	Kitchen Serveries	
Config/Style	Packaged Heating DOAS with ERW	
Mfr.	AAON	
Model #	RN-010 -8-0-0000-3L9	
Serial #	201205-ANGJ22562	
Age (years)	2012	
System CFM		
Max OA CFM		
V/Hz/Ph	208 / 60 /3	
SF Qty/HP	2 hp Direct Drive	Behind Door with Duct Smoke on Panel. Did not open for concern of DSD trip
SF VFD Data	YASKAAWA J1000 Series	
RF Qty/HP	1 Hp	A-48 Belt
RF VFD Data		
Filter Data (Size Quantity)	(1) 16 X 25 X 4 Pre, (4) 20 X 16 X 4	
Filter Status	Clean 4-26-22 changed	
Controls Type	JCI FX Explorer	
Controls Mfr.	JCI	
Economizer	Packaged with Power Exhaust	
CO ₂ DCV	NA	
Damper Styles	Opposed	ODA Closed
Damper Status	Need Cleaning and Lubrication	
Heating Type	Natural Gas	168 MBH
Heating Coil Condition	Burners Clean but header showing age	
Cooling Type	DX 1 Compressors	
Cooling Coil Condition		
Drain Pan Status	Should be cleaned

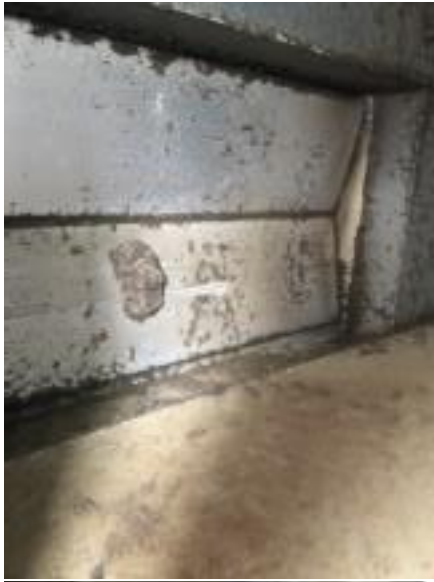
<u>Unit Tag</u>	<u>DOAS-11</u>	<u>Addition comments descriptions</u>
Location	Main Roof Right	
Serving	Kitchen	
Config/Style	Packaged Heating DOAS with ERW	
Mfr.	AAON	
Model #	RN-010 -8-0-0000-3K9	
Serial #	201203-ANGJ21334	
Age (years)	2012	
System CFM		
Max OA CFM		
V/Hz/Ph	208 / 60 /3	
SF Qty/HP	2 hp Direct Drive	Behind Door with Duct Smoke on Panel. Did not open for concern of DSD trip
SF VFD Data	YASKAWA J1000 Series	
RF Qty/HP	1 Hp	A-48 Belt
RF VFD Data		
Filter Data (Size Quantity)	(1) 16 X 25 X 4 Pre, (4) 20 X 16 X 4	
Filter Status	Clean 4-26-22 changed	
Controls Type	JCI FX Explorer	
Controls Mfr.	JCI	
Economizer	Packaged with Power Exhaust	
CO ₂ DCV	NA	
Damper Styles	Opposed	ODA Closed
Damper Status	Need Cleaning and Lubrication	
Heating Type	Natural Gas	120 MBH
Heating Coil Condition	Burners Clean but header showing age	
Cooling Type	DX 1 Compressors	
Cooling Coil Condition		
Drain Pan Status	Should be cleaned

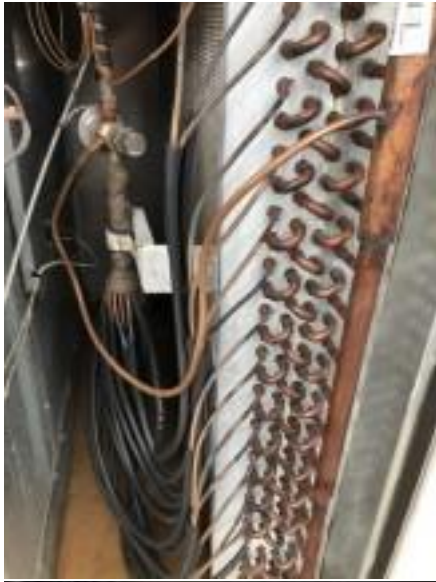
<u>Unit Tag</u>	<u>RTU-1</u>	<u>Addition comments descriptions</u>
Location	Main Roof	
Serving	Central Offices	
Config/Style	Packaged Heating and Cooling VFD ERW	
Mfr.	AAON	
Model #	RN010 -8-0-EA09-3L9	
Serial #	Not readable	
Age (years)	2012	
System CFM		
Max OA CFM		
V/Hz/Ph	208 / 60 /3	
SF Qty/HP	3 hp Belt Drive	Behind Door, may be 2 HP per handwriting
SF VFD Data	YASKAAWA J1000 Series	
RF Qty/HP	1	
RF VFD Data	YASKAAWA J1000 Series	
Filter Data (Size Quantity)	(1) 16 X 25 X 4 Pre, (4) 20 X 16 X 4	
Filter Status	Clean 4-26-22 changed	
Controls Type	JCI FX Explorer	
Controls Mfr.	JCI	
Economizer	Packaged with Power Exhaust	
CO ₂ DCV	NA	
Damper Styles	Opposed	
Damper Status	Need Cleaning and Lubrication	
Heating Type	Natural Gas	
Heating Coil Condition	Burners Clean	
Cooling Type	DX 1 Compressors	
Cooling Coil Condition		
Drain Pan Status	Should be cleaned	
Notes:	Power Exhaust running yet ERW was Off and Bypass Closed. No outside air being introduced

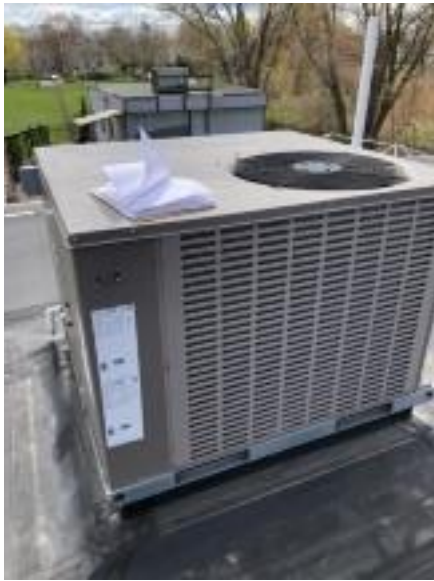
<u>Unit Tag</u>	<u>RTU-A</u>	<u>Addition comments descriptions</u>
Location	Modular	
Serving	A6	
Config/Style	Packaged Heat Pump	
Mfr.	York ?	
Model #	B6HX036A25A	
Serial #	W1G4871848	
Age (years)		
System CFM		
Max OA CFM		
V/Hz/Ph	208 / 60 /3	
SF Qty/HP	3/4 Hp	
SF VFD Data		
RF Qty/HP		
RF VFD Data		
Filter Data (Size Quantity)	(2)14 X 22 X 1	Change access restricted with electrical conduit
Filter Status	Clean 4-25-22 changed	
Controls Type	Local Programmable Thermostat	
Controls Mfr.		
Economizer	Packaged Minimum ODA only	
CO ₂ DCV	NA	
Damper Styles	Flapper Blades	ODA Closed
Damper Status	Need Cleaning and Lubrication	Poor condition
Heating Type	Heat Pump	Emergency Electric Heat not?
Heating Coil Condition		
Cooling Type	DX 1 Compressors	
Cooling Coil Condition	Dirty	
Drain Pan Status	Should be cleaned	
Notes:

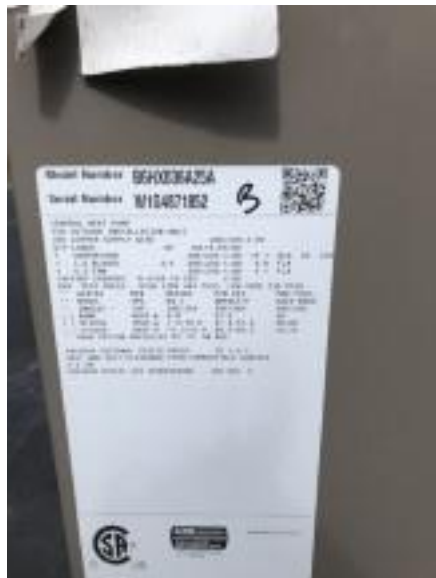
<u>Unit Tag</u>	<u>RTU-B</u>	<u>Addition comments descriptions</u>
Location	Modular	
Serving	A1	
Config/Style	Packaged Heat Pump	
Mfr.	York ?	
Model #	B6HX036A25A	
Serial #	W1G4871852	
Age (years)		
System CFM		
Max OA CFM		
V/Hz/Ph	208 / 60 /3	
SF Qty/HP	¾ hp	
SF VFD Data		
RF Qty/HP		
RF VFD Data		
Filter Data (Size Quantity)	(2)14 X 22 X 1	Change access restricted with electrical conduit
Filter Status	Clean 4-25-22 changed	
Controls Type	Local Programmable Thermostat	
Controls Mfr.		
Economizer	Packaged Minimum ODA only	
CO ₂ DCV	NA	
Damper Styles	Flapper Blades	ODA Closed
Damper Status	Need Cleaning and Lubrication	Poor condition
Heating Type	Heat Pump	Emergency Electric Heat ?
Heating Coil Condition		
Cooling Type	DX 1 Compressors	
Cooling Coil Condition	Dirty	
Drain Pan Status	Should be cleaned	
Notes:

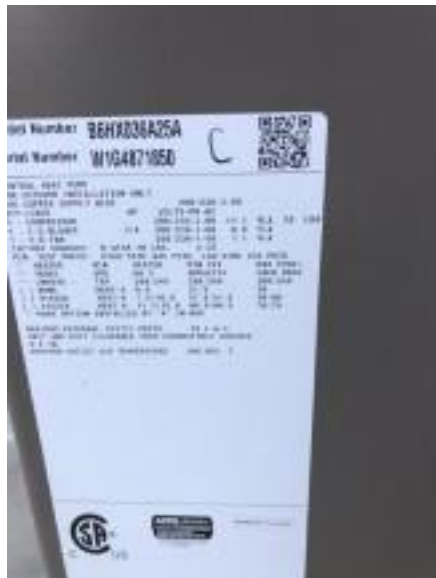
<u>Unit Tag</u>	<u>RTU-C</u>	<u>Addition comments descriptions</u>
Location	Modular	
Serving	A5	
Config/Style	Packaged Heat Pump	
Mfr.	York ?	
Model #	B6HX036A25A	
Serial #	W1G4871850	
Age (years)		
System CFM		
Max OA CFM		
V/Hz/Ph	208 / 60 /3	
SF Qty/HP	¾ Hp	
SF VFD Data		
RF Qty/HP		
RF VFD Data		
Filter Data (Size Quantity)	(2)14 X 22 X 1	Change access restricted with electrical conduit
Filter Status	Clean 4-25-22 changed	
Controls Type	Local Programmable Thermostat	
Controls Mfr.		
Economizer	Packaged Minimum ODA only	
CO ₂ DCV	NA	
Damper Styles	Flapper Blades	ODA Closed
Damper Status	Need Cleaning and Lubrication	Poor condition
Heating Type	Heat Pump	Emergency Electric Heat ?
Heating Coil Condition		
Cooling Type	DX 1 Compressors	
Cooling Coil Condition	Dirty	
Drain Pan Status	Should be cleaned	
Notes:

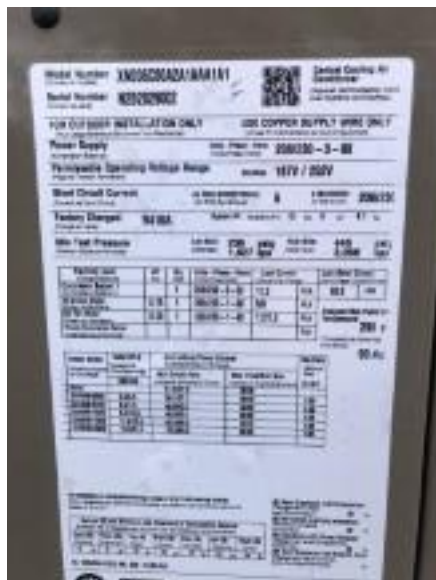
<u>Unit Tag</u>	<u>RTU-F</u>	<u>Addition comments descriptions</u>
Location	Modular	
Serving	A3	
Config/Style	Packaged Heat Pump	
Mfr.	York ??	
Model #	XN036C00A2A1AAA1A1	
Serial #	N2B2029002	
Age (years)	2022	
System CFM		
Max OA CFM		
V/Hz/Ph	208 / 60 /3	
SF Qty/HP	¾ HP	
SF VFD Data		
RF Qty/HP		
RF VFD Data		
Filter Data (Size Quantity)	(1)20 X 30 X 1, (1) 14 X 25 X 1	
Filter Status	Clean 4-26-22 changed	
Controls Type	Local Programmable Thermostat	
Controls Mfr.		
Economizer	NA	
CO ₂ DCV	NA	
Damper Styles	Not Provided	
Damper Status		
Heating Type	Heat Pump	Emergency Electric Heat not!
Heating Coil Condition		
Cooling Type	DX 1 Compressors	
Cooling Coil Condition		
Drain Pan Status	No Condensate Trap Installed	
Notes:

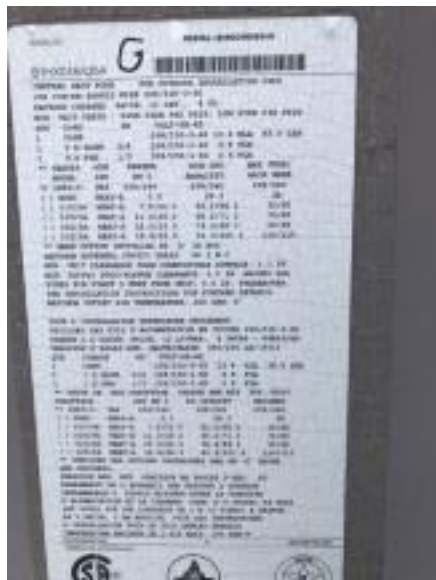
<u>Unit Tag</u>	<u>RTU-G</u>	<u>Addition comments descriptions</u>
Location	Modular	
Serving	Restrooms	
Config/Style	Packaged Heat Pump	
Mfr.	York ?	
Model #	B1HX048A25A	
Serial #	N0C9658549	
Age (years)		
System CFM		
Max OA CFM		
V/Hz/Ph	208 / 60 /3	
SF Qty/HP	¾ Hp	
SF VFD Data		
RF Qty/HP		
RF VFD Data		
Filter Data (Size Quantity)	(2)14 X 22 X 1	Change access restricted with electrical conduit
Filter Status	Clean 4-25-22 changed	
Controls Type	Local Programmable Thermostat	
Controls Mfr.		
Economizer	Packaged Minimum ODA only	
CO ₂ DCV	NA	
Damper Styles	Flapper Blades	ODA Closed
Damper Status	Need Cleaning and Lubrication	Poor condition
Heating Type	Heat Pump	Emergency Electric Heat 7
Heating Coil Condition		
Cooling Type	DX 1 Compressors	
Cooling Coil Condition	Dirty	
Drain Pan Status	Should be cleaned	
Notes:	Overall unit shows signs of age and is very dirty internally
