Stratfield Elementary School

Fairfield Public Schools Recommissioning (RCx) and Testing, Adjusting, & Balancing (TAB) Study van Zelm Project # 2020102.00 (13-SES) October 07, 2022

FAIRFIELD PUBLIC SCHOOLS RECOMMISSIONING (RCX) AND TESTING, ADJUSTING, & BALANCING (TAB) STUDY

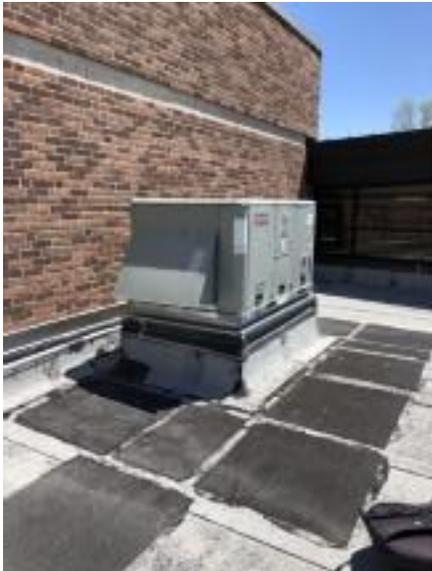
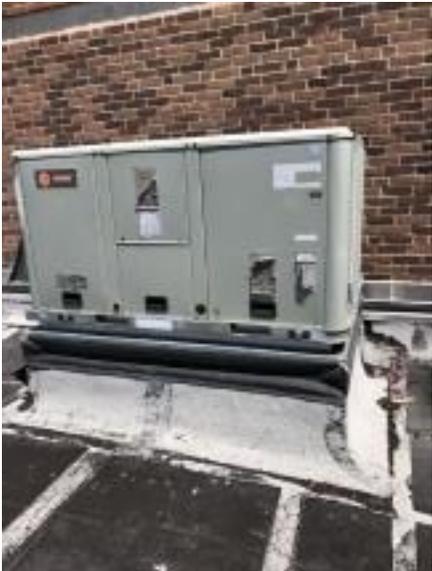
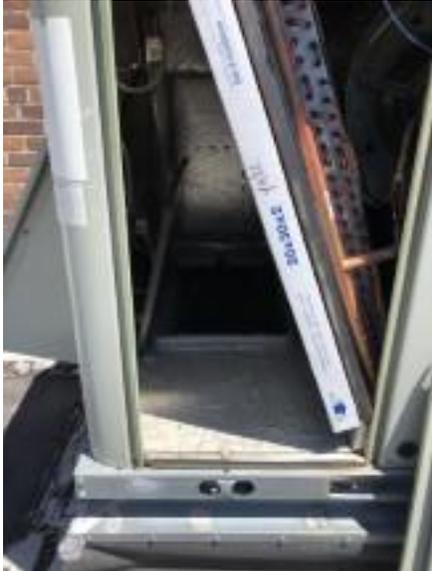
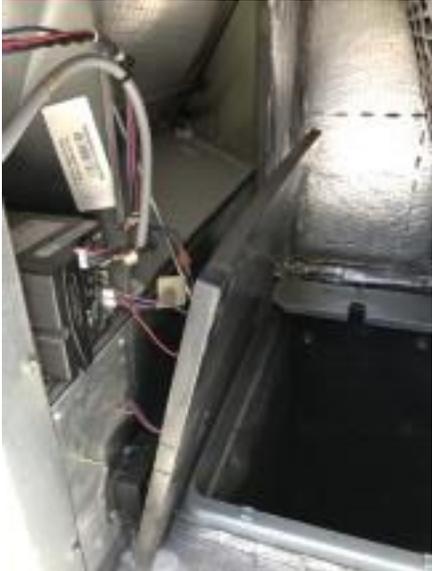
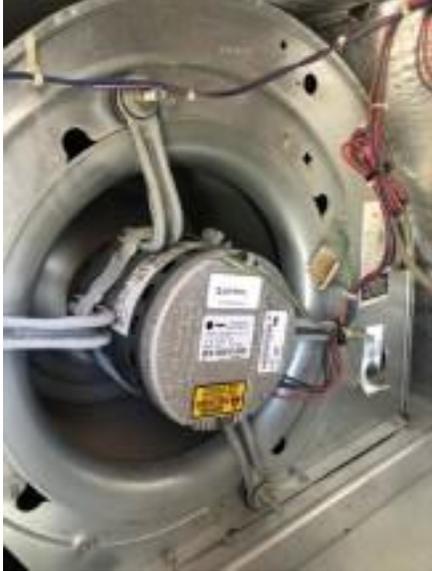
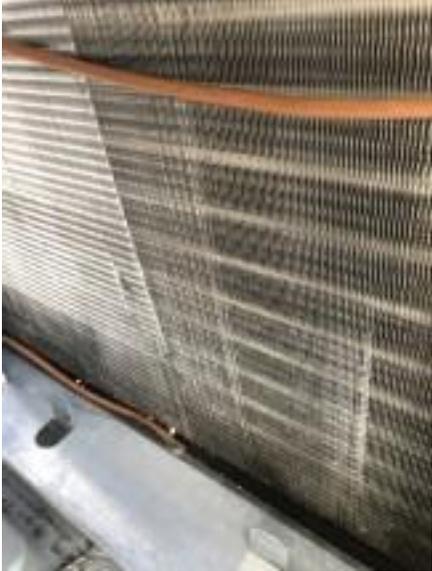
<u>Unit Tag</u>	<u>AHU-2 5-10-22 by RCM</u>	<u>Addition comments descriptions</u>
Location	Special Ed Roof	
Serving	Special Ed	
Config/Style	Rooftop AHU with packaged CU	
Mfr.	Trane	
Model #	THC036E3R0A17J8	
Serial #	102111?05L??	
Age (years)	+5	
System CFM	2000	
Max OA CFM	350	
V/Hz/Ph	208/230	
SF Qty/HP	Direct Drive ¾ HP	
SF VFD Data		
RF Qty/HP		
RF VFD Data		
Filter Data (Size Quantity)	(2) 20 x 30 x2	
Filter Status	Clean	
Controls Type	Package CTI	
Controls Mfr.	Trane with Distech relay interface	
Economizer	Package	
CO ₂ DCV	No	
Damper Styles	Flapper	
Damper Status		
Heating Type	NA	
Heating Coil Condition		
Cooling Type	DX Single stage 3 ton	
Cooling Coil Condition	Clean	
CU Mfr.		
CU Model		
CU Serial		
Drain Pan Status	Clean but Trap broken off	
Notes:	On a 60 degree day only Min ODA being introduced

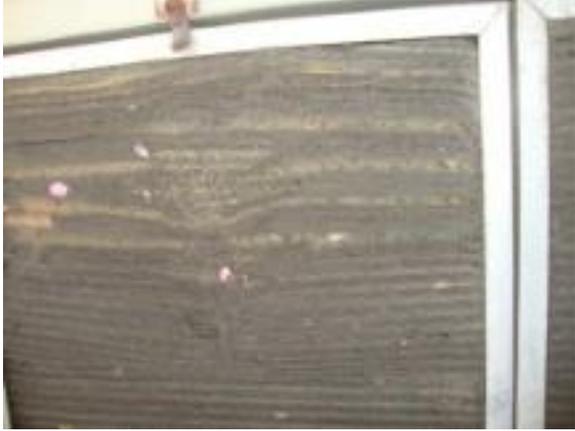
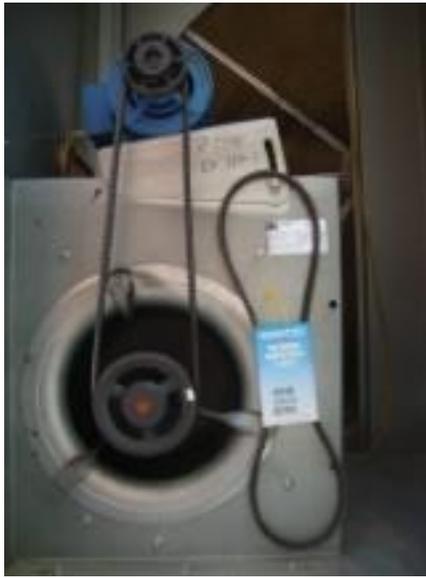
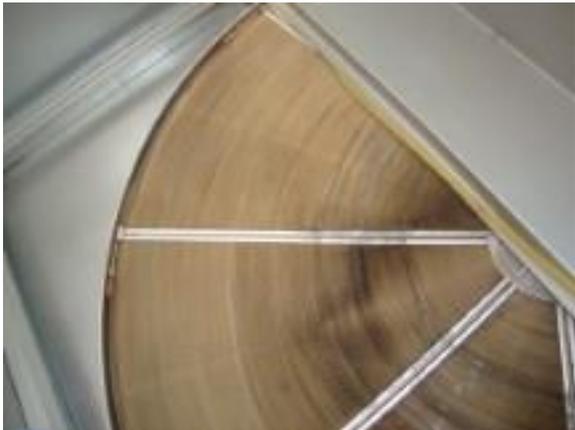
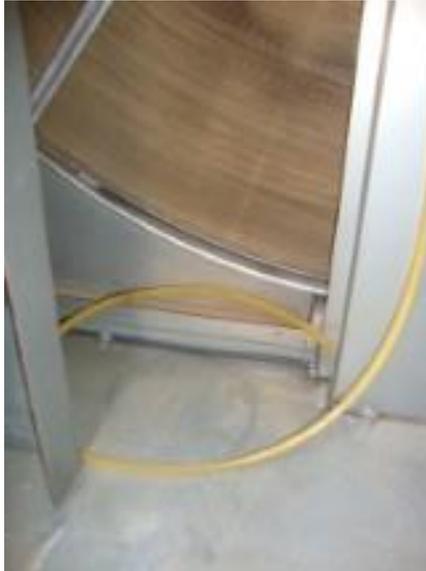
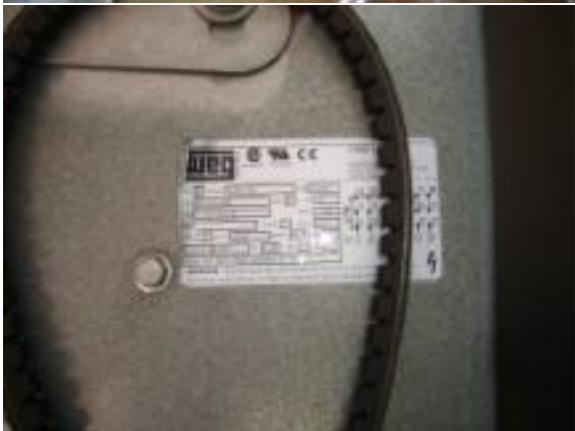
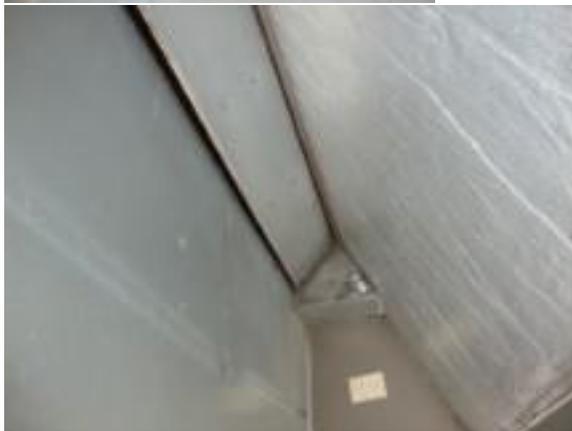
<u>Unit Tag</u>	<u>AHU-3</u>	<u>Addition comments descriptions</u>
Location	Cafeteria Roof Parapet.	
Serving	Cafeteria	
Config/Style	Rooftop AHU with packaged CU	
Mfr.	Trane Voyager	Energy Recovery Cassette, Thybar
Model #	TFD241E30AAB	
Serial #	102310059D	
Age (years)	6/2010	
System CFM	8000	
Max OA CFM	3000	
V/Hz/Ph	208-230/60/3	
SF Qty/HP	5.0	
SF VFD Data	N/A	
EF Qty/HP	2.0 (1) AX-48	OFF
EF VFD Data	N/A	
Filter Data (Size Quantity)	(8) 20x20x2 (4) 16x20x2 coil (6) 20x24x2 wheel	
Filter Status	Not Great for 1 month Old, Dirty	Metal Pre-Filters need replacement
Controls Type	Packaged with DDC interface	
Controls Mfr.	Trane/Thybar/Distech CTC	
Economizer	Yes, available, operation in question	Operation in question
CO ₂ DCV	Wires connected to unit CO2 terminals, will need to explore BAS drawings	
Damper Styles	Trane, Flap. Functional, clean lubricate and adjust.	Thybar Parallel, BDD
Damper Status	OK, functionality to be verified

Heating Type	Hot Water	
Heating Coil Condition	Unknown	
Cooling Type	DX R-410A	
Cooling Coil Condition	Very Dirty	
Wheel	Aire Xchange Inc. Ser. 124526/1023 Mod. ERC-5245-04-X30 Energy Cassette-1/6 HP	BELT ON WHEEL BROKEN
Drain Pan Status	Dirty	
Notes:	Supply fan on, O.A fan on, No exhaust, no wheel	Operation, sequence in question

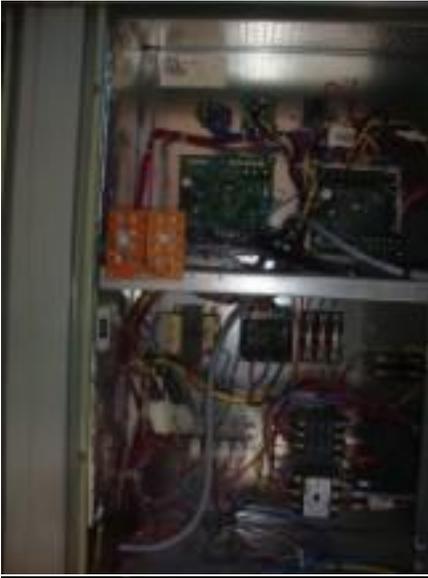
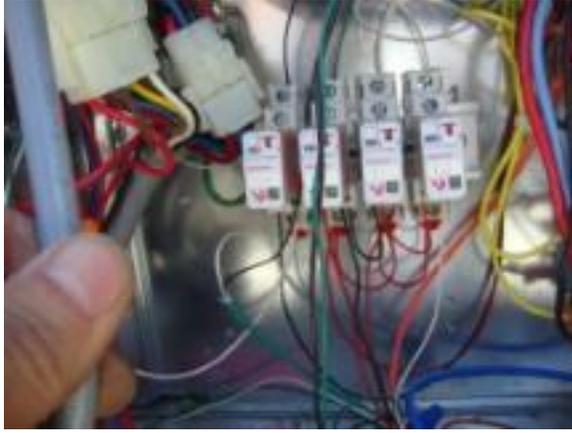
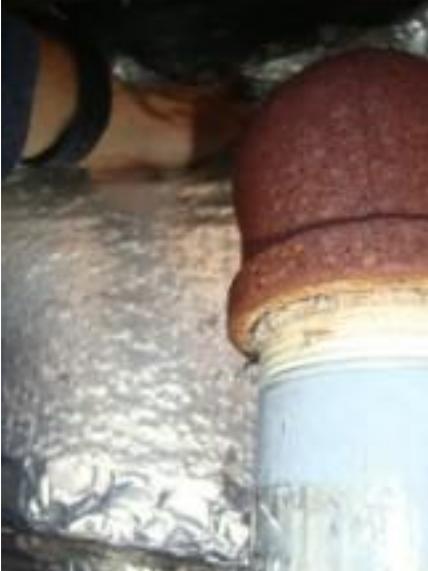
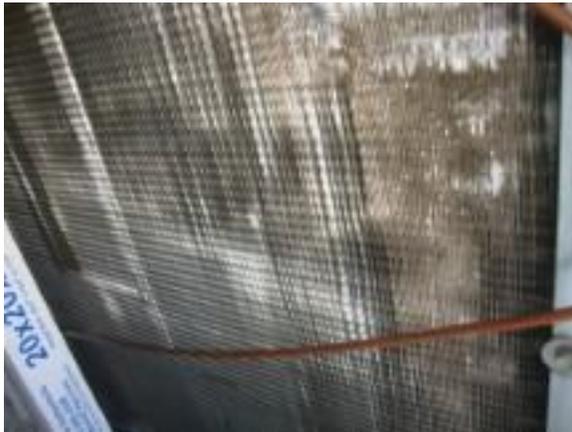
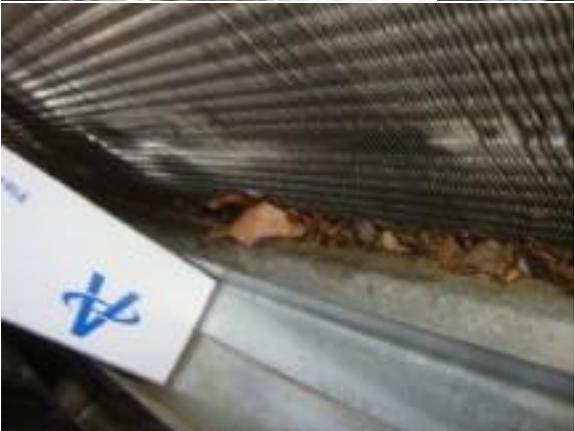
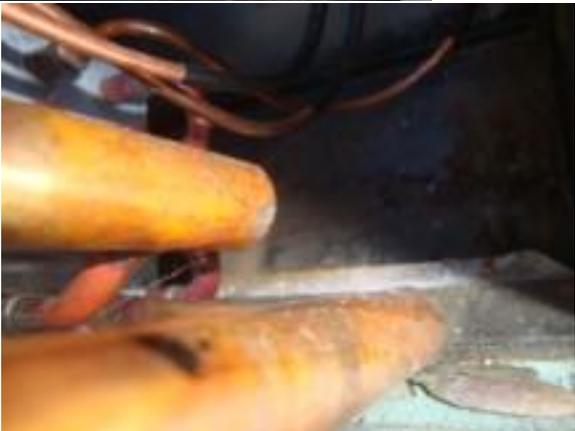
<u>Unit Tag</u>	<u>AHU-4 REA 5-10-22</u>	<u>Addition comments descriptions</u>
Location	Administration Roof	
Serving	Conference	
Config/Style	Rooftop DX cooling Hot water heating	
Mfr.	Trane Precedent	
Model #	TCH092E3ROA03EOB1A1B00004E	
Serial #	102111905L	
Age (years)	2010	
System CFM	3000	
Max OA CFM	390	
V/Hz/Ph	208-230/60/3	
SF Qty/HP	Direct Drive	
SF VFD Data	ECM .75 HP	
RF Qty/HP	N/A	
RF VFD Data	N/A	
Filter Data (Size Quantity)	(6) 20 X 25 X 2	
Filter Status	Standard filters Clean, Metal Pre filters are plugged, should be replaced	4-14-22
Controls Type	Packaged with DDC interface	
Controls Mfr.	CTC BAS Vendor	
Economizer	Yes	
CO ₂ DCV	Wires connected to unit CO2 terminals, will need to explore BAS drawings	
Damper Styles	Flapper packaged	
Damper Status	OK	
Heating Type	Hot water	
Heating Coil Condition	OK	
Cooling Type	DX Dual Compressor	
Cooling Coil Condition	Dirty	
Drain Pan Status	Dirty	
Notes:	Lots of air leakage under cooling coil. Should be reviewed.

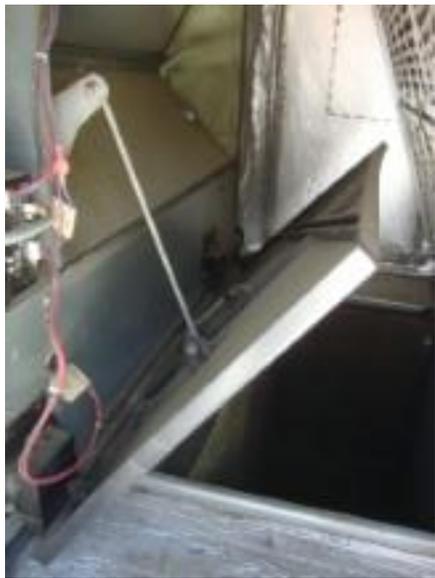
<u>Unit Tag</u>	<u>AHU-5</u>	<u>Addition comments descriptions</u>
Location	Media Center Roof	
Serving	Media Center	
Config/Style	Rooftop AHU with packaged CU	
Mfr.	Trane	
Model #	THC060E3R0A0PEOB1A1B00004C	
Serial #	102111876L	
Age (years)	2010	
System CFM	2000	
Max OA CFM	350	
V/Hz/Ph	208-230/60/3	
SF Qty/HP	7.6 Amps	
SF VFD Data	ECM	
RF Qty/HP	N/A	
RF VFD Data	N/A	
Filter Data (Size Quantity)	(4) 16x25x2	
Filter Status	Clean 4/14/22	
Controls Type	Packaged with DDC interface	
Controls Mfr.	CTC BAS Vendor	
Economizer	Yes	
CO ₂ DCV	Wires connected to unit CO2 terminals, will need to explore BAS drawings	
Damper Styles	Flap	
Damper Status	OK	
Heating Type	N/A	
Heating Coil Condition	N/A	
Cooling Type	DX Cooling R-410A	
Cooling Coil Condition	OK	
Drain Pan Status	OK	
Notes:	No heat in unit

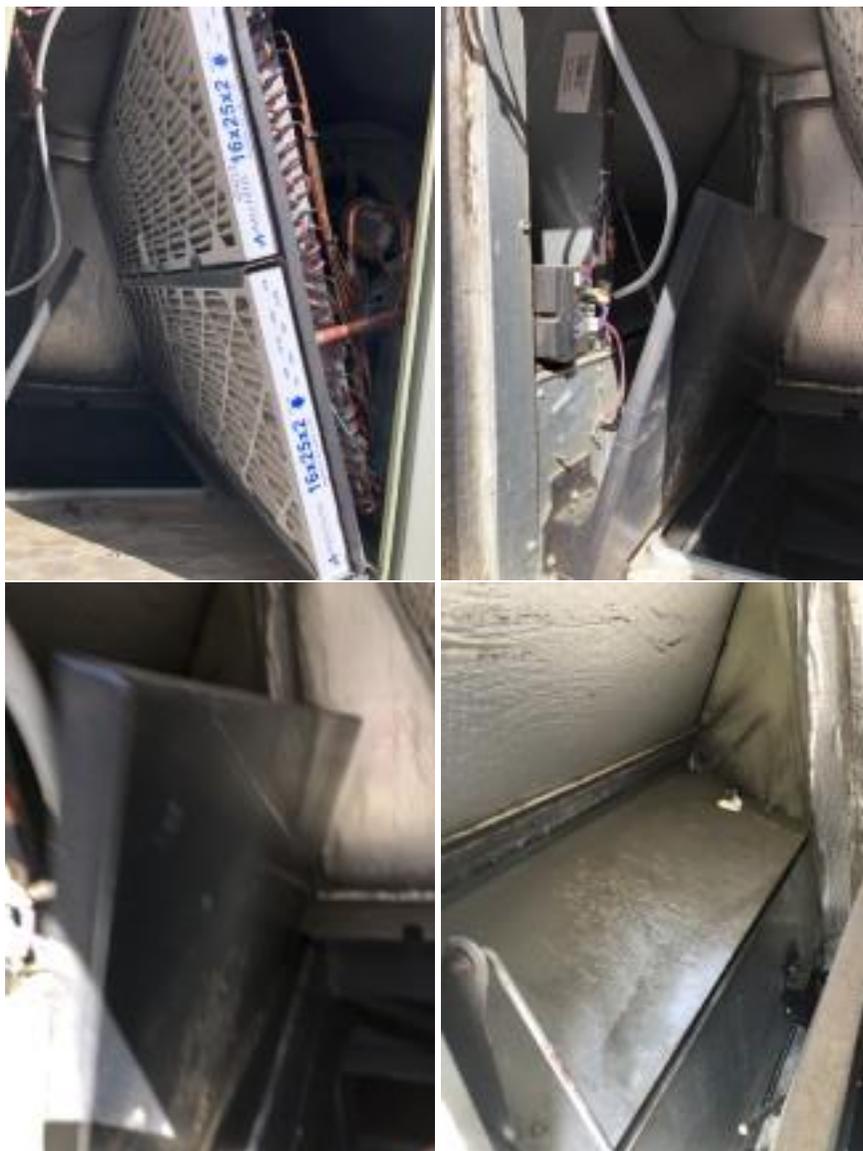
<u>Unit Tag</u>	<u>AHU-6</u>	<u>Addition comments descriptions</u>
Date: 5-10-11	Auditor: RCM	
Location	Media Center Roof	
Serving	Conference Room	
Config/Style	Rooftop Cooling Only	
Mfr.	Trane	
Model #	THC060ER0A0PE0B1A1B00004	
Serial #	102111866L	
Age (years)	2010	
System CFM	1200	
Max OA CFM	150	
V/Hz/Ph	208-230/60/3	
SF Qty/HP	1HP	
SF VFD Data	ECM	
RF Qty/HP		
RF VFD Data		
Filter Data (Size Quantity)	(4) 16 X 25 X 2	
Filter Status	Clean	
Controls Type	Packaged with DDC interface	Fan/Y1/Filter/Motor Status
Controls Mfr.	CTC BAS Vendor	
Economizer	Yes	
CO ₂ DCV	Wires connected to unit CO ₂ terminals, will need to explore BAS drawings	
Damper Styles	Flapper	
Damper Status	OK	
Heating Type	NA	
Heating Coil Condition		
Cooling Type		
Cooling Coil Condition		
Drain Pan Status	OK, trap needs repair	
Notes:	Cooling Running with 0% OA Intake

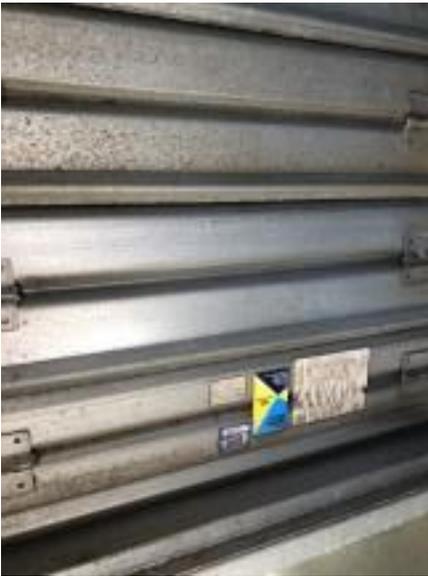
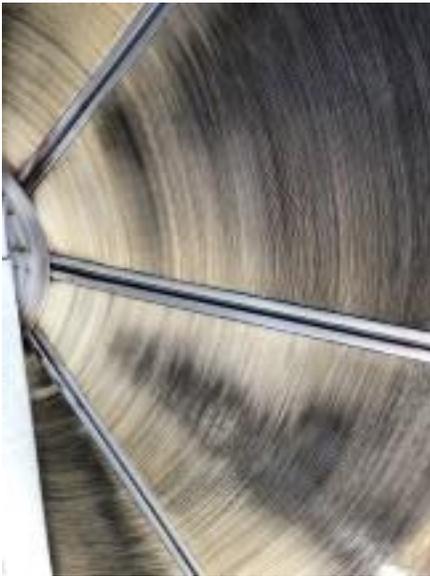
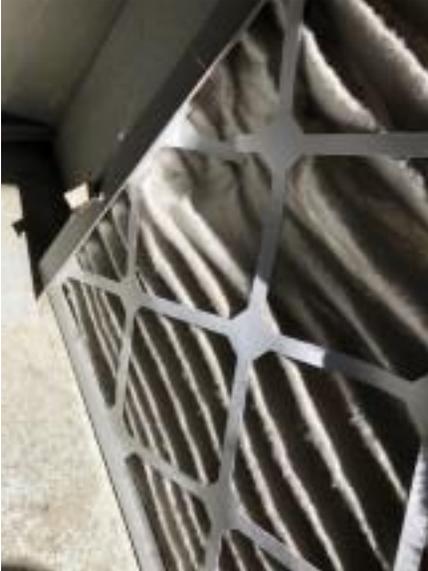
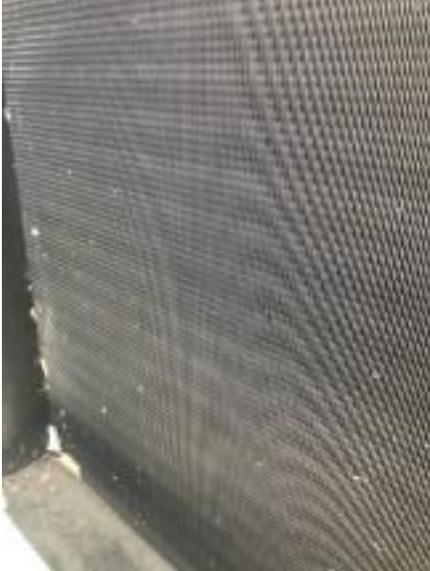
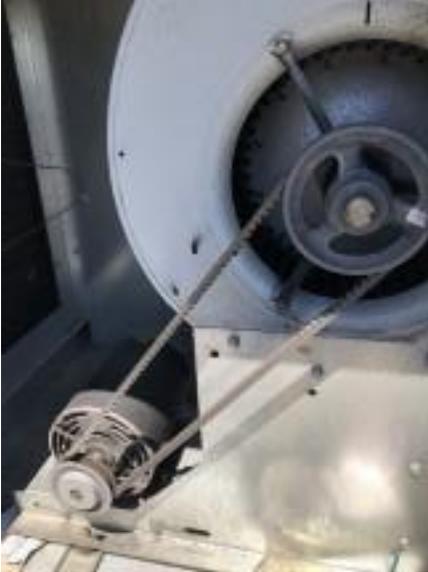
<u>Unit Tag</u>	<u>ERV-4</u>	<u>Addition comments</u>
Location	West Wing Classroom Roof	
Serving	West Wing Classrooms	
Config/Style	Rooftop Energy Recovery Ventilator	
Mfr.	Greenheck with Trane CU	
Model #	ERCH-45H-15	
Serial #	12108442	
Age (years)	2010	
System CFM		
Max OA CFM		
V/Hz/Ph		
SF Qty/HP	3 HP	AX 53 Belt
SF VFD Data	Yaskawa J100	
RF Qty/HP	3 HP ERW .17 HP	AX 53
RF VFD Data		
Filter Data (Size Quantity)	OA (3) 20 X 25 X 2, RA (3) 20 X 25 X 2 OA Prefilter Metal: 15.5 X 19.5 X .5	
Filter Status	Clean last changed	
Controls Type	Package with DDC interface	SST, Frost, Status
Controls Mfr.	Distech, CTC	
Economizer	No	
CO ₂ DCV	100% OA	
Damper Styles	Opposed	
Damper Status	Exhaust Damper Actuator non-functioning. OA intake Dirty	
Heating Type	HW	
Heating Coil Condition	Not Accessible	
Cooling Type	Remote DX Single Compressor	
Cooling Coil Condition		
CU Mfr.	Trane	
CU Model	Tag Covered	
CU Serial		
Drain Pan Status	Moderate

Notes:	Exh Damper Stuck open. OA intake very restricted due to plugged OA Metal Pre-Filters causing high negative pressure bypassing ERW with OA intake. OA door seals partially missing or had fallen off
