# Tomlinson Middle School

## **Fairfield Public Schools Recommissioning (RCx) and Testing, Adjusting, & Balancing (TAB) Study** van Zelm Project # 2020102.00 (04-TMS) July 06, 2022

### **FAIRFIELD PUBLIC SCHOOLS RECOMMISSIONING (RCx) AND TESTING, ADJUSTING, & BALANCING (TAB) STUDY**

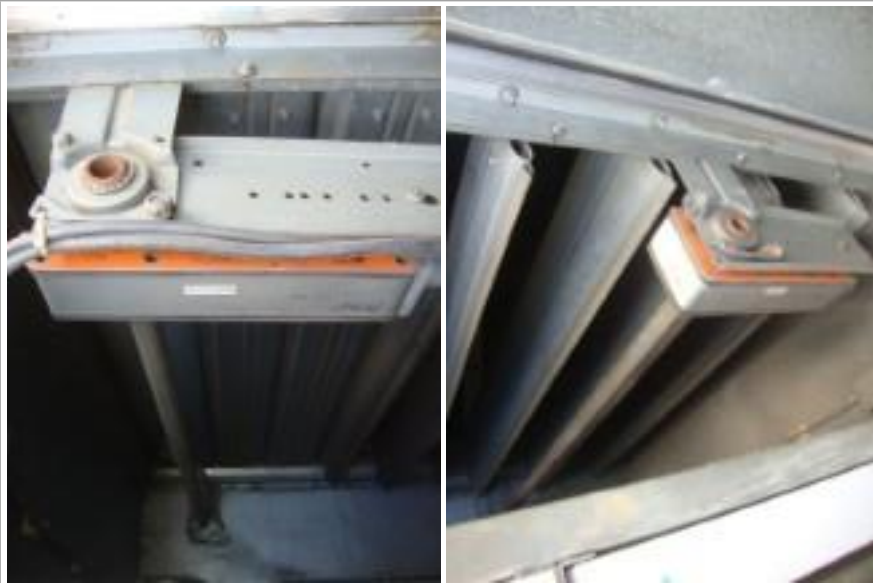
Control Dampers

<u>Unit Tag</u>	<u>HX-1</u>	<u>Addition comments descriptions</u>
Location	Roof	System actually functions
Serving	Tech	
Config/Style	100% OA Heat exchanger, area reheat coils, bypass dampers	
Mfr.	Innovent	
Model #	E-5000-1F-6750-FR-1-C-R	
Serial #	204118-1	
Age (years)	9/2004	
System CFM		
Max OA CFM		
V/Hz/Ph	460/60/3	
SF Qty/HP	5.0 Belt B69	
SF VFD Data	N/A	
EF Qty/HP	5.0 Belt PB69	
EF VFD Data	N/A	
Filter Data (Size Quantity)	(8) 20"X25"X2"	
Filter Status	Dirty	10/8/21
Controls Type	Factory	
Controls Mfr.		
Economizer	100% O.A.	
CO <sub>2</sub> DCV	-	
Damper Styles	Opposed Blade, face and bypass, economizer, freeze bypass	Actuator AF-24-MFT-5-US
Damper Status	OK	
Heating Type	(Duct mounted Reheat, H.W.)	
Heating Coil Condition	Unknown	
Cooling Type	N/A	
Cooling Coil Condition	N/A	
CU Mfr.	N/A	
CU Model	N/A	
CU Serial	N/A	
Drain Pan Status	OK Trap intact	
Notes:	Discharge restricted

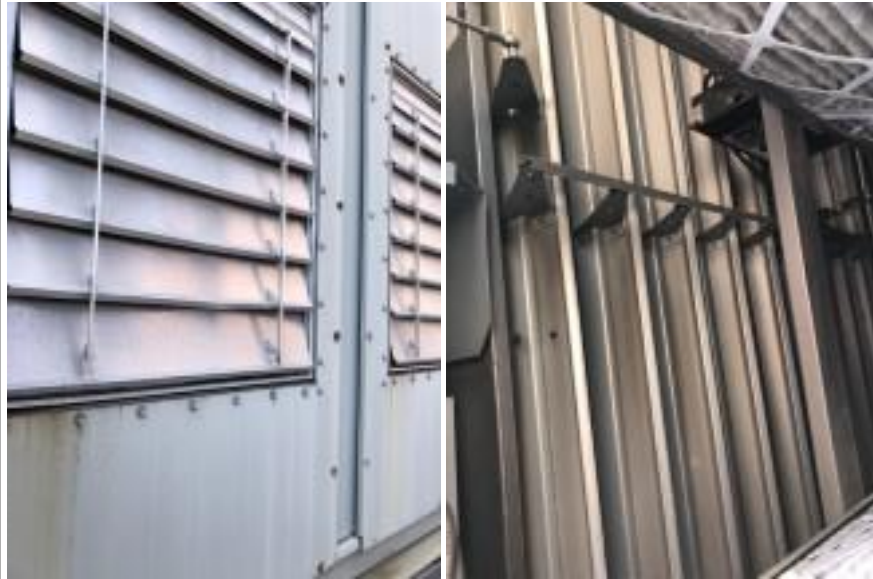
Control Dampers

<u><b>Unit Tag</b></u>	<u><b>RTU-3</b></u>	<u><b>Addition comments descriptions</b></u>
Location	Roof	
Serving	New Science Wing	
Config/Style	100% OA capable with ERW, HW, and DX	
Mfr.	Trane	
Model #	SSHFC6045777C79D9001A0CE0000L00RT0Y8600	
Serial #	C04L09545	
Age (years)		
System CFM	18,500	
Max OA CFM		
V/Hz/Ph	440 – 460 -480	
SF Qty/HP	25-HP Century E-plus 3, 230/460	
SF VFD Data	Trane	
RF Qty/HP	ERW Power Exhaust 3- HP 208-230-460 Building Power Exhaust 15-HP Baldor	(2) BX 96 Belts. Wheel Very Dirty
RF VFD Data	Trane TR1- 18B554 Building PE, TR1 for ERW Exh	
ERW	Wheel Very Dirty 1/6 HP Motor	Belt off ERW
Filter Data (Size Quantity)	OA ERW Pre-Filters Metal Mesh (4) 24 x 24 x 2, (2) 12 x 24 x2 (25) 20 x 22 x 2 not correct size used	Very Dirty  Dirty
Filter Status	Needs Changing	
Controls Type		
Controls Mfr.		
Economizer	Not operational	
CO <sub>2</sub> DCV		
Damper Styles	Opposed	Dirty, frozen
Damper Status	With unit off OAD 30% open with missing end seals	UV Lights hitting dampers

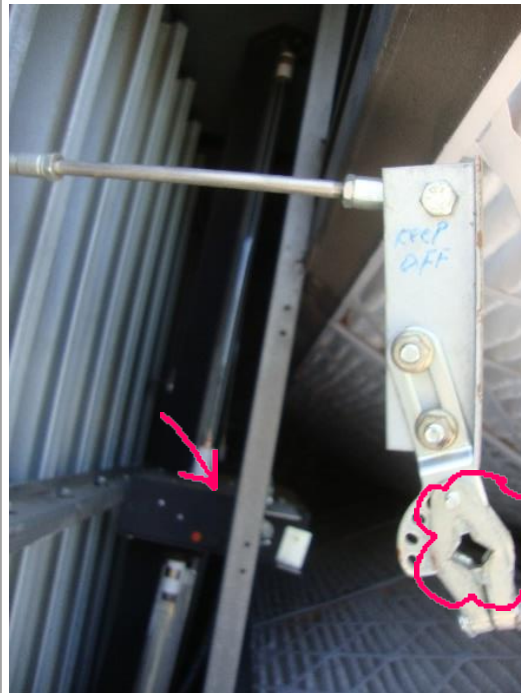
Control Dampers

<b><u>Unit Tag</u></b>	<b><u>RTU-5</u></b>	<b><u>Addition comments descriptions</u></b>
Location	Roof: Roof Pipe penetrations under unit missing insulation.	Fan was and has been off for a long time as filters are clean
Serving	Cafe	
Config/Style	100% OA capable with ERW, HW, and DX	
Mfr.	Trane Intellipak	
Model #	SSHFC3043736C5BD9001ADCE0000L00RTOY8600	
Serial #	C04L09546	
Age (years)		
System CFM	9,050	
Max OA CFM		
V/Hz/Ph	460/60/3	
SF Qty/HP	15 (1) BELT 5VX780	
SF VFD Data	VFD	
EF Qty/HP	3.0 (1) A67	
EF VFD Data	VFD	
Filter Data (Size Quantity)	(16) 20"x22"x2	10-7-21
Filter Status	Like new, factory end plates missing. End plates made up from Stud material, no seals on ends. Wheel O.A. intake filter in poor condition	
Controls Type	Factory	
Controls Mfr.	BMS	
Economizer	Not functional	
CO <sub>2</sub> DCV	-	
Damper Styles	Damper linkage unhooked, UV lamp brackets hitting dampers, seals falling off blades	
Damper Status	Contact with UV lights, Actuator unhooked, no control

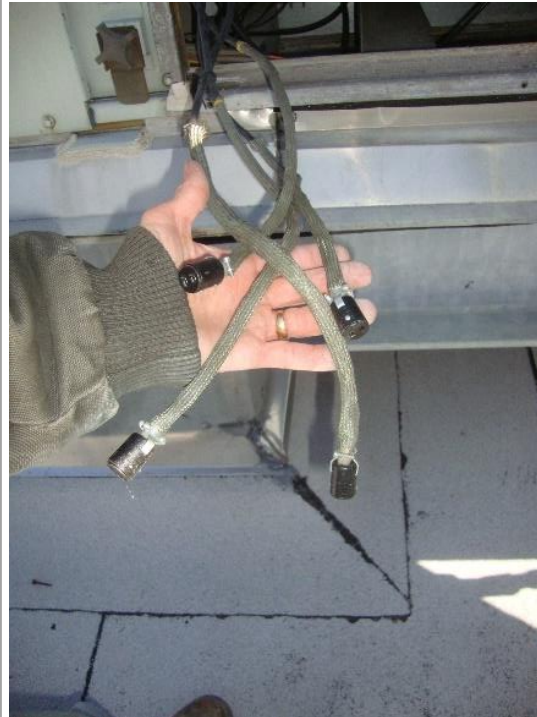
Controls UV Lights

A previous installation of UV lights meant to help address indoor air quality has resulted in an improper placement of said units. These lights and brackets often interfere with the internal unit dampers, forcing a system that already has issues with control to have further reduced capabilities when it is functioning. Additionally, some of the UV lights were found disconnected, broken, or abandoned in place, so not only is the air not necessarily being sterilized but this damper interference does not have any positive side. The immediate relocation of the UV lights or removal in such cases where they cannot be relocated should be performed. This system would need to be commissioned properly if it is intended to be used as it is unclear if any services have been completed post-installation.
