# Walter Fitzgerald Campus

Fairfield Public Schools Recommissioning (RCx) and Testing, Adjusting, & Balancing (TAB) Study

van Zelm Project # 2020102.00 (17-WFC) December 12, 2022

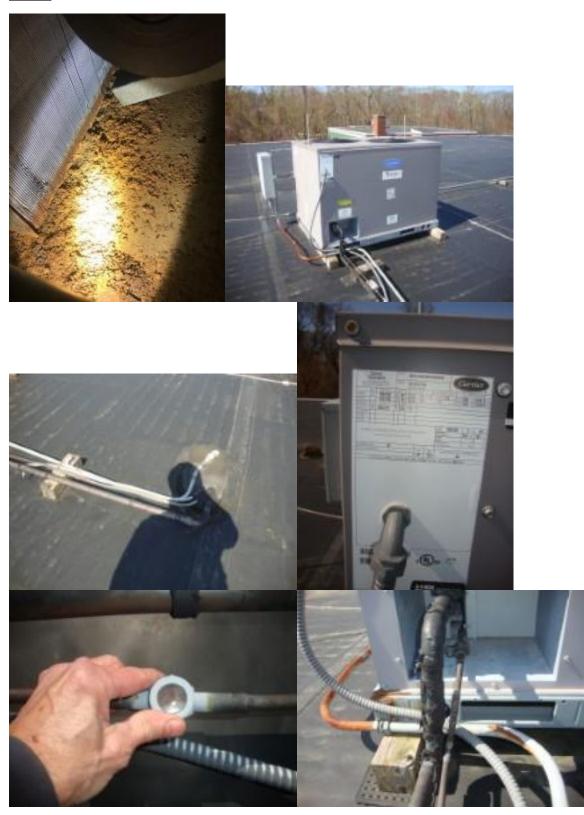
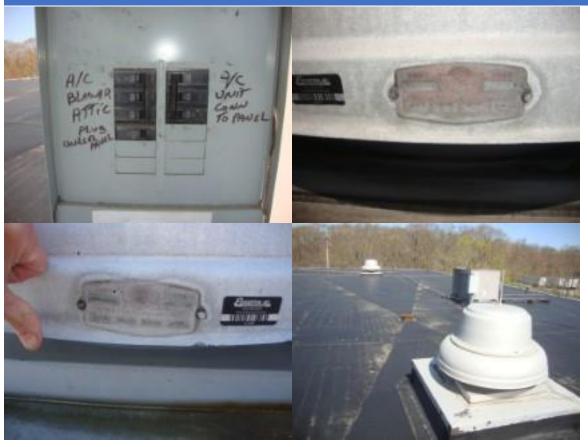
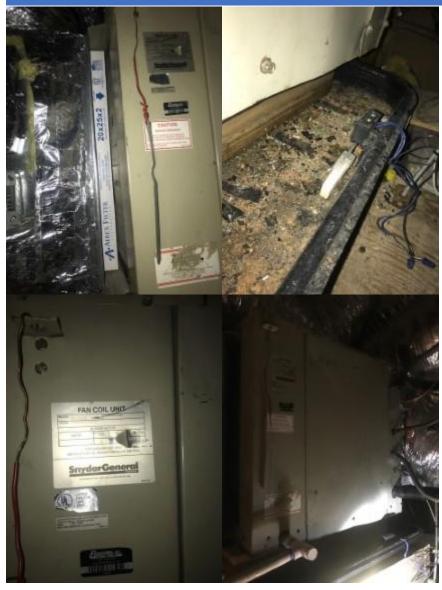
<u>Unit Tag</u>	<u>AHU-1</u>	<u>CU-1</u>
Location	Attic	High Roof
Serving	Café, Aerobics	AHU-1
Config/Style	DX- Air Handler	Condensing Unit
Mfr.	Snyder General	Carrier Gemini
Model #	B100C3	38AUZA08AOAOA5A0A0A0
Serial #	R885100012	3012C91328
Age (years)	Unknown	Unknown
System CFM		
Max OA CFM		
V/Hz/Ph	208-230/60/3	208-230/60/3
SF Qty/HP	1.5 (1) A-43 Belt	
SF VFD Data	N/A	
RF Qty/HP	N/A	
RF VFD Data	N/A	
Filter Data (Size Quantity)	(3) 20x25x2 Filters do not cover air stream 100%	
Filter Status	Clean, Filters do not cover air stream 100%	
Controls Type	Factory DDC	
Controls Mfr.	Trane	
Economizer	No	
CO <sub>2</sub> DCV	No	
Damper Styles	No	
Damper Status	No	
Heating Type	Gas Burner	
Heating Coil Condition	New, did not witness operation.	
Cooling Type	DX Cooling did not witness operation.	
Cooling Coil Condition	Coil clean.	
Drain Pan Status	Pan clean	
Notes:	Unit has no Outdoor air hood and or damper controls. Strictly a recirculation residential install. No lightning protection on RTU's. No Service outlets on roof.	Refrigerant line insulation has failed, single compressor, dual condenser fans crankcase heater.

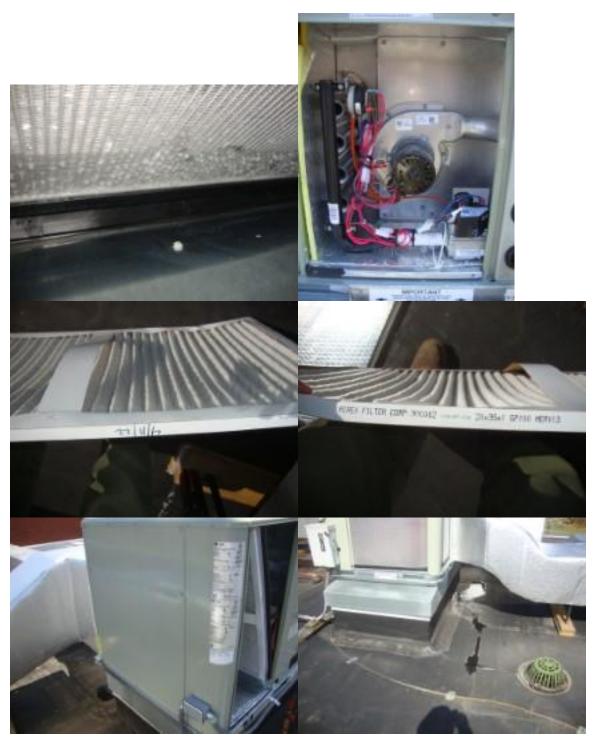
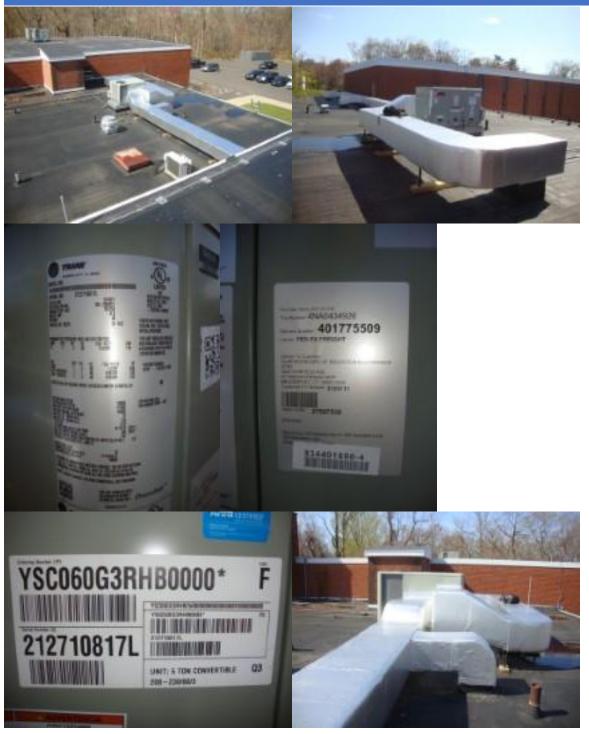
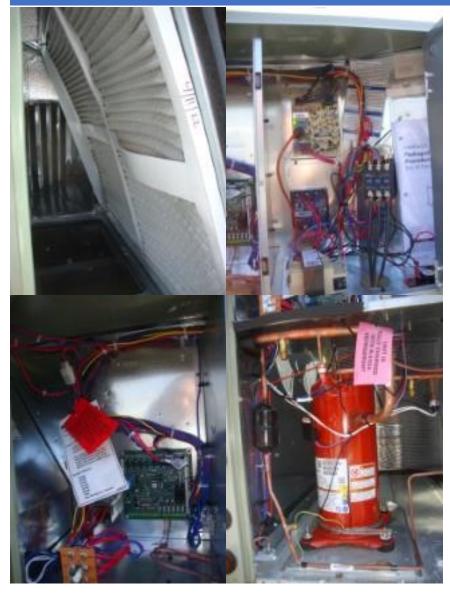
Unit Tag	<u>RTU-1</u>	Addition comments descriptions
Location	Roof	
Serving	Admin	
Config/Style	Packaged Gas DX- Precedent Convertible	
Mfr.	Trane	
Model #	YSC060G3RHB250000	
Serial #	212710817L	
Age (years)	7/2021	
System CFM		
Max OA CFM		
V/Hz/Ph	208-230/60/3	
SF Qty/HP	1.0	
SF VFD Data	ECM Direct Drive	
RF Qty/HP	N/A	
RF VFD Data	N/A	
Filter Data (Size Quantity)		1" Filter in a 2" Rack, filter deflection, sagging present
Filter Status	4/11/22 Clean, 2" filter would be a better fit	
Controls Type	Factory DDC	
Controls Mfr.	Trane	
Economizer	No	
CO <sub>2</sub> DCV	No	
Damper Styles	No	
Damper Status	No	
Heating Type	Gas Burner	
Heating Coil Condition	New, did not witness heating operation.	
Cooling Type	DX Cooling	
Cooling Coil Condition	Coil clean but bottom ¼ ice buildup, Refrigerant charge? 40-degree O.A. temperatures, compressor running, no economizer	
Drain Pan Status	Ice present, pan clean and draining with door access open

Notes:	Unit has no Outdoor air hood and or damper controls. Strictly a recirculation residential install. No lightning protection on RTU's. No Service outlets on roof

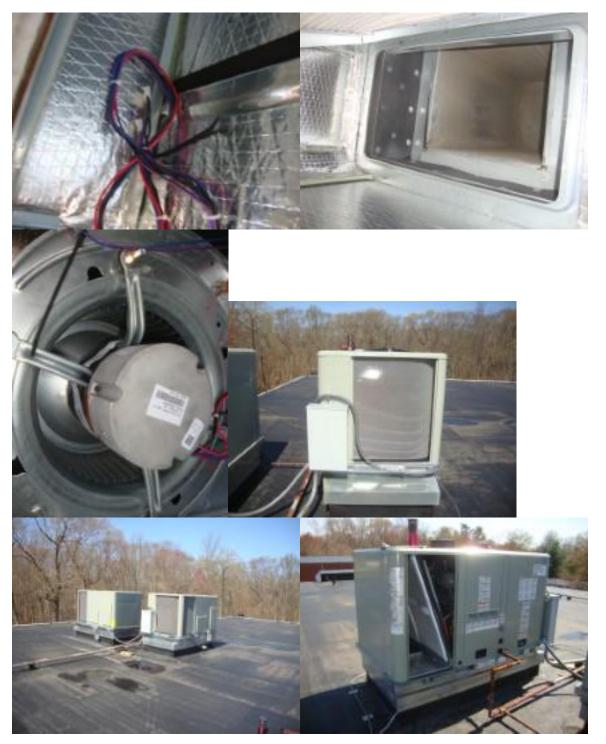
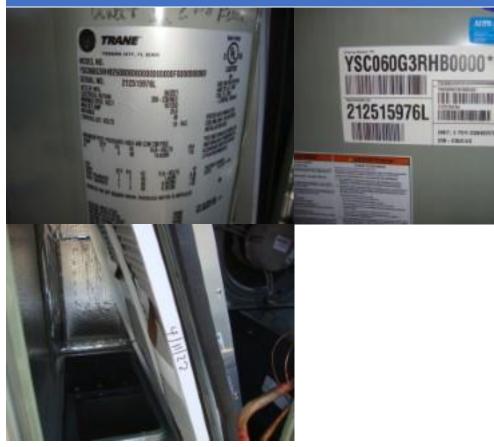
Unit Tag	RTU-2	Addition comments descriptions
Location	Roof	
Serving	2 <sup>nd</sup> Floor Classrooms	
Config/Style	Packaged Gas DX- Precedent Convertible	
Mfr.	Trane	
Model #	YSC060G3RHB250000	
Serial #	21251597L	
Age (years)	6/2021	
System CFM		
Max OA CFM		
V/Hz/Ph	208-230/60/3	
SF Qty/HP	1.0	
SF VFD Data	ECM Direct Drive	
RF Qty/HP	N/A	
RF VFD Data	N/A	
Filter Data (Size Quantity)	(2) 20x34x1	1" Filter in a 2" Rack, filter deflection, sagging present
Filter Status	4/11/22 Clean, 2" filter would be a better fit	
Controls Type	Factory DDC	
Controls Mfr.	Trane	
Economizer	No	
CO <sub>2</sub> DCV	No	
Damper Styles	No	
Damper Status	No	
Heating Type	Gas Burner	
Heating Coil Condition	New, did not witness operation.	
Cooling Type	DX Cooling	
Cooling Coil Condition	Coil clean.	
Drain Pan Status	Pan clean	
Notes:	Unit has no Outdoor air hood and or damper controls. Strictly a recirculation residential install. No lightning protection on RTU's. No Service outlets on roof

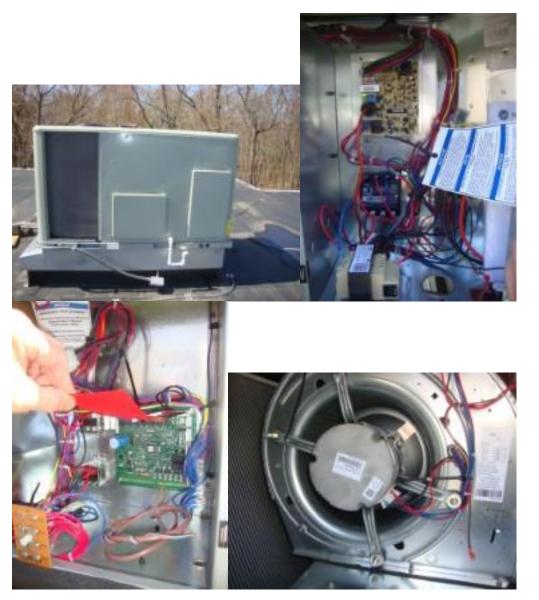
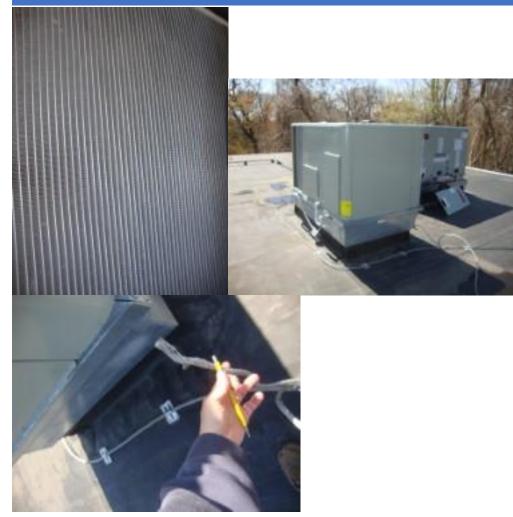
Unit Tag	<u>RTU-3</u>	Addition comments descriptions
Location	Roof	
Serving	1st Floor Classrooms	
Config/Style	Packaged Gas DX- Precedent Convertible	
Mfr.	Trane	
Model #	YSC060G3RHB250000	
Serial #	212515994L	
Age (years)	6/2021	
System CFM		
Max OA CFM		
V/Hz/Ph	208-230/60/3	
SF Qty/HP	1.0	
SF VFD Data	ECM Direct Drive	
RF Qty/HP	N/A	
RF VFD Data	N/A	
Filter Data (Size Quantity)	(2) 20x34x1	1" Filter in a 2" Rack, filter deflection, sagging present
Filter Status	4/11/22 Clean, 2" filter would be a better fit	
Controls Type	Factory DDC	
Controls Mfr.	Trane	
Economizer	No	
CO <sub>2</sub> DCV	No	
Damper Styles	No	
Damper Status	No	
Heating Type	Gas Burner	
Heating Coil Condition	New, did not witness operation.	
Cooling Type	DX Cooling did not witness operation.	
Cooling Coil Condition	Coil clean.	
Drain Pan Status	Pan clean	
Notes:	Unit has no Outdoor air hood and or damper controls. Strictly a recirculation residential install. No lightning protection on RTU's. No Service outlets on roof
