OSWSD Facility Assessment Summary

Site visits conducted to observe, record and assess current conditions at all district schools.

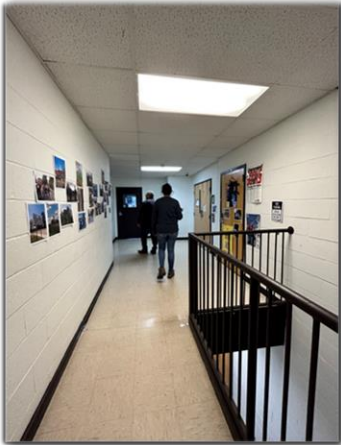
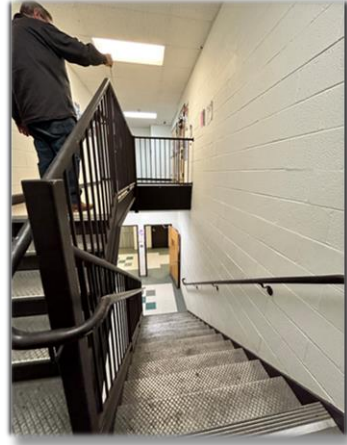
Stair Exit Enclosure Compromised

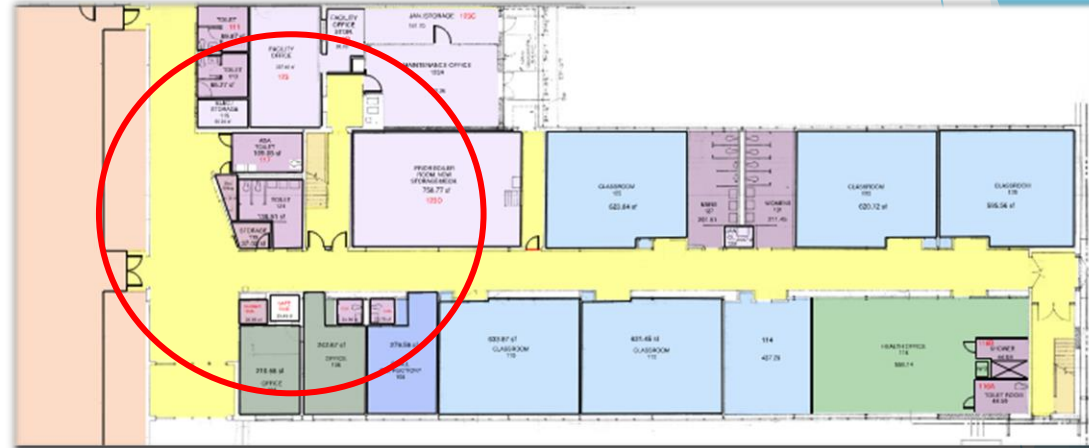
First Floor RUHS/MS

RUHS – Noncompliant Egress configuration

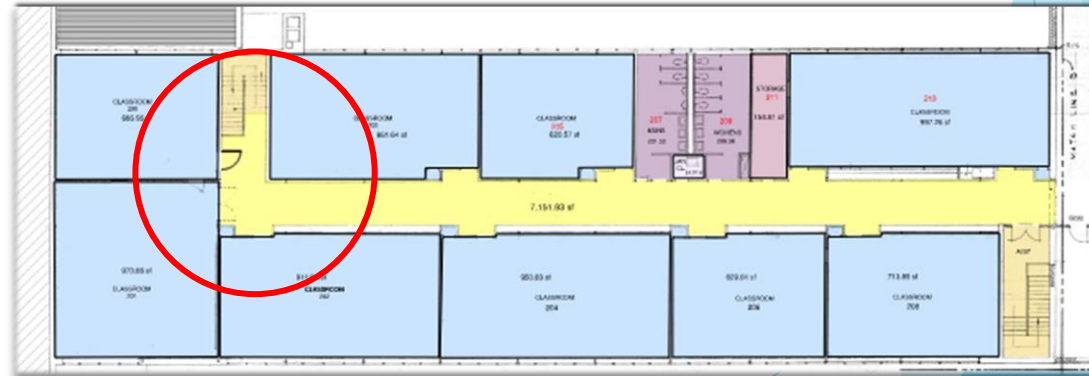
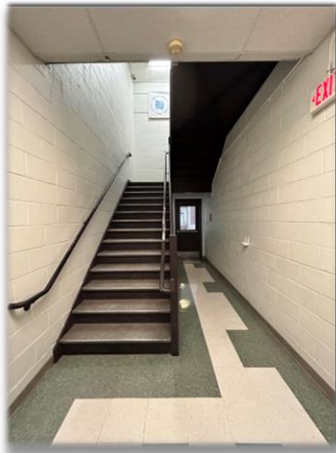
Second Floor RUHS/MS

Modified condition disrupts stair exit discharge design.

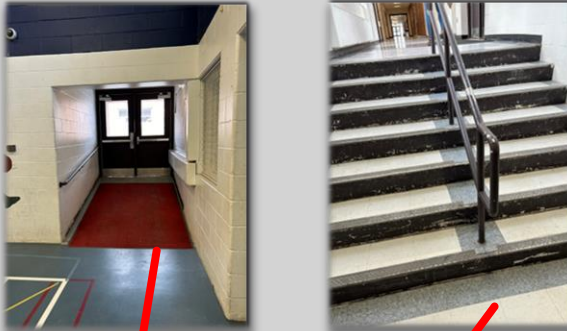
RUMS Gym Barrier to Access

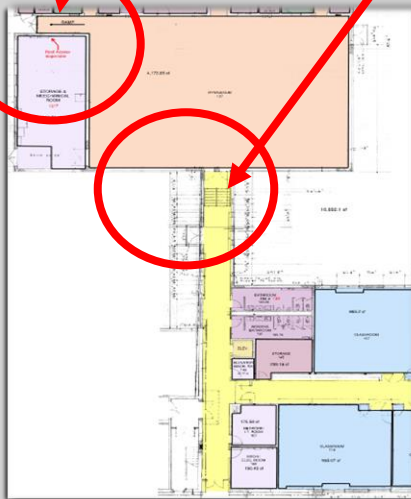
RUMS Partial Floor Plan, Steep Ramp leads to outdoors

Steep Ramp

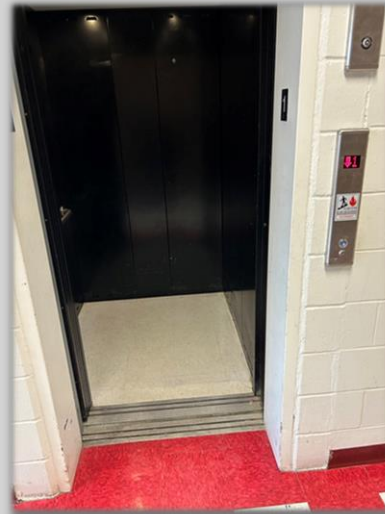
RUHS/RUMS Non-Compliant Elevator

Lacks rotation & stretcher compliance regulations.

Equipment has surpassed life expectancy, difficult to find replacement parts to maintain etc.

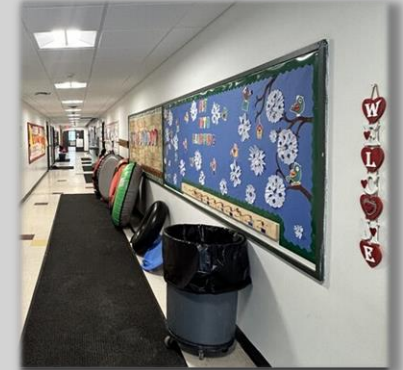
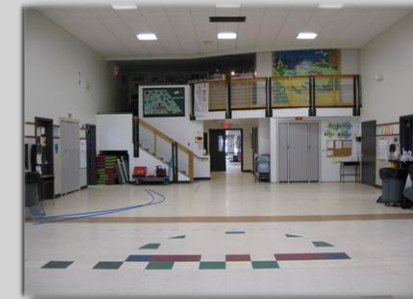
Brookfield Corridors & Mezzanine

Inadequate storage leads to egress conditions posing life safety threats

Mezzanine lacks accessibility and secondary means of egress

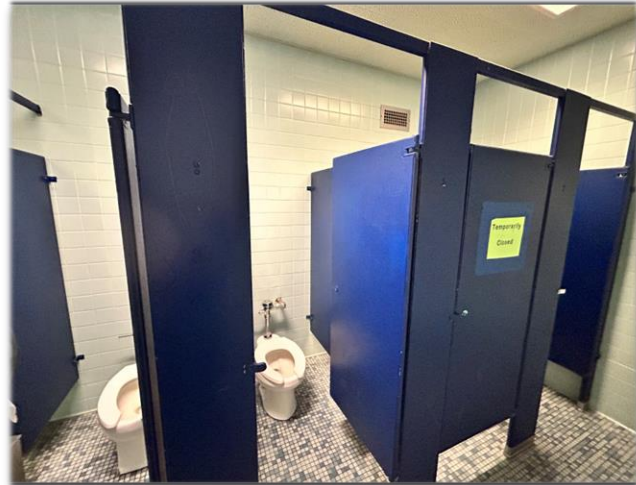
141 Bathroom - Non-ADA, old fixtures & partitions, old floor & wall tile finishes. Recurrent concerns through Middle/High School & Brookfield Elem. with minimal ADA access bathrooms

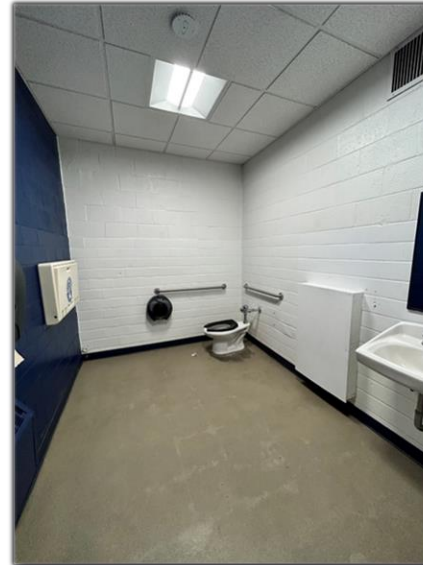
HS Gym Lobby Bathroom

- ADA Non-compliance:
- Wood panel covering on wall conflicting with required clearance
 - Toilet Seat height falls below compliant range
 - Exposed Combustible materials to be avoided.

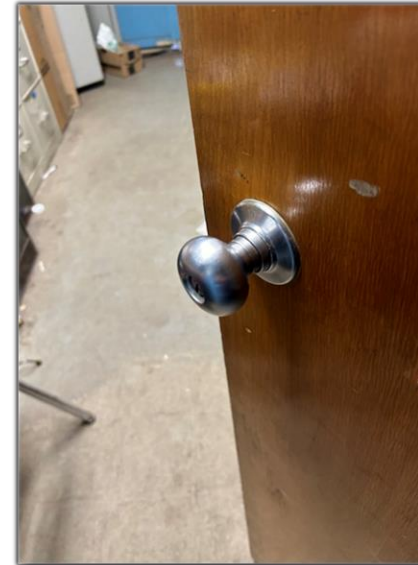
Non-Compliant Hardware

This condition repeats itself numerous times throughout RUHS/RTCC

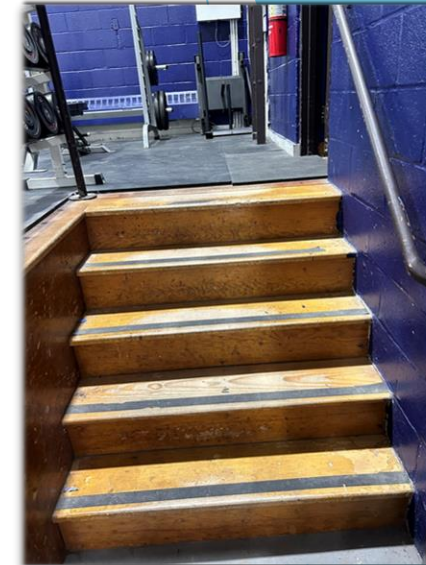
No ADA access:

Stairs to former stage - Repurposed as a Fitness Exercise Space

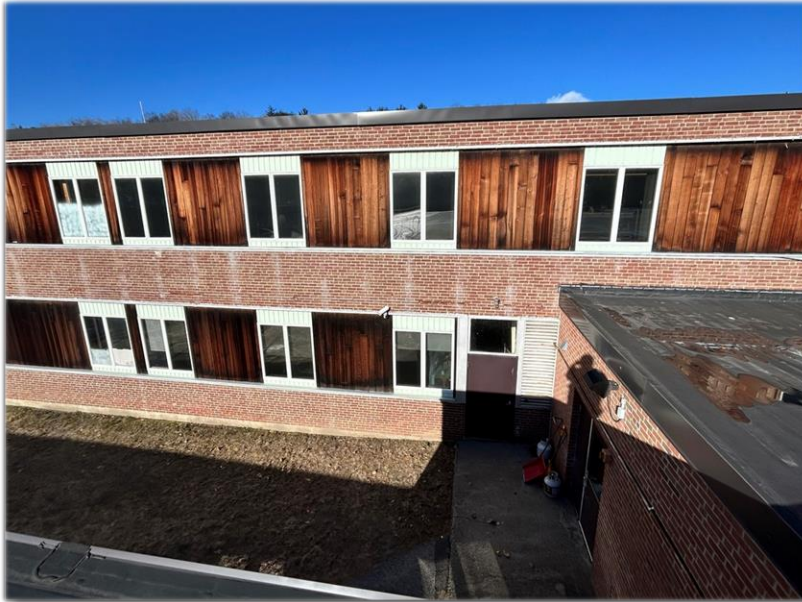
Combustible skin material of RUHS/MS/RTCC
- Former original window ban opening

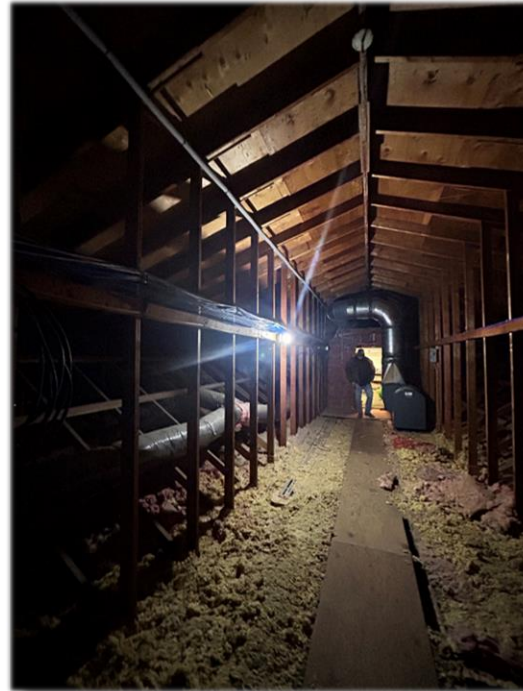
Smoke control features need repairs in Brookfield attic space
Non sprinklered schools require increased levels of smoke and fire control features that are more challenging to maintain

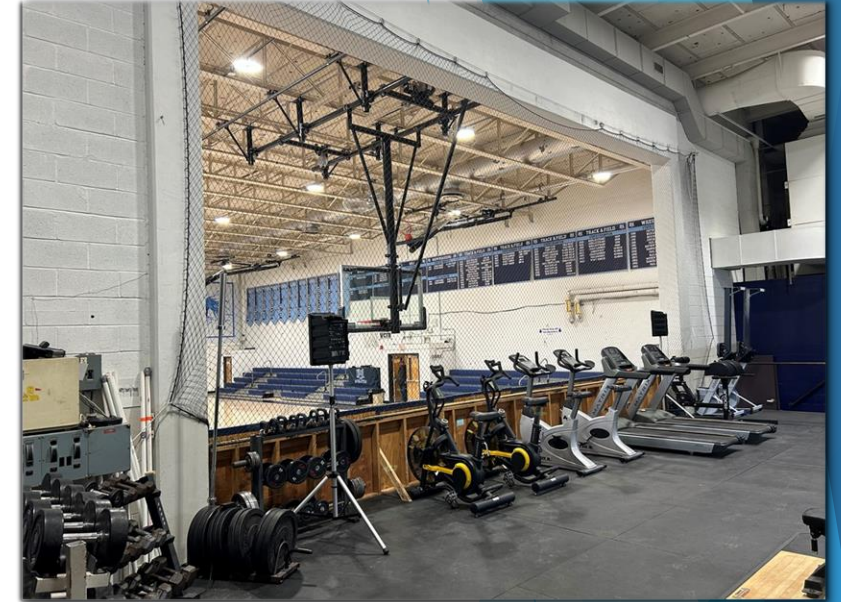
Exposed combustible framing at former RUHS gym stage proscenium opening. Combustible framing materials are not permitted in construction type.
Combustible framing and materials have been observed in numerous areas throughout RUHS/RUMS/RTCC

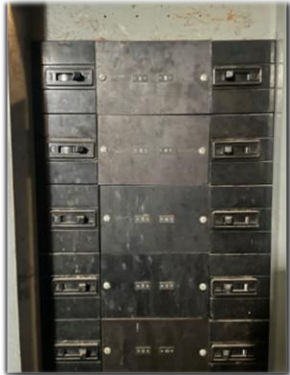
70-year-old switchgear

- ❖ 55 - 70-Year-old Switch Gear & Panel Boards
- ❖ 40 Year is considered max. Life expectancy
- ❖ Old equipment is costly to maintain, not reliable, often not work, and nearly impossible to source replacement parts reliably
- ❖ Many conditions throughout the older facilities lack GFCI receptacles where required by code
- ❖ Elementary schools require tamper resistant receptacles
- ❖ Inefficient outdated lighting and controls

- ❖ Cost to replace & update these Electrical Systems to current safe & compliant system likely exceed costs of new electrical infrastructure in new build

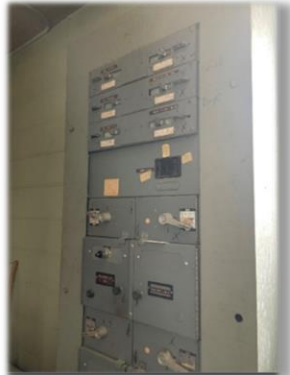
Very old 480-volt fused switch panelboard

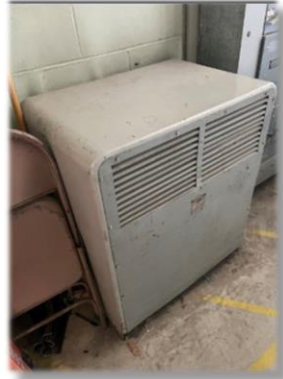
60-year-old transformer

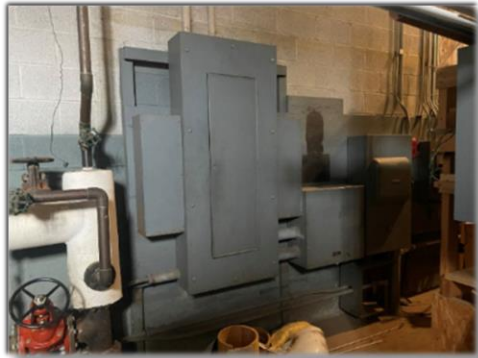
Trumbell electric panelboard circuit breakers

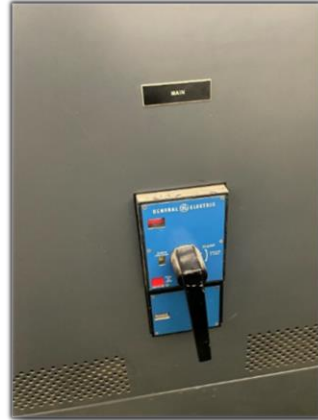
Switchboard protection device with no ground fault protection or energy reduction switch (ERMS)

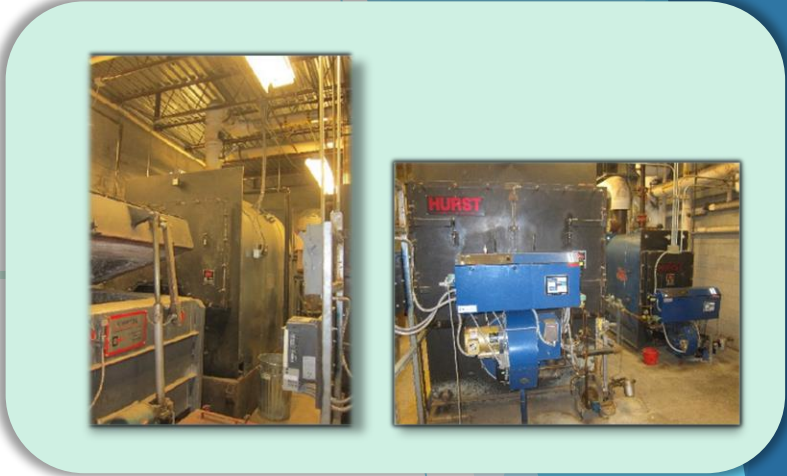
- CONTROLS - MIX OF DDC & OLD PNEUMATIC
- A/C - HIGH QTY OF WINDOW UNITS
- VENTILATION - OLD UNIT VENTILATORS & ROOFTOP UNITS
- THERE IS NO ENERGY RECOVER OF EXHAUSTED WARM INDOOR AIR (ERV SHOULD CAPTURE 70-80%)
- RUHS AUDITORIUM LACKS REQ. SMOKE RELIEF
- MANY SPACES LACK CODE COMPLIANT VENTILATION AIRE

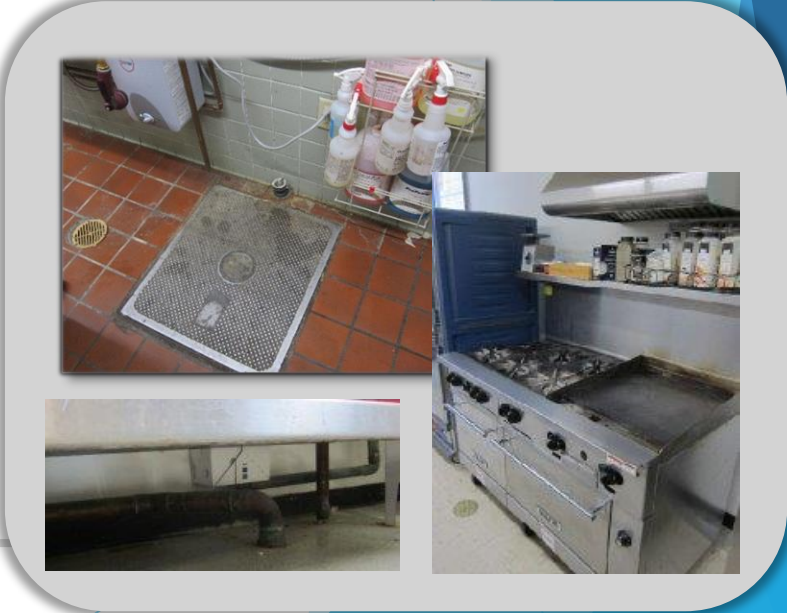
- BROOKFIELD KITCHEN - LACKS COMPLIANT HOOD EXHAUST & FIRE SUPPRESSION
- RUHS/RUMS HOOD - ON/OFF FAN, SHOULD BE VARIABLE SPEED & COLD AIR ISOLATION DAMPER - ENERGY HOG
- GREASE TRAPS NOT SERVICING ALL REQUIRED KITCHEN FIXTURES
- SINKS REQUIRE INDIRECT DRAIN WASTE TO MEET CODE
