HOLBROOK MIDDLE SCHOOL

ASSESSMENT REPORT

November 5, 2019

HOLBROOK MIDDLE SCHOOL BUILDING ASSESSMENT

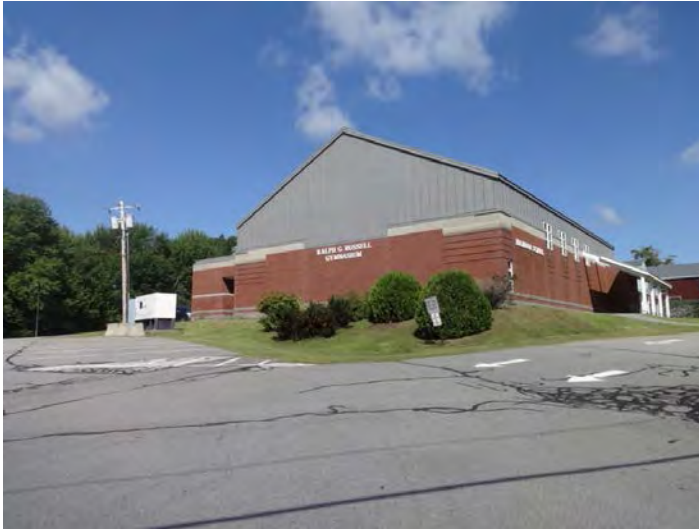
There are paved sidewalks located around the building and to the ball fields. The pavement is in fair to good condition with cracks that have recently been sealed. The paved sidewalks on the north and east sides are in good condition. An access road to the east of the upper parking lot has recently been rehabbed and drainage added. The drainage ditch along Rte. 46 on the upper end of the drop off area was filled with water due to collection of debris at the culvert.

Paving with Sealant

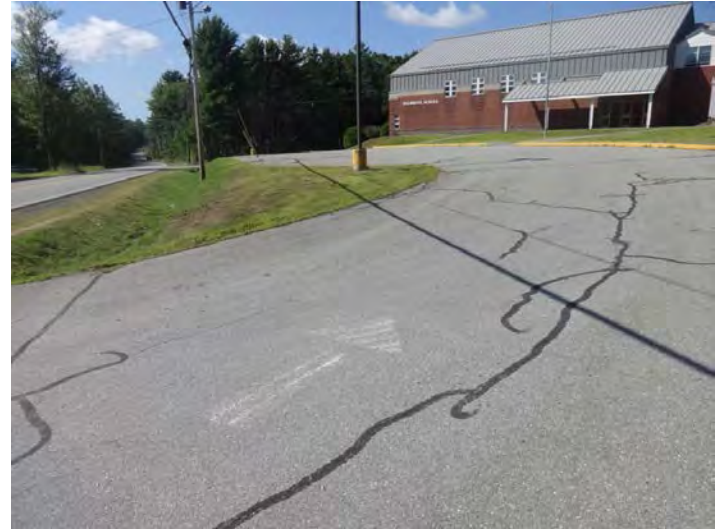
Paving with Sealant

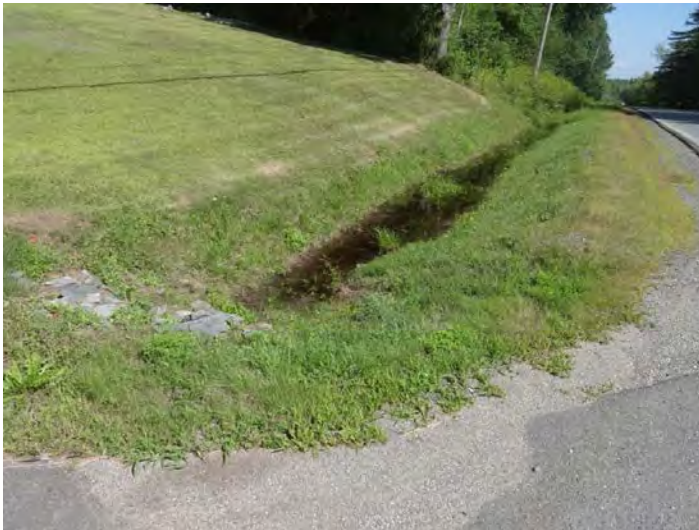
Drainage issue at main road

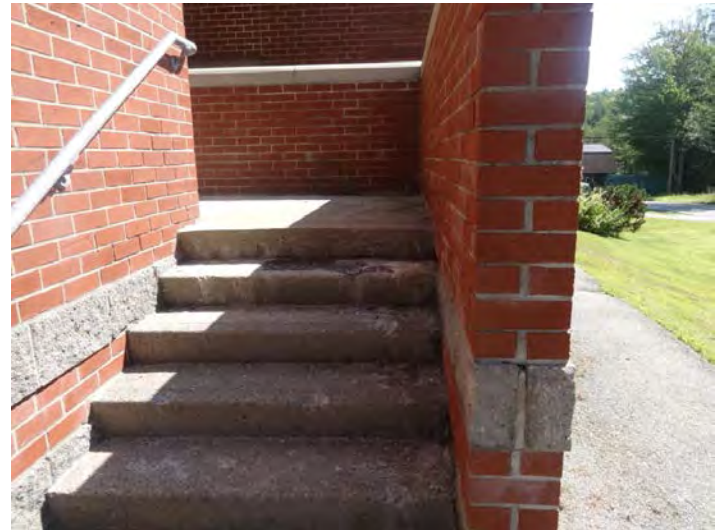
The south gym exit concrete stairs and brick retaining wall are starting to degrade with broken concrete treads and brick joint failure. The railings at the stairs leading to the front cafeteria entrance have heaved from frost and are tilting up. The rear gym entrance has a set of concrete stairs along with a paved ADA walkway. The large roof structure located next to the entrance walkway empties water runoff and snowmelt onto the surface, causing a great deal of work to keep it de-iced in the winter.

Exterior Concrete Steps

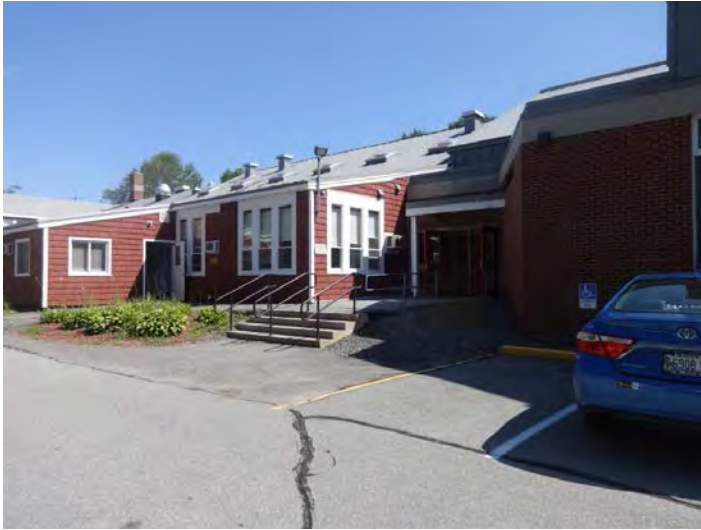
Exterior Steps

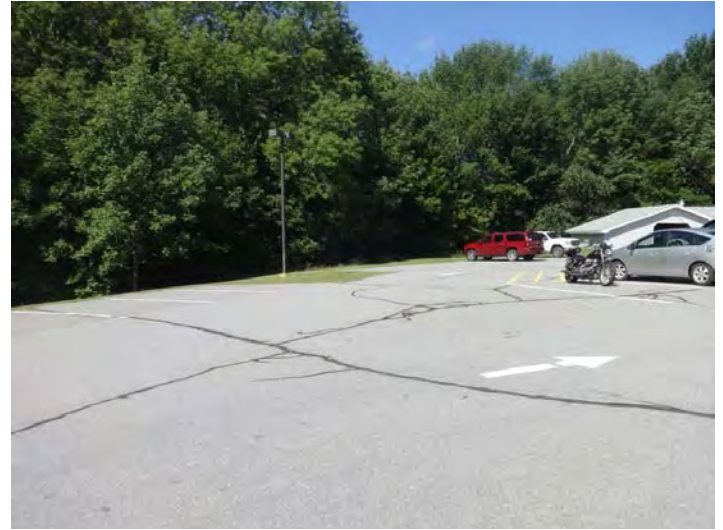
Site lighting consists of 6 pole mounted high pressure sodium lights in the lower parking lot and student drop-off area. There are surface mounted lights located under the entrance canopy and around the building entrances, the library entrance and along the west side of the school. The upper parking lot at the athletic fields has inadequate lighting with 2 pole mounted area floodlights. Consider adding more lighting to cover the area along with pathway lighting.

Parking Lot Lighting

Action: Replace exterior fixtures with LED lighting (6). **Priority:** 1 \$ 12,000

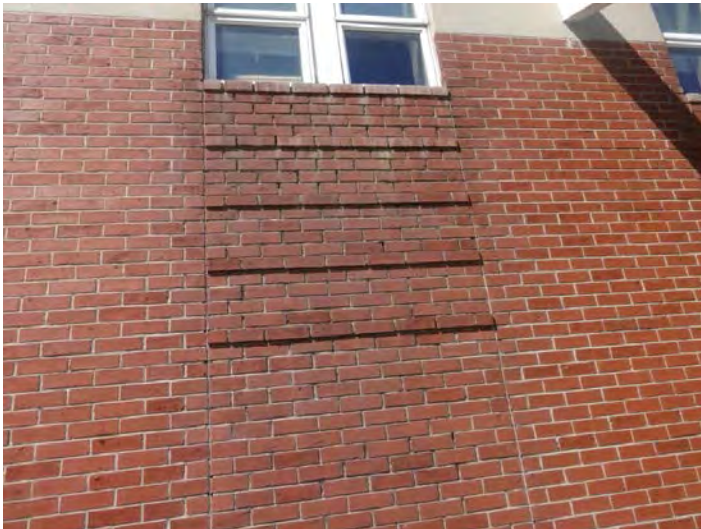
The original building and classroom additions are wood wall construction with vinyl siding completed in 2012. The 1995 gym addition is metal stud framed walls with standing seam and brick facades. The brick wall joints are failing in some areas. Most of the building has metal clad trim, in good condition. The front student drop-off area has a sloping shed roof along the walkway and entrances framed with 6"x6" posts. We expect the insulation within the walls to vary given the different ages of construction. The soffit areas should be inspected to insure proper attic ventilation.

Exterior Brick

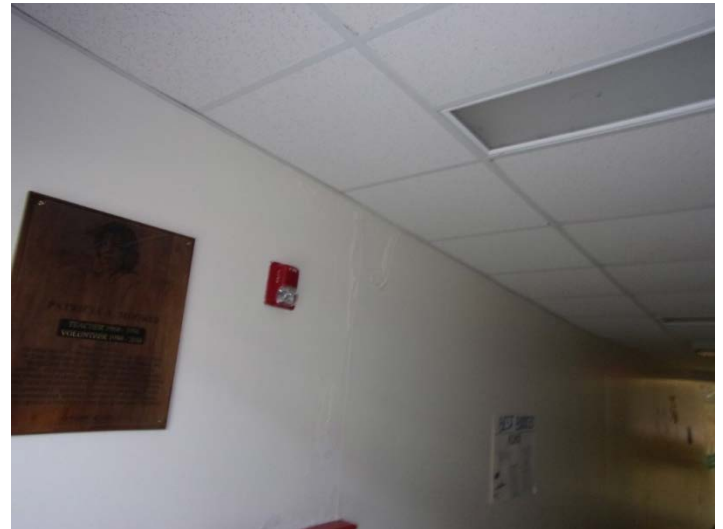
In the interconnecting corridor of the original building near the office and 2000 addition, there are three large stress cracks visible in the exterior hall walls.

Stress Crack in Hallway

Action: We recommend performing a structural analysis in areas with visible signs of stress cracks or damage.

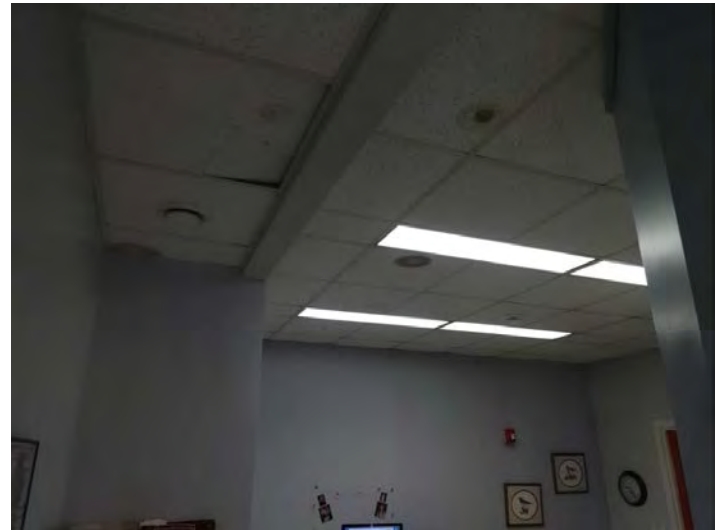
The ceilings consist of mostly suspended acoustical tile grid system in good to fair condition. There are a number of stained tiles due to roof leaks. We recommend replacement after roof repairs are finished. The kitchen has painted drywall. The gymnasium and cafeteria ceiling have stained and varnished knotty pine boards within the glulam arches. The library's vaulted ceiling also has a knotty pine finish. All wood on the ceilings is in good condition, however for the purpose of this report it is recommended the substructure be brought up to current fire code. This would include removal and/or concealing exposed wood.

Ceiling Tile

Action: Replace/install suspended ceilings as they fail. **Priority:** 1 \$ 2,000/yr

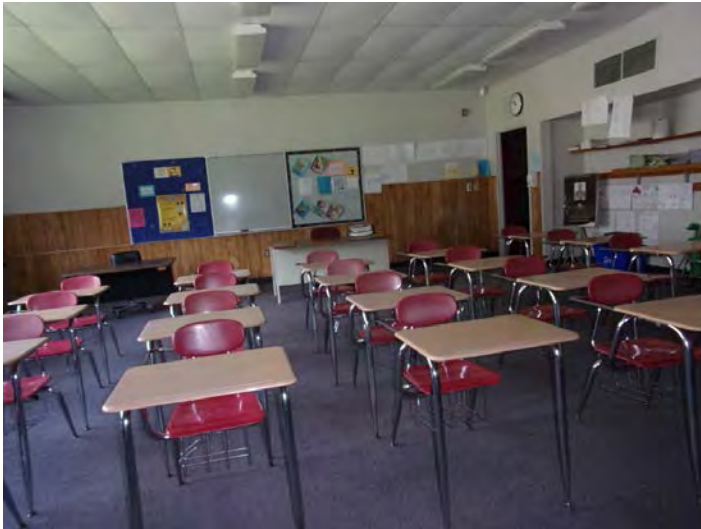
The walls throughout the school consist mostly of drywall and CMU (Concrete Masonry Unit) which appear to be in good condition. The older 1968 walls have painted CMU block the hallways. The 2000 addition has painted drywall in the hallway. The 68/74 classrooms have paneling halfway up the walls with drywall above. Many of the classrooms have wood bookcases on the exterior walls in fair condition. Some of the classrooms have built-in cabinet and storage areas. Also in the 1960s' wing hallway, numerous vertical stress cracks in the drywall are visible. The locker rooms, cafeteria and kitchen walls are exposed painted CMU walls in good condition. The gymnasium walls have wood paneling and insulated sound board above in good condition. The student restrooms in all wings have drywall with ceramic tile wainscoting below; all rooms are in good condition.

Classroom with wood panels

Action: Remove exposed paneling in 1960s' wings, replace with drywall.

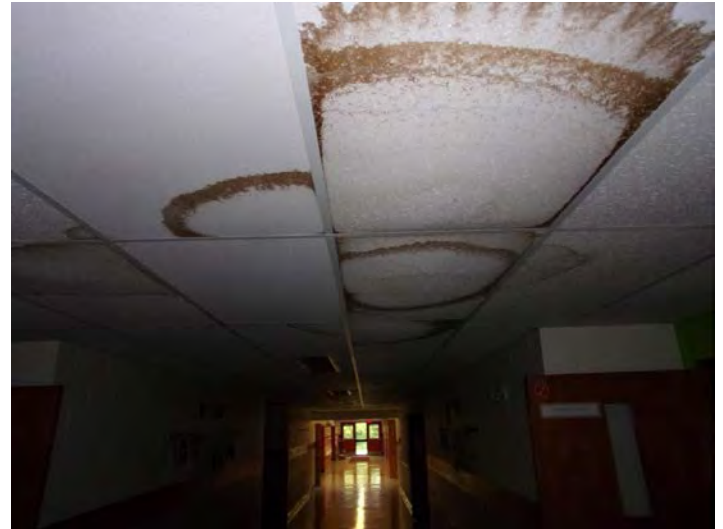
Stained Ceiling Tile

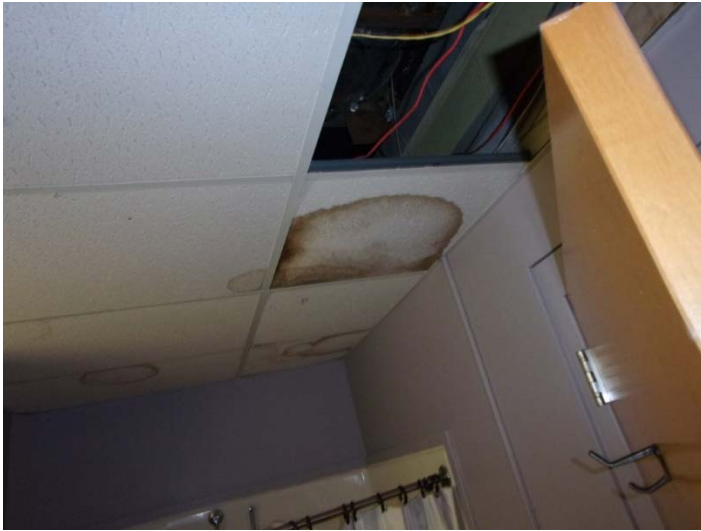
Ceiling Tile Stains

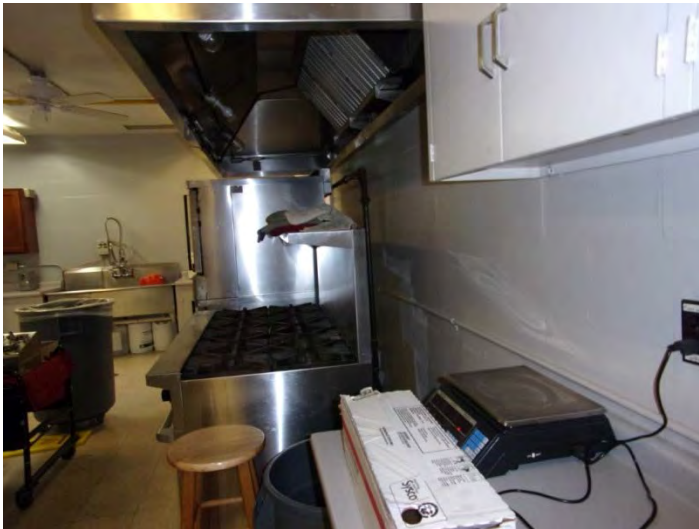
The Kitchen is a full commercial kitchen with appliances, walk-in freezers, coolers, ranges, ventilation hoods, wash stations, and serving lines. The walls are painted CMU block and the floors are VCT tile/painted concrete. The condition and operation of equipment and interiors appear to be in good order. The counter spaces are laminate surface and hard to clean and noted on health inspection. The kitchen's domestic hot water is served via water heater in boiler room. The hot water tank is an 80-gallon unit that is beyond its useful life; additionally the tank does not appear to have a thermostatic mixing valve, which is required by the state plumbing code. The kitchen hood did not appear to be working when tested. The kitchen hood does not meet current guidelines for clearances over appliances. The kitchen hood and makeup air unit should be studied further to ensure adequate ventilation and exhaust rates are being met.

Kitchen Hood

Action: Provide ventilation study and replace hood system.

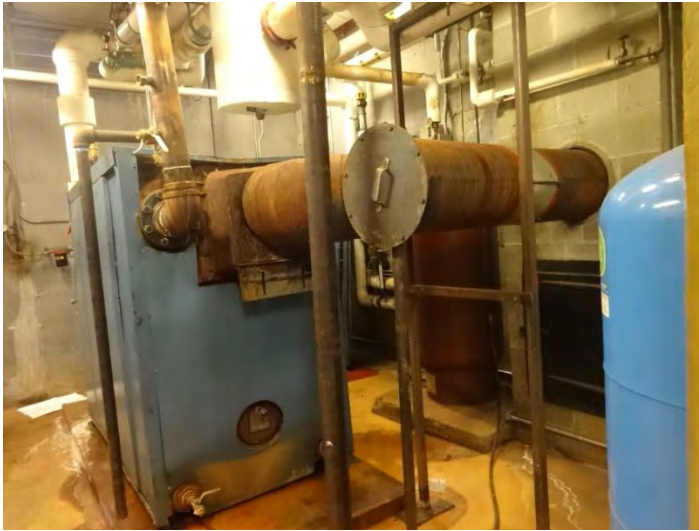
The boiler is exhausted through a masonry flue chimney through the roof. The chimney appears to be lined but could not verify at this time. Boiler breaching was in poor condition and should be replaced as part of the larger boiler replacement project.

Boiler Exhaust

Action: Inspect chimney for any defects or combustible deposits, and repair as stated previously.
