# **HOLDEN ELEMENTARY SCHOOL**

## **ASSESSMENT REPORT**

**November 5, 2019**

## **HOLDEN ELEMENTARY SCHOOL BUILDING ASSESSMENT**

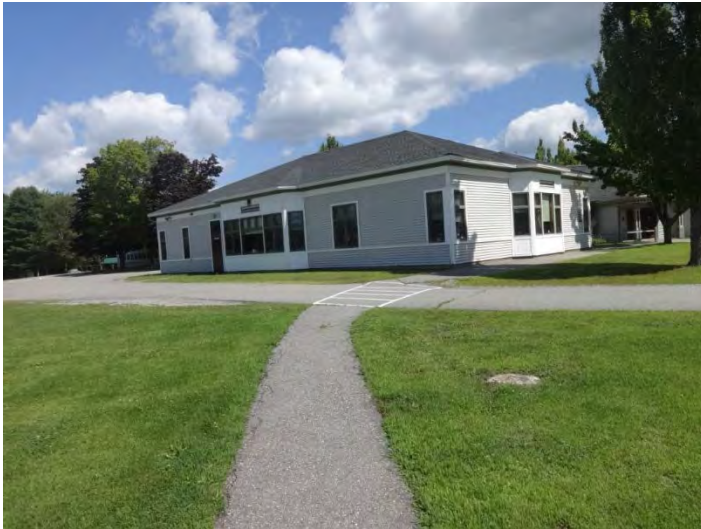
Sidewalk

There is a paved entrance and exit drive from Route 1A that leads to a drive around the building, with parking on the east side as well as the west side. A large parking lot added in 2008 extends to the west of the exit drive. The site includes a network of sidewalks. The pavement is in fair condition overall. The majority of the paved sidewalks are in good condition. Handicap parking, striping and signage, including van accessible parking, should be marked. Access into and out of the site appears to be adequate.

**Action:** Repave sidewalks (back side of school). **Priority:** 1      \$ 12,000

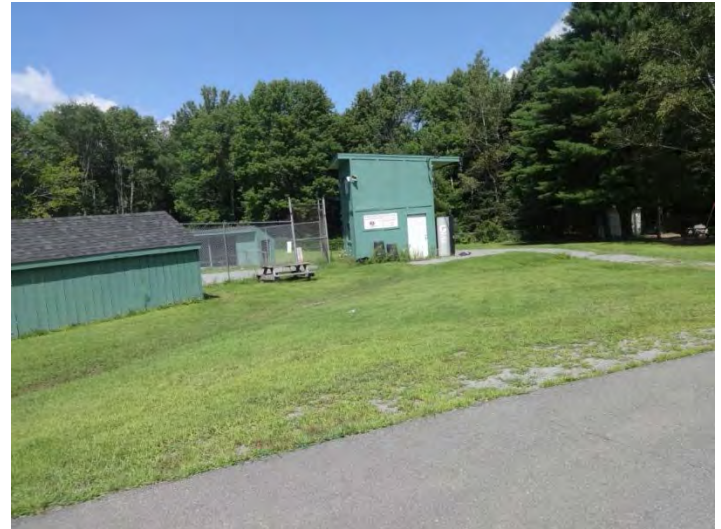
Lighting on Athletic Field

Site lighting consists of 5 pole lights installed in 2008 at the new parking lot, which consist of downward shielding fixtures. The parking lots on either side of the building and athletic fields lack adequate lighting for safety. Building mounted fixtures are in place around the building. We recommend replacing all existing fixtures with LED fixtures. Additional LED fixtures should be placed on the west and east sides of the school to provide secure lighting in several dark areas.

**Action:** Add additional site lighting. **Priority:** 2      \$ 40,000

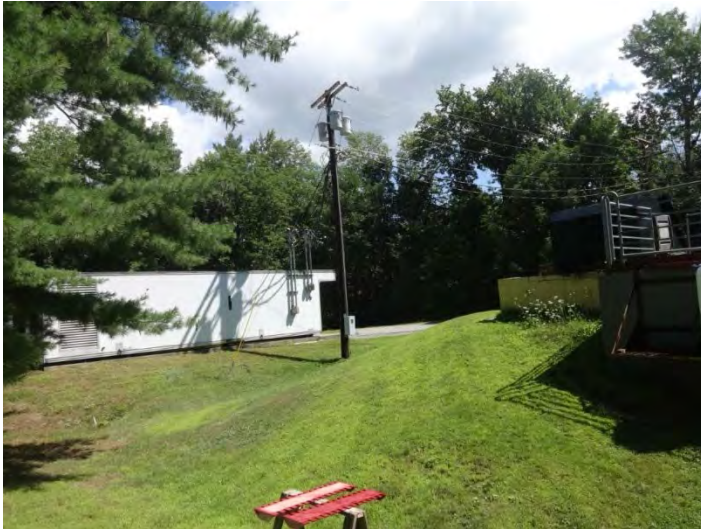
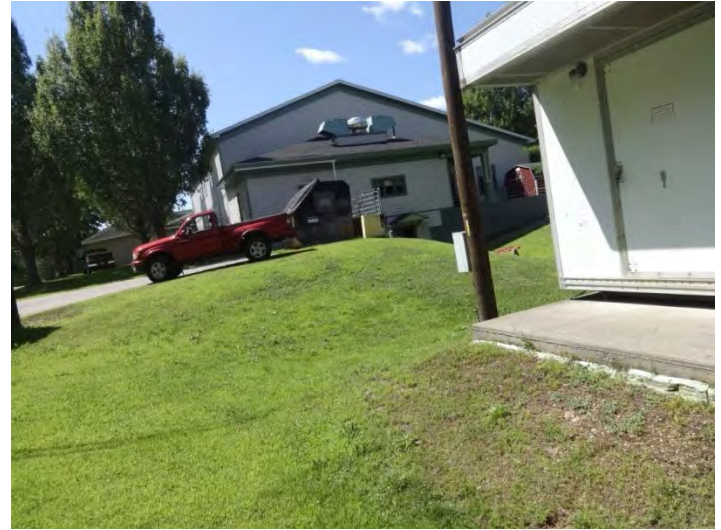
Exterior Drainage

**Action:** Recommend a topography survey and engineering study to alleviate storm water issues in the maintenance entrance area.

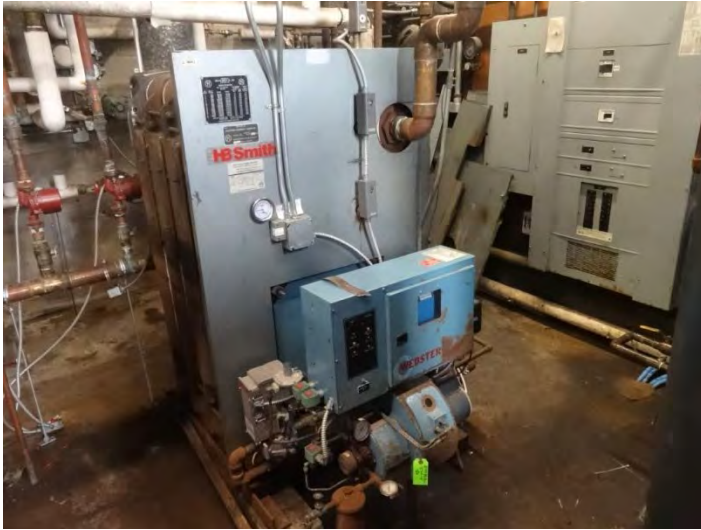
Two hydronic boilers heat the building. The boilers are dual fueled by No. 2 heating oil and propane from an underground 4,000-gallon storage tank, as well as a propane tank farm near the back of the property. Boiler one is a 1996 HB Smith and the other boiler is a 1998 HB Smith. The boilers are fueled with Webster burners. The burners were replaced several years ago, however due to the extremely corrosive environment the burners need to be replaced. As part of the heating plant, there are numerous pumps, tanks, and supply and return piping. Consider replacing the original boilers as it is at the end of their useful life. Continue to maintain equipment per specifications according to Operation and Maintenance manuals. The pumps that distribute the hydronic heat to each wing are single speed. We recommend replacing the pumps with new variable speed pumps, which will reduce energy consumption. The piping that is connected to the boilers is in poor condition, as well as much of the piping that is connected to pumps and associated valves should be replaced as well.

**Action:** Replace original boilers and burners. **Priority:** 2 \$100,000

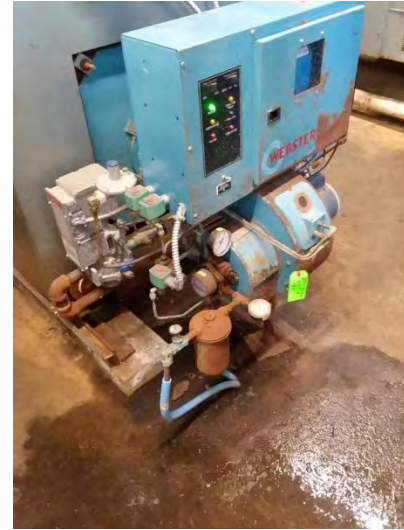
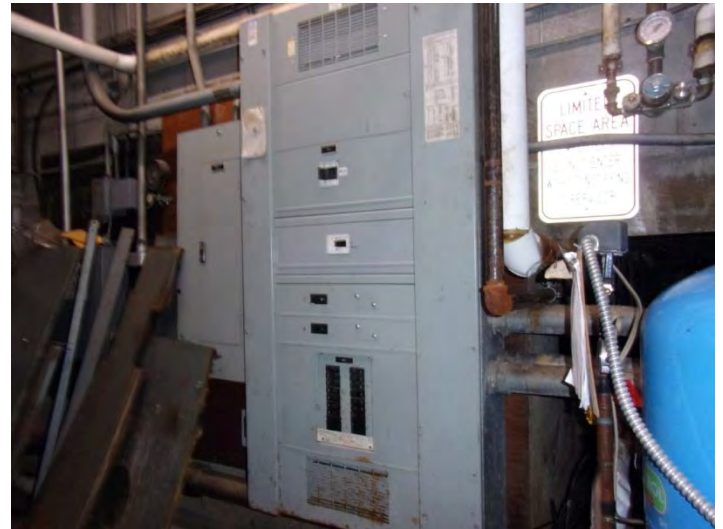
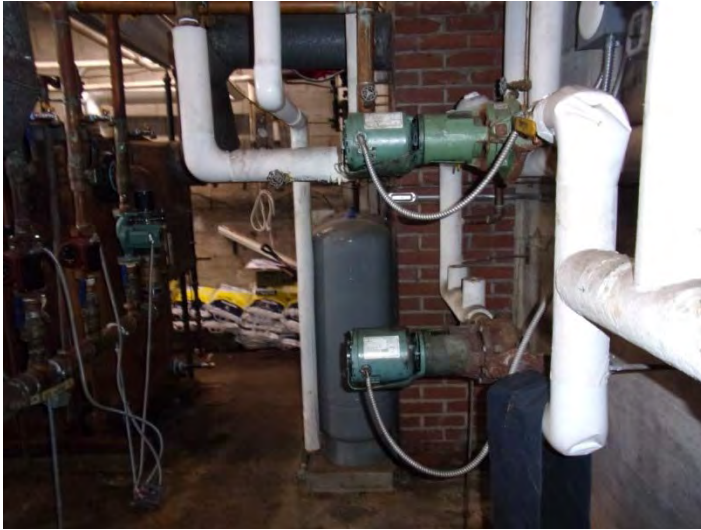
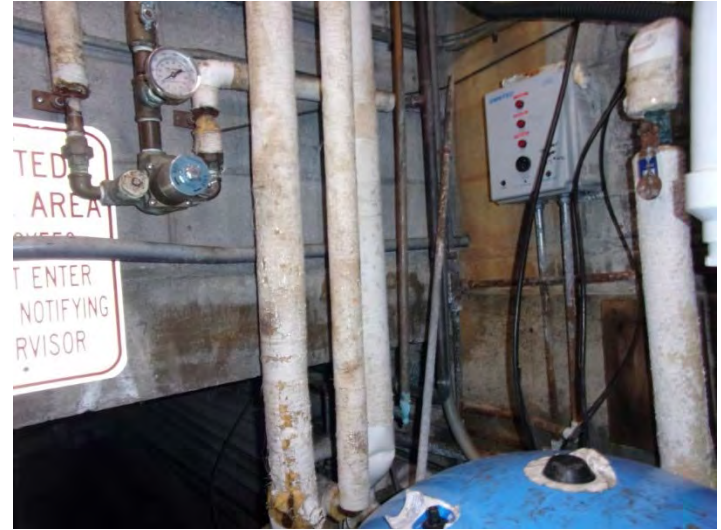
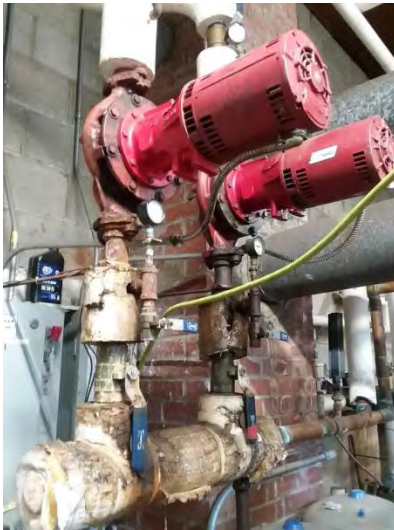
The original boiler room is located under the 1955 wing. The boiler room is in very poor condition. The ceiling has numerous holes and penetrations due to water leaks, poor installation of piping and associated supports, and the age and material of the ceiling. All boiler rooms are required to be completely sealed and fire rated. Water infiltration thru the utility trenches is evident and a sump pump is located in the floor. The doghouse roof is in poor condition and wood framing

is not fire protected. The doors are wood and do not seal the boiler room. The boiler room is a very corrosive environment that houses the boiler, water distribution system, as well as the main electrical panelboard and associated wiring. This is a safety concern.

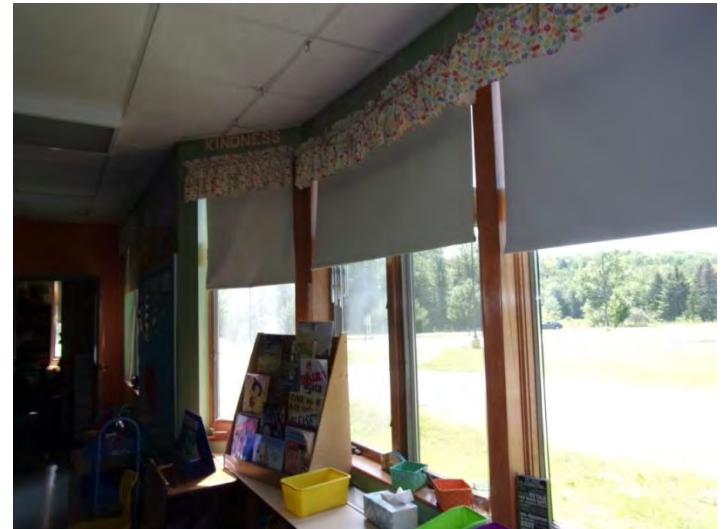
Classroom Wood Framed Windows

The windows located in the original 1955 classrooms are double hung vinyl windows with estimated age of installation in the 90s. Some windows open with difficulty and do not stay open in some cases. The 1990 additions have wood casement windows with stained wood trim. Some of the windows cranking system did not work. There are some windows with condensation between the panes indicating seal failure. Overall the windows are in poor to fair condition.

**Action:** Replace the exterior wood windows (100±) with new vinyl single-hung and casement windows. Modern windows are much improved with higher R-values and should improve energy savings.

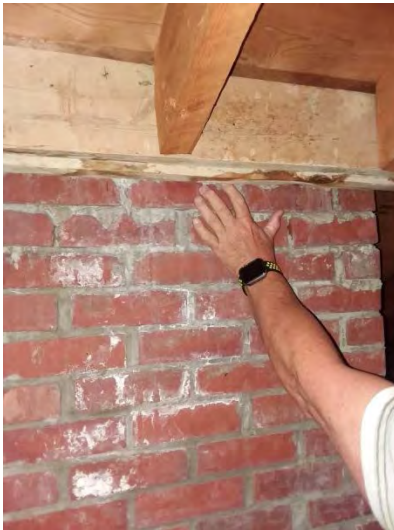
Chimney

The brick chimney is located in the boiler room. The chimney appears to be in fair condition.

**Action:** Inspect chimney for any defects or combustible deposits, and repair as stated previously.

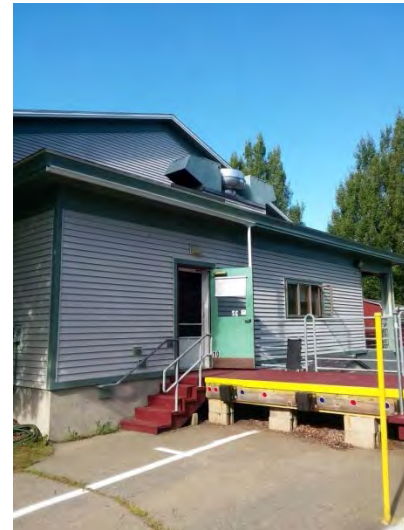
Loading Area

The loading dock is constructed with wood and has concrete blocks for supports. The concrete blocks do not offer resistance to frost movement.

**Action:** Install frost protected loading dock supports. **Priority:** 3 \$ 30,000

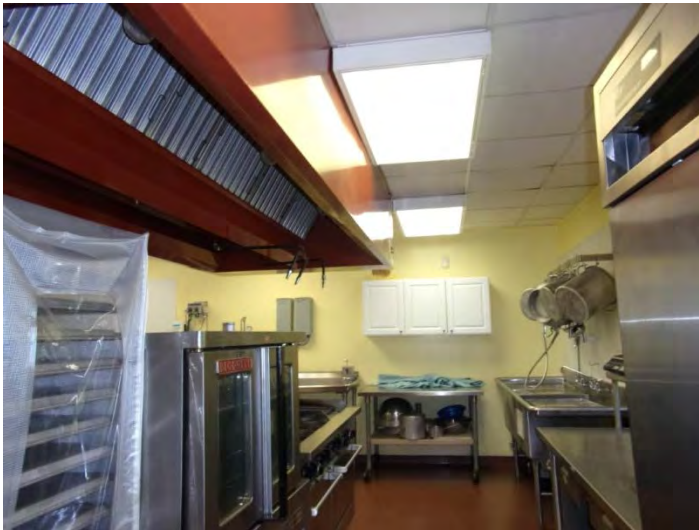
The Kitchen is a full commercial kitchen with appliances, walk-in freezers, coolers, ranges, ventilation hoods, wash stations, and serving lines. The walls are painted drywall and the floors are vinyl sheet goods. The condition and operation of equipment and interiors appear to be in good order. The kitchen's domestic electric hot water is served via water heater in the janitor's room below the kitchen. The hot water tank is a 40-gallon unit that was replaced within the past several years; however the tank does not appear to have a thermostatic mixing valve, which is required by the state plumbing code. The kitchen hood and makeup air unit should be studied further to ensure adequate ventilation and

**Action:** Provide ventilation study and replace hood. **Priority:** 1 \$ 50,000

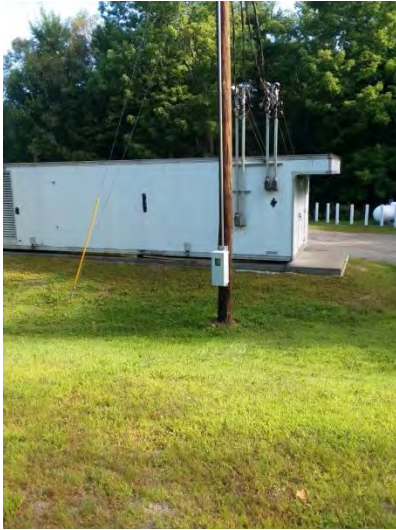
Generator

The emergency generator is a 175kw military surplus generator. The generator is designed to automatically run once there is a loss of power and service the entire building during power outages. The generator is fueled via Diesel. The generator is not currently operational and needs to be replaced.

**Action:** Replace generator and transfer switch. **Priority:** 1 \$150,000

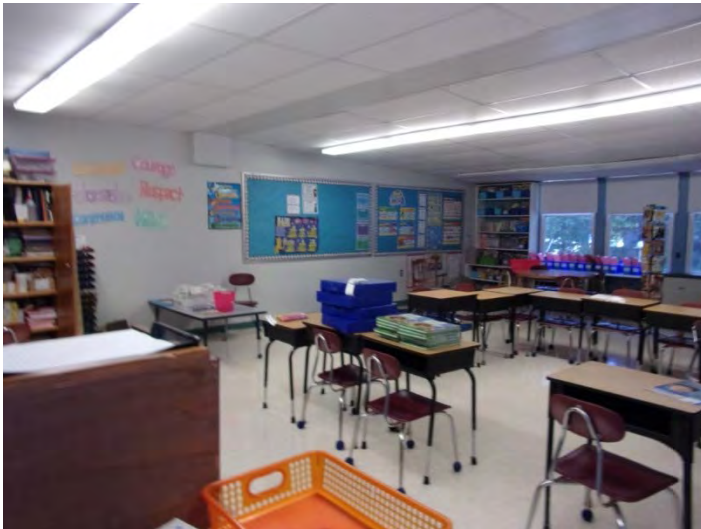
Classroom Lighting

A variety of lighting fixtures are in place throughout the classrooms and common areas. The majority are fluorescent fixtures and appear to be in fair condition. The Gymnasium, Library, and Kitchen have more specific task lighting. Energy savings can be improved with newer LED style light fixtures that also come with occupancy sensors to shut down lighting when not being used. Replacement should result in noticeable energy savings.

**Action:** Replace interior lighting with LED fixtures throughout. **Priority:** 3 \$110,000
