1MWO25001-RPT-01

PRELIMINARY Report – Structural and Fire Protection Concerns at Jenkins Middle School, Colorado Springs, CO

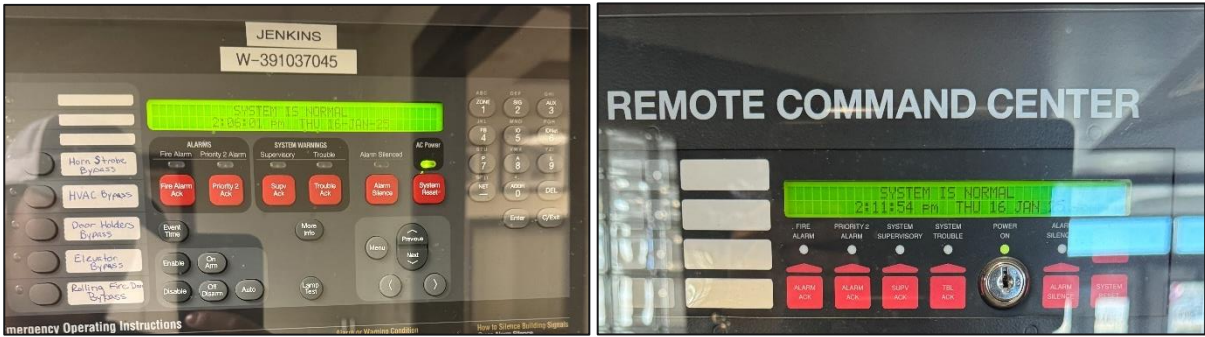
Figure 5.2. JMS Fire Alarm Control Panel and Remote Command Center

- b. **Visual Inspection** – A walkthrough of the fire detection and alarm system in the main areas indicated that the fire alarm initiating devices and notification appliances appeared to be in general good condition, with no apparent damages resulting from structural issues within the building. The fire alarm control panel and the remote command center panel both indicated that the system was normal and had no troubles or faults. Limited inspection of wiring and conduit supporting the system resulted in no findings that could impact system function.

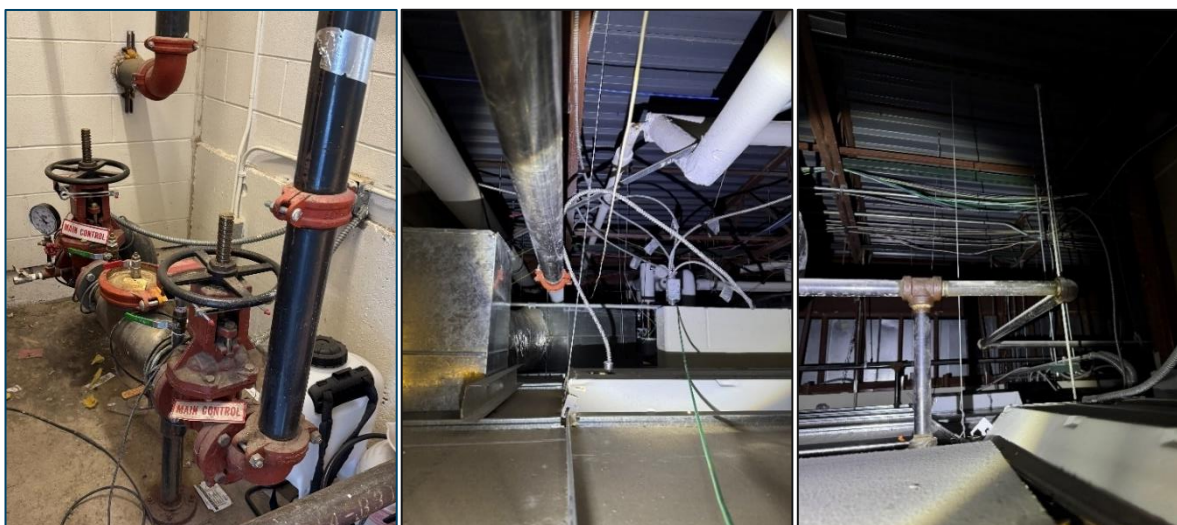
Figure 5.4. JMS Fire Sprinkler System Riser Room and Piping

- b. **Visual Inspection** – A walkthrough of the fire sprinkler system was conducted. At and around the fire riser and fire water entry, there were no apparent signs of damage, resulting from structural issues. The fire sprinkler piping above the ceiling did not have signs of physical damage (cracking, dents, warping, etc.). Fire sprinkler piping appeared to be properly supported and restrained throughout.

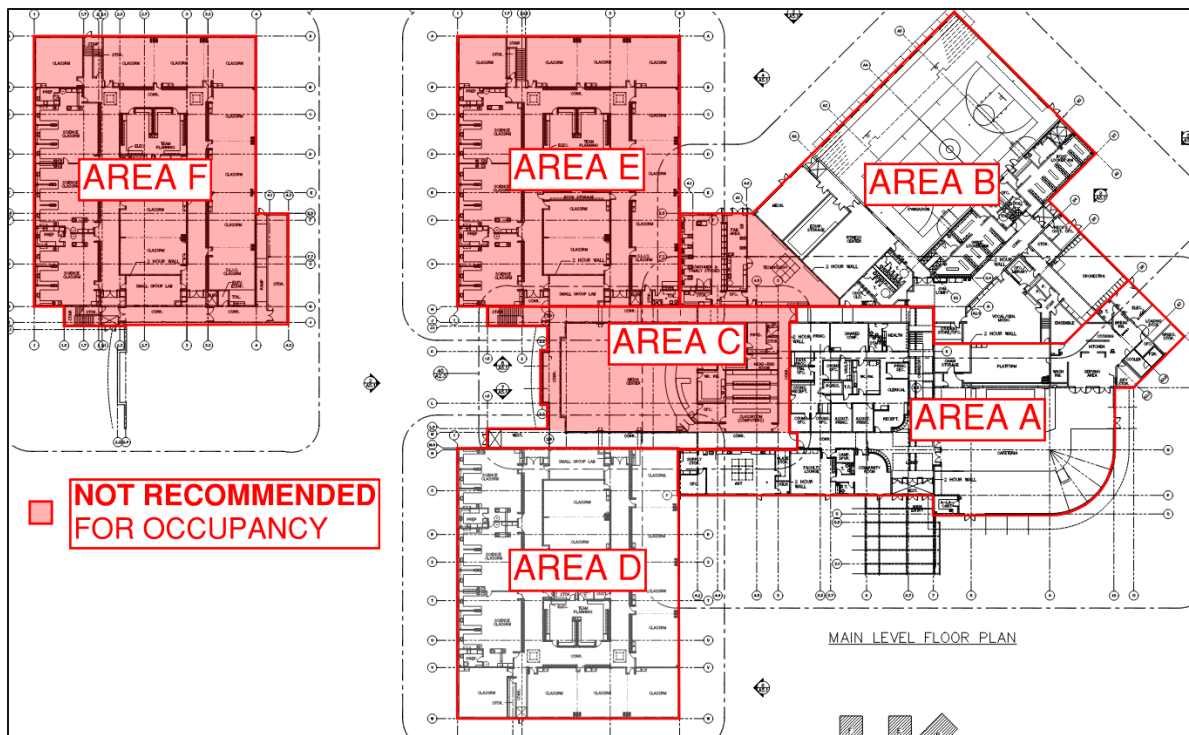
Figure 5.5. Areas Not Recommended for Occupancy by Structural Assessment

1. **Walls** – Walls (both CMU and gypsum assemblies) had significant cracking below and above the ceiling. In some corridor walls, where CMU walls transition to drywall above the ceiling, significant gaps are identified between the transitions due to differential movement of the foundation (primary support for the lower wall sections) and the roof (primary support for the upper wall sections).

2. **Fire Doors** – Excessive door-to-frame or door-to-floor gaps were identified at the top, sides, and bottoms of fire-rated doors. Excessive gaps are also identified around the frame. Many doors have been cut or otherwise modified to fit door frames. Some doors did not latch. Gaskets intended to restrict smoke movement were missing on some doors.

3. **Firestopping** – Multiple penetration seals have started to become dislodged or are completely missing. It is not clear if the dislodged/missing seals are the result of structural movement as opposed to some other condition or issue.

These observations add significant risk to occupants beyond the pre-damaged condition of the structure, and it is recommended that these areas not be occupied until the observations can be remediated.

4. See Figure 5.5 of this report for an annotated drawing of which areas of the site are recommended to not be occupied.

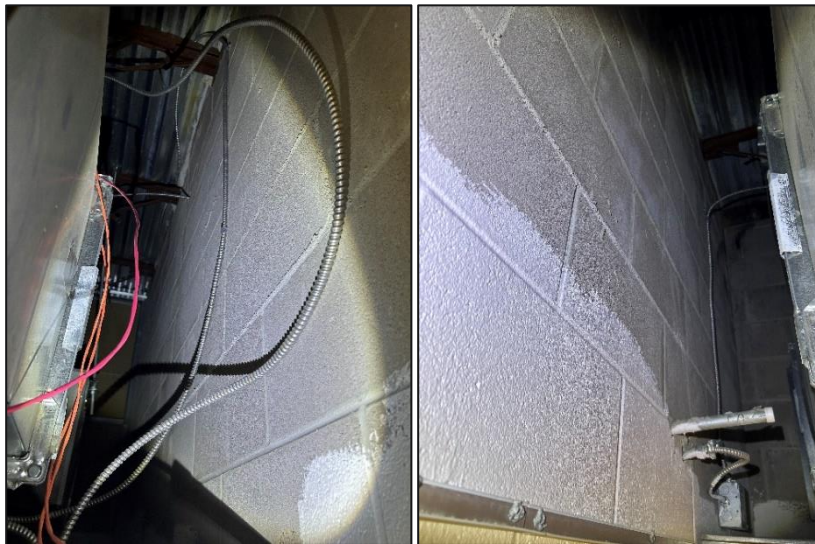
Figure 5.7. Picture of ASW-1 Wall

Construction: This area separation wall is primarily CMU from the floor to the roof deck. No major cracking was observed within the CMU wall.

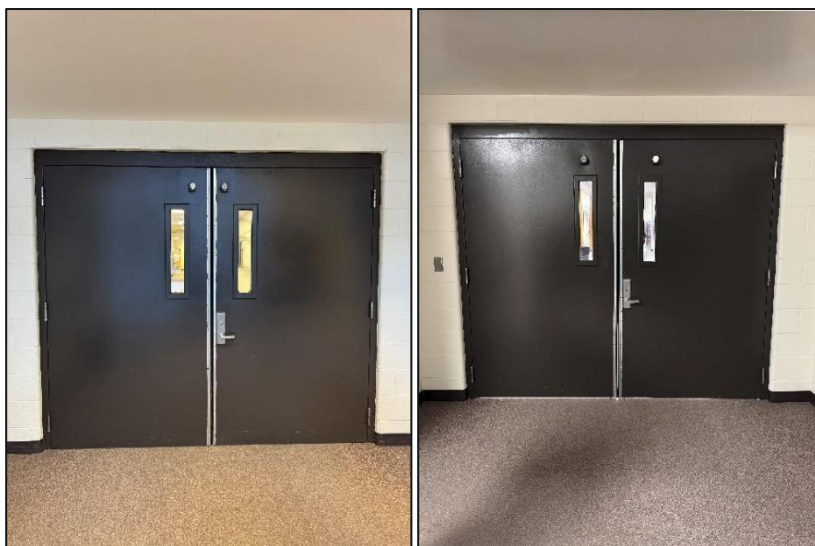
*Figure 5.8. Picture of ASW-1 Doors*

Openings: The two sets of double doors within the area separation wall were provided with magnetic hold-open devices connected to the fire detection and alarm system. The fire detection and alarm system function that would release the doors from the magnetic hold-open devices was not evaluated. The doors were manually released from the hold-open devices for this evaluation. The doors were confirmed to be provided with a listing label, self-closing after manual release, and positive latching. Door-to-frame and door-to-floor gaps were outside of the allowable tolerances. No major damage to the doors was observed.

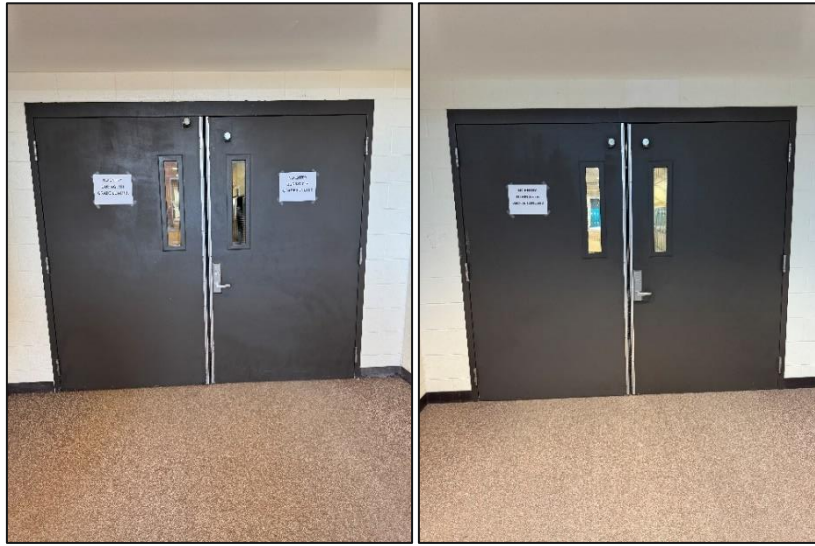
Figure 5.9. Picture of ASW-2 Doors

Openings: The two sets of double doors within the area separation wall were on mag-holds. They were confirmed to be labeled, self-closing, and positive latching. Door-to-frame gaps were outside of the allowable tolerances. No major damage to the doors was observed.

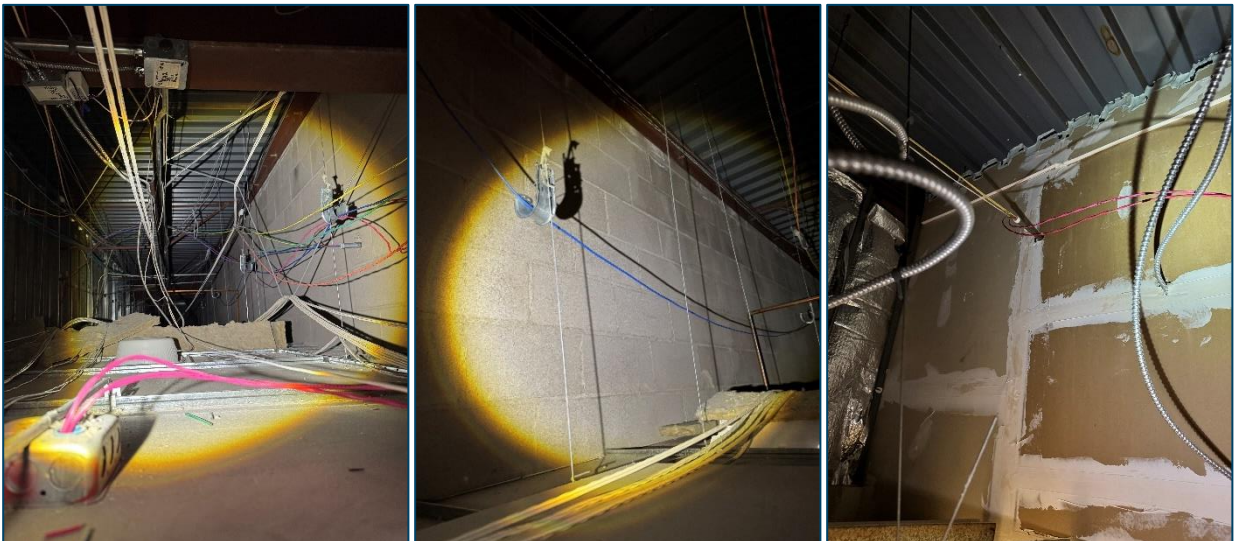
Figure 5.10. Picture of ASW-3 Wall

Construction: This area separation wall is primarily CMU from the floor to the roof deck. No visible cracking within the CMU wall was observed. At the south end of the wall, the wall above-ceiling transitions from CMU to drywall. Within the Kiln Room, the drywall appears to be slightly separated from the deck above. It is unclear if this is a result of structural damage (the floor of the room has significant damage) or if it is a result of thermal expansion of metal construction elements due to the heat from the kiln within the room.

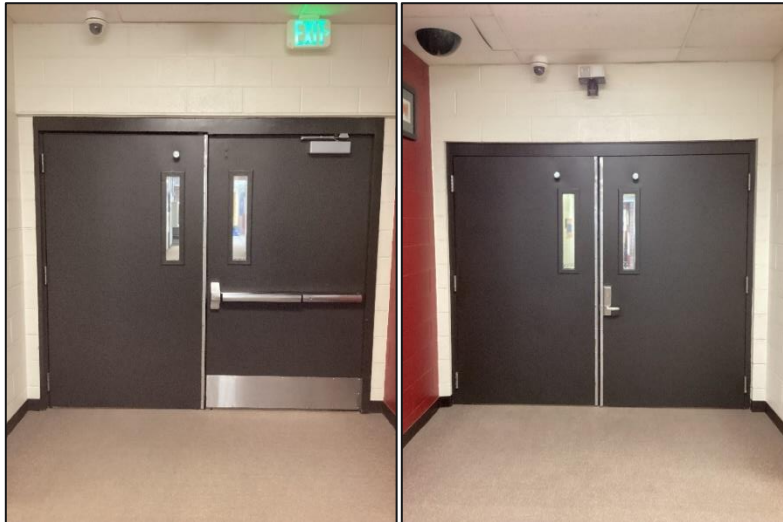
Figure 5.11. Picture of ASW-3 Doors

Openings: The two sets of double doors within the area separation wall were on mag-holds. They were confirmed to be labeled, self-closing, and positive latching. Door-to-frame and door-to-floor gaps were

outside of the allowable tolerances. Windows were provided by rated glazing or fire-rated shutters. No major damage to the doors or windows was observed.

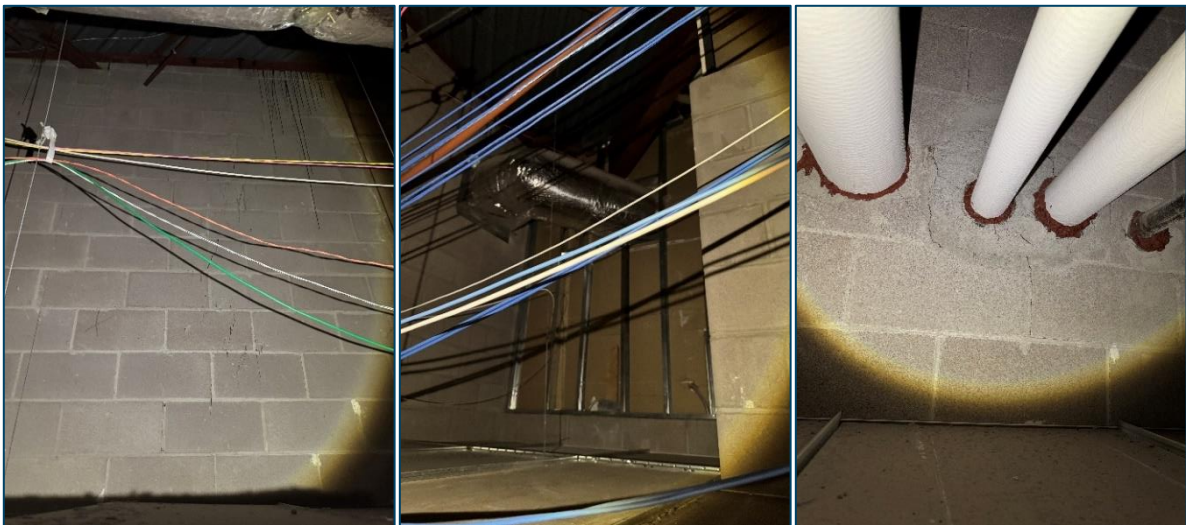
Figure 5.12. Picture of ASW-4 Walls

Construction: This area separation wall is primarily CMU from the floor to the roof deck. In certain areas above the ceiling, the CMU wall transitions to drywall with metal studs. Some visible cracking within the CMU wall was observed below and above the ceiling. Where the CMU transitions to drywall, the transition appears smooth without gaps.

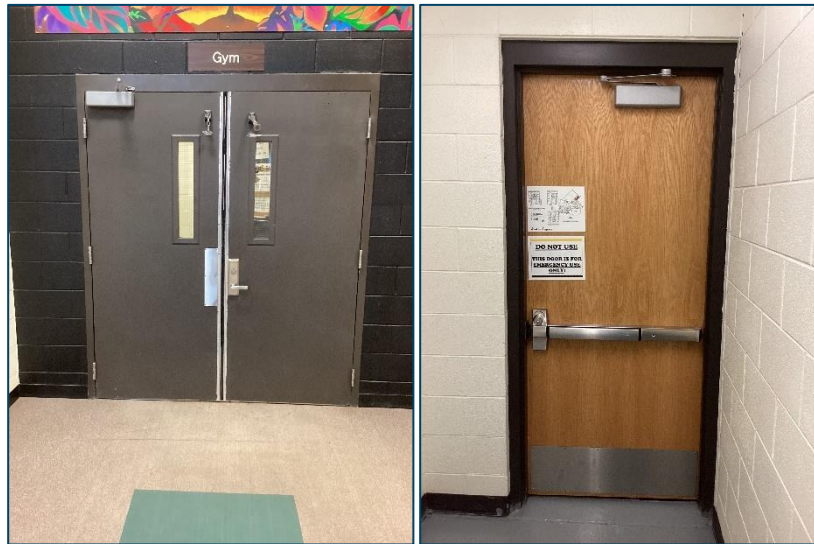
Figure 5.13. Picture of ASW-4 Doors

Openings: There is a set of double doors serving the Gymnasium within the area separation wall on mag-holds. The Boy's and Girl's Locker Room doors were also within the area separation wall. They were confirmed to be labeled, self-closing, and positive latching. Door-to-frame gaps were outside of the allowable tolerances and at least one of the doors has been shaved, and the latch has been modified. Windows were provided by rated glazing or fire-rated shutters. No major damage to the doors or windows was observed.

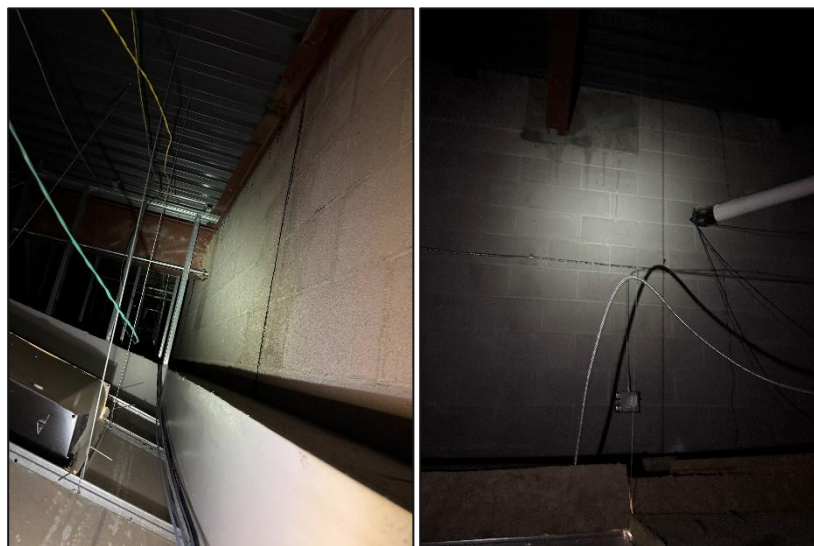
Figure 5.14. Picture of ASW-5 Walls

Construction: This area separation wall is primarily CMU from the floor to the roof deck. No visible cracking within the CMU wall was observed.

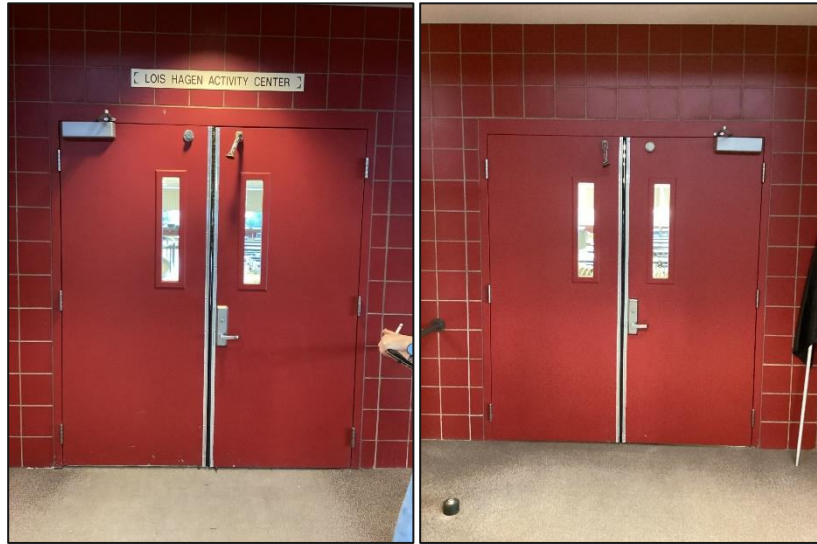
Figure 5.15. Picture of ASW-5 Doors

Openings: The two sets of double doors within the area separation wall were on mag-holds. They were confirmed to be labeled, self-closing, and positive latching. Door-to-frame and door-to-floor gaps were outside of the allowable tolerances. Windows were provided by rated glazing or fire-rated shutters. No major damage to the doors or windows was observed.

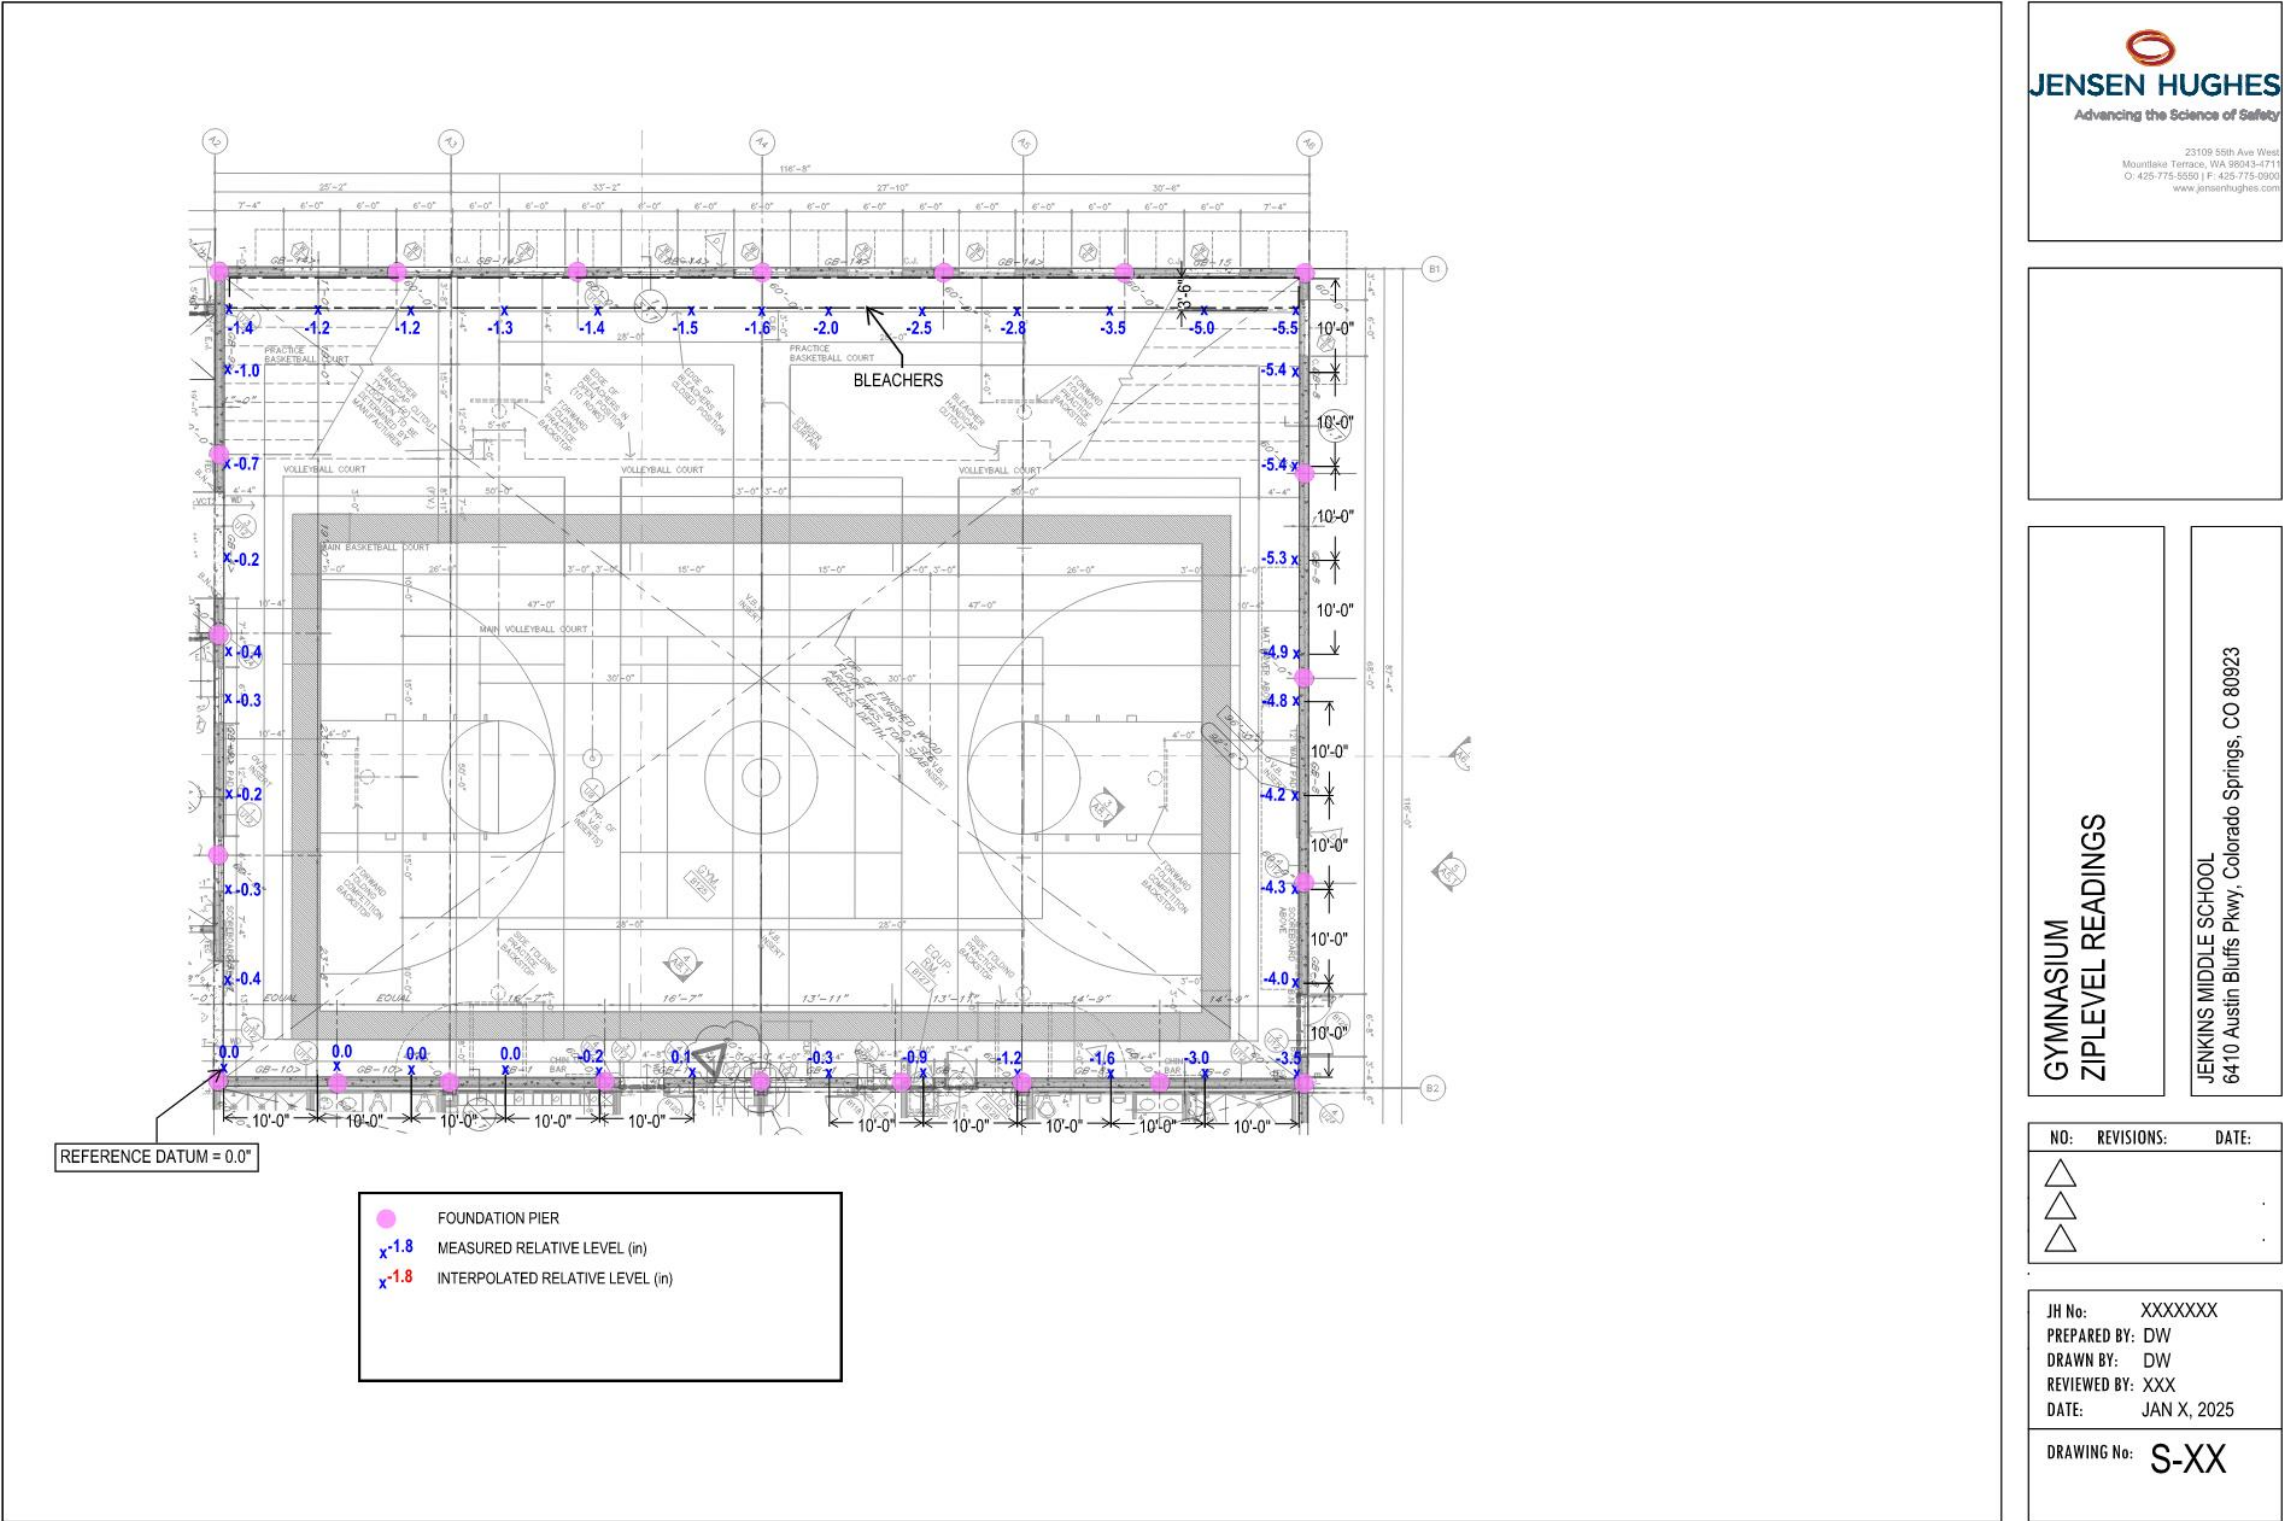
A.1 AREA B (GYM)

2. Area B (Gym, Fitness Center Locker Rooms, Music, Mechanical Room, Consumer & Family Studies Room) contained observable differential displacement and CMU cracking at several places within and near the gym.

These observations are most likely due to foundation settlement of the structure. The upcoming geotechnical report will make a final determination of the root cause(s).

However, to reduce the long-term risk of future differential settlement, remediation of Area B is recommended.

Remediations of Area B will be the subject of a future feasibility study and will range from major repair of the affected walls and foundations to the removal and replacement of the entirety of the Area B structure.

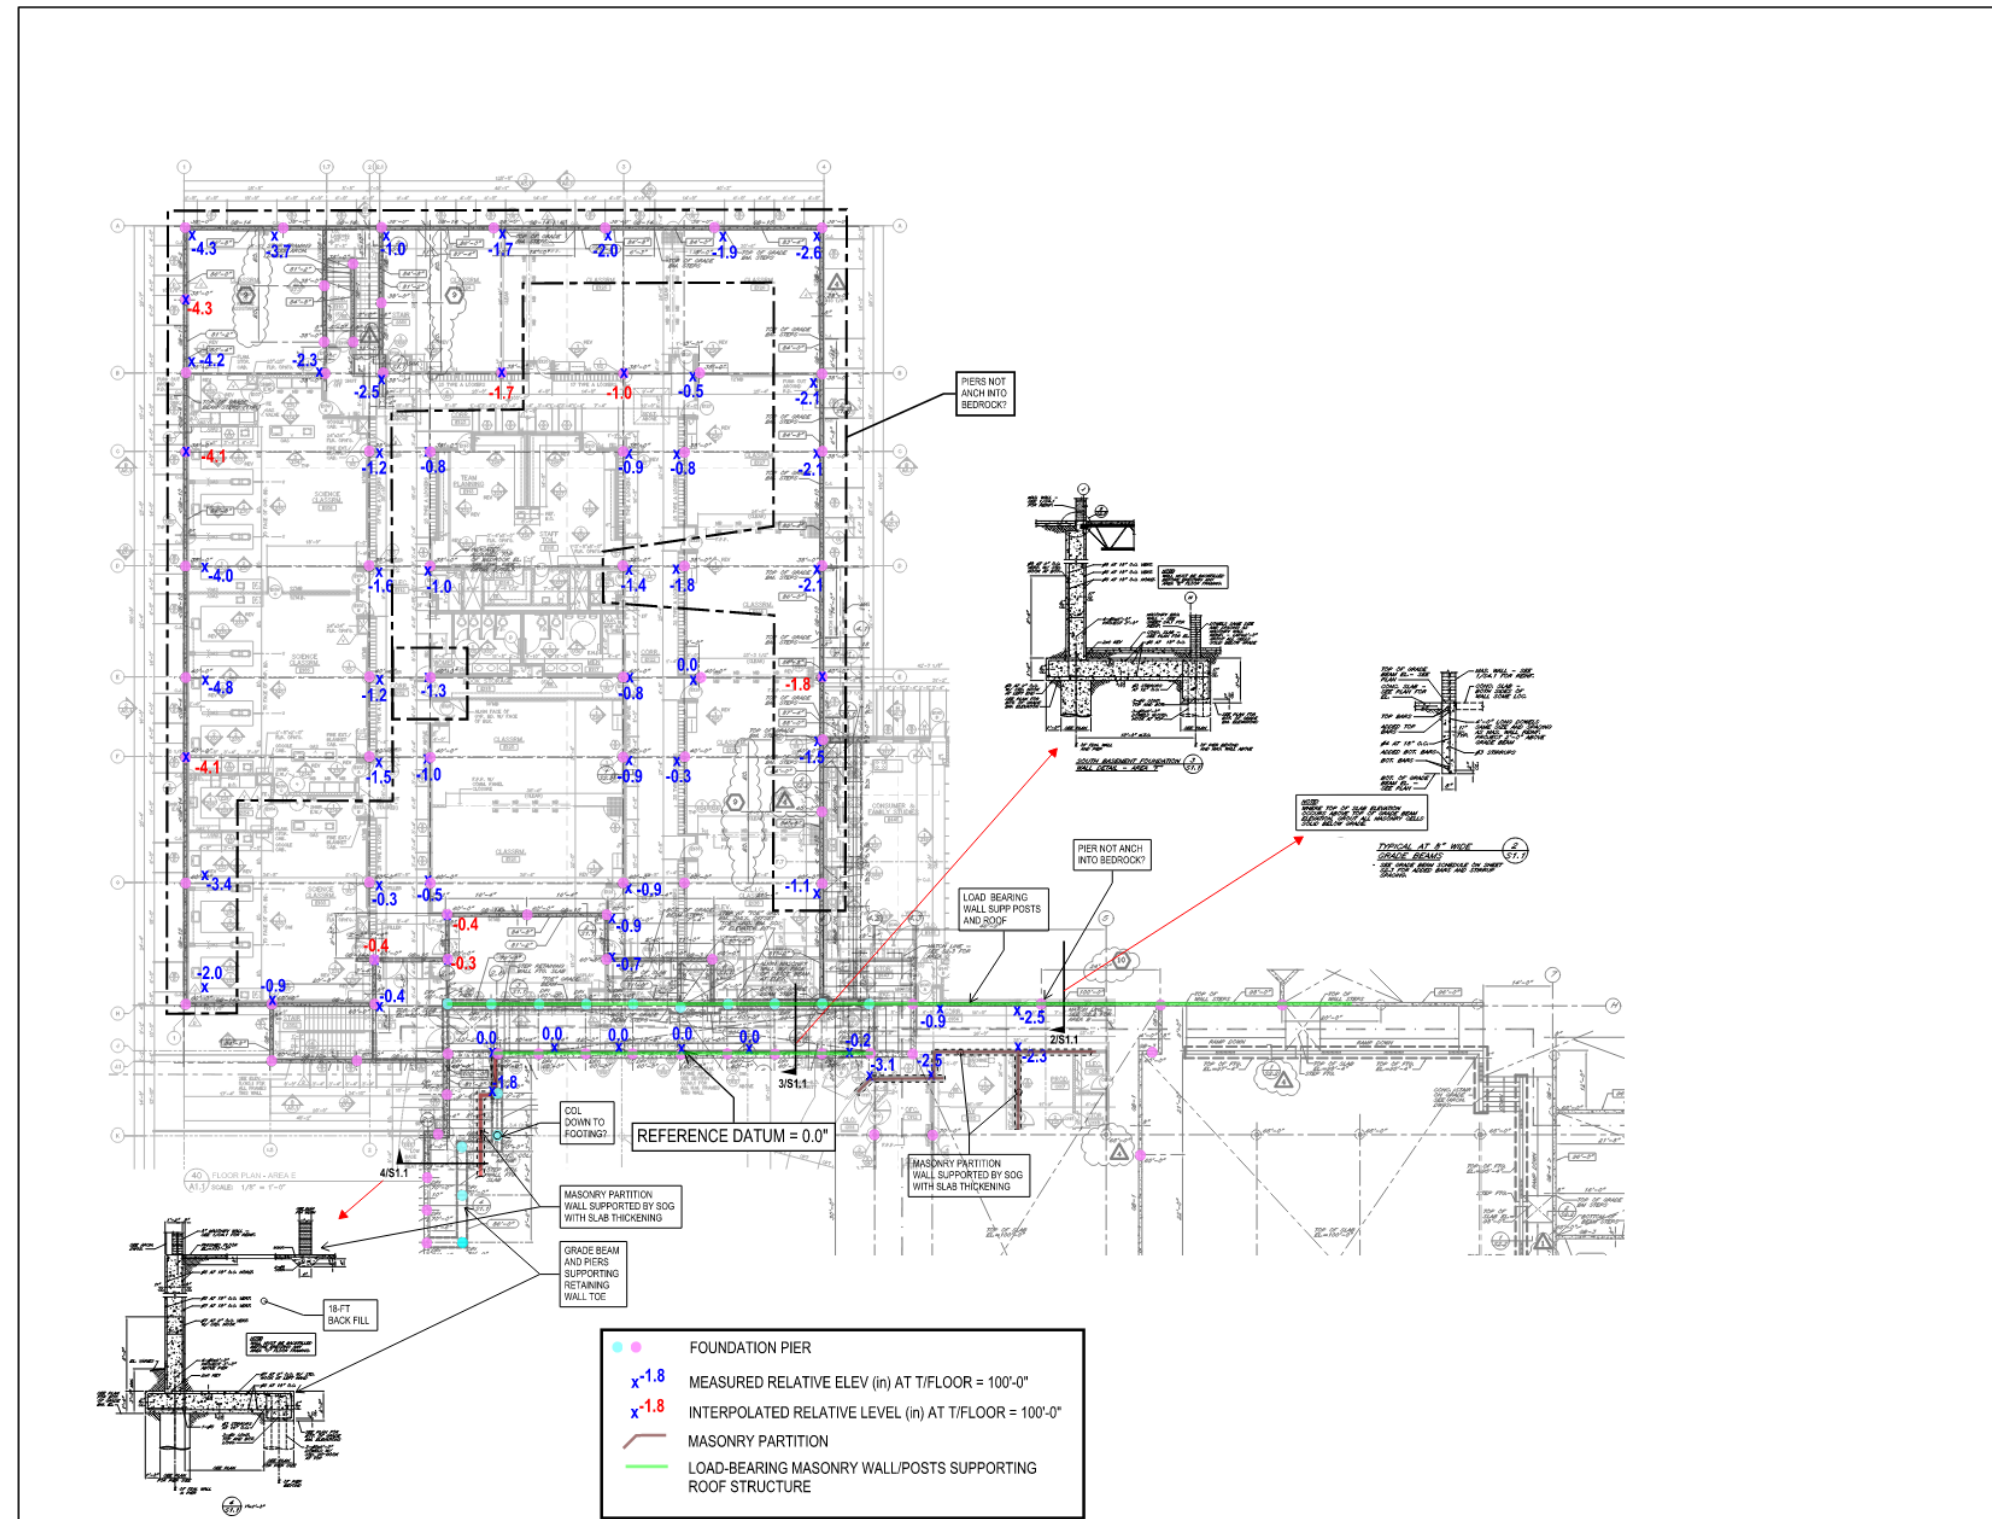
A.2 AREAS C (MEDIA CENTER), E (SEVENTH GRADE), & F (EIGHTH GRADE)

3. Areas C (Media Center), E (Seventh Grade), and F (Eighth Grade) contained observable differential displacement, severe CMU wall cracking, and loss of partition wall restraint at several places throughout the areas.

These observations are most likely due to foundation settlement of the structure. The upcoming geotechnical report will make a final determination of the root cause(s).

Remediations of Area C will be the subject of a future feasibility study and will likely consist of the removal and replacement of the western wall of the Media Center (i.e., the 2.6-Line wall).

Remediations of Areas E and F will be the subject of a future feasibility study and will range from major repairs of the affected walls, foundations, and structural framing to the removal and replacement of the entirety of the Areas E and F structures.
