Town of New Hartford, Connecticut  
**Air Quality & HVAC  
Review for New Hartford  
Schools  
New Hartford Elementary  
School**

## **TOWN OF NEW HARTFORD REPORT**

Prepared for:  
**New Hartford, CT**  
**New Hartford Elementary School, Pine Meadow, CT 06061**

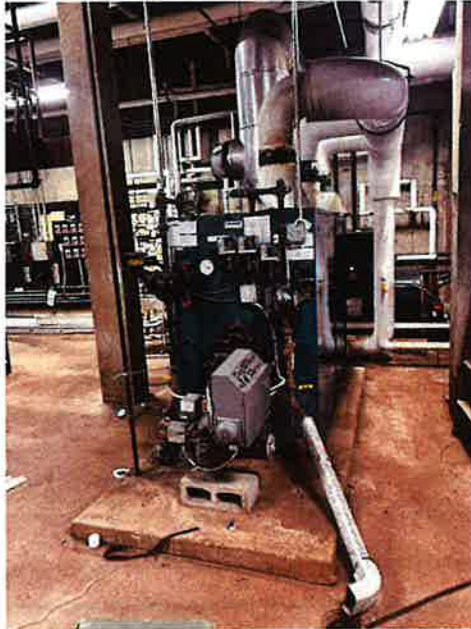
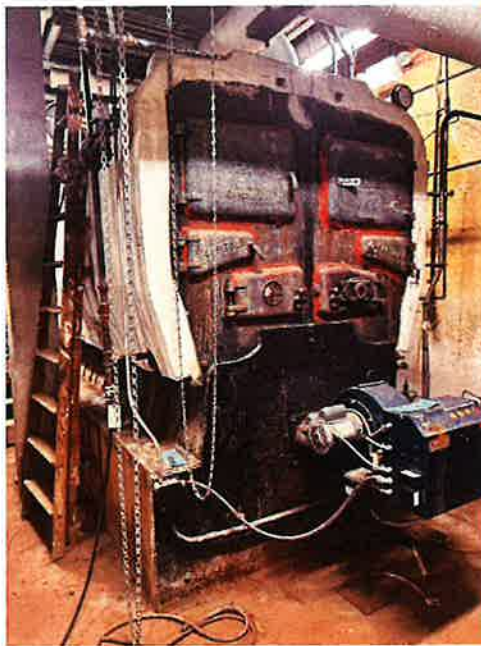
Photo 1: Steam Boilers

There are two (2) fuel oil fired steam boilers that serve the schools (see Photos 1 and 2: Steam Boilers).

The Burnham boiler is in good condition and the other, SP+A was informed is well beyond its useful lifespan. With proper maintenance, the typical lifespan of a cast iron boiler is about 35 years. For current consideration, SP+A recommends testing all the steam traps in the system to ensure that there is no steam leaking by.

For future consideration, SP+A recommends replacing both the boilers with propane fired condensing boilers. Changing the fuel to propane can provide savings for the building and condensing boilers are more efficient than traditional cast iron boilers because they recover heat from the flue exhausts. Installing condensing hot water boilers will require the removal of all steam piping, traps and fittings as well as the installation of hot water piping and equipment.

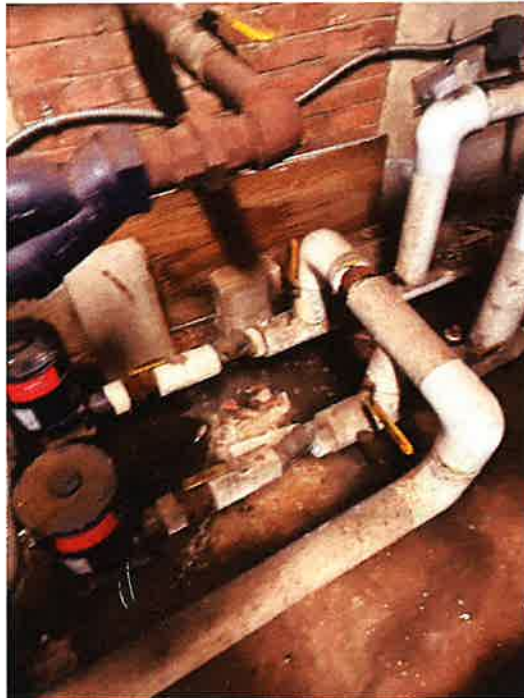
Photo 1: Condensate Insulation

The existing steam and condensate insulation is in poor condition as well (see Photos 1 and 2: Steam and Condensate Insulation).

SP+A also recommends insulating the entire steam and condensate recovery system with insulation in compliance with energy code.

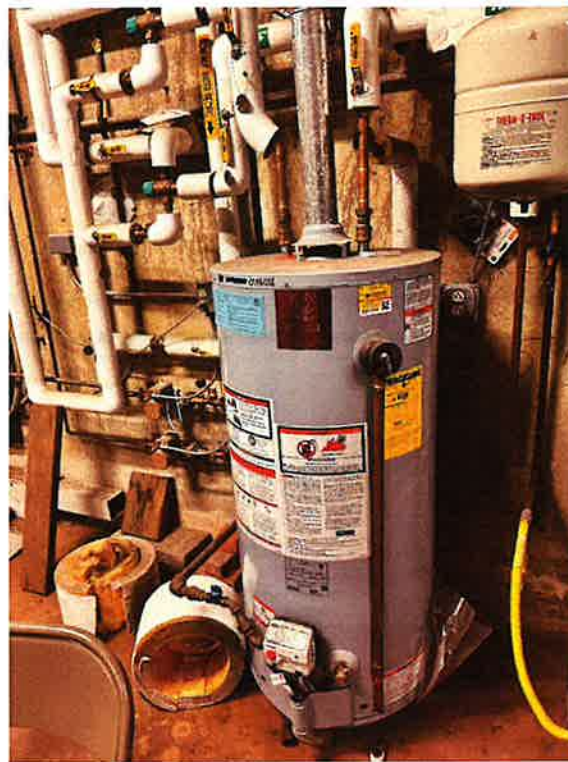
Photo 3: Domestic Hot Water Heater

There is one (1) propane fired domestic hot water heater (see Photo 3: Domestic Hot Water Heater)

The heater was manufactured in 2015 and is in good condition. The typical lifespan of a propane fired domestic hot water heater is about 10 years. SP+A recommends replacing the domestic hot water heater with a new propane fired heater and insulating the piping with code compliant insulation. The Taco hot water recirculation pumps are in fair condition. SP+A recommends replacing the hot water recirculation pumps with new pumps with electrically commutate motors (ECM). ECMs are more efficient because they have less motor losses than traditional motors.

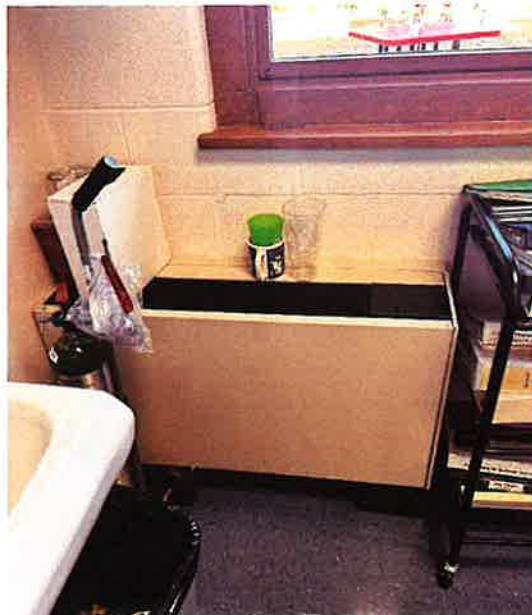
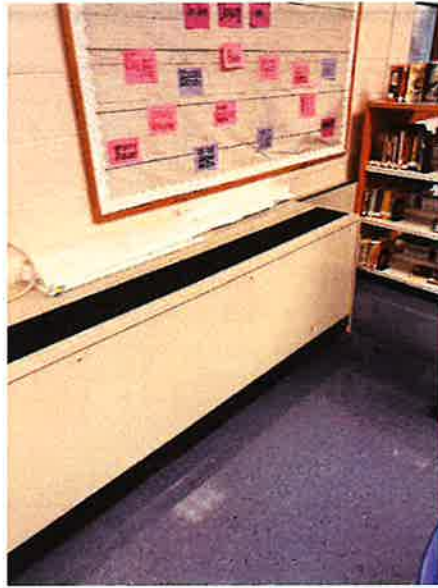
**Photo 5: Unit Ventilator**

The multiple unit ventilators in the school serve offices and Gymnasium (see Photos 5 and 6: Unit Ventilator).

Unit ventilators are not good solutions for air quality concerns because they pull return air through the bottoms of the units and drag dust and debris across the floor. SP+A recommends removing all unit ventilators and replacing them with the proposed hot water fin tube radiation. To provide ventilation air to those spaces, SP+A recommends installing dedicated outdoor air systems (DOAS). DOAS units serve only the code required ventilation air to the classrooms and offices which is an energy efficient option that will improve the school's overall air quality. Coordination will have to be done to determine the best location for the DOAS units.

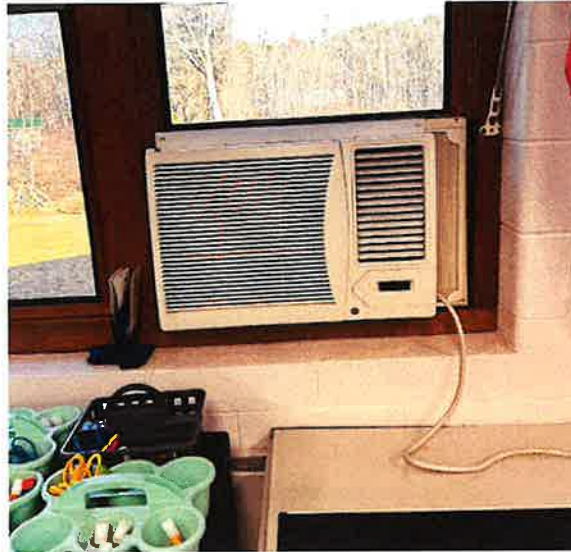
Photo 7: Window Air Conditioner

Many of the classrooms install window air conditioners in warmer weather (see Photo 7: Window Air Conditioner).

To provide heating and introduce cooling to the building, SP+A recommends installing variable refrigerant flow (VRF) heat pumps. Heat pumps provide heating or cooling by removing or adding heat to the space depending on the system. VRF changes the flow of the refrigerant to modulate the heat transfer capability of the system depending on the heating and cooling load. Overall, VRF is an energy efficient system that will provide supplemental heating to the fin tube radiation as well as introduce cooling to the building. Provisions will have to be made for the heat pump outdoor units and their locations.

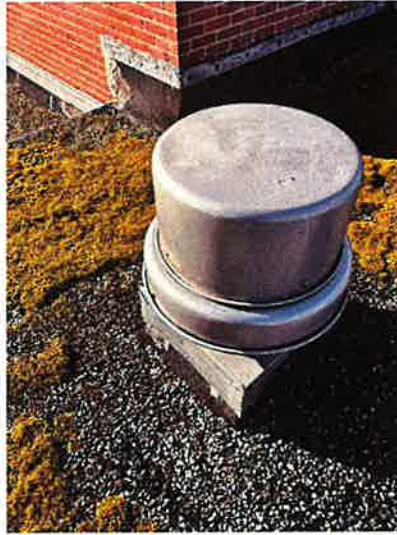
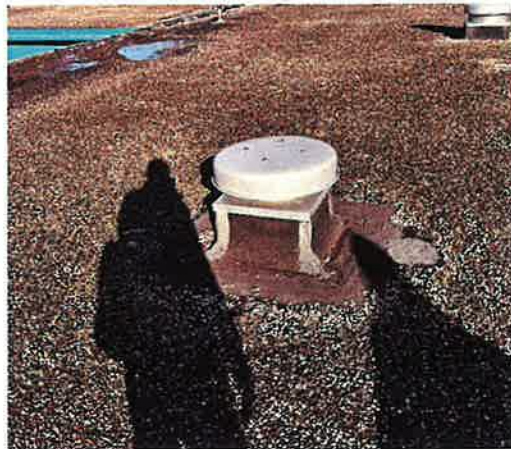
Photo 8: Rooftop Exhausts

Many of the rooms that require exhaust have no mechanical ventilation, which is a code violation as they are to be negative pressure spaces to contain odors and gases.

Many of the existing exhaust fans are in only fair condition as well (see Photos 8 and 9 Rooftop Exhausts).

SP+A recommends replacing all the exhaust fans in the school to ensure that the proper spaces are negative pressure according to CT mechanical code. For all applicable exhaust fans, SP+A recommends variable speed fans that change their exhaust capacities based on what is required.

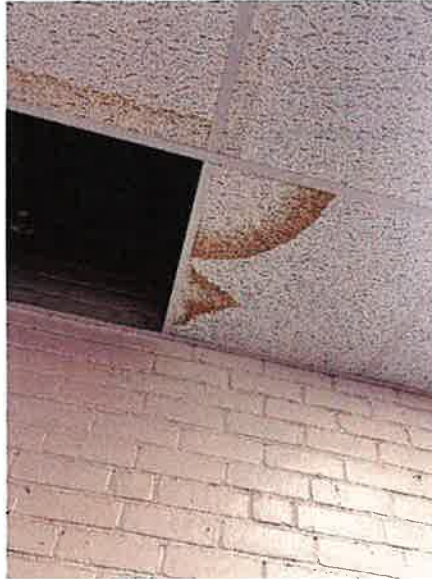
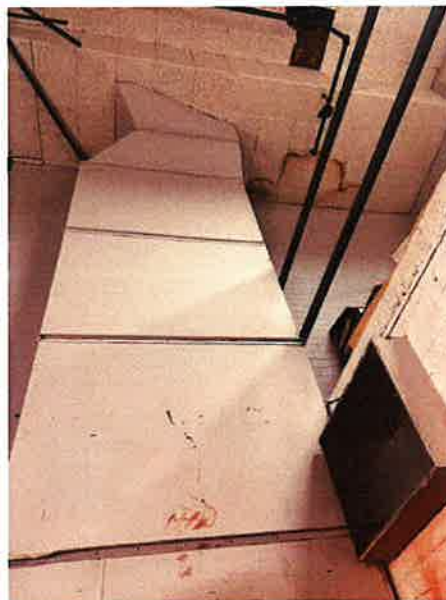
Photo 10: Ceiling Discoloration

- There is some ceiling discoloration which could be a sign of a humidity issue or a leak (see Photos 10 and 11: Ceiling Discoloration).

SP+A recommends investigating all ceiling and wall discoloration as well as the wall peeling to determine what the source of the moisture is. Any form of moisture or humidity build up can promote the growth of microorganisms and decrease the overall quality of the air.

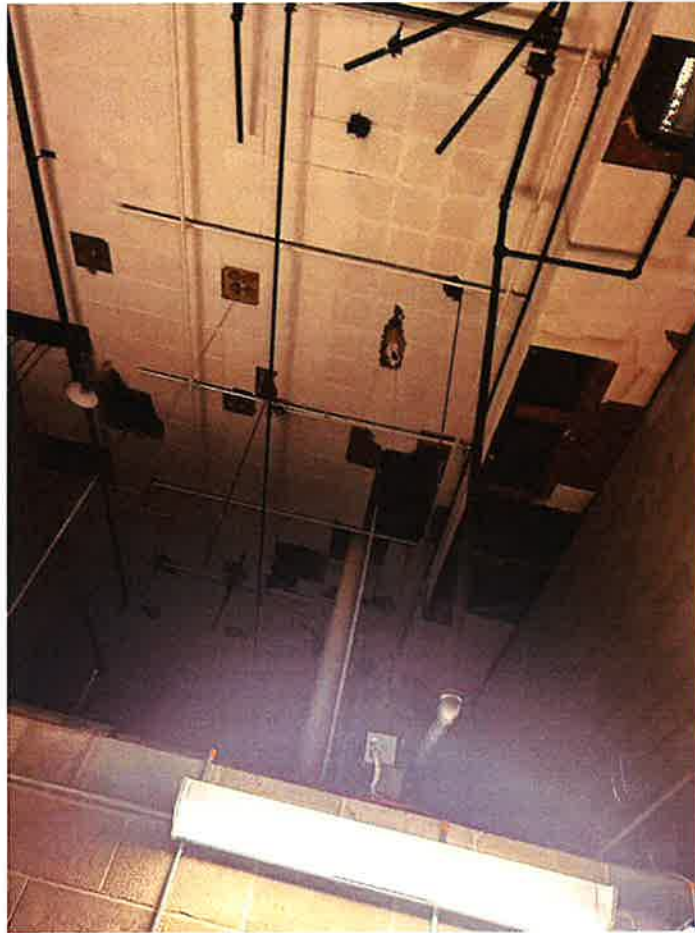
Photo 12: Gymnasium Ceiling

- The Gymnasium is missing various sections of the ceiling (see Photo 12: Gymnasium Ceiling)

When sections of a ceiling are missing, the particulates above the ceiling are more likely to fall into the occupied space and affect the air quality. SP+A recommends replacing all ceilings that are past their useful lifespans and ensuring the above ceiling spaces are adequately sealed.
