## Burbank Early Childhood School Physical Assessment

January 24, 2025

# UPPER ARLINGTON SCHOOLS 2025 FACILITIES ASSESSMENT BURBANK EARLY CHILDHOOD SCHOOL

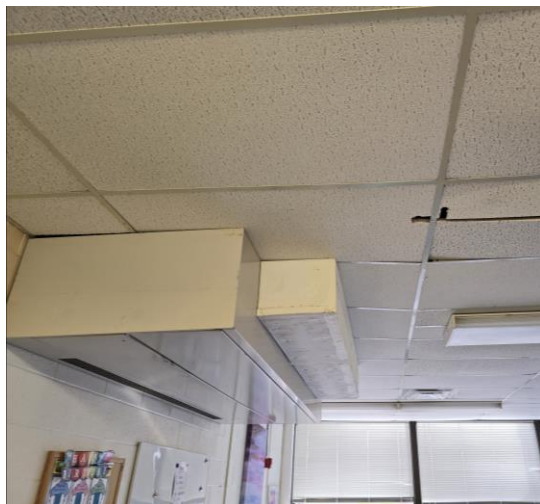
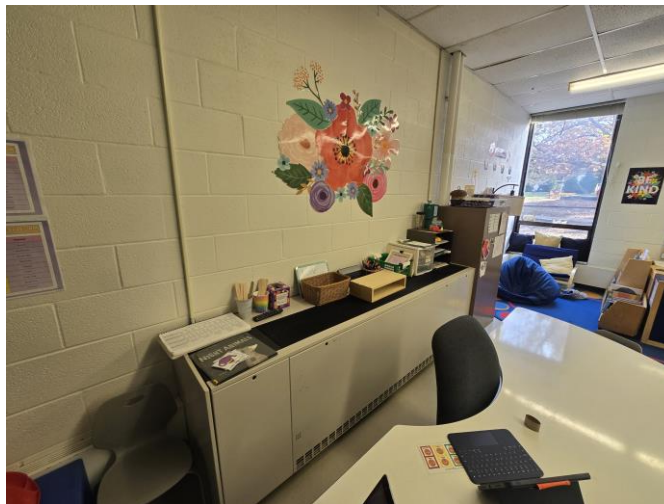
Classroom unit ventilators are original to the building, noisy, disruptive to teaching and inefficient.

- Gymnasium air handling unit replacement with effective cooling of space.
- Various HVAC replacements: classroom ventilation, kitchen and general building exhaust.

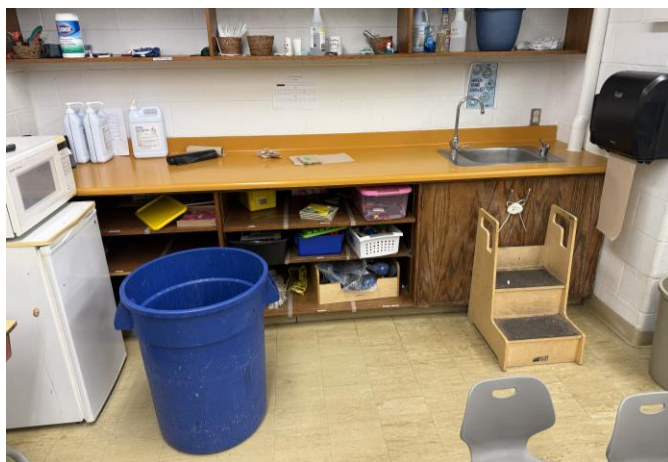
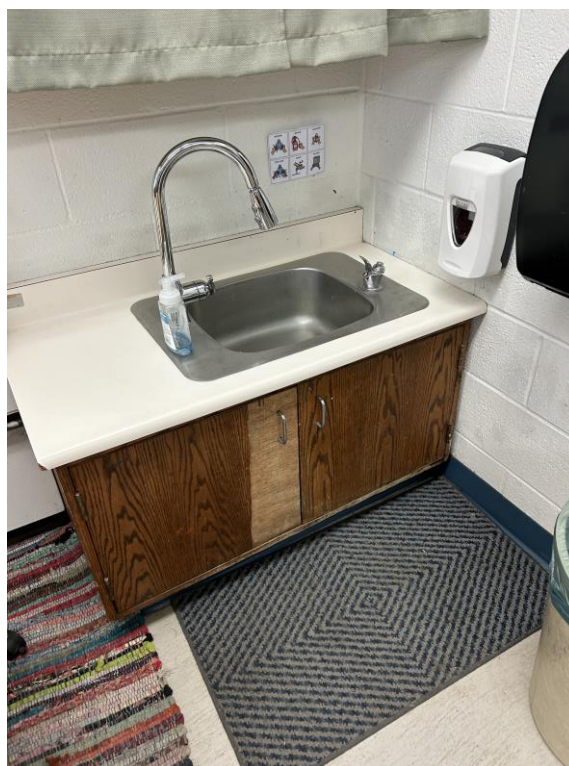
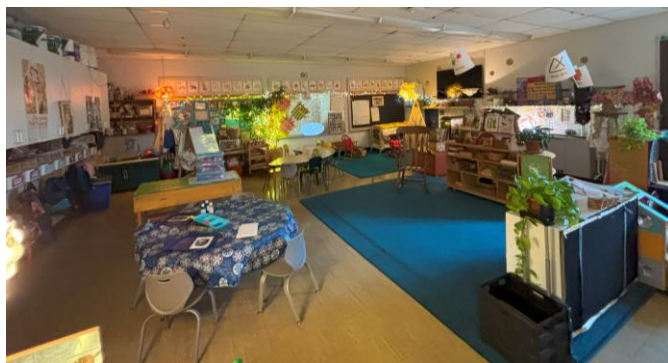
*Built-in cabinets are original, delaminating, damaged and limited, which minimizes the ability to store classroom materials.*

| a. | ACT ceilings are in poor condition due to age and water/moisture damage. Casework in classrooms are original, delaminating and in poor condition. |

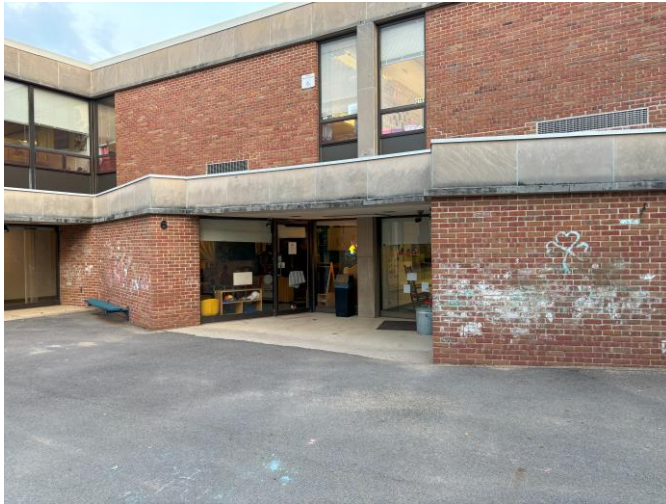
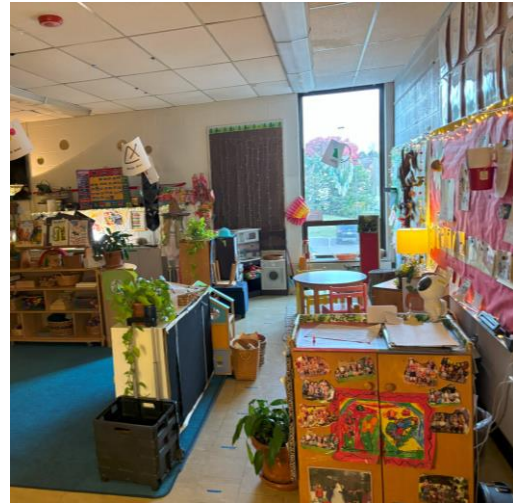
*Original non-insulated single pane aluminum windows with limited daylighting in each classroom.*

| a. | Replace all exterior windows and storefront in the facility. |

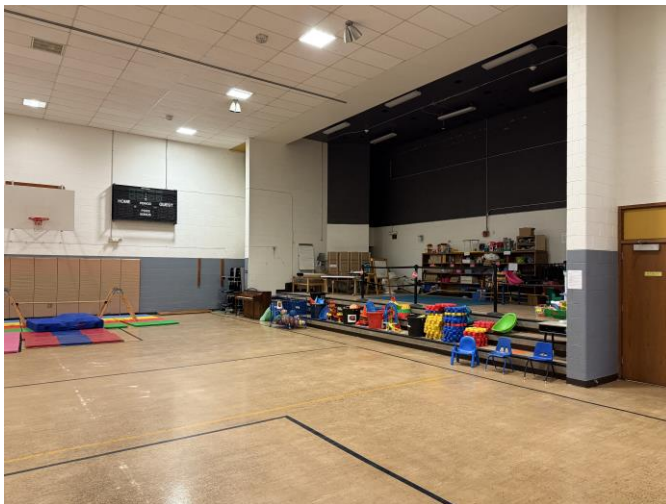
Gymnasium without air conditioning

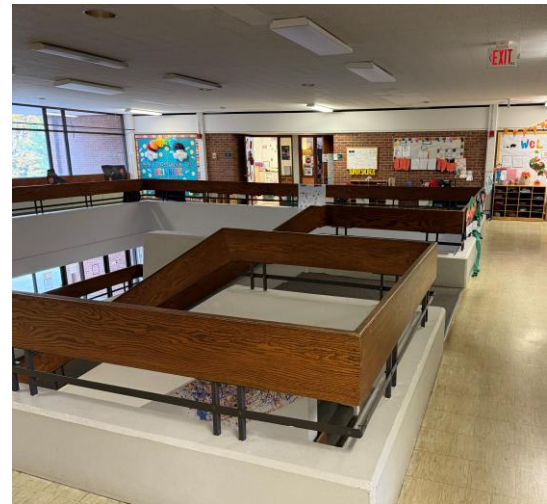
Guardrail height below Building Code

- Monumental stair in atrium does not need to be enclosed provided that Second floor occupants could exit through Staff Lounge 201 to Stair 223. Enclosed stairwell needs direct access to the exterior. Note: Recommend review with building official on enclosing stairwells due to existing layout.
- Provide 42" H guardrail along stairs, at the landing and second floor atrium area.
- 
- 
- 
- 
- 
- 
- 
-
