## Jones Middle School Physical Assessment

January 24, 2025

# UPPER ARLINGTON SCHOOLS 2025 FACILITIES ASSESSMENT JONES MIDDLE SCHOOL

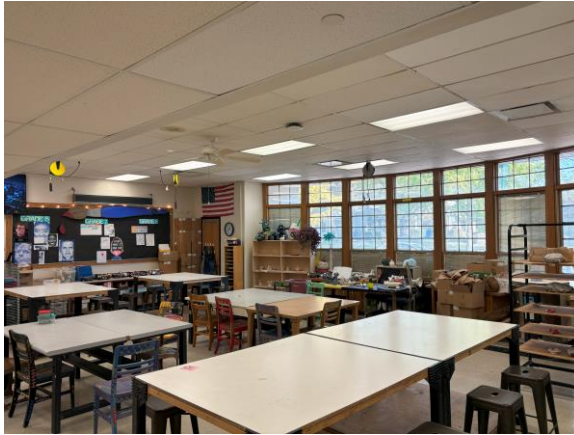
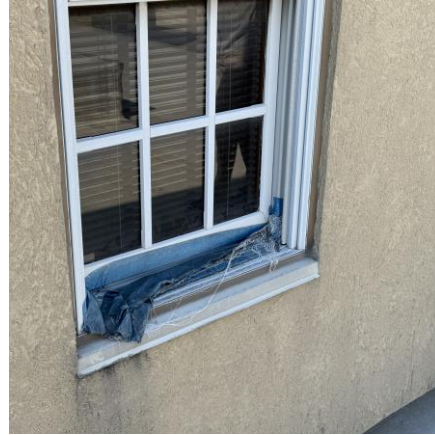
Windows installed in 1997 are at the end of their life requiring repairs & unable to find necessary parts

a. The aluminum clad wood windows were installed in 1997. According to school officials, they are starting to deteriorate and having difficulty finding parts.

- Replace all exterior windows and storefront glazing.
- Eliminate water infiltration at the west cafeteria wall below grade and exterior doors.
- Replace wood subfloor with gypcrete in rooms 116, 116A, 216 and 216A.

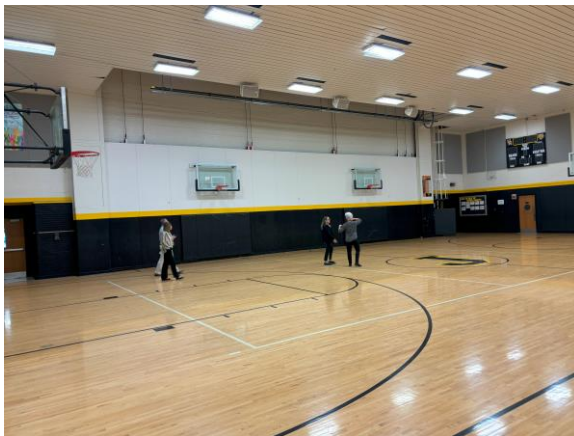
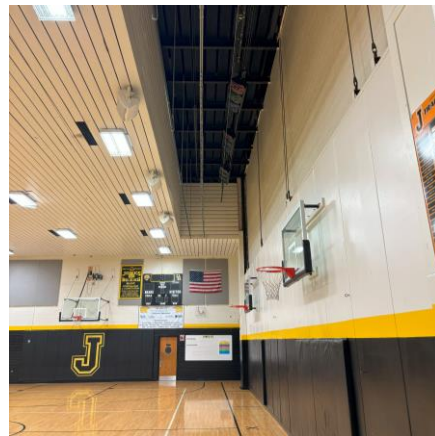
Stage shares the floor with the gymnasium. When an event is occurring on the stage, no events can occur in the gym because a third of the gym is part of the stage

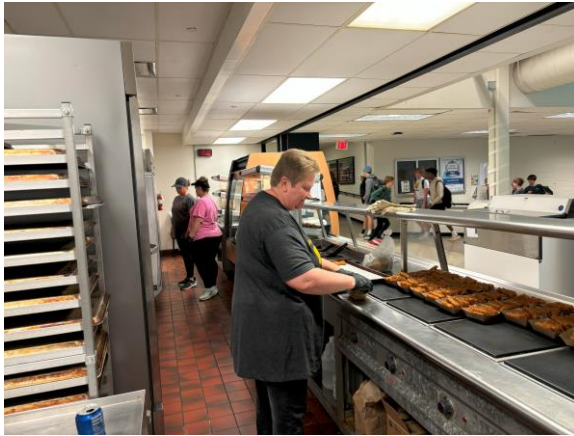
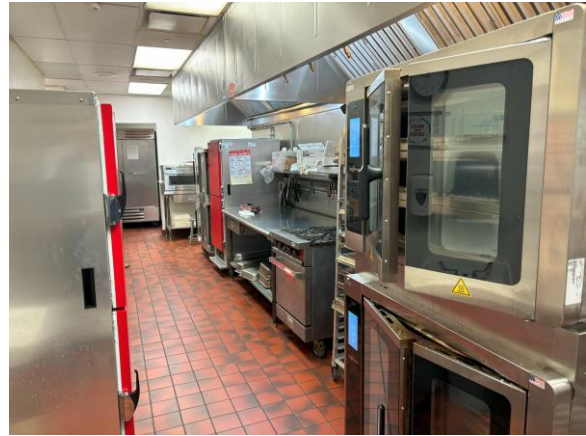
Kitchen and serving areas are undersized.

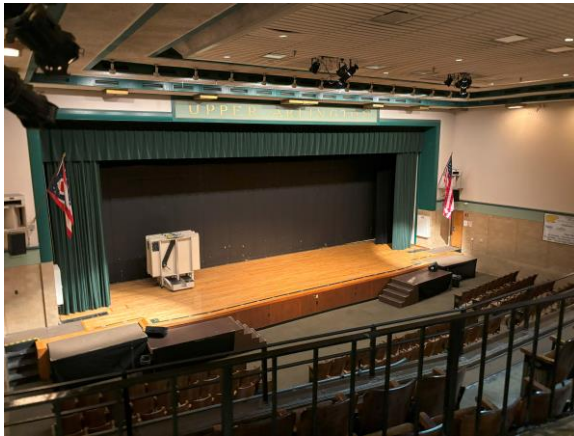
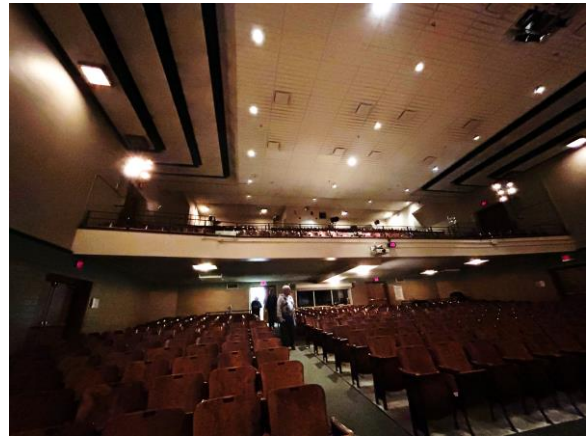
Auditorium upgrades for finishes, seats, railings and platforms

- Add energy efficient exterior lighting for safety and after-hours use of the site.
- Provide proper railings at the stage steps and side platforms.
- Full replacement of HVAC systems throughout the building.

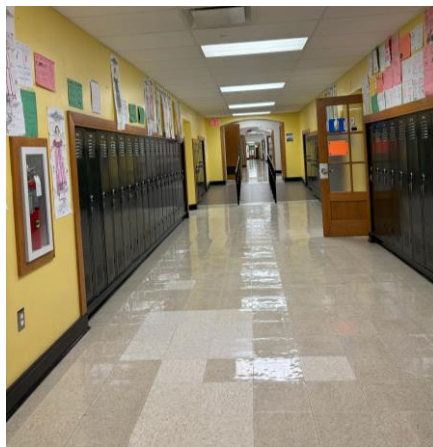
Flooring is aged and mismatching

- Replace all finishes including most flooring, ceilings, painting, and furnishings.
- Replace specialty equipment such as marker boards, tack boards, signage, doors/hardware, toilet partitions, theater chairs, etc.

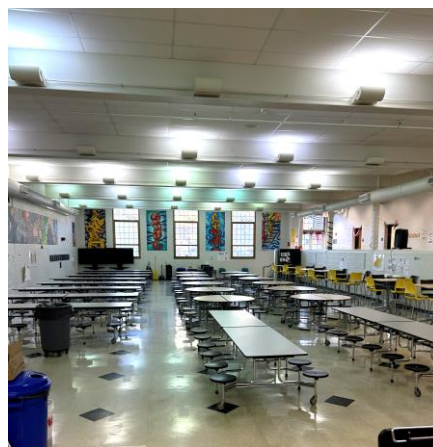
Water infiltration reported in cafeteria

- a. School district reports water infiltration into the cafeteria via the west exterior below the slab and pushing up and through the exterior doors.
- b.
- c.
- d.
- e.
- f.
- g.
- h.
- i.
- j.

- a. Sitework allowance indicated for work related to installation of foundation waterproofing and drainage tile on west side of cafeteria wall.
- b.
- c.
- d.
- e.
- f.
- g.
