Re: Cornerstone Elementary School, Facility Upgrade Opinion  
Wooster City School District  
Wooster, OH  
Project No. 225005.00

Cornerstone Elementary School, Facility Upgrade Opinion  
 Wooster City School District  
 144 North Market Street  
 Wooster, OH 44691  
 Page 2

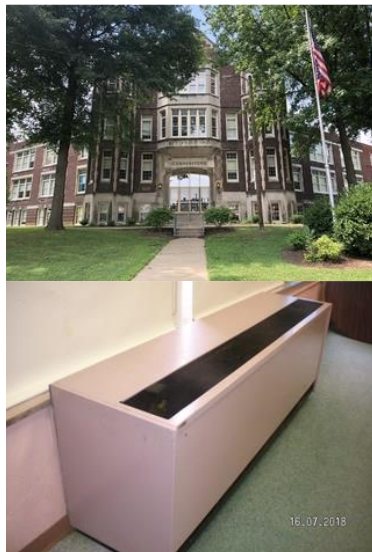
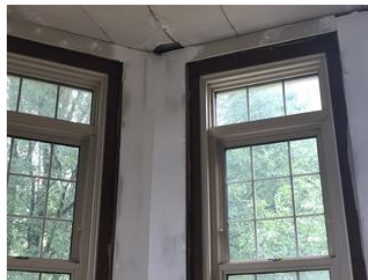
While the building has significant curb appeal (especially the main entrance shown in the left image below), the essential elements of a modern school, including the infrastructure (heating, ventilation, and air conditioning (HVAC), plumbing, electrical, and technology), safety/security of the occupants, and basic comfort, are in need of upgrading. The images below (center and right) represent some of the poor conditions and outdated HVAC systems.

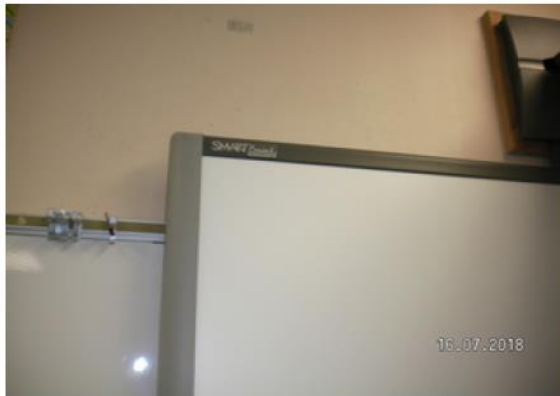
Smart Board

Description: The classrooms are equipped with Smartboards and have adequate technology data ports to meet OSDM compliance requirements.

Rating: 3 Needs Replacement

Recommendations: Provide complete replacement of technology systems to meet OSDM guidelines, due to extent of renovations under taken and to sustain the capacity to keep pace with technology development.

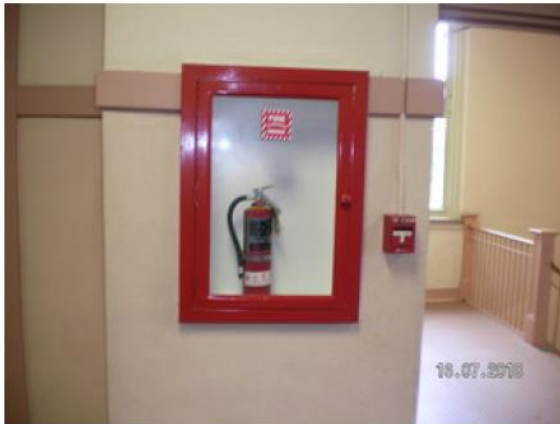
Pull station

Description: Building is equipped with a Simplex fire alarm system with pull stations horns/strobes alarms and some smoke detectors. A/V devices are located in restrooms but not in classrooms. The fire alarm system is not monitored by a third party and is not equipped with flow switches or tamper switches. There are a minimum number of smoke detectors (at elevator lobbies). Stair doors are not automatically closed during an emergency. The unusable fourth floor, old music room, is not fully detected or sprinklered. The system is not fully compliant with Ohio School Design Manual requirements.

Rating: 3 Needs Replacement

Recommendations: Provide for complete replacement of the Fire Alarm System. Expand to include classroom audio and visual horns and strobes. Provide hold open devices on stairwell doors to close during a fire. Add flow switches, tamper switches with funding of fire suppression system in Item U.

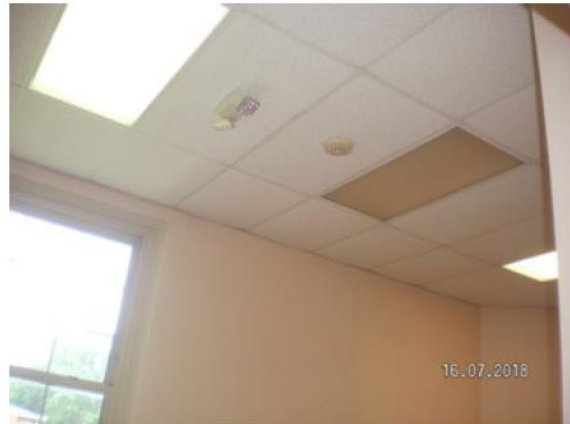
Egress light

Description: Dual head emergency lighting in corridors and stairwells (battery backup) incorporate incandescent lamp sources. Exit signs with battery back-up are located at each exit door and in the egress corridors. The egress lights are not LED illuminated which is not in compliance with OSDM guidelines. The emergency lighting system is not on an emergency generator.

Rating: 3 Needs Replacement

Recommendations: Add a natural gas generator and transfer switch to power egress lights during a power outage. This cost is included in Item D. Replace exit lights and egress lights with LED lamps in stairwells or replace some corridor fixtures with emergency back-up ballasts to avoid dual head fixtures.
