## FACILITY NEEDS ASSESSMENT

### ESSEX ELEMENTARY SCHOOL AND MANCHESTER ESSEX MIDDLE-HIGH SCHOOL

#### Manchester Essex Regional School District

DRAFT REPORT: January 27, 2023  
H&A JN 2217.01

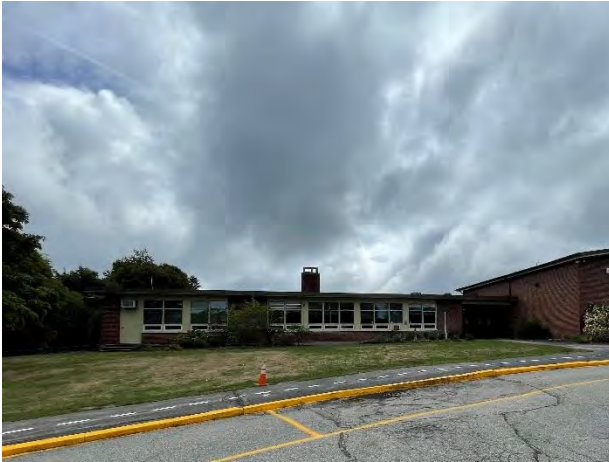
1. Bituminous driveway shows signs of cracking and freeze/thaw damage.

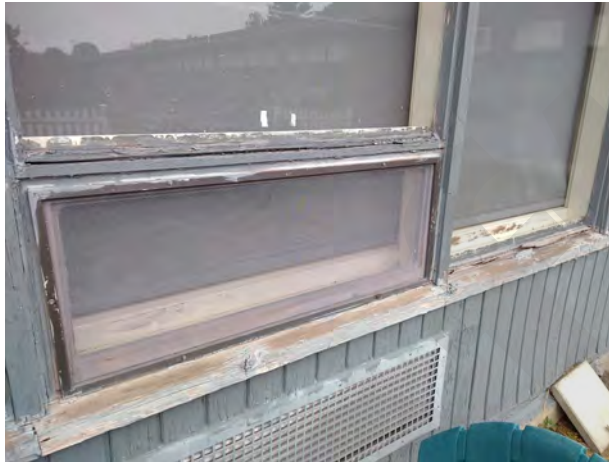
2. Original windows and trim have deteriorated.

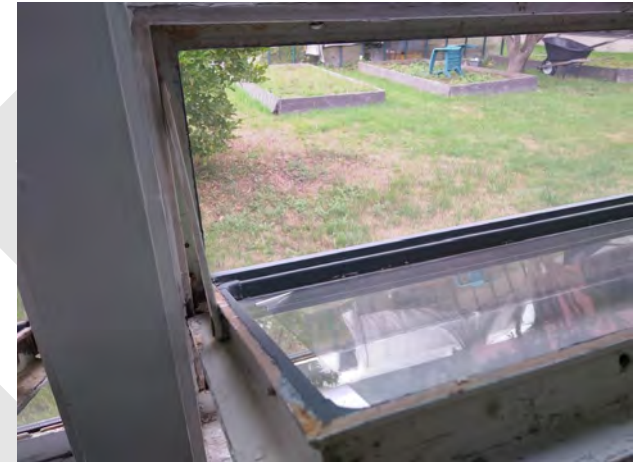
3. Operable steel hopper window has no weather strip.

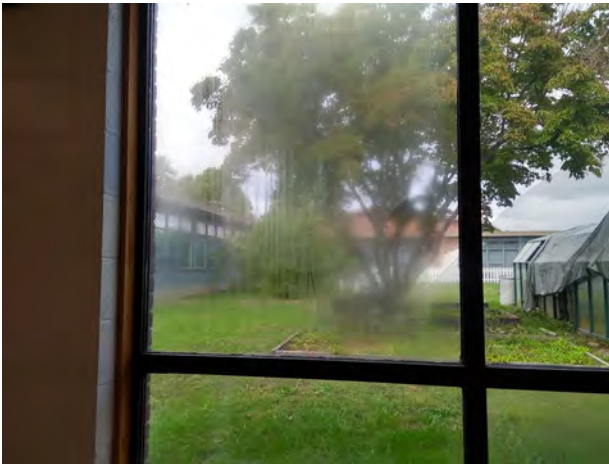
4. Thermal pane window has seal failure.

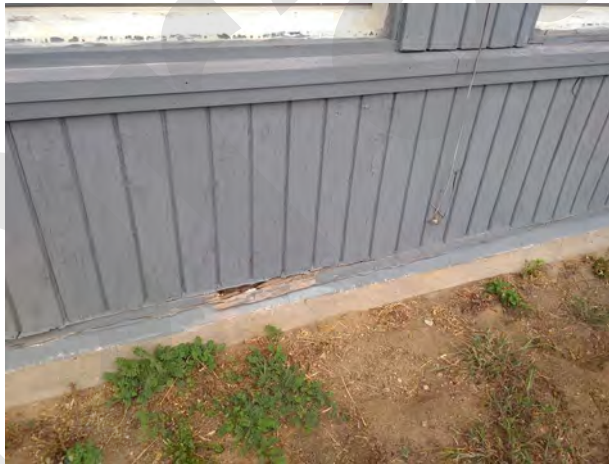
5. The wood siding is rotted and damaged.

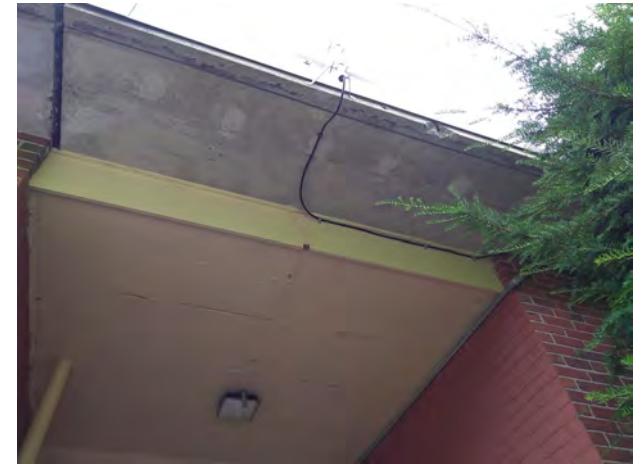
6. The concrete fascia and soffits have spalled.

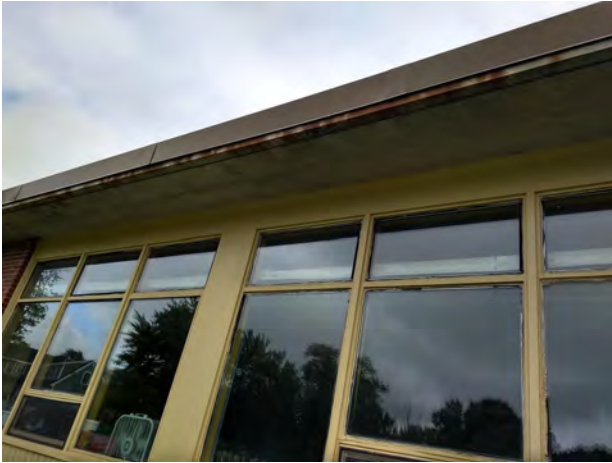
7. Original roof soffits have corroded.

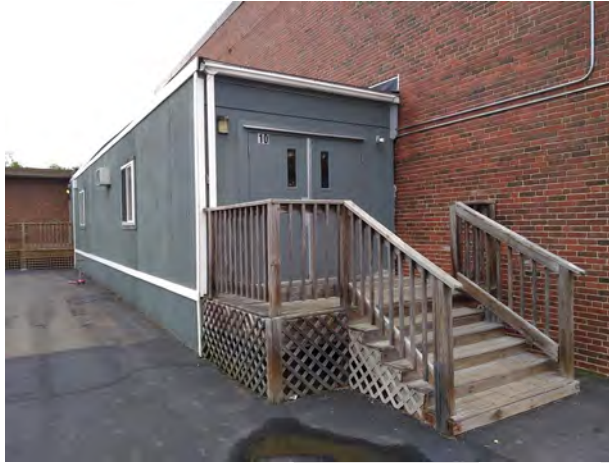
8. Modular addition has deteriorated and leaks at connection to main building.

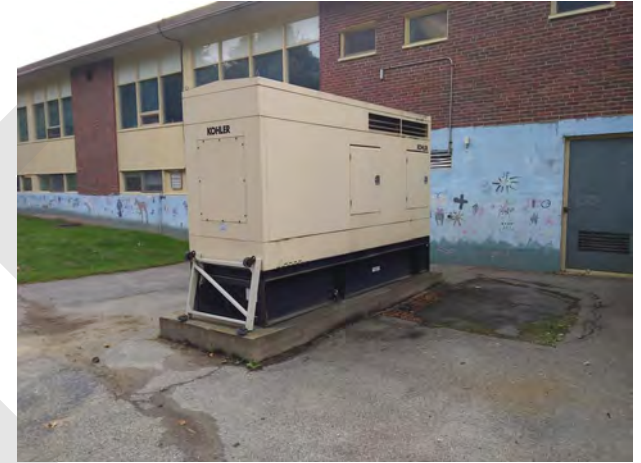
9. Confirm that generator has been maintained per manufacturer's recommendations.

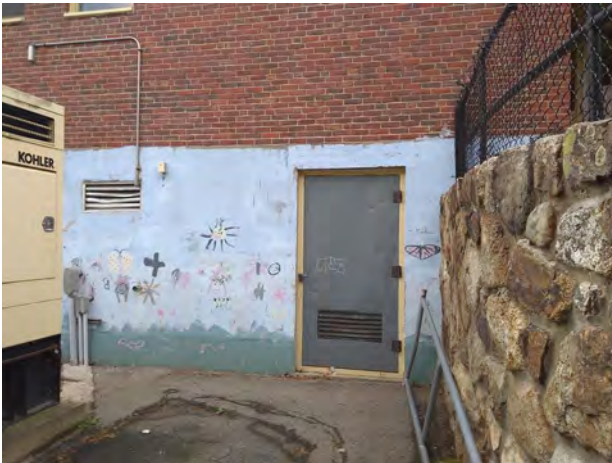
10. Bituminous pavement is damaged, original hollow metal doors require repair/replacement.

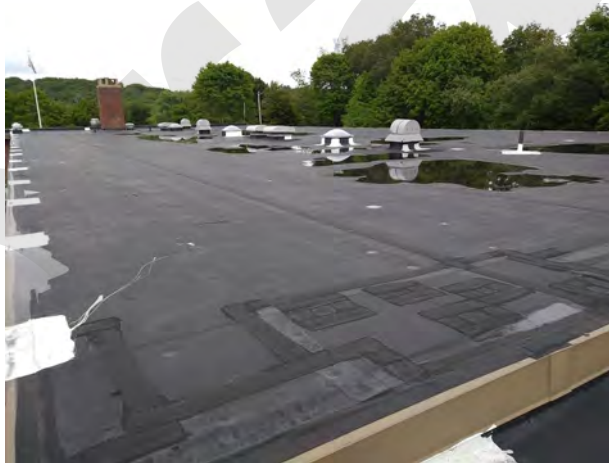
11. Rubber membrane roof has many areas of standing water and is extensively patched.

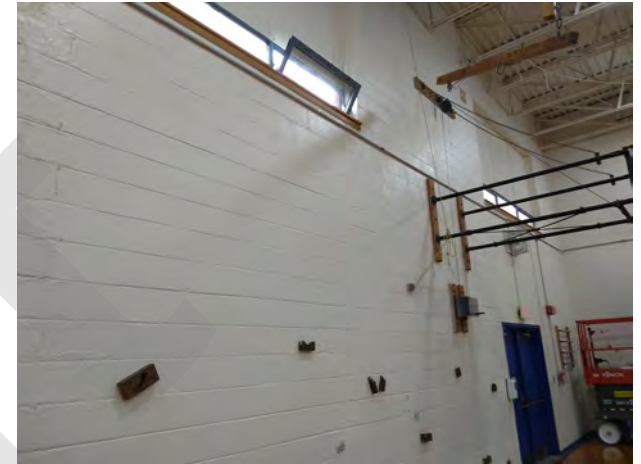
15. The brick/CMU wall of Gym shows signs of extensive water damage and is not insulated.

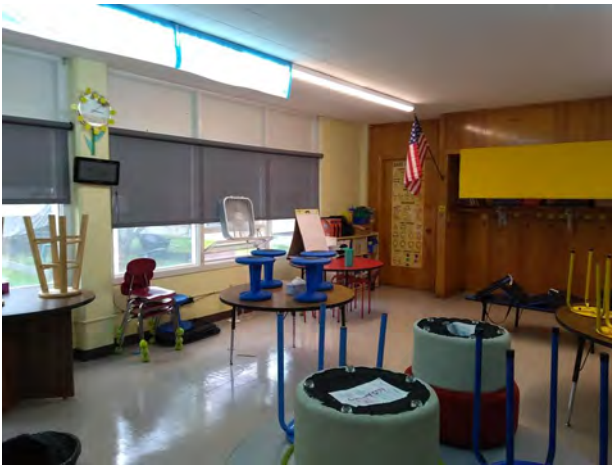
16. Classrooms have outdated spline ceiling and insufficient ventilation.

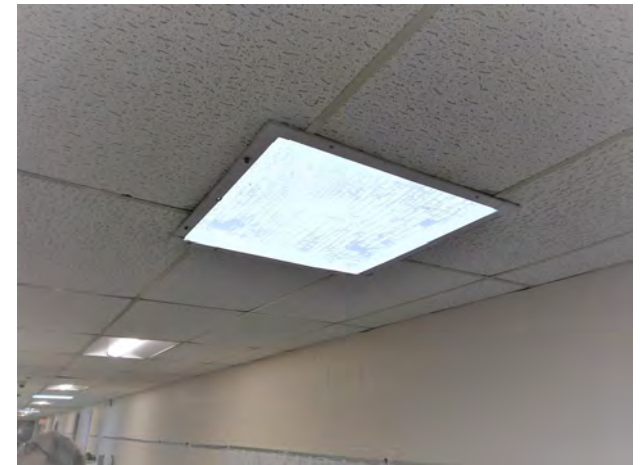
18. The skylights in the corridors are damaged.

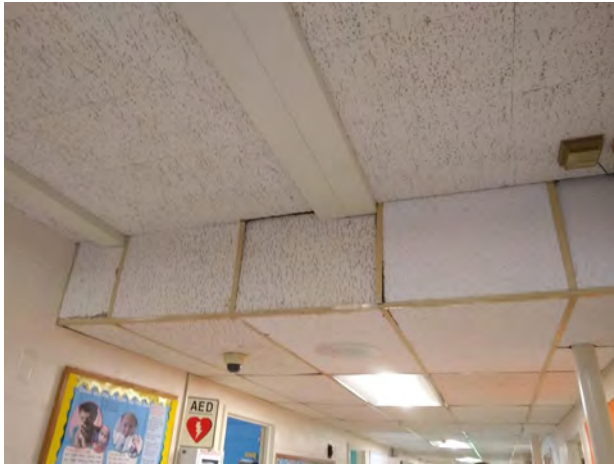
19. Existing 2x4 ceilings are discolored and tiles are mis-matched.

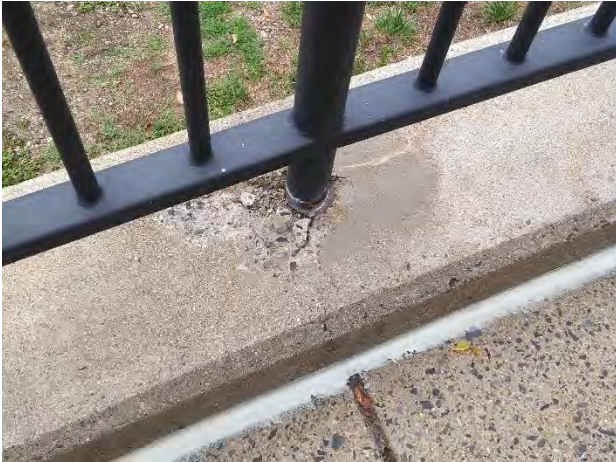
1. Concrete has spalled at some rail posts.

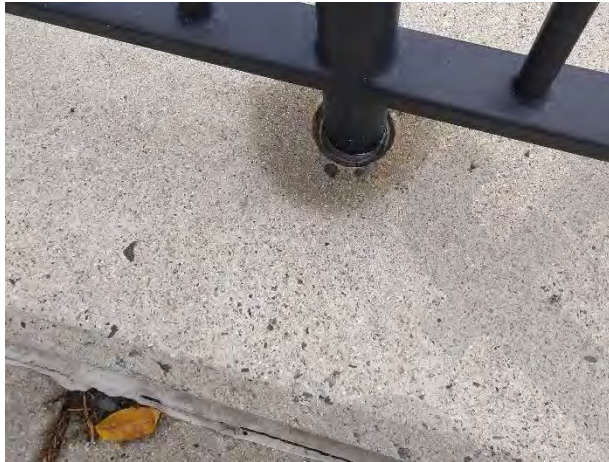
2. Rail posts do not have sealants and some sealants are failing.

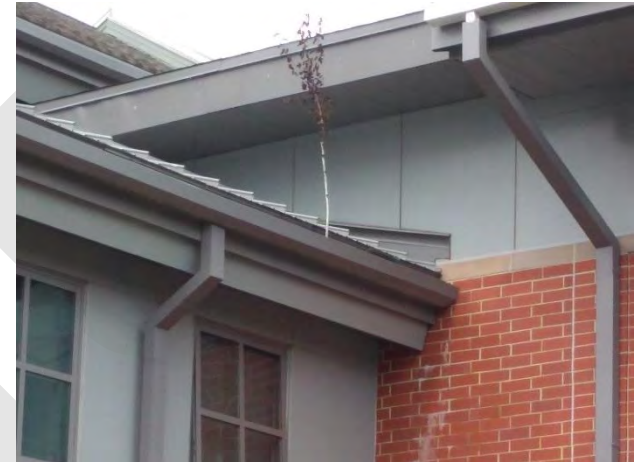
3. Some gutters are clogged with vegetation.

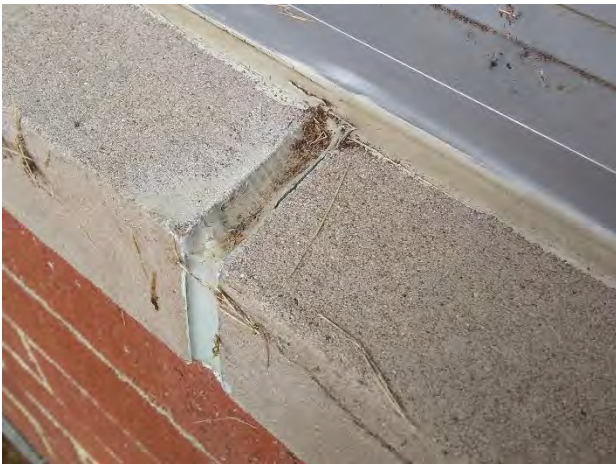
4. Some sealant shows early signs of deterioration.

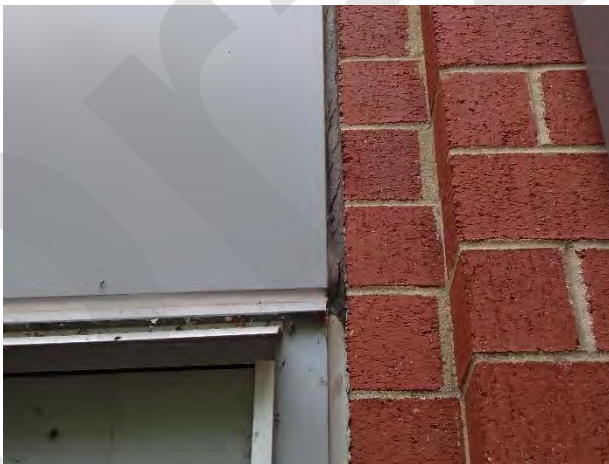
5. Sealant at metal panel is showing signs of deterioration.

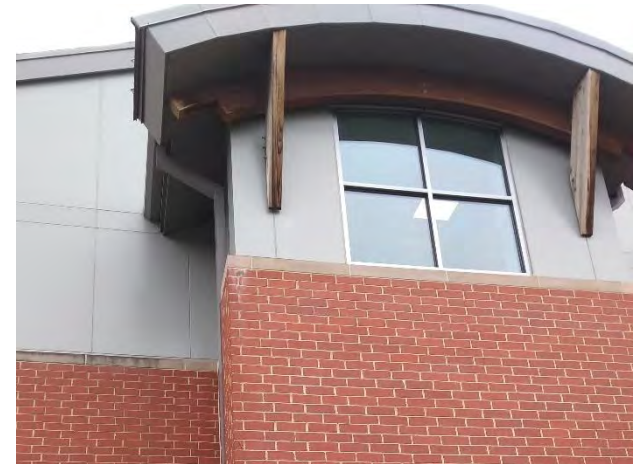
6. Discoloration is evident at wood accents, brick and precast.

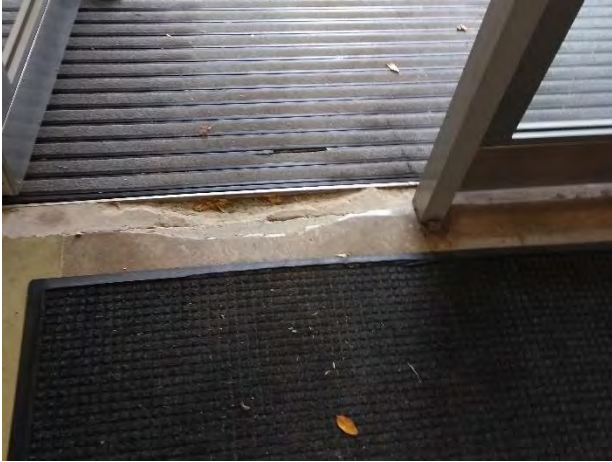
7. Threshold at entry is damaged. Walk off matt is worn.

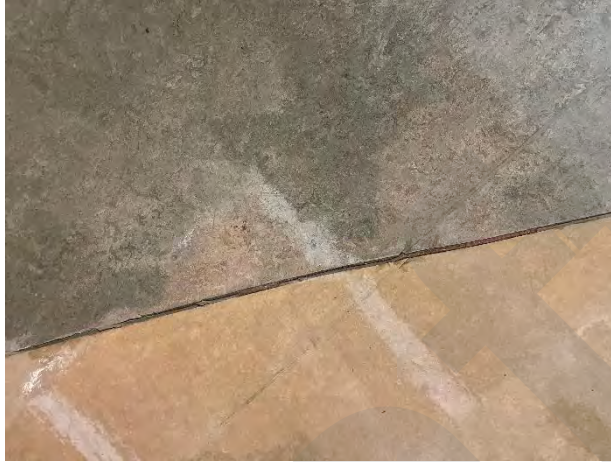
8. Some floor joints at natural linoleum are damaged.

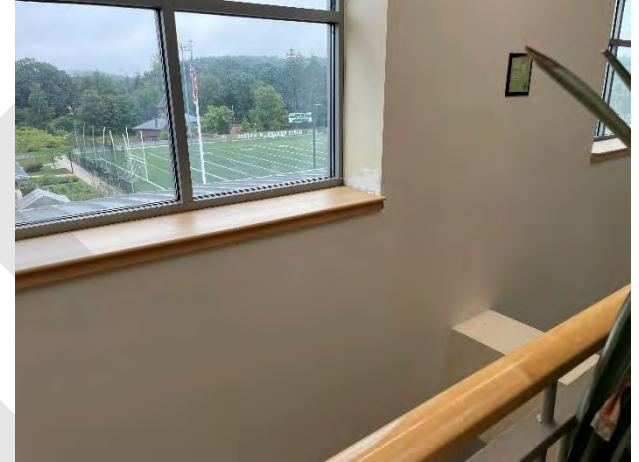
9. Several windows show signs of water damage.

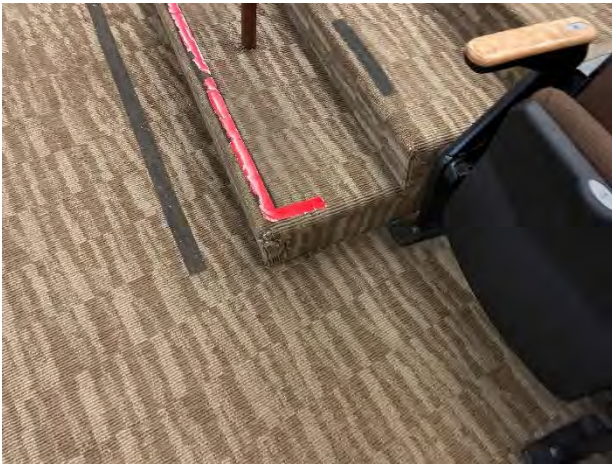
10. Original carpet at Auditorium is showing signs of wear.

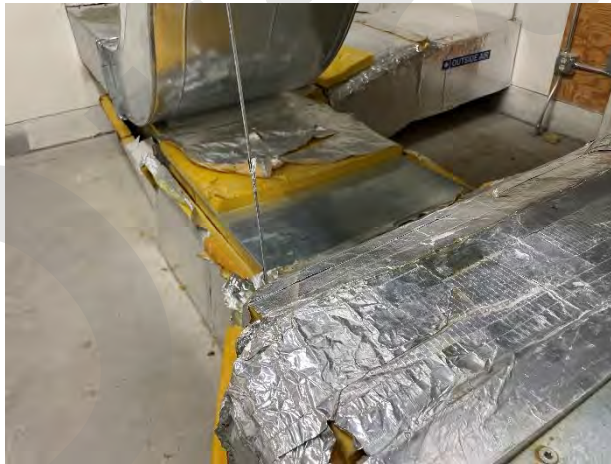
11. Some duct work has damaged or missing insulation.

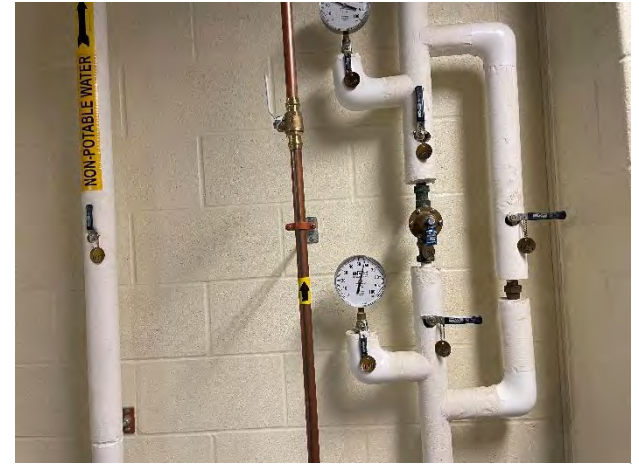
12. Plumbing valves require frequent replacement due to high mineral content in water supply.

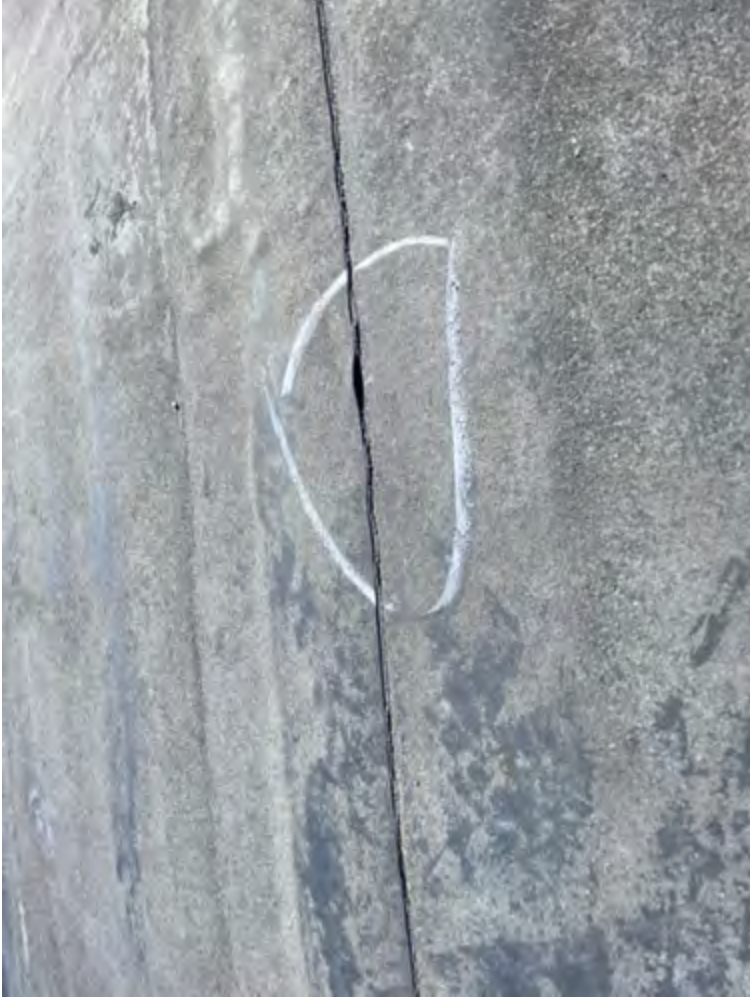
*Photo 3*

**Failed seam in ponding area.**

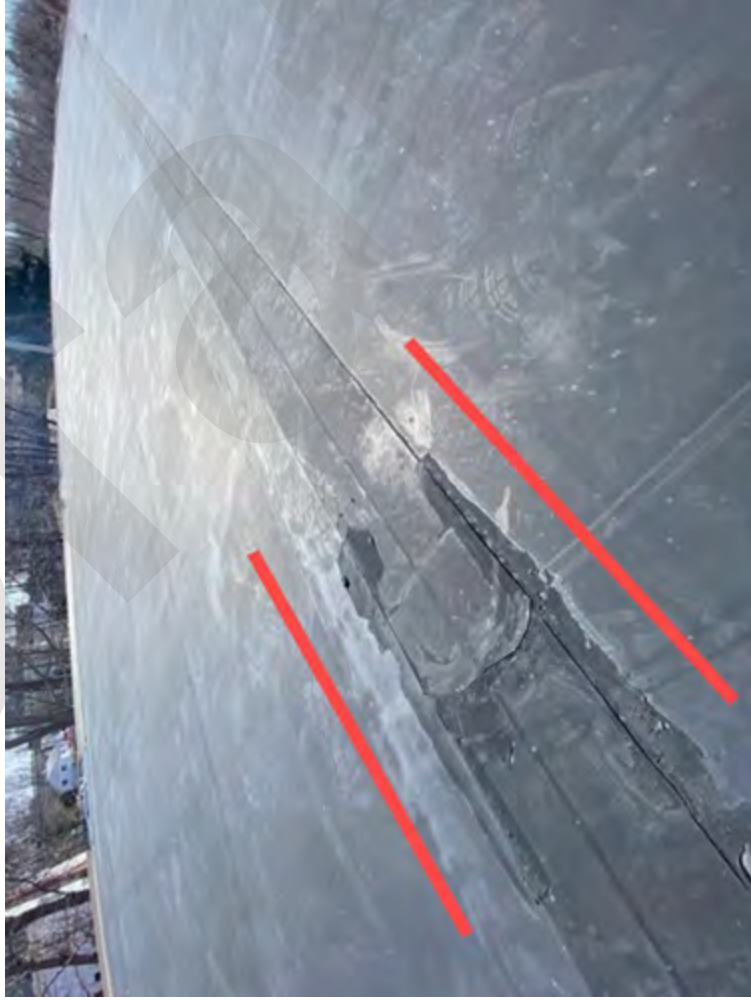
*Photo 4*

**Deteriorating coverstrip repair over seam.**

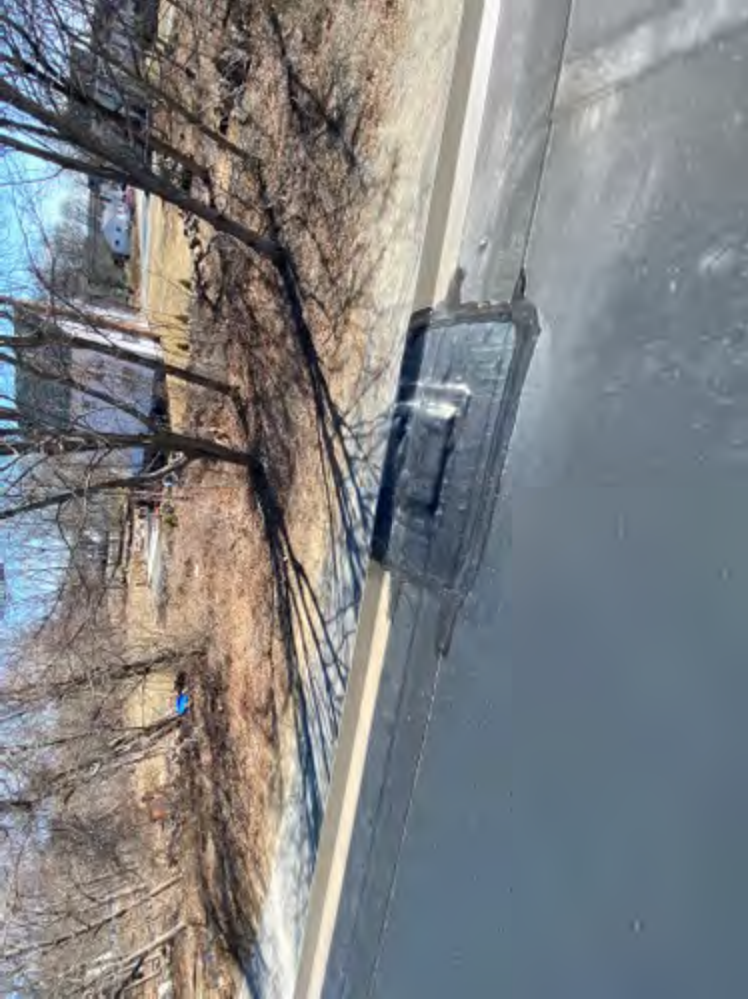
*Photo 5*

**Previously repaired open condition at lap in edge metal.**

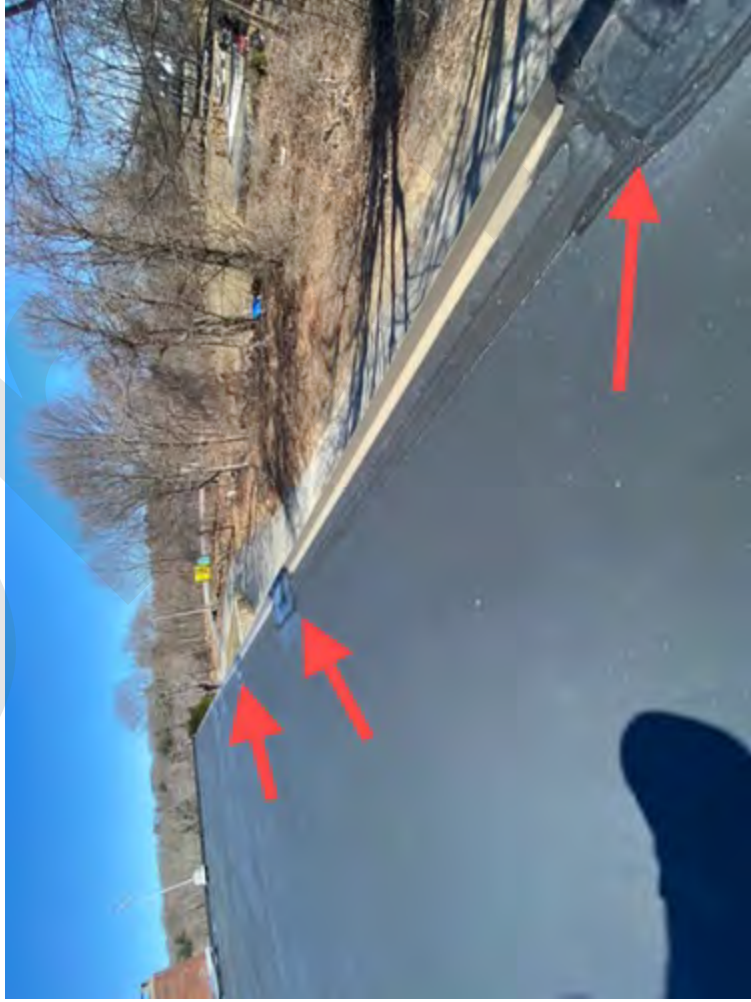
*Photo 6*

**Previously repaired laps in edge metal.**

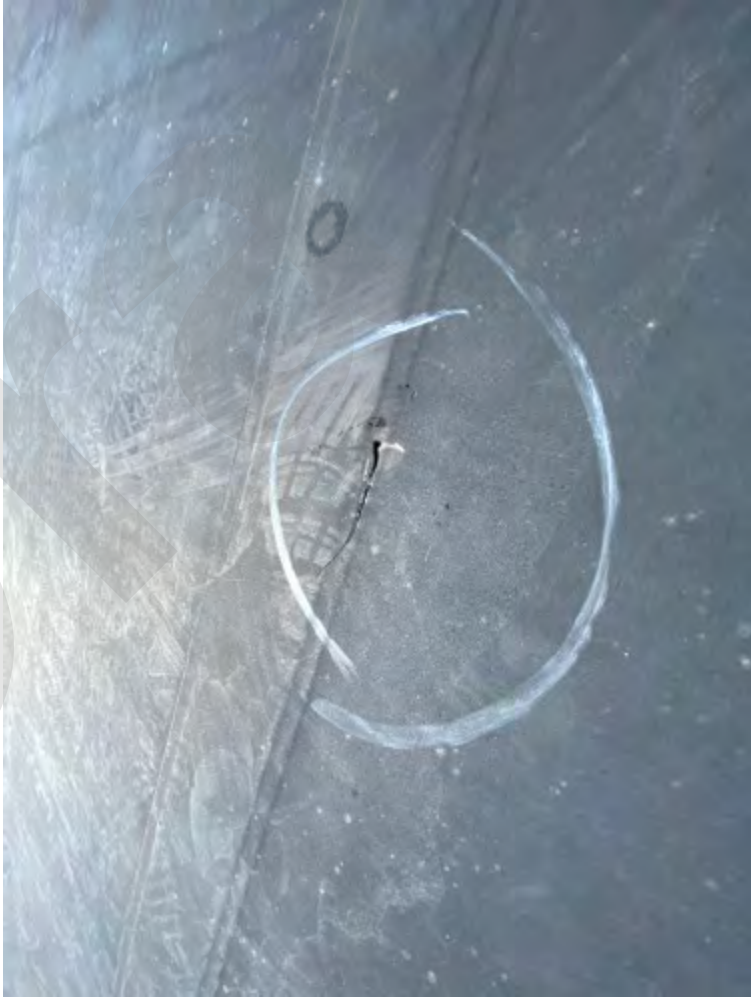
*Photo 8*

**Penetration in membrane.**  
This is a source of water infiltration to the roofing assembly.

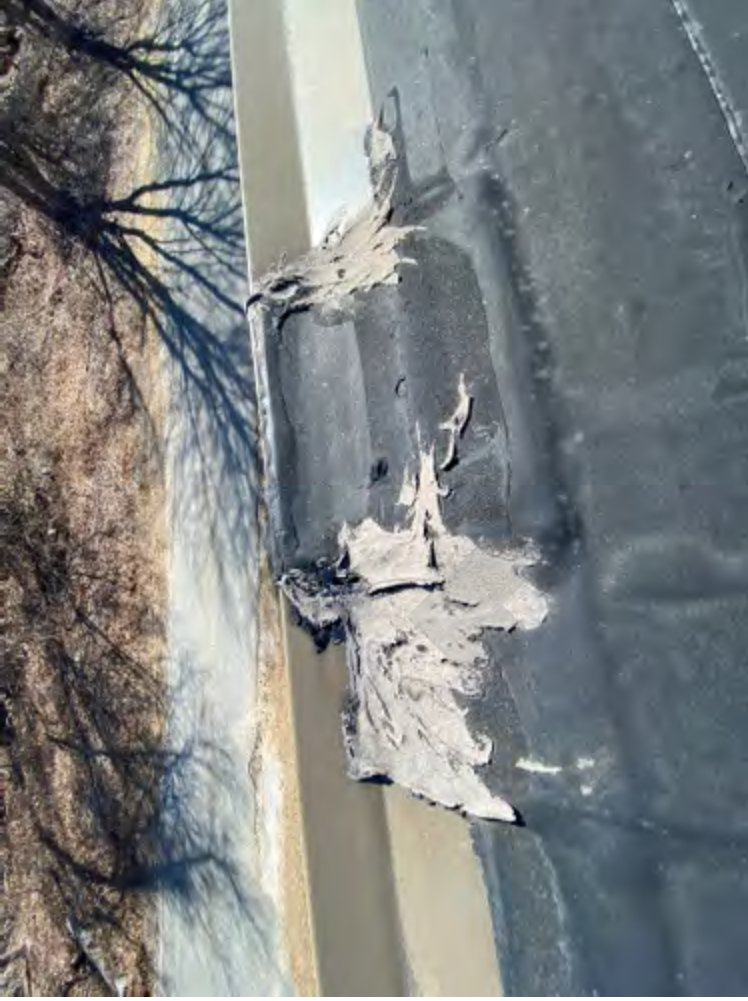
*Photo 9*

**Failed patch over lap in edge metal.**  
This failed condition was observed in approximately 30 locations.

- Troubleshoot & repair **20 failed patches and flashing conditions** on all roof sections.
- Troubleshoot & repair **30 failed patches over edge metal laps** on all roof sections.
- For penetrations and failed coverstrip/flashing:
  - Clean roof surface with high grade cleaner
  - Apply peel and stick Uni-Bond 6" tape to penetration or seam
  - Apply White Knight Plus WC to Uni-Bond tape and extend coating 4" past all seams of tape. Ensure felt backing of tape is fully saturated.
- Apply GreenLock Structural Adh at termination bars.
- All debris will be cleared up and removed.

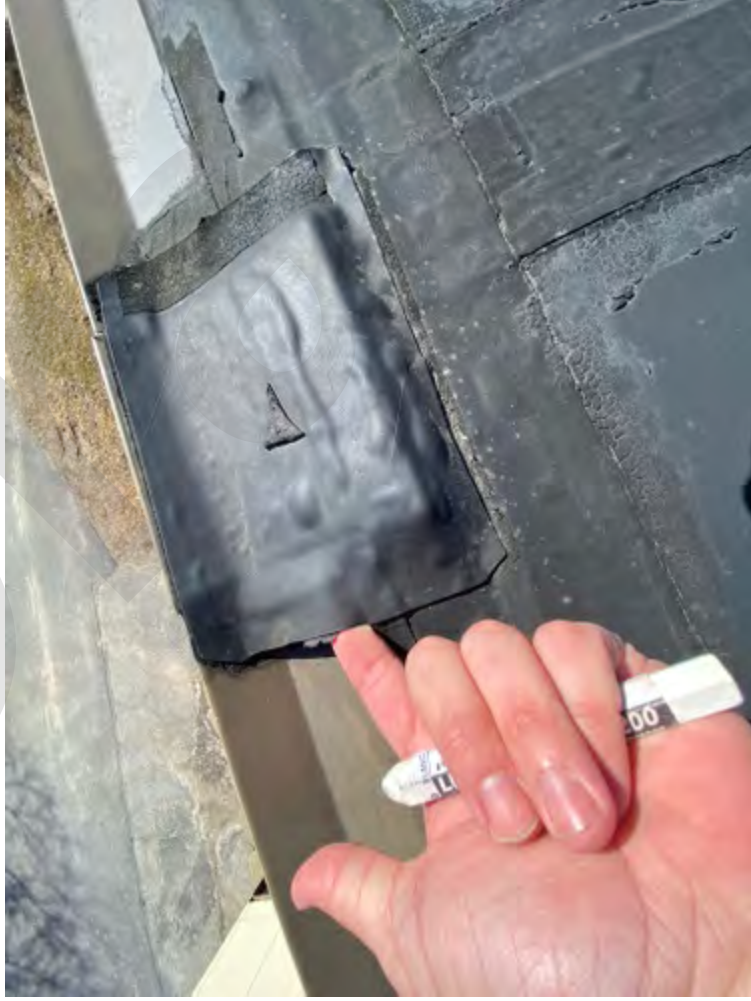
*Photo 10*

**Failed patch over lap in edge metal.**  
This failed condition was observed in approximately 30 locations.

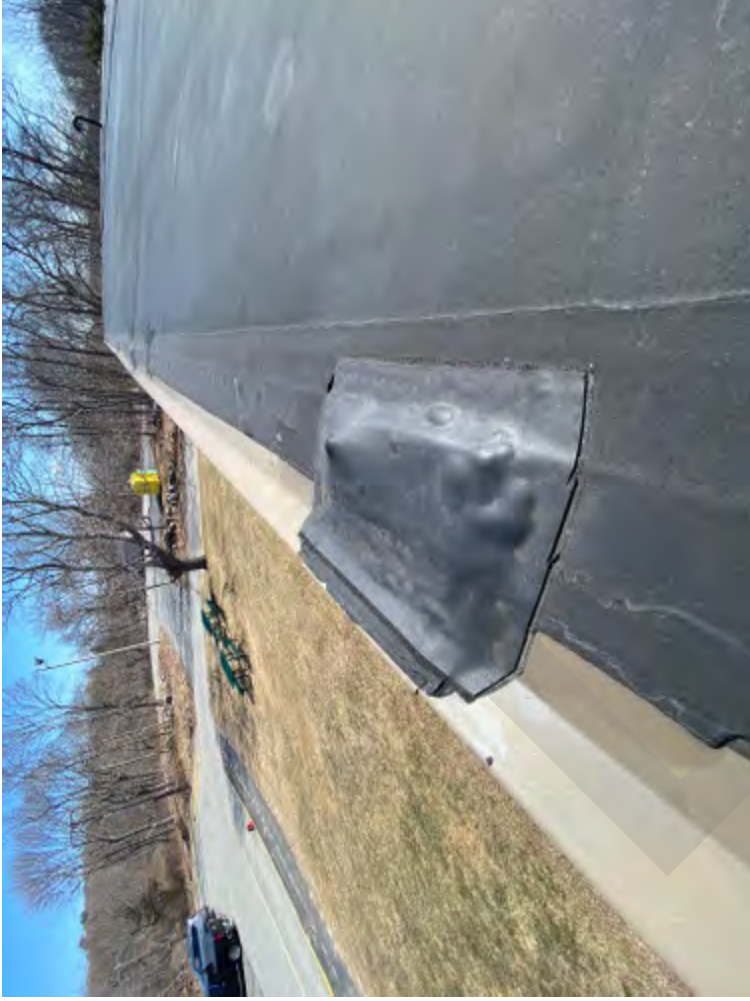
*Photo 11*

**Failed patch over lap in edge metal.**  
This failed condition was observed in approximately 30 locations.

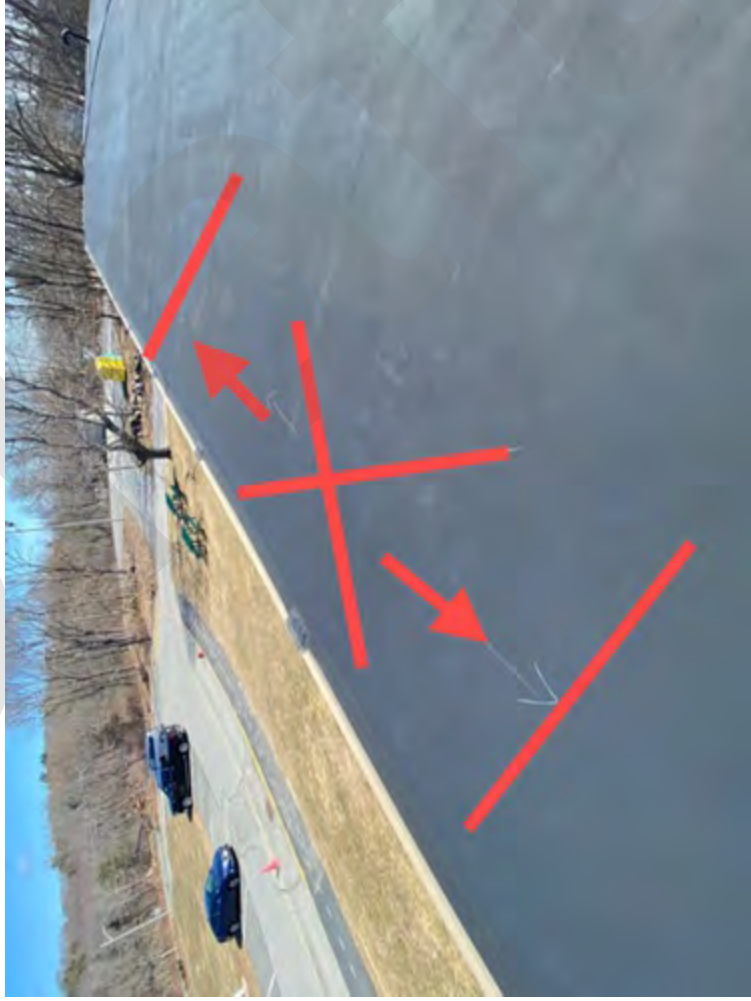
*Photo 12*

**Area of delaminated membrane from insulation.**

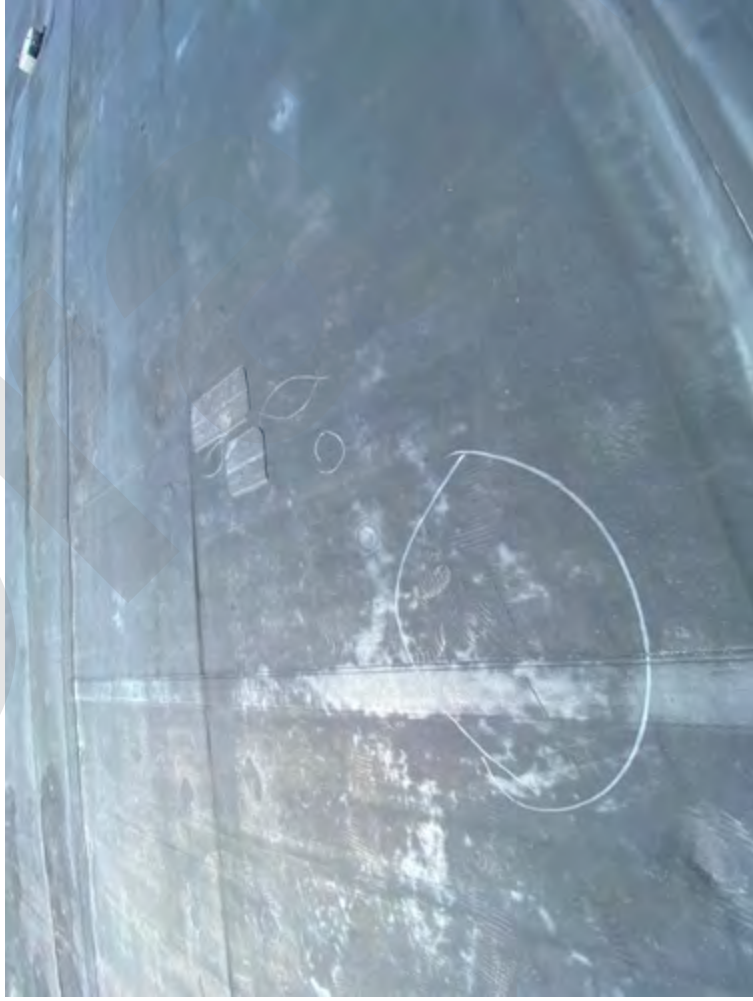
*Photo 14*

**Multiple penetrations observed in membrane.**

The following conditions are associated with water infiltration:

- Interior water damage
- Mold/Mildew
- Saturated insulation resulting in loss of dimensional stability and R Value
- Delamination of the membrane from sub-straight.
- Rust/rot of fasteners and decking

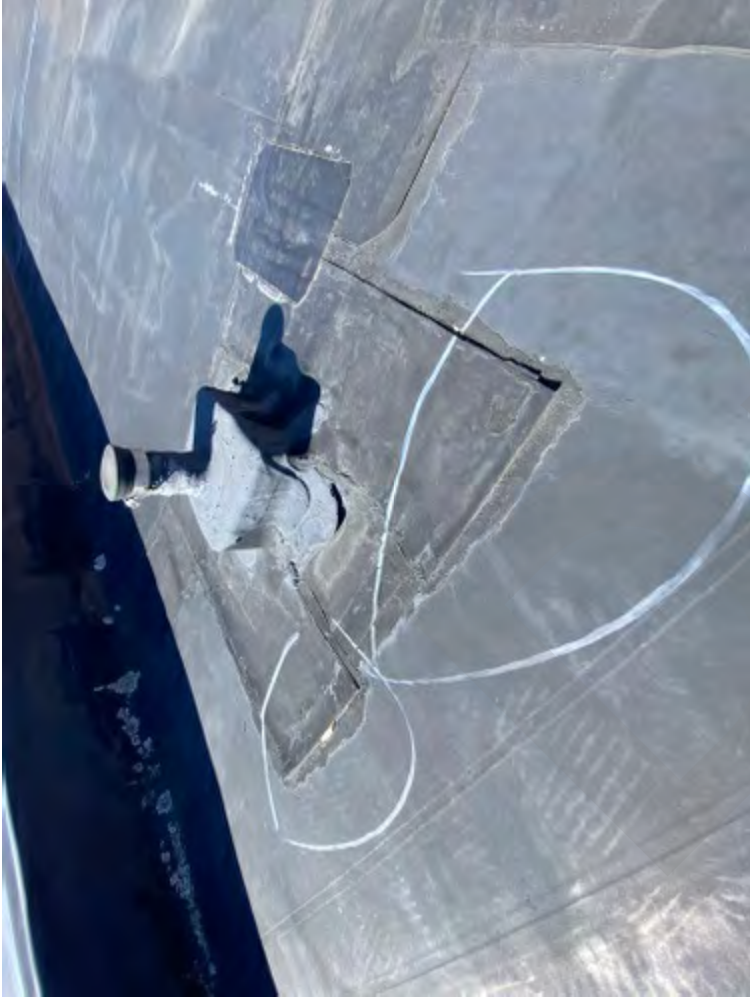
*Photo 15*

**Failed flashing around pitch pocket.**

The following conditions are associated with water infiltration:

- Interior water damage
- Mold/Mildew
- Saturated insulation resulting in loss of dimensional stability and R Value
- Delamination of the membrane from sub-straight.
- Rust/rot of fasteners and decking

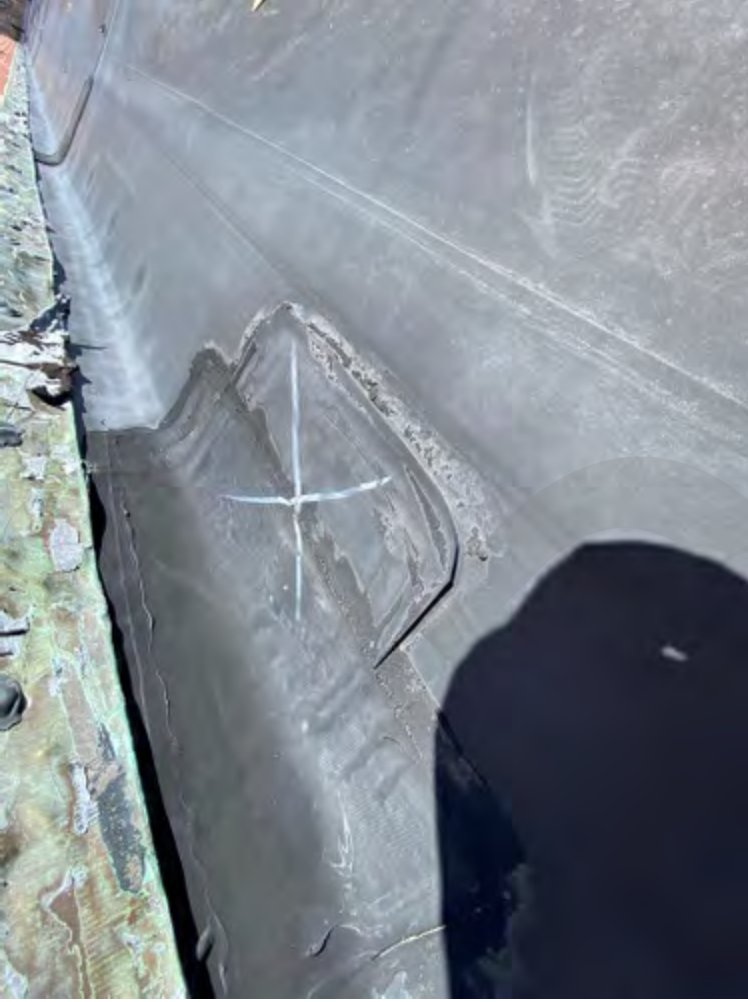
*Photo 19*

**Failed flashing.**

The following conditions are associated with water infiltration:

- Interior water damage
- Mold/Mildew
- Saturated insulation
- resulting in loss of dimensional stability and R Value
- Delamination of the membrane from sub-straight.
- Rust/rot of fasteners and decking

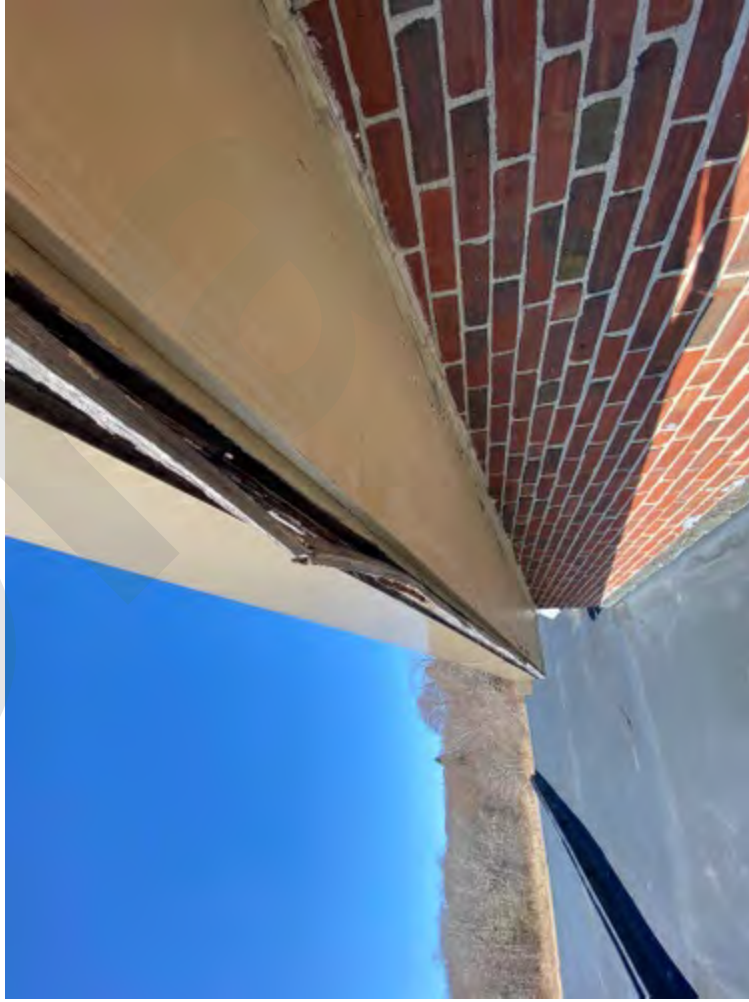
*Photo 20*

**Rotted fascia board under edge metal.**

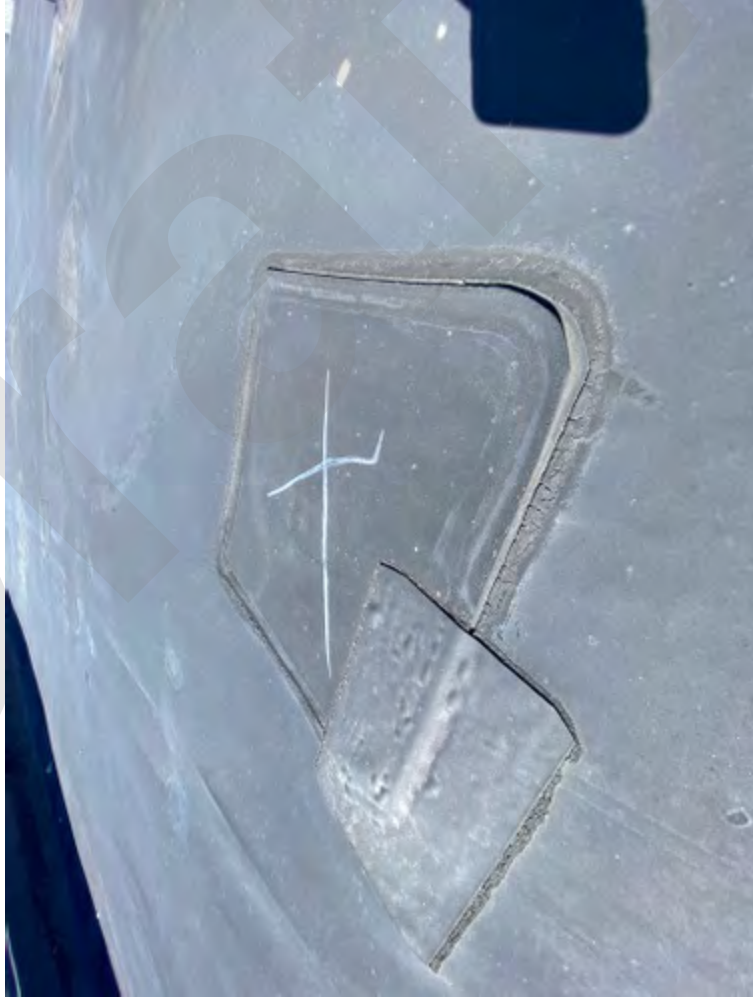
Photo 22

**Failed patch.**

The following conditions are associated with water infiltration:

- Interior water damage
- Mold/Mildew
- Saturated insulation resulting in loss of dimensional stability and R Value
- Delamination of the membrane from sub-straight.
- Rust/rot of fasteners and decking

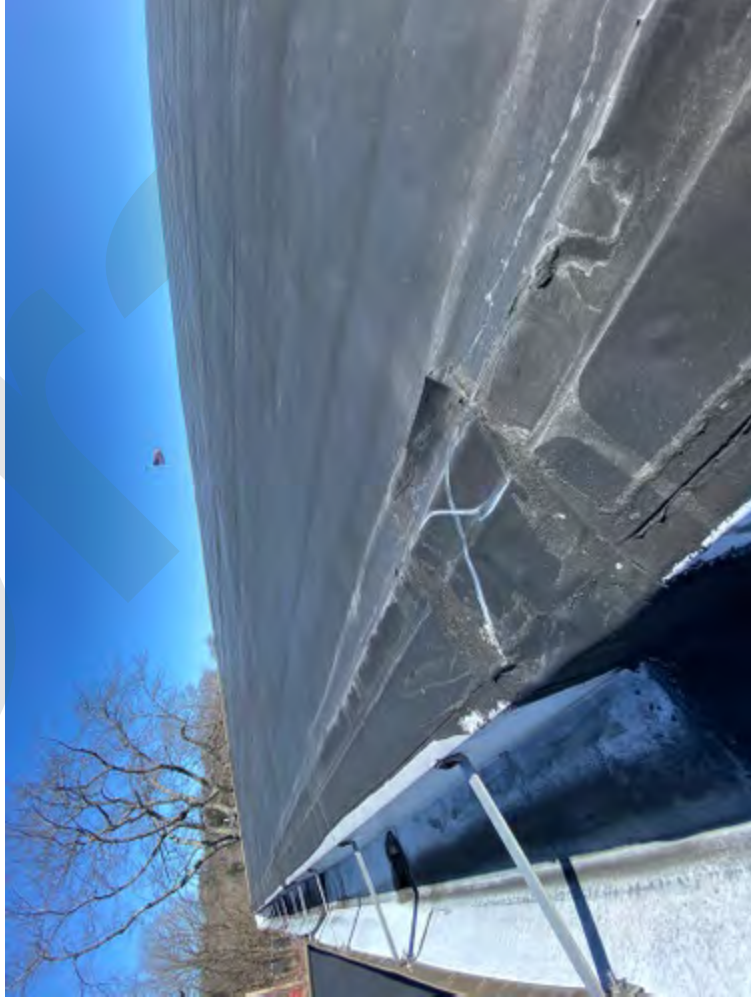
*Photo 24*

**Failed flashing above gutter.**

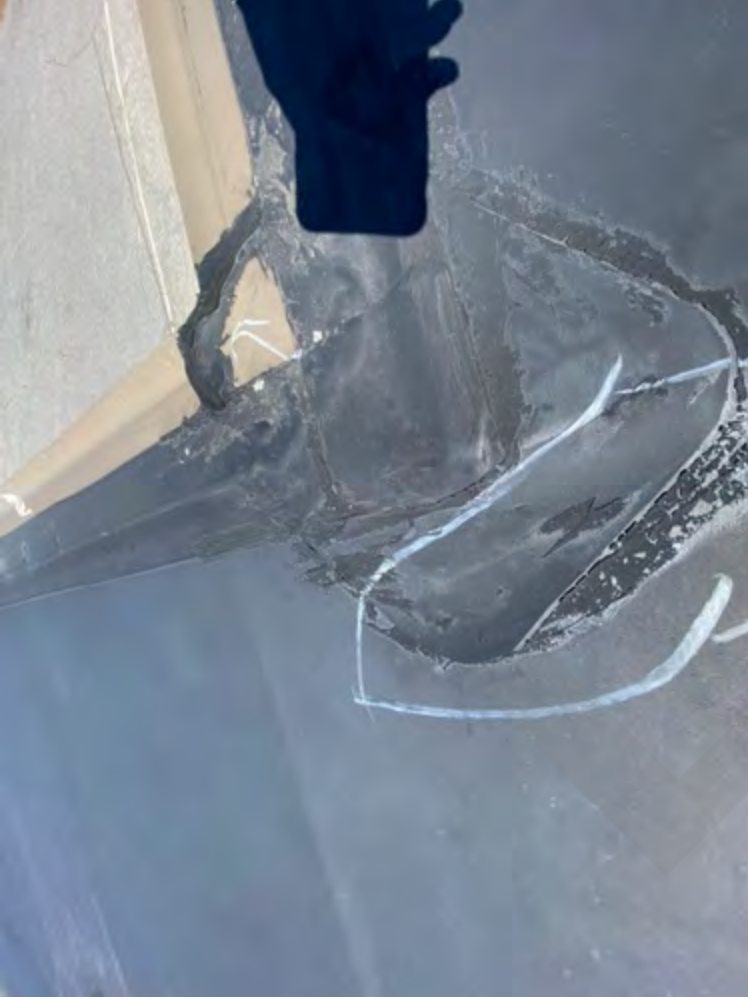
Photo 25

**Failed corner flashing.**

- Interior water damage
- Mold/Mildew
- Saturated insulation resulting in loss of dimensional stability and R Value
- Delamination of the membrane from sub-straight.
- Rust/rot of fasteners and decking

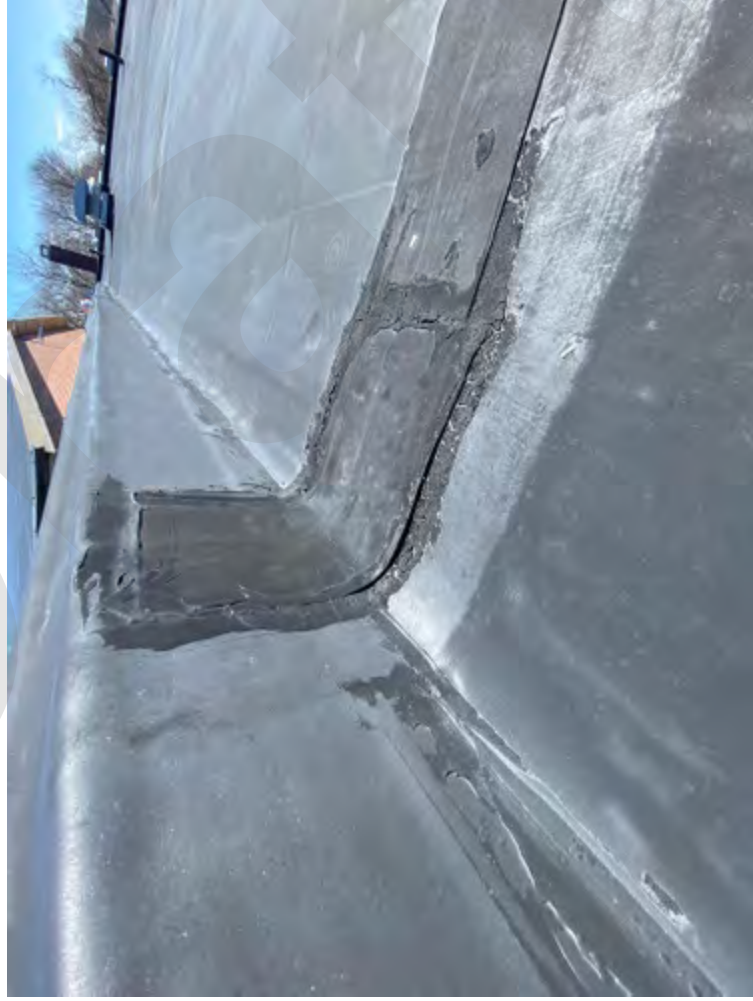
Photo 26

**Failed vertical flashing.**

The following conditions are associated with water infiltration:

- Interior water damage
- Mold/Mildew
- Saturated insulation resulting in loss of dimensional stability and R Value
- Delamination of the membrane from sub-straight.
- Rust/rot of fasteners and decking

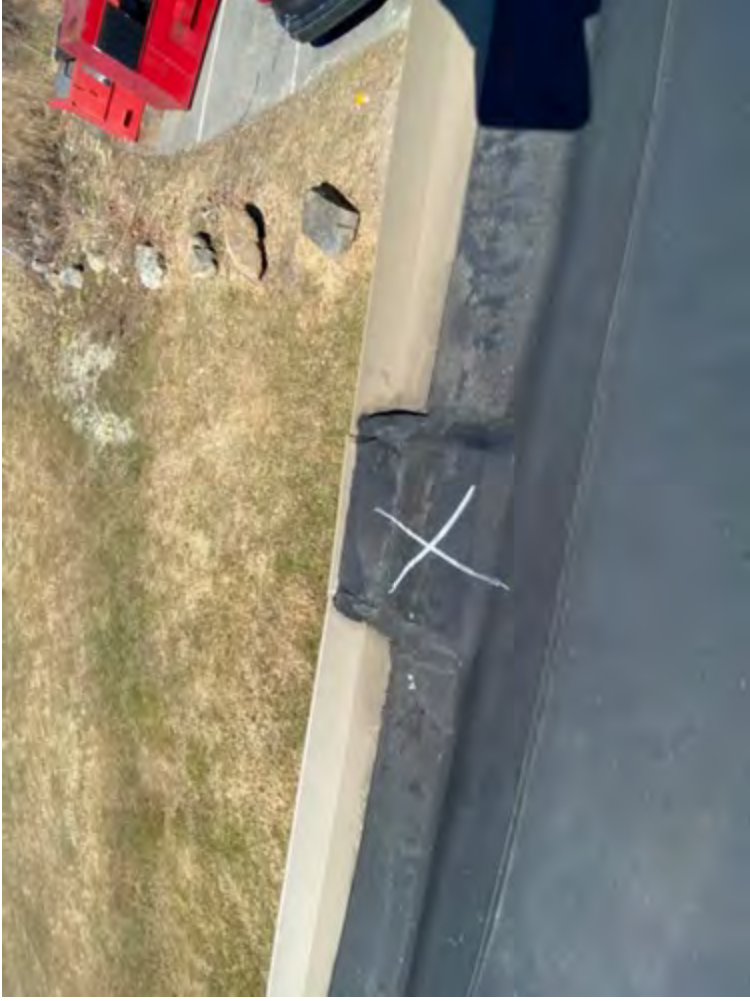
*Photo 27*

**Failed patch over lap in edge metal.**

This failed condition was observed in approximately 30 locations.
