## FACILITY NEEDS ASSESSMENT

### ESSEX ELEMENTARY SCHOOL AND MANCHESTER ESSEX MIDDLE-HIGH SCHOOL

#### Manchester Essex Regional School District

DRAFT REPORT: January 27, 2023  
H&A JN 2217.01

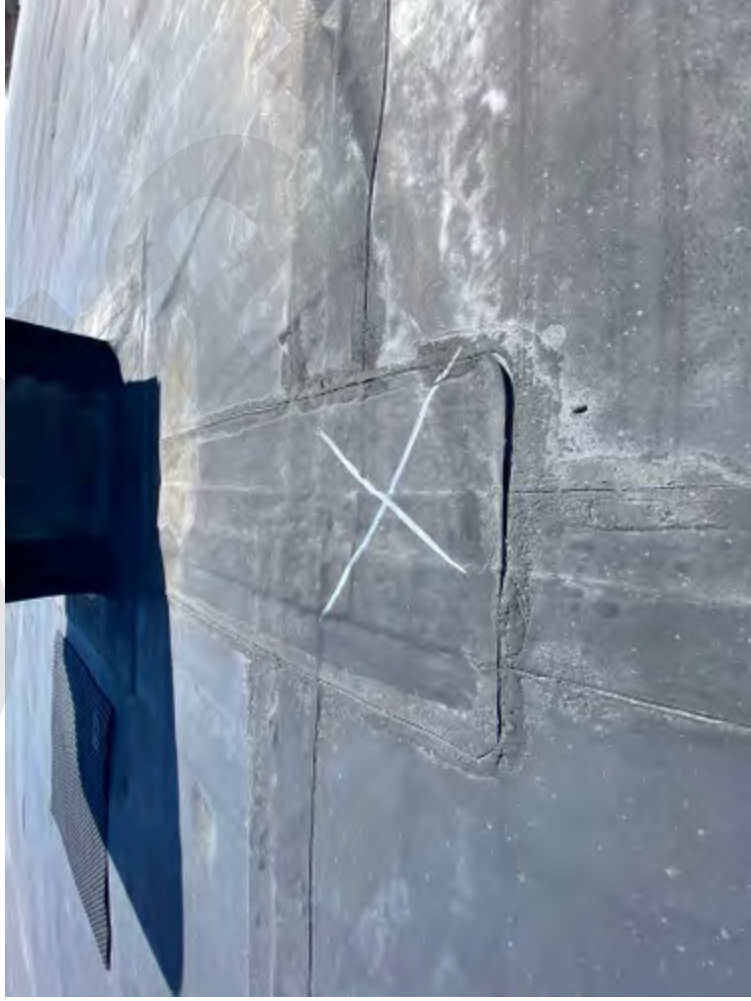
*Photo 28*

**Failed patch.**

The following conditions are associated with water infiltration:

- Interior water damage
- Mold/Mildew
- Saturated insulation resulting in loss of dimensional stability and R Value
- Delamination of the membrane from sub-straight.
- Rust/rot of fasteners and decking

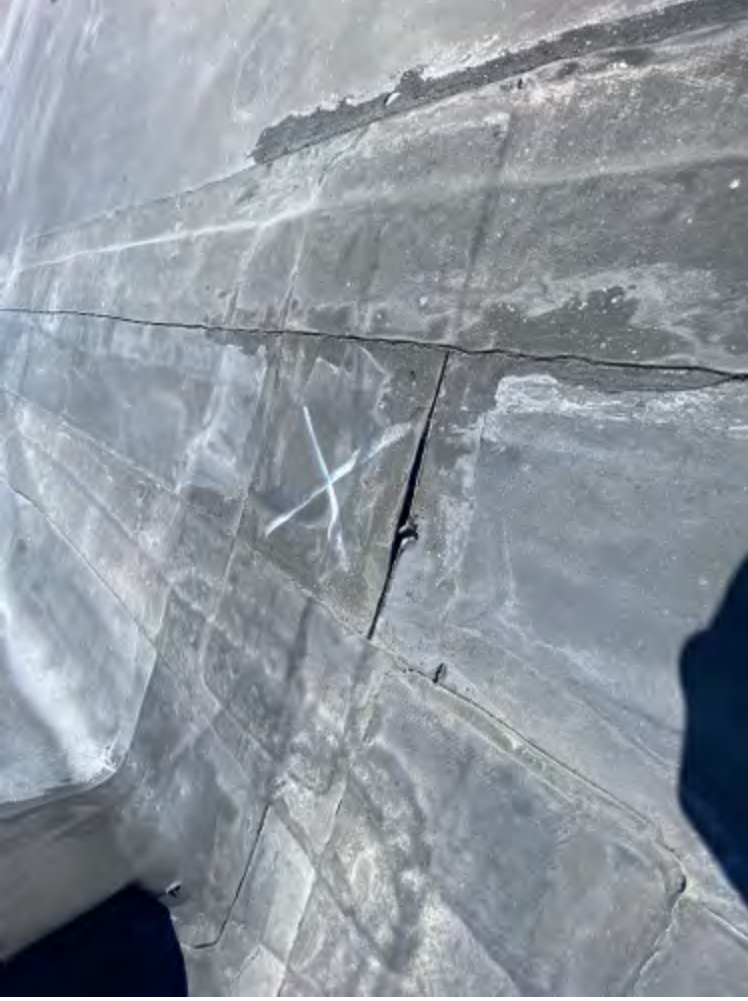
*Photo 29*

**Failed patch.**

- Interior water damage
- Mold/Mildew
- Saturated insulation
- resulting in loss of dimensional stability and R Value
- Delamination of the membrane from sub-straight.
- Rust/rot of fasteners and decking

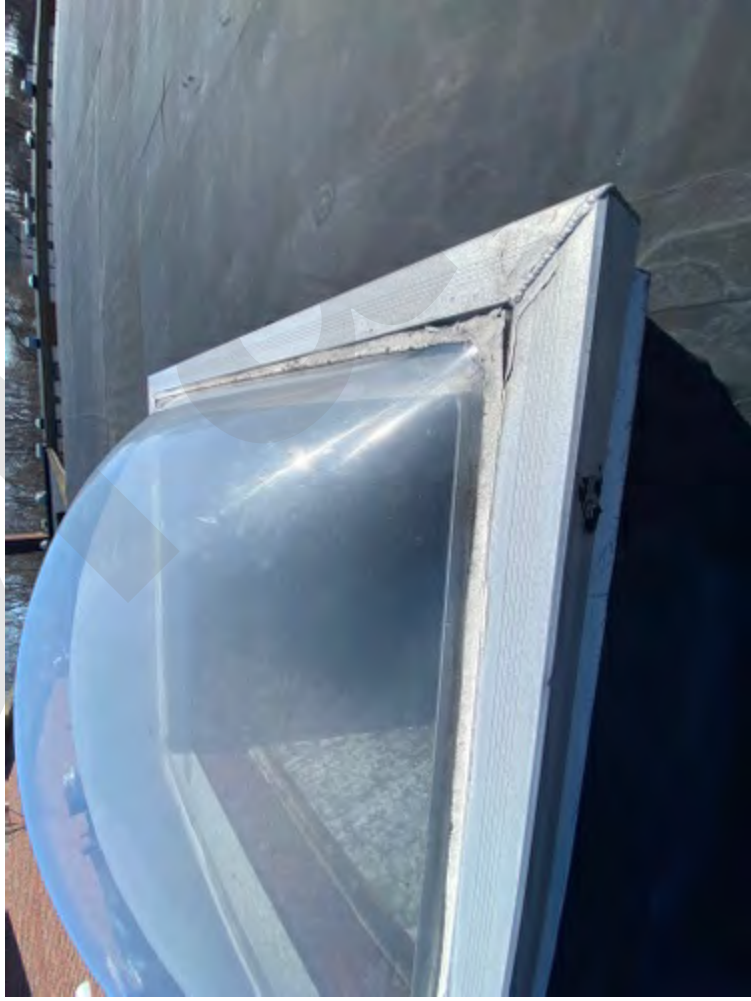
*Photo 30*

**Deteriorated sealant around skylight.**

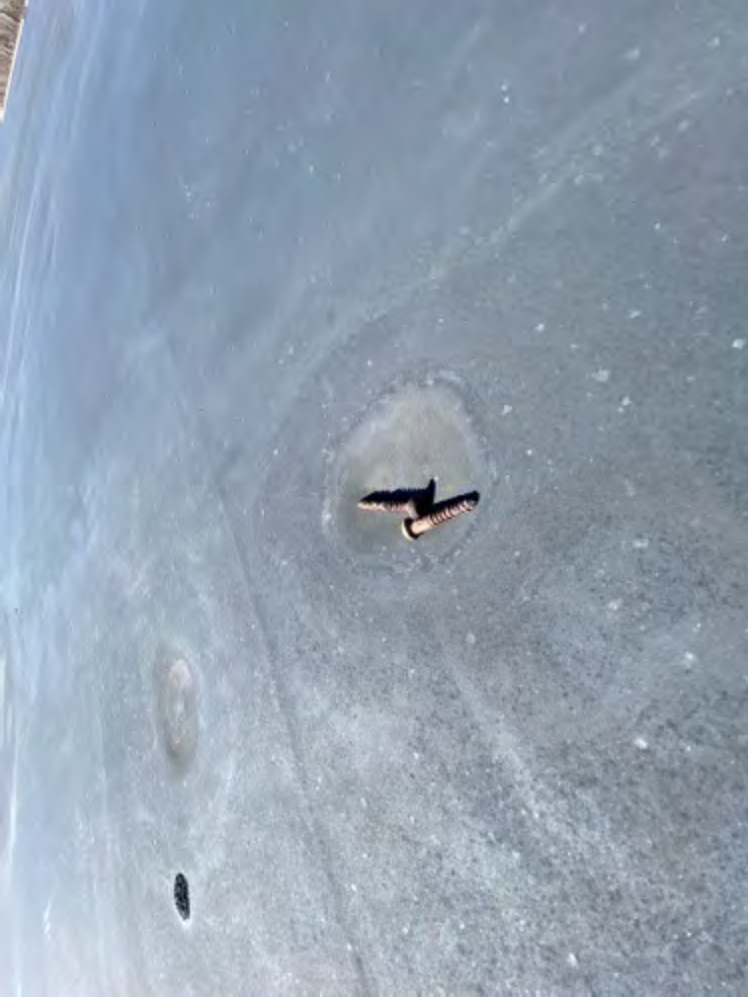
*Photo 31*

**Fasteners were observed around the roof.**  
These are potential puncture points in the membrane.

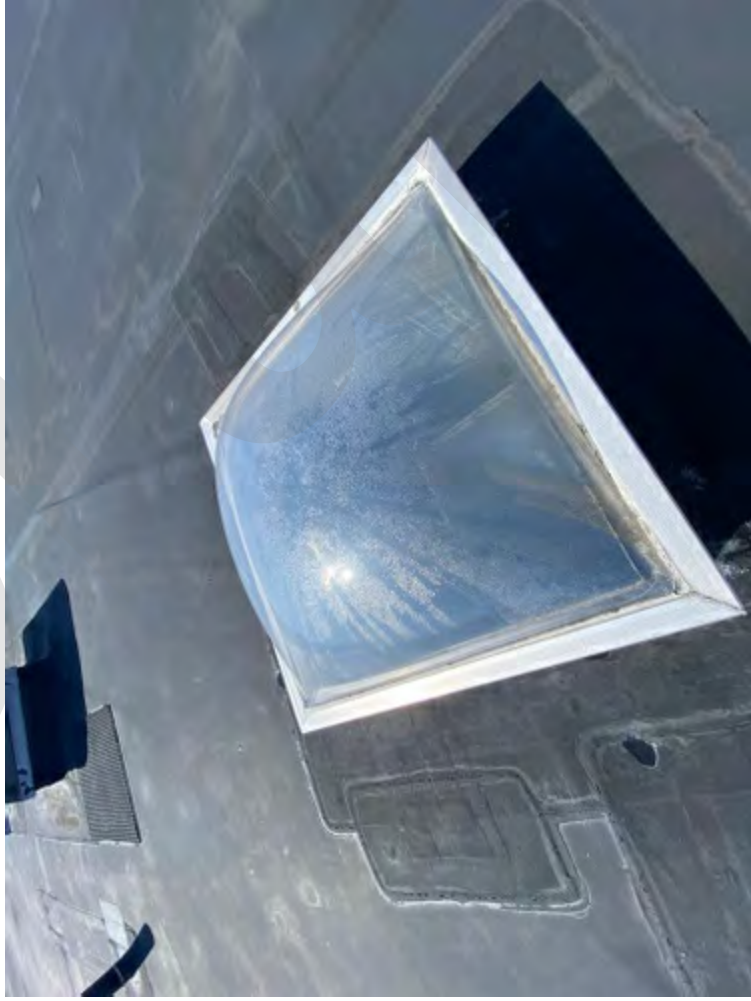
*Photo 32*

**Condensation was observed between the layers of the skylight.**  
This is a sign of end of life cycle.

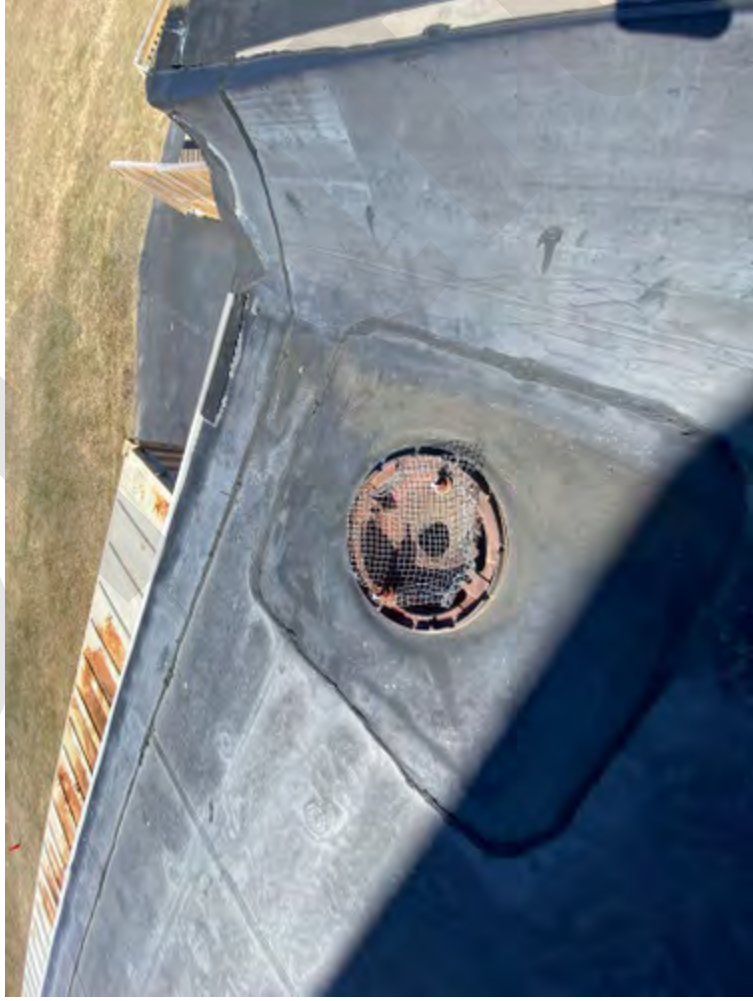
*Photo 34*

**Missing drain basket.**

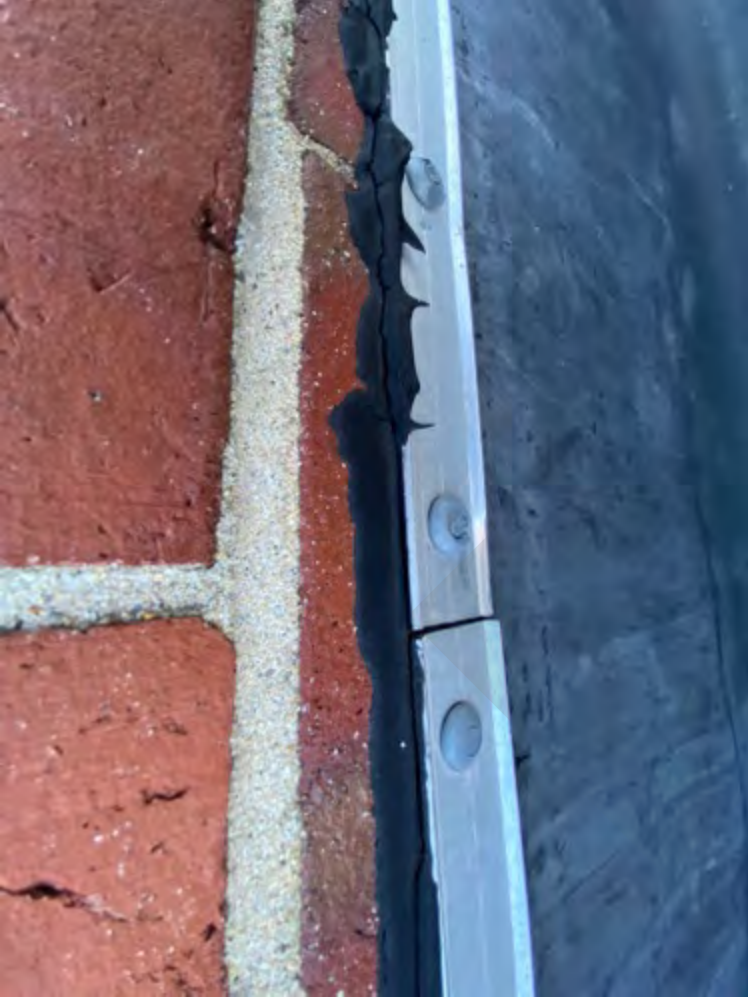
*Photo 35*

**Deteriorated sealant above surface mounted termination bar.**

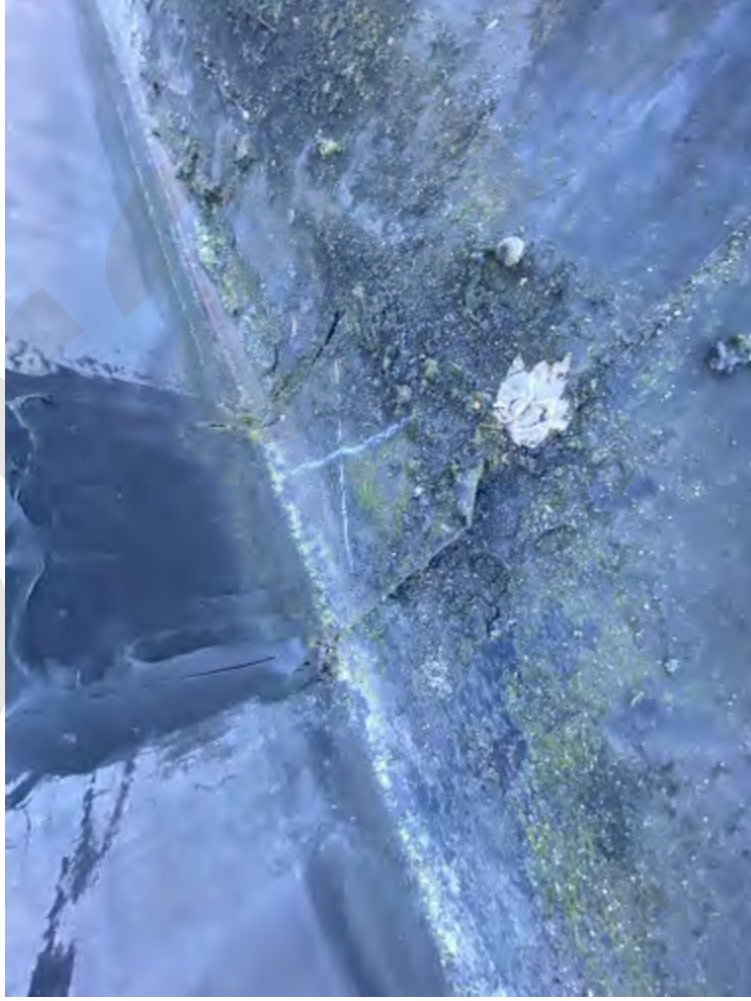
*Photo 36*

**Failed patch.**

The following conditions are associated with water infiltration:

- Interior water damage
- Mold/Mildew
- Saturated insulation resulting in loss of dimensional stability and R Value
- Delamination of the membrane from sub-straight.
- Rust/rot of fasteners and decking

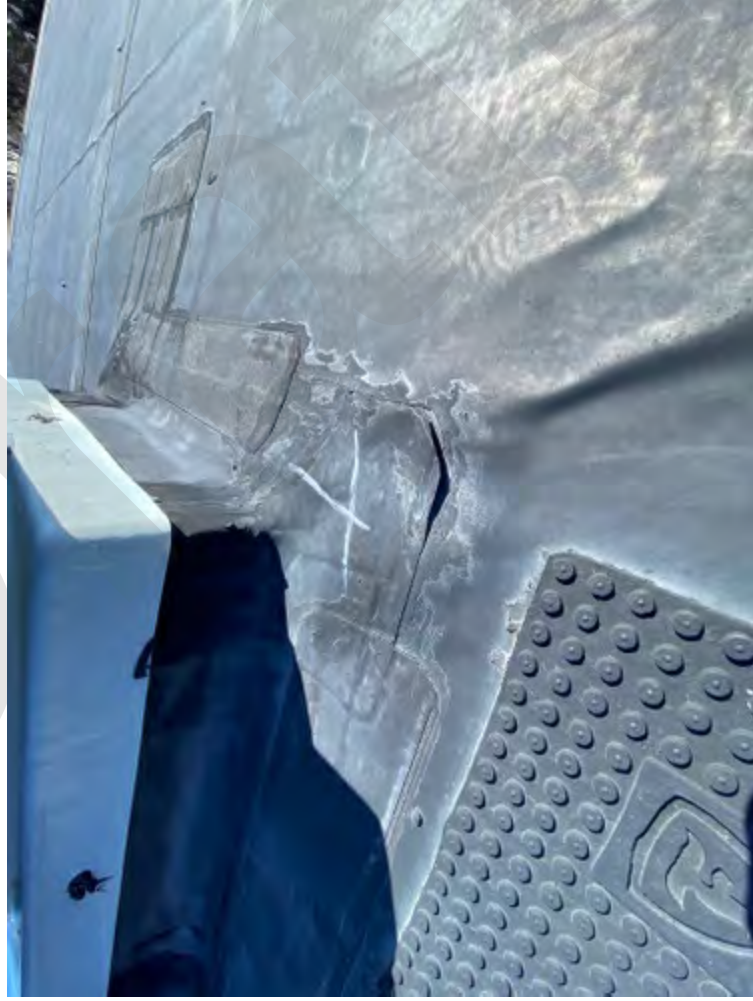
Photo 38

**Failed patch.**
