February 24, 2025

RE: General Microbial (Mold) Assessment Report for
Pembroke High School
80 Leaning Lanes, Pembroke, MA
PMEC Project #25-113

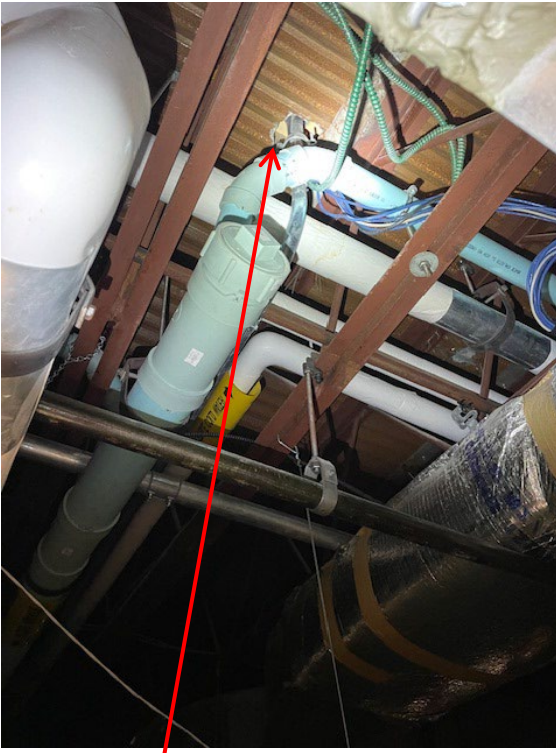
- A. Classroom:
 - 1. Existing Conditions:
 - The classroom at the back right side wall contains water stained and missing ceiling tiles. The tiles are currently dry with no visible active mold growth. Water piping above the ceiling tile rises up through the corrugated steel deck to a pipe chase on the floor above. The piping and openings in the steel decking has allowed a condition which promotes condensation dripping onto surfaces, including ceiling tiles, below the chase openings.
 - 2. Recommendations:
 - Seal openings in the corrugated steel deck with an approved fire retardant material (ex. spray foam, etc.).
 - Ensure piping is properly insulated with no openings in the vapor barrier (insulation, tape, etc.)
 - Replace missing and stained ceiling tiles.
 - Monitor area during the cooling season for additional condensation issues.

Photo 1: View of Room A173 ceiling plenum above stained tiles. Opening in steel decking above water and drain piping may allow for condensation dripping.

- A. PMEC recommends initially investigating and correcting conditions above the stained ceiling tiles to the fullest extent possible. This may include repairing vapor barrier breaks in fiberglass insulation, added insulation, etc. Equipment and openings in metal covers, etc. may require repair and sealing.
- B. Stained and missing ceiling tiles should be replaced after ceiling plenum (piping, HVAC) repairs are completed. New water stains should be regularly investigated and tiles replaced on an on-going basis.

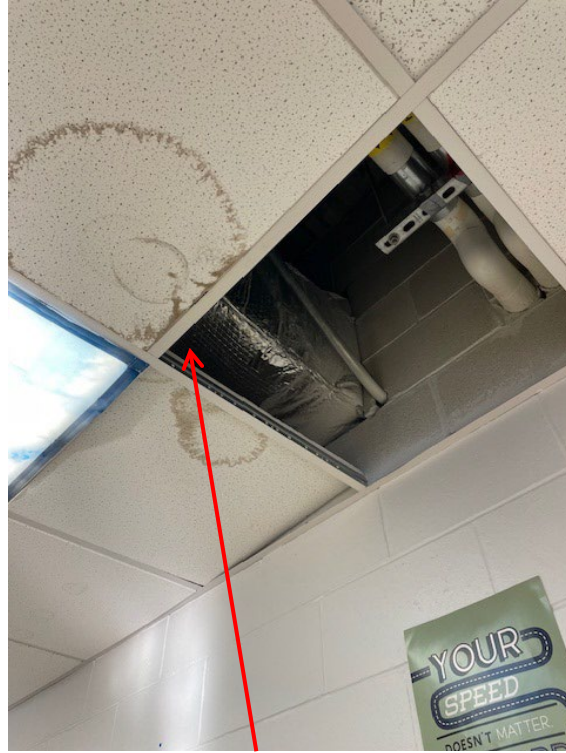
Photo 2: View of missing/stained ceiling tiles in Room A173 below pipe chase.

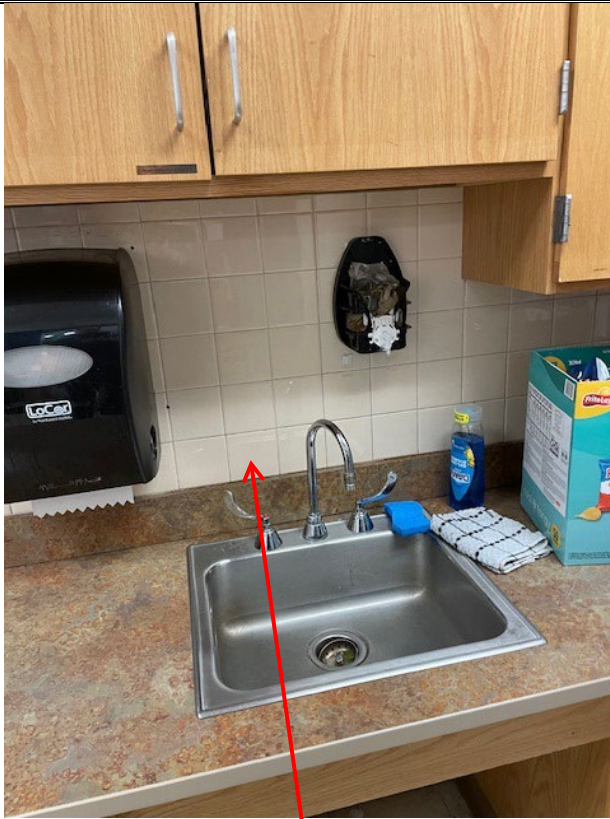
- PMEC did not identify any suspect mold growth on exposed surfaces. The ceramic tile above the sink, wallboard below the sink, and wallboard around the refrigerator did not exhibit any suspect mold growth. The exhaust fan was not operating but the system schedule operation was not confirmed. Minor dirt and water stains (splashing) may exist around and under the sink.

Photo 3: View of A173 kitchen at sink. No visible mold growth on ceramic tile and backsplash.

- Ensure the HVAC supply and exhaust systems are properly operating to provide proper ventilation.
- Clean and disinfect (wet-wipe) surfaces of concern, including back splashes and walls, on a regular (weekly) basis.

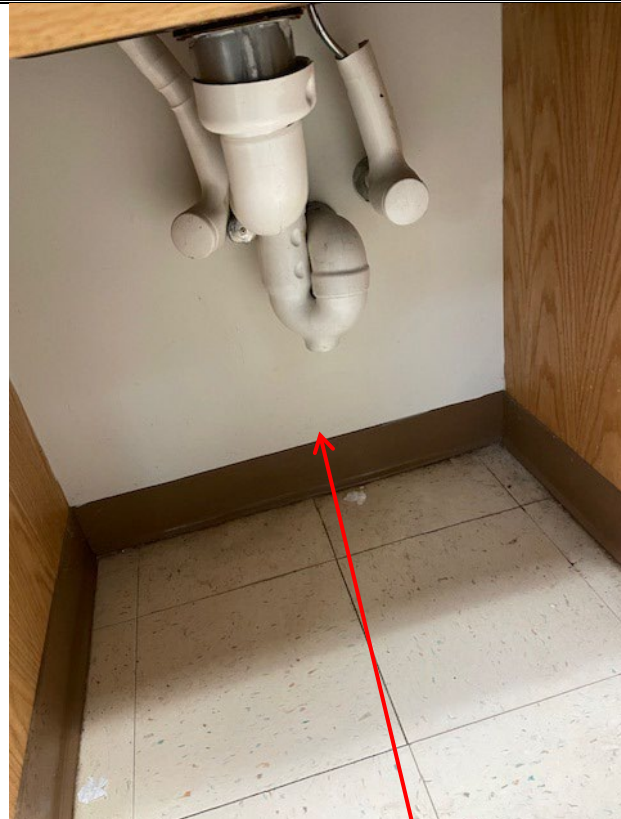
Photo 4: View under sink at A173 kitchen. No visible mold growth present on lower wall. Regular general housekeeping cleaning recommended.

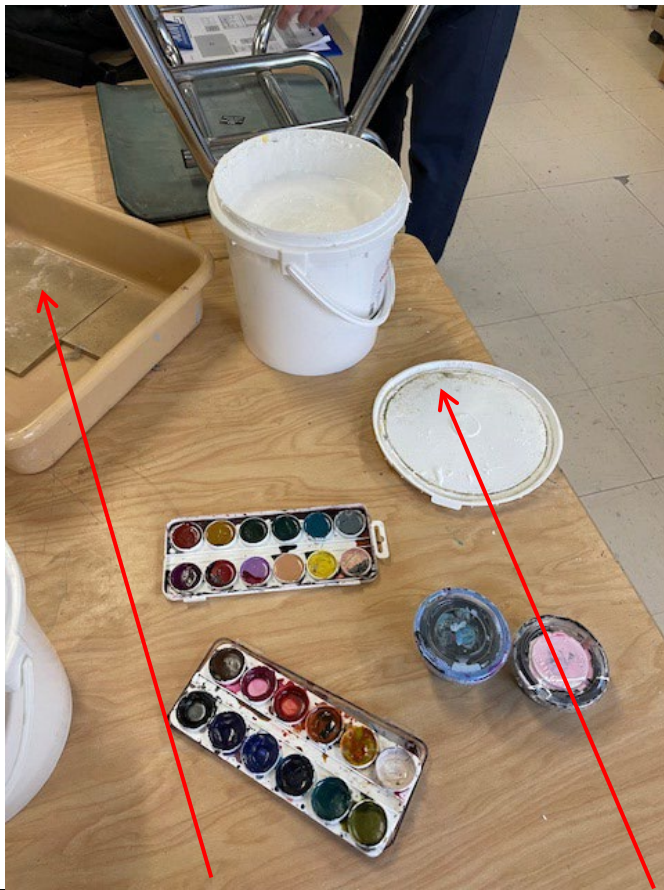
- Visible mold growth was observed on the following surfaces:
 - Small paint pail and small wooden storage box
 - Small individual plastic paint trays
 - Ceramic/clay tiles
- Items containing visible mold growth are (or may be) stored in wood storage cabinets. The moisture within the paint as well as potential humid conditions within the enclosed unventilated cabinet(s) allow for condensation and mold growth. Ceramic tile may absorb moisture and allow for mold growth on tiles. Dusty, dirty tiles will act as a food source to allow for mold growth.
- Items containing suspect mold within the classroom(s) may result from increased room humidity, increased moisture from the paint and residual water (post cleaning) which allows for mold growth.

- The teacher stated that an unopened paint pail was observed to contain suspect mold growth upon opening the pail cover seal. The paint from this pail was still used going forward.

Photo 5: Art Room B245: View of containers, trays, and tiles with visible mold growth.

3. Recommendations:
- Items stored in enclosed cabinets should be thoroughly cleaned and dried to reduce moisture and humidity levels prior to storage in the cabinets.

- Ceramic/clay tiles should be dry and clean prior to storage.
 - Cabinets may require ventilation to prevent high humidity conditions during the summer and fall seasons. Cabinets doors should be opened on a regular basis to allow air to mix with existing room air. Keep doors open during the summer season during periods of limited use.

- Air diffuser vents may be cut into the cabinet doors to allow for additional interior cabinet ventilation. This will allow for cabinets to mix with room air.

- Items containing any suspect mold should be placed in sealed bags and discarded upon discovery.
 - Utilize clean, dry plastic trays and containers where possible.

- Monitor conditions and materials for future mold growth.

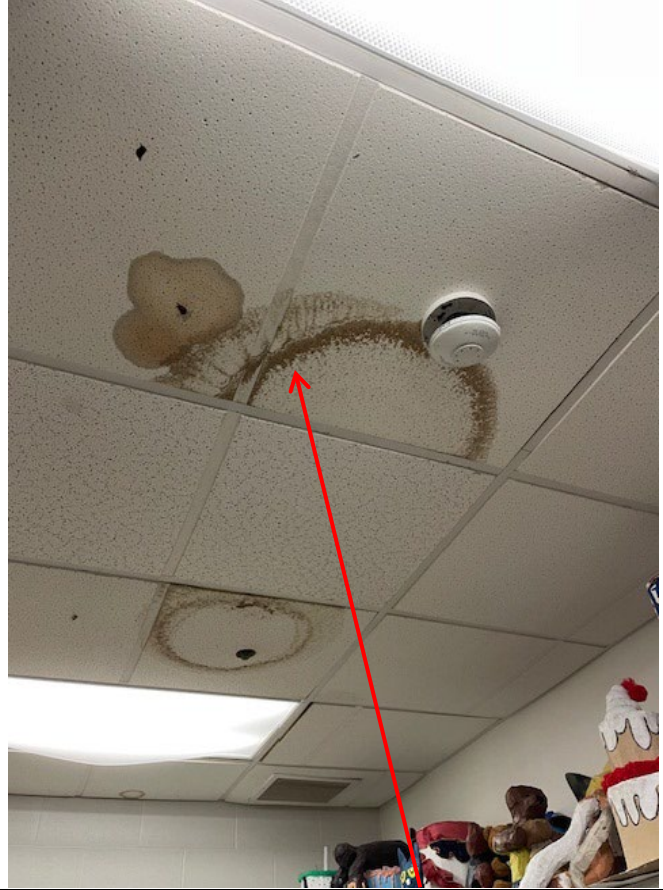
- Stained ceiling tiles exist in the back middle side. No current water leaks or visible mold were present. The ceiling plenum above the stained ceiling tiles was not accessed due to stored items to determine potential sources of the water staining.

Photo 6: View of Art Room middle Kiln Room: Stained ceiling tiles present. Investigate plenum above and replace tiles.

- Investigate source of water leaks (condensation, poorly insulated piping, etc.) and correct as needed.
- Replace stained ceiling tiles.
- Monitor area for future water staining.

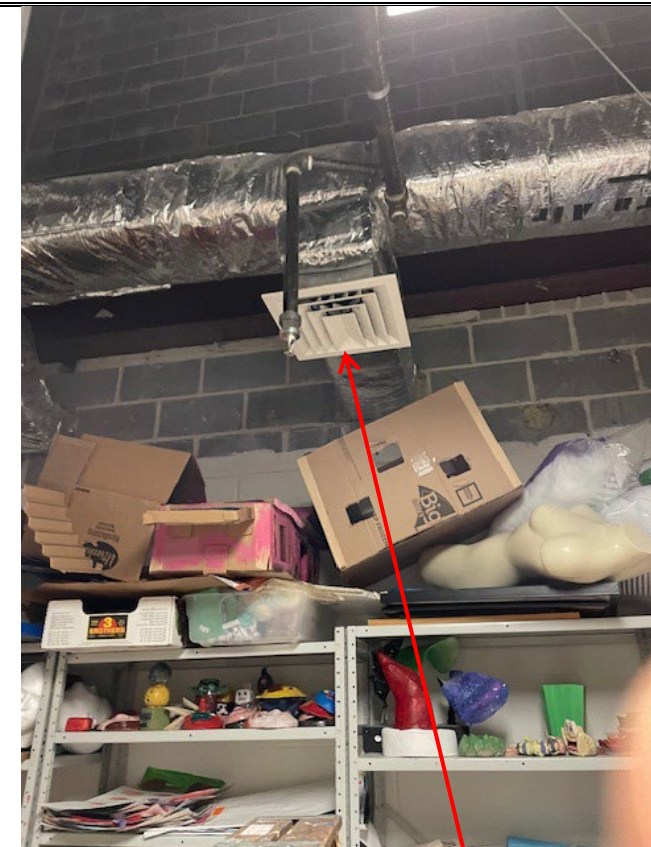
- Ceiling level supply and return diffusers in the classrooms and kiln room show a minor buildup of settled dust. No visible mold growth (spotting) was observed on the metal diffusers.
- The main storage room HVAC supply diffuser was recently cleaned.

Photo 7: View of A173 Storage room. Ceiling level supply diffuser recently cleaned.

- Clean and disinfect ceiling level HVAC diffusers free of dust and debris.
- Ensure the HVAC system is operating as designed to supply sufficient adequate supply and exhaust ventilation. Operate the HVAC system for a longer period of time during the summer and fall seasons to remove excess humidity.
