February 24, 2025

RE: General Microbial (Mold) Assessment Report for  
**Pembroke Community Middle School**  
559 School Street, Pembroke, MA  
PMEC Project #25-113

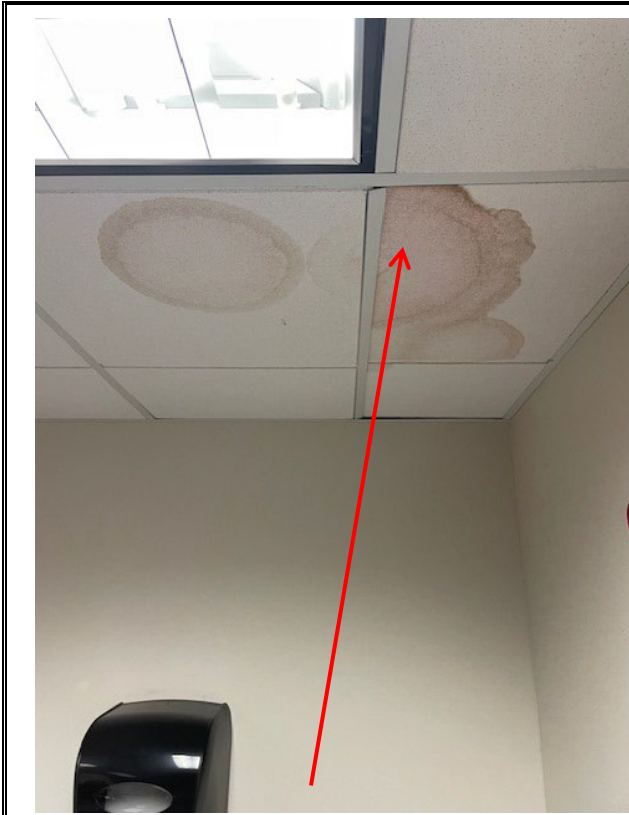
- A. Existing Conditions:
- The front side contains 2-3 water stained ceiling tiles. The tiles are currently dry with no visible active mold growth. Fiberglass insulated ducting above the ceiling contains loose and open insulation. This break in the vapor barrier may allow for condensation to form when humid air contacts the cold HVAC duct. The resulting condensation drips onto the ceiling tile below during the cooling season.
- B. Recommendations:
- Seal (retape) openings and breaks in the fiberglass duct insulation. Ensure proper sealing of duct insulation.
  - Replace missing and stained ceiling tiles.
  - Monitor area during the cooling season for additional condensation issues.

Photo 1: View of Room C119 with stained ceiling tiles. No visible mold growth present.

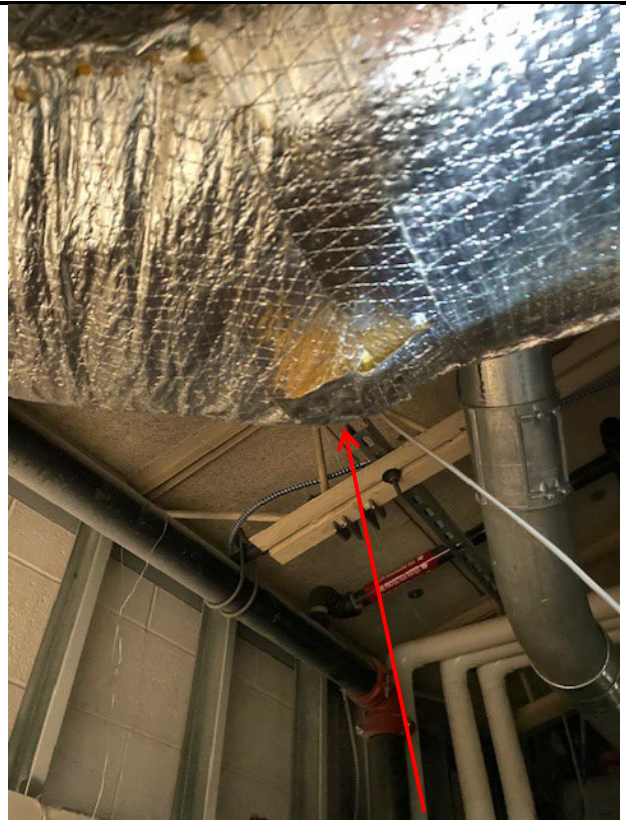
Photo 2: Room C119 - View of ceiling plenum with loose/torn fiberglass duct insulation allowing for condensation.

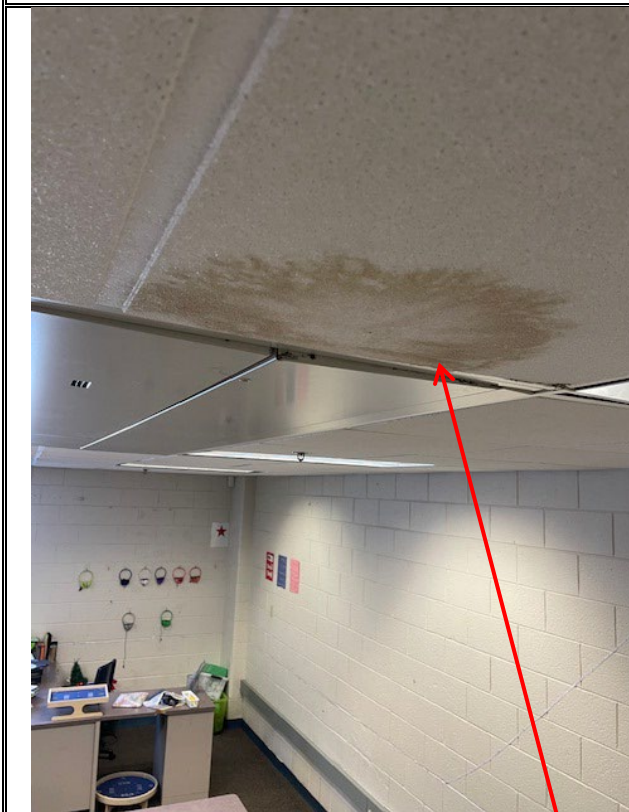
- The classroom contains water stained ceiling tiles at the ceiling mounted AHU (fan coil) in the center of the room. The stained tiles are currently dry with no visible active mold growth. Bare piping (valves, etc.) at the fan coil controls are uninsulated potentially allowing for condensation dripping. Water stained ceiling tiles are present directly under this area.

Photo 3: View of Classroom B032 with stained ceiling tiles at ceiling AHU unit

- Properly insulate and seal HVAC piping at the fan coil above the ceilings.
- Replace missing and stained ceiling tiles.
- Monitor area during the cooling season for additional condensation leak issues.

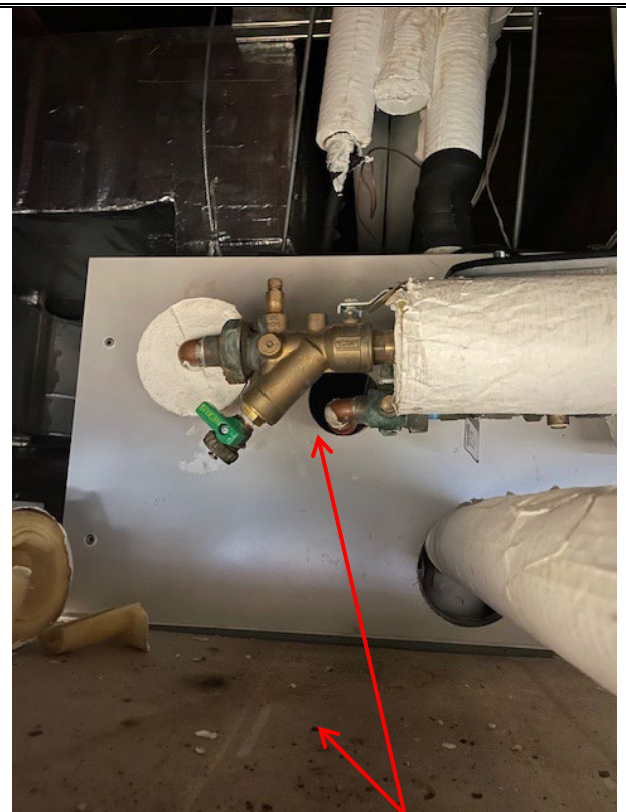
Photo 4: Classroom B032 - View in ceiling plenum at AHU showing uninsulated HVAC piping allowing for condensation dripping onto ceiling tile below.
