1MWO25001-RPT-01

Final Report – Structural and Fire Protection Concerns at Jenkins Middle School, Colorado Springs, CO

3/10/2025

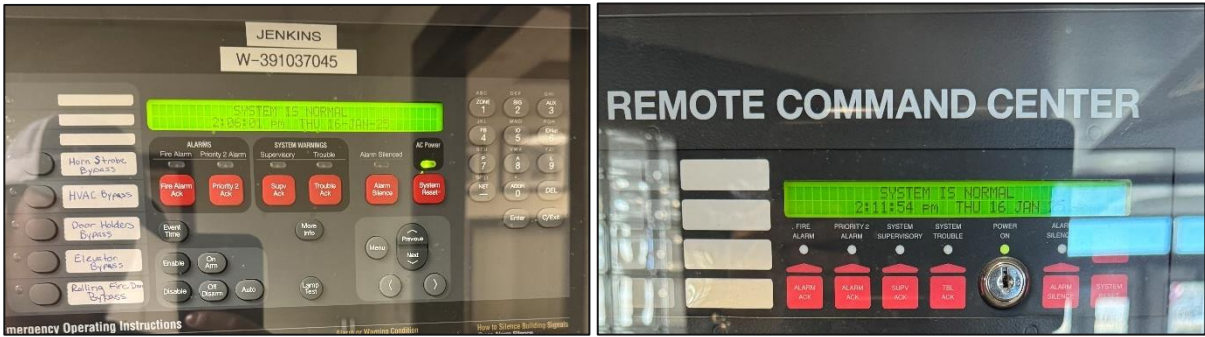
Figure 5.2. JMS Fire Alarm Control Panel and Remote Command Center

- b. **Visual Inspection** – A walkthrough of the fire detection and alarm system in the main areas indicated that the fire alarm initiating devices and notification appliances appeared to be in general good condition, with no apparent damages resulting from structural issues within the building. The fire alarm control panel and the remote command center panel both indicated that the system was normal and had no troubles or faults. Limited inspection of wiring and conduit supporting the system resulted in no findings that could impact system function.

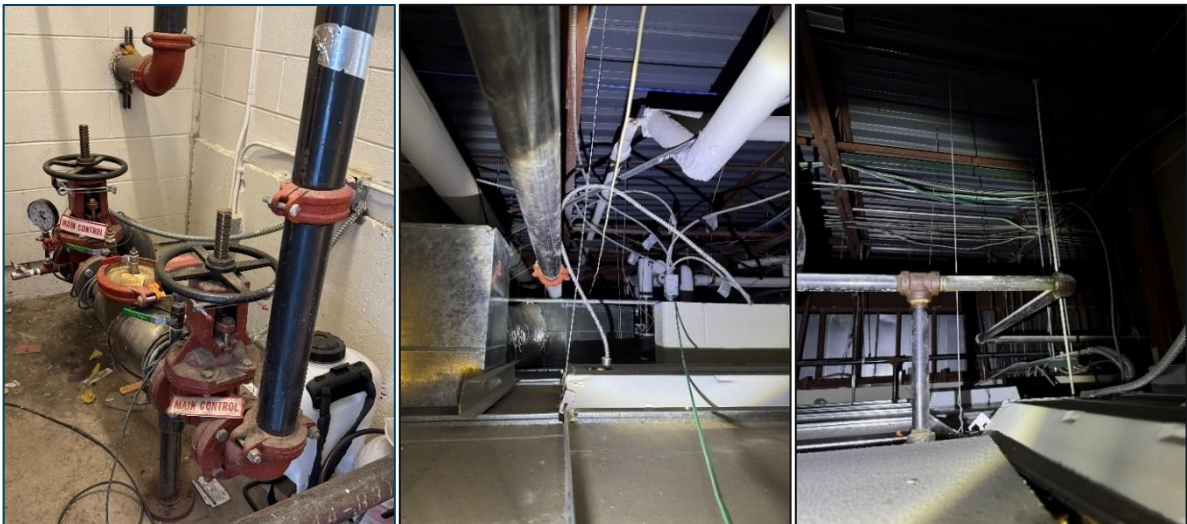
Figure 5.4. JMS Fire Sprinkler System Riser Room and Piping

- b. **Visual Inspection** – A walkthrough of the fire sprinkler system was conducted. At and around the fire riser and fire water entry, there were no apparent signs of damage, resulting from structural issues. The fire sprinkler piping above the ceiling did not have signs of physical damage (cracking, dents, warping, etc.). Fire sprinkler piping appeared to be properly supported and restrained throughout.

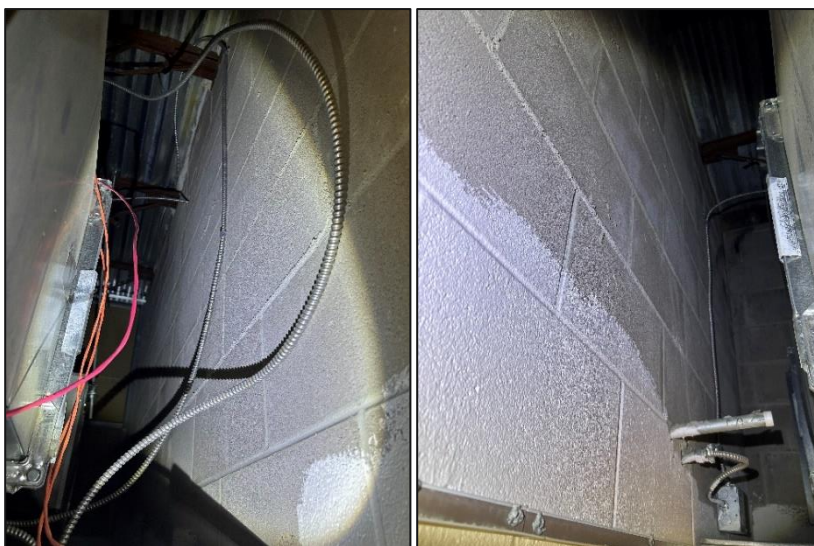
Figure 5.7. Picture of ASW-1 Wall

A limited assessment of this wall was conducted as the area it is within was found to be structurally compromised. An above-ceiling assessment was conducted in areas where the wall was accessible.

Construction: This area separation wall is primarily CMU from the floor to the roof deck. No major cracking was observed within the CMU wall.

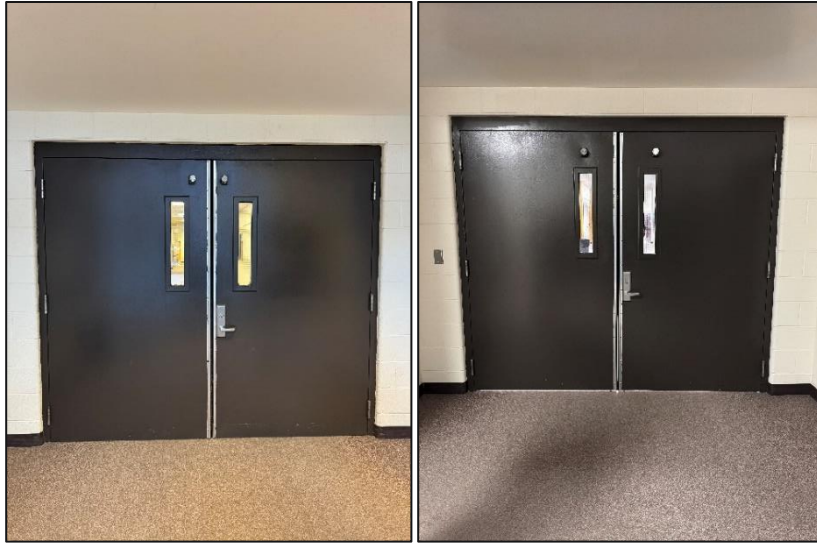
*Figure 5.8. Picture of ASW-1 Doors*

Openings: The two sets of double doors within the area separation wall were provided with magnetic hold-open devices connected to the fire detection and alarm system. The fire detection and alarm system function that would release the doors from the magnetic hold-open devices was not evaluated. The doors were manually released from the hold-open devices for this evaluation. The doors were confirmed to be provided with a listing label, self-closing after manual release, and positive latching. Door-to-frame and door-to-floor gaps were outside of the allowable tolerances. No major damage to the doors was observed.

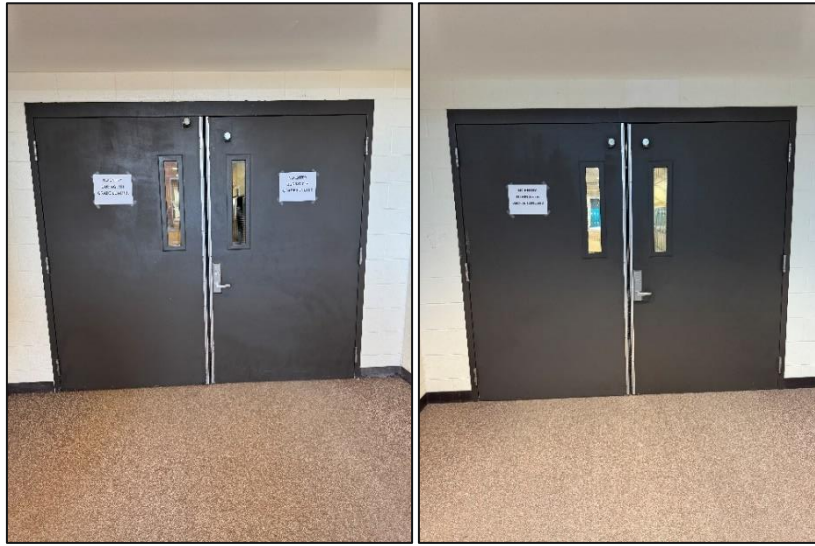
Figure 5.9. Picture of ASW-2 Doors

Openings: The two sets of double doors within the area separation wall were on mag-holds. They were confirmed to be labeled, self-closing, and positive latching. Door-to-frame gaps were outside of the allowable tolerances. No major damage to the doors was observed.

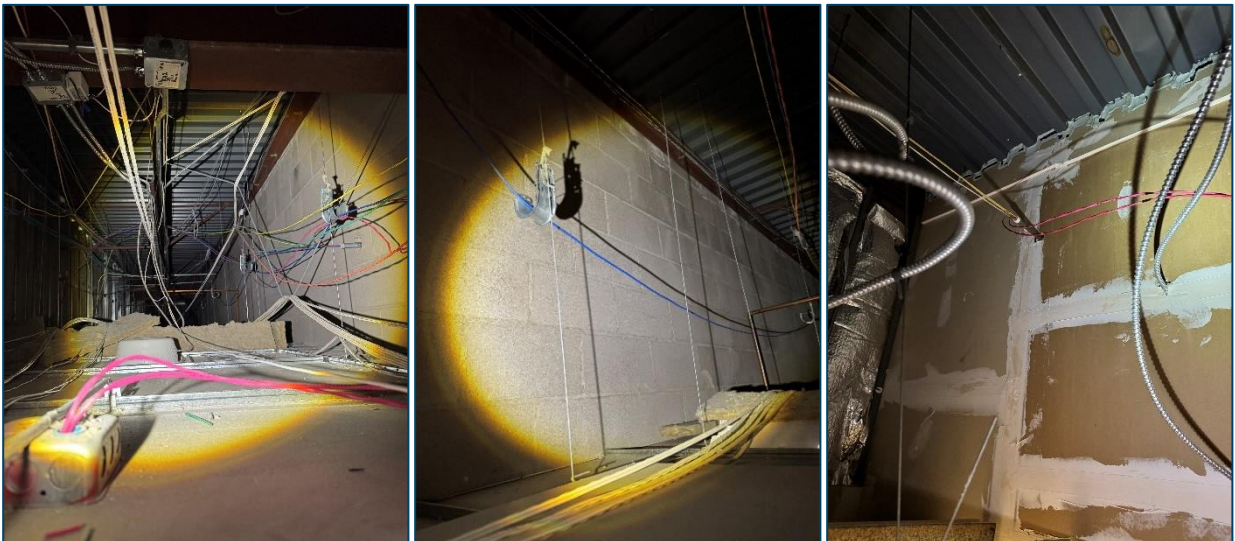
Figure 5.10. Picture of ASW-3 Wall

Construction: This area separation wall is primarily CMU from the floor to the roof deck. No visible cracking within the CMU wall was observed. At the south end of the wall, the wall above-ceiling transitions from CMU to drywall. Within the Kiln Room, the drywall appears to be slightly separated from the deck above. It is unclear if this is a result of structural damage (the floor of the room has significant damage) or if it is a result of thermal expansion of metal construction elements due to the heat from the kiln within the room.

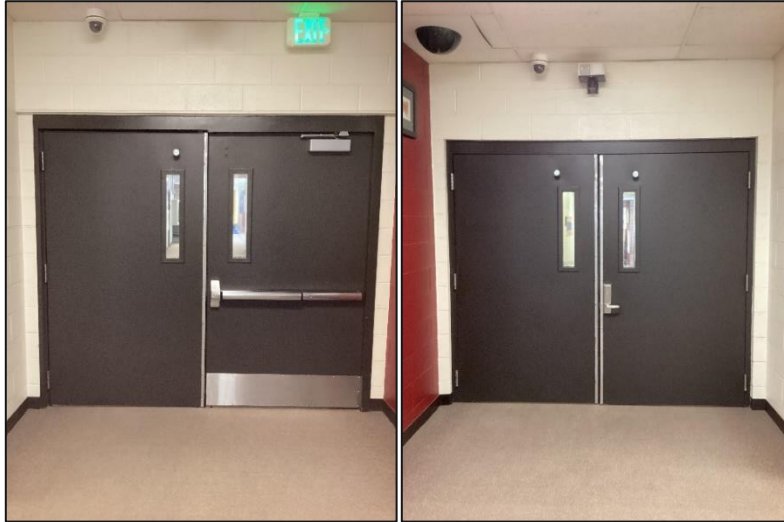
Figure 5.11. Picture of ASW-3 Doors

Openings: The two sets of double doors within the area separation wall were on mag-holds. They were confirmed to be labeled, self-closing, and positive latching. Door-to-frame and door-to-floor gaps were

outside of the allowable tolerances. Windows were provided by rated glazing or fire-rated shutters. No major damage to the doors or windows was observed.

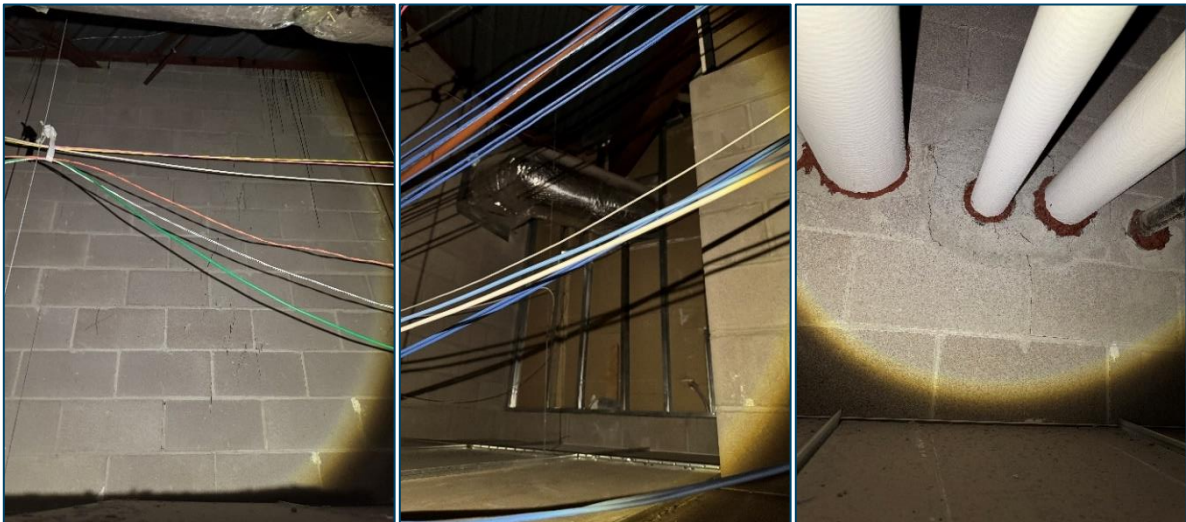
Figure 5.12. Picture of ASW-4 Walls

Construction: This area separation wall is primarily CMU from the floor to the roof deck. In certain areas above the ceiling, the CMU wall transitions to drywall with metal studs. Some visible cracking within the CMU wall was observed below and above the ceiling. Where the CMU transitions to drywall, the transition appears smooth without gaps.

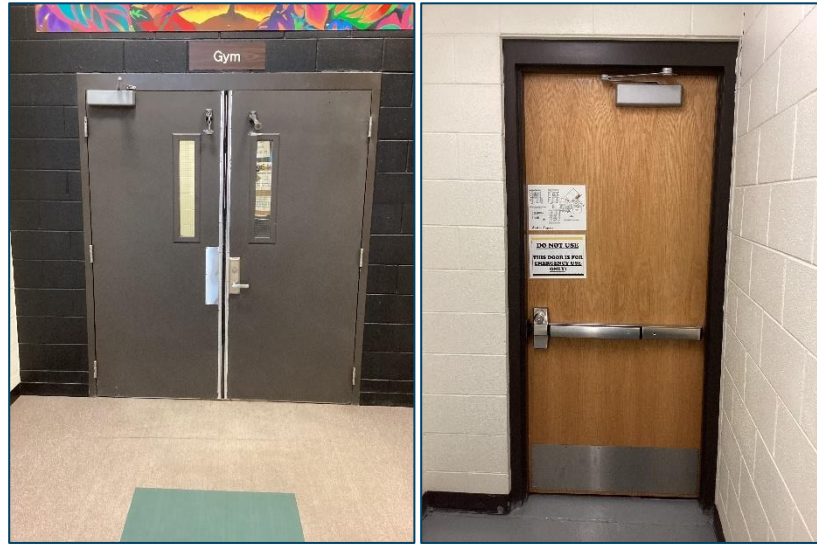
Figure 5.13. Picture of ASW-4 Doors

Openings: There is a set of double doors serving the Gymnasium within the area separation wall on mag-holds. The Boy's and Girl's Locker Room doors were also within the area separation wall. They

were confirmed to be labeled, self-closing, and positive latching. Door-to-frame gaps were outside of the allowable tolerances and at least one of the doors has been shaved, and the latch has been modified. Windows were provided by rated glazing or fire-rated shutters. No major damage to the doors or windows was observed.

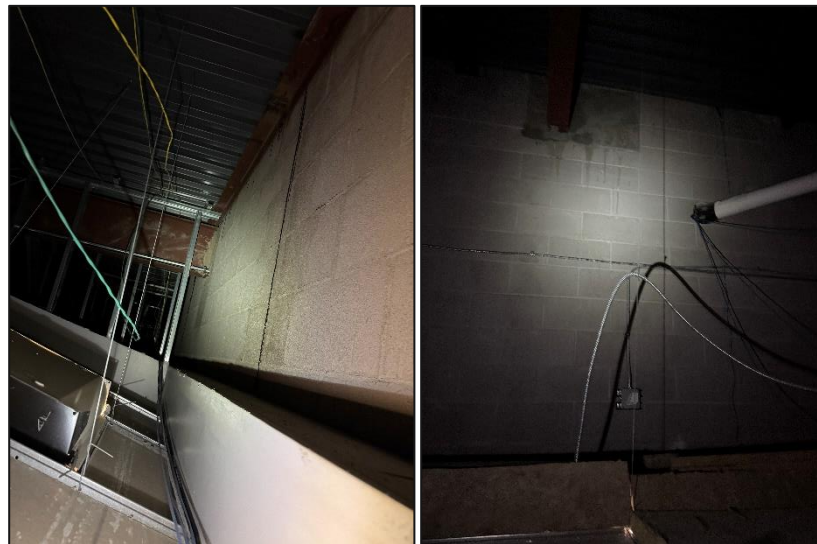
Figure 5.14. Picture of ASW-5 Walls

Construction: This area separation wall is primarily CMU from the floor to the roof deck. No visible cracking within the CMU wall was observed.

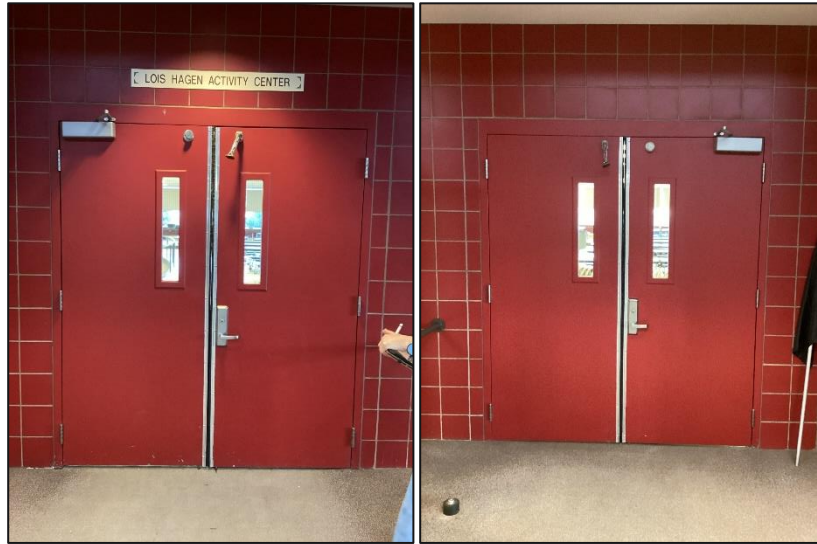
Figure 5.15. Picture of ASW-5 Doors

Openings: The two sets of double doors within the area separation wall were on mag-holds. They were confirmed to be labeled, self-closing, and positive latching. Door-to-frame and door-to-floor gaps were outside of the allowable tolerances. Windows were provided by rated glazing or fire-rated shutters. No major damage to the doors or windows was observed.

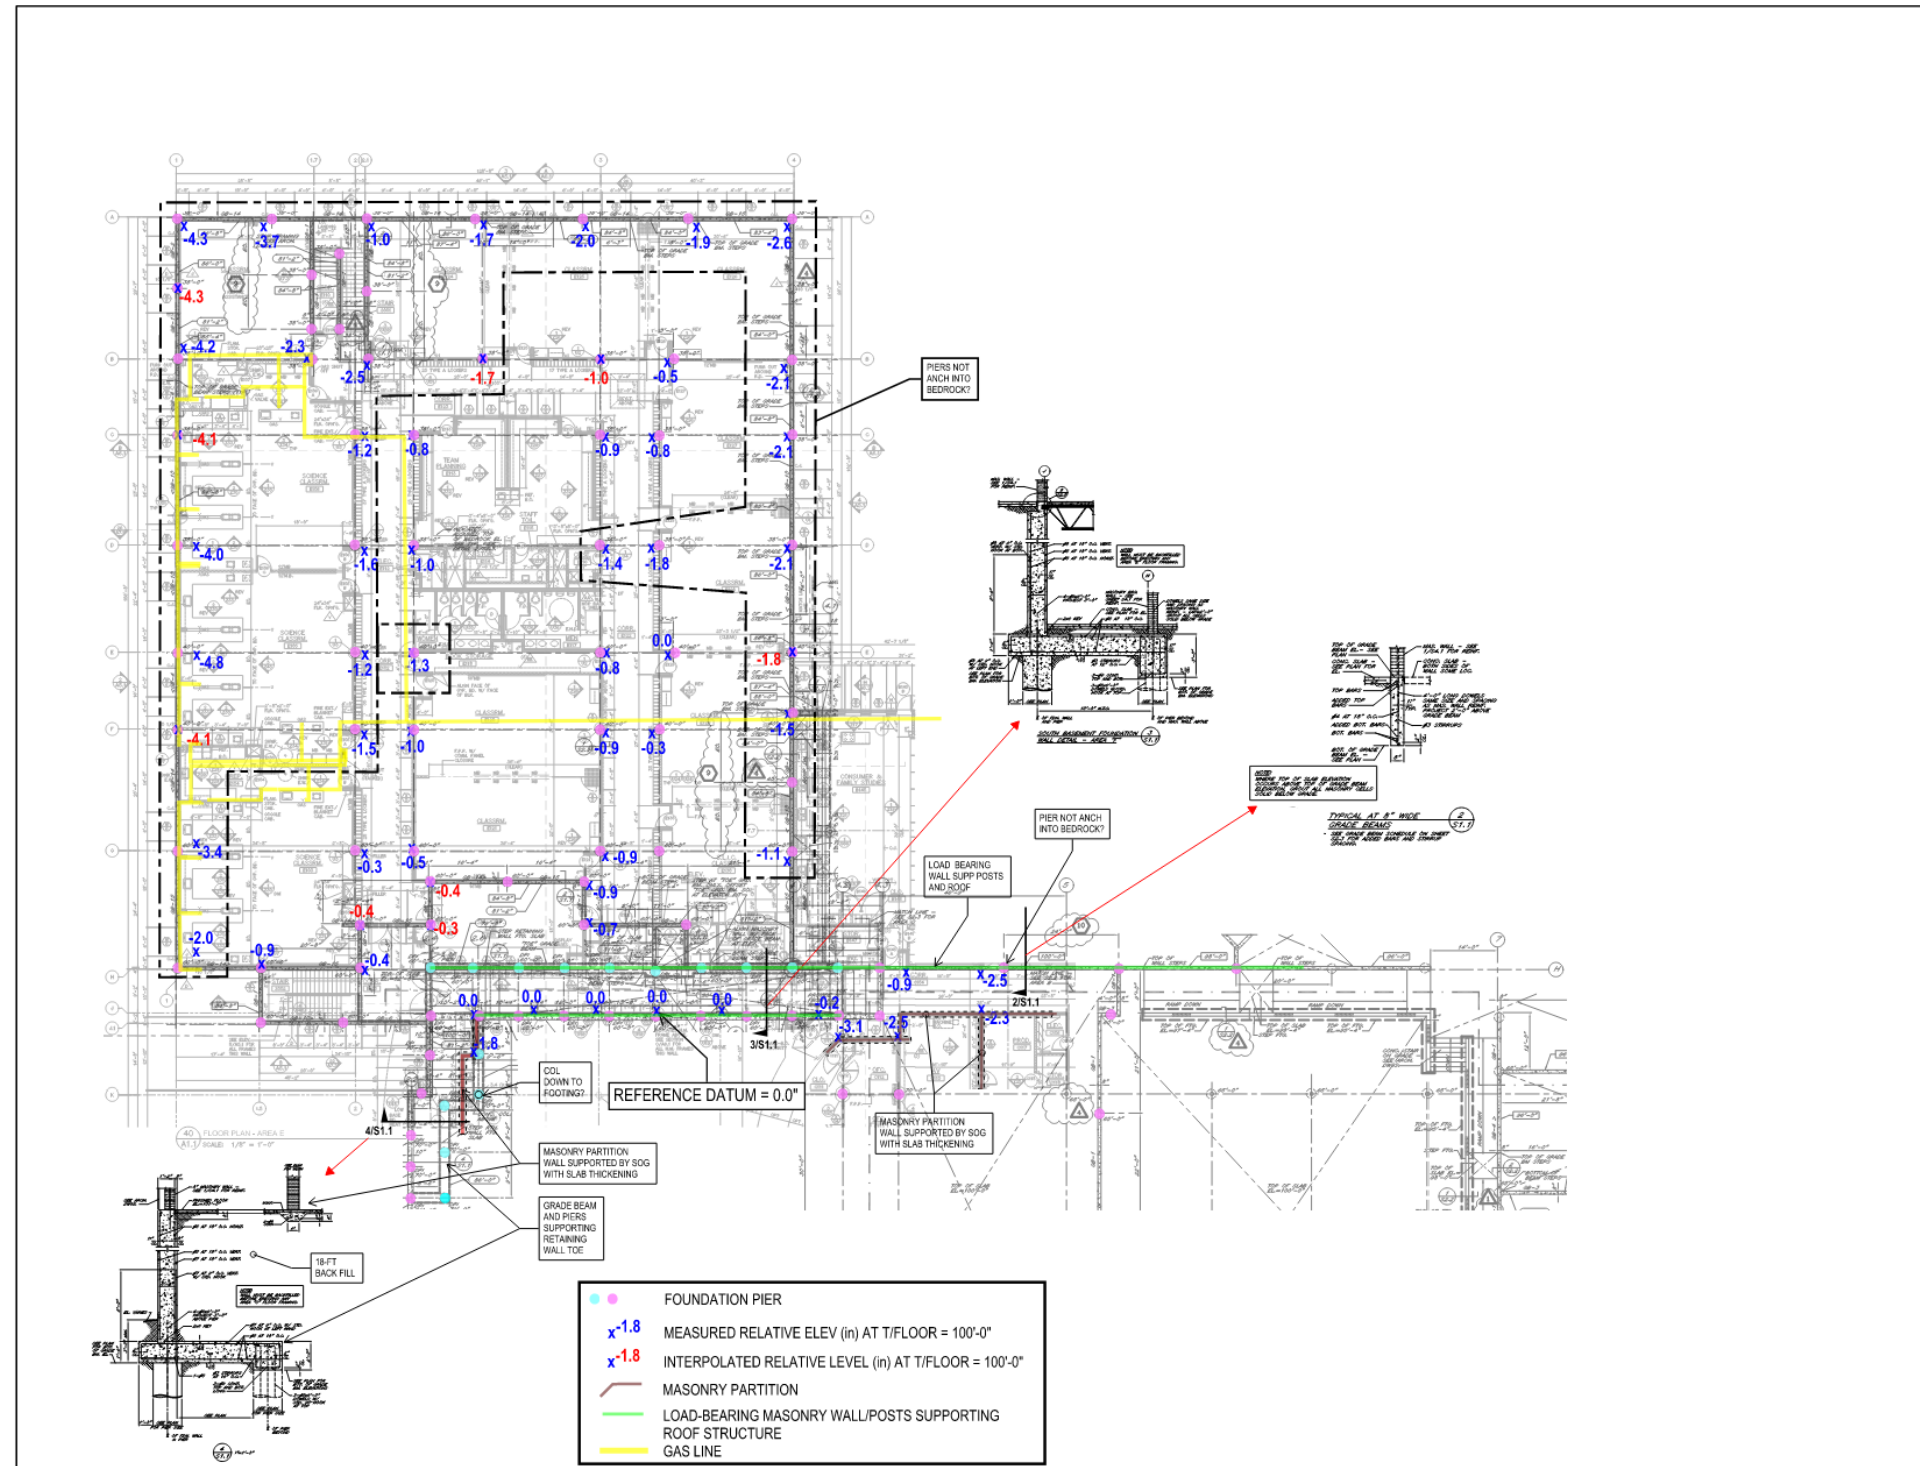
Appendix B Overlay of Gas Lines onto Areas with Significant Differential Displacement

1. See Appendix B for a markup of the gas lines within the JMS areas affected by structural differential displacements. Affected areas were determined to be limited to Areas E and F (7th and 8th Grade Wing).
2. Where accessible, gas piping from the Mechanical Room (B130) to each 7th and 8th Grade Science Classroom was visually inspected, and there was no indication of undue stress or damage that appeared to be impacted by the displaced structural components. Note that within the Science Classrooms, much of the gas piping is run through walls and under floors to feed gas nipples. This piping was not accessible and not inspected; however, this piping is downstream of the gas valves (which are all visually identified as closed).
3. Underground and exterior gas systems were not evaluated.
