## **Re: Statement of Interest - Medford High School - Core Program**

# Report of Findings: Focused Facility Condition Review

Medford High School

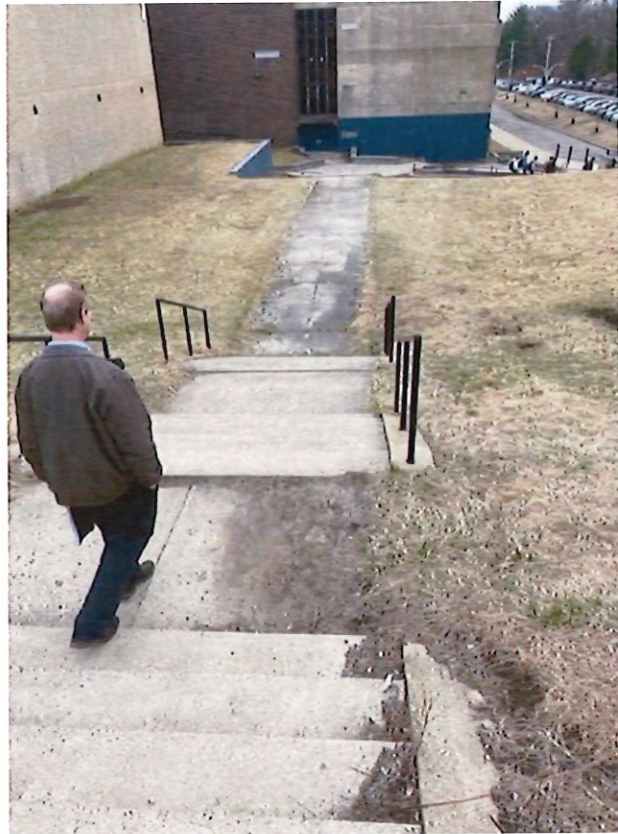
The site walkways around the perimeter of the facility are beyond their useful life expectancy, and pose safety and accessibility challenges, specifically on the west elevation noted in the picture to the right.

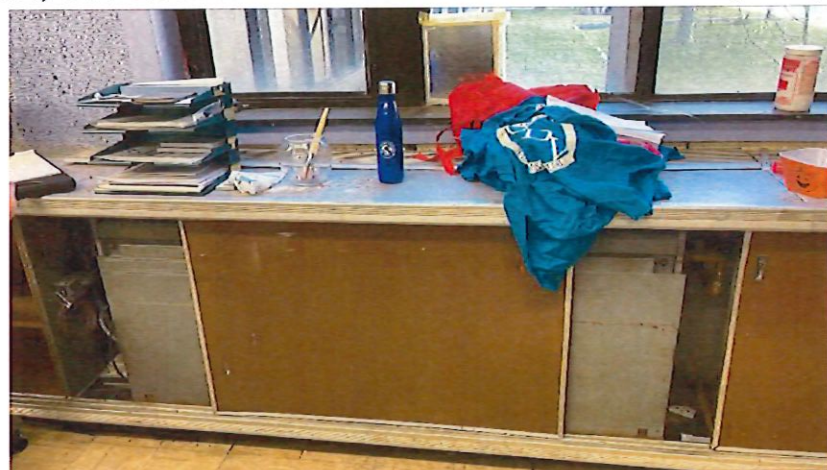
Univents (Unit Ventilators) were observed in each classroom and function as the primary ventilation. The ventilators were installed during the original school construction and were observed to be in poor condition, and well beyond useful life expectancy. In most of the classrooms the exhaust did not appear to function. The ventilators are of particular concern, as they are not only a significant factor of the buildings' HVAC performance, but also are part of the exterior opening assembly. Both interior and exterior sealants and caulking were in poor and most cases failing condition and in need of immediate abatement, improvement and/or replacement. It should be noted that the staff has found it exceedingly difficult to find parts for these obsolete units.

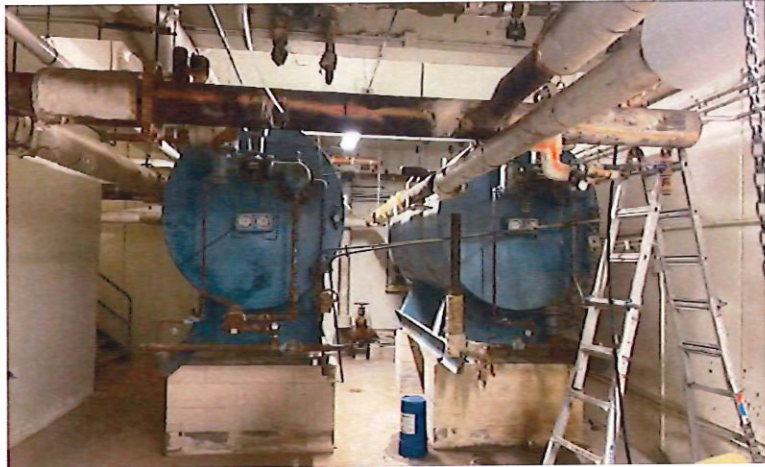
On each day during the field inspection period significant amounts of water had pooled on the floor. It was reported that the origin of the water was a combination of equipment leaks and ground water seepage. **This standing water is of particular concern. Its origin is possibly related to hydraulic pressure from below the slab system. The under-slab drainage system should be assessed to confirm whether pockets of water or artesian wells are present below the building and are a contributing factor to the standing water in the main mechanical room.** Key pieces of equipment within the room included heat exchangers for buildings A, B and D; two handler units, domestic hot water

decommissioned air tanks and pumps, boilers, electric motor control panels and transformers, the main chemical waste tank, the sprinkler standpipe servicing the new science wing on the third floor, and an obsolete pneumatic control system. All but the new domestic water equipment was observed to be installed at the time the Building was constructed, in poor condition and beyond useful life expectancy.

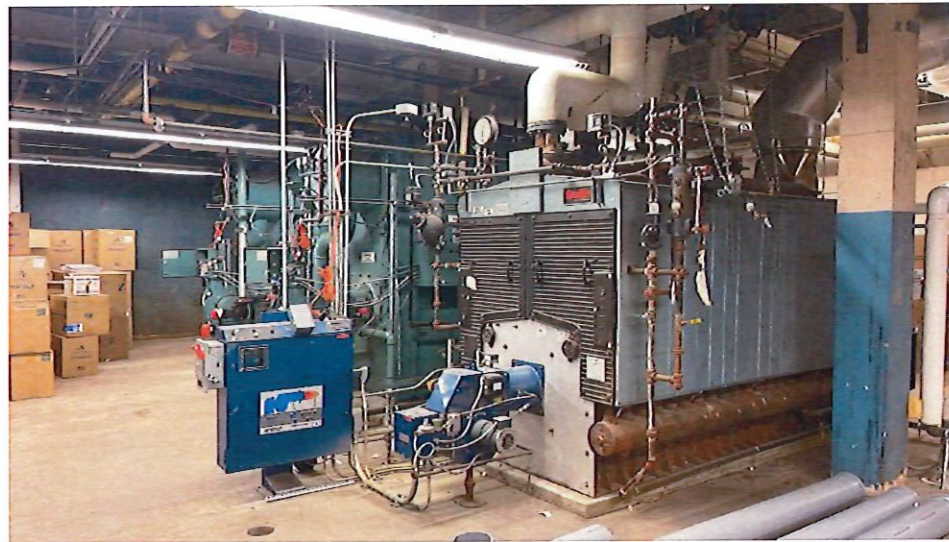
The school's boiler room provides hot water through facility. Three replacement boilers (2008, 2016) and a hot water system under construction during the site tour are housed within the space. The walls were observed to be painted concrete and CMU. The slab on grade is concrete with 3-4" equipment pads. The condition of the room and the existing equipment was poor the equipment is beyond its useful life expectancy.

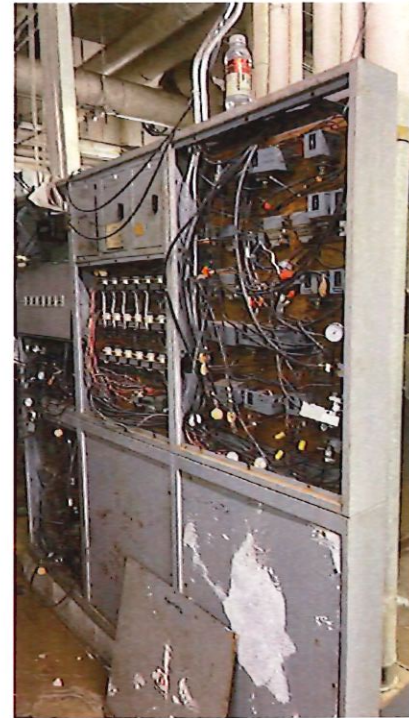
The building's HVAC systems were observed to be controlled pneumatically. This system is considered obsolete and requires significant maintenance to be operational. The DDC panel installed to control AHU 1 and AHU 2 is no longer functioning. Please refer to the EH&E Report attached for further condition performance assessment.

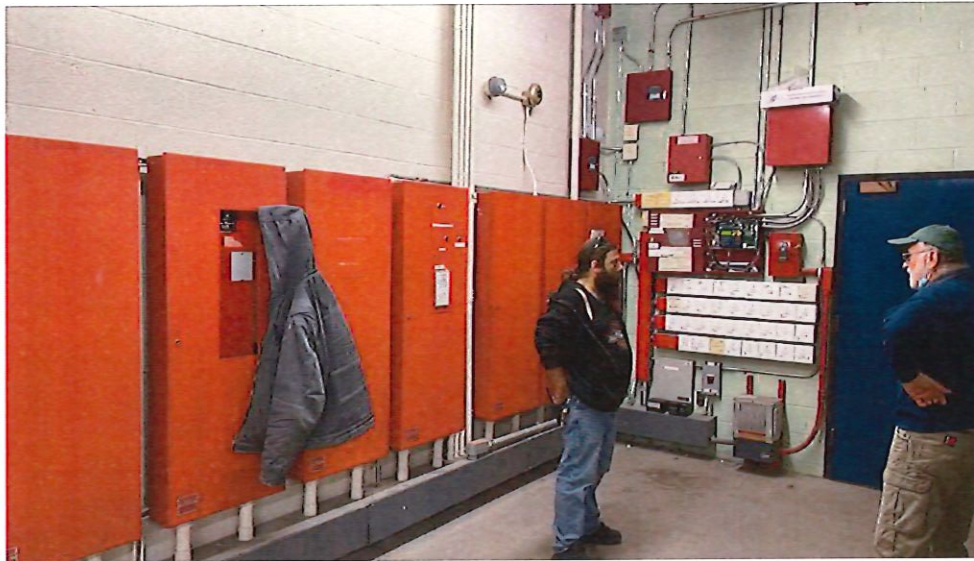
The building fire alarm system on the first and second floor was observed to have been installed during the original construction, in poor condition and beyond its useful life expectancy.

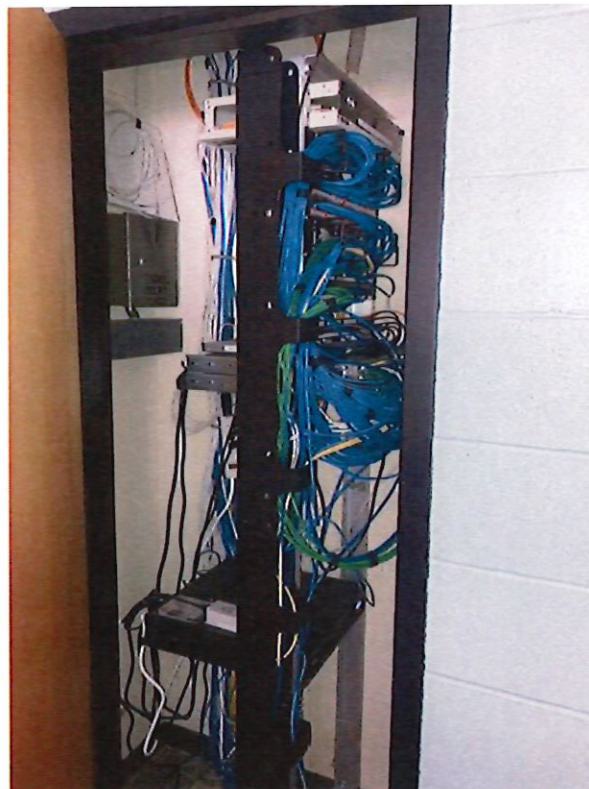
The Building's IDF closets have been added to the structure ad-hoc and are not located in the optimal locations, do not have appropriate cooling/HVAC, and do not have enough dedicated power to support the infrastructure as it stands and cannot be upgraded. These deficiencies are liable to result in future outages and issues directly as a result of the ad-hoc nature of the installations (e.g., unshielded CAT5/6 cables running directly over equipment causing melting/breaks). The Building and will result in major infrastructure problems down the line.

As noted in other sections, the Building's construction is aging and beyond its useful life expectancy. This is also reflected in many of the IDF rooms where leaks are present. This jeopardizes both the infrastructure and the health of the employees, due to the noted hazardous material condition referenced in Appendix A.
