# Michigan City Areas Schools

## District Master Plan - Condition Assessment

February 25, 2025  
Board of Education Update

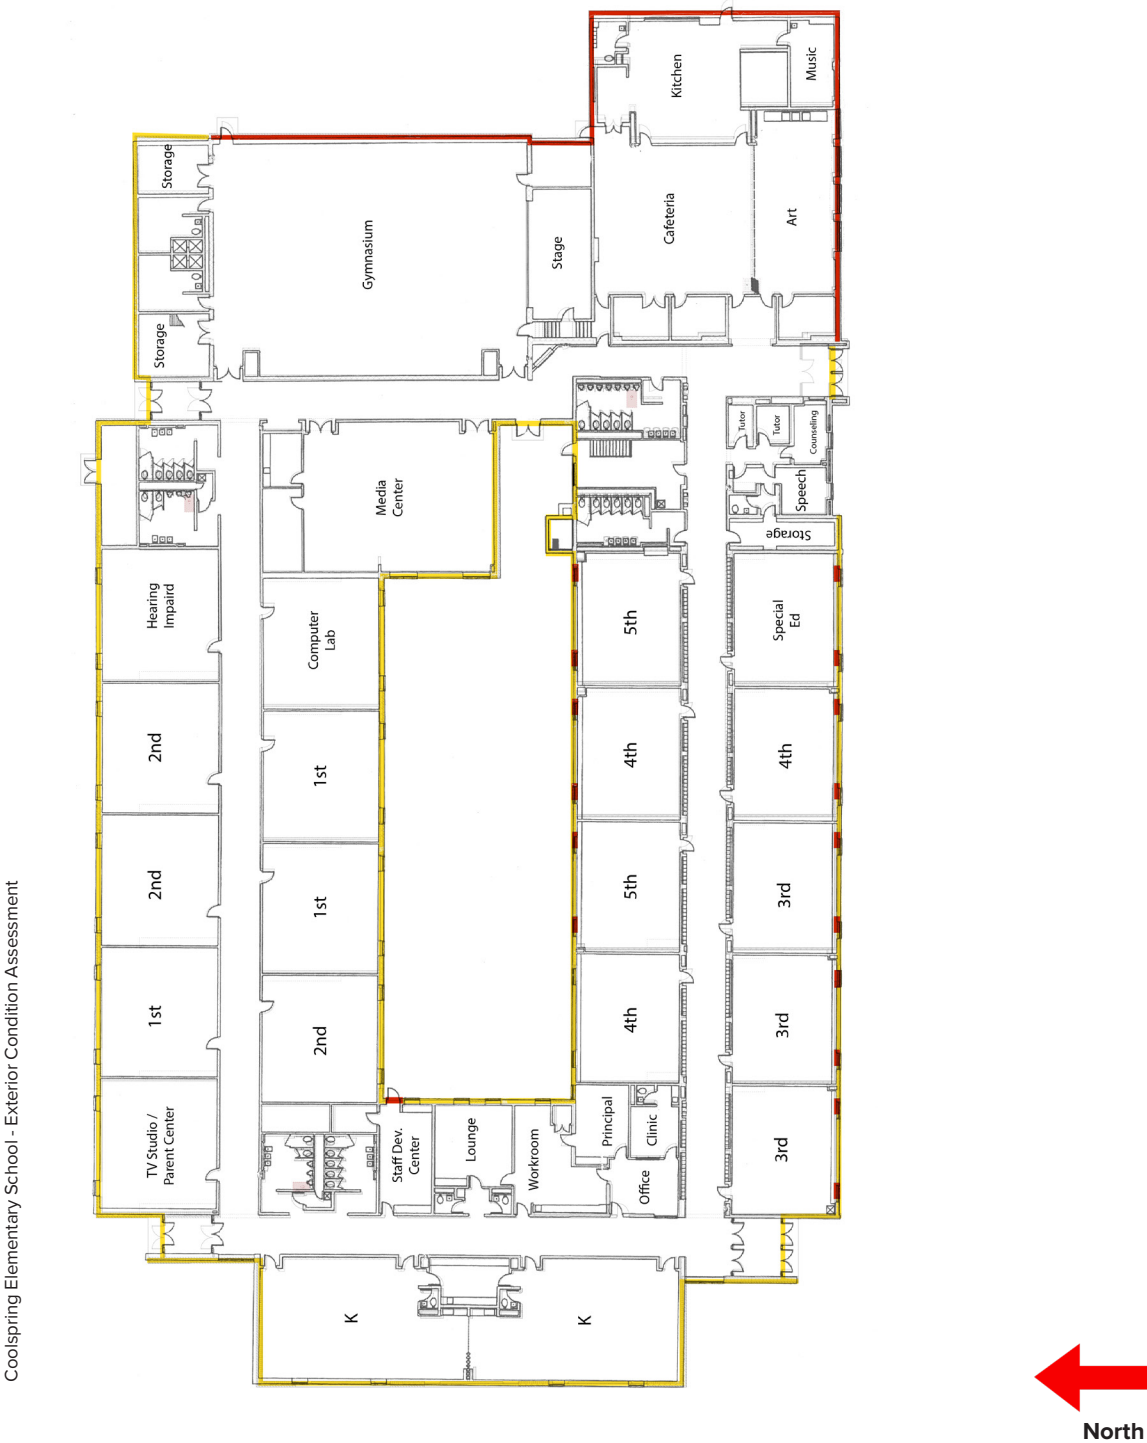
## Coolspring Elementary School Exterior Floorplan

- The exterior walls, including within the central courtyard, are constructed of various materials consistently around the building. The majority of the exterior walls are constructed of framing with masonry veneer. The masonry is generally in good condition, although some cleaning and minor tuckpointing is recommended. Across the façade, there are infills of an Exterior Insulation and Finish System (EIFS). All of the EIFS is in need of maintenance or repair, particularly on the southeast façade and the soffit on the east is missing or was never installed. The upper most portion of the exterior walls is made of framing with metal siding. Overall, the metal panel is in good condition, though it is faded and in need of a refresh.

- The exterior of the building has numerous windows. The window materials vary, including, wood, steel, aluminum, and aluminum storefront. The wood and steel windows are older and indicate clear signs of aging, particularly along the south side. The aluminum windows are thermal windows and are in good condition overall. Although, these windows could use new sealant. Finally, the storefront systems are older, but in above-average condition.

- There are also several doors around the exterior of the building. The doors are either hollow metal or aluminum. The hollow metal doors and frames are showing signs of rust and deterioration. The aluminum doors and frames have thermal sidelites/glazing and are in above-average condition.

- a. Clean and repair exterior wall systems. Masonry needs cleaning. Minor tuckpointing will be necessary in select areas. EIFS should be cleaned and painted. The system should be patched as needed prior to painting. Metal panel should be cleaned and painted.
- b. Remove old wood and steel windows. Replace with a consistent material. Consideration should be given to operational needs for each window. Remove old sealant and reseal around aluminum windows.
- c. Remove and replace all exterior hollow metal doors and frames with hollow metal. New hardware will be required.

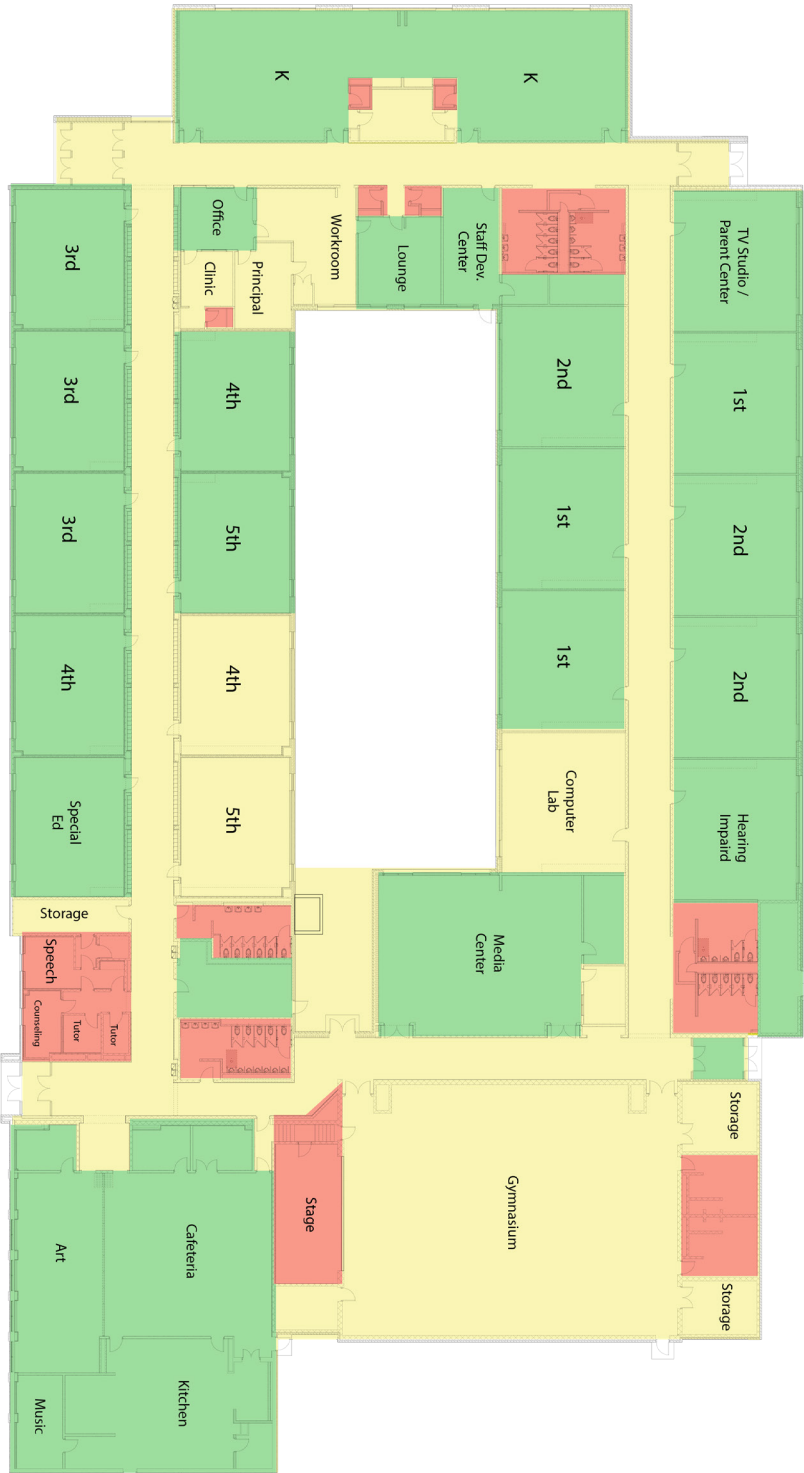
Coolspring Elementary School Interior Floorplan

Coolspring Elementary School - Interior Condition Assessment

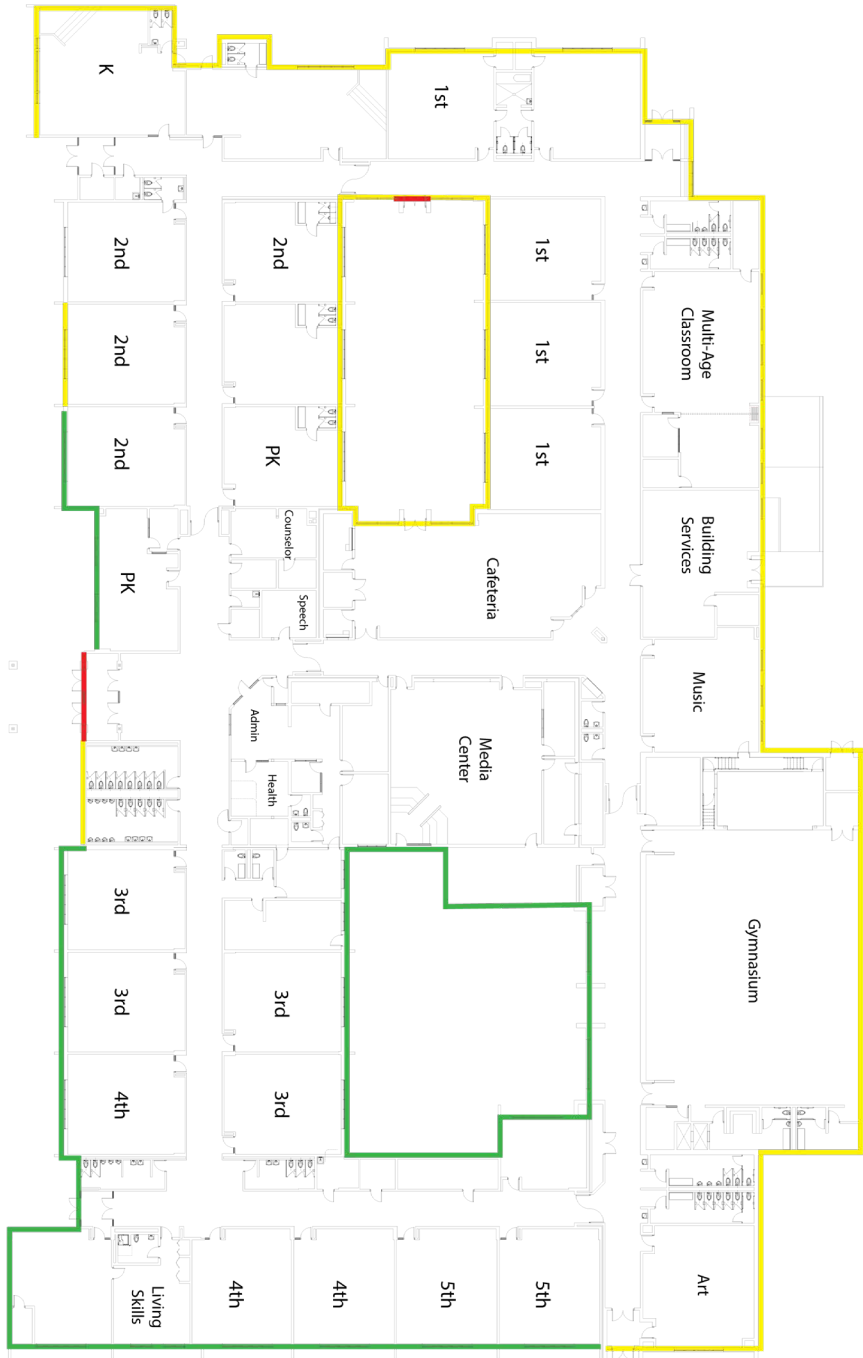
Joy Elementary School Exterior Floorplan

Joy Elementary School - Exterior Condition Assessment

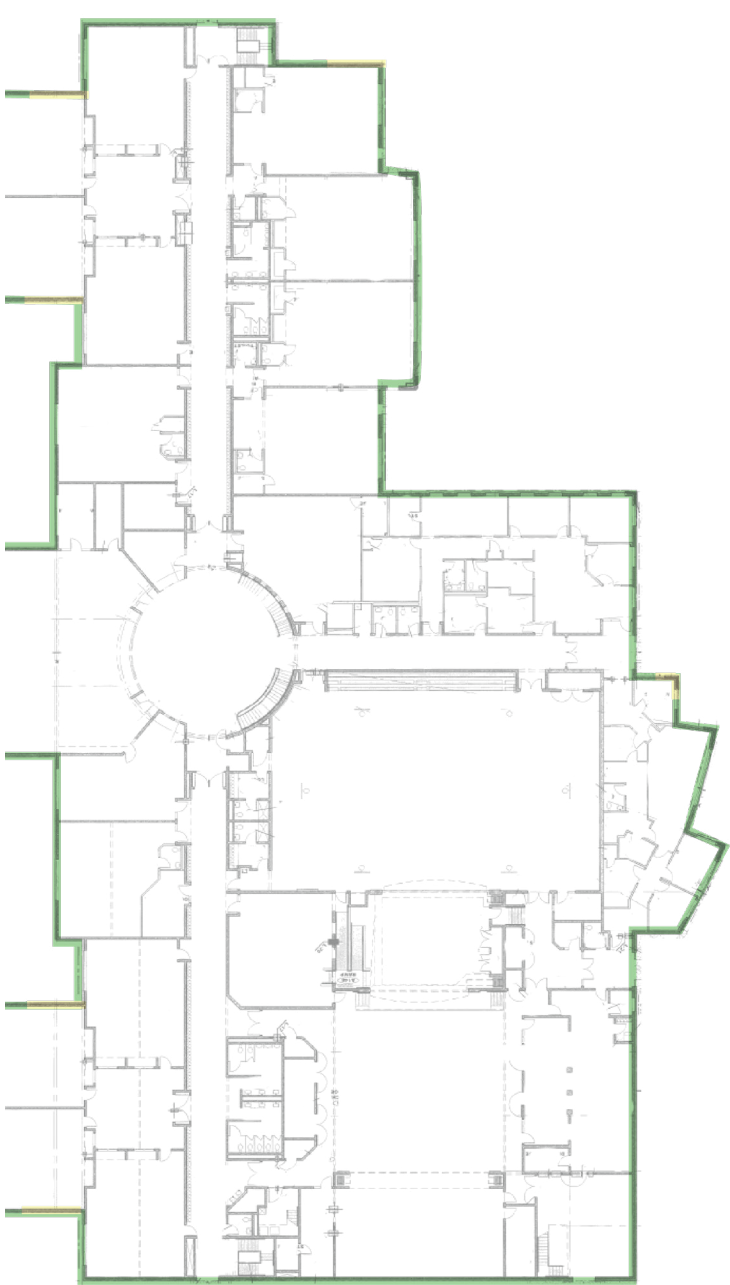
Lake Hills Elementary School Exterior Floorplan - Main Level

Lake Hills Elementary School - Main Level Exterior Condition Assessment

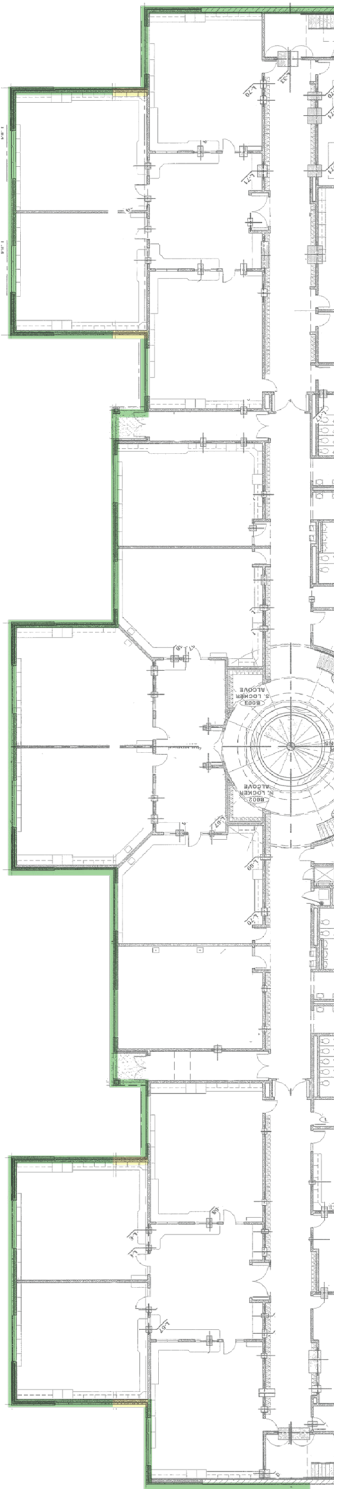
Lake Hills Elementary School Exterior Floorplan - Lower Level

Lake Hills Elementary School - Lower Level Condition Assessment

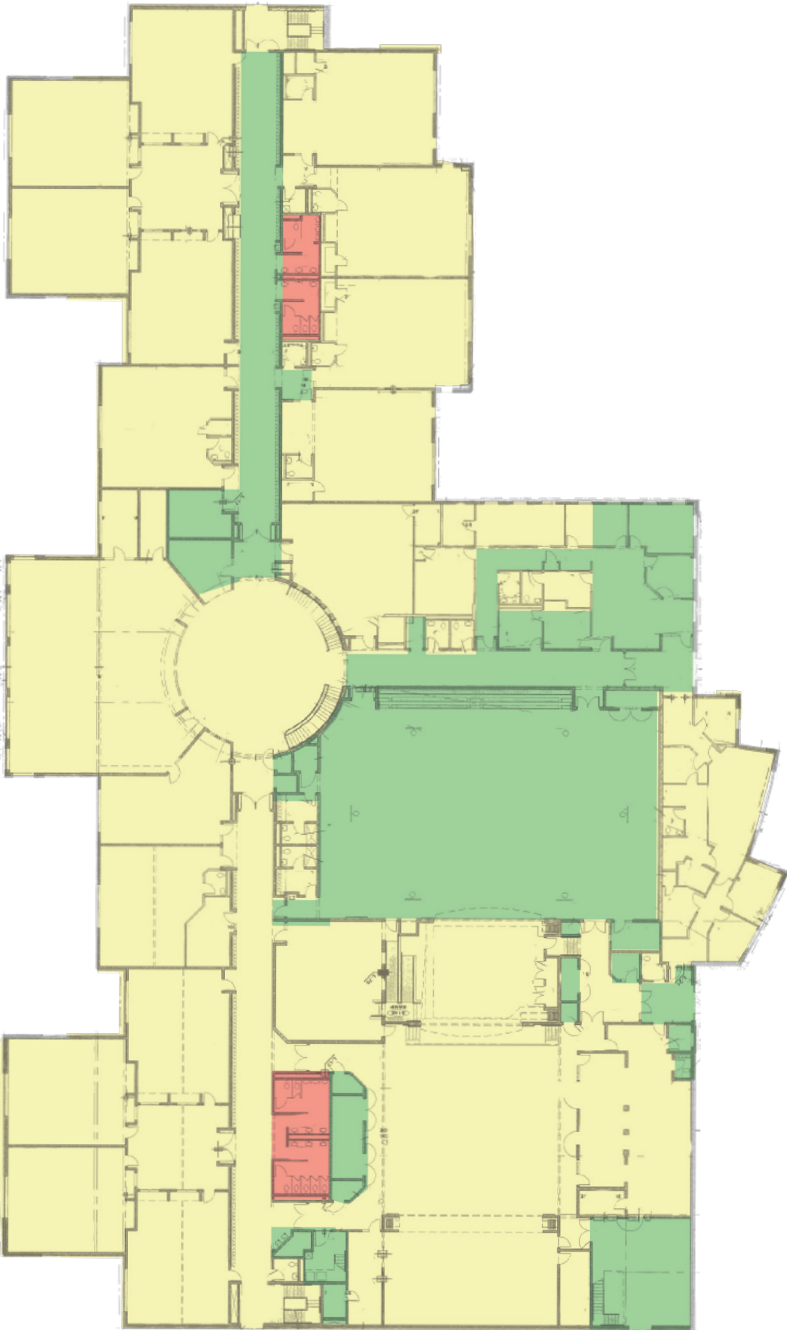
Lake Hills Elementary School Interior Floorplan

Lake Hills Elementary School - Interior Condition Assessment  
1st Floor Plan

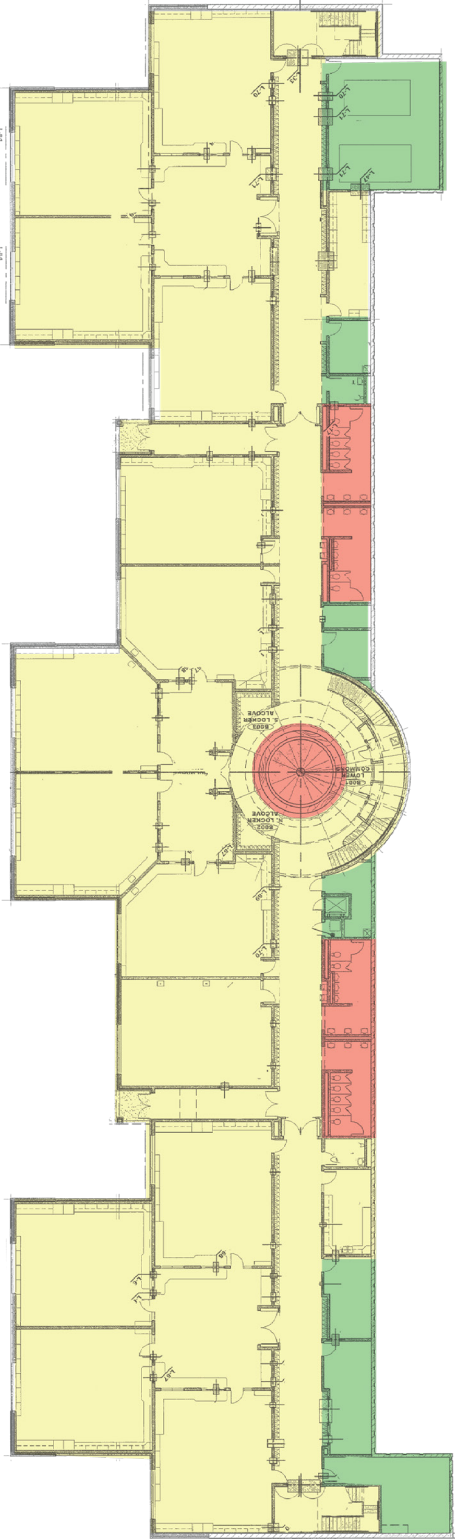
Lake Hills Elementary School - Interior Condition Assessment  
Second Floor Plan

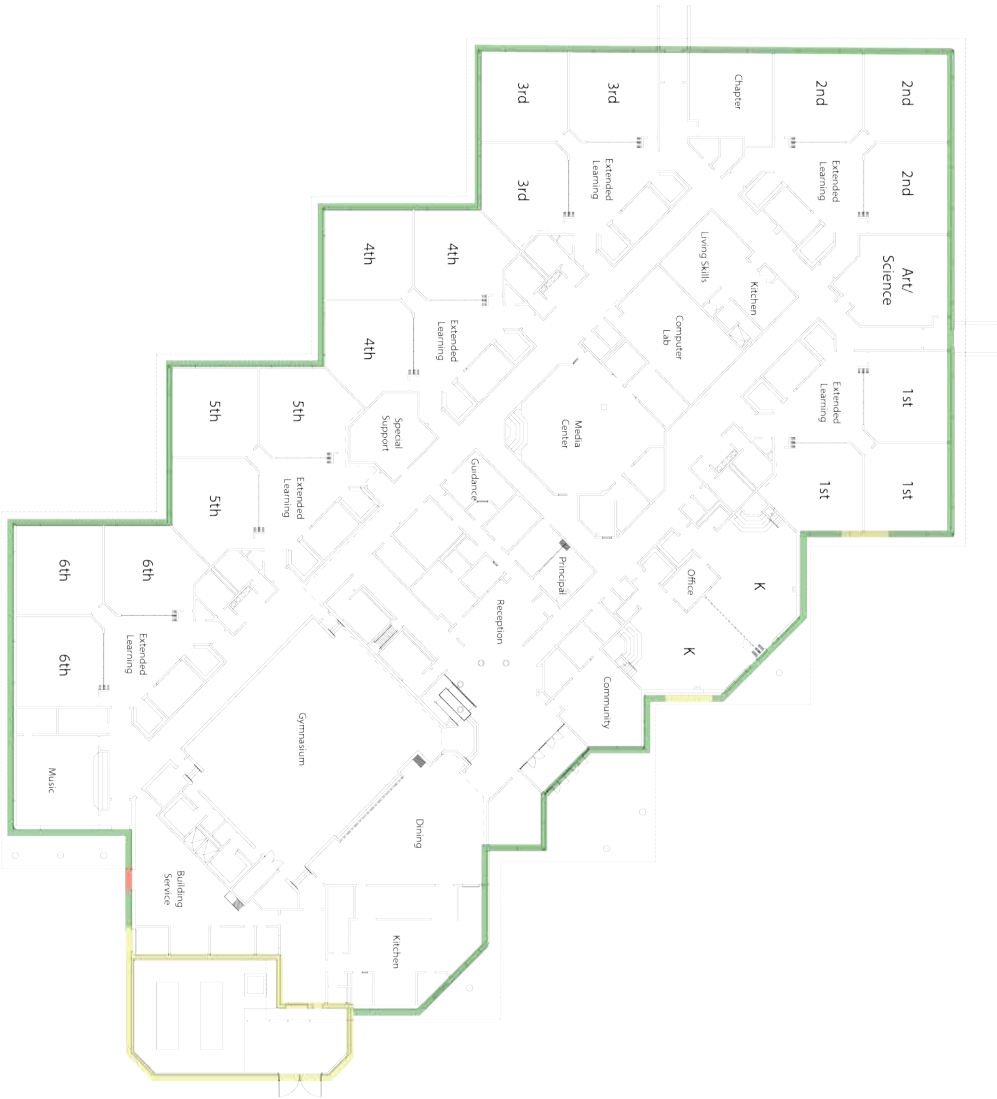
Springfield Elementary School Exterior Floorplan

Springfield Elementary School - Exterior Condition Assessment

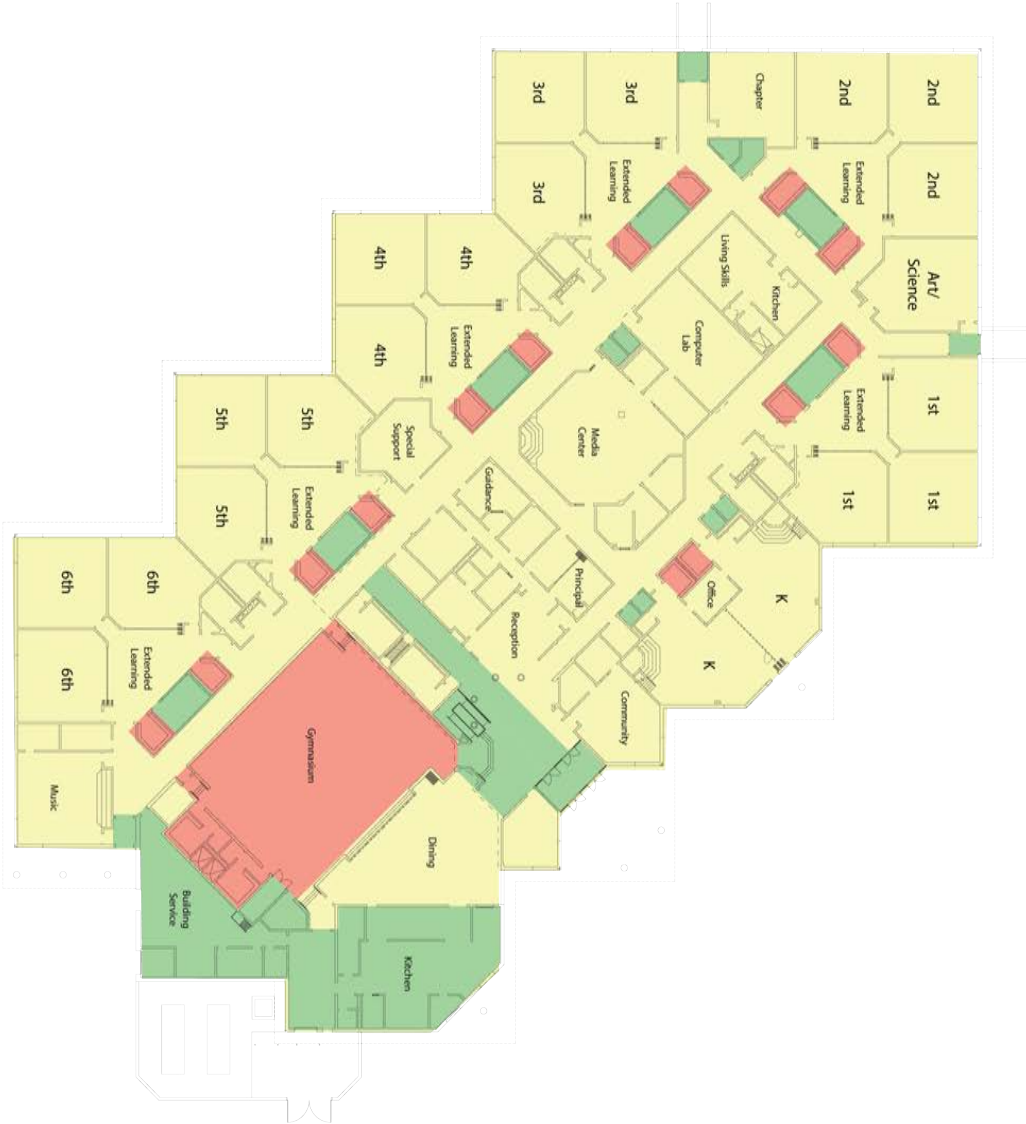
Springfield Elementary School Interior Floorplan

Springfield Elementary School - Interior Condition Assessment

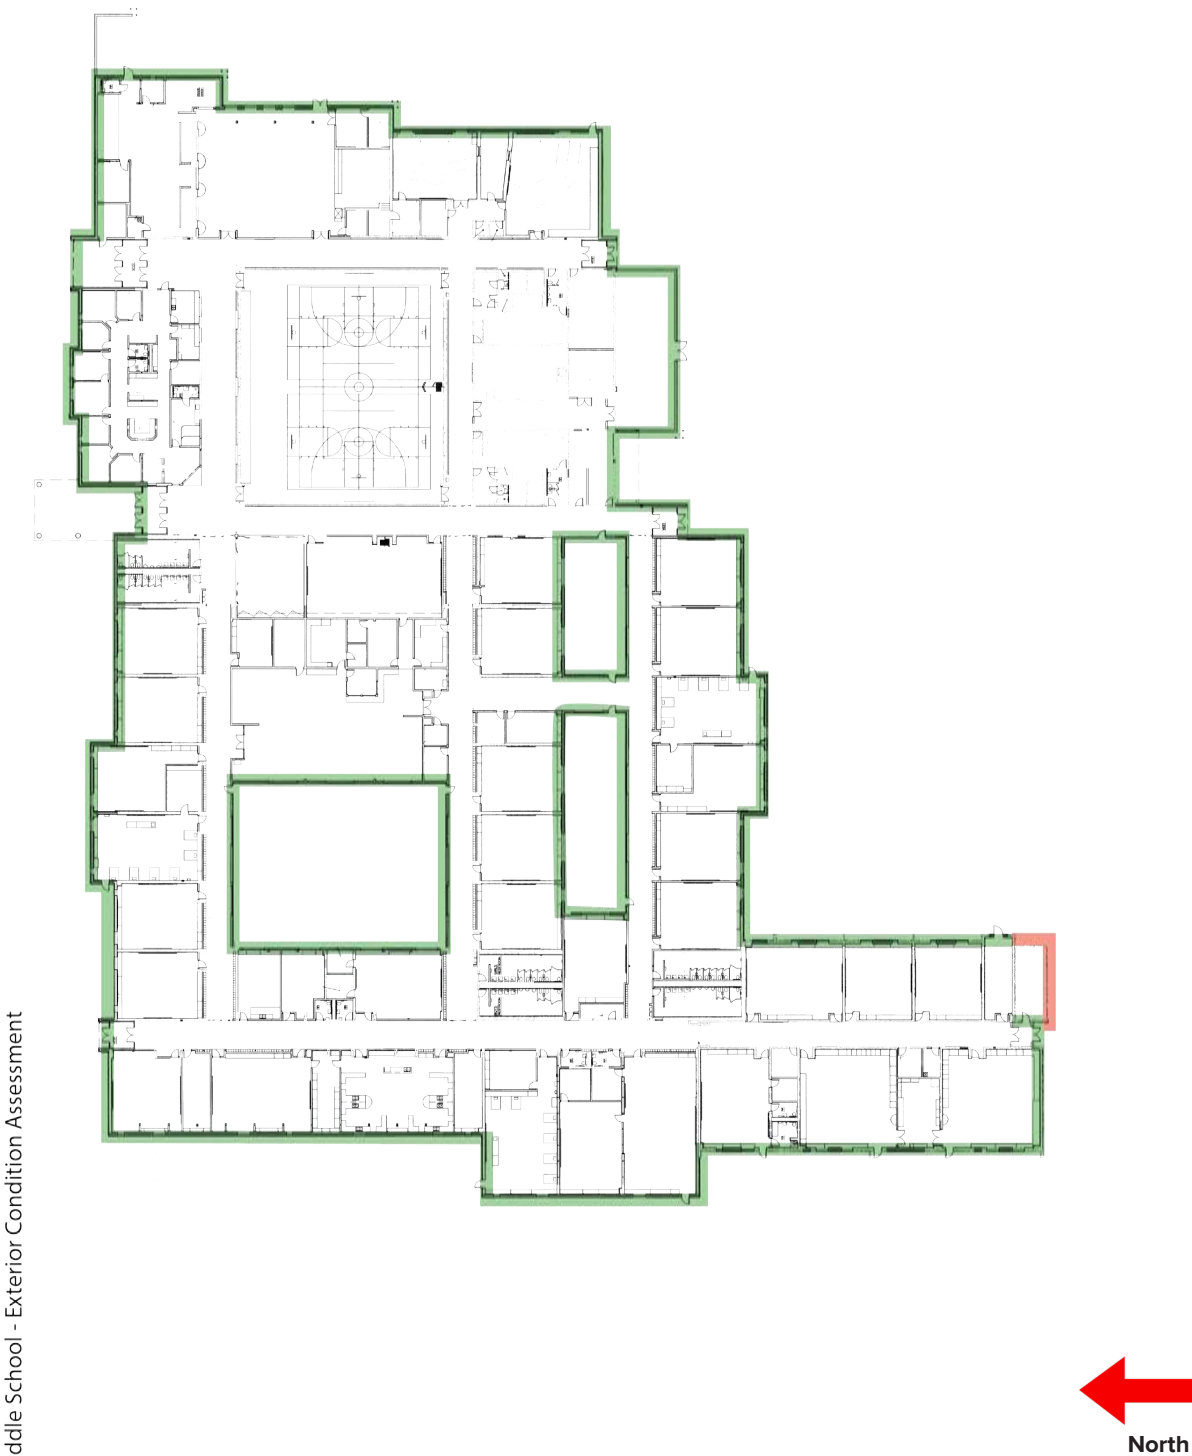
## Barker Middle School Exterior Floorplan

Barker Middle School - Exterior Condition Assessment

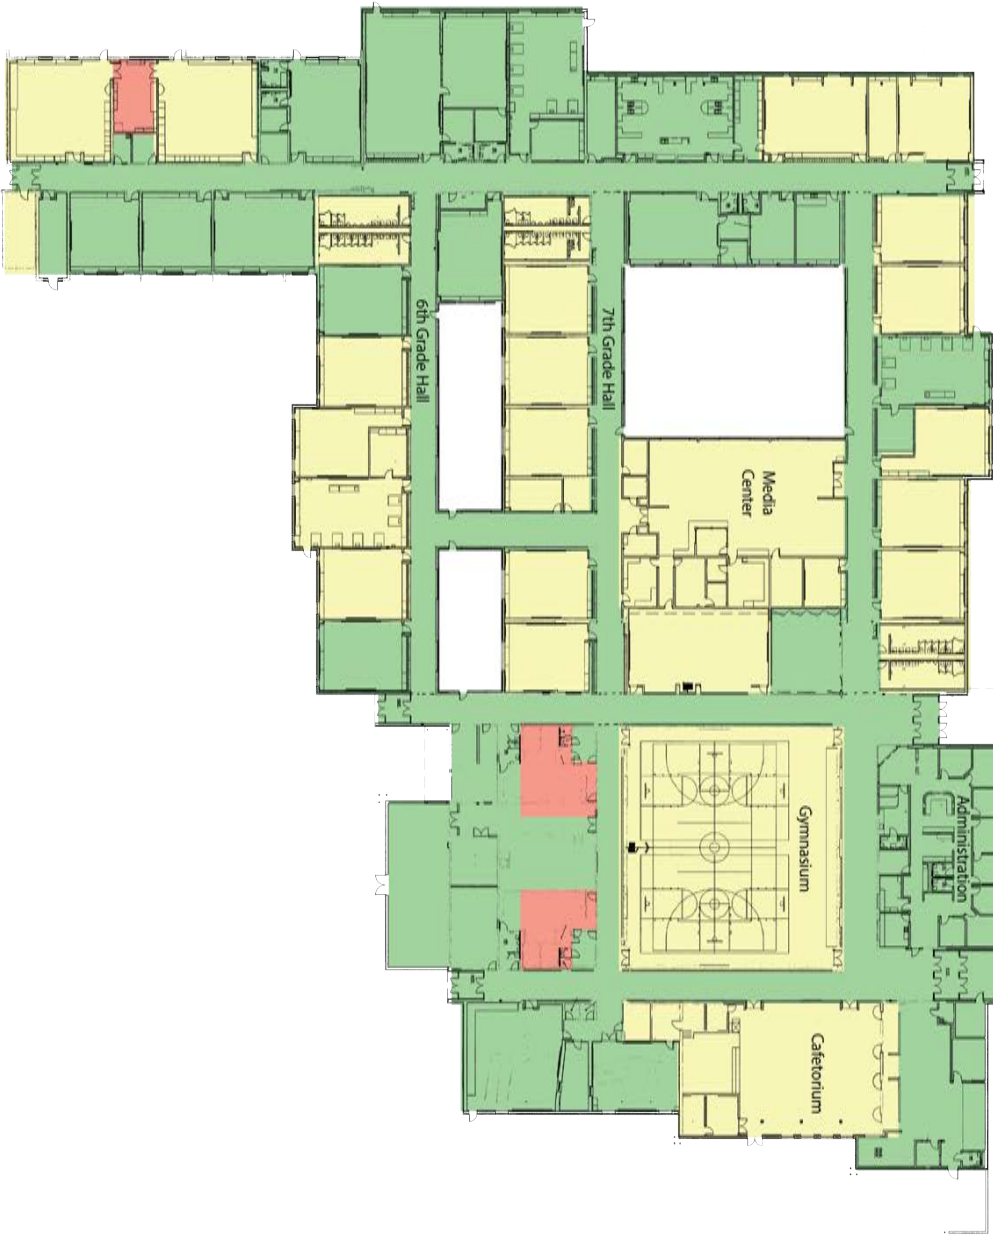
Barker Middle School - Interior Condition Assessment

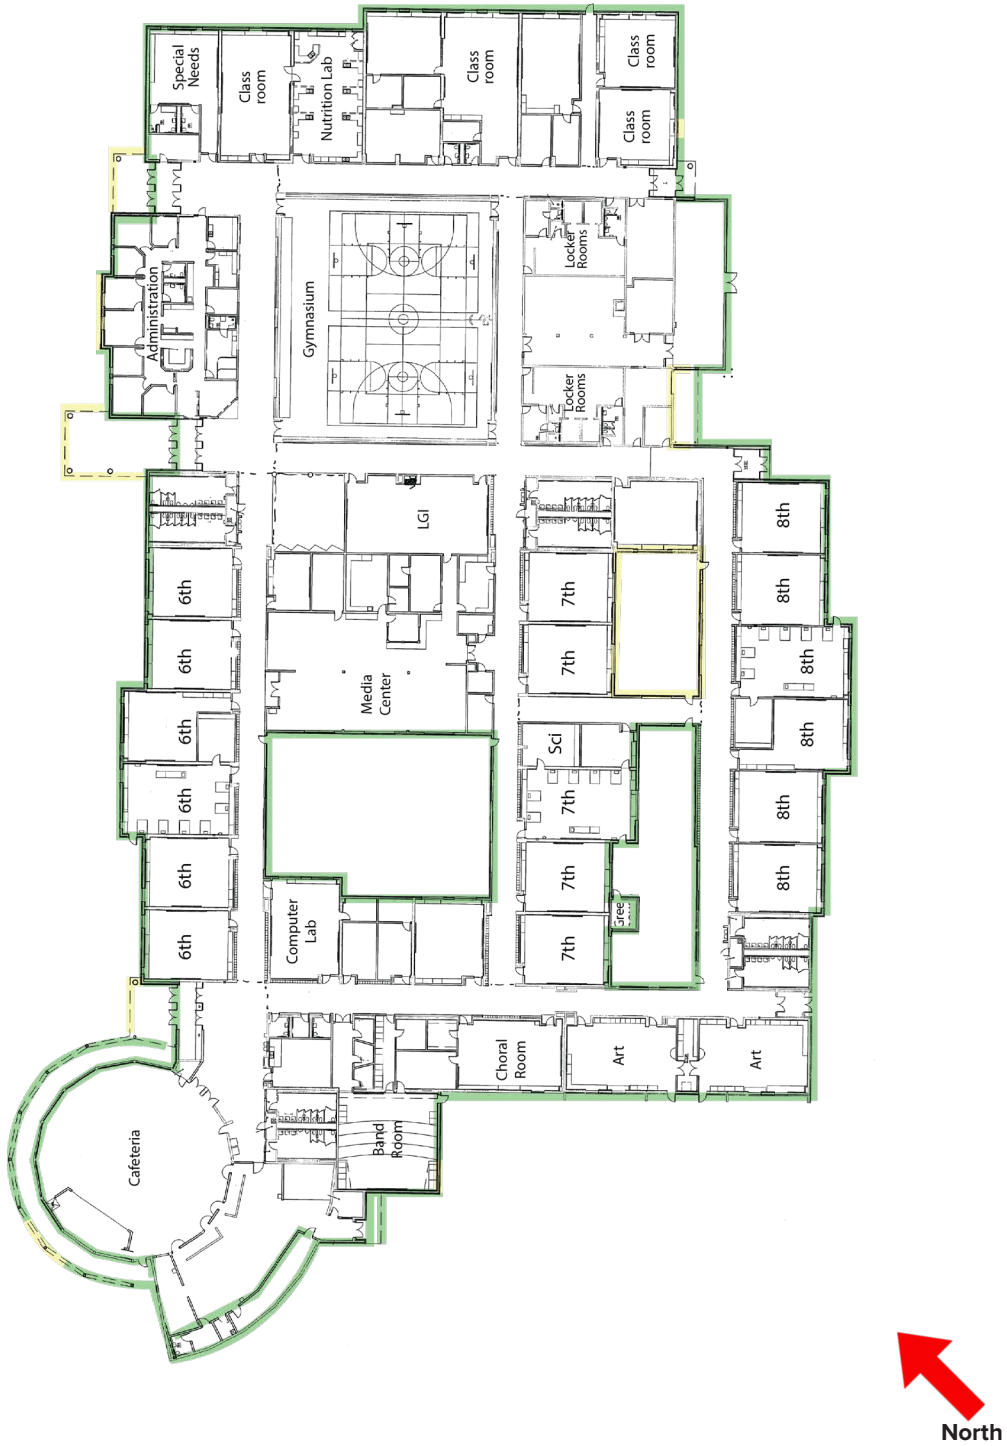
## Krueger Middle School Exterior Floorplan

Krueger Middle School - Exterior Condition Assessment

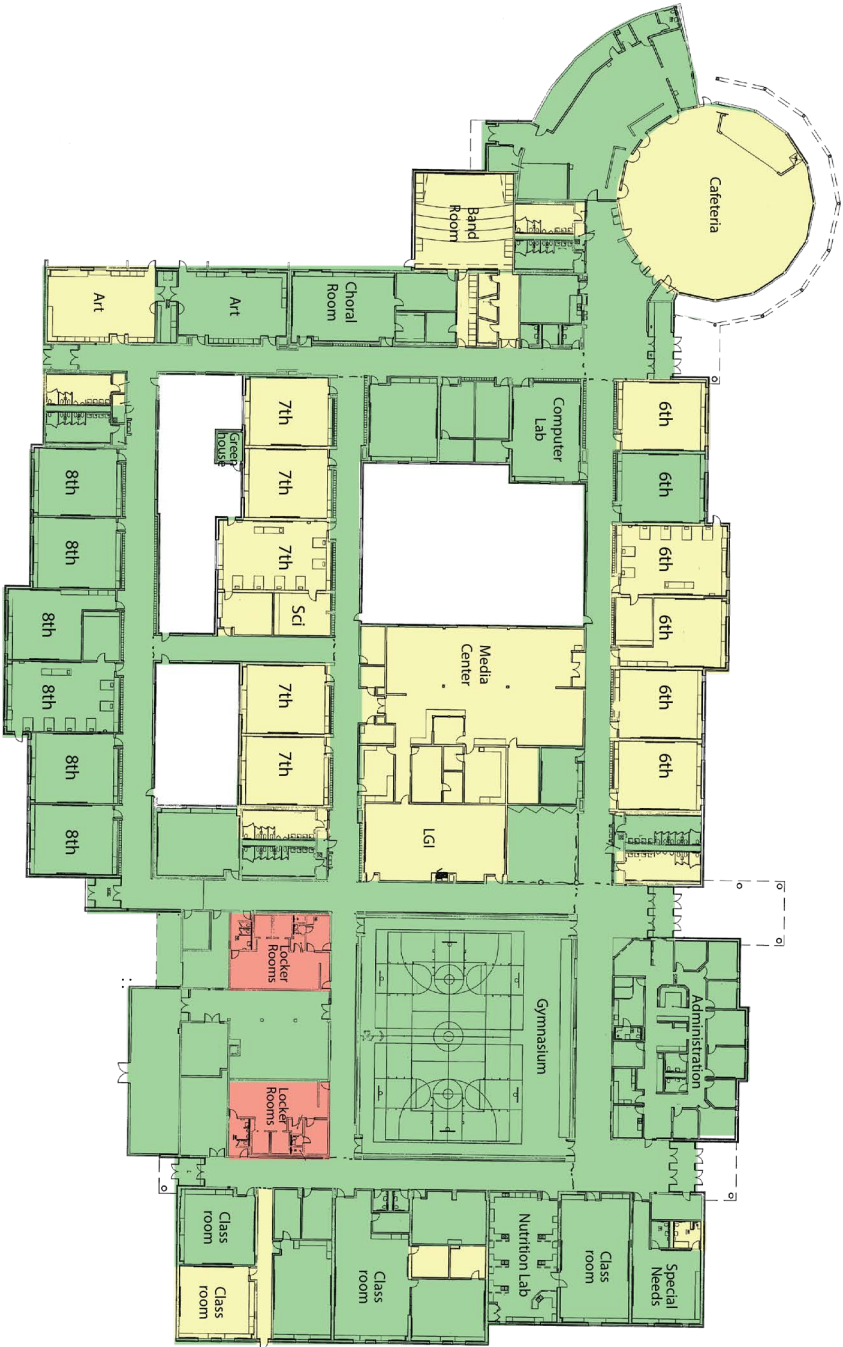
Krueger Middle School Exterior Floorplan

Krueger Middle School - Interior Condition Assessment

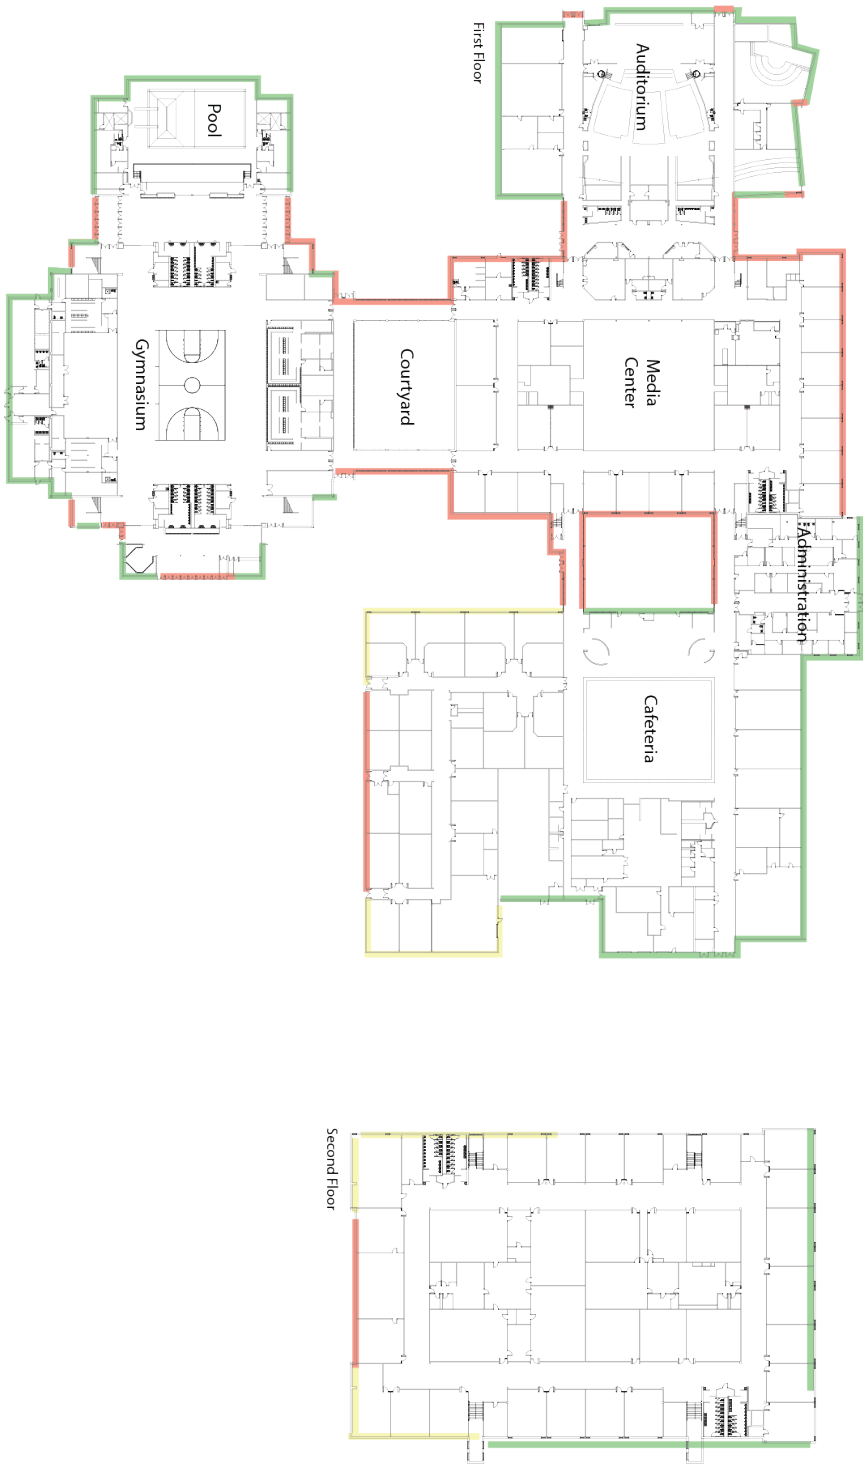
Michigan City High School Exterior Floorplan

Michigan City High School - Exterior Condition Assessment

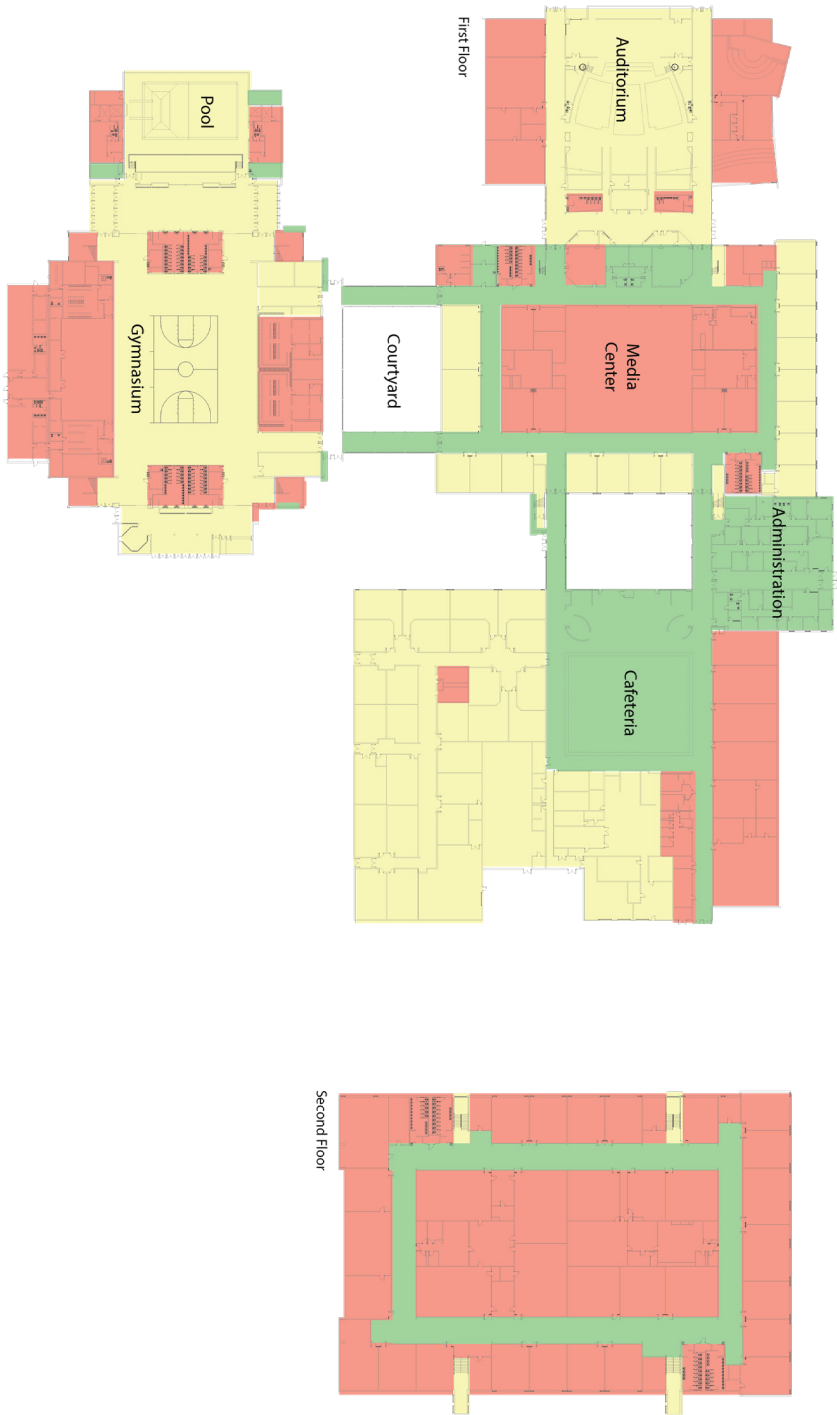
Michigan City High School Interior Floorplan

Michigan City High School - Interior Condition Assessment

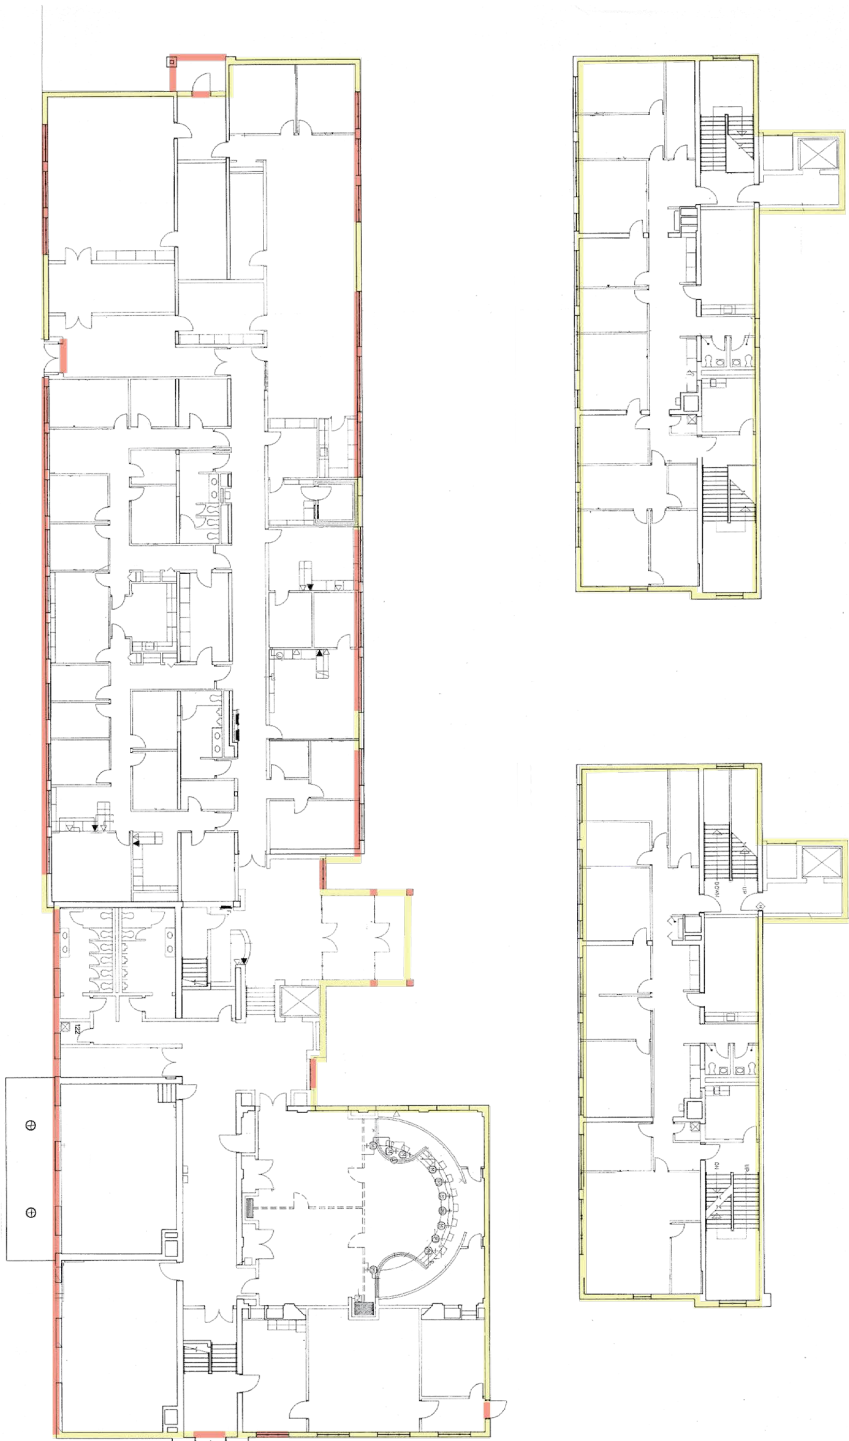
Administration Building Exterior Floorplan

Administration Building - Exterior Condition Assessment
