**Agenda Item Title:** Amendment to the FY26 Capital Request (GHS Pool Repairs)

# Facility Assessment and Recommendations for the Swimming Pool at Greenwich High School Greenwich, CT

TLB Architecture, LLC  
92 West Main Street  
Chester, Connecticut  
**March 3, 2025**  
TLBA Project # 2025-002

## III. Existing Conditions Analysis

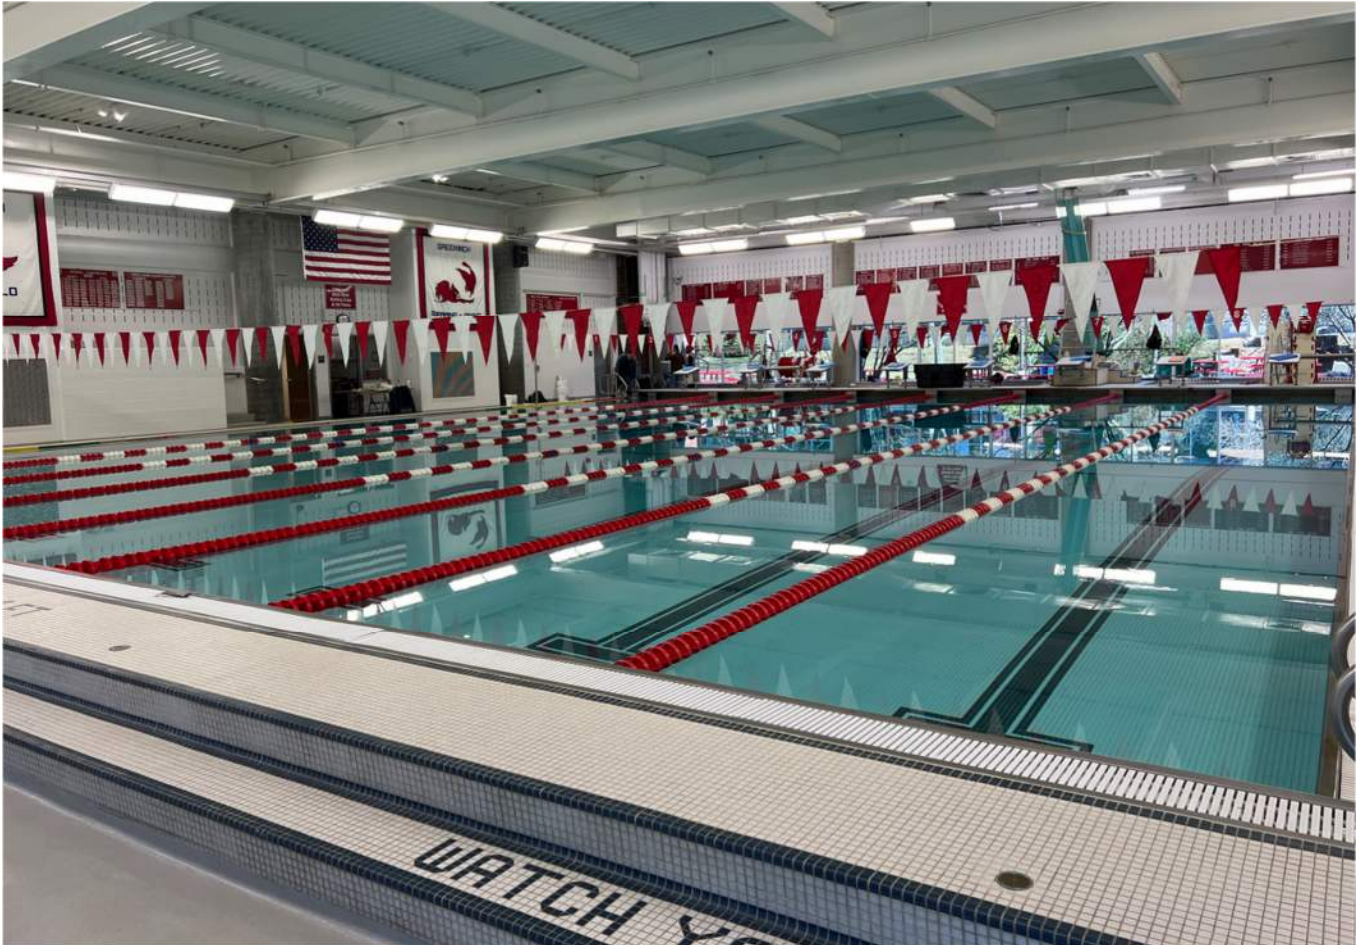
Photo 1 (Above): Overall view of pool from shallow-end. Pool edge is built up with a bulkhead curb and steps to form a recessed gutter on the touch walls.

Exposed steel structure is painted and appears to be in good condition, with minimal indications of rust or degradation. Pool lighting and south facing glass results in glare on the surface of the water which is less than optimal for guarding, officiating meets and diving. Light levels are about half of that recommended by sanctioning bodies.

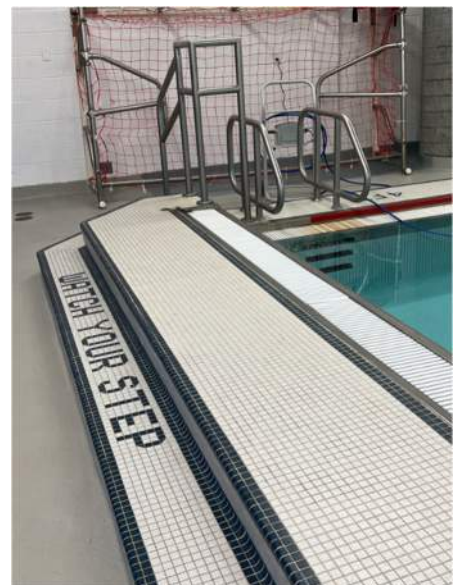
Photo 2 (Right): At the sidewalls, pool gutter transitions to semi-recessed, with a bulkhead curb lower than that at the touch walls.

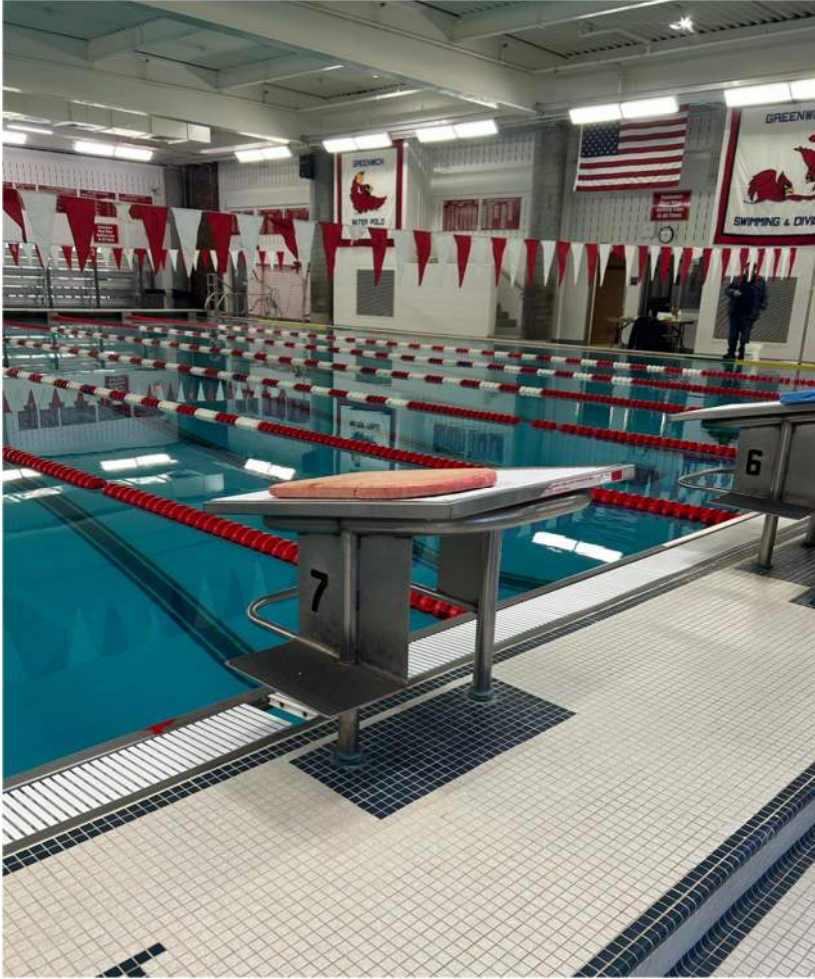
Photo 3 (Left): The Natatorium structure is comprised of structural steel girders, spanning 95-feet, supporting steel beams and deck. The girders are supported by round cast-in-place concrete columns. Perimeter walls are concrete masonry units (CMU) with acoustical CMU in the upper half of the wall. All structural systems appear to be in good condition. Refer to Appendix 1 for Structural Engineer's Assessment.

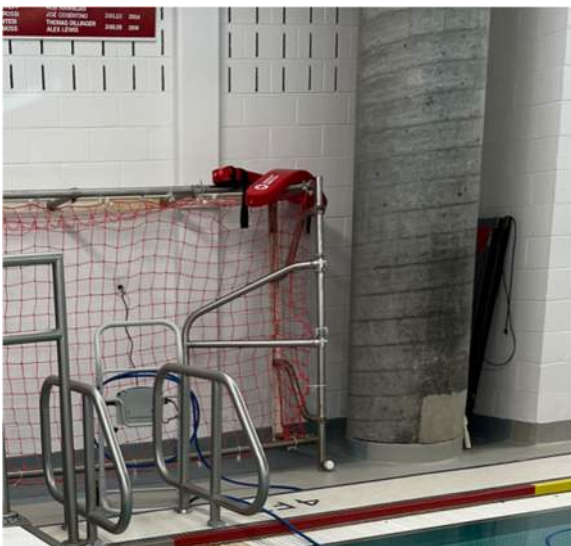
Photo 4 (Below Left): Typical concrete column supporting steel girders.

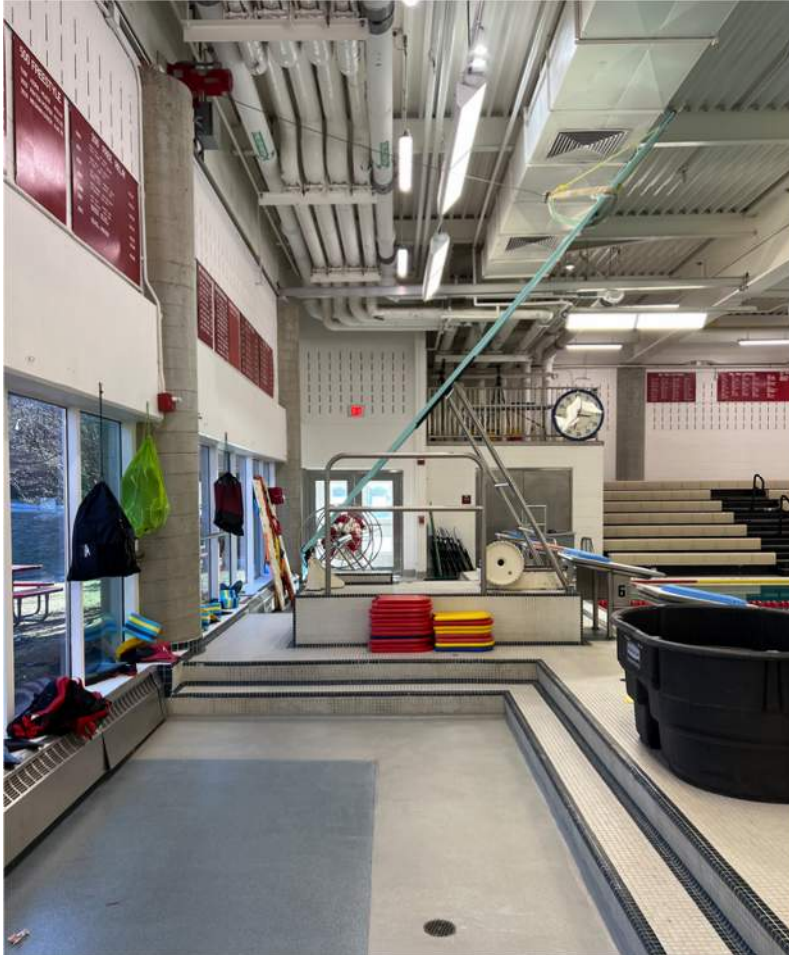
Photo 6 (Left): Pool decks are resinous epoxy with individual floor drains located around the pool perimeter. At the diving board a multi-level, tiered platform is provided to achieve the proper elevation to mount a 1-meter, short-stand diving board. The deep end of the pool also has an extended bulkhead curb to provide mounting space for competitive starting blocks.

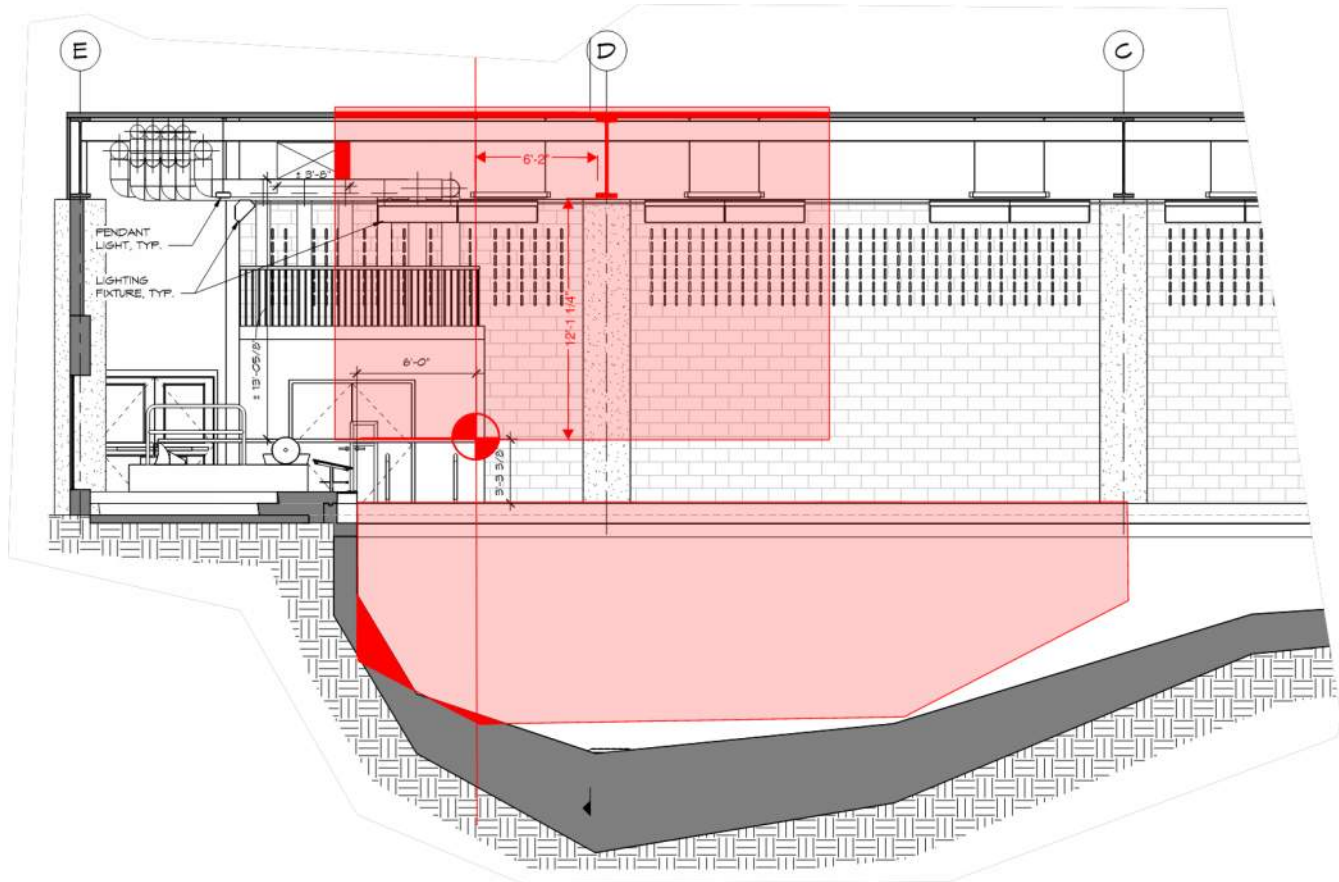
Figure 3: Above is a pool section at the Diving Hopper. Drawing in black indicates existing conditions. Light red indicates the minimum clearance required at the diving board, both overhead and below the water line. The dark red indicates objects that are in conflict with the clearances required.

**Overhead:** There are major obstructions within the required overhead clearance, including a steel girder, about 4-feet lower and 10-feet closer than allowed. Also encroaching into the clearance is the roof beam and deck structure, sprinkler piping and ductwork. All of these elements are reachable from the diving board, as evidenced by a water bottle placed on the flange, and names written on the beam, which would require a diver to actually hang from the beam to write the name. It should also be noted that when the board needs to be replaced, no manufacturer will sell a board to a facility with a non-compliant diving area.

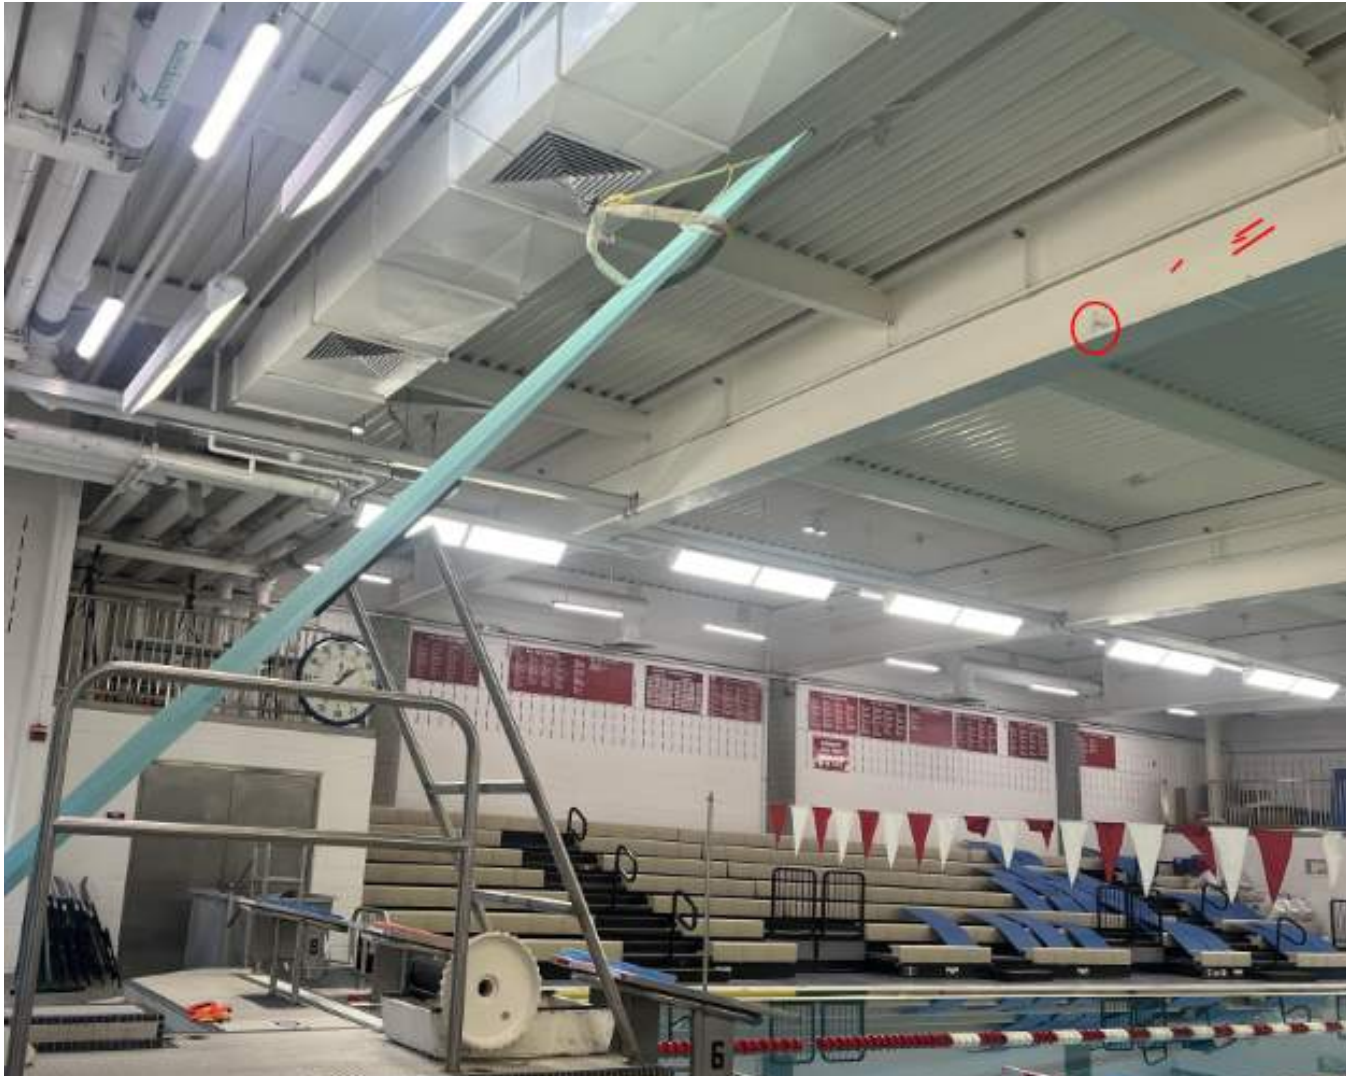
Currently, there is a steel girder approximately 12-feet above and 6'-2" ahead of the board in violation of the requirements, and posing a risk to divers. In addition to the girder, other steel structure, ductwork and piping encroach on this clearance. It also appears the entire roof deck is lower than the 16'-5" high clearance requirement. This report addresses the issue with graphics and photographs, and offers a potential solution for planning purposes, recognizing that further discussion is required to align the project approach with the long-term goals of the School. Options may include eliminating the diving board from the pool, raising the roof structure, which may be impractical, or expanding the footprint of the Natatorium to construct a taller space to accommodate the diving well. Constructing a new facility in another location is also an option, but the scope of this report focuses on the High School Pool options only.

Photo 9: The steel girder, beams, ductwork and sprinkler piping are all within the required overhead clearance for diving, as shown in Figure 3.

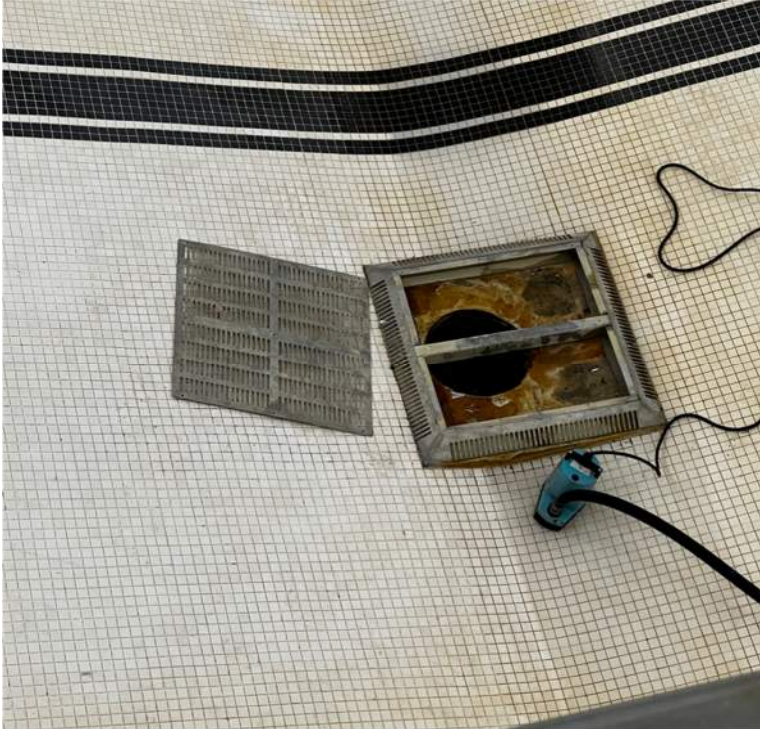
Photo 10: There are four main drains at the deep end of the pool. Each drain has a 10" diameter sump, approximately 7" deep, with a 6" pipe stubbed up to the bottom of the sump. The original sump is adjacent to the change in floor plane. As such, the frame and covers installed in 2008 were leveled on grout in order to properly secure them.

However, even if the drains are reconfigured, the buried 6-inch diameter pipe is too small to comply with the DPH velocity requirements. It is also likely that the pipe configuration doesn't comply with requirements for safe drain operation.

**VGB Compliance:** VGB compliance requires that the drain sumps and covers be replaced with an assembly certified by the drain cover manufacturer. However, it is important to note that a drain upgrade that brings the pool into compliance with VGB, without a piping replacement, does not address Health Department violations related to the piping size and configuration. There is also information from the pool maintenance company that the piping is heavily tuberculated and three of the four drains have no flow. Below are some scenarios for consideration:

*Option 1:* Replace main drain sumps and covers. VGB compliance will be met but DPH requirements will not be met. There is also a risk lack of flow or pipe failure if pipes cannot be properly cleared and lined. There is some “surplus” pool depth that would allow sumps and drain covers to be installed with little to no demolition of concrete. Utilizing a system such as Aquastar VGBA 1824-18f would provide a retrofit solution if properly installed.

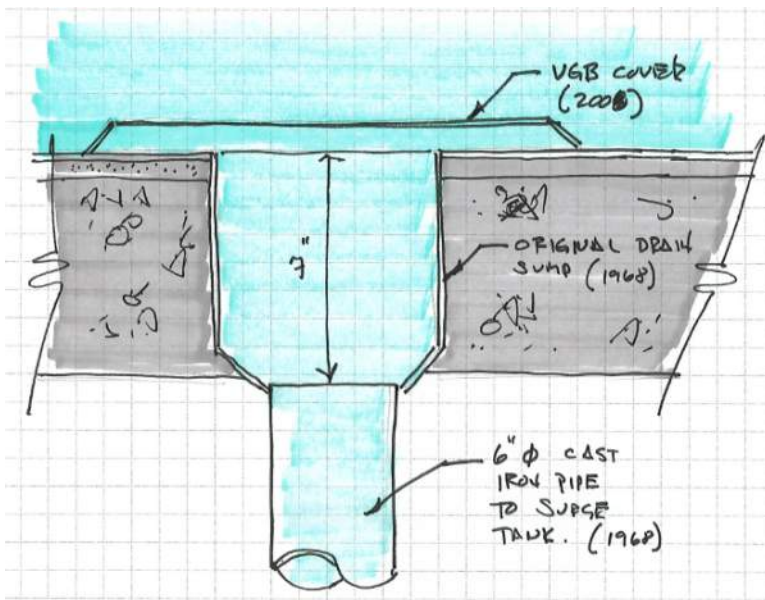
Figure 4: Existing Main Drain configuration, with 10" diameter, 7" deep sump and 6" diameter pipe to surge tank. There are four of these drains, piped in a series, as was typical at the time (1968).

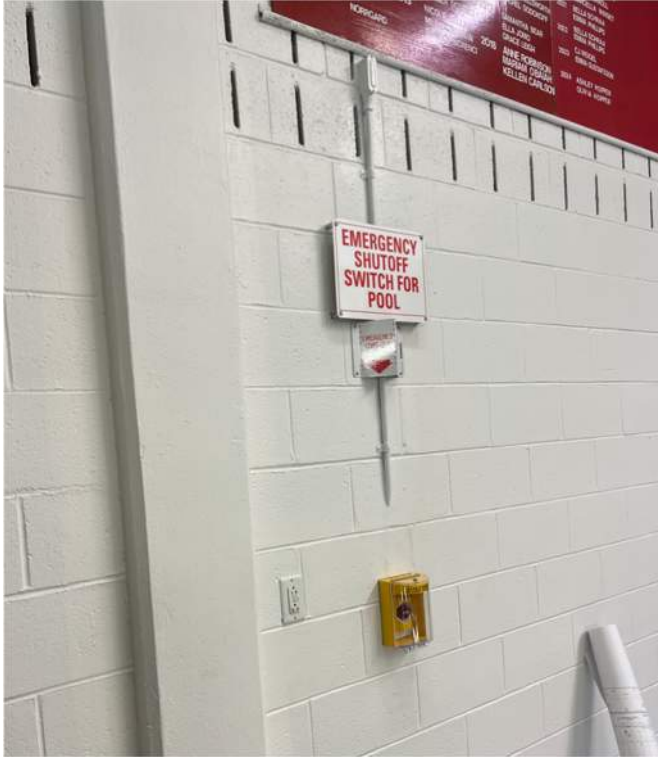
Photo 11: To mitigate risk resulting from the main drain configuration, Greenwich Public Schools installed an emergency shut-off switch to shut down the pumps in the case of an emergency, releasing suction at the drains. Our understanding is that the shut-off plunger is staffed by a trained individual at all times when the pool is occupied.

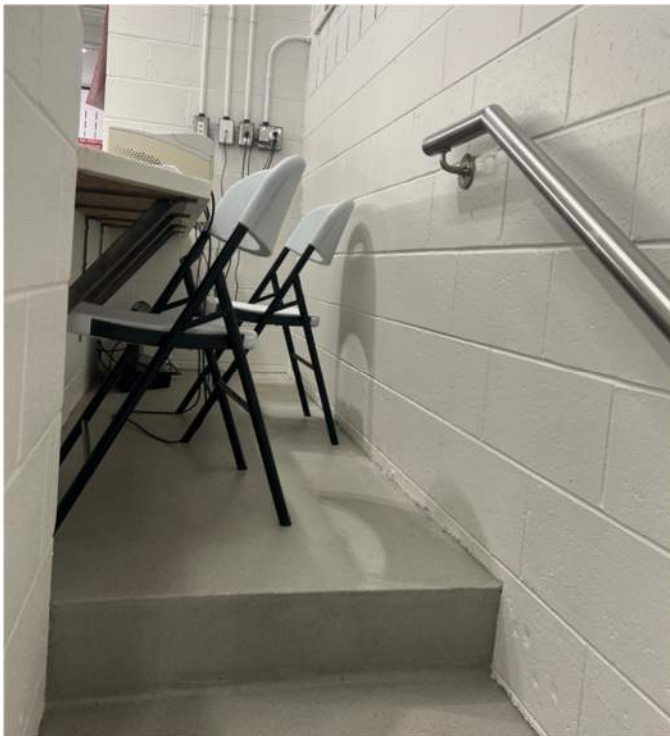
Photo 12: The scorer's platform was constructed as part of the 1997 renovation, on the east side of the pool. It is not handicapped accessible and contributes to the narrow deck along that side of the pool. (See Photo 13)

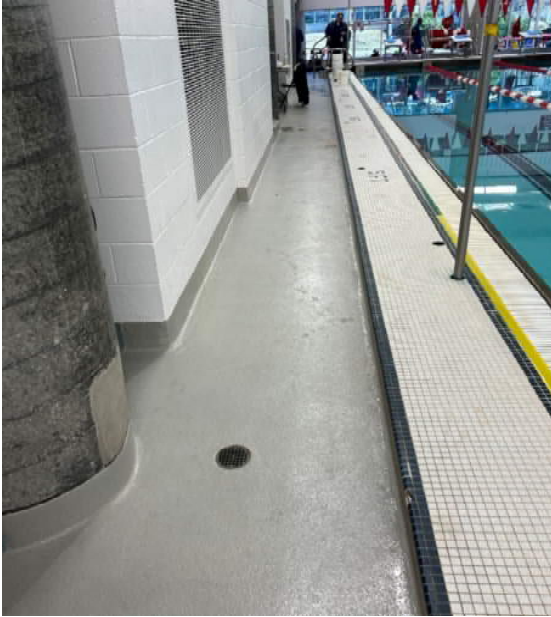
Photo 13: The pool deck at the east side is reduced to about 3-feet wide, well shy of the 5-feet required by the DPH regulations.

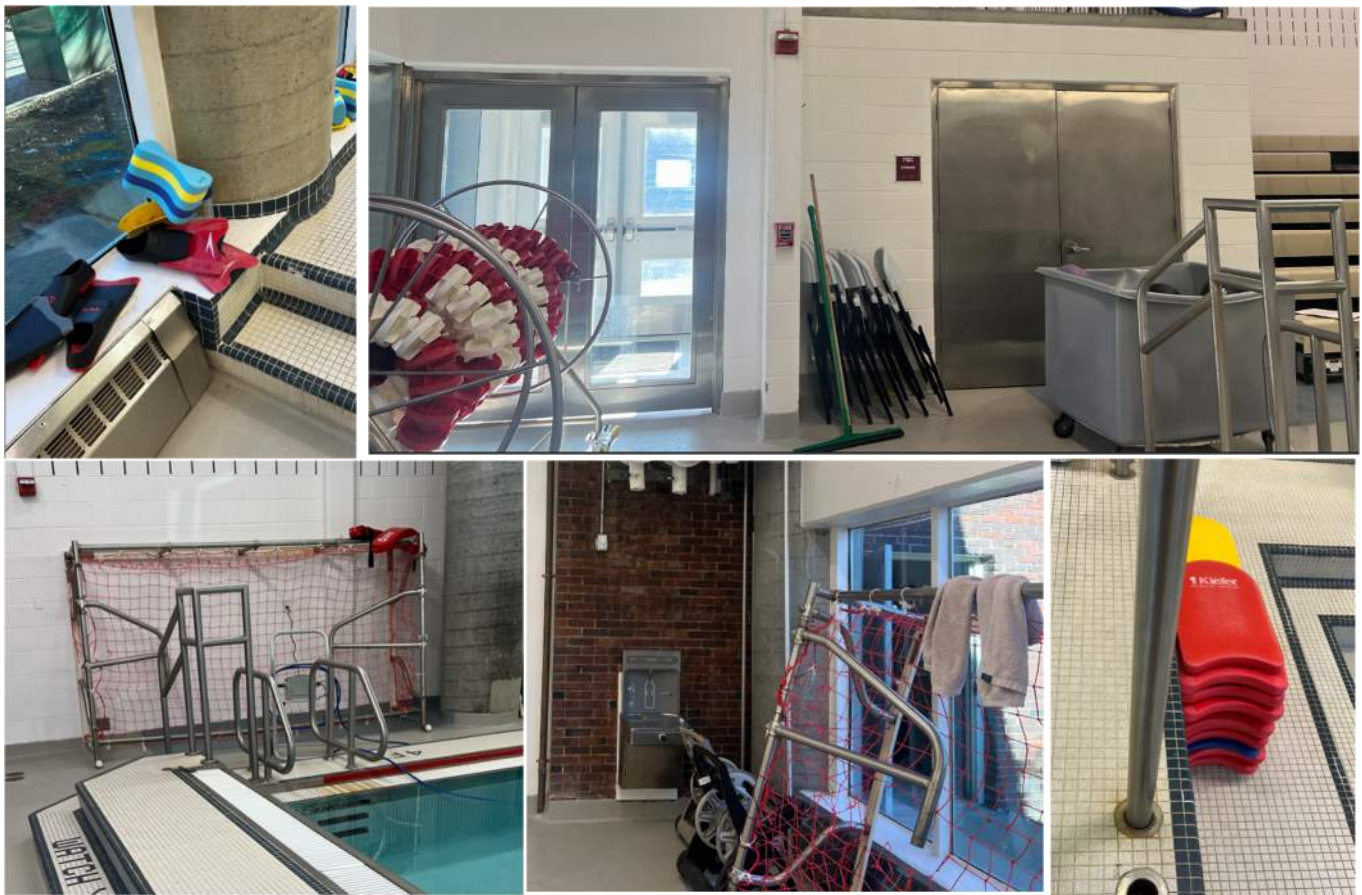
Photos 14 - 19: Pool decks are used for storage of pool equipment, further reducing deck clearance and maneuverability. Options for storage of equipment off of the deck should be explored. In addition to concerns over space restrictions, storage of wet equipment on window sills, bleachers, etc. will eventually cause damage those assemblies.

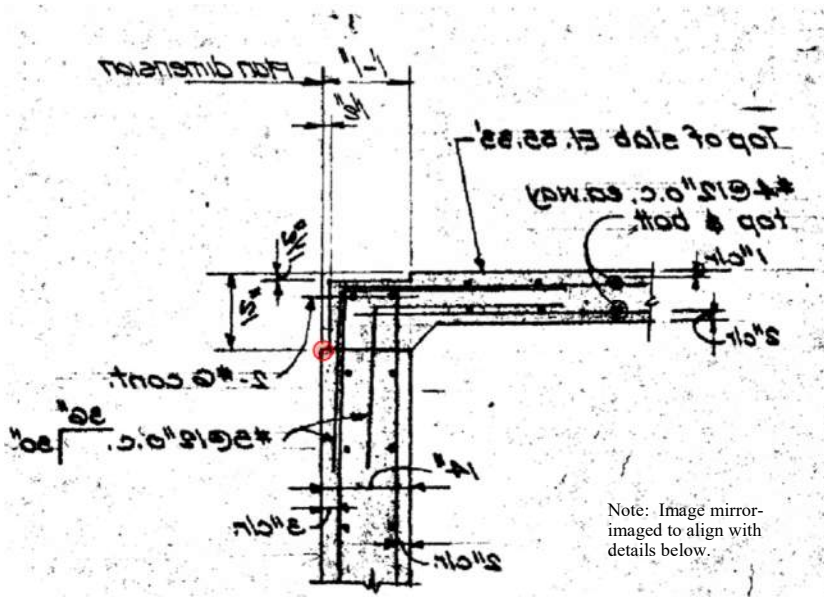
Figure 5: The original construction documents (1968) show the concrete configuration to accommodate a tile gutter or skimmer system. The gutter was removed in the 1997 renovation and the overbuild was constructed on top of the pool wall. (On the details, the red dot is a common reference point.)

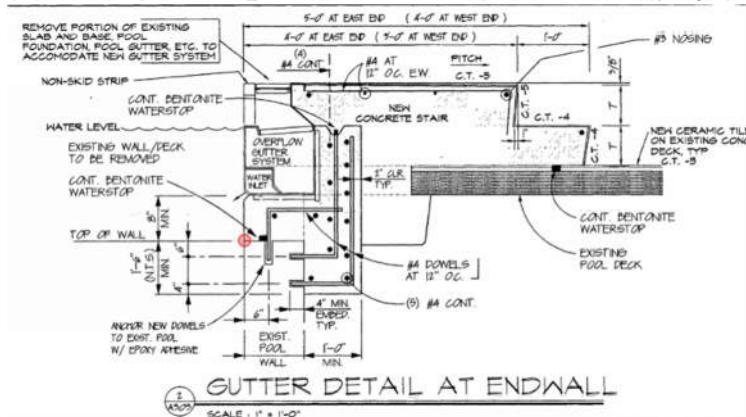
Figure 6: The 1997 construction drawings indicate a fully recessed stainless steel gutter at the touch walls, built on top of the existing pool wall and extending a total of 5-feet from the face of pool wall, onto the deck.

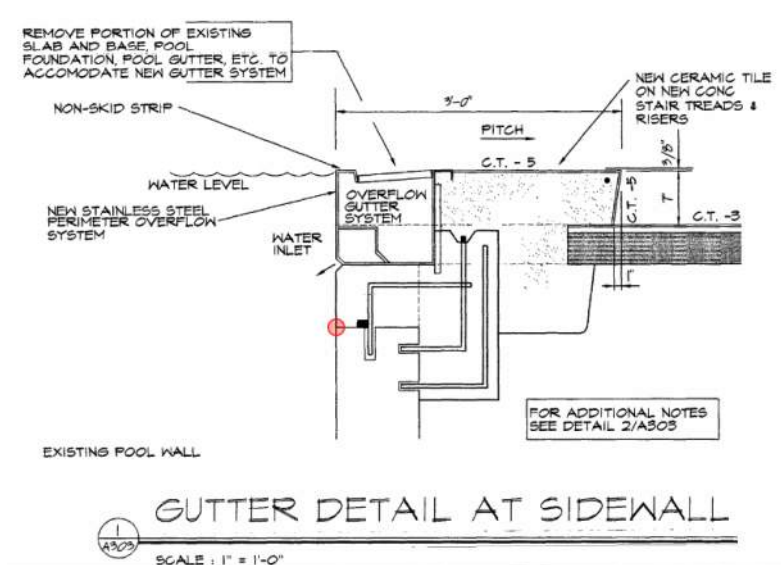
Figure 7: The 1997 construction drawings indicate a semi-recessed stainless steel gutter, built on top of the existing pool wall and extending a total of 3-feet from the face of pool wall, onto the deck.

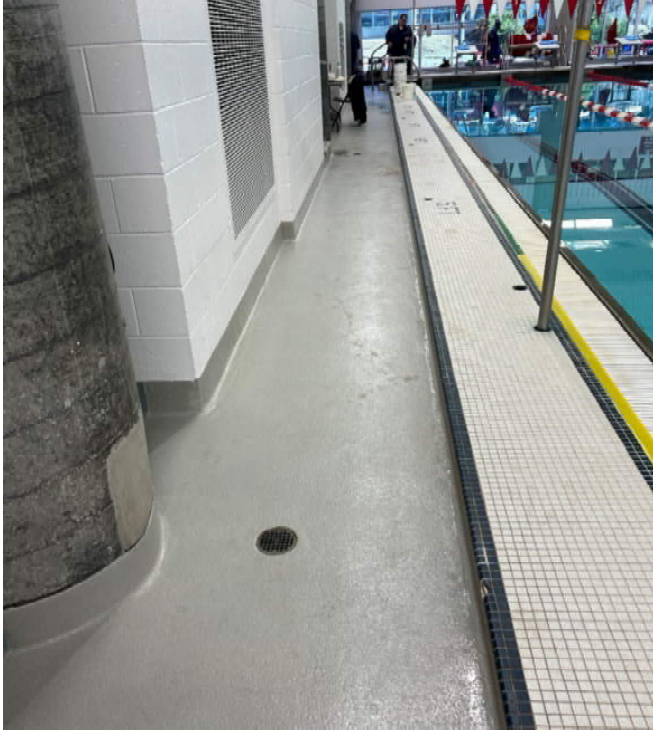
Photo 20, Left: The result of the overbuild as shown in Figure 7 is a reduced pool deck at both sides of the pool. At the east side, the deck reduction is most impactful, as it reduces the deck clearance significantly.

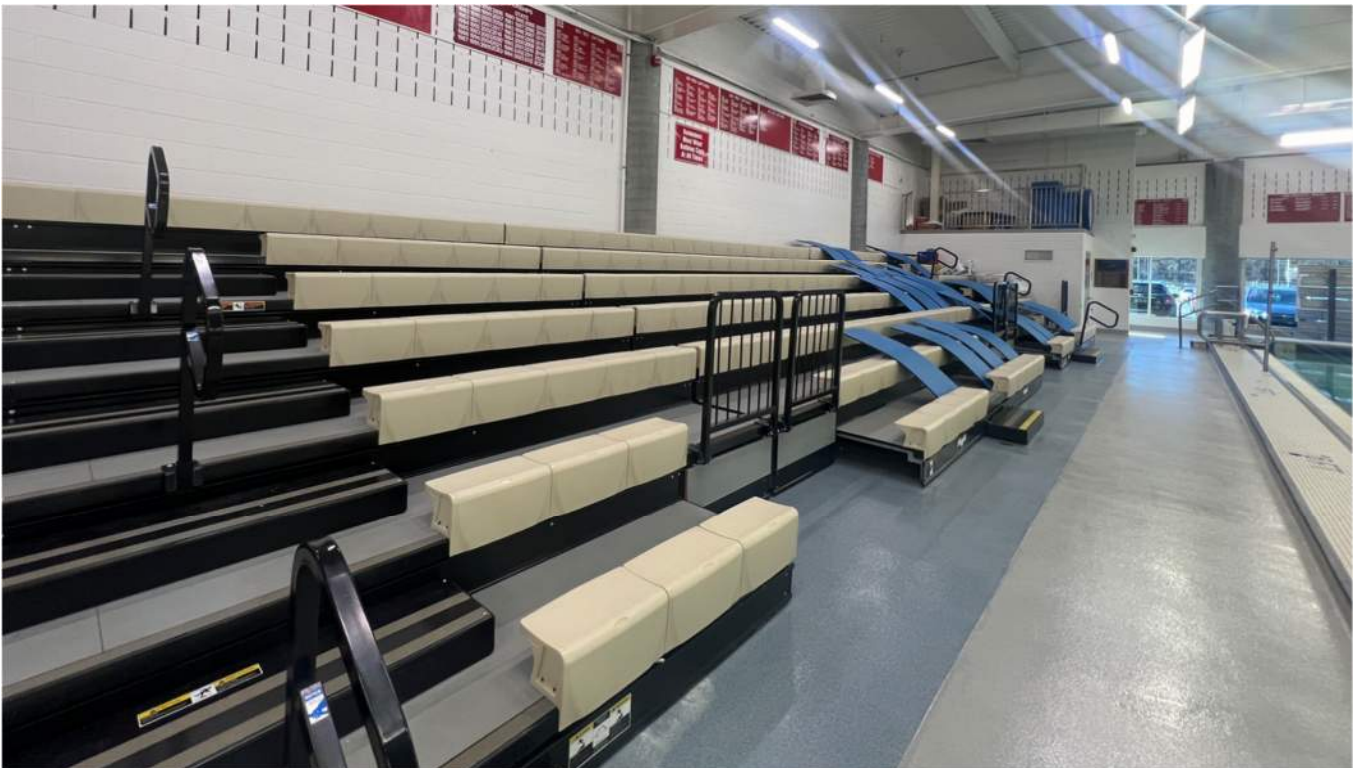
Photo 21, below: At the west side, there is more space, but the bulkhead curb reduces the available deck between the pool and the bleachers. DPH regulations prohibit deck being shared by spectators and swimmers. There is an attempt to distinguish these areas by use of color on the deck, but the Regulations require an “absolute separation”.

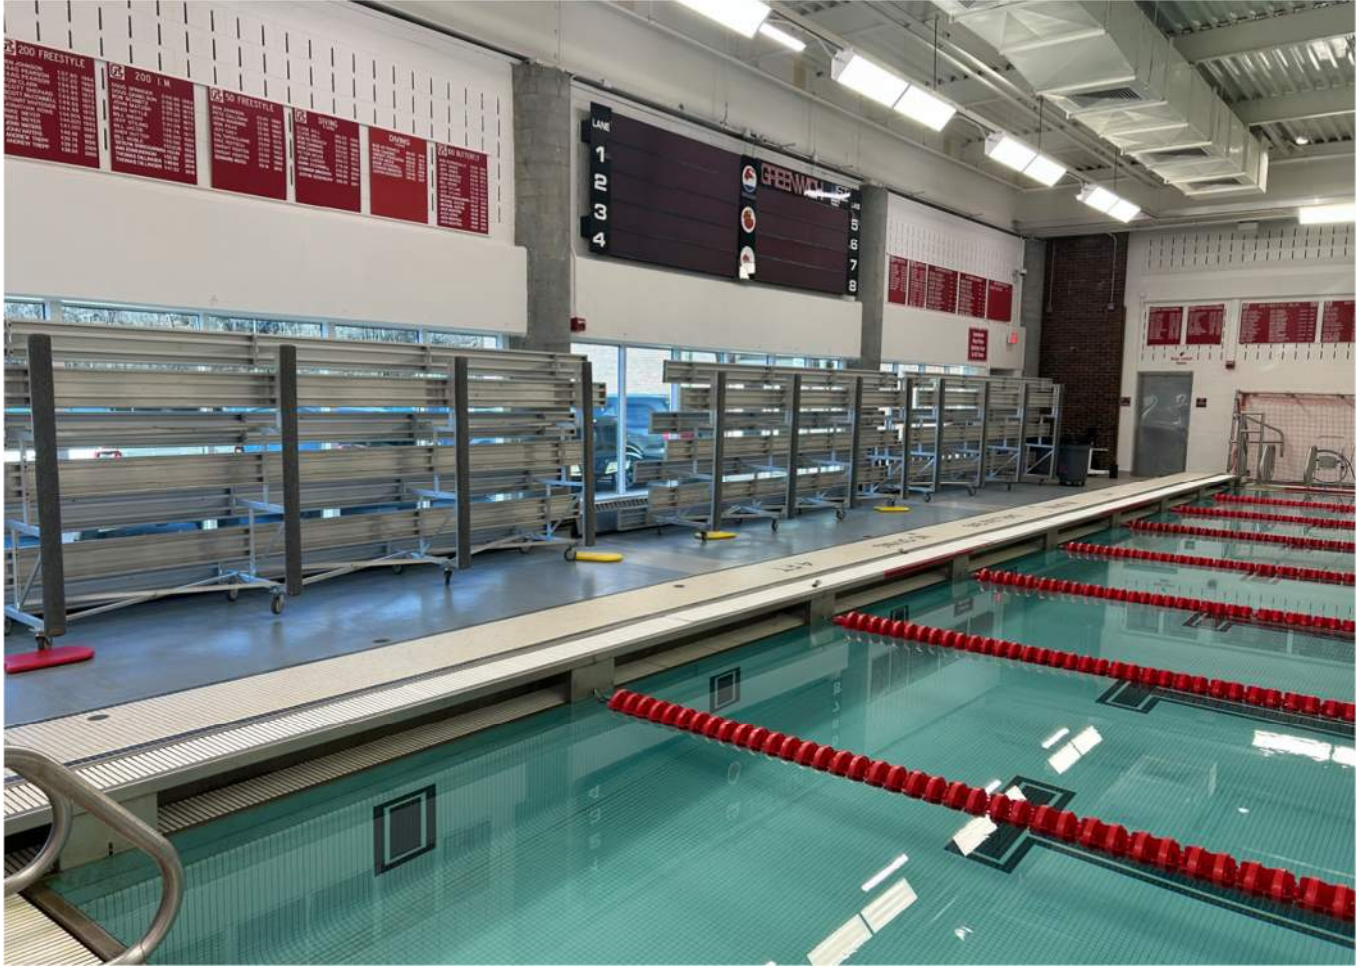
Photo 22, Above: Three sections of portable bleachers have been placed on the pool deck at the shallow end of the pool. When deployed, these virtually eliminate deck space along that end the pool. If used by spectators, the deck is shared by swimmers and spectators, which is prohibited by DPH.

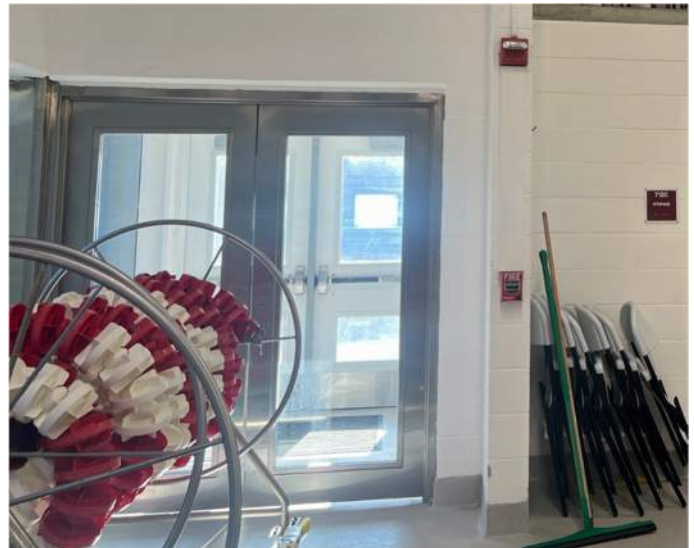
Photo 23, Right: Entrance doors for spectators enter directly onto the pool deck at the north and south end of the west side of the pool. This leads to dirty decks, contamination of pool water, potential slip and falls and interference with meets.

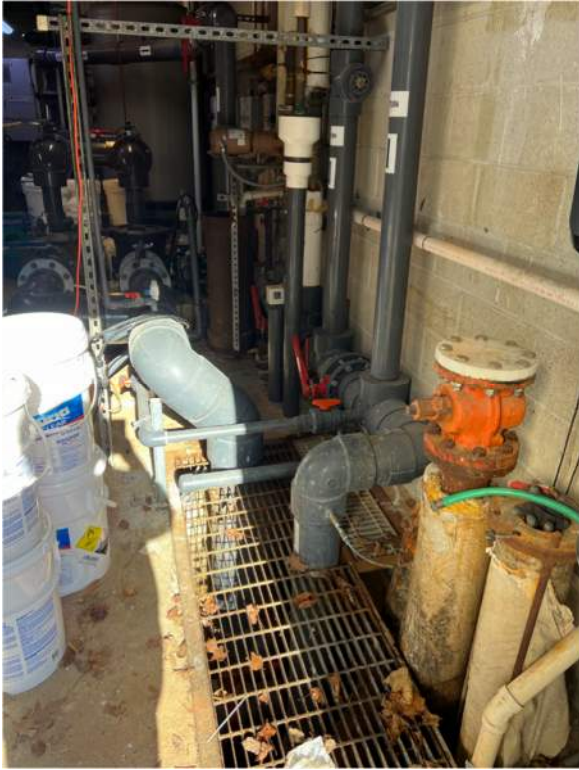
Photo 24: (Left) Pipe pit provides an area way for piping into and out of surge tank, which is located below grade south of the Filter Room Wall.

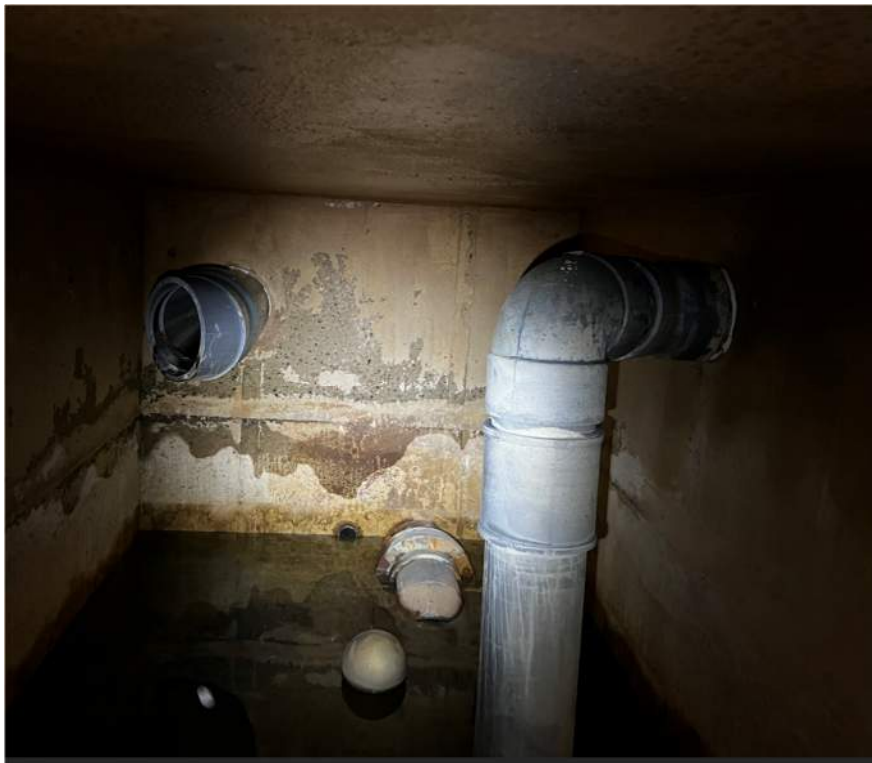
Photo 25: The surge tank is comprised of two, pre-cast concrete tanks with manhole access at grade. The two tanks communicate by means of connection pipes that allow water to equalize in the tanks. Water gravity flows from the gutter drains into the tank. Main drain flow enters the tank through a modulating valve.

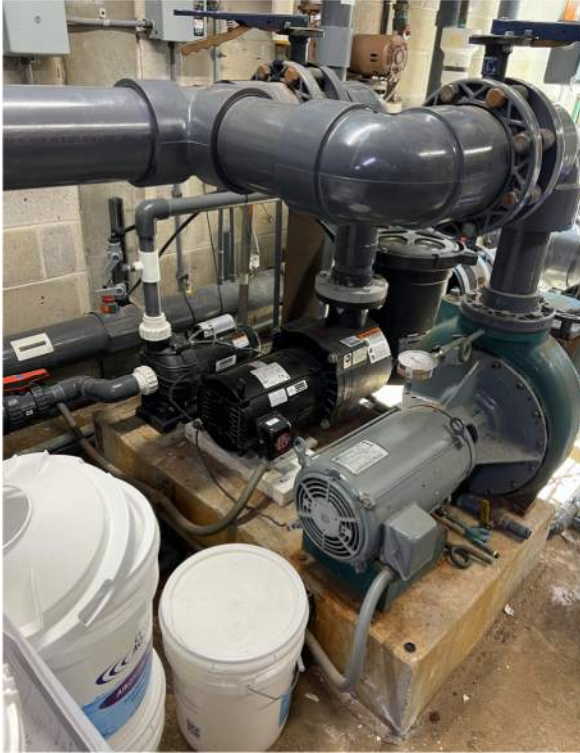
Photo 26: Dual recirculation pumps draw water from the surge tanks and send it to the filters. Pumps run in tandem to deliver 635 GPM through the system.

The small pump to the left is the booster pump for the chemical delivery system.

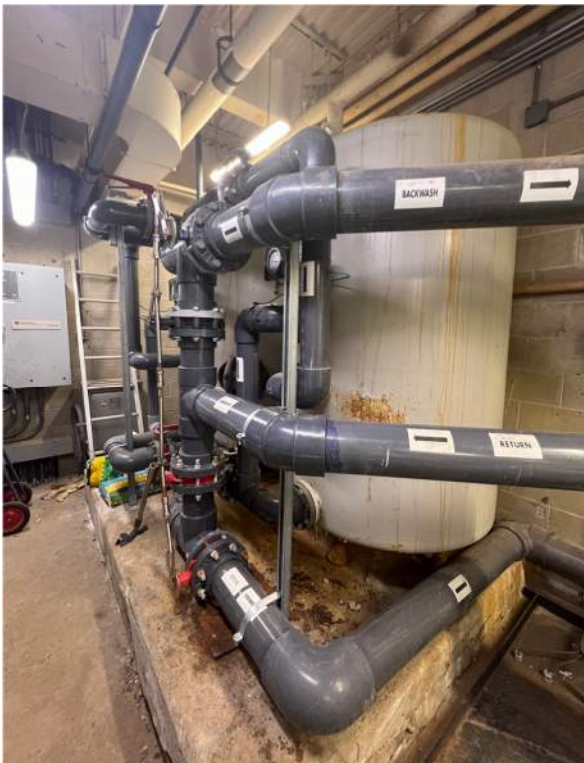
Photo 27: Pool water is filtered through two, dual-cell, high rate sand filters. Each cell has 12.57 sf of sand bed for a total of 50.28 sf. At a flow rate of 635 GPM, the filter operates at 12.63 GMP/sf, which is an acceptable filtration rate.

These filters were installed as part of the 1997 renovation. They are at the end of their useful life and need to be replaced.

Each cell is backwashed individually at a flow rate of 189 GPM. A typical 5 minute cycle will discharge 945 gallons per cell. When all four cells are cleaned, this is 3,780 gallons of chlorinated greywater to the brook at each complete backwash cycle. When filters are replaced, backwash water should be directed to sanitary sewer.

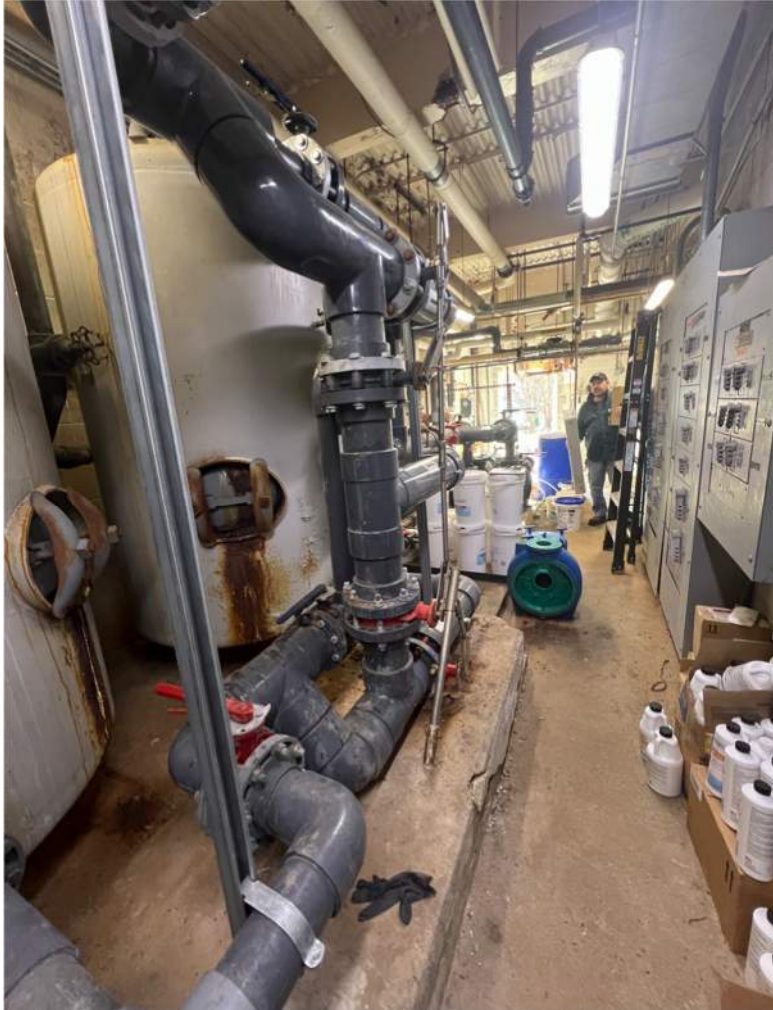
Photo 28: The proximity of the filters to the electrical panels is problematic, as is the storage of chemicals in close proximity to the electrical equipment.

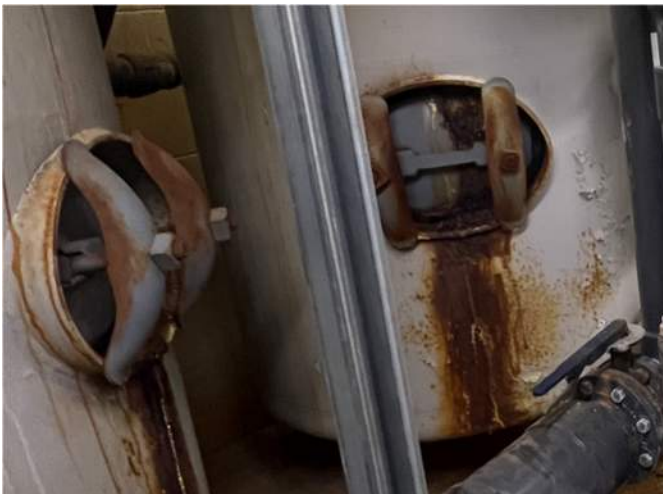
Photo 29: Significant rust at the filter manways, indicates leaks and likely weakening of the pressure vessel's steel shell. It has been reported that filter media is discharged to the pool during backwash, indicating failed laterals within the filters.

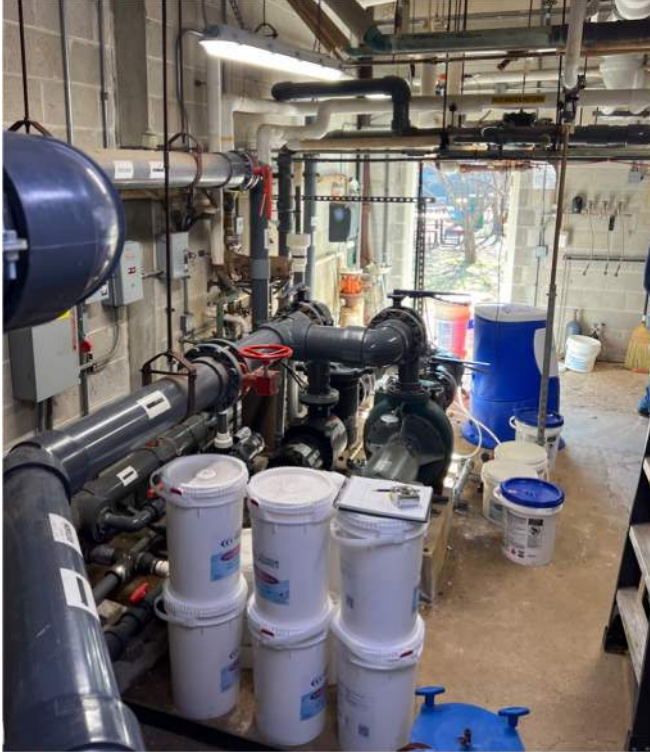
Photo 30: Chemical control systems include a calcium hypochlorite erosion feeder for disinfectant and a dry acid erosion feeder for pH control. Chemicals are delivered in dry briquette form in 5-gallon buckets. A dedicated storage areas should be planned for chemical stock.

This system is appropriate for the pool and can continue use in a planned renovation.

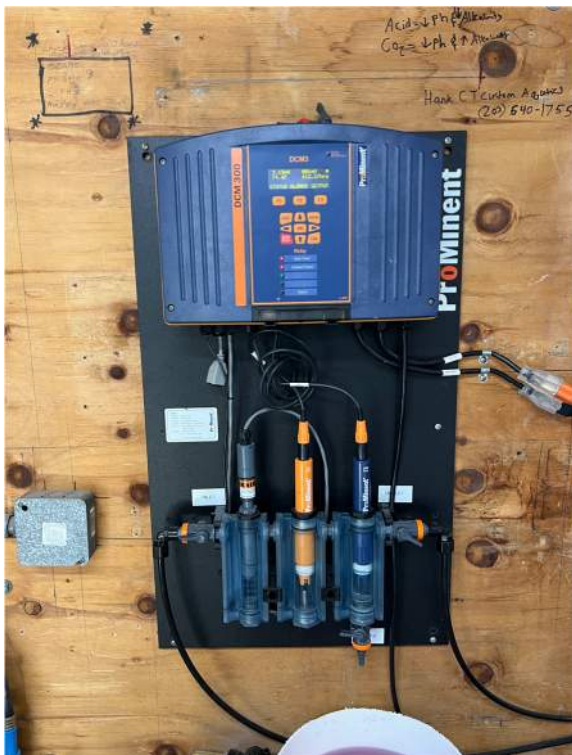
Photo 31: Chemicals are automatically monitored and fed through a chemical controller. The Prominent Unit installed at the pool is relatively new and is appropriate for continued use.

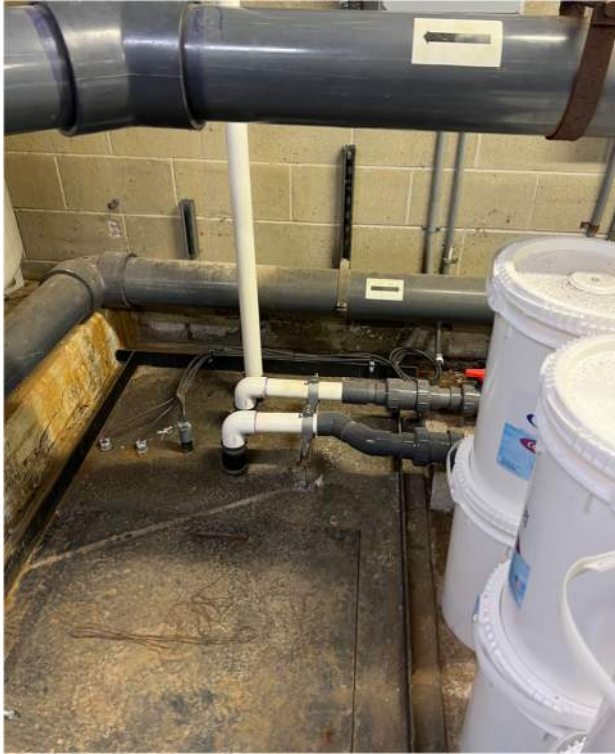
Photo 32: An sewage ejector pit is located in the Filter Room. When renovations are planned, the capacity and location of discharge of this system should be confirmed to determine if it can be used for filter back-wash water, in addition to other sanitary waste it serves.

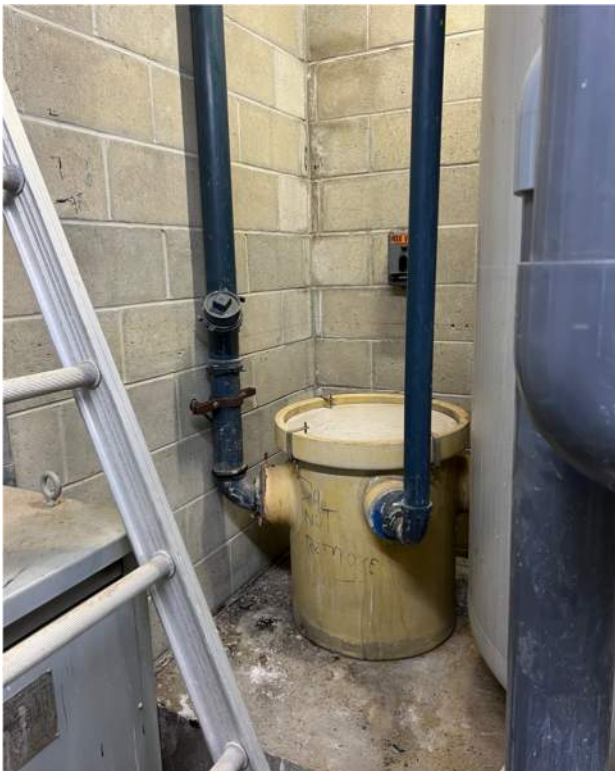
Photo 33: There is an acid neutralization system located behind the filters, that serves laboratories in another area of the building. Its condition and function was not reviewed as part of this report, but in a planned renovation it needs to be accounted for in the space planning.
