# 5.3 Kings Highway Elementary School

### Master Plan Facility Study for Westport Public Schools

# KINGS HIGHWAY ELEMENTARY SCHOOL

## 5.3.1 Architectural Conditions Analysis

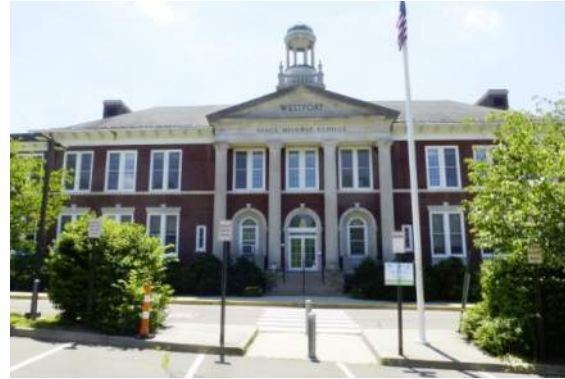
The brick veneer and mortar joints are in good condition given their age. Mortar at rough stone veneer is cracked in multiple locations (predominantly at window heads; see structural facility survey) and requires repointing. Multiple joints in the stone belt courses are missing mortar. Minimal brick repointing required.

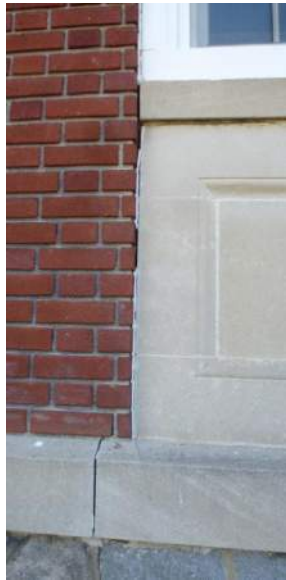
There are numerous areas where mortar or caulking is deteriorated at vertical joints between stone elements and brick. Joints should be raked clean and a soft sealant joint provided. Steel lintels above many window and door openings are showing signs of rust and should be scraped, primed, and repainted.

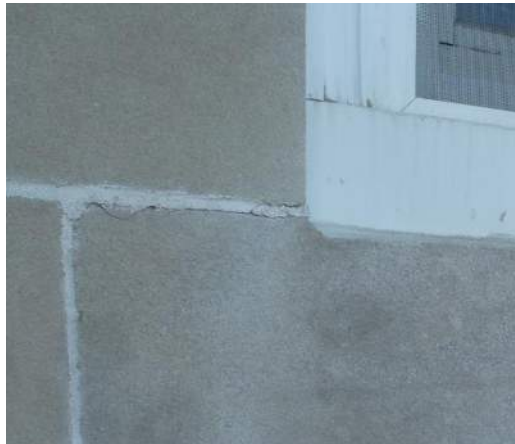
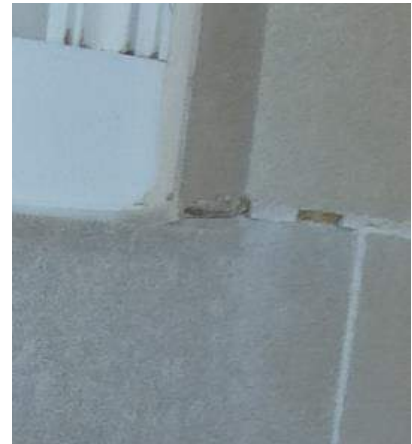
Some areas of smooth stone veneer need mortar repointing, primarily adjacent to window sills.

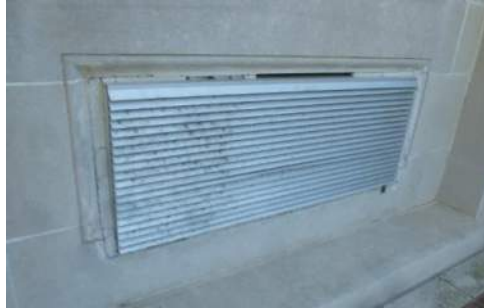
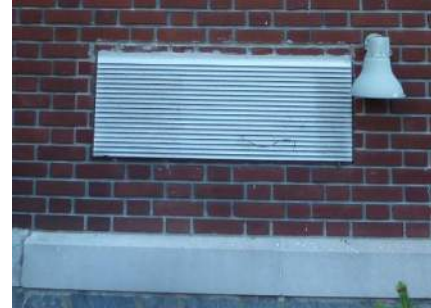
Exterior vents and louvers remain in place from removed old HVAC units at the Main Office (interior infill not directly observed). If vents are to remain, need to remove hard, crumbling mortar joints and provide soft joints/sealant between vent and masonry. Alternatively, infill with recessed masonry or stone panels.

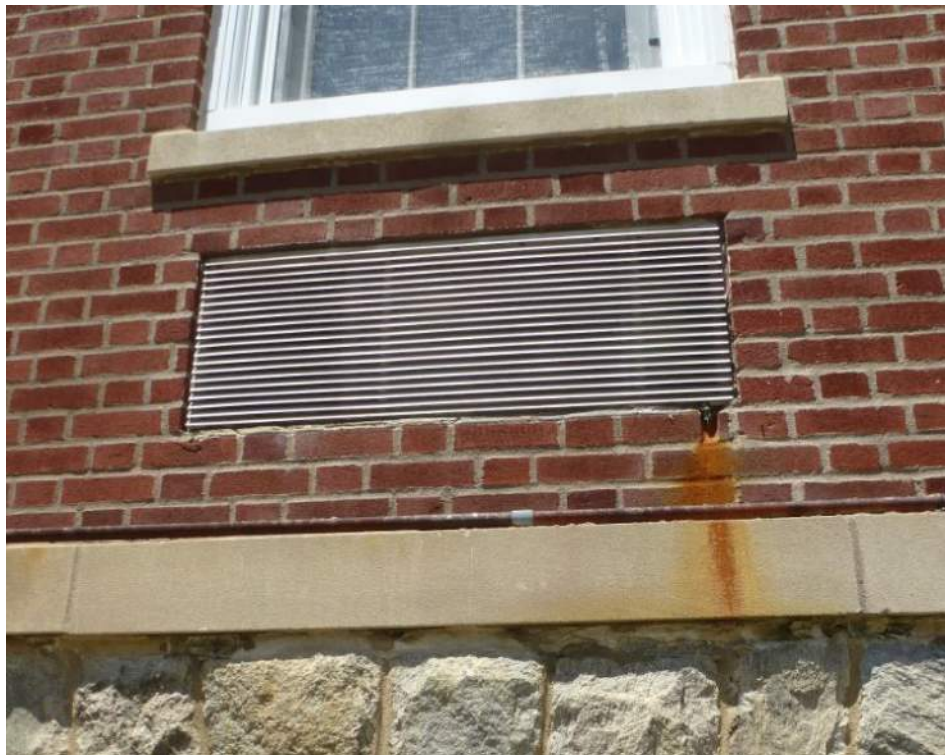
Evidence of rust staining on brick from vents and louvers that remain (primarily on south elevation). Paint or seal rusting components; clean brick.

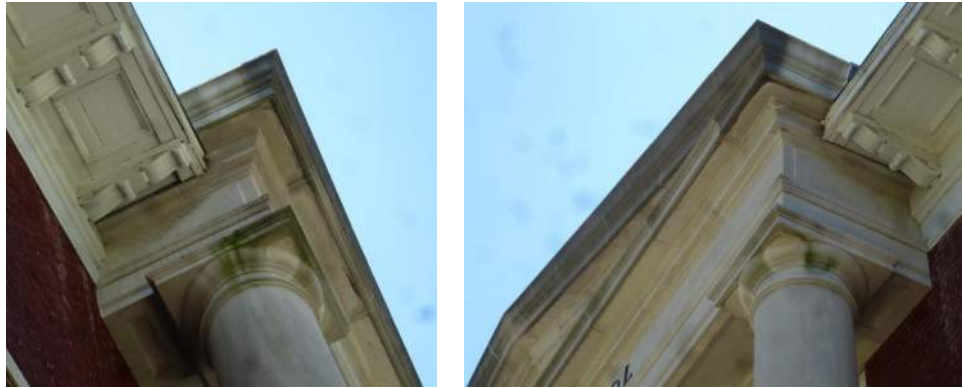
The main entrance stone columns and pediment are in good condition given their age but have staining, some of which could be from copper flashing. Cleaning recommended. Metal bird deterrent spikes were noted on top of exposed column capital ledges in good condition.

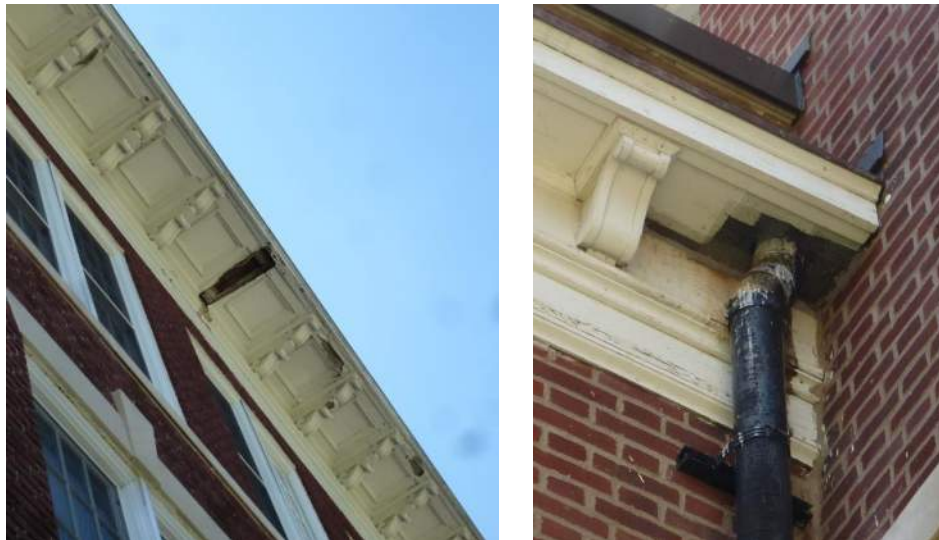
Soffits, brackets, and cornice trim appear to be painted wood in fair condition, but many areas have peeling paint. There are a few missing brackets, and at least one soffit requiring repair at downspout. Missing brackets should be fabricated to match existing, soffits repaired, then all surfaces scraped, primed, and painted.

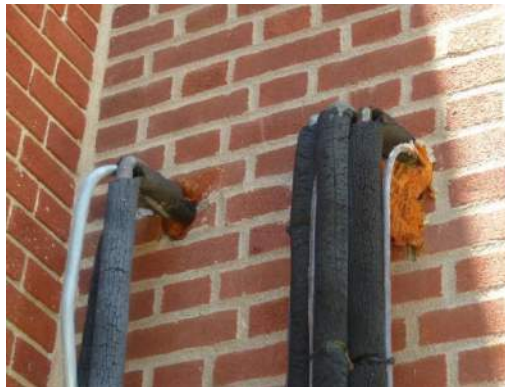
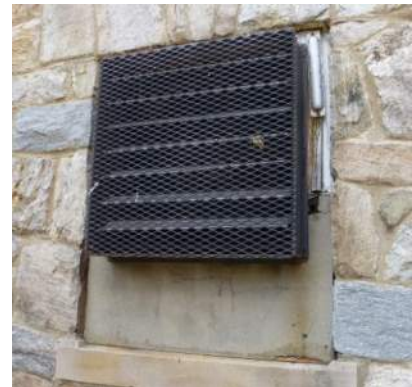
Some existing pipe penetrations require proper sealing.

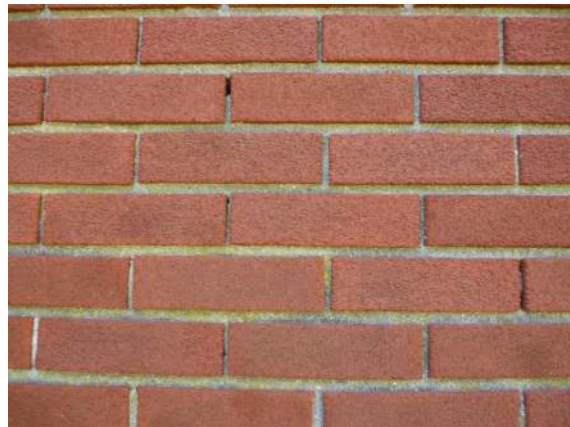
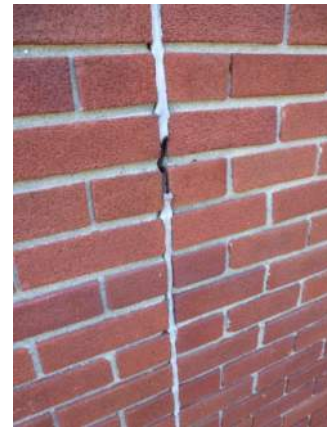
The brick veneer and mortar joints are in good condition with some mortar repointing required (notably on the east side). The Head Custodian conveyed that the brick of the entire south wall above the roof of the 1-story portion of the Addition was recently repointed. The sealant in most brick movement joints is aged and stiff (and missing in some areas). Rake joints completely and provide appropriate backer rod and sealant to complement mortar color.

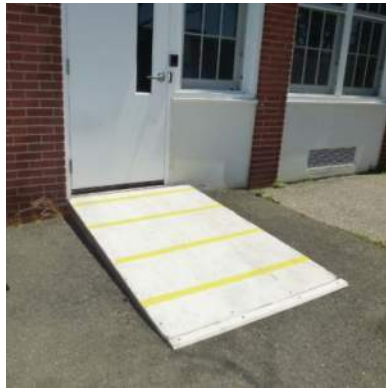
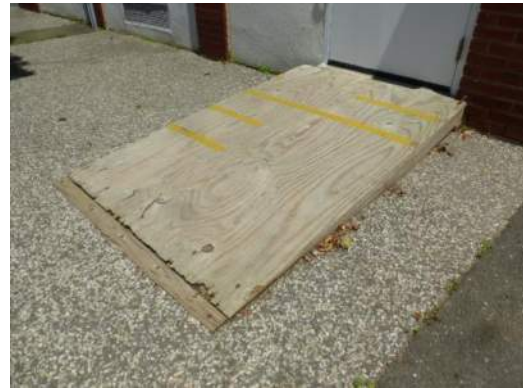
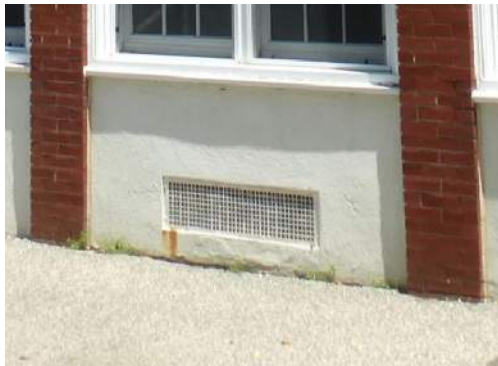
Two temporary plywood ramps were fabricated by custodial staff to provide access to (or egress from) Music Room 6 and O.T./P.T. Room 5 when the school had an injured, wheelchair-bound student. These ramps are not securely fastened (floating on the asphalt) and are cannot be considered accessible (do not provide accessible maneuvering areas or clearances, do not have handrails and edge protection, no landing at door, etc.). If permanent accessibility is required at these doors, stable Code-compliant ramps should be built. All First Floor doors exiting the West Addition have a step except for the flush north main entrance doors.

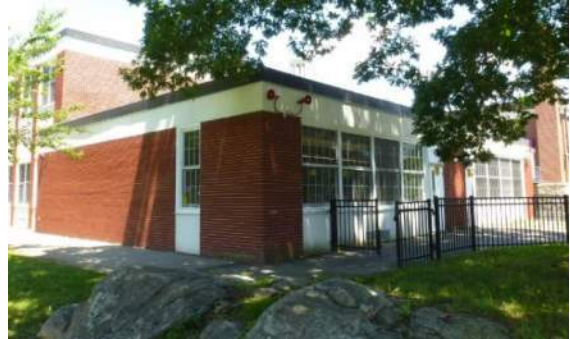
Branches of nearby large tree at southwest corner of building should be trimmed back to prevent damage to building and minimize leaves collecting on the roof.

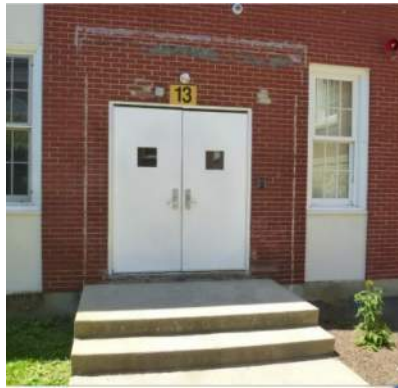
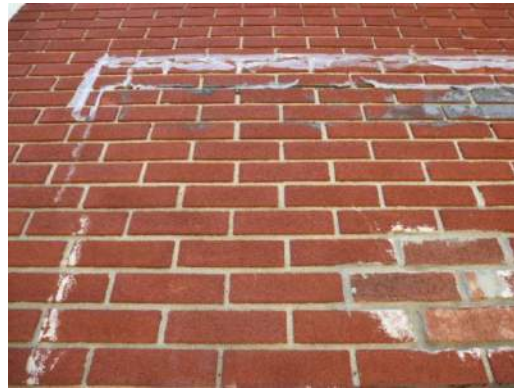
A portable classroom building was removed from the courtyard outside Door 13 but sealant, mastic, paint, etc. from the connecting corridor were never removed from the remaining building. The masonry should be cleaned and restored.

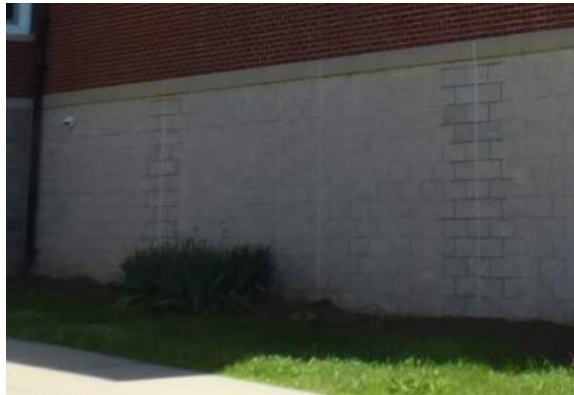
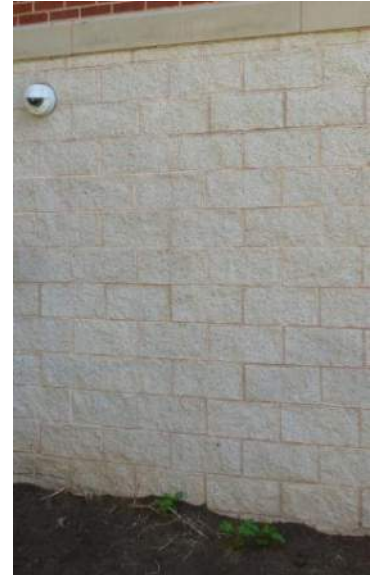
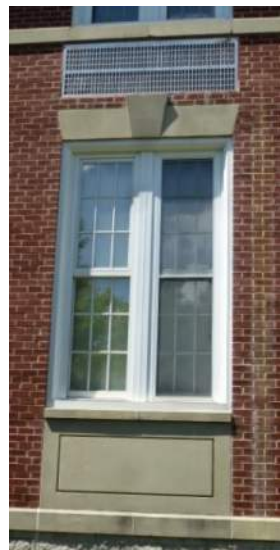
Mortar repointing appears to have occurred on either side of the CMU movement joints on the west wall. Mortar color does not match remainder of CMU area. Along this same wall, a crack runs through the vertical mortar joints and faces of the split-face CMU veneer but no evidence of cracking on the interior (in Girls Toilet Room).

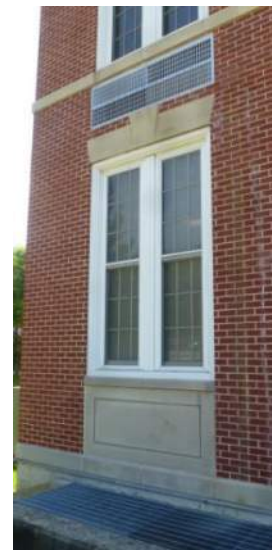
Unit ventilator grilles are no longer active (blanked off on the interior). Long vertical areas of yellow staining were observed on brick and CMU in multiple locations around the Addition that may be related to ventilator grilles from the Second Floor. Investigate cause of staining, then clean masonry once corrected.

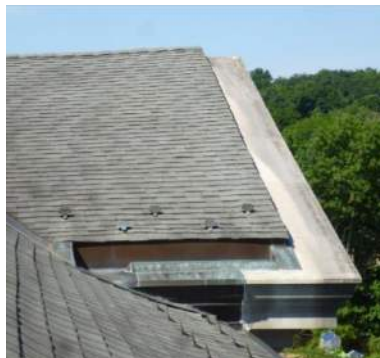
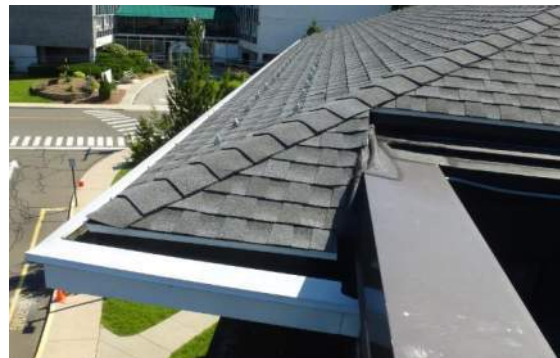
Roof drainage consists of box gutters (copper at Original Building; aluminum and rubber membrane at East Addition) attached to various downspouts (painted round metal pipe at Original Building; galvanized square at East Addition) which empty to grade, onto other roof surfaces, or piped underground. Gutters and downspouts appear to be in good condition except that paint on downspouts is scratched in some areas.

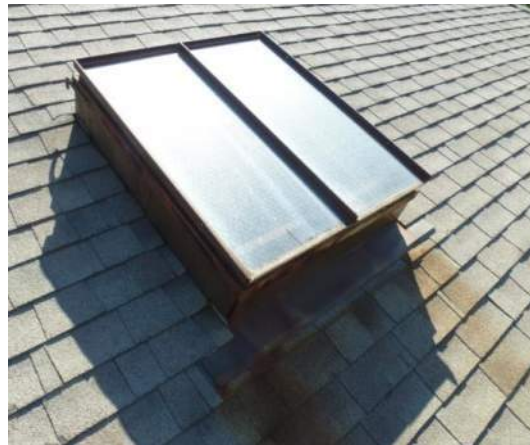
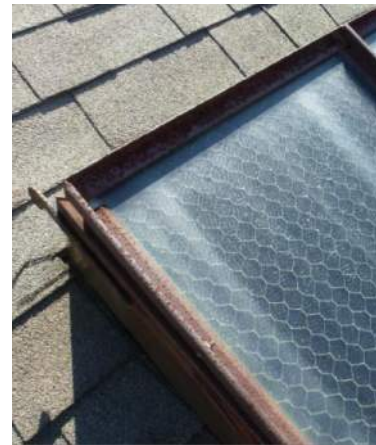
The steep roof structure in the Original Building is 3x8 wood rafters that create an open attic space for roof access, mechanical equipment, etc. There are four (4) old metal skylights on the south, east, and west-facing roofs. The skylights are significantly rusted, causing staining on the roof shingles. The glass appears to have been replaced at some point with translucent wired glazing which is in reasonable condition. Original manual hardware is most likely no longer operational.

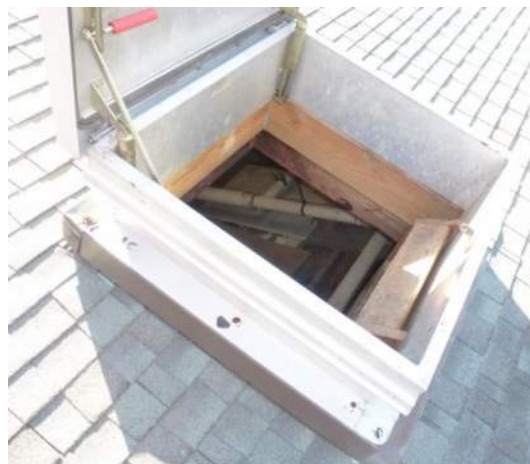
Roof access is generally provided by roof hatches that are in good condition except for some rusting and scraped flashing around exposed fasteners. Traversing from the hatch to the lower flat roof is wearing the asphalt shingles and damaging unsupported shingles at the roof edge. An access ladder and platform are recommended to safely traverse the sloped roof and roof height difference and to prevent shingle damage.

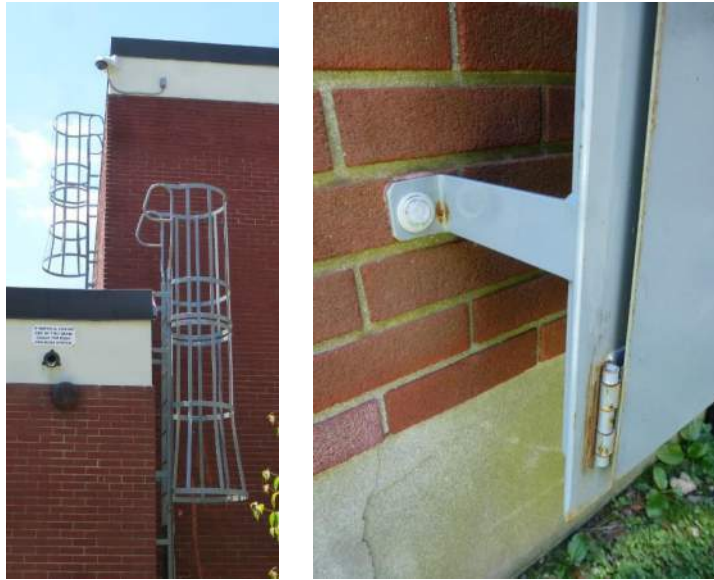
Relatively new caged metal roof ladders were installed on the West Addition to provide an alternative from the interior ladder in the Kindergarten classrooms below. The lower caged ladder already has signs of rusting.

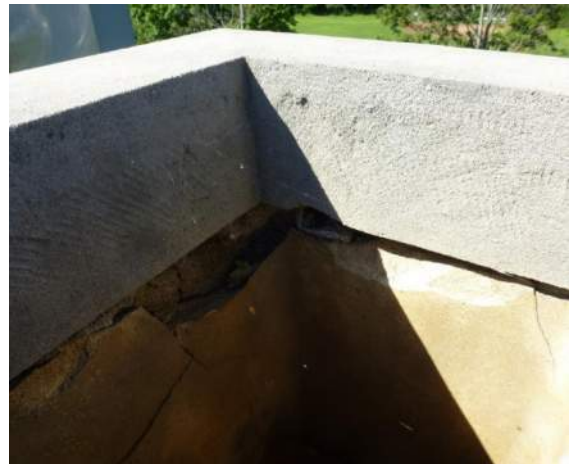
At least one chimney on the west side of the Original Building has a deteriorating clay flue liner under the stone coping. Condensation resulting from combustion can deteriorate the flue liner further. Flue should be cleaned and inspected for additional deterioration. WPS Facilities reported this chimney may be the seasonal nesting place for chimney swallows. Verify in field and coordinate accordingly.

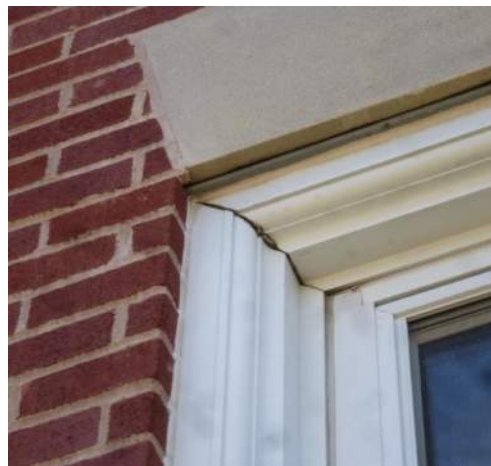
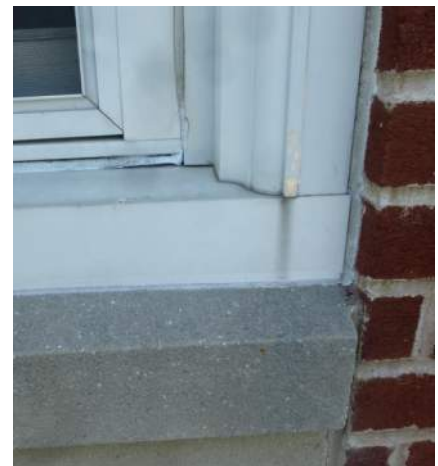
Exterior window trim typically consists of white aluminum; flat stock at sills, prefabricated scotia profile at jambs and head. Although trim appears to be in moderate condition, some joints have opened up and require sealing. The sealant in general is in fair condition, but has signs of drying/cracking, mildew on north and west exposures, and missing in spots. Resealing all windows and exterior trim is recommended.

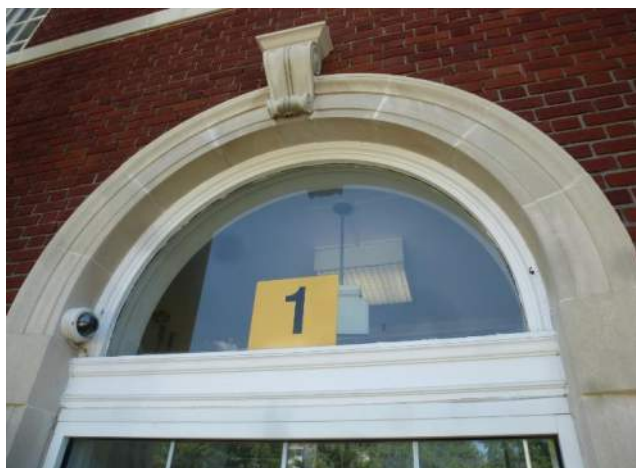
At the main entrance doors of the Original Building, the half-round transom is still single-pane glass even though the aluminum storefront transom / door system below was replaced with insulated units. Replacing this transom would provide better energy efficiency.
