5.2 Greens Farms Elementary School

5.0 Existing Facility Survey

Master Plan Facility Study for Westport Public Schools

5.2.1 Architectural Conditions Analysis

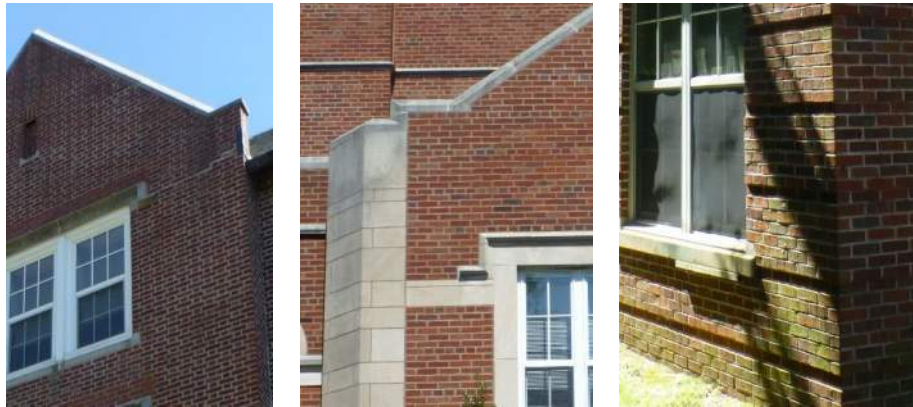
Several locations throughout the façade were noted to be in need of cleaning. Black and green algae were observed on the north gable as well as many of the limestone sills, headers, and corners throughout. It was also observed along the masonry walls of the southeast corner of the school.

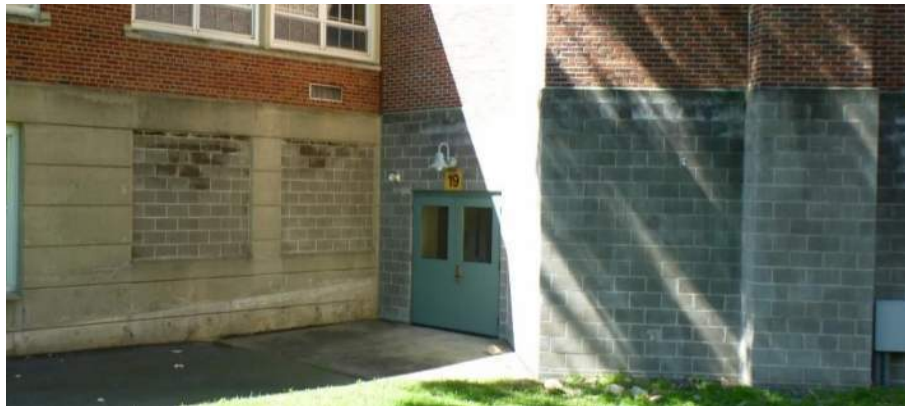
Black staining was noted on the CMU walls along the southwestern façade.

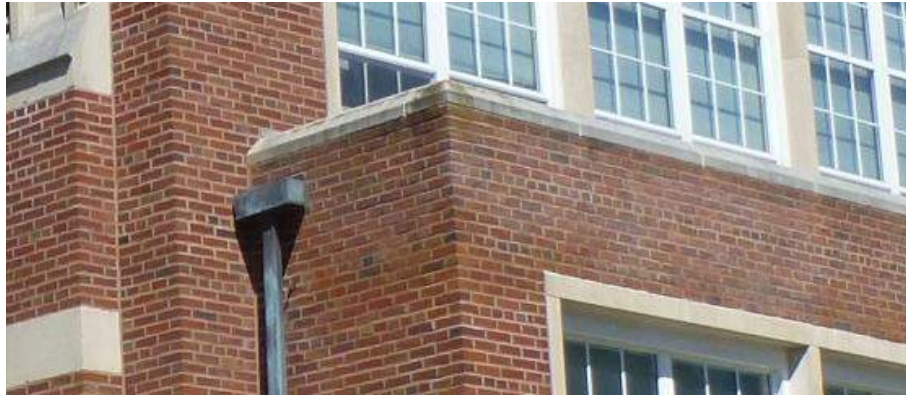
Lichen at the limestone parapet roof coping can be found along the southwestern portion of the school.

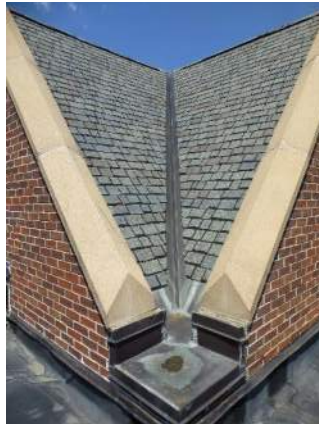
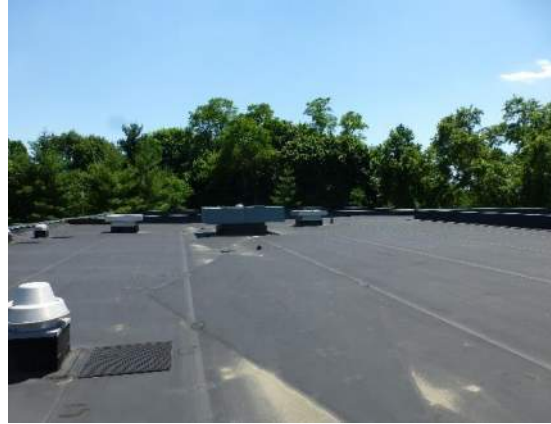
The school roof consists of two distinct types: asphalt shingles at the gabled roofs; and EPDM at the flat roofs. Both roof systems appear to be in fairly good condition.

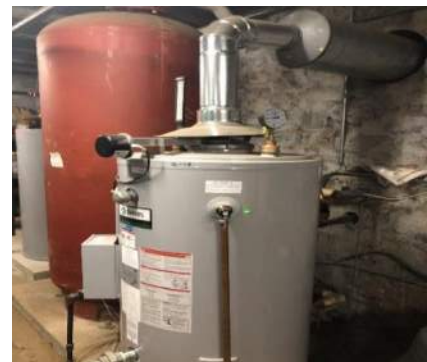
1. Domestic hot water is generated by an AO Smith BT-120 gas fired water heater which was installed in 2017 and is in excellent condition. The system also includes a 119 Gallon AO Smith Storage Tank to accommodate a higher domestic hot water usage. One Lawler 802 domestic hot water tempering valve was observed in fair condition.
2. Domestic hot water was previously generated utilizing a water to water heat exchanger which was interconnected to the boiler system. This heat exchanger and associated accessories are no longer in use and are abandoned in place.

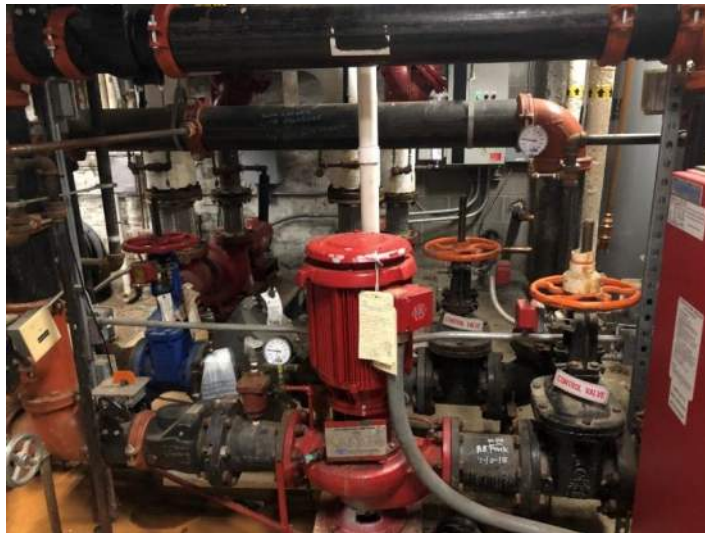
1. The building is served by a 6” fire protection service and is sprinklered throughout.
2. The system utilizes a Sterling Peerless Fire Pump with a Webtrol Econo-flo jockey pump. This arrangement was observed to be in fair to good condition.
3. Controllers for the pumps are TornaTech installed in 1999.
4. Five (5) zone control valves were observed in good condition.

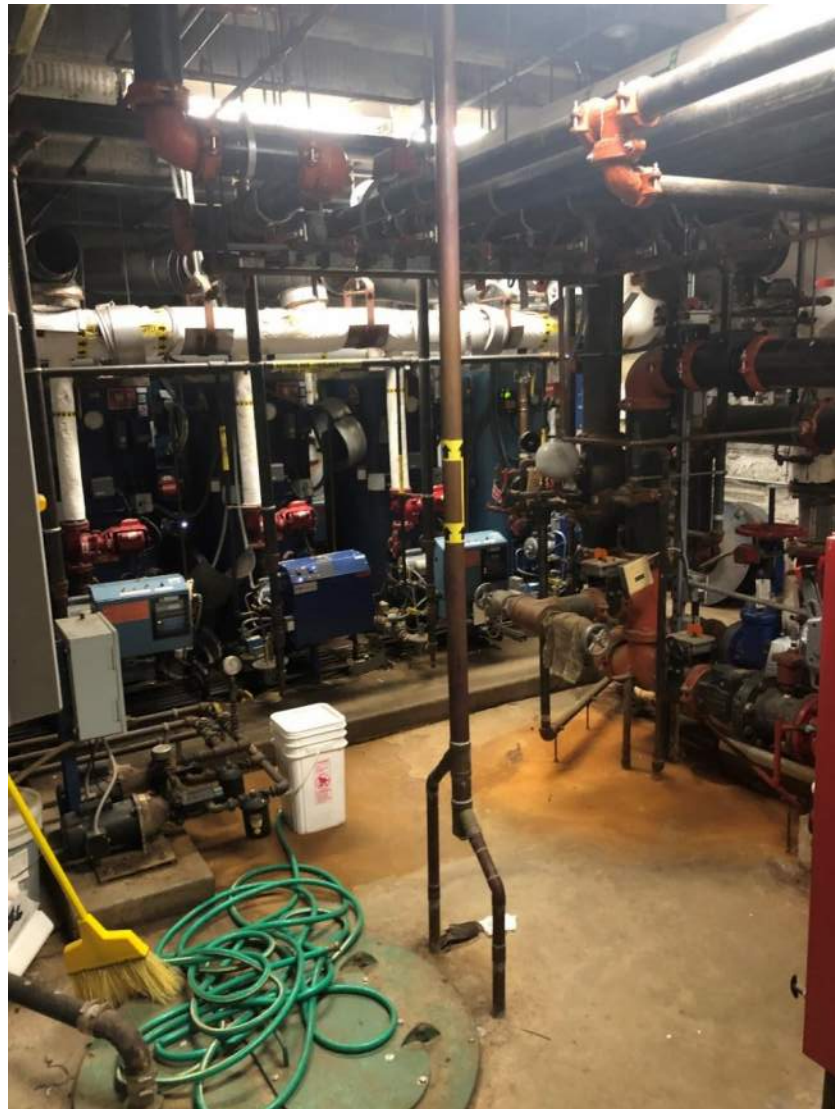
- a. The boiler plant is located in Mechanical 3B and is comprised of eight (8) dual fuel, hot water boilers. Boilers are all Triad Boilers model G0PS 900 SH. At the time of field observation, all boilers were under maintenance for cleaning and appeared in fair condition. Upon observation it was noted that Boiler B-4 had been replaced in 2018 and appeared in excellent condition.

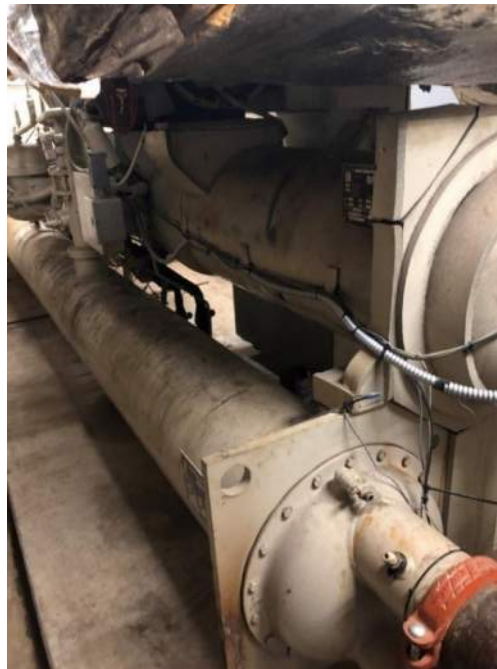
8. Chiller Plant:
 - a. The chiller plant is located in Mechanical 2B. A single (1) McQuay chiller was observed in fair condition.
 - b. The pumps for the primary chilled water (P-2), condenser water (P-3), and secondary chilled water (P-4) are each Bell & Gossett and appeared in fair condition.

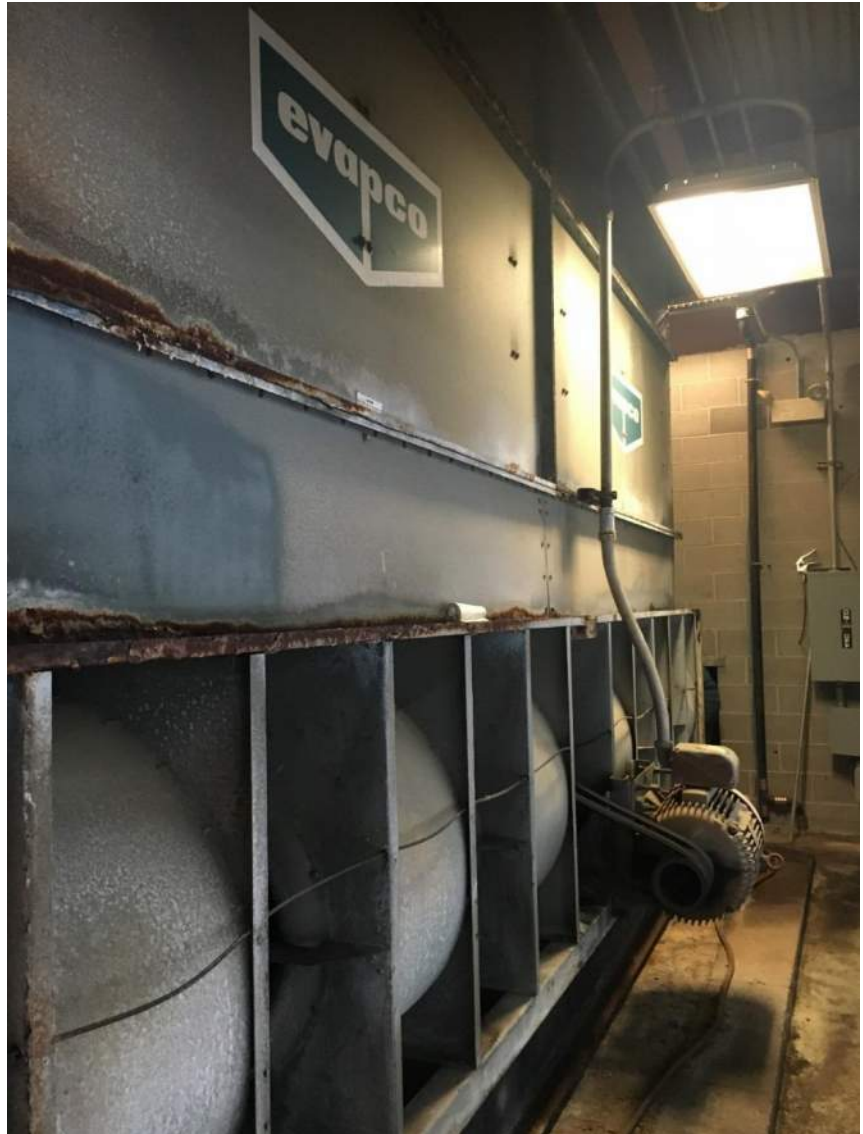
- c. The Evapco cooling tower is located in a mechanical room on the roof and is in poor condition.

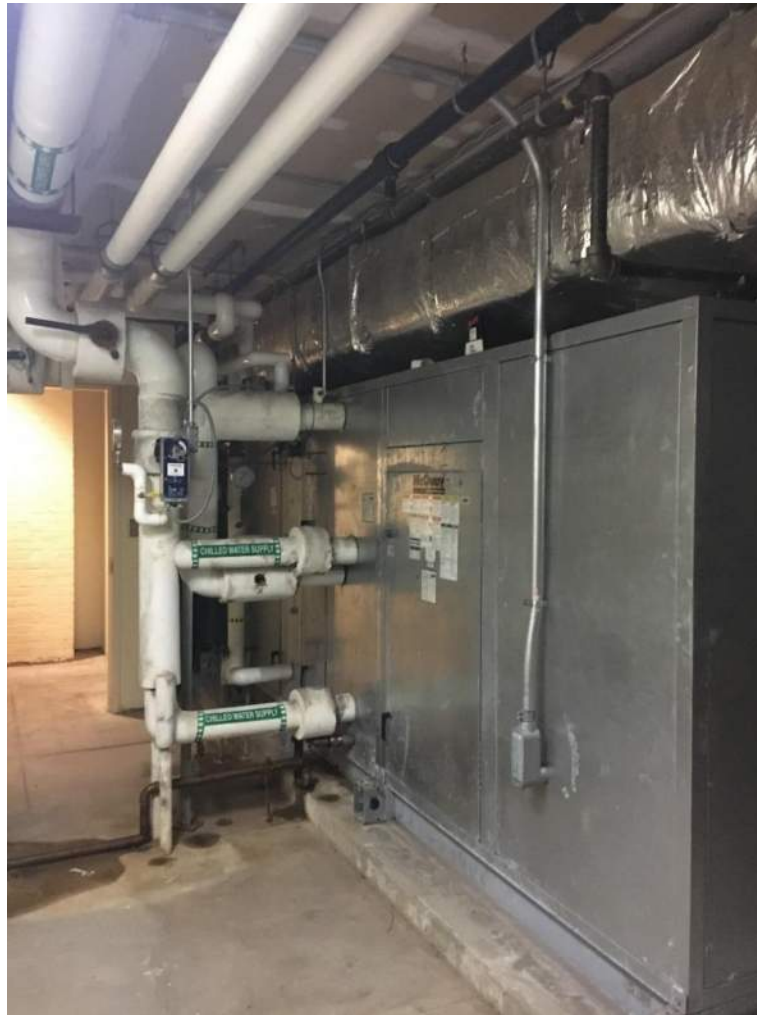
1. There are twelve (12) indoor air handling units conditioning in the building. Most of these units are manufactured by McQuay and are in fair condition at the time of observation.
2. There are numerous fan powered VAV boxes throughout which have older fans that are failing. In addition the vibration isolators do not perform well and the controls need updating.

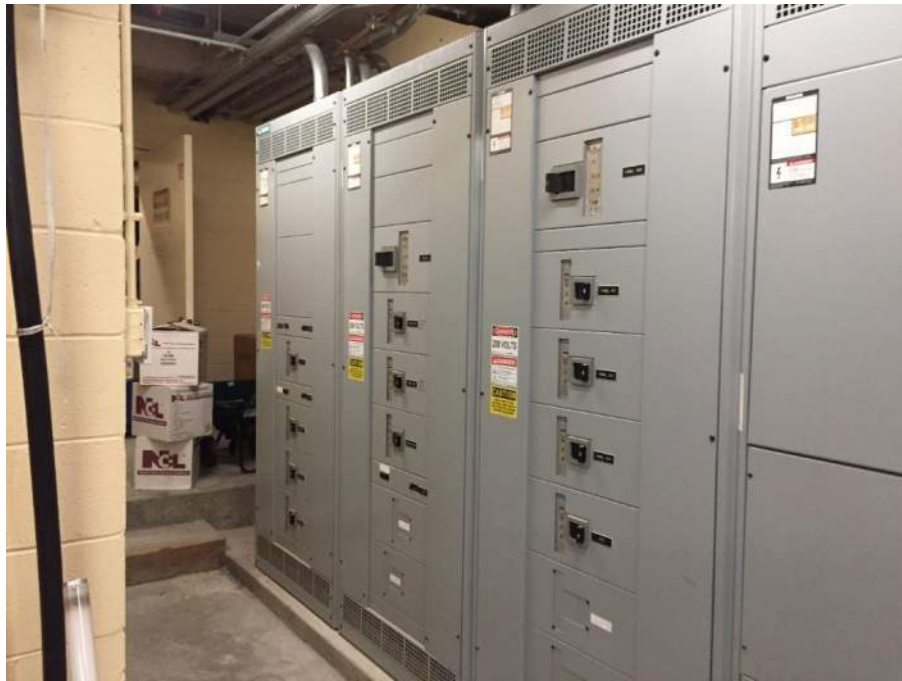
1. The building is served by a Siemens switchgear at the service entrance which is rated at 3000 amperes, 208Y/120 volts, 3-phase, 4 wire. There is a separate Siemens switchgear dedicated to the Fire Pump CT/Disconnect which is rated at 600 amperes, 208Y/120 volts, 3-phase, 4 wire. Each service were observed to be in good condition.
