# **ADDENDUM NO. 2 TO ASBESTOS ABATEMENT SPECIFICATIONS**

**Asbestos Abatement Prior to Renovations  
@  
Thompson K-8 International Academy**

Building(s):  
**Thompson K-8 International Academy**  
16300 Lincoln Drive  
Southfield, Michigan 48076

# NESHAPs ASBESTOS INSPECTION REPORT – REVISION

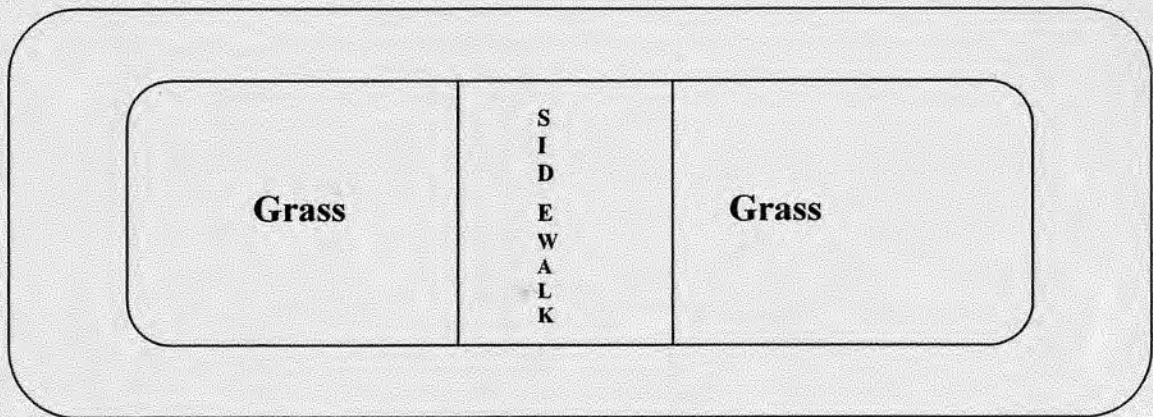
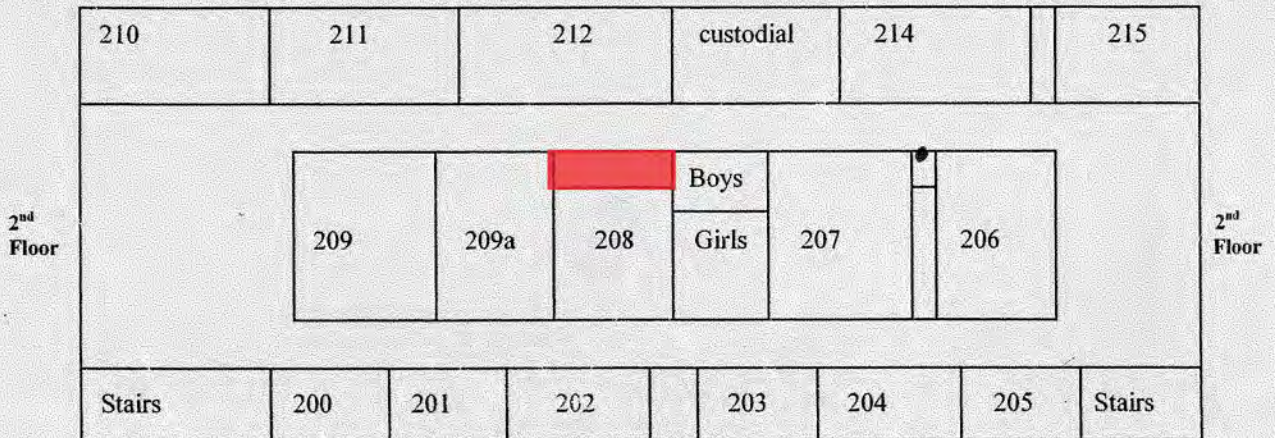
ACM Door Caulk

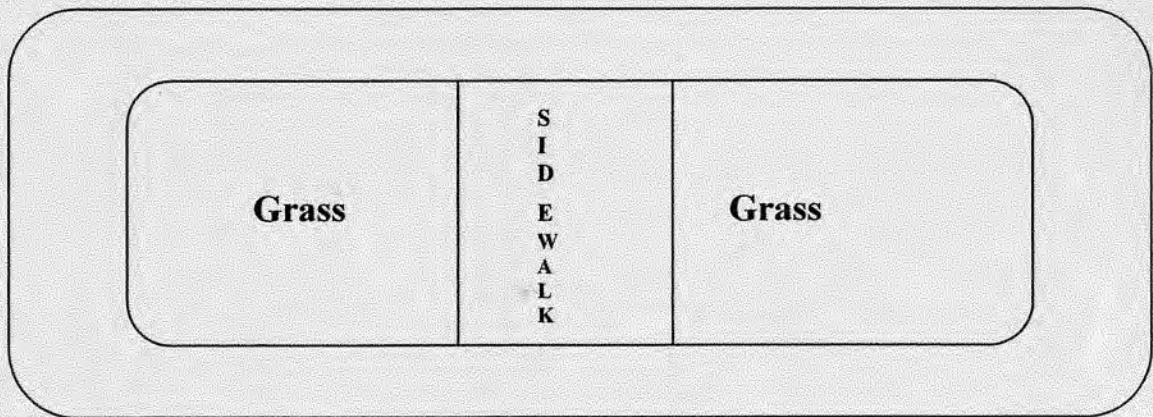
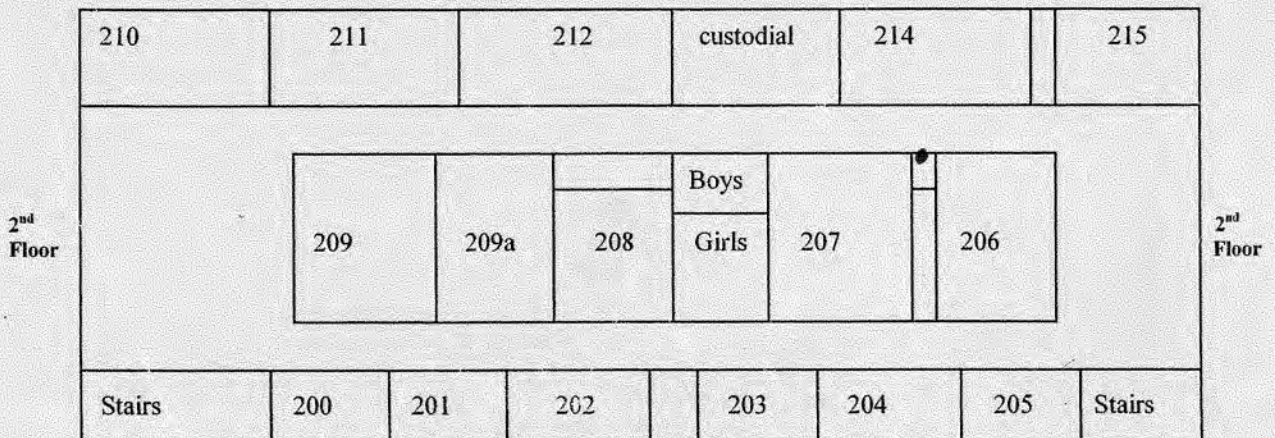
Assumed Fire Door/Frame
